Re: Aboriginal Heritage Due Diligence Report – New Car Park at William Carey Christian School

Artefact Heritage and Environment Pty Ltd (Artefact) have been engaged by Gardner Wetherill & Associates to prepare an Aboriginal Due Diligence Report for the proposed new car park at William Carey Christian School, Bumbera Street Prestons NSW 2170.

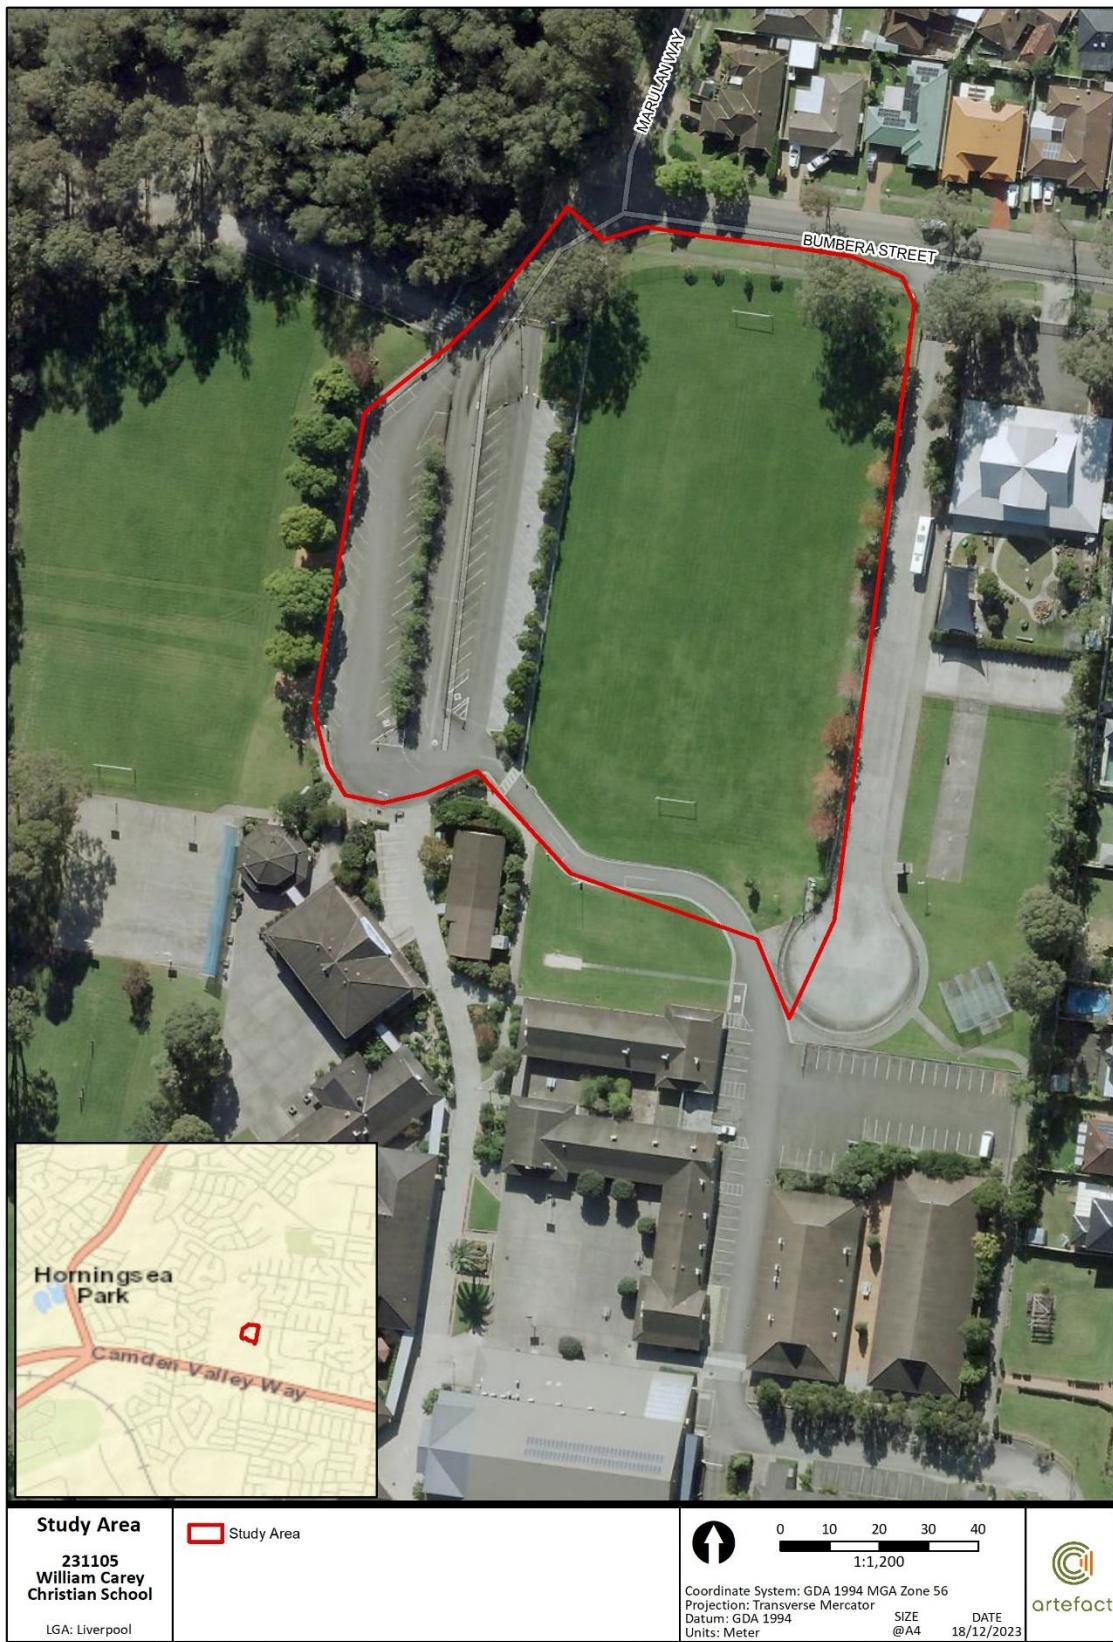
Figure 1: The study area

The study area is shown in Figure 1. It measures approximately 1.3ha. It is located in Prestons NSW, immediately north of the main William Carey Christian School campus. The study area is bounded to the north by Bumbera Street, to the east by an internal school roadway and to the west by parklands that run alongside Cabramatta Creek. The study area is wholly within 200m of Cabramatta Creek.

The study area currently contains a large rectangular sports field and a car park within its western boundary. The surrounds of the study area consist of relatively modern residential, industrial and semi-rural developments. The study area is within the Liverpool Local Government Area (LGA) and is in the lands of the Gandangara Local Aboriginal Land Council (LALC). The study area and its immediate surrounds west of Cabramatta Creek are situated on the shallow residual Blacktown Soil landscape.

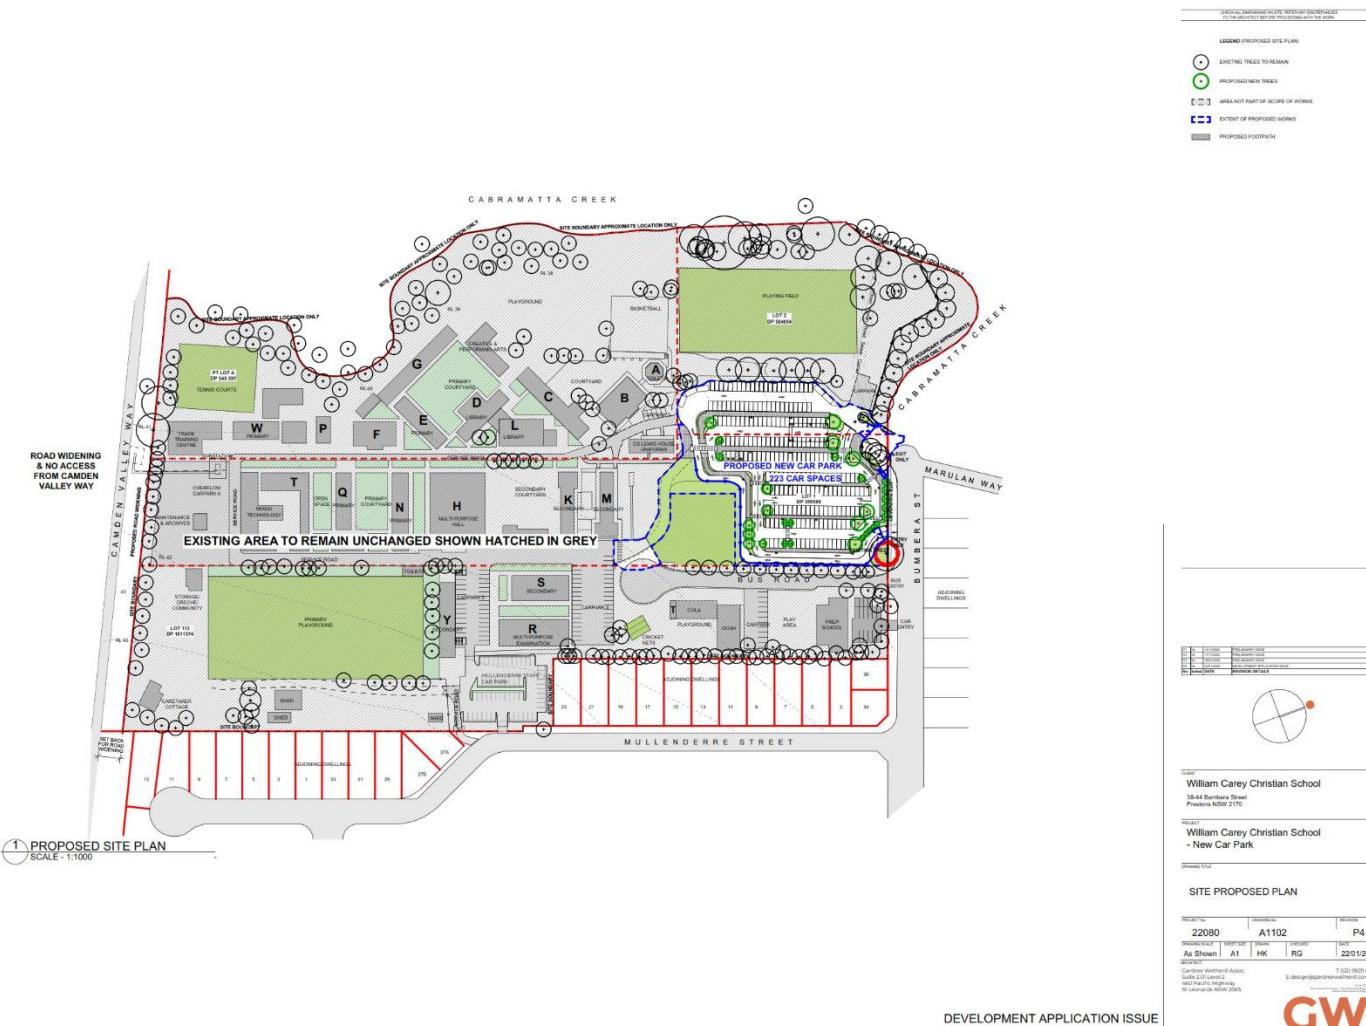
Figure 2: Proposed works part site overview

The proposed works for the new car park are shown in Figure 2 and Figure 3. They comprise the removal of grassed surfaces and some trees, excavation and levelling for construction of concrete and tarmac hardstand, construction of these surfaces, and the installation of new paving and turf to connect new with existing surfaces.

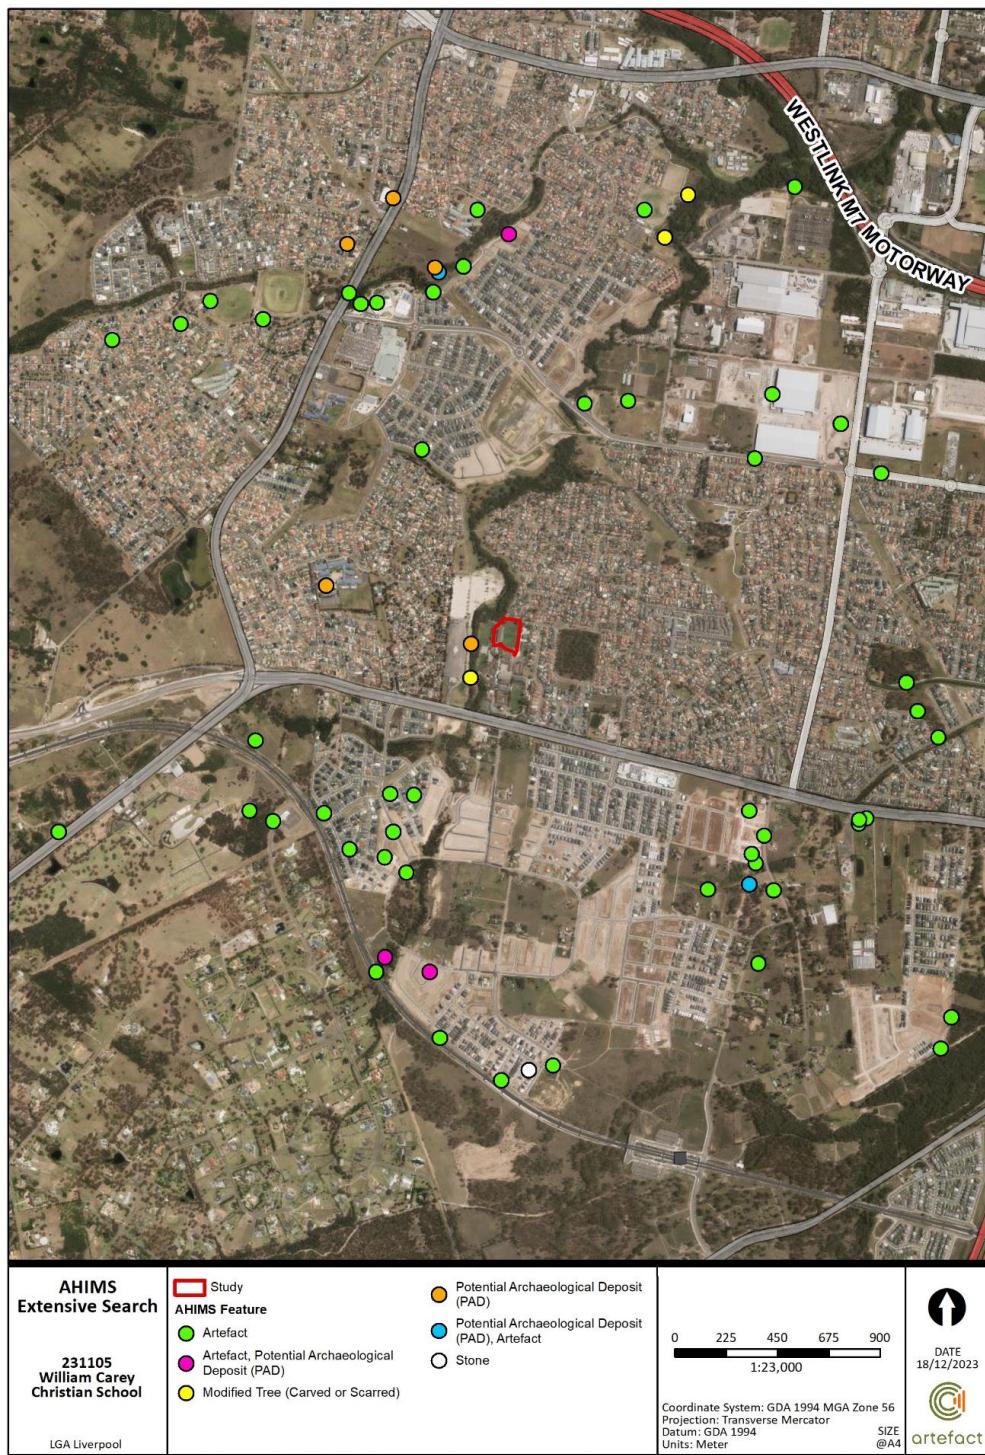
Figure 4: AHIMS extensive search results

A search of the Aboriginal Heritage Information Management System (Client ID 849506) was completed on 15/12/2023 for a search area measuring approximately 4km x 4km square surrounding the centroid of the study area (Figure 4). The parameters of this search were:

The search determined that there are 64 registered Aboriginal sites within the search area. There were no registered Aboriginal sites within the study area. The AHIMS database records sites using a list of twenty standard site features, of which five were found within the extensive search (OEH, 2012) summarised in Table 2. The distribution of recorded sites within 250m of the study area is shown in (Figure 5). The closest AHIMS sites identified in the search are PADs AHIMS ID 45-5-3285 and AHIMS ID 45-5-3307, which appear to be recorded for the same location, both across Cabramatta Creek and approximately 90 m from the study area. PAD AHIMS ID 45-5-3285 is listed as valid on AHIMS, but has been subject to three AHIPs and may no longer be present. AHIMS site ID 45-5-0777 is 165m south west of the study area and is a deregistered item once recorded as a Modified Tree (Carved or Scarred).

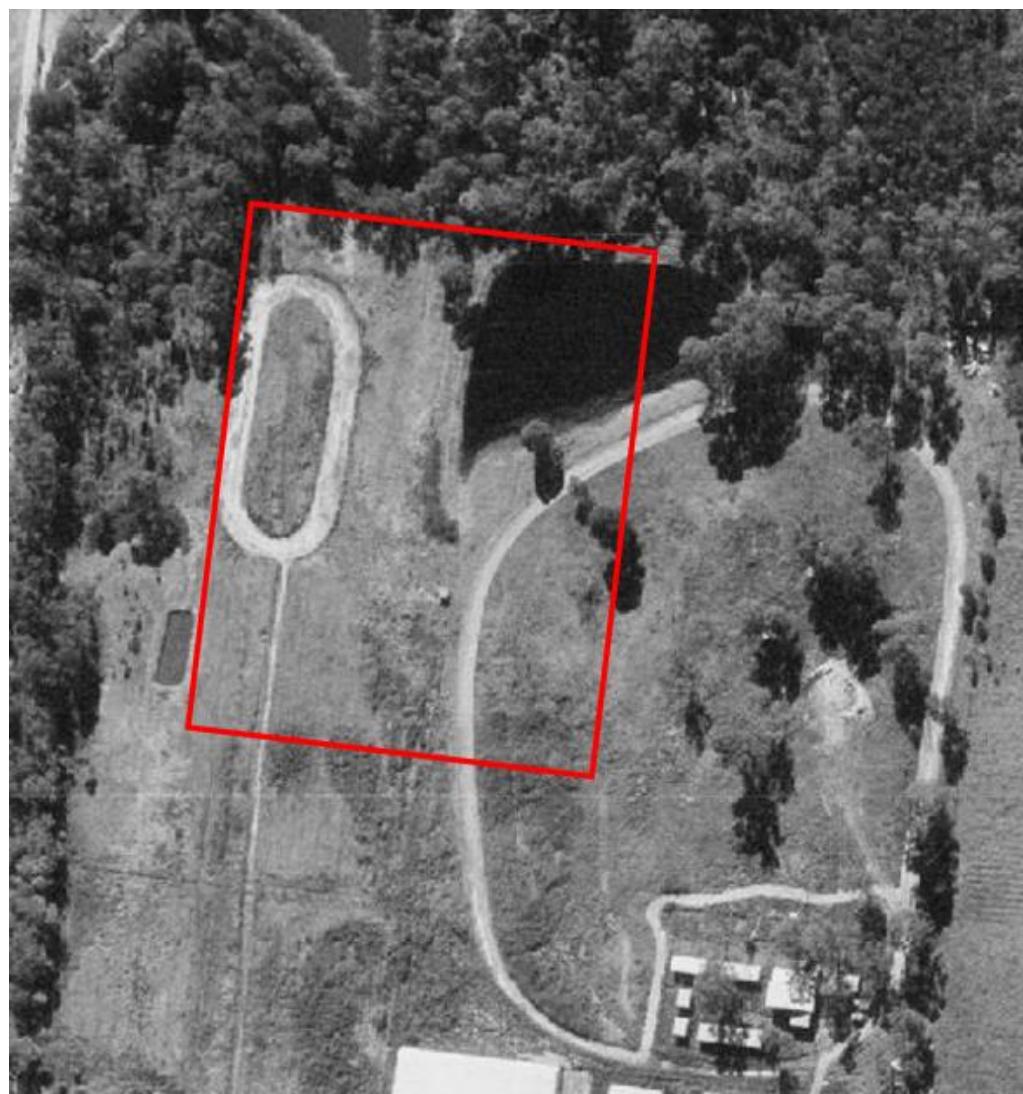
Figure 6: Study area in 1978 (approximately indicated). NSW Historical Image Viewer

The study area was predominantly pastoral land up to the 1960's. Aerial imaging from 1978 shows construction within it of a trotting or training track and a dam. Possible evidence for ploughed agriculture is visible in north to south lines in Figure 6. Significant ground disturbance is evident through the entirety of the study area in Figure 7. Here the former agricultural dam has been infilled, soils spread across the wider area, and a hardstand carpark (present structure) constructed on the west side of the study area. Some vegetation is preserved in the eastern portion of the study area. Removal of this vegetation and levelling and grading required to bring ground surfaces to their present level state, from the condition visible in Figure 7, would have entailed considerable soil disturbance.

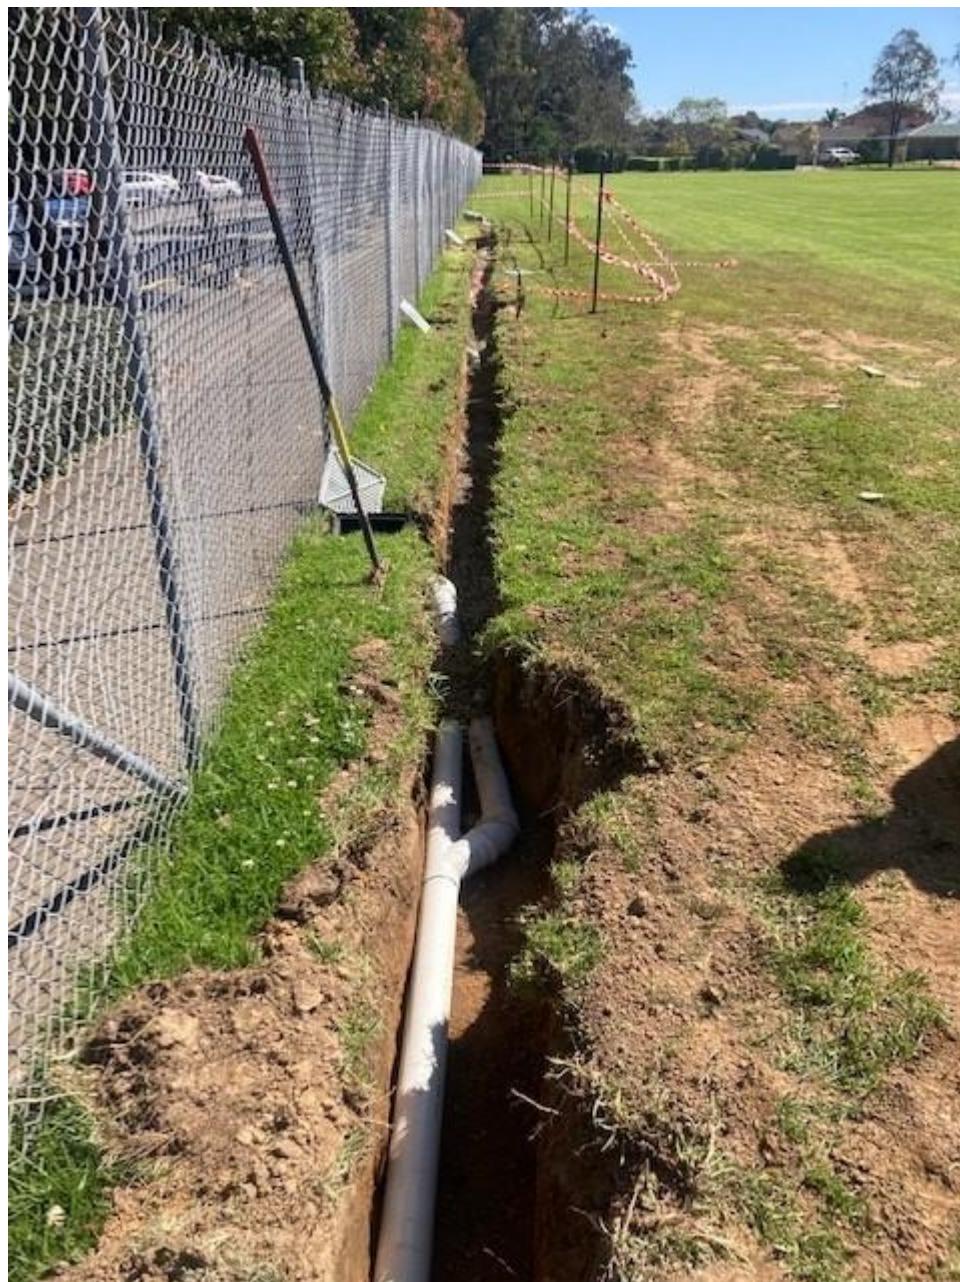
Figure 8: Drainage excavation in the study area

We installed some small surface pits and 100mm agg pipe along the fence line as shown on the attached image, but this is all the drainage that is on this oval. There is a pop up irrigation system that we use on this oval, from memory there are 10 individually controlled rows of 5 pop ups per row down the length of the oval. (email from Hyun Kim (GW) to Michael Lever (Artefact) 20/12/2023)

Soil conditions in previously installed drainage as mentioned above are seen in the image below (Figure 8) provided by GW.

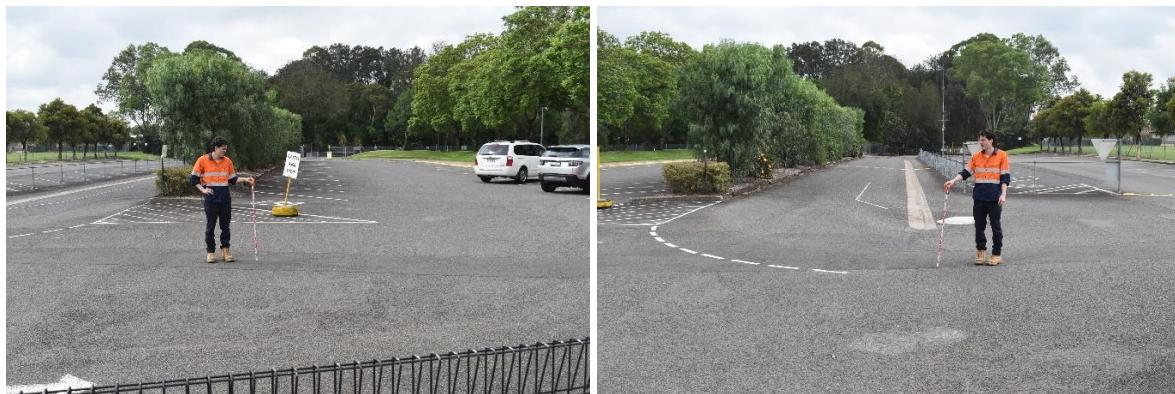
Figure 9: View north along western car park Figure 10: View north along western carpark

The study area ground surface was wholly covered beneath either hardstand carpark to the west and south east extremities (Figure 9, Figure 10, Figure 14), or beneath thickly grassed playing field in the centre (Figure 11, Figure 12). The playing field has been artificially levelled and has evidently been subject to grading. The ground levels of the playing field do not conform to immediately adjacent ground levels, being generally sunken and set below surrounding ground and bordered by battered sloped or mounds.

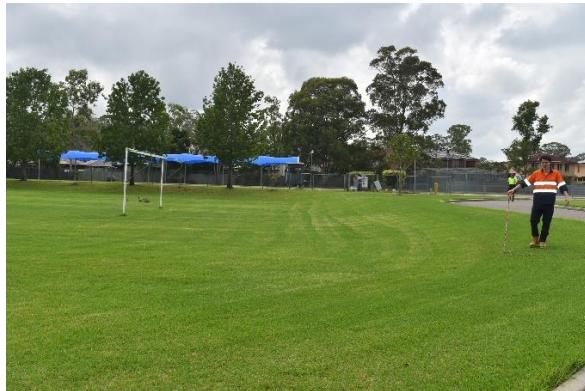
Figure 11: View east along south end of playing field showing lowered levels relative to surrounds

The study area has been subject to disturbance through the previous construction of hardstand carpark and through extensive ground remodelling and devegetation, including the infill of a former large agricultural dam, redistribution of surrounding soils and excavation, and grading and levelling of the area to provide the current level sports playing field. This playing field sits below surrounding street level providing further evidence for bulk removal of soils.

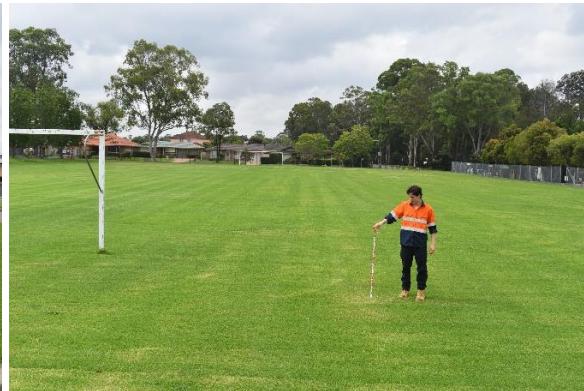
Figure 12: View north along playing field showing artificially levelled surface

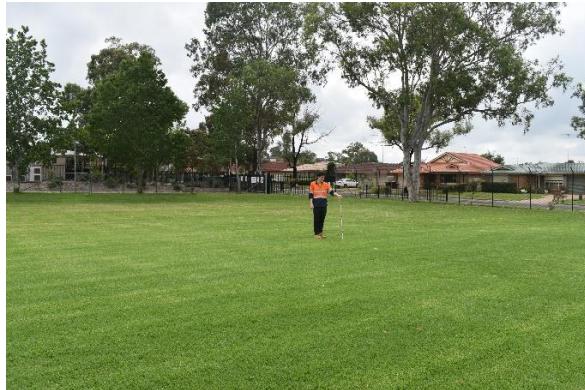
Figure 13: View north east at north east corner of playing field showing field as above street level of Bumbera Road (to left) and below level of internal road to right

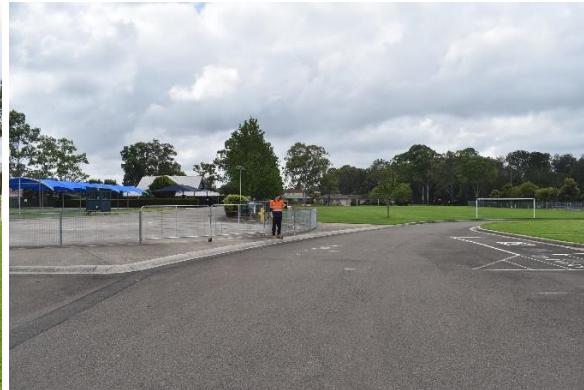
Figure 14: South east terminus of study area showing wholly constructed surfaces and surrounding artificially levelled grass
