Endeavour  
Energy

## Asbestos Product Guide

October 2013

## Introduction

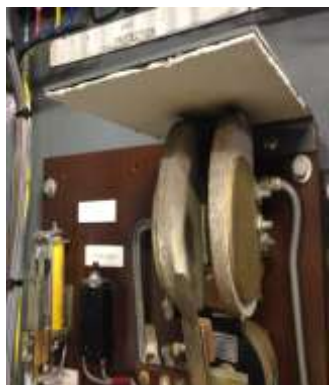
| <b>Description</b> | Medium density asbestos cement sheet on a metal backing to protect protection relays against heat and electrical arcs from the contactor's arc chute when operating. | |
| <b>Identification</b> | <p>These have been found in 11kV Westinghouse J18/B18 family of circuit breakers, in South Wales DX4 breakers at Kellyville and in 33kV GCN breakers.</p> <p>33kV GCN approx. pre 1965 breakers which have contactor covers that have a square box that is the same colour as the rest of the breakers. Ex-Electricity Commission breakers tend to have silver coloured boxes which do not contain asbestos.</p> | |
| | <b>11kV Arc Chute Contactor Covers</b> | <b>33kV GCN Arc Chute Contactor Covers</b> |

| <b>Friability</b> | <p> <b>Friable Risk - HIGH</b></p> <p>Asbestos rope seal is classified as a friable material and can pose an immediate risk to employees if touched or disturbed. During maintenance activities the potential for asbestos fibres to be released into the air is higher if material is broken or in very bad condition. Any occurrences should be reported to Asbestos Management and scheduled for removal.</p> | |

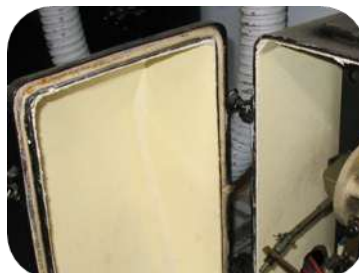
| <b>Description</b> | Soft flexible rope usually fitted in the door, lid, and hatch recess to seal the associated enclosure/box.<br>The rope seal becomes quite hard with the age. Can be found in 100A Wilco power outlets, 11kV OCB contactor boxes and other boxes where a heat resistance seal is required. |
| <b>Identification</b> | The rope seal can range in colours from white through grey to brown. Asbestos-containing rope seals are not easily distinguished visually from seals that are asbestos-free and tests have shown out of all known (104) 100A Wilco power outlets 10 per cent were non asbestos. |
| <b>Photographs</b> | <div style="display: flex; justify-content: space-around; align-items: flex-end;"> <div style="text-align: center;"> <p><b>Asbestos rope seal at the hatch of 100A Wilco power outlets (usually in zone substations)</b></p> </div> <div style="text-align: center;"> <p><b>Seal of 11kV OCB closing contactor box</b></p> </div> </div> |

| <b>Friability</b> | <p> <b>Friable Risk - HIGH</b></p> <p>Asbestos rope seal is classified as a friable material and can pose an immediate risk to employees if touched or disturbed. During maintenance activities the potential for asbestos fibres to be released into the air is higher if material is broken or in very bad condition. Any occurrences should be reported to Asbestos Management and scheduled for removal.</p> |

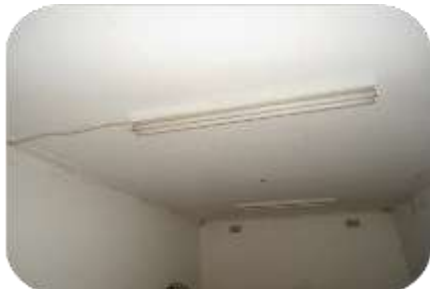
| Description | <p>Asbestolux was typically used as wall and ceiling panels, often in high humidity applications.</p> <p>It has been used for fire protection, thermal and acoustic insulation and for general building work in industrial and commercial buildings, education facilities and domestic premises. It was manufactured in the late 1950s to mid-1960s and is unlikely to be found in buildings constructed after 1982. It can be found only in a few locations in Endeavour Energy, mainly in old zone substation amenities and control room ceilings.</p> |
| Identification | <p>Asbestolux is a low density asbestos fibre board, lightly compressed, it looks similar to asbestos cement sheeting or plaster board, but asbestos fibres are not bound in a cement matrix as with asbestos cement sheeting but in calcium silicate plaster, which makes Asbestolux quite soft and the pressure of a fingernail into the surface can leave an indentation. Samples of Asbestolux have shown it contains up to 70 per cent (by volume) asbestos fibres. It is usually painted white.</p> |
| Photographs | <div> </div> <div> <p>Unpainted board</p> <p>Control room ceiling</p> <p>Amenities ceiling</p> </div> |

| Friability | <p><b>✗ Friable Risk - HIGH</b></p> <p>Due to the high percentage of asbestos fibres present in Asbestolux and the soft nature of the product, Asbestolux is regarded as a friable asbestos containing material.</p> <p>Asbestolux is softer than asbestos cement sheeting and will crumble easily if disturbed. If the material is in good condition and left undisturbed, it presents a low risk to building occupants. However, release of airborne fibres can occur even with minor mechanical disturbance.</p> <p>During maintenance activities the potential for asbestos fibres to be released is high if Asbestolux is broken, removed or disturbed without adequate precautions.</p> |

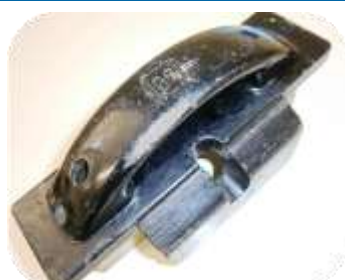
| Identification | Black colour, distinct embossed letters “EE” and the characteristic shape. | | |
| Photographs | <div><p>English Electric fuse holder containing asbestos commonly in underground subs in CBD</p></div> <div><p>St George type fuse holders NOT containing asbestos</p></div> <div><p>Caspar type fuse holder commonly used in chamber subs NOT containing asbestos</p></div> <div><p>A view of embossed English Electric symbol</p></div> <div><p>Mackellar type fuse holders NOT containing asbestos</p></div> | | |

| Friability | <div></div> Non friable material, very hard to break or reduce to rubble or dust | | |

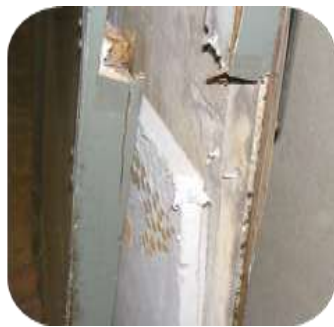
| <b>Identification</b> | <p>As most of older type of fire doors don't have any labels or distinct markings it is very hard to positively identify asbestos content. The only way to do it is by sampling, but this is a destructive process and hygienists prefer to classify them as: 'suspected positive' or 'suspected negative', based on their age and appearance. Newer types of fire doors are labelled, which make it easier to identify them as asbestos-free.</p> |
| <b>Photographs</b> | <div style="display: flex; flex-wrap: wrap; justify-content: space-around;"> <div style="text-align: center;"> <p><b>Damaged substation fire door</b></p> </div> <div style="text-align: center;"> <p><b>Damaged fire door exposing asbestos core</b></p> </div> <div style="text-align: center;"> <p><b>Wooden frame door</b></p> </div> <div style="text-align: center;"> <p><b>Damaged fire door leaking asbestos as white powder on floor</b></p> </div> </div> |

| <b>Friability</b> | <p> <b>Friable Risk – LOW</b></p> <p>Although classified as friable, fire doors have an asbestos component encapsulated within the door frame. Only in cases of the outside frame/cover being damaged (e.g. rust, mechanical damage etc) the asbestos core can become friable and should be treated accordingly.</p> |

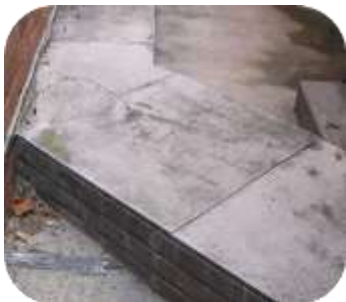
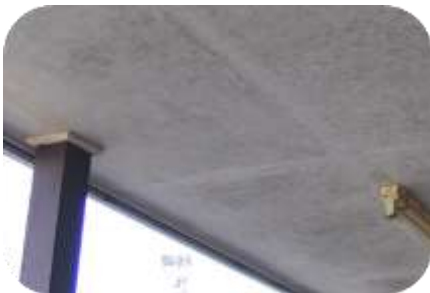
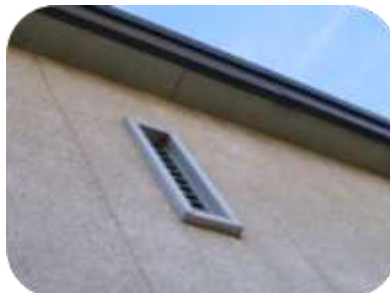
| <b>Description</b> | <p>Flat cement sheets were made of asbestos fibres and cement mix, commonly in the ratio of 1 to 9. In the asbestos cement sheet, asbestos fibres are bound within the cement matrix and are considered to be well immobilised in the cement and less prone to be released into the environment.</p> <p>Due to its asbestos content, cement sheets are heat and moisture resistant. Asbestos cement sheets were used as ceiling panelling, walls and external eaves of some older type substations and depots.</p> |
| <b>Identification</b> | Asbestos cement sheets are white to grey in colour and are quite hard and brittle. When subjected to machining, power tools or extensive weathering this product can become friable and the internal fibres that were originally bounded by cement can become liberated into the air. |
| <b>Photographs</b> | <div> <p><b>Mascot zone cable troughing cover</b></p> </div> <div> <p><b>Depot building awning</b></p> </div> <div> <p><b>Asbestos cement substation building eaves</b></p> </div> |

| <b>Friability</b> | <p> Non Friable Risk – <b>LOW</b>, Can only become friable when subjected to fire, extensive weathering or worked on by power tools.</p> |

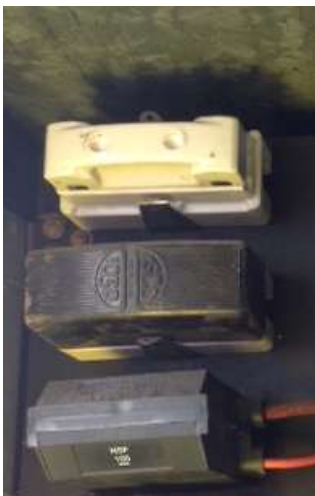
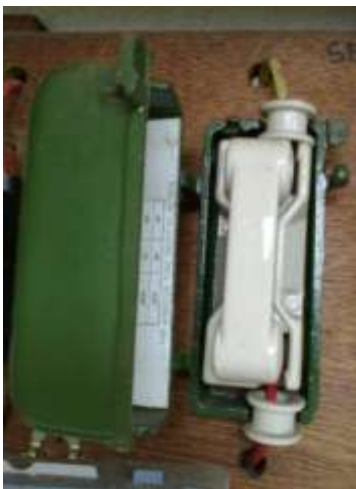
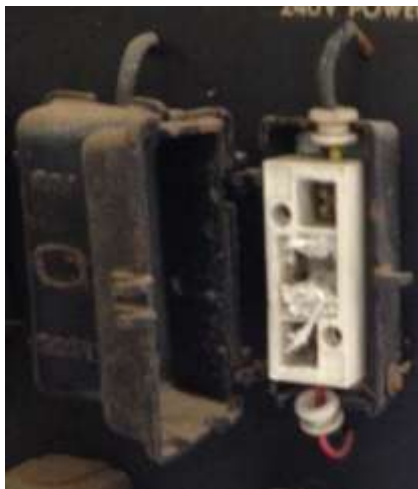
| <b>Other names</b> | Henley Fuses, Service Fuses, Council Fuses |
| <b>Photographs</b> | <div> </div> <div> <p>Top – Henley Fuse with cover off<br/> Middle – Henley Fuse with cover on<br/> Right – Henley fuse removed from meter board</p> <p>Federal Type Asbestos containing fuse</p> <p>Henley Type Asbestos Fuse Arc Quenching Wrap</p> </div> |

| <b>Friability</b> | <p> <b>Friable Risk – High</b></p> <p>These fuses should not be touched. These fuses can be bypassed with a modern fuse where urgent operational needs are identified.</p> |

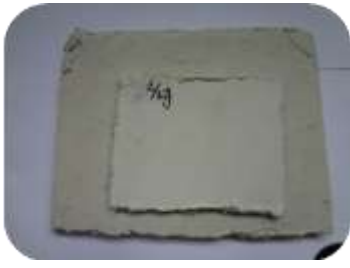
| <b>Identification</b> | <p>Millboard is white to grey in colour, soft flexible material which can be easily damaged.</p> <p>Similar non-asbestos products are made with asbestos substituting substances such as Rockwool mineral fibres, which provide heat-resistance.</p> |
| <b>Photographs</b> | <div> </div> <div> <p><b>Millboard lining inside the fuse box</b></p> <p><b>Millboard sheet</b></p> <p><b>Millboard lining in OCB closing contactor box</b></p> <p><b>Millboard lining in 33kV CB closing contactor box</b></p> </div> |

| <b>Friability</b> | <p><b>✗ Friable Risk - HIGH</b></p> <p>Due to the high percentage of asbestos fibres present in millboard and the soft nature of the product, it is regarded as a friable asbestos-containing material.</p> <p>Millboard is usually soft and release of airborne fibres can occur even with minor mechanical disturbance. During maintenance activities the potential for asbestos fibres to be released is higher if millboard is broken or in very bad condition.</p> |

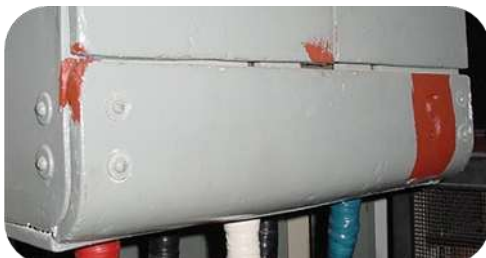
| <b>Identification</b> | If not painted they are white to grey in colour quite hard, strong, fibrous material. |
| <b>Photographs</b> | <div> <p>End of Busbar trunking in CBD underground substation</p> </div> <div> <p>Moulded cement sheet – bottom of fuse box in CBD underground substation</p> </div> <div> <p>Busbar trunking and fuse box in CBD underground substation</p> </div> <div> <p>Moulded cement sheet troughing</p> </div> |

| <b>Friability</b> | <b>Non Friable Risk – LOW.</b> |

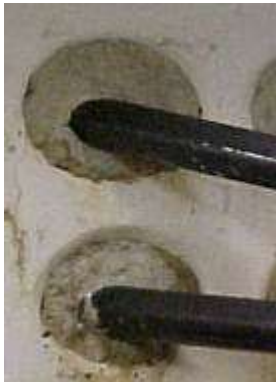
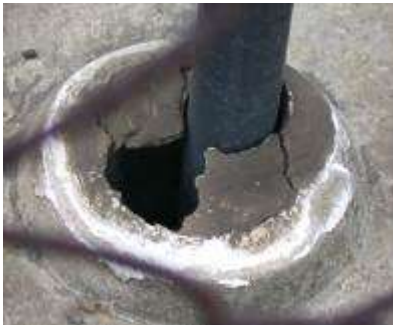
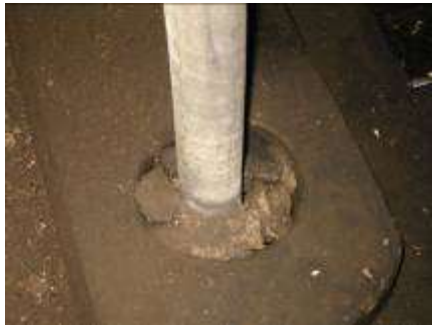
| <b>Description</b> | Asbestos-containing dark grey to brown in colour, mastic flexible 'Non Corrosive' putty, typically used for fire-proofing and to prevent the entry of water into substations and cable pits, specifically in cable ducts and equipment hatches. It also seals cables inside conduits to prevent vermin or any other contamination entering conduits and damaging cables. |
| <b>Identification</b> | <p>It is impossible to tell if the NC compound contains asbestos or not. Reliable identification can only be achieved by laboratory analysis. Non-asbestos NC compound looks exactly the same as that which contains asbestos.</p> <p>Includes cable penetration caulking in the form of mastic sealant.</p> |
| <b>Photographs</b> | <p>NC compound in substation wall      Damaged NC compound      Tx cable sealed with NC compound</p> |

| <b>Friability</b> | <p> All NC or caulking compound/putty, unless it is damaged or visibly deteriorating, is classed as non-friable asbestos.</p> |

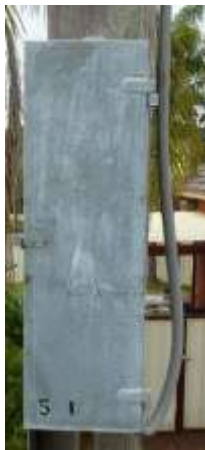
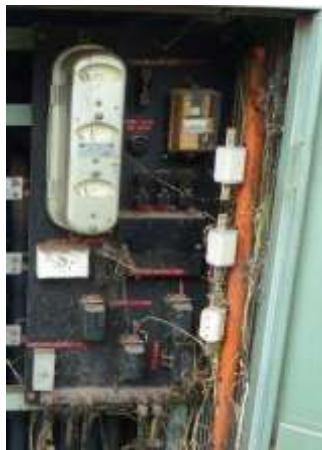
| <b>Identification</b> | Used in older areas, identified by a metal box, modern boxes made from |
| <b>Photographs</b> | <p>Pole mounted street light control panel      The external metal cover of a street light control panel      A street light control panel located within a kiosk substation in the Illawarra</p> |

| <b>Friability</b> | <b>Non Friable Risk – LOW.</b> |

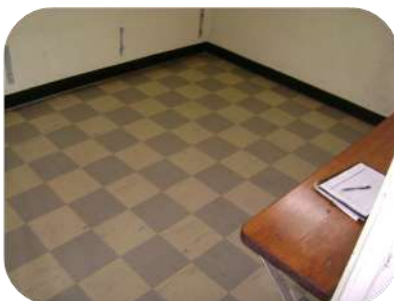
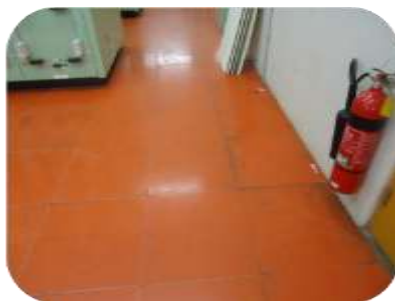
| <b>Identification</b> | Asbestos-containing vinyl floor tiles can have a variety of colours and shapes, but they will look exactly the same as non-asbestos-containing vinyl floor tiles. Reliable identification can only be achieved by laboratory analysis. |
| <b>Photographs</b> | <div> <p>Floor tiles at zone substation</p> <p>Amenities at zone substation</p> <p>Control room floor tiles</p> </div> |

| <b>Friability</b> | <b>Non Friable Risk – LOW</b> |

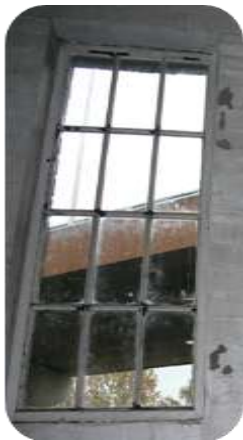
| <b>Description</b> | Soft, flexible or brittle when dry material, grey dark colour used in old style steel framed windows as the glazing putty. Generally found in older chamber substations. |
| <b>Photographs</b> | <p><b>Window putty in substation steel frame window</b></p> |

| <b>Friability</b> | All window putty is classified as non-friable asbestos |

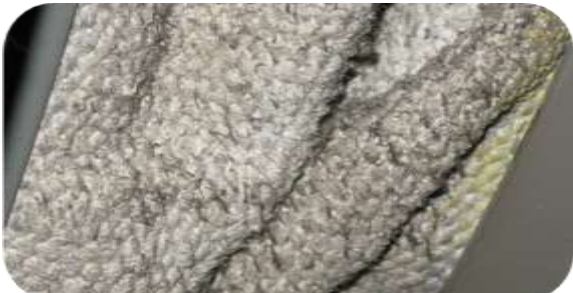
| <b>Description</b> | <p>Soft woven material, white to grey in colour with high asbestos content, used for flexible fireproof couplings, air conditioning and other ducting.</p> <p>Not very common on Endeavour Energy assets.</p> |
| <b>Identification</b> | <p>Similar to cable bandages, physical appearance could be misleading, it should always be sampled and tested.</p> <p>Could look like non-asbestos woven material.</p> |
| <b>Photographs</b> | <div> <p>Opera House ventilation duct with asbestos cloth coupling (now removed)</p> </div> <div> <p>Close up of asbestos clothing at Opera House substation (now removed)</p> </div> <div> <p>Asbestos cloth wrapped around green resistors inside distance relay box</p> </div> |

| <b>Friability</b> | <p> <b>Friable Risk - HIGH</b></p> <p>Due to the high percentage of asbestos fibres present in asbestos cloth and the soft nature of the product, it is regarded as a friable asbestos-containing material.</p> <p>Asbestos cloth is usually soft and the release of airborne fibres can occur even with minor mechanical disturbance with touching by hand or brushing against it.</p> |
