# ARBORICULTURAL IMPACT ASSESSMENT

RACING NSW C/O MOSTYN COPPER

61 RICKABY ST, CLARENDON

13 JUNE 2025

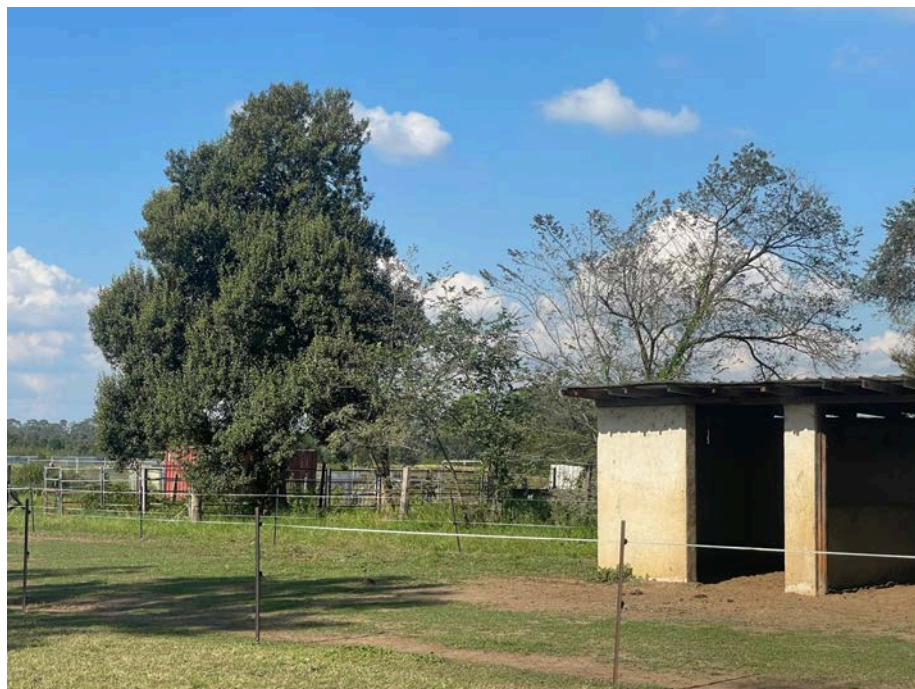
**Photo 2:** Trees 2-6

| No. | Botanical Name<br>(Common Name) | HT | CS | DBH<br>(mm) | DRC<br>(mm) | TPZ<br>(m) | SRZ<br>(m) | Age | Health/<br>Cond. | SRIV | Defects /<br>Comments | Risk<br>Rating | SULE | Significance /<br>Retention<br>Value) | Recommendations |
|---|---|---|---|---|---|---|---|---|---|---|---|---|---|---|---|
| 2 | Ulmus minor (Field Elm) | 5 | 4 | 90 | 100 | 1.1 | 1.3 | Y | G/F | YGVF | Small specimen | LOW | M | LOW / LOW | Remove & Replace |
| 3 | Ulmus minor (Field Elm) | 5 | 3 | 60 | 90 | 0.7 | 1.2 | Y | G/F | YGVF | Small specimen, too close to fence | LOW | M | LOW / LOW | Remove & Replace |

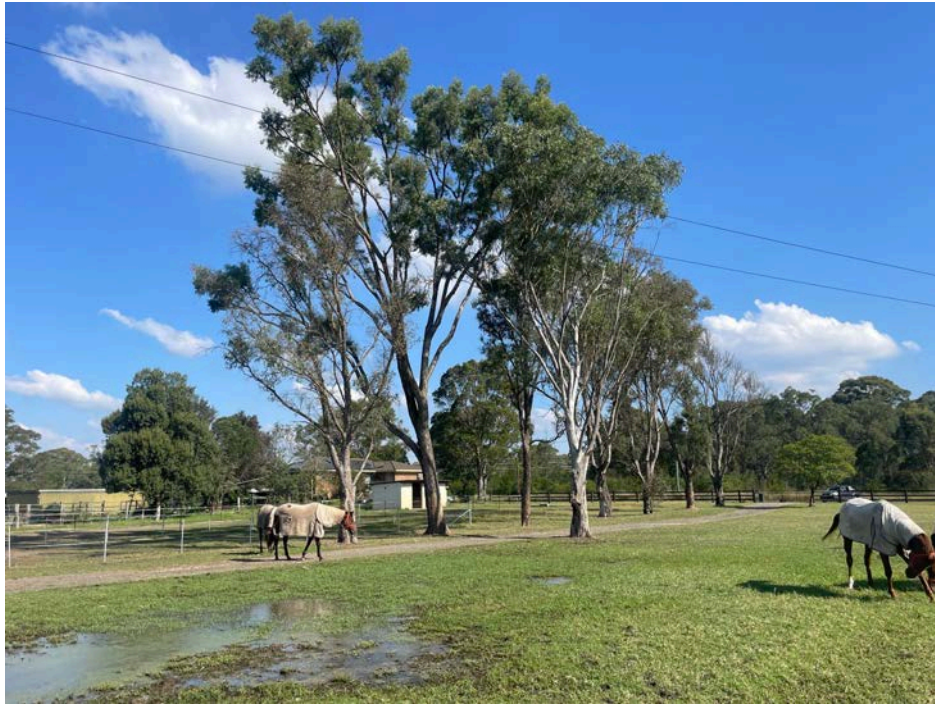
**Photo 3:** Trees 7-15

| No. | Botanical Name<br>(Common Name) | HT | CS | DBH<br>(mm) | DRC<br>(mm) | TPZ<br>(m) | SRZ<br>(m) | Age | Health/<br>Cond. | SRIV | Defects /<br>Comments | Risk<br>Rating | SULE | Significance /<br>Retention<br>Value) | Recommendations |
|---|---|---|---|---|---|---|---|---|---|---|---|---|---|---|---|
| 7 | Jacaranda mimosifolia<br>(Jacaranda) | 5 | 5 | 200 | 200 | 2.4 | 1.7 | M | G/G | MGVG | Small specimen | LOW | L | LOW / LOW | Remove & Replace |

| No. | Botanical Name<br>(Common Name) | HT | CS | DBH<br>(mm) | DRC<br>(mm) | TPZ<br>(m) | SRZ<br>(m) | Age | Health/<br>Cond. | SRIV | Defects /<br>Comments | Risk<br>Rating | SULE | Significance /<br>Retention<br>Value) | Recommendations |
|---|---|---|---|---|---|---|---|---|---|---|---|---|---|---|---|
| 10 | Eucalyptus amplifolia<br>(Cabbage Gum) | 14 | 7 | 400 | 480 | 4.8 | 2.4 | O | P/P | MGVP | Poor health and condition. Very sparse canopy and decay throughout trunk. | LOW | S | LOW / LOW | Remove & Replace |
| 11 | Eucalyptus amplifolia<br>(Cabbage Gum) | 14 | 10 | 550 | 600 | 6.6 | 2.7 | O | P/P | MGVP | Poor health and condition. Very sparse canopy and decay throughout trunk. | LOW | S | LOW / LOW | Remove & Replace |
| 13 | Eucalyptus punctata<br>(Grey Gum) | 12 | 9 | 550 | 600 | 6.6 | 2.7 | O | F/P | MGVP | Poor health and condition with significant internal decay at root crown / trunk | LOW | S | LOW / LOW | Remove & Replace |
| 15 | Eucalyptus amplifolia<br>(Cabbage Gum) | 11 | 7 | 450 | 550 | 5.4 | 2.6 | O | P/P | MGVP | Poor health and condition with decay throughout trunk | LOW | S | LOW / LOW | Remove & Replace |

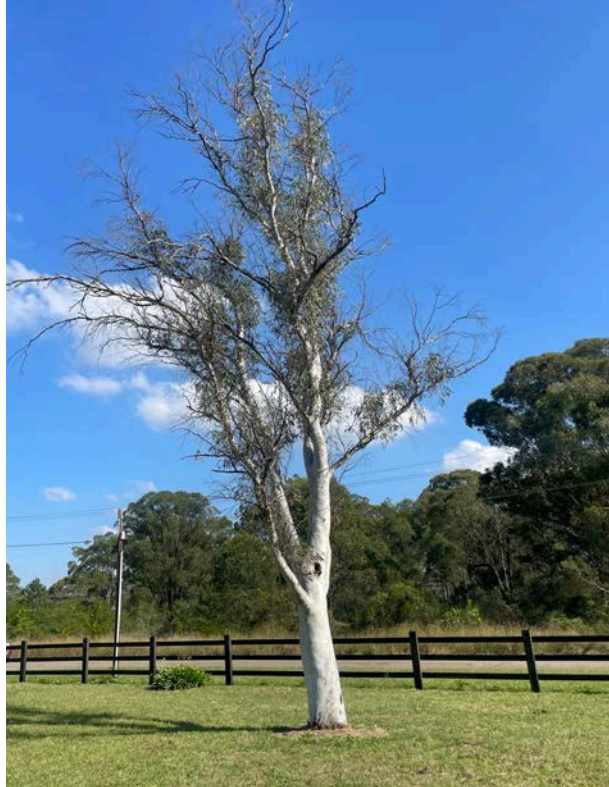
**Photo 4:** Tree 16

| No. | Botanical Name<br>(Common Name) | HT | CS | DBH<br>(mm) | DRC<br>(mm) | TPZ<br>(m) | SRZ<br>(m) | Age | Health/<br>Cond. | SRIV | Defects /<br>Comments | Risk<br>Rating | SULE | Significance /<br>Retention<br>Value) | Recommendations |
|---|---|---|---|---|---|---|---|---|---|---|---|---|---|---|---|
| 16 | Eucalyptus sp.<br>(Eucalyptus) | 12 | 8 | 450 | 500 | 5.4 | 2.5 | O | P/P | MGVP | 95% dead, only few<br>epicormic growths | LOW | S | LOW / LOW | Remove & Replace |

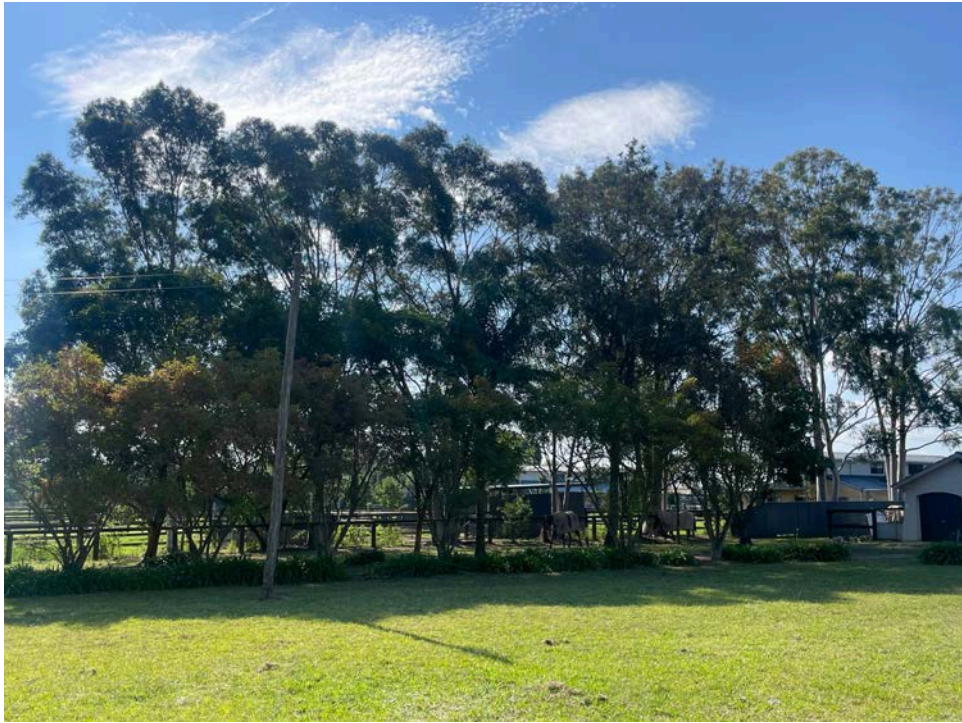
**Photo 5:** Trees 17-32

| No. | Botanical Name<br>(Common Name) | HT | CS | DBH<br>(mm) | DRC<br>(mm) | TPZ<br>(m) | SRZ<br>(m) | Age | Health/<br>Cond. | SRIV | Defects /<br>Comments | Risk<br>Rating | SULE | Significance /<br>Retention<br>Value) | Recommendations |
|---|---|---|---|---|---|---|---|---|---|---|---|---|---|---|---|
| 17 | Fraxinus ornus (Manna<br>Ash) | 5 | 4 | 140 | 160 | 1.7 | 1.5 | Y | G/F | YGVF | Manna Ash - Stand of 9,<br>2 only 3m tall | LOW | L | LOW / LOW | Remove & Replace |
| 18 | Thuja orientalis<br>(Bookleaf Conifer) | 5 | 4 | 130 | 180 | 1.6 | 1.6 | M | G/F | MGVF | Small specimen | LOW | M | LOW / LOW | Remove & Replace |
| 20 | Callistemon<br>sp.(Bottlebrush) | 8 | 6 | 250 | 350 | 3.0 | 2.1 | M | G/F | MGVF | Poor form, codominant<br>stems, damage to trunk | LOW | S | LOW / LOW | Remove & Replace |
| 21 | Jacaranda mimosifolia<br>(Jacaranda) | 7 | 4 | 250 | 180 | 3.0 | 1.6 | M | F/F | MGVF | Mechanical damage to<br>roots and trunk | LOW | S | LOW / LOW | Remove & Replace |

| No. | Botanical Name<br>(Common Name) | HT | CS | DBH<br>(mm) | DRC<br>(mm) | TPZ<br>(m) | SRZ<br>(m) | Age | Health/<br>Cond. | SRIV | Defects /<br>Comments | Risk<br>Rating | SULE | Significance /<br>Retention<br>Value) | Recommendations |
|---|---|---|---|---|---|---|---|---|---|---|---|---|---|---|---|
| 22 | <i>Syagrus romanzoffiana</i><br>(Cocos Palm) | 6 | 4 | 300 | 380 | 3.6 | 2.2 | M | G/G | MGVG | Exempt species | LOW | M | LOW / LOW | Remove & Replace |
| 23 | <i>Grevillea robusta</i> (Silky Oak) | 13 | 8 | 260 | 400 | 3.1 | 2.3 | M | F/F | MGVF | Sparse canopy, very shallow rooted, most of roots on surface | LOW | S | LOW / LOW | Remove & Replace |
| 24 | <i>Tradica sebifera</i><br>(Chinese Tallow) | 7 | 6 | 280 | 350 | 3.4 | 2.1 | M | G/F | MGVF | Weed species in most council areas | LOW | S | LOW / LOW | Remove & Replace |
| 25 | <i>Ulmus parvifolia</i><br>(Chinese Elm) | 6 | 5 | 100 | 130 | 1.2 | 1.4 | Y | G/F | YGVF | Tiny specimen | LOW | L | LOW / LOW | Remove & Replace |

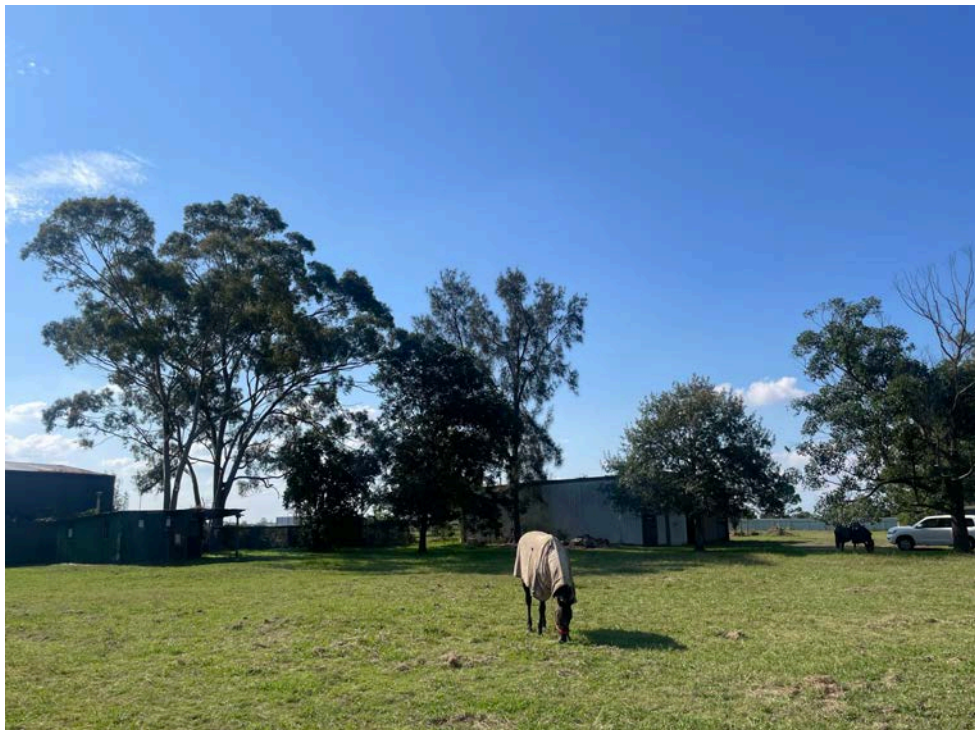
**Photo 6:** Trees 33-39

| No. | Botanical Name<br>(Common Name) | HT | CS | DBH<br>(mm) | DRC<br>(mm) | TPZ<br>(m) | SRZ<br>(m) | Age | Health/<br>Cond. | SRIV | Defects /<br>Comments | Risk<br>Rating | SULE | Significance /<br>Retention<br>Value) | Recommendations |
|---|---|---|---|---|---|---|---|---|---|---|---|---|---|---|---|
| 35 | Tradica sebifera<br>(Chinese Tallow) | 5 | 5 | 220 | 260 | 2.6 | 1.9 | M | G/F | MGVF | Small specimen | LOW | M | LOW / LOW | Remove & Replace |
| 36 | Carya illinoensis<br>(Pecan) | 10 | 10 | 300 | 350 | 3.6 | 2.1 | M | G/G | MGVG | | LOW | M | MED / MED | Remove & Replace |
| 37 | Casuarina<br>cunninghamiana (River<br>She Oak) | 17 | 12 | 500 | 650 | 6.0 | 2.8 | M | G/F | MGVF | | LOW | M | MED / MED | Remove & Replace |
| 38 | Quercus palustris (Pin<br>Oak) | 9 | 9 | 300 | 360 | 3.6 | 2.2 | M | G/G | MGVG | Pin oak | LOW | L | HIGH / HIGH | Remove & Replace |
| 39 | Eucalyptus robusta<br>(Swamp mahogany) | 10 | 10 | 500 | 550 | 6.0 | 2.6 | O | P/P | MGVP | Top half of canopy dead | LOW | S | LOW / LOW | Remove & Replace |

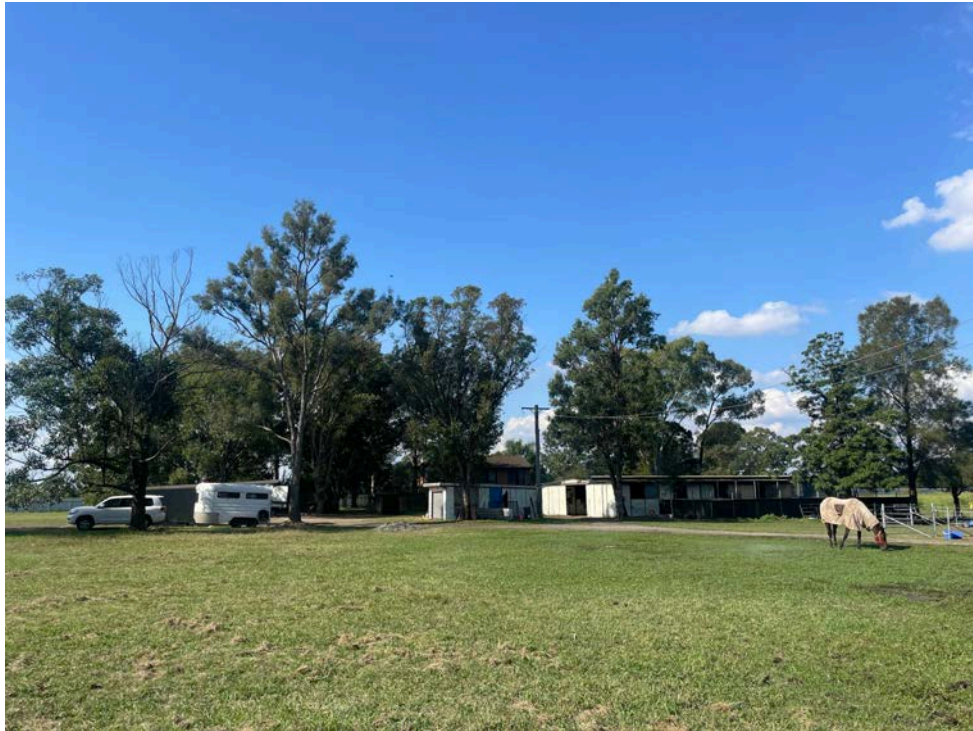
**Photo 7:** Trees 39-45

| No. | Botanical Name<br>(Common Name) | HT | CS | DBH<br>(mm) | DRC<br>(mm) | TPZ<br>(m) | SRZ<br>(m) | Age | Health/<br>Cond. | SRIV | Defects /<br>Comments | Risk<br>Rating | SULE | Significance /<br>Retention<br>Value) | Recommendations |
|---|---|---|---|---|---|---|---|---|---|---|---|---|---|---|---|
| 40 | Eucalyptus moluccana<br>(Grey Box) | 16 | 12 | 500 | 580 | 6.0 | 2.6 | M | F/F | MGVF | Lots of epicormic growth<br>showing stress | LOW | L | HIGH / HIGH | Remove & Replace |
| 42 | Angophora floribunda<br>(Rough barked Apple) | 18 | 10 | 560 | 600 | 6.7 | 2.7 | M | G/G | MGVG | | LOW | L | HIGH / HIGH | Remove & Replace |
| 43 | Grevillea robusta (Silky<br>Oak) | 15 | 8 | 400 | 460 | 4.8 | 2.4 | M | F/F | MGVF | Die back in top section<br>of canopy | LOW | M | LOW / LOW | Remove & Replace |
| 44 | Casuarina<br>cunninghamiana (River<br>She Oak) | 16 | 10 | 400 | 480 | 4.8 | 2.4 | M | G/G | MGVG | | LOW | L | MED / MED | Remove & Replace |
| 45 | Eucalyptus robusta<br>(Swamp mahogany) | 5 | 6 | 300 | 320 | 3.6 | 2.1 | M | G/G | MGVG | | LOW | L | MED / MED | Remove & Replace |

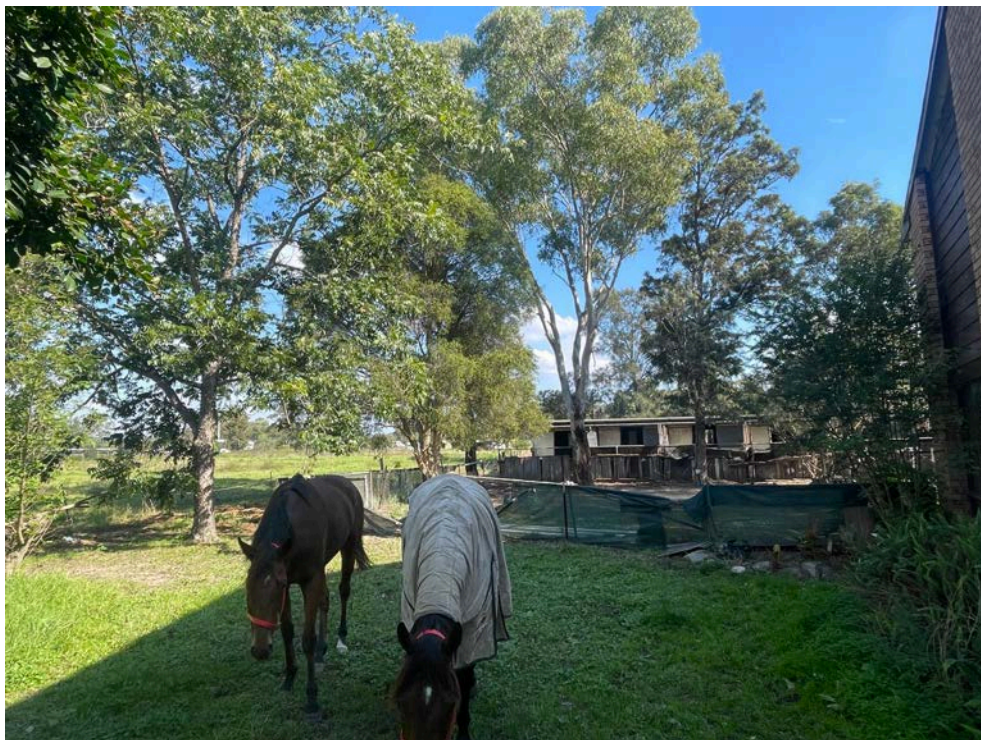
**Photo 8:** Trees 46-51

| No. | Botanical Name<br>(Common Name) | HT | CS | DBH<br>(mm) | DRC<br>(mm) | TPZ<br>(m) | SRZ<br>(m) | Age | Health/<br>Cond. | SRIV | Defects /<br>Comments | Risk<br>Rating | SULE | Significance /<br>Retention<br>Value) | Recommendations |
|---|---|---|---|---|---|---|---|---|---|---|---|---|---|---|---|
| 46 | Carya illinoensis<br>(Pecan) | 10 | 10 | 300 | 380 | 3.6 | 2.2 | M | G/G | MGVG | | LOW | L | MED / MED | Remove & Replace |
| 47 | Melaleuca<br>styphelioides (Prickly<br>leaved Paperbark) | 10 | 10 | 450 | 550 | 5.4 | 2.6 | M | G/G | MGVG | | LOW | L | MED / MED | Remove & Replace |
| 49 | Eucalyptus punctata<br>(Grey Gum) | 15 | 12 | 720 | 780 | 8.6 | 3.0 | M | F/F | MGVF | Large canker on trunk<br>and internal decay | LOW | M | MED / MED | Retain and Protect<br>(AS-4970-2009) |
| 50 | Grevillea robusta (Silky<br>Oak) | 14 | 8 | 300 | 400 | 3.6 | 2.3 | O | F/P | MGVP | Large canker and decay<br>throughout trunk | LOW | S | LOW / LOW | Remove & Replace |
| 51 | Grevillea robusta (Silky<br>Oak) | 10 | 5 | 130 | 150 | 1.6 | 1.5 | M | G/G | MGVG | | LOW | M | MED / MED | Remove & Replace |

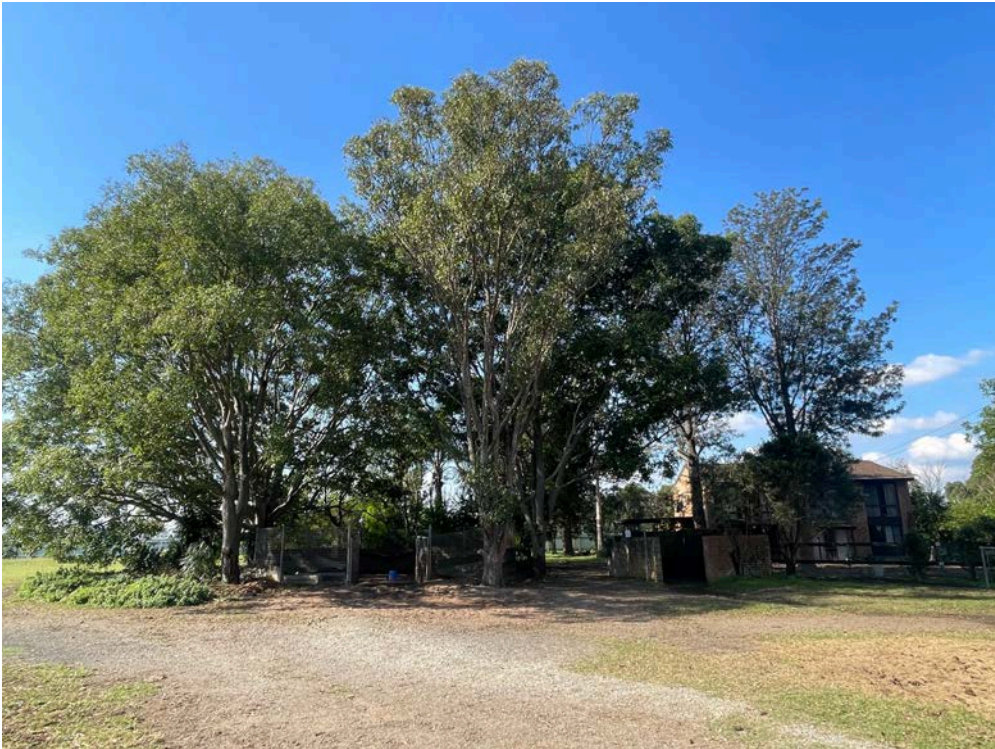
**Photo 9:** Trees 52-65

| No. | Botanical Name<br>(Common Name) | HT | CS | DBH<br>(mm) | DRC<br>(mm) | TPZ<br>(m) | SRZ<br>(m) | Age | Health/<br>Cond. | SRIV | Defects /<br>Comments | Risk<br>Rating | SULE | Significance /<br>Retention<br>Value) | Recommendations |
|---|---|---|---|---|---|---|---|---|---|---|---|---|---|---|---|
| 54 | Corymbia torelliana (Cadaghi) | 12 | 6 | 280 | 340 | 3.4 | 2.1 | M | G/G | MGVG | | LOW | L | MED / MED | Remove & Replace |
| 55 | Corymbia torelliana (Cadaghi) | 13 | 11 | 400 | 450 | 4.8 | 2.4 | M | G/G | MGVG | | LOW | L | HIGH / HIGH | Remove & Replace |
| 56 | Corymbia gummifera (Red bloodwood) | 14 | 8 | 500 | 500 | 6.0 | 2.5 | M | G/F | MGVF | | LOW | L | HIGH / HIGH | Remove & Replace |
| 57 | Corymbia torelliana (Cadaghi) | 13 | 12 | 420 | 450 | 5.0 | 2.4 | O | F/P | MGVP | Major decay at base of trunk | LOW | S | LOW / LOW | Remove & Replace |

| No. | Botanical Name<br>(Common Name) | HT | CS | DBH<br>(mm) | DRC<br>(mm) | TPZ<br>(m) | SRZ<br>(m) | Age | Health/<br>Cond. | SRIV | Defects /<br>Comments | Risk<br>Rating | SULE | Significance /<br>Retention<br>Value) | Recommendations |
|---|---|---|---|---|---|---|---|---|---|---|---|---|---|---|---|
| 58 | Corymbia torelliana<br>(Cadaghi) | 16 | 18 | 900 | 1000 | 10.8 | 3.3 | M | G/G | MGVG | Good specimen, great<br>feature tree | LOW | L | HIGH / HIGH | Remove & Replace |
| 59 | Jacaranda mimosifolia<br>(Jacaranda) | 7 | 4 | 170 | 200 | 2.0 | 1.7 | M | G/F | MGVF | Small specimen | LOW | L | LOW / LOW | Remove & Replace |
| 60 | Jacaranda mimosifolia<br>(Jacaranda) | 7 | 5 | 220 | 250 | 2.6 | 1.8 | M | G/G | MGVG | | LOW | L | MED / MED | Remove & Replace |
| 61 | Melaleuca linariifolia<br>(Narrow-leaved<br>Paperbark) | 11 | 8 | 460 | 500 | 5.5 | 2.5 | M | G/P | MGVP | Poor form, codominant<br>stems ground level | LOW | S | LOW / LOW | Remove & Replace |
| 62 | Syagrus romanzoffiana<br>(Cocos Palm) | 5 | 4 | 400 | 400 | 4.8 | 2.3 | M | G/F | MGVF | Exempt species | LOW | S | LOW / LOW | Remove & Replace |
| 63 | Livistona australis<br>(Cabbage Tree Palm) | 13 | 4 | 380 | 450 | 4.6 | 2.4 | M | G/F | MGVF | | LOW | M | MED / MED | Remove & Replace |

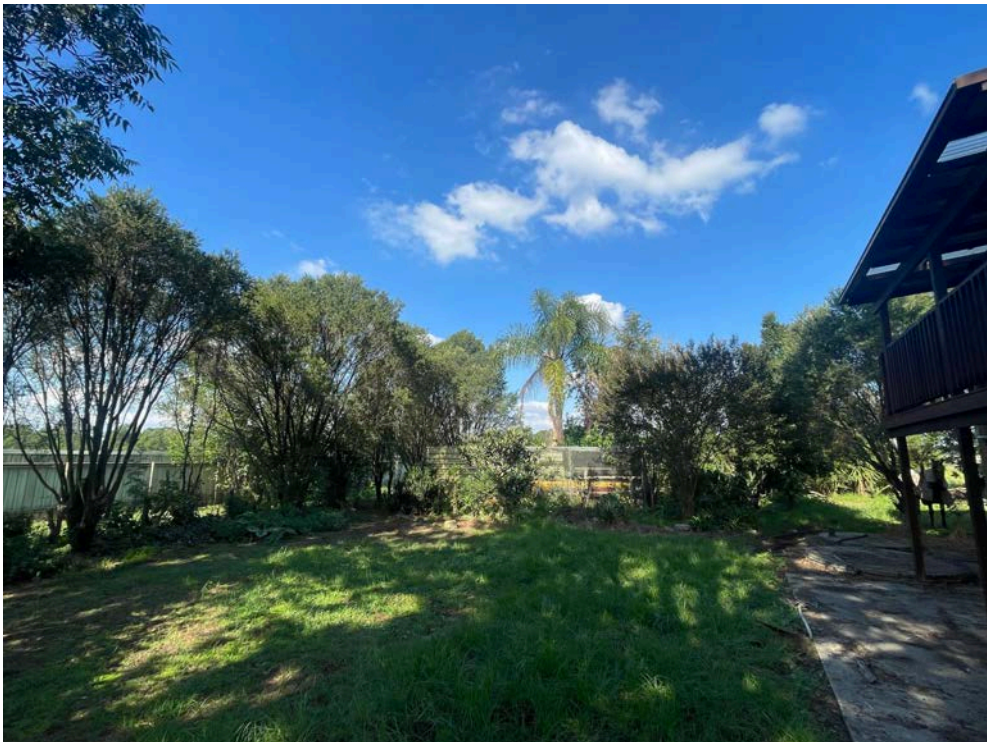
**Photo 10:** Trees 66-70

| No. | Botanical Name<br>(Common Name) | HT | CS | DBH<br>(mm) | DRC<br>(mm) | TPZ<br>(m) | SRZ<br>(m) | Age | Health/<br>Cond. | SRIV | Defects /<br>Comments | Risk<br>Rating | SULE | Significance /<br>Retention<br>Value) | Recommendations |
|---|---|---|---|---|---|---|---|---|---|---|---|---|---|---|---|
| 67 | Syagrus romanzoffiana<br>(Cocos Palm) | 5 | 4 | 240 | 260 | 2.9 | 1.9 | M | G/F | MGVF | Exempt species | LOW | S | LOW / LOW | Remove & Replace |
| 68 | Liquidambar styraciflua<br>(American sweetgum) | 5 | 3 | 250 | 350 | 3.0 | 2.1 | M | G/F | MGVF | Small specimen | LOW | M | LOW / LOW | Remove & Replace |
| 69 | Fraxinus ornus (Manna Ash) | 5 | 5 | 300 | 400 | 3.6 | 2.3 | O | P/P | MGVP | Poor health and<br>condition | LOW | S | LOW / LOW | Remove & Replace |

| No. | Botanical Name<br>(Common Name) | HT | CS | DBH<br>(mm) | DRC<br>(mm) | TPZ<br>(m) | SRZ<br>(m) | Age | Health/<br>Cond. | SRIV | Defects /<br>Comments | Risk<br>Rating | SULE | Significance /<br>Retention<br>Value) | Recommendations |
|---|---|---|---|---|---|---|---|---|---|---|---|---|---|---|---|
| 70 | Syzygium australe<br>(Brush Cherry) | 5 | 4 | 120 | 150 | 1.4 | 1.5 | Y | G/F | YGVF | Small specimen | LOW | M | LOW / LOW | Remove & Replace |

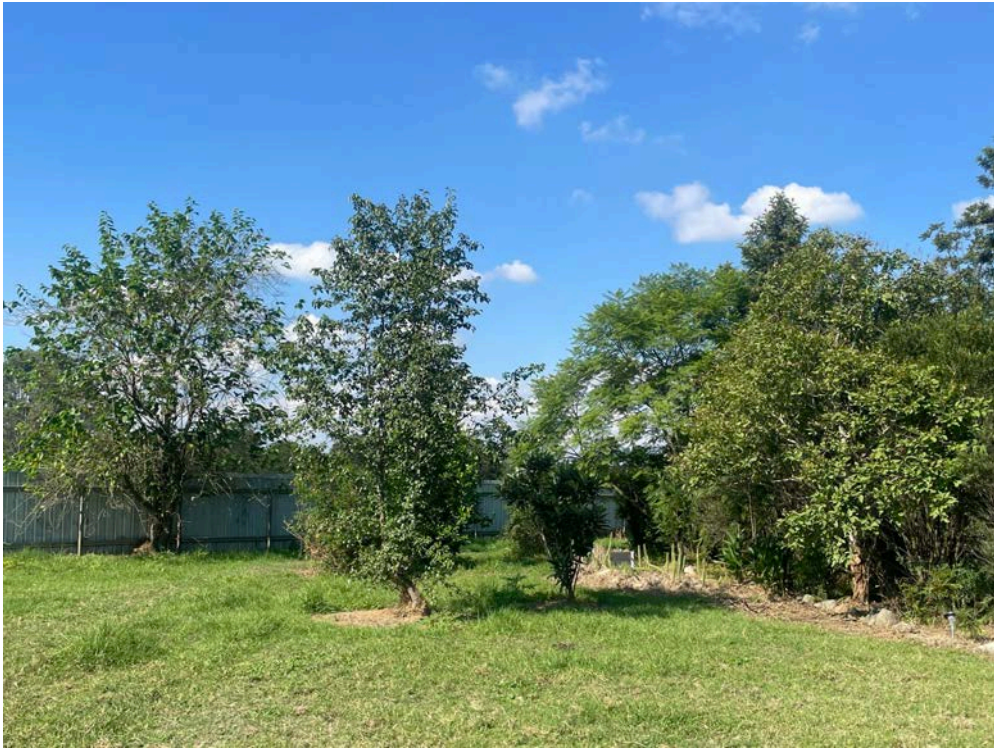
**Photo 11:** Trees 71-73

| No. | Botanical Name<br>(Common Name) | HT | CS | DBH<br>(mm) | DRC<br>(mm) | TPZ<br>(m) | SRZ<br>(m) | Age | Health/<br>Cond. | SRIV | Defects /<br>Comments | Risk<br>Rating | SULE | Significance /<br>Retention<br>Value) | Recommendations |
|---|---|---|---|---|---|---|---|---|---|---|---|---|---|---|---|
| 71 | Jacaranda mimosifolia<br>(Jacaranda) | 5 | 5 | 170 | 200 | 2.0 | 1.7 | M | G/F | MGVF | Small specimen | LOW | M | LOW / LOW | Remove & Replace |
| 73 | Grevillea robusta (Silky<br>Oak) | 8 | 3 | 140 | 160 | 1.7 | 1.5 | Y | G/G | YGVG | | LOW | L | LOW / LOW | Remove & Replace |
