Report on
Preliminary Geotechnical Investigation

Proposed Mixed-Use Development

87-91 Union Rd, 634-638 High St, 640-652 High St
Penrith

Project 85867.00
February 2020

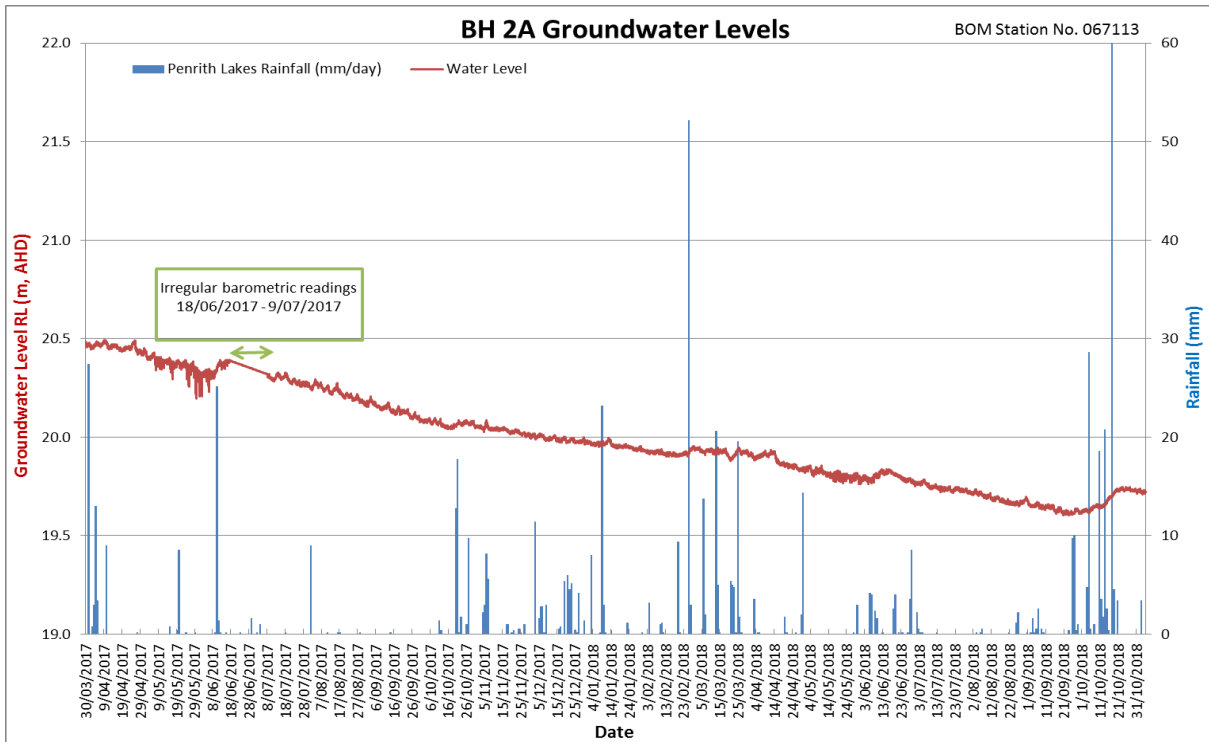
Figure 1 – Data-logger and rainfall data for BH2A

The groundwater levels obtained from the data loggers between 30 March 2017 to 5 November 2018 are presented in Figure 1 and 2 below. The results show the groundwater levels together with rainfall measurements recorded at Penrith Lakes AWS (BOM Station Number 067113, www.bom.gov.au).

The groundwater table was encountered during the field work (drilling, well development and groundwater monitoring programme) at approximately 6.5 m to 9 m depth (between RL 20.5 to RL 18.3 m AHD). Design should allow for a rise in the water table, especially in times of flooding. Records held by DP for Penrith Plaza show groundwater level fluctuations of up to 3 m. A preliminary design groundwater level of RL 23.5 m AHD is therefore recommended, however, higher short term levels may occur during flooding.
