## HIGH 618 PTY LTD

# Geotechnical Investigation

614-632 High Street, Penrith

E24300.G03  
9 August 2019

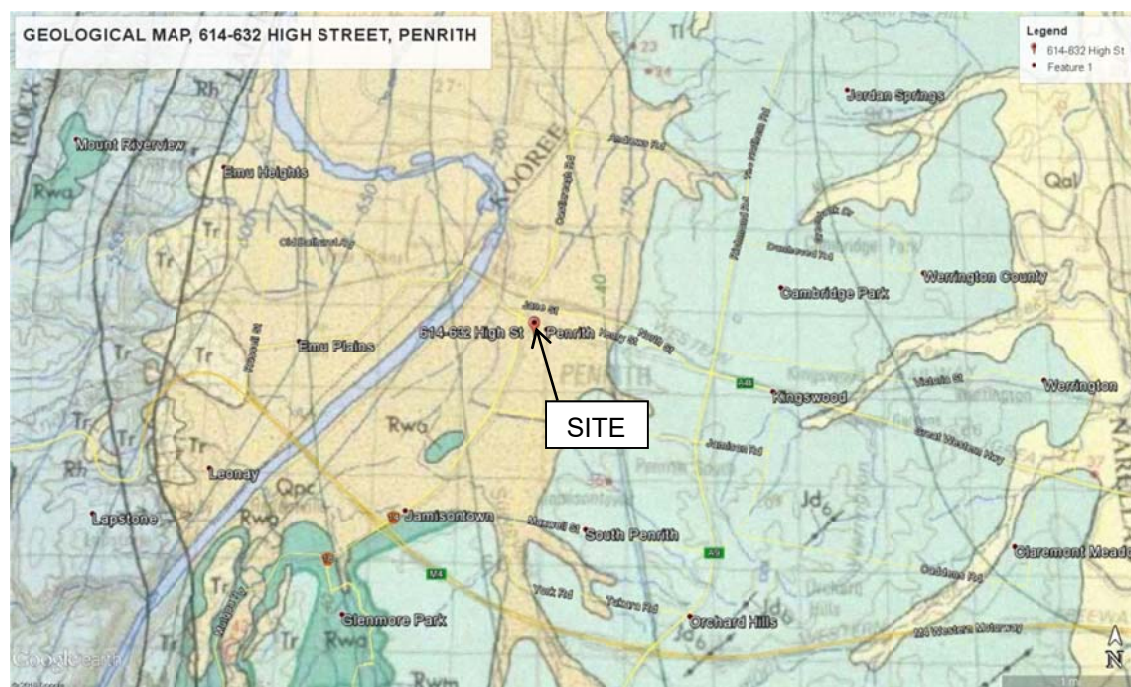
Figure 1 Excerpt of geological map showing location of site

| Attribute | Description |
|---|---|
| <b>Regional Geology</b> | Information on regional sub-surface conditions, referenced from the Department of Mineral Resources Geological Map Penrith 1:100,000 Geological Series Sheet 9030 (DMR 1991) indicates the site to be underlain by the Cranebrook Formation (Qpc). The Cranebrook Formation is of fluvial origin consisting of gravel (commonly known as 'Penrith Gravels'), sand, silt, and clay. Based on the geology, the Cranebrook Formation is likely to be further underlain by Wianamatta Group shale and sandstone. An excerpt from the geological map is shown below in <b>Figure 1</b> . |

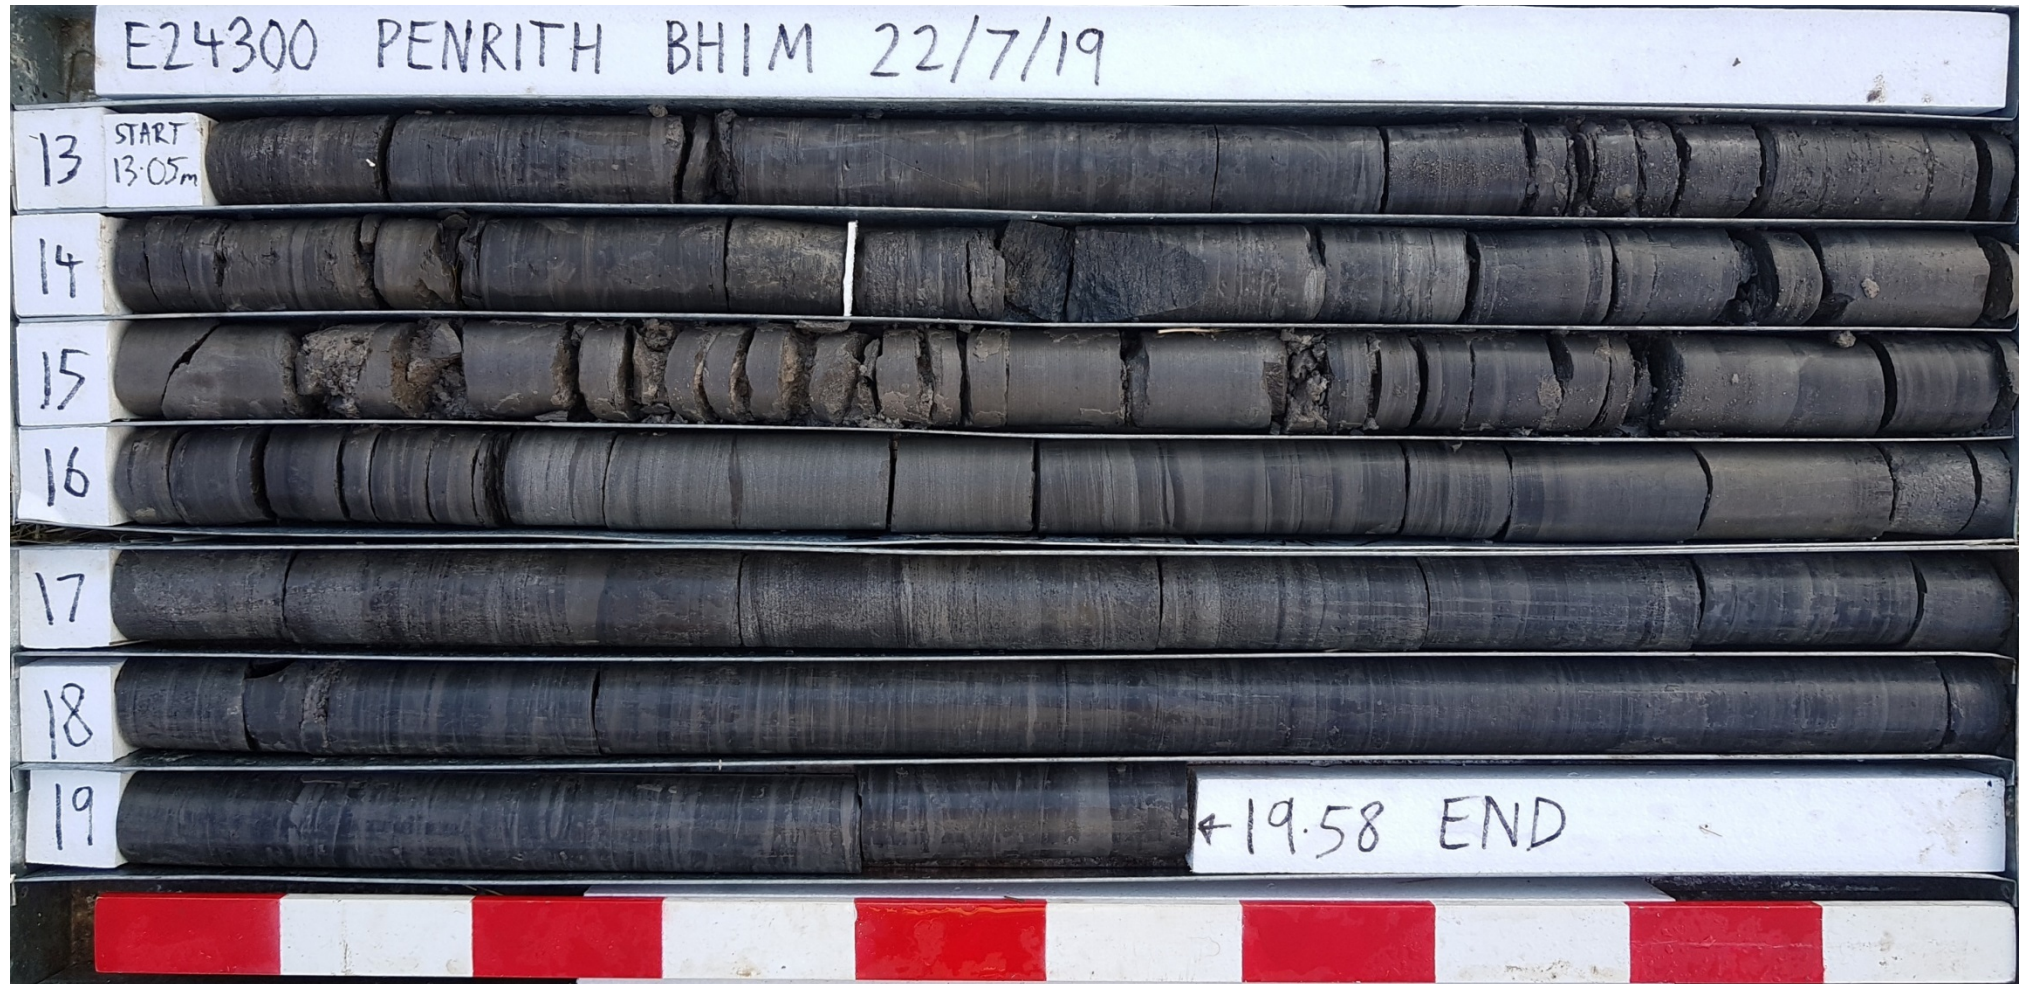
| <b>Job No.</b> | E24300.G03 | <b>Logged</b> | DS | <b>Date</b> 22 / 07 / 2019 |
| <b>Client</b> | High 618 Pty Ltd | <b>Box</b> | 1-2 of 2 | <b>Checked</b> NJ <b>Date</b> 07 / 08 / 2019 |

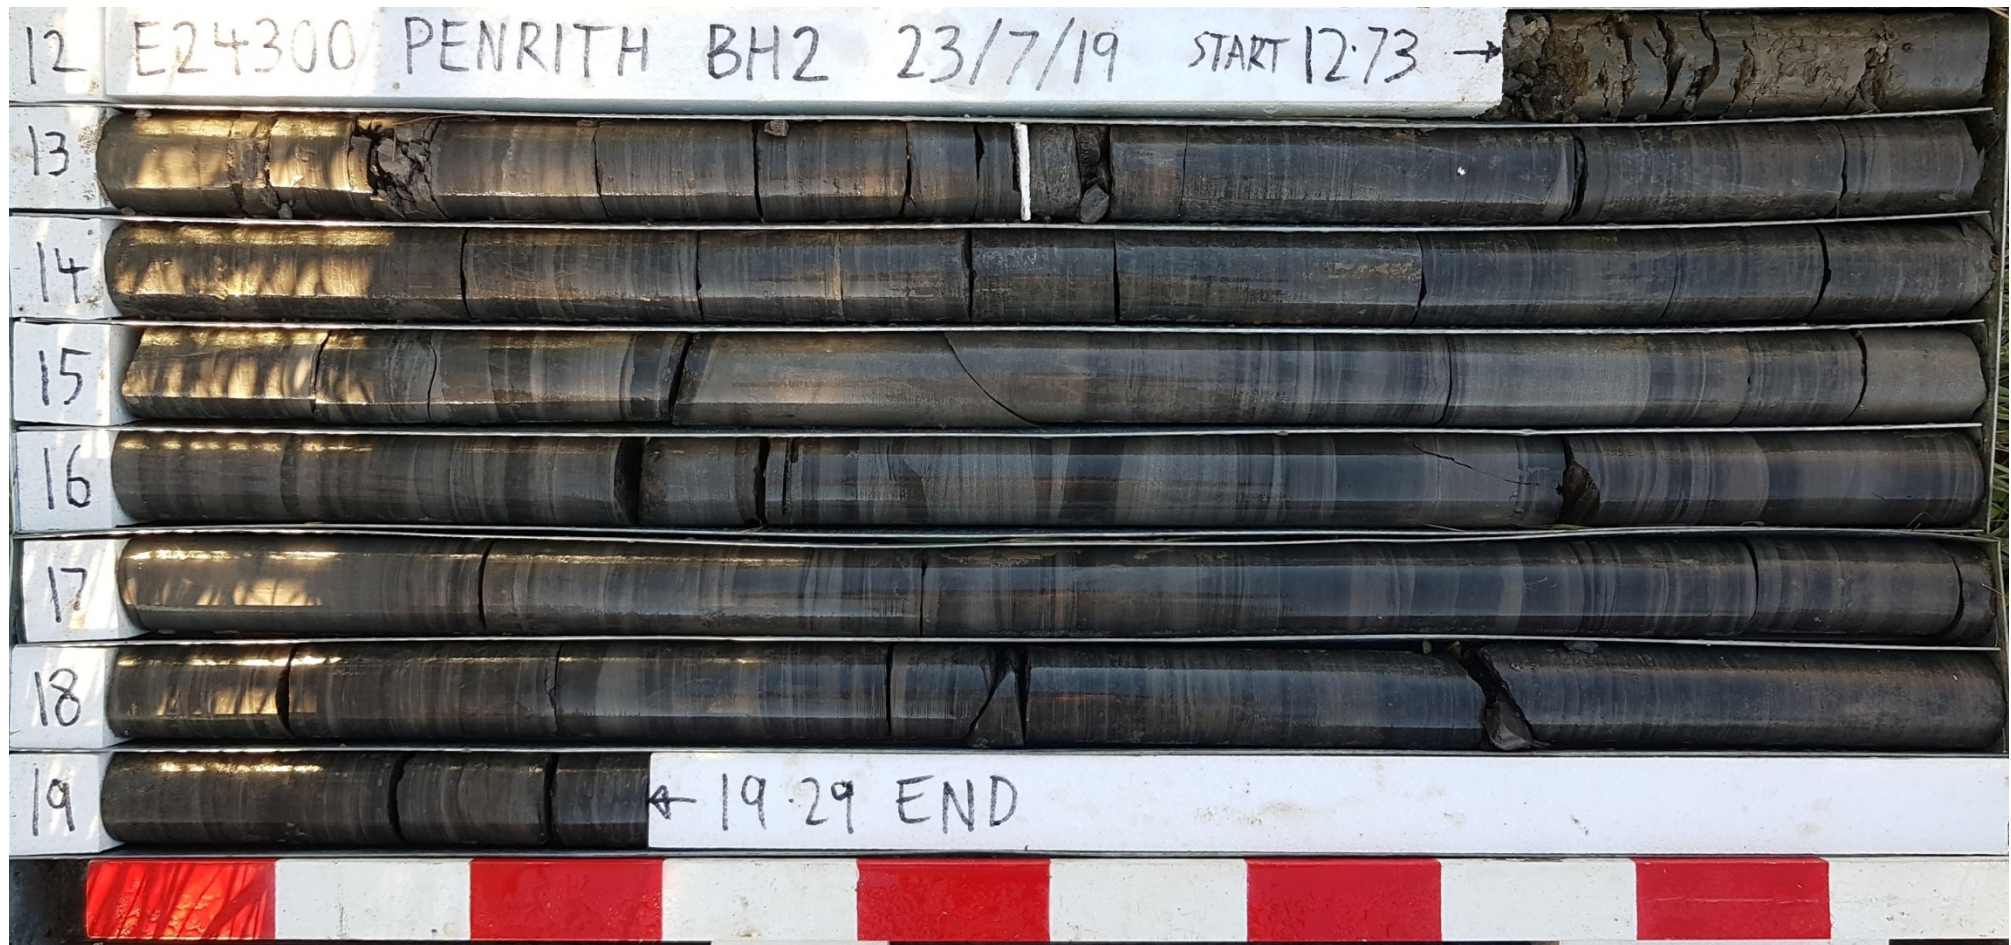
| <b>Job No.</b> | E24300.G03 | <b>Inclination</b> | -90° | <b>Logged</b> | DS <b>Date</b> 23 / 07 / 2019 |
| <b>Client</b> | High 618 Pty Ltd | <b>Box</b> | 1-2 of 2 | <b>Checked</b> | NJ <b>Date</b> 07 / 08 / 2019 |

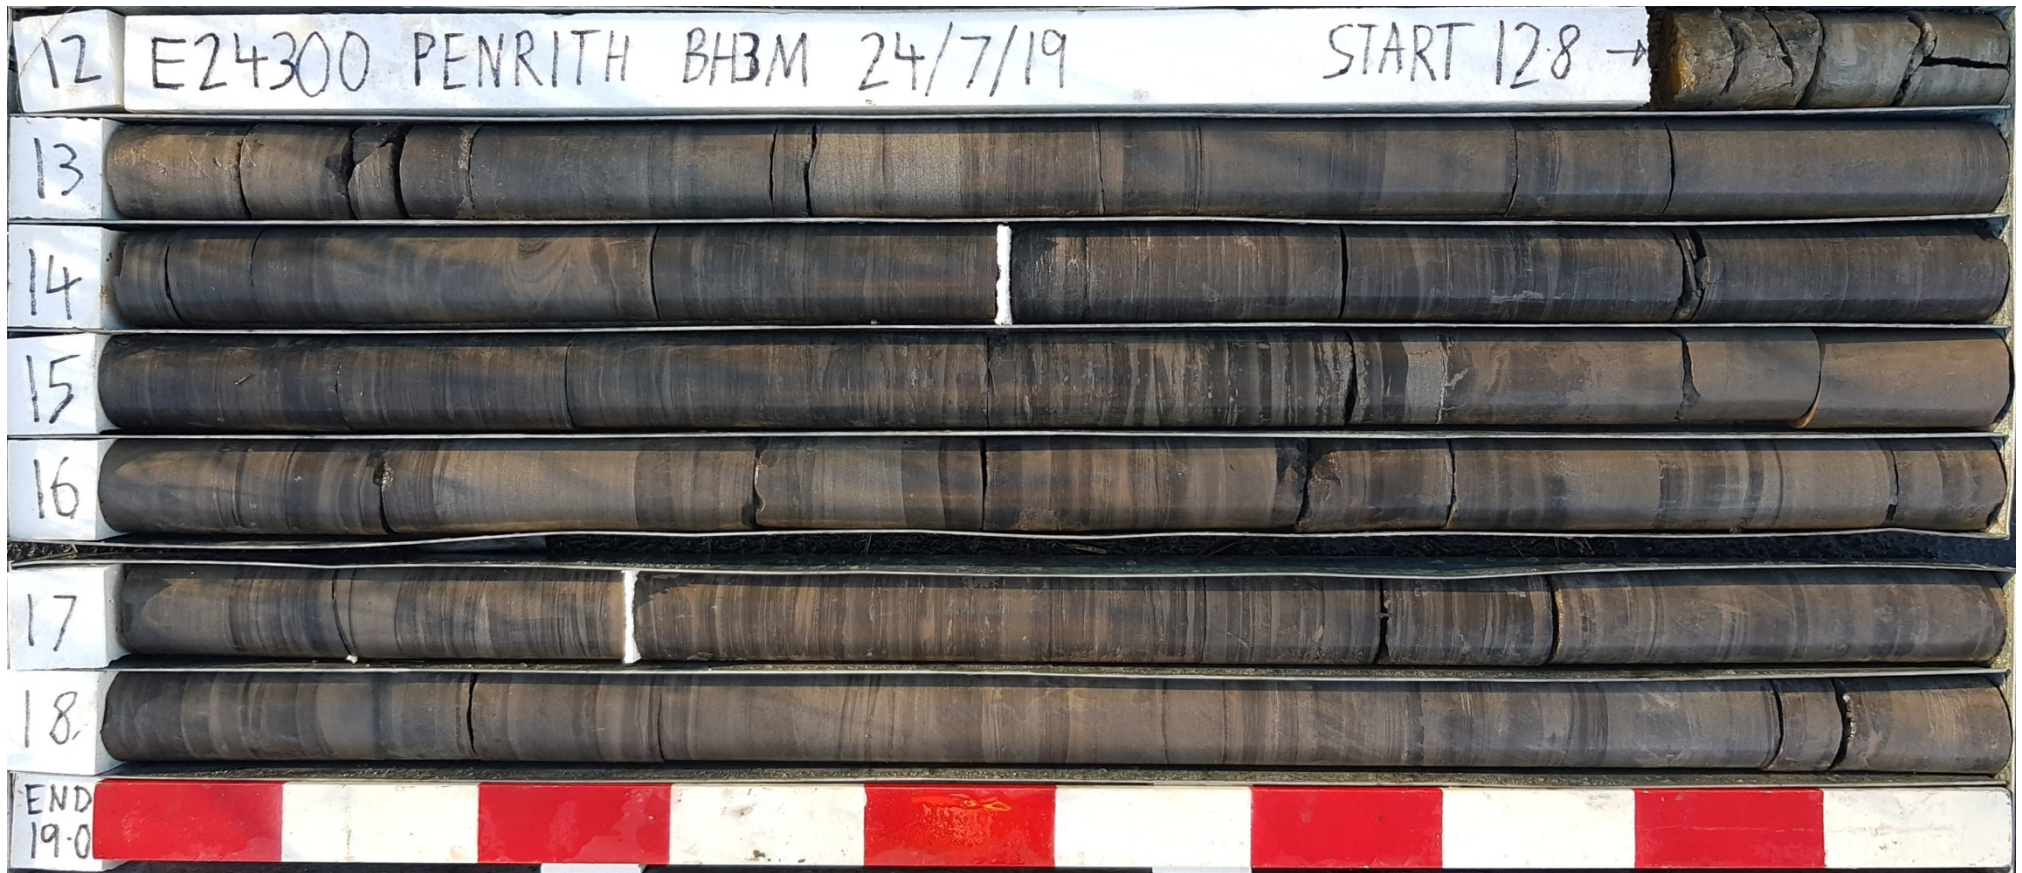
| <b>Job No.</b> | E24300.G03 | <b>Inclination</b> | -90° | <b>Logged</b> | DS <b>Date</b> 24 / 07 / 2019 |
| <b>Client</b> | High 618 Pty Ltd | <b>Box</b> | 1-2 of 2 | <b>Checked</b> | NJ <b>Date</b> 07 / 08 / 2019 |

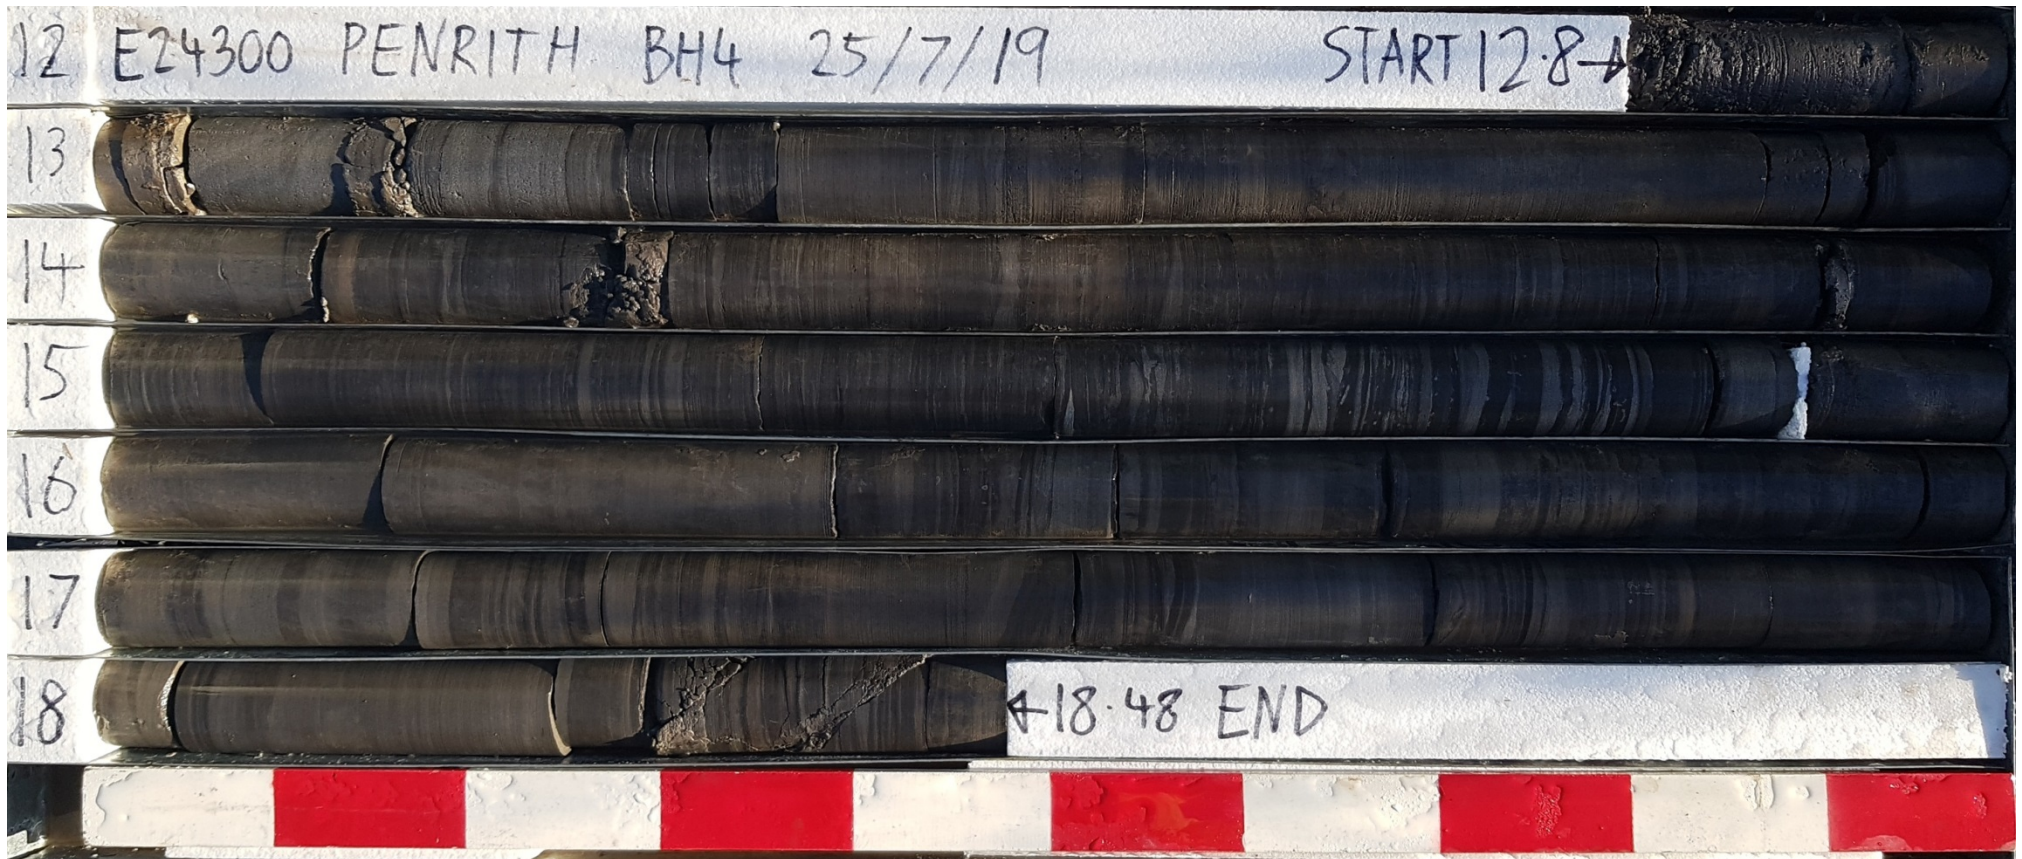
| <b>Job No.</b> | E24300.G03 | <b>Inclination</b> | -90° | <b>Logged</b> | DS <b>Date</b> 25 / 07 / 2019 |
| <b>Client</b> | High 618 Pty Ltd | <b>Box</b> | 1-2 of 2 | <b>Checked</b> | NJ <b>Date</b> 07 / 08 / 2019 |

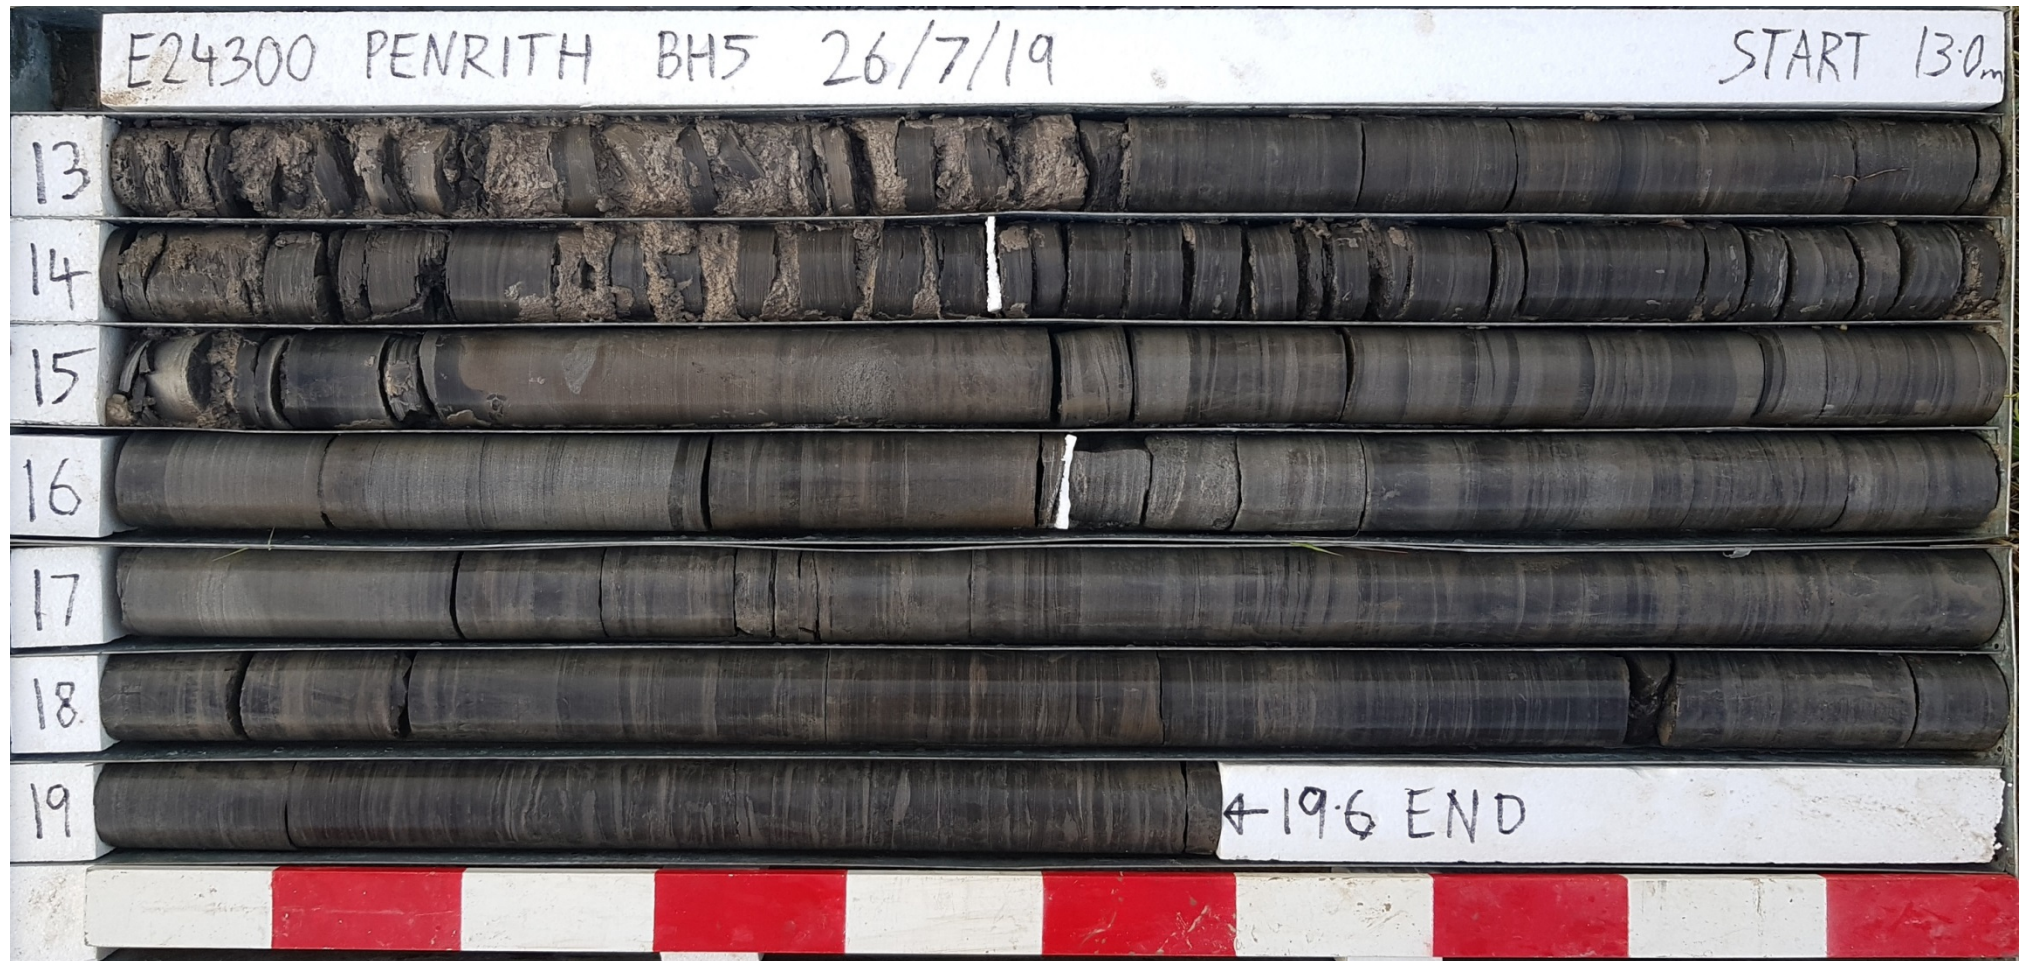
| <b>Job No.</b> | E24300.G03 | <b>Logged</b> | DS | <b>Date</b> 26 / 07 / 2019 |
| <b>Client</b> | High 618 Pty Ltd | <b>Box</b> | 1-2 of 2 | <b>Checked</b> NJ <b>Date</b> 07 / 08 / 2019 |

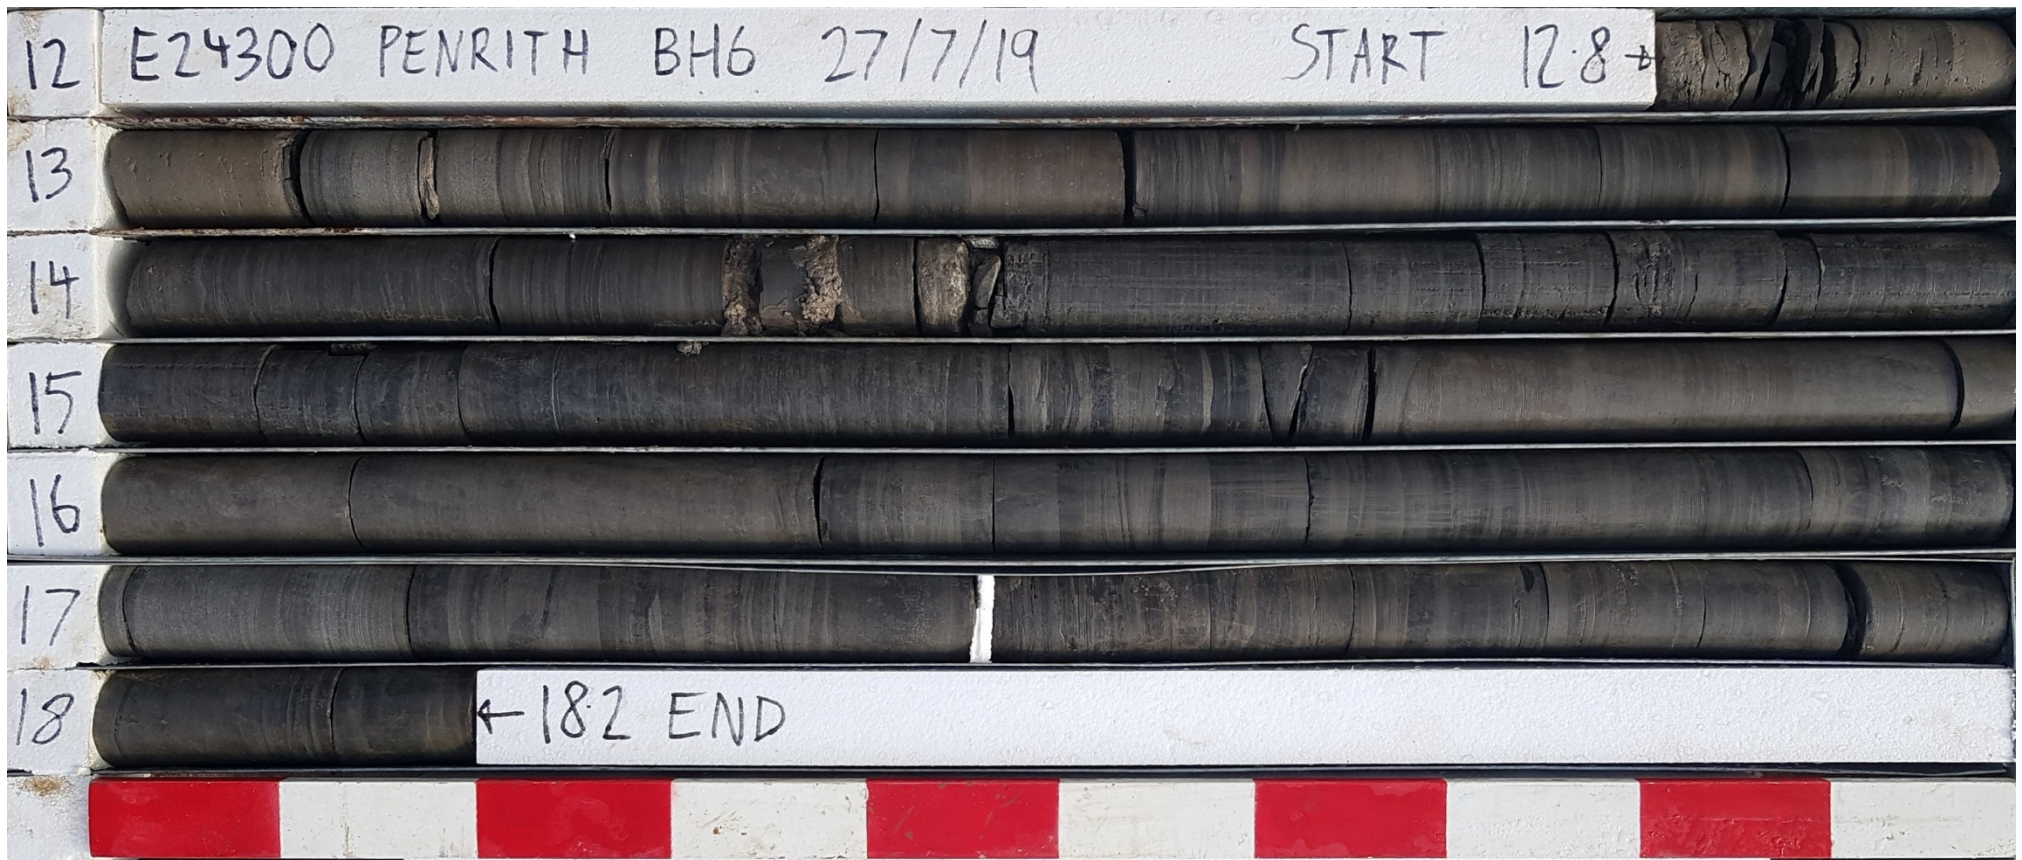
| <b>Job No.</b> | E24300.G03 | <b>Inclination</b> | -90° | <b>Logged</b> | DS <b>Date</b> 27 / 07 / 2019 |
| <b>Client</b> | High 618 Pty Ltd | <b>Box</b> | 1-2 of 2 | <b>Checked</b> | NJ <b>Date</b> 07 / 08 / 2019 |

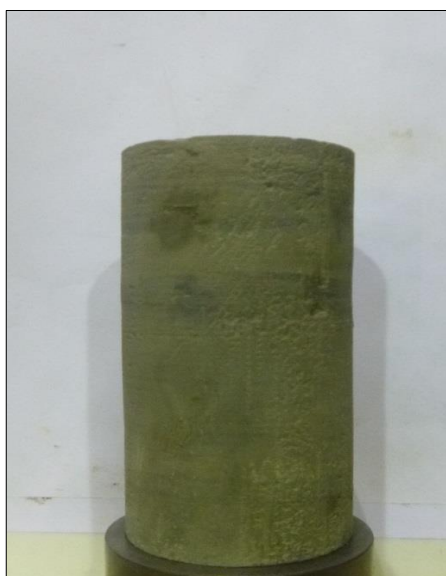
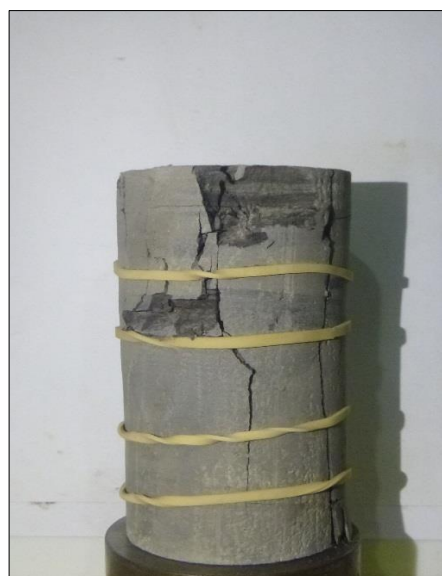
## Uniaxial Compressive Strength      22      MPa

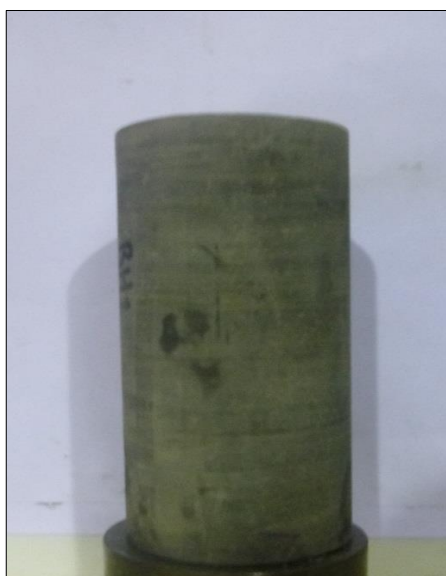
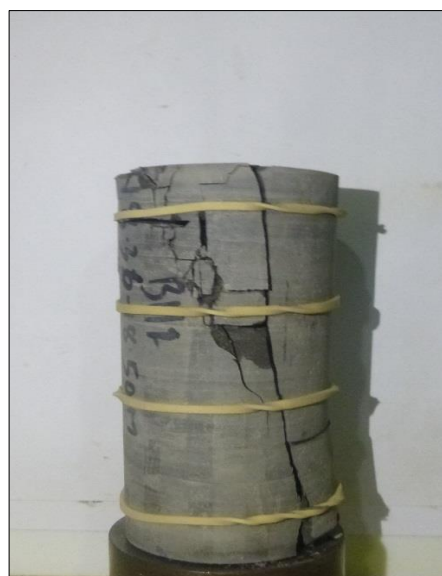
## Uniaxial Compressive Strength      17      MPa

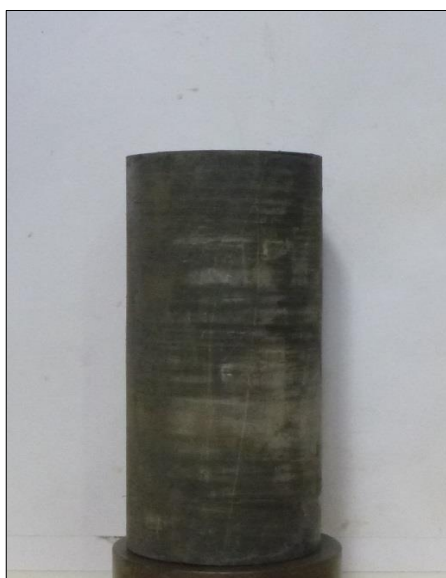
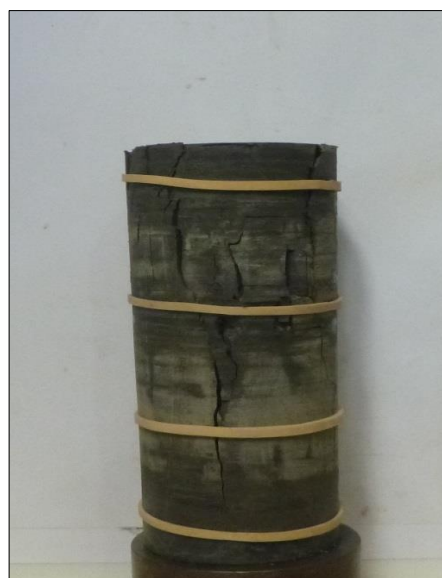
## Uniaxial Compressive Strength      15      MPa

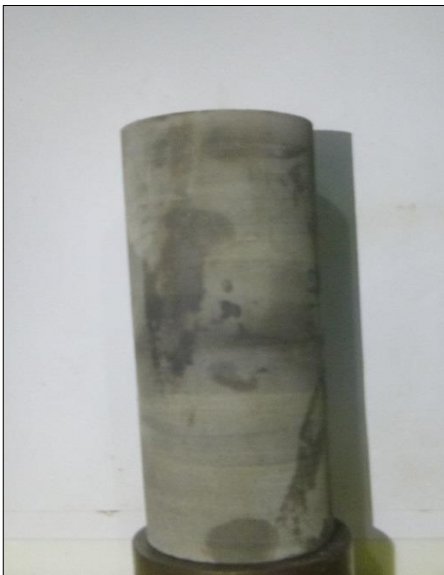
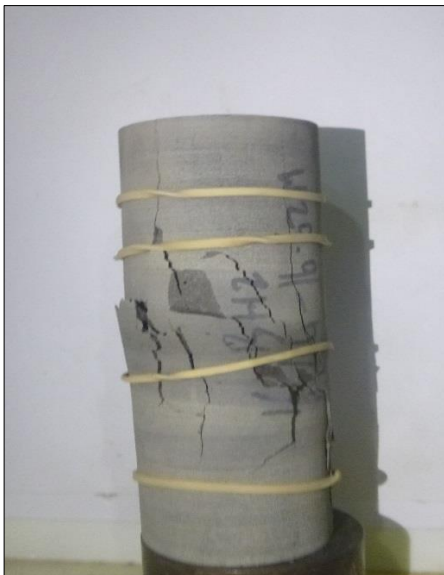
| Uniaxial Compressive Strength | | | |
|---|---|---|---|
| <b>Uniaxial Compressive Strength      31      MPa</b> | | | |

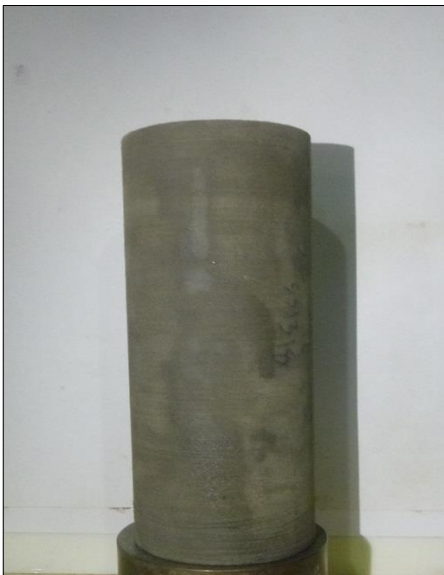
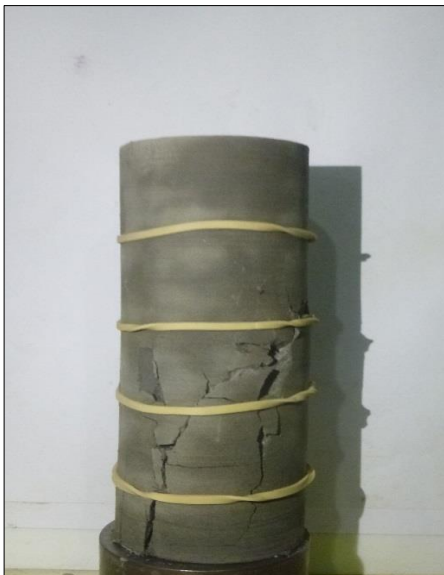
| Uniaxial Compressive Strength | | | |
|---|---|---|---|
| <b>Uniaxial Compressive Strength      27      MPa</b> | | | |

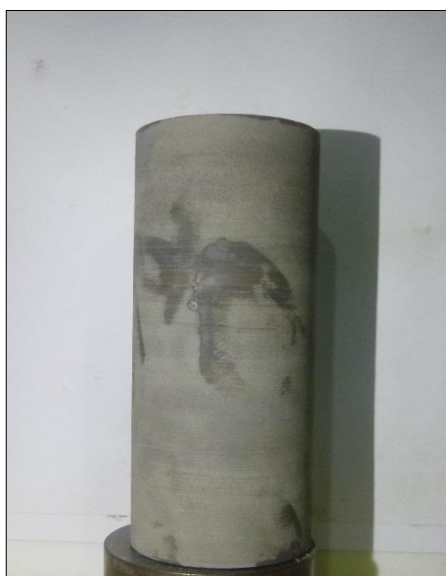
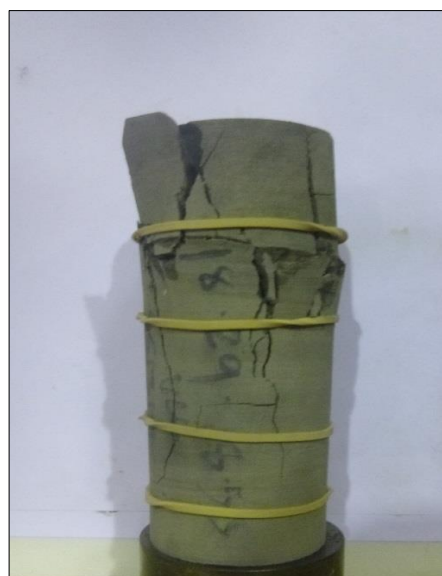
## Uniaxial Compressive Strength      31      MPa

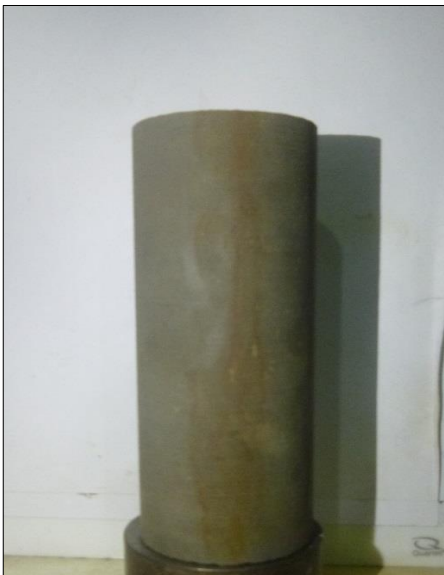
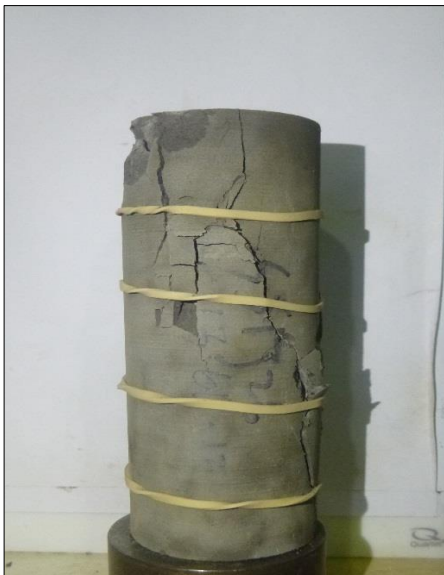
| Uniaxial Compressive Strength | | | |
|---|---|---|---|
| <b>Uniaxial Compressive Strength      26      MPa</b> | | | |

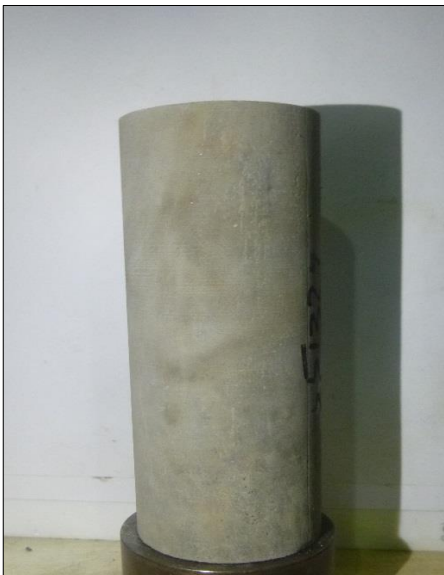
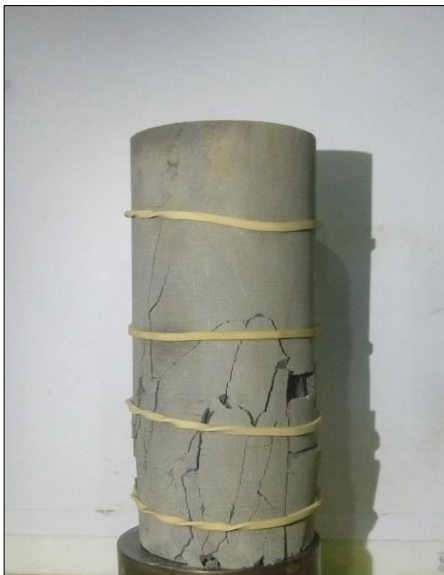
| Uniaxial Compressive Strength | | | |
|---|---|---|---|
| <b>Uniaxial Compressive Strength      47      MPa</b> | | | |

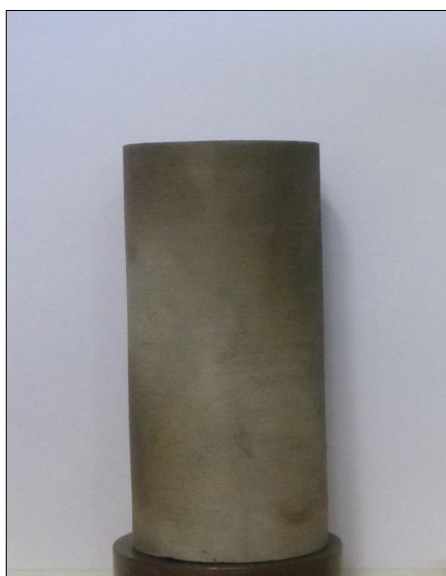
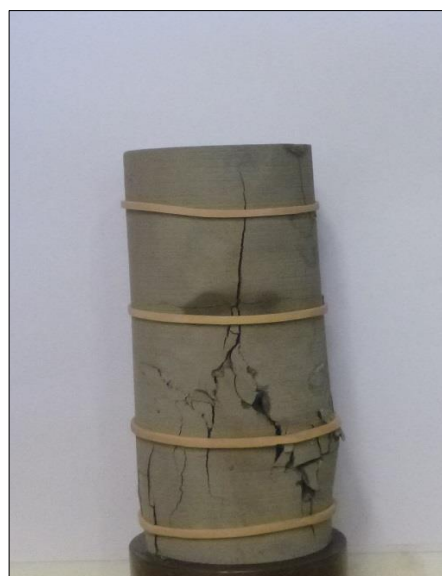
## Uniaxial Compressive Strength      28      MPa

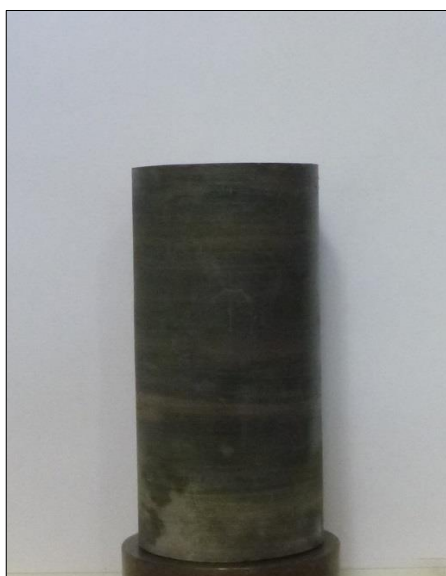
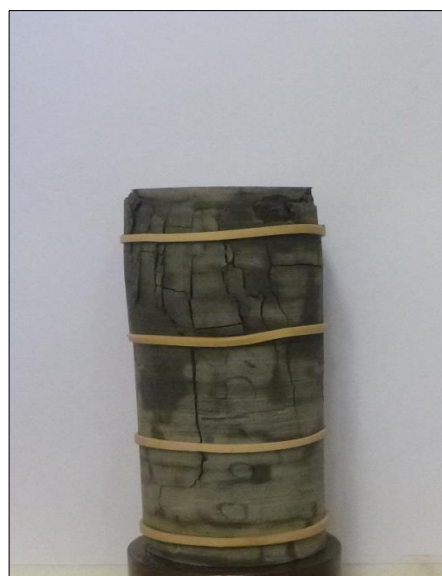
## Uniaxial Compressive Strength      15      MPa

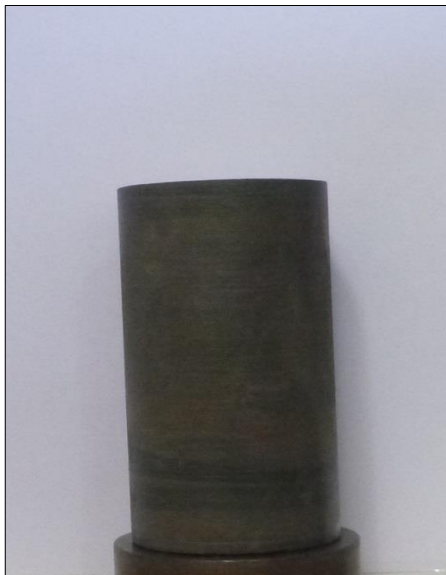
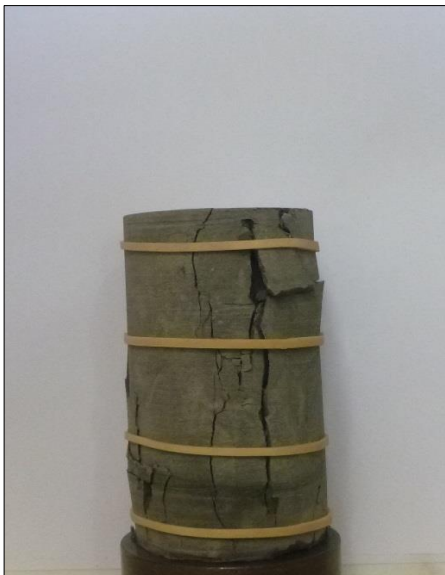
| Uniaxial Compressive Strength | | | |
|---|---|---|---|
| <b>Uniaxial Compressive Strength      19      MPa</b> | | | |

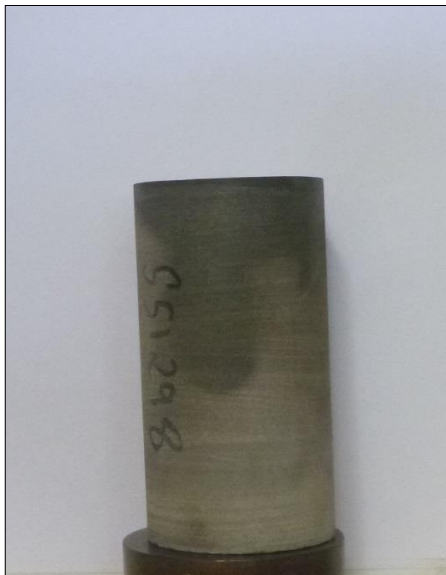
| Uniaxial Compressive Strength | | | |
|---|---|---|---|
| <b>Uniaxial Compressive Strength      51.7      MPa</b> | | | |
