CES Document Reference:  
CES161003-HC-AH

**RE: HPE CM: LCC: 18 Randwick Close Casula Review**

Consulting Earth Scientists Pty Ltd (CES) was commissioned by Centurion Group Pty Ltd (the Client) to carry out groundwater sampling and assessment at 18 Randwick Close, Casula, New South Wales (NSW) (the Site) in order to respond to two issues raised by Liverpool City Council in their letter *RE: HPE CM: LCC: 18 Randwick Close Casula Review* dated 23 October 2020.

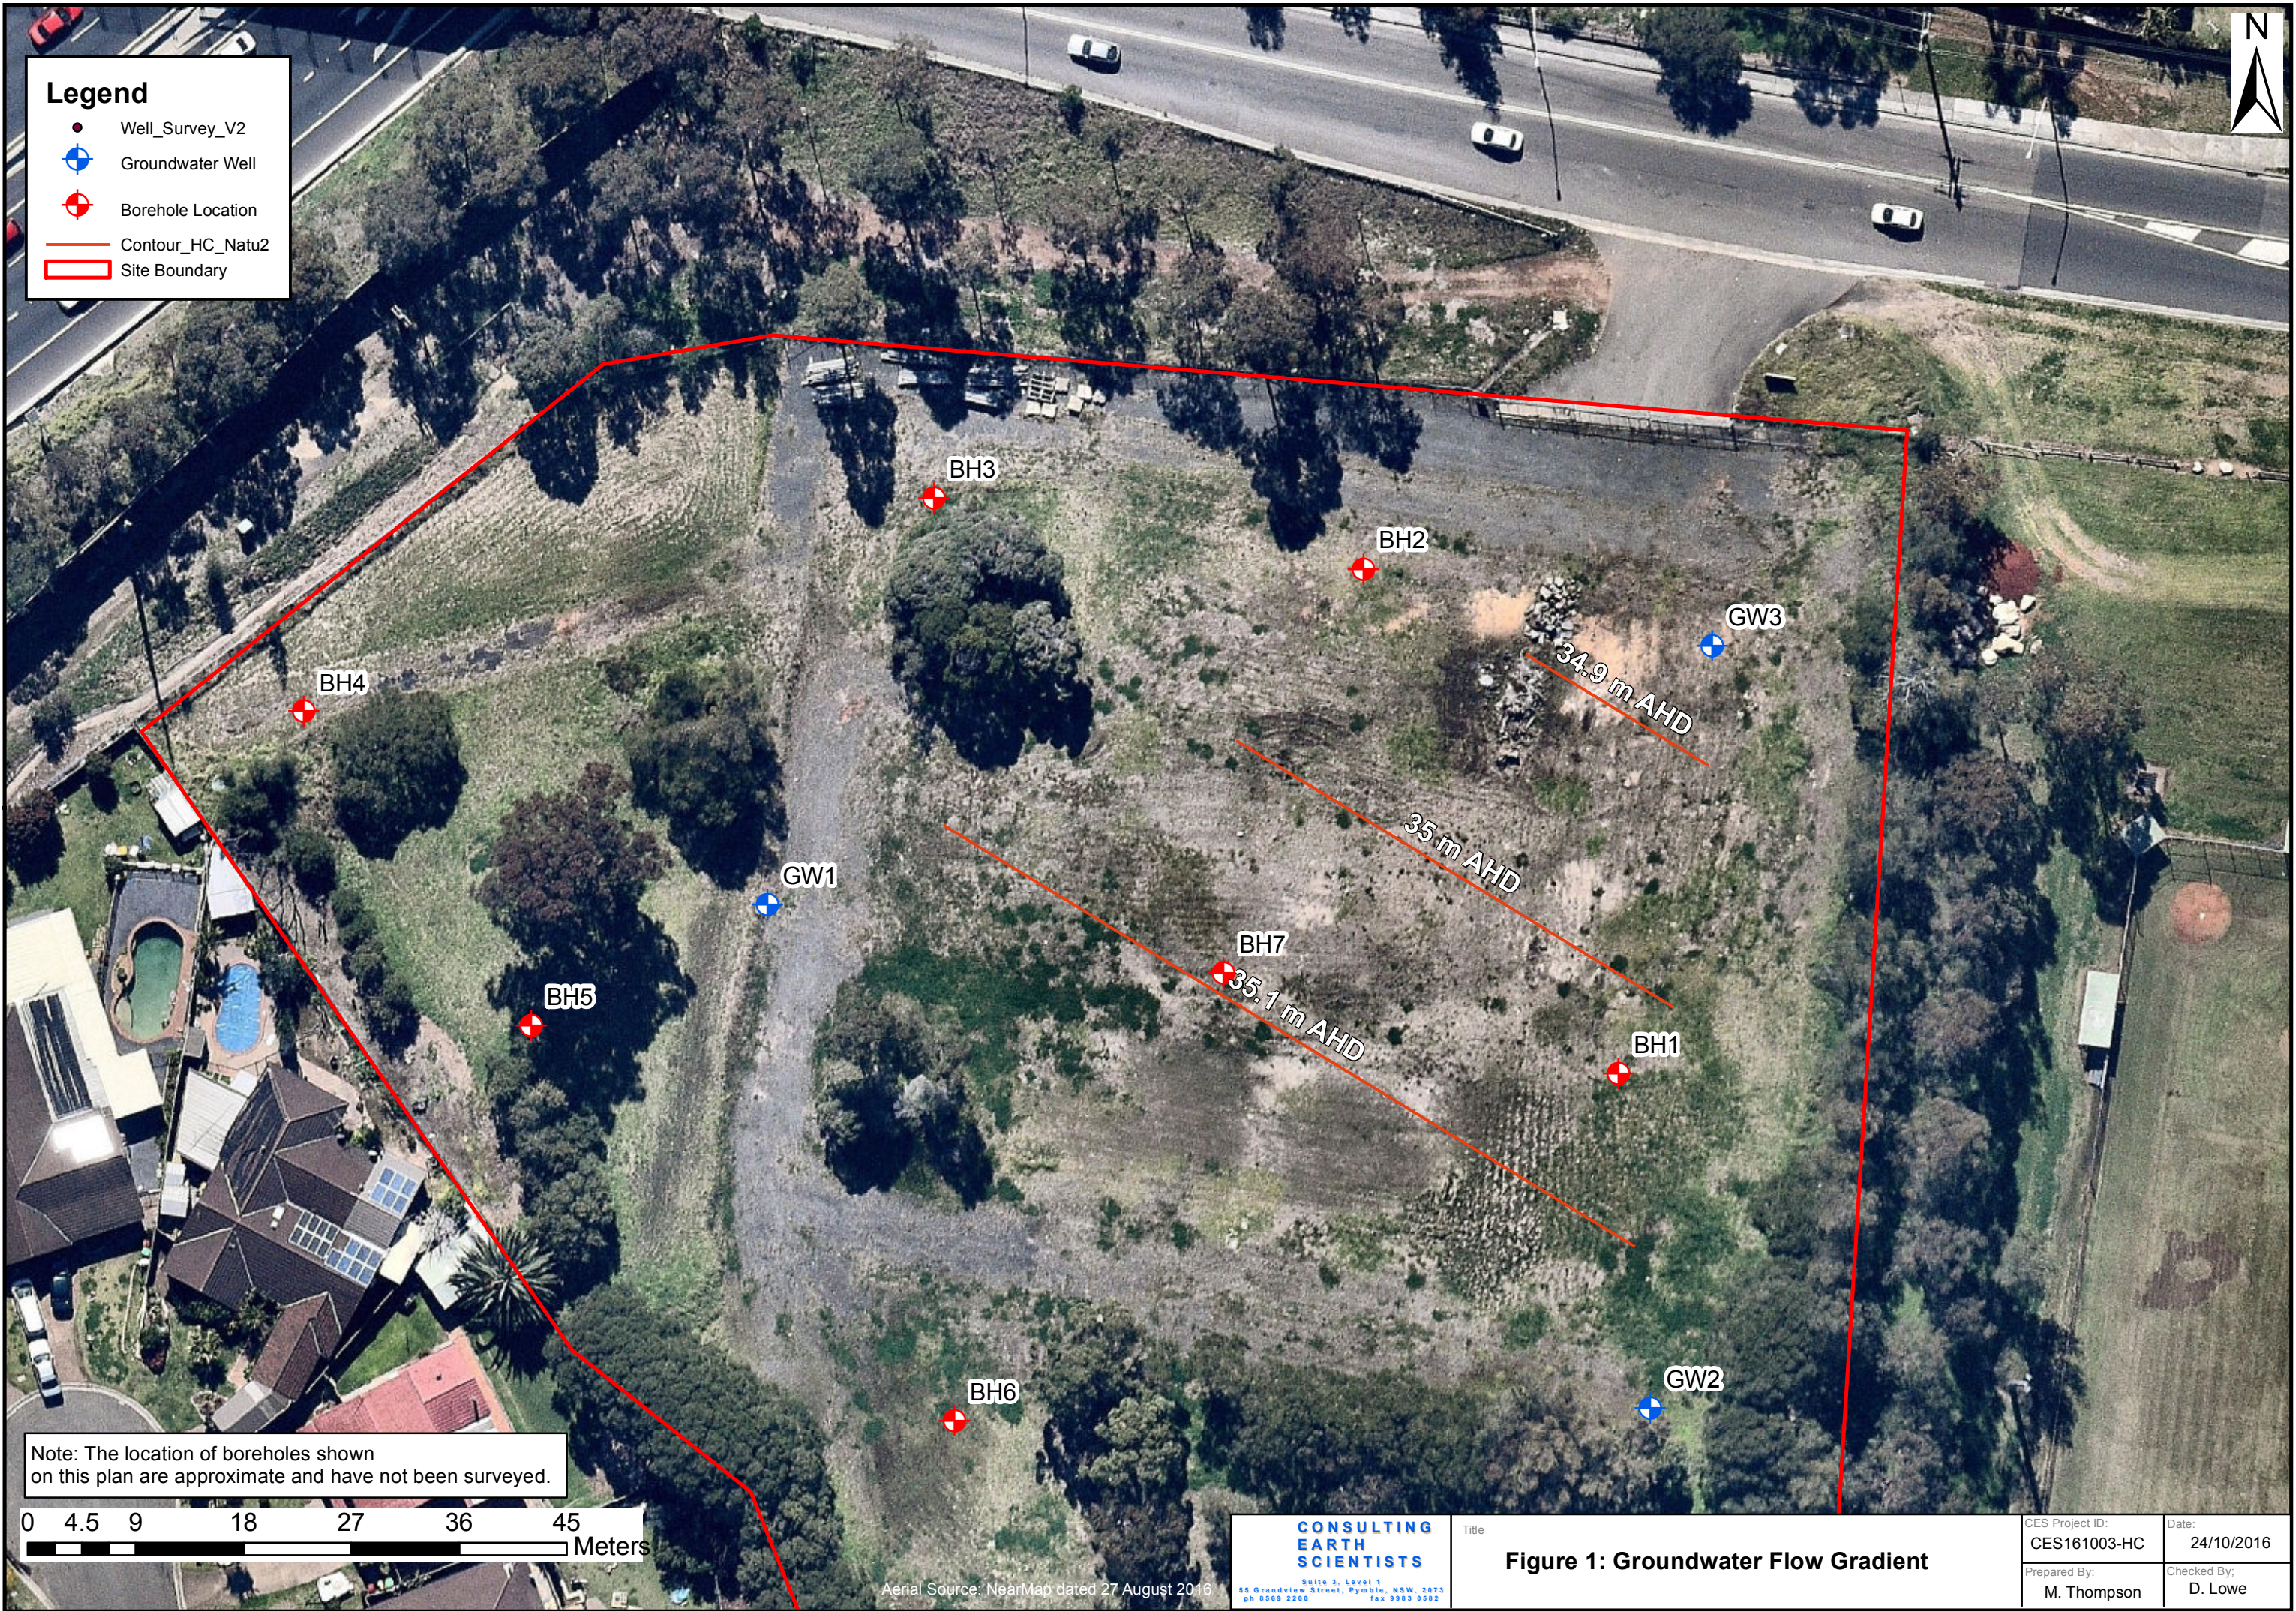
Groundwater contours have been prepared based on the measured groundwater elevations using the nearest neighbour method and are presented on Figure 1. Groundwater contours indicate the groundwater flow direction is likely to be towards the north-east.

Based on the groundwater contours presented on Figure 1, the direction of groundwater flow is likely to be to the north-east. This differs from the groundwater flow direction assumed in the DSI (CES,2020), which assessed the likely groundwater flow to be to the east based on site topography and nearby water bodies.

- Groundwater flow has been calculated (using gauging and survey data from the 23 November and 22 December 2020, respectively) to be towards the north-east;
- Copper is not a contaminant generally associated with the Site's main historical activity of poultry processing. That is to say that an onsite potential source of copper has not been identified.

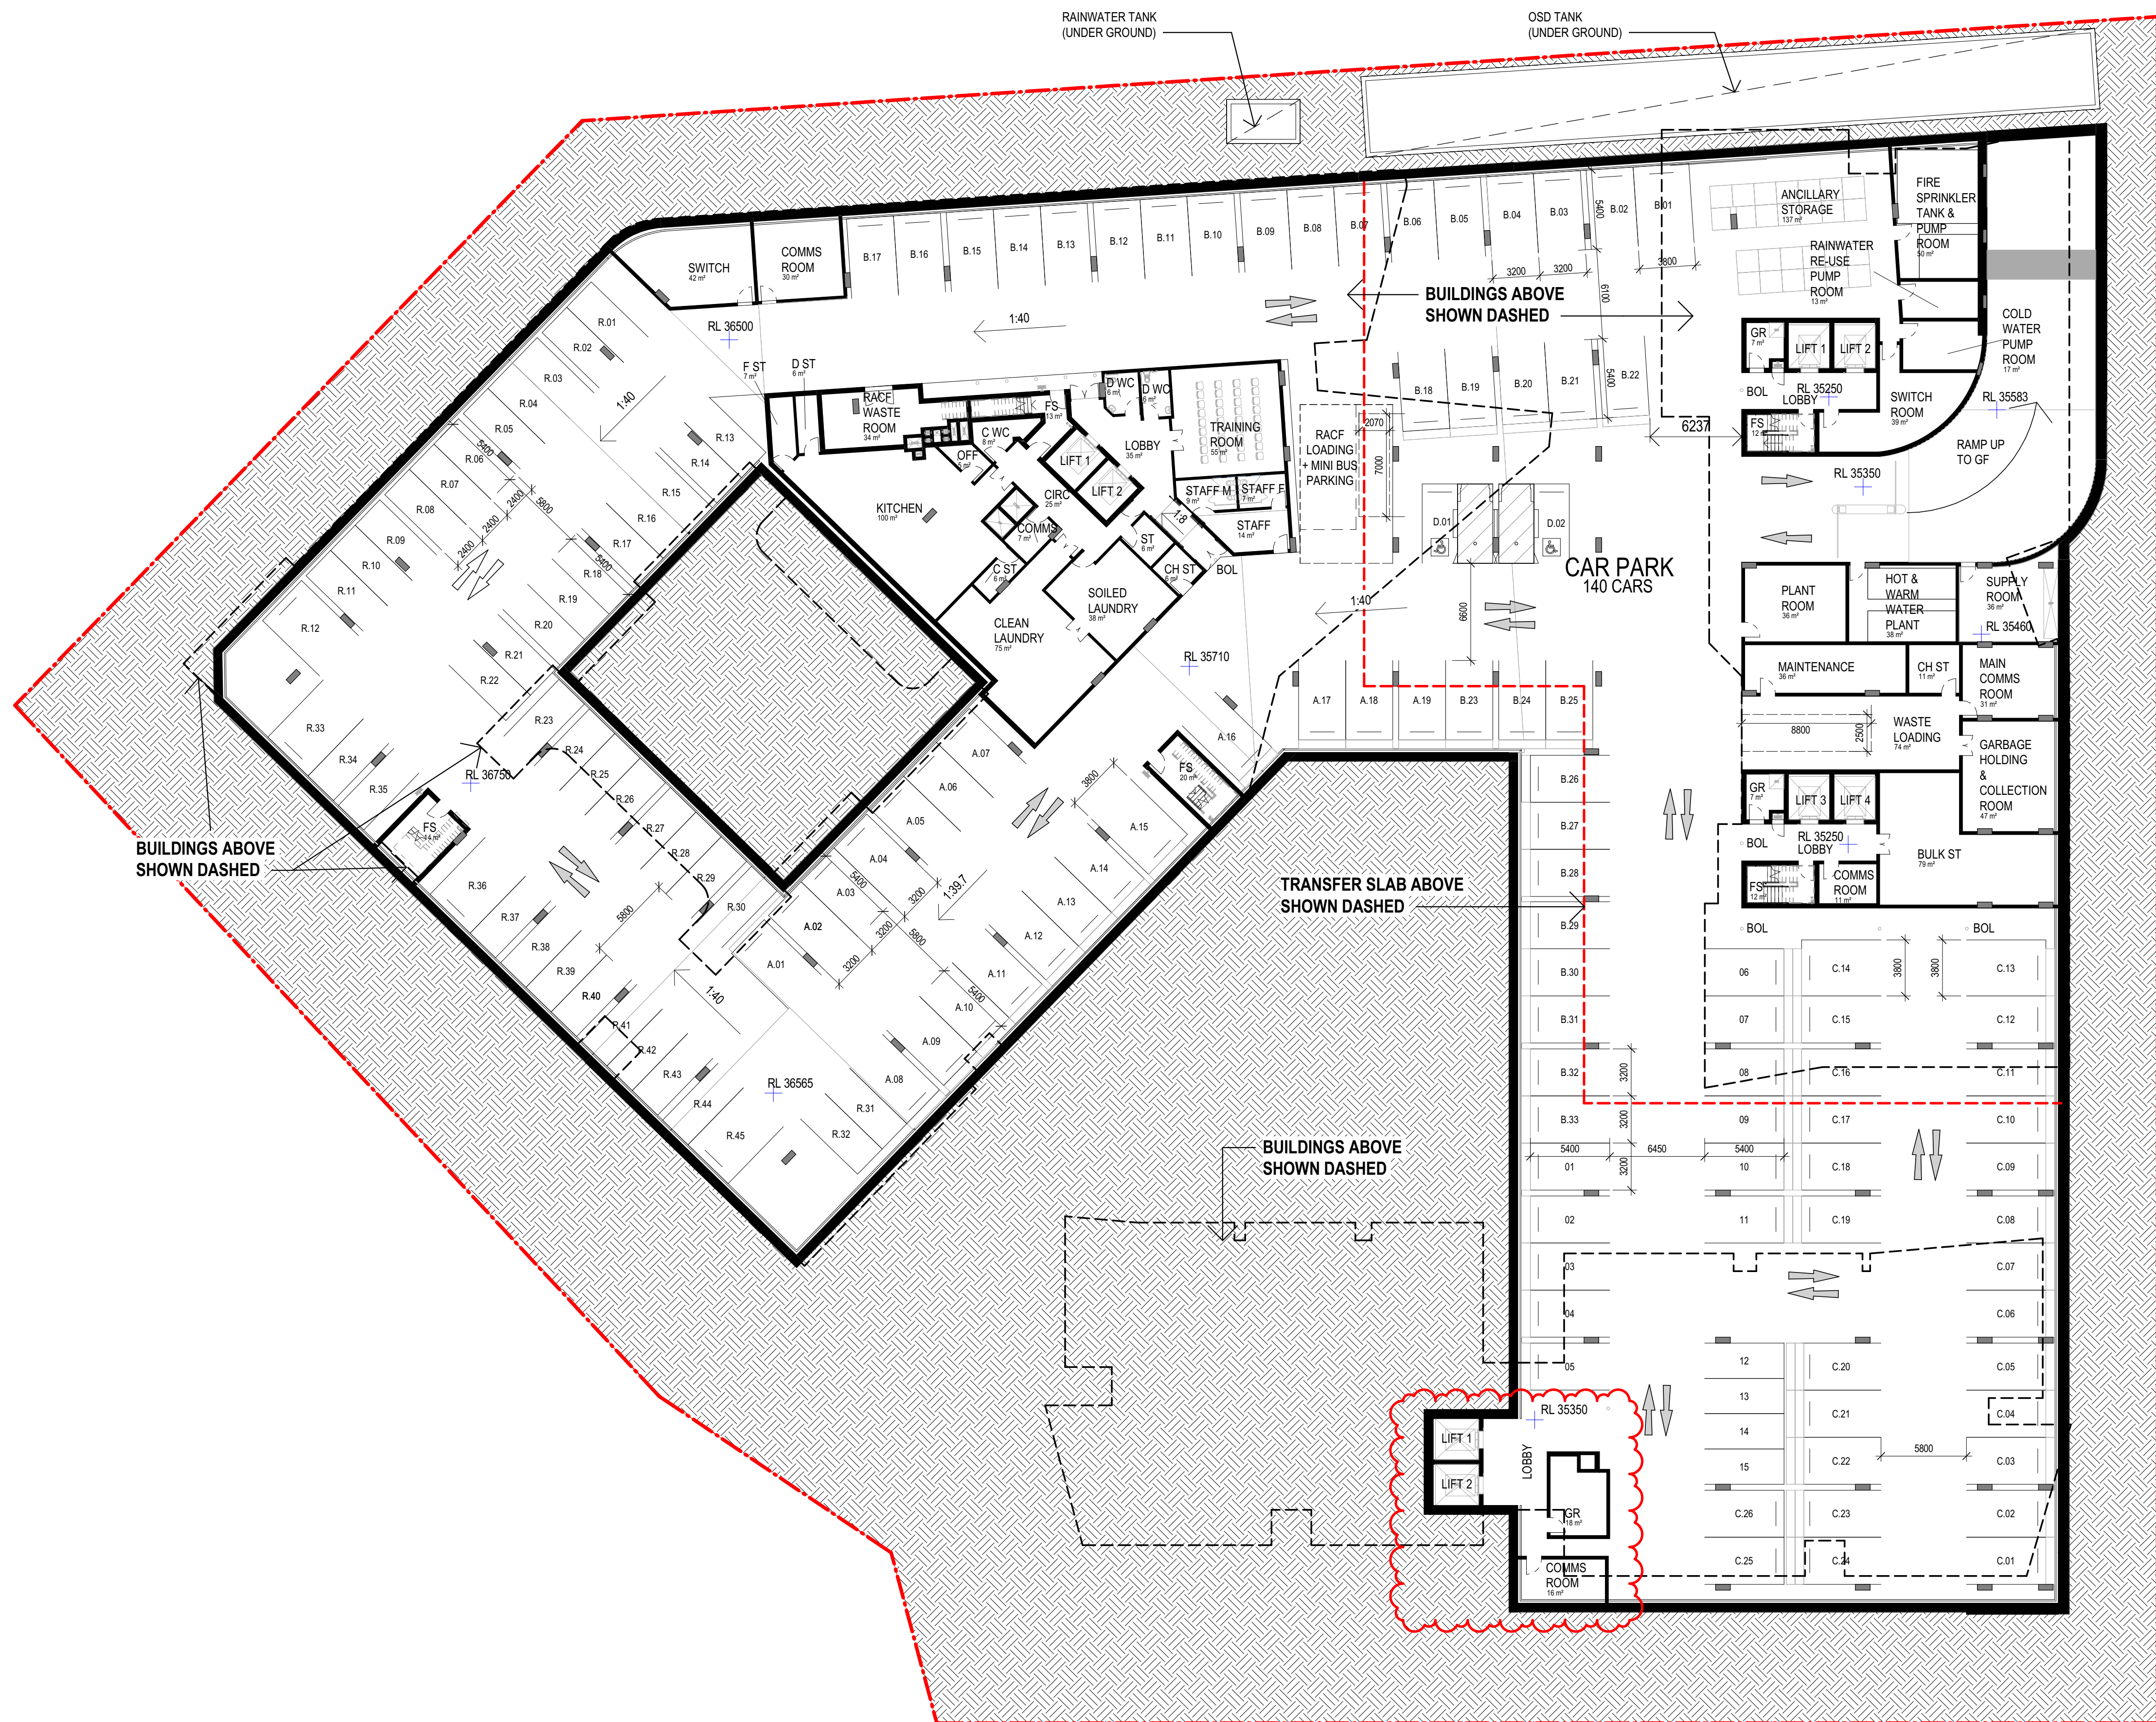
Groundwater gauging results indicate groundwater levels range between 34.83 and 35.29 mAHD. Development plans (Project No. 2016098, Drawing No. DA-109, FLOOR PLAN –

BASEMENT 1, provided in Appendix E) indicate that the lowest point of the proposed basement is to be constructed at 35.35 m AHD, 0.06 m above the highest groundwater elevation detected. As such based on the measured groundwater levels, discharge of groundwater is highly unlikely to be required.

- The basement floor slab and lowest 1 m of the basement walls will be water-proofed;
- Any localised sumps or shafts extending below the groundwater table will be fully tanked;
- In the highly unlikely event of groundwater seepage into the basement from above 1 m from the basement floor, approximately 1.0 m above the recorded groundwater level, suitable seepage collection infrastructure (Agricultural Lines) is proposed to collect seepage. Seepage water will be combined with site stormwater prior to discharge; and
- Groundwater seepage into the basement is considered highly unlikely, given the low permeability formation encountered at the site, the groundwater elevation detected below the basement floor slab and the treatment of basement slab and walls.
