# Preliminary Site Investigation: Proposed Warehouse 28 Yarrunga Street, Prestons, NSW

P1907209JR01V01  
September 2019

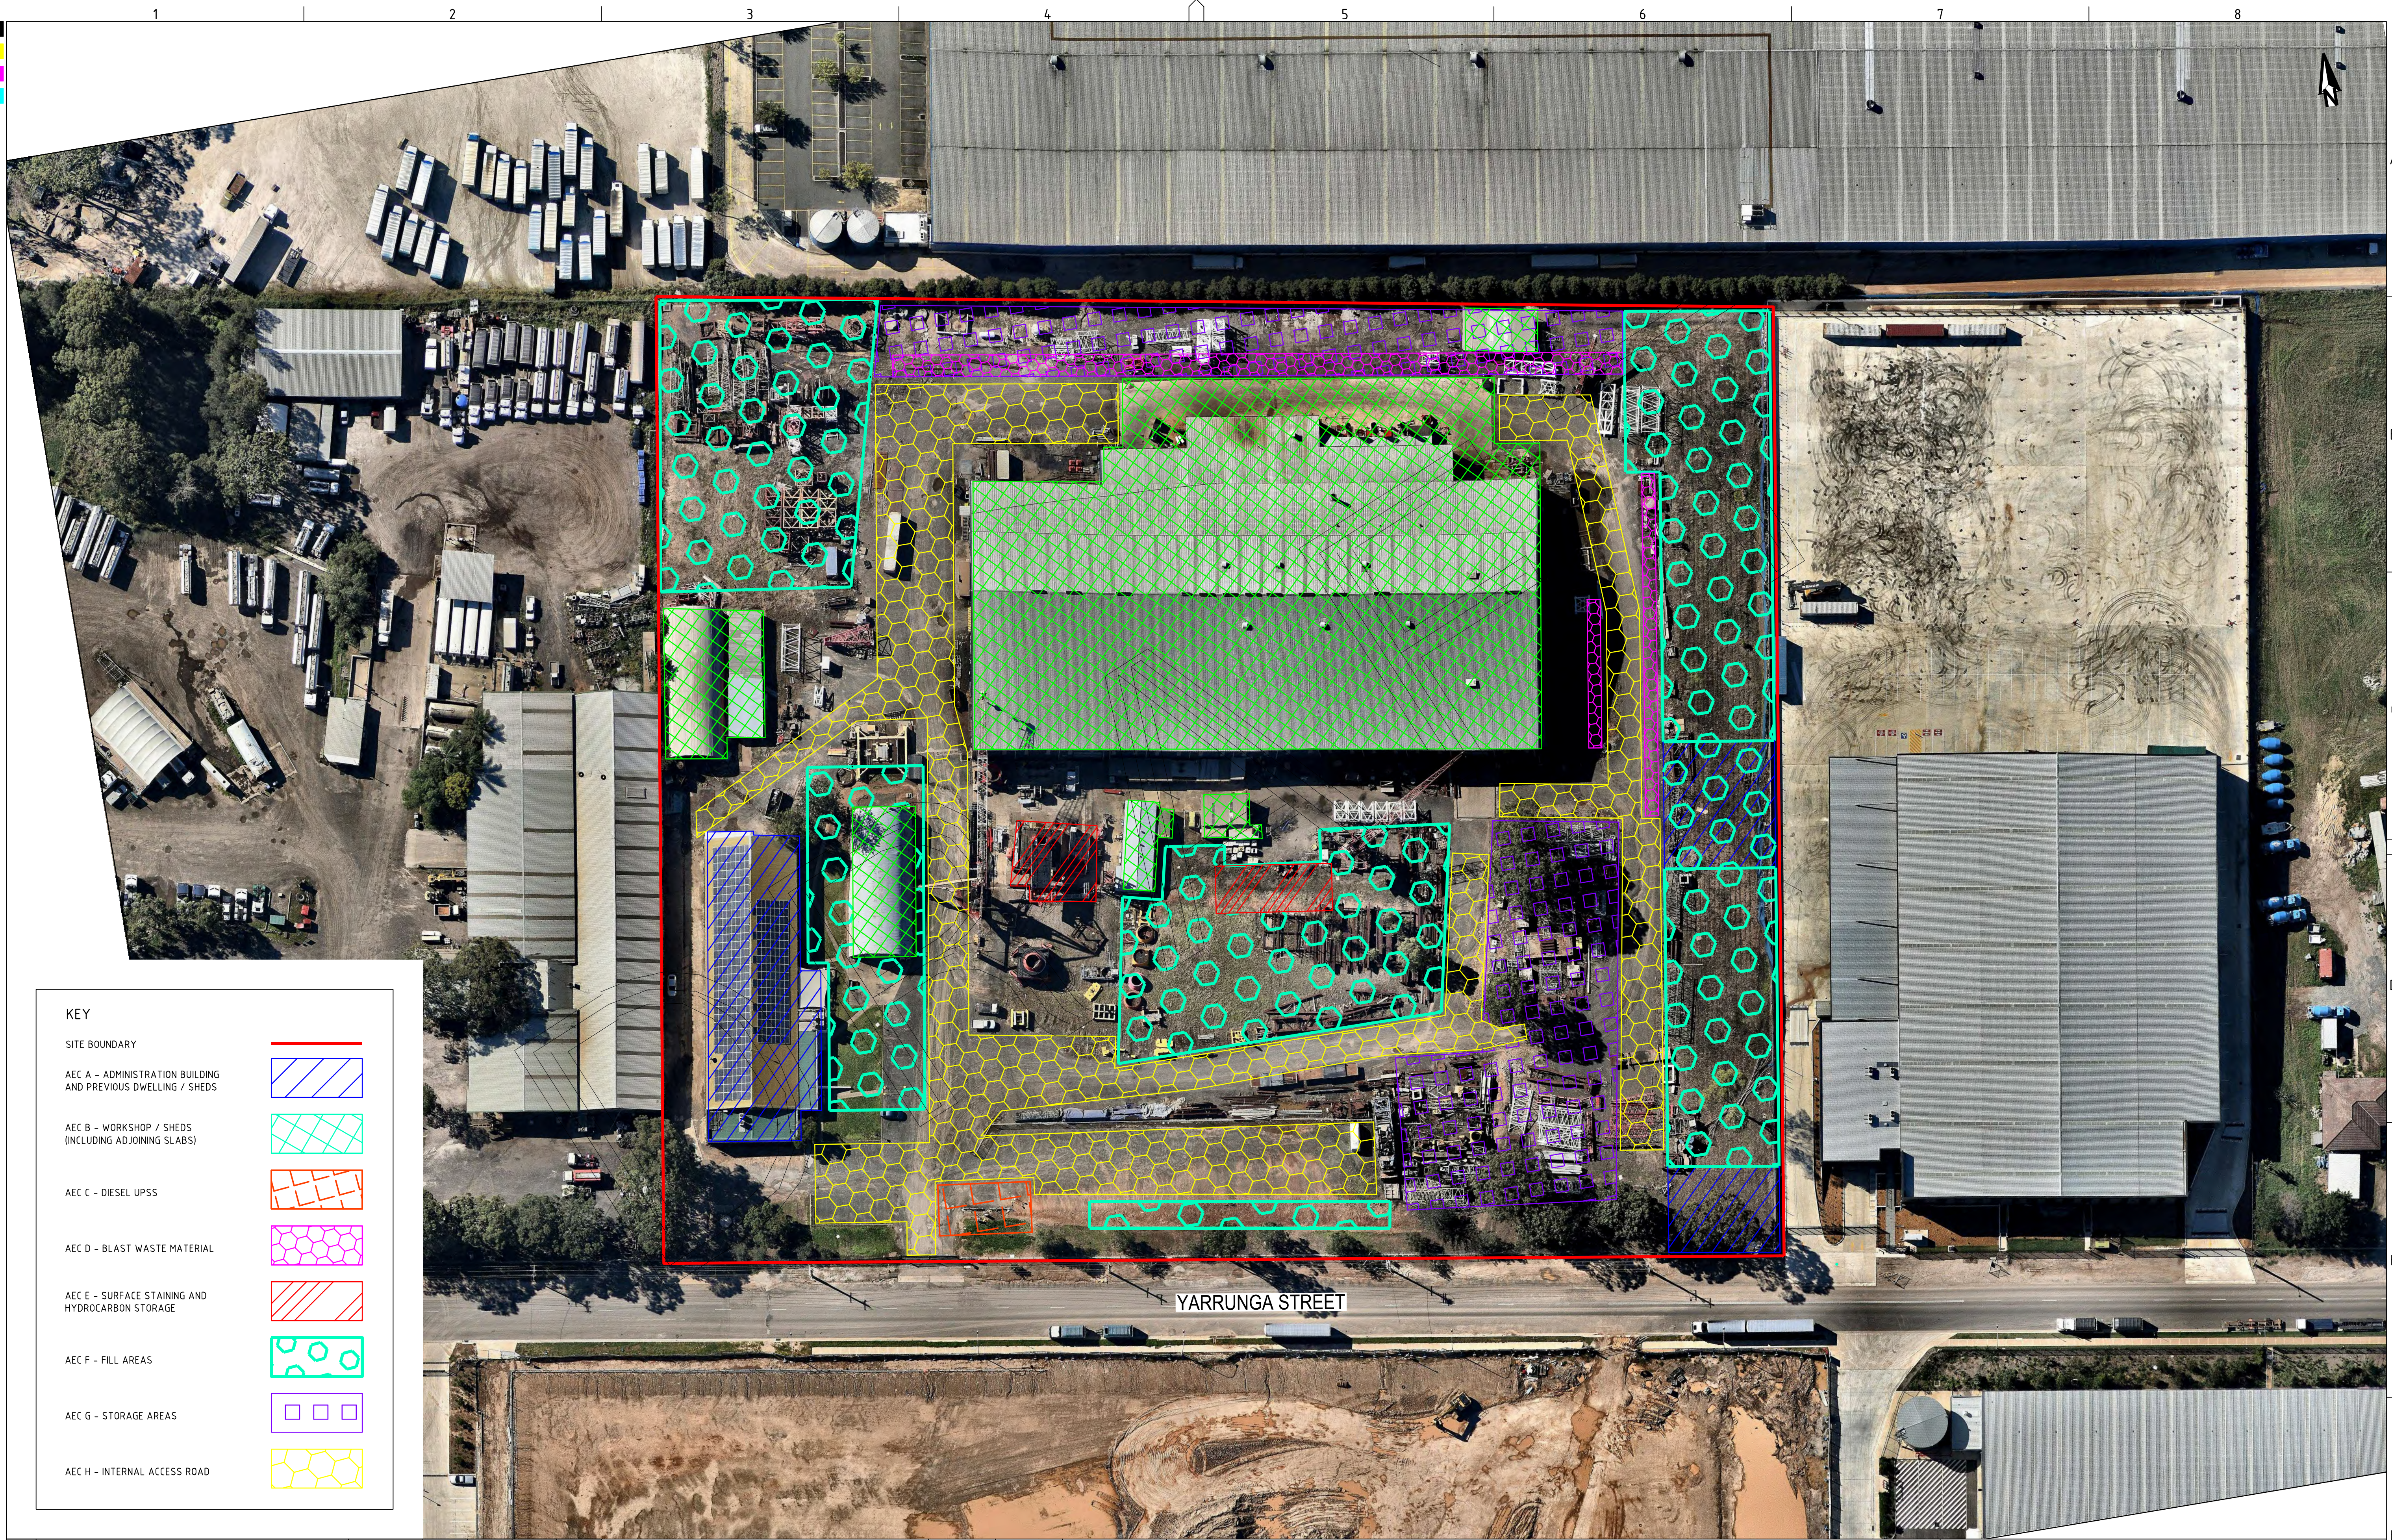
## Attachment B – Areas of Environmental Concern

- SITE BOUNDARY
- AEC A - ADMINISTRATION BUILDING AND PREVIOUS DWELLING / SHEDS
- AEC B - WORKSHOP / SHEDS (INCLUDING ADJOINING SLABS)
- AEC C - DIESEL UPSS
- AEC D - BLAST WASTE MATERIAL
- AEC E - SURFACE STAINING AND HYDROCARBON STORAGE
- AEC F - FILL AREAS
- AEC G - STORAGE AREAS
- AEC H - INTERNAL ACCESS ROAD

Our assessment of site AEC and COPC (Table 6) for the IA is made on the basis of available site history, aerial photograph interpretation, site walkover and geotechnical drilling (MA, 2019). A figure showing locations of identified AEC is provided in Attachment B.

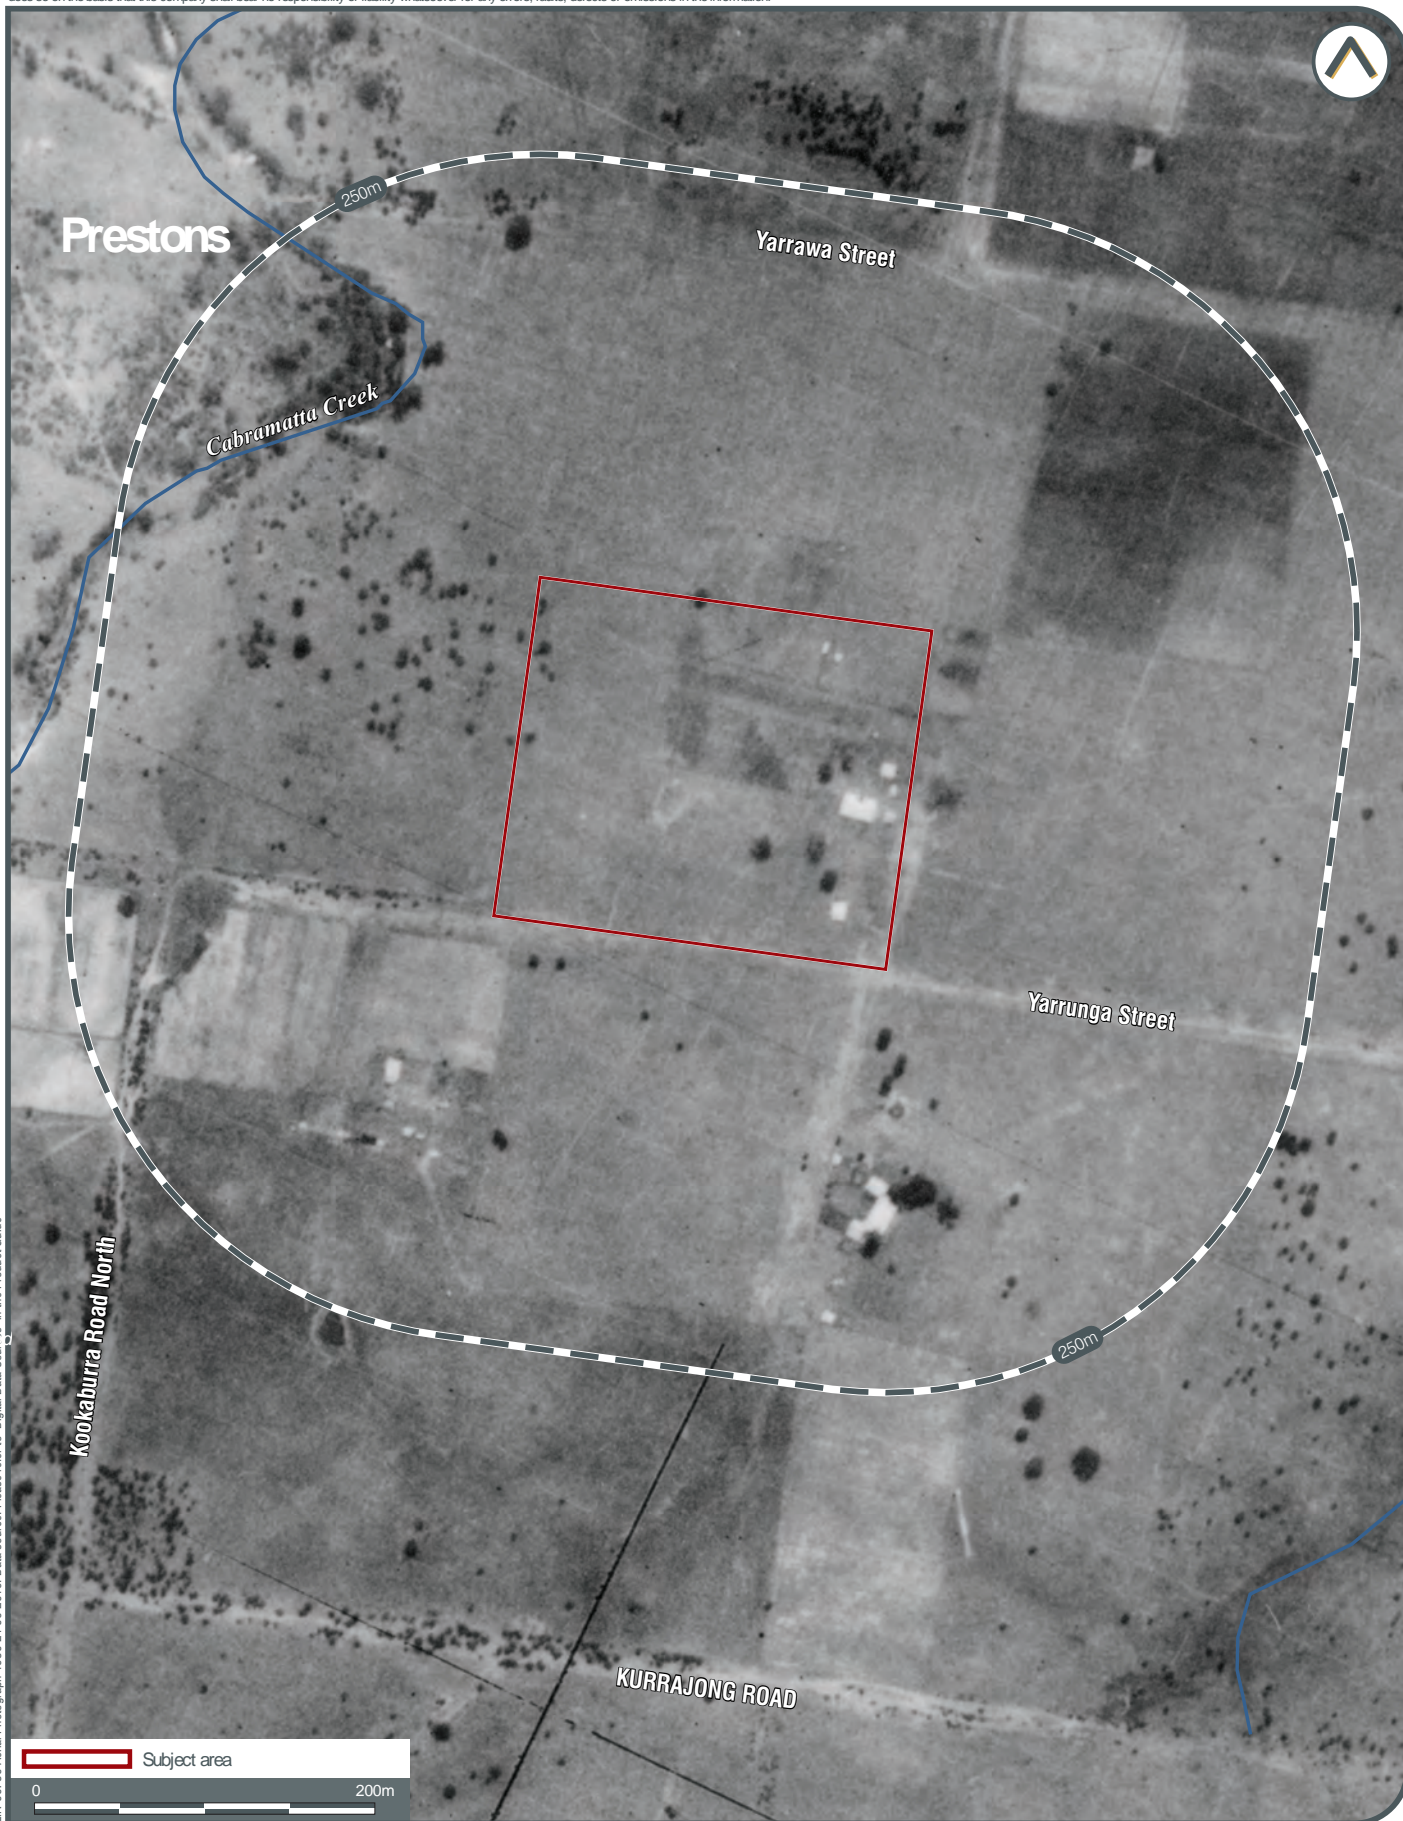
## HISTORIC AERIAL PHOTOGRAPH - 1930

Year (Source)	Site Activity	Surrounding Land Use
1930-1940 (LIR)	Pasture land with sheds in the eastern portion, additional shed constructed between 1930 – 1940.	Surrounding land is rural residential properties consisting of pastoral land.
1955 (LIR)	Warehouse through the western boundary and two sheds (likely existing) dwelling constructed in the southeast corner.	Little to no change from previous.
1970 (LIR)	Large warehouse (likely existing) with land clearing in the centre of the site. Fill in northwest corner and storage along the western boundary.	Market gardens to the south and north, otherwise little to no change from previous.
1975 (LIR)	Increase in clearing for parking and outdoor storage with dwelling possibly being demolished in the southeast.	Land clearing to the west, and shed constructed.
1986	Site occupying current allotment.	Expansion of market gardens to the north.
1994	Expansion of equipment/storage across the site. Fill observed along hard roads and storage areas.	Expansion of market gardens to the south.

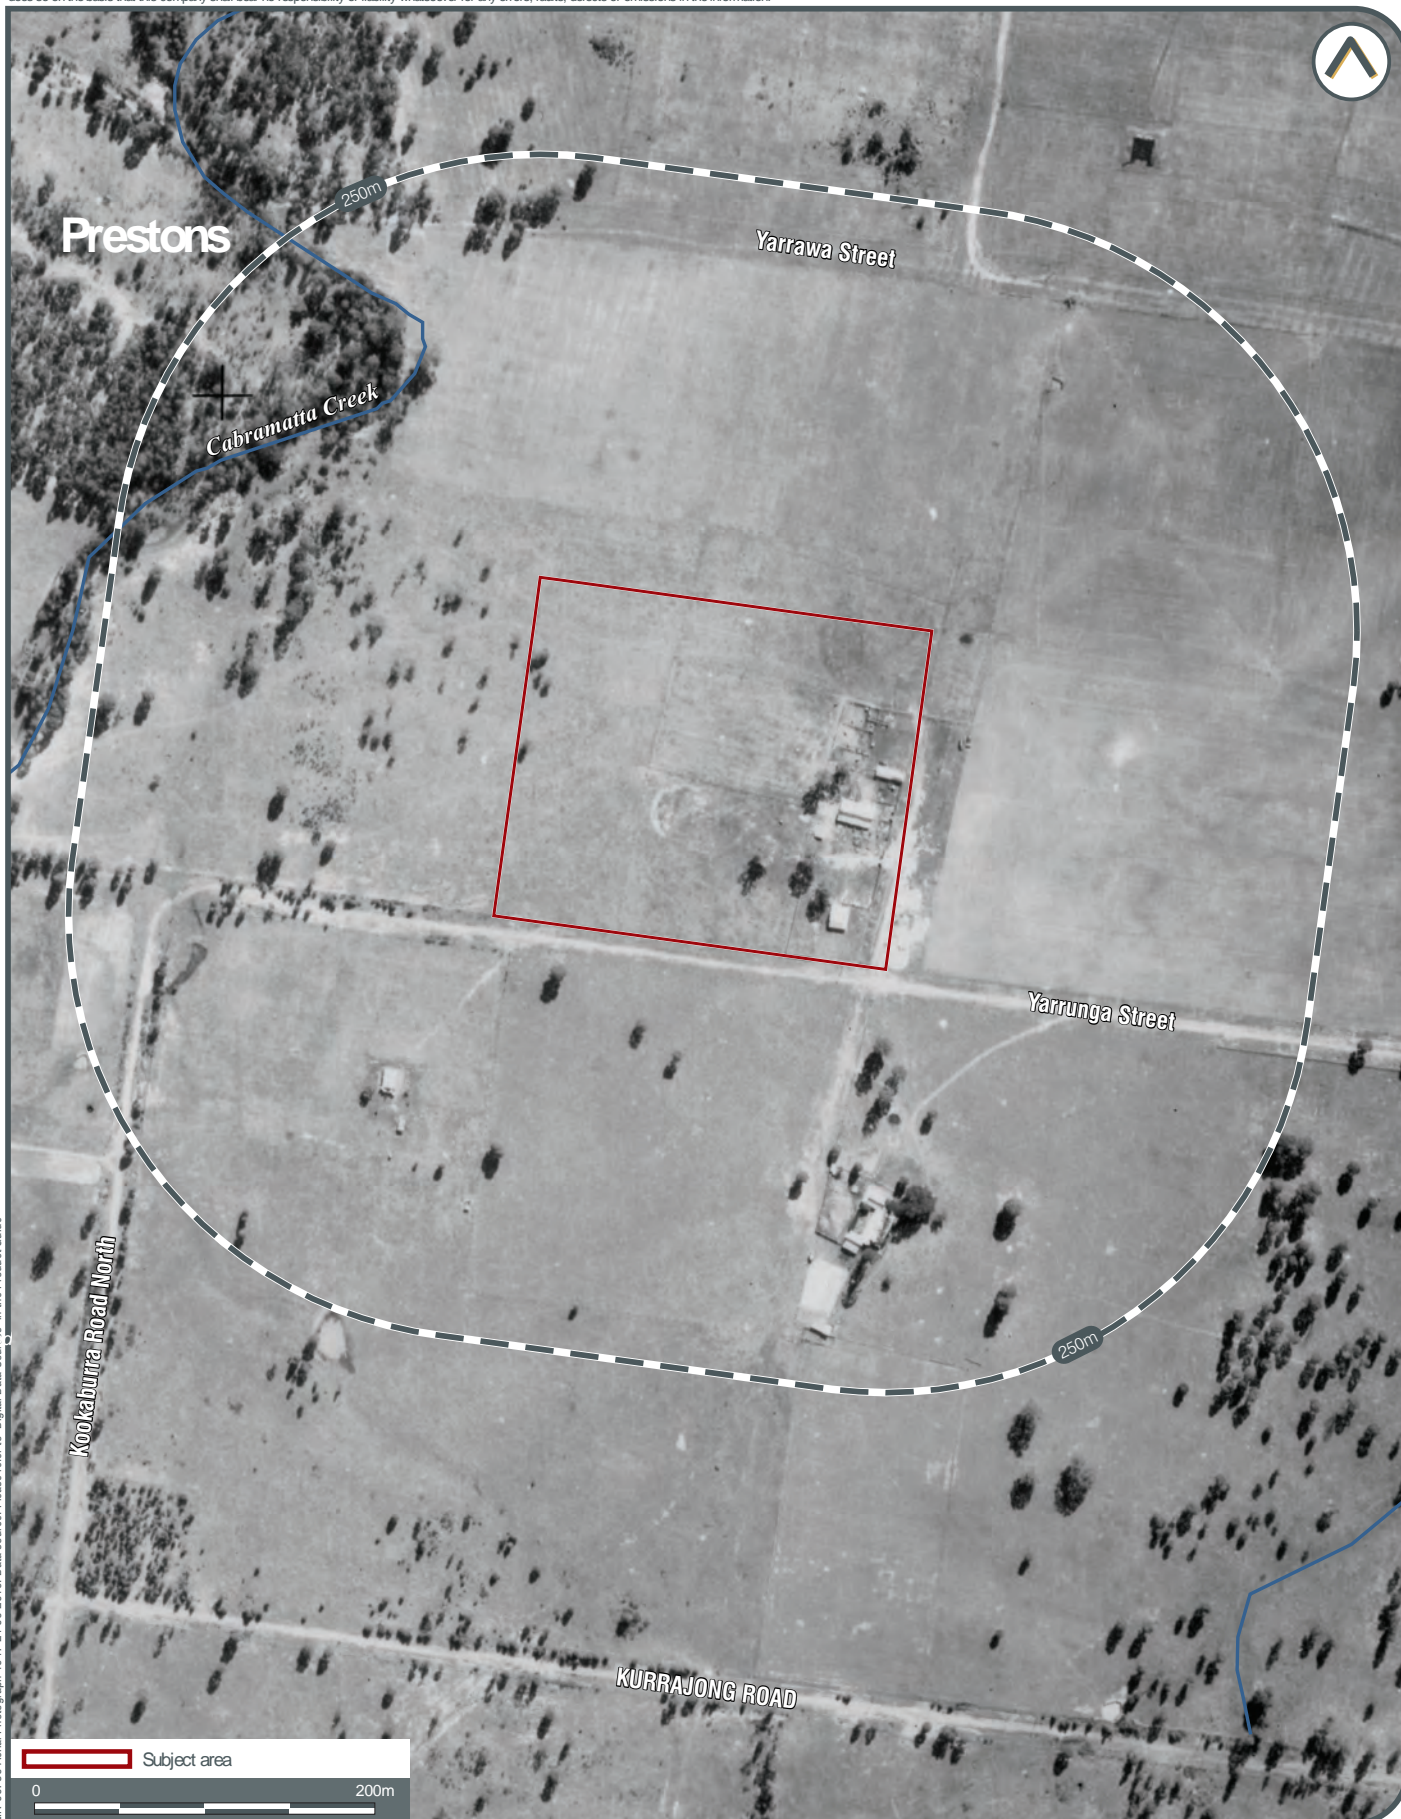
The aerials indicated that the current site conditions were constructed prior to 1970. Prior to 1970, the site appeared to be rural pasture land.

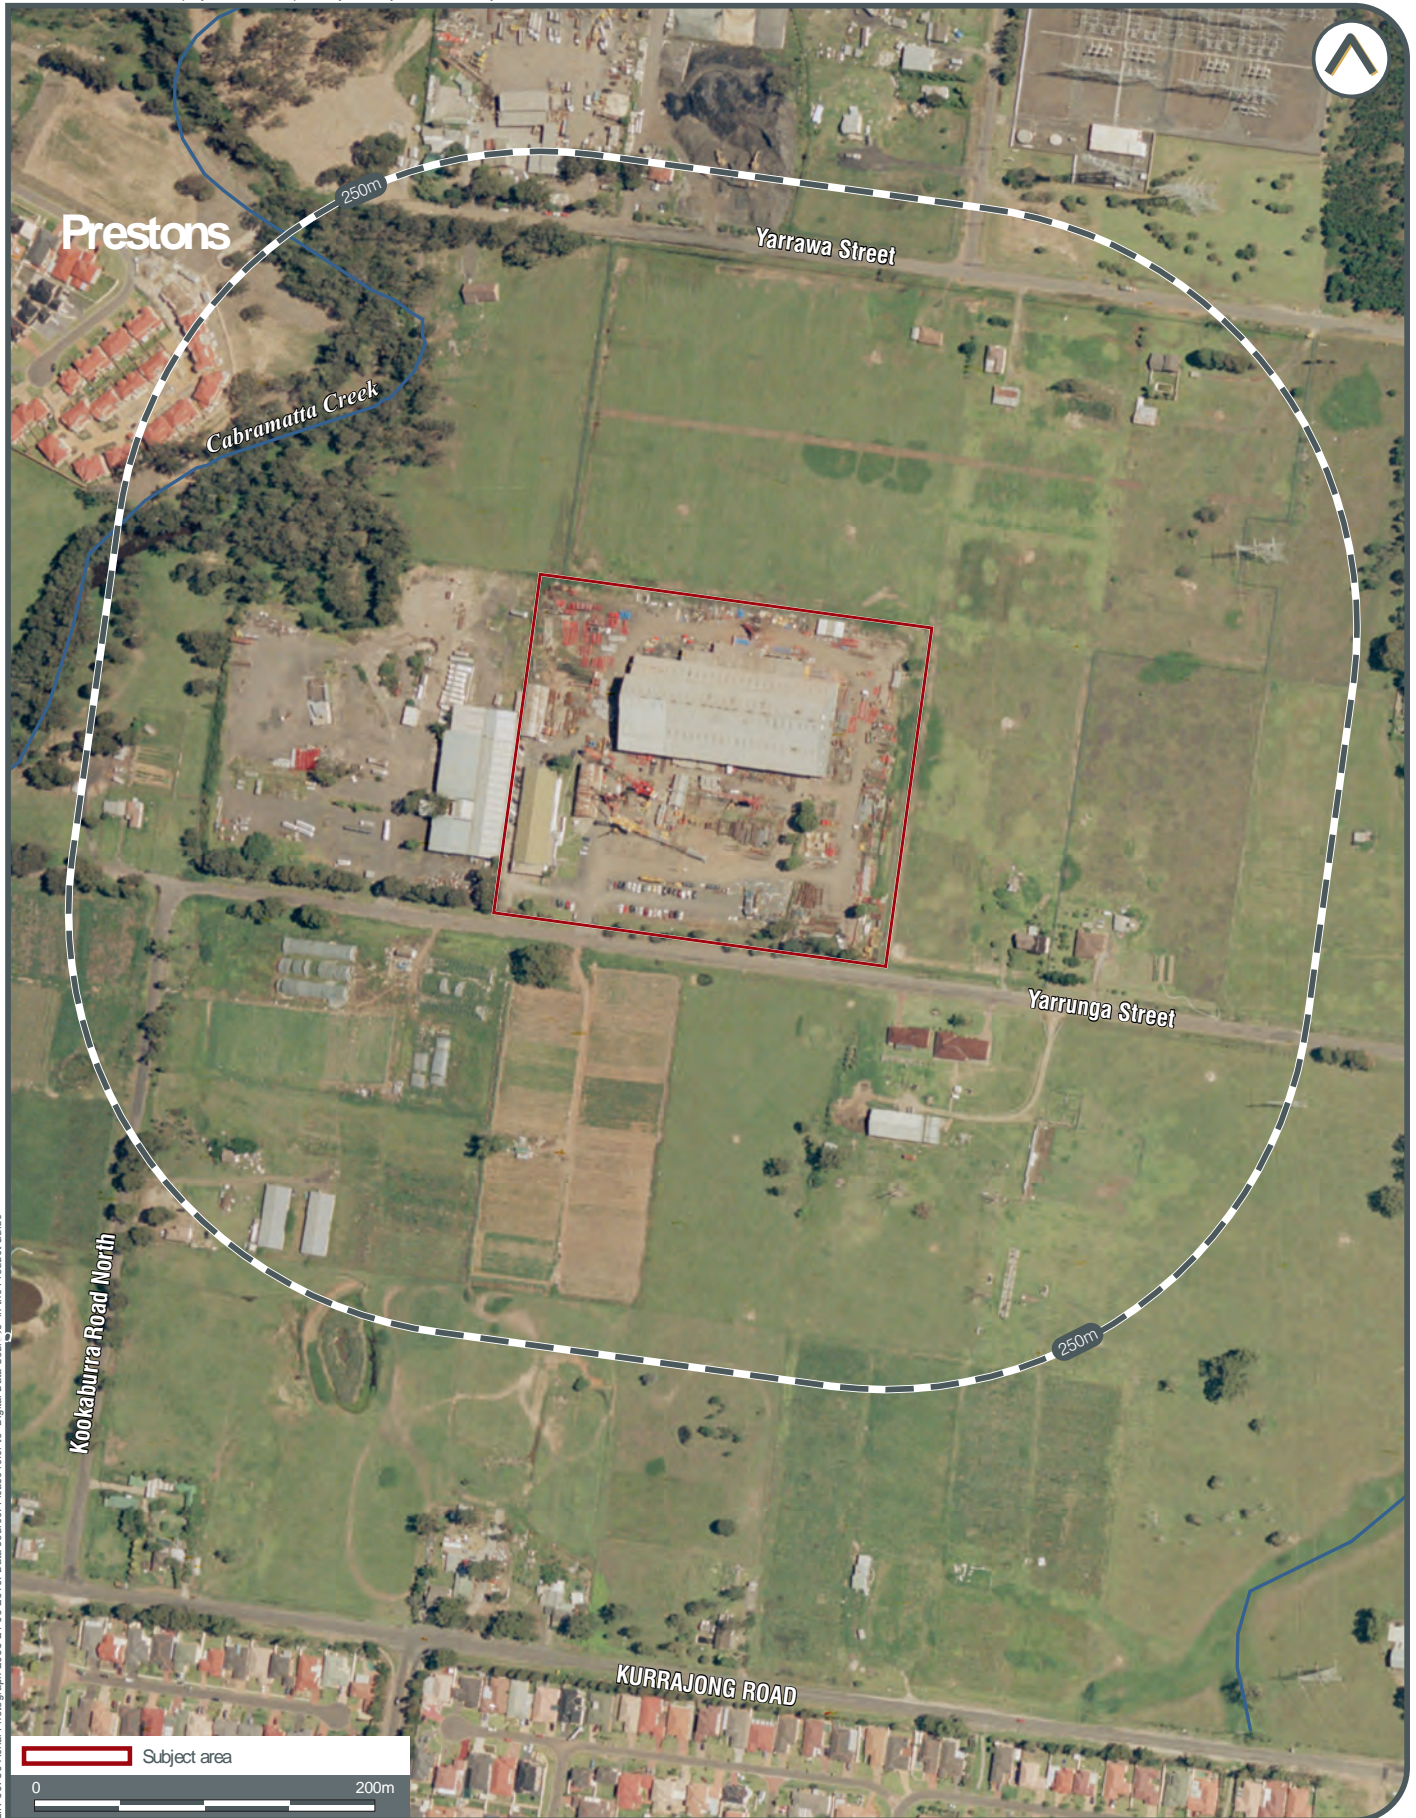
## HISTORIC AERIAL PHOTOGRAPH - 2005

2005	Sheds constructed along the northern boundary (likely current hazardous materials storage)	Little to no change from previous.
2008 (LIR)	Little to no change from previous.	Industry/warehouses to the north, development of building along the western boundary.
2010	Stockpiles in northwest and eastern portion of the site.	Expansion of warehouses to the north.
2013	Stockpiles levelled out into fill roads.	Area to the northwest under excavation.
2016	Additional stockpiles along the eastern boundary, concrete slab constructed at the warehouse.	Expansion of industry to the north.
2019 (LIR)	Little to no change from previous.	Expansion of industrial warehouses to the south.
