# Detailed Site Investigation: Proposed Warehouse Development- 28 Yarrunga St, Prestons, NSW.

P1907209JR03V01  
November 2019

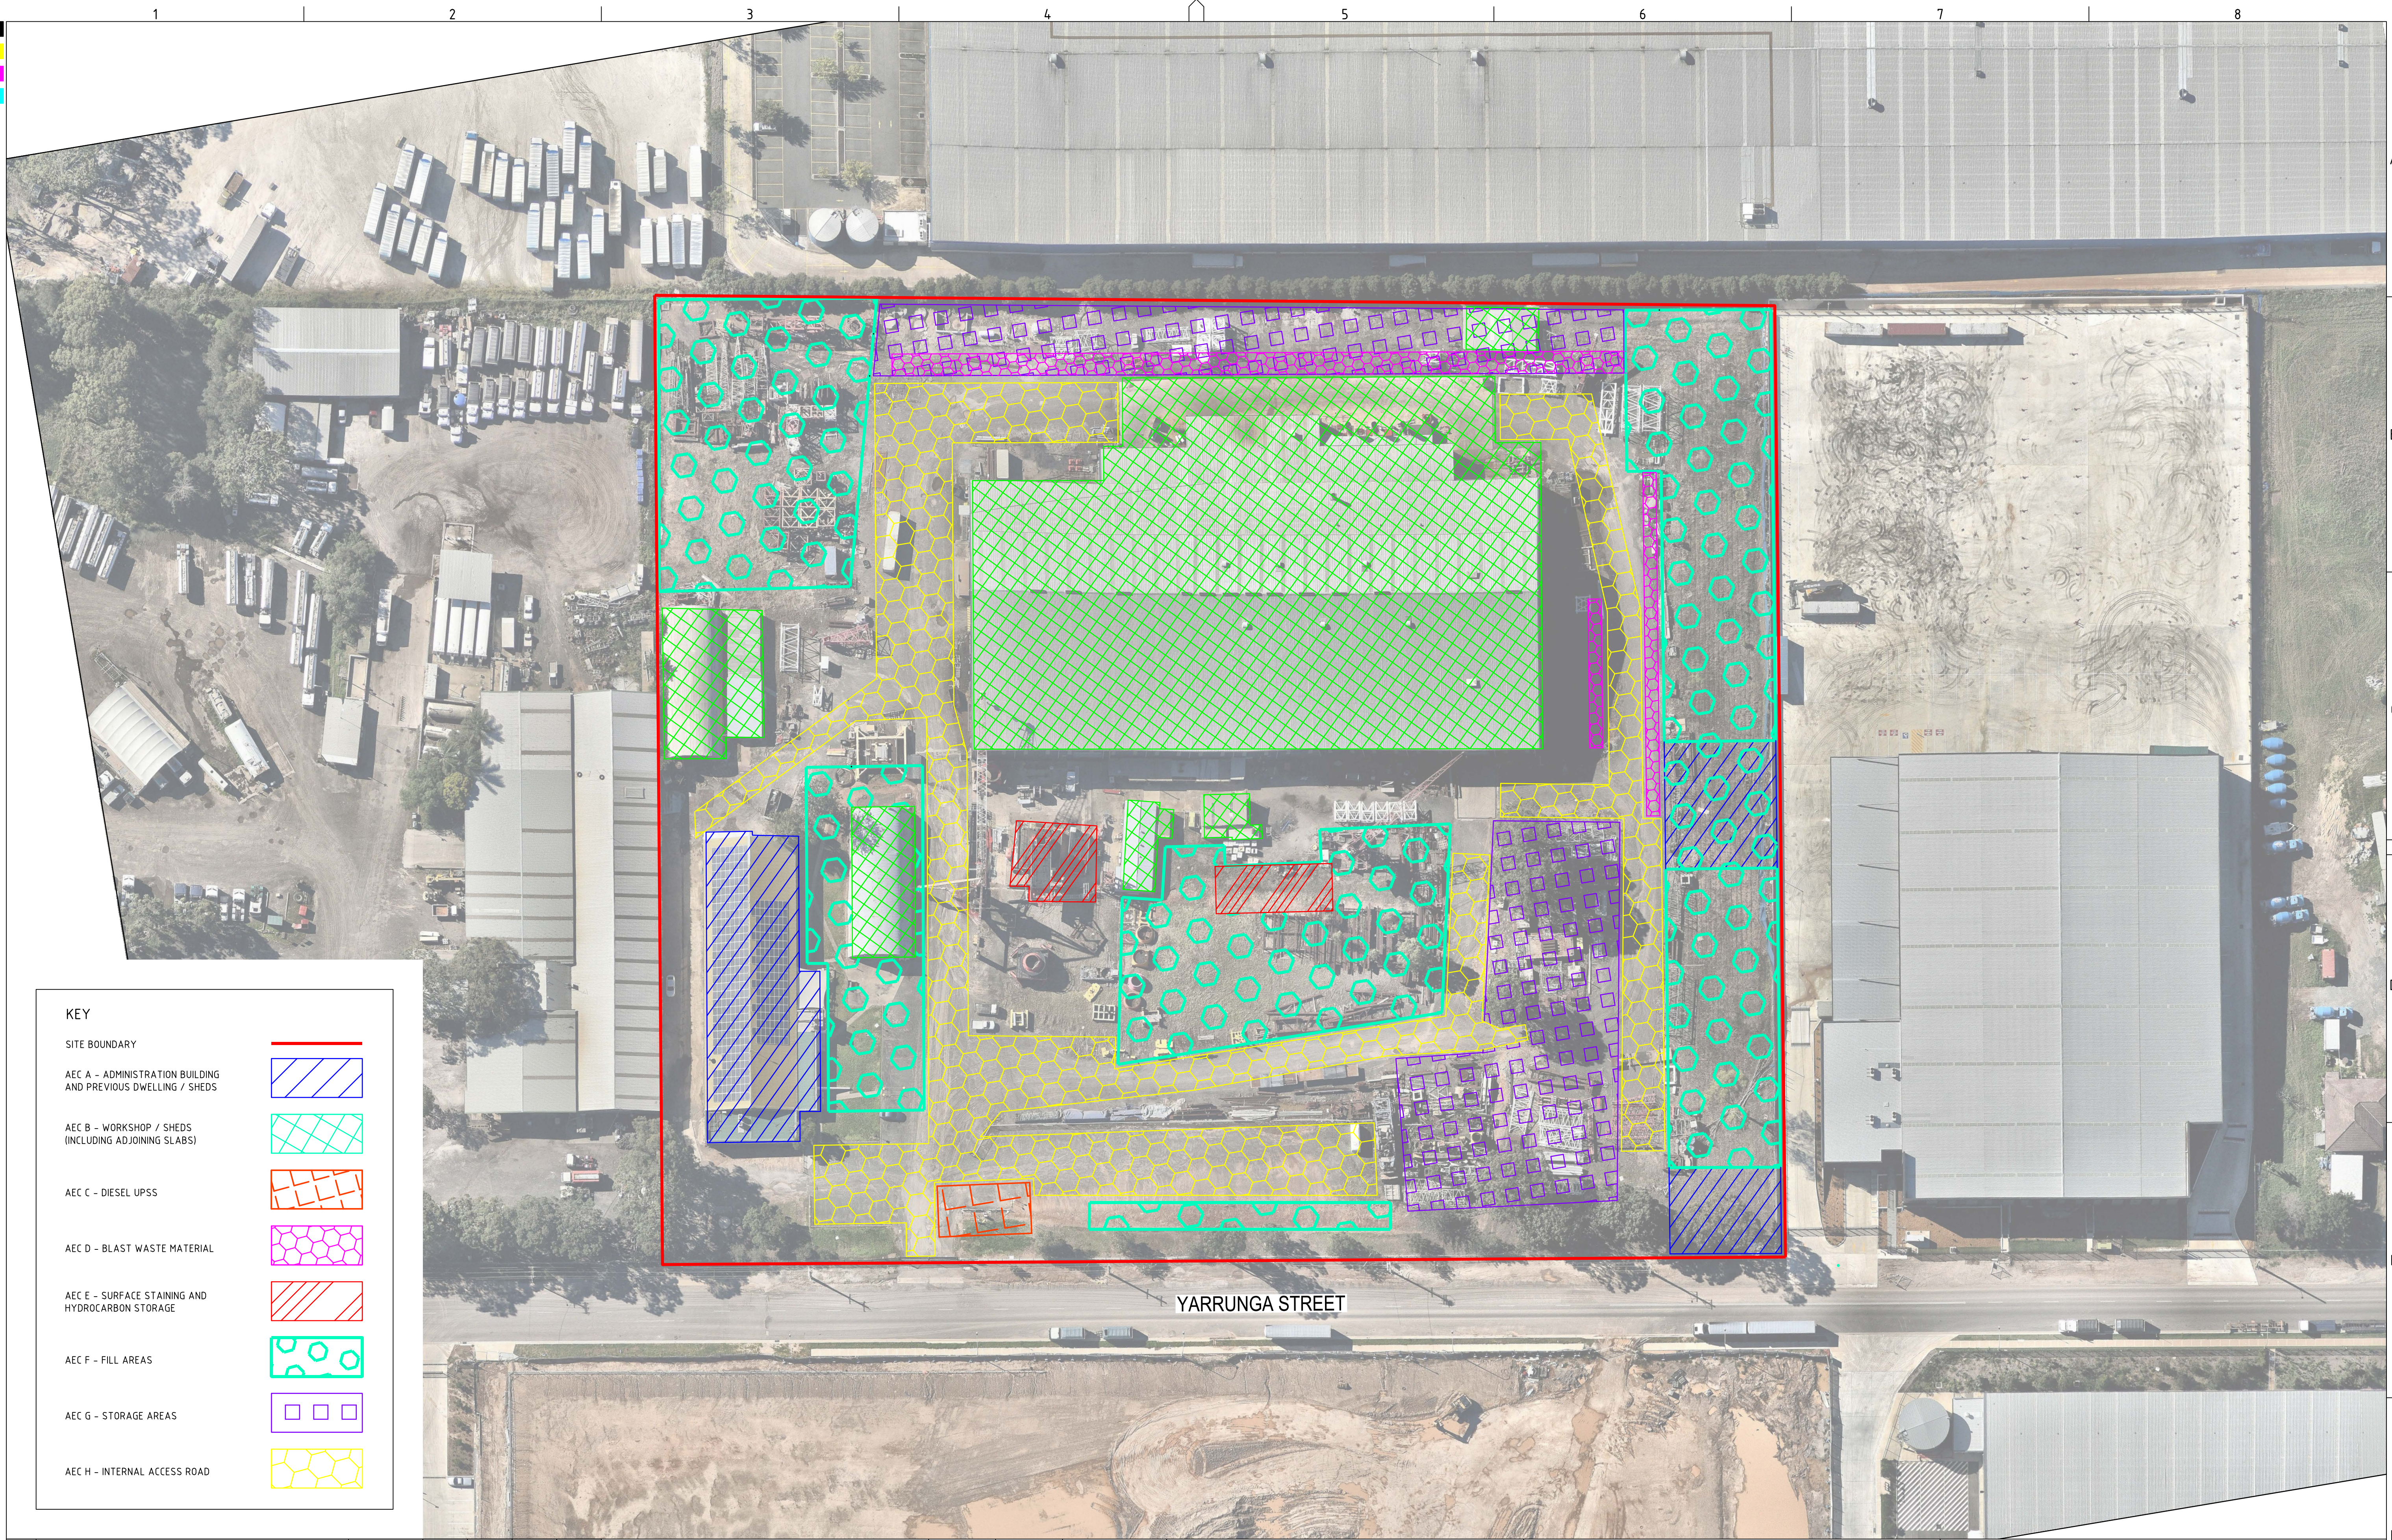
| DRAWING TITLE<br>FIGURE 1: SITE AEC MAP | | | | |

| Investigation Details | Investigation Task and Finding |
|---|---|
| Identified AEC | <p>AEC identified included:</p> <ol style="list-style-type: none"> <li>Existing administration building and previous sheds and dwellings, including a 1 m curtilage.</li> <li>Existing workshop areas and slabs, including a 1 m curtilage.</li> <li>Diesel UPSS in the southern portion of the site.</li> <li>Observed blast waste material in the northeast and along the northern boundary.</li> <li>Hydrocarbon storage areas and observed hydrocarbon soil staining.</li> <li>Observed fill material of unknown origin or quality.</li> <li>Storage areas and general refuse.</li> <li>Constructed access / haul road around the workshop.</li> </ol> <p>A plan showing AEC locations is provided in Attachment A.</p> |

AEC E - SURFACE STAINING AND  
HYDROCARBON STORAGE

AEC G - STORAGE AREAS

Footprints of existing structures at the site (AEC A and AEC B) have not been assessed due to underlying soil access constraints and have been identified as data gaps in this assessment, as shown in Attachment A. We recommend that an additional site walkover and sampling event is undertaken post demolition of structures to address data gaps. Should contamination be identified, the project RAP shall be amended to address required additional remediation.

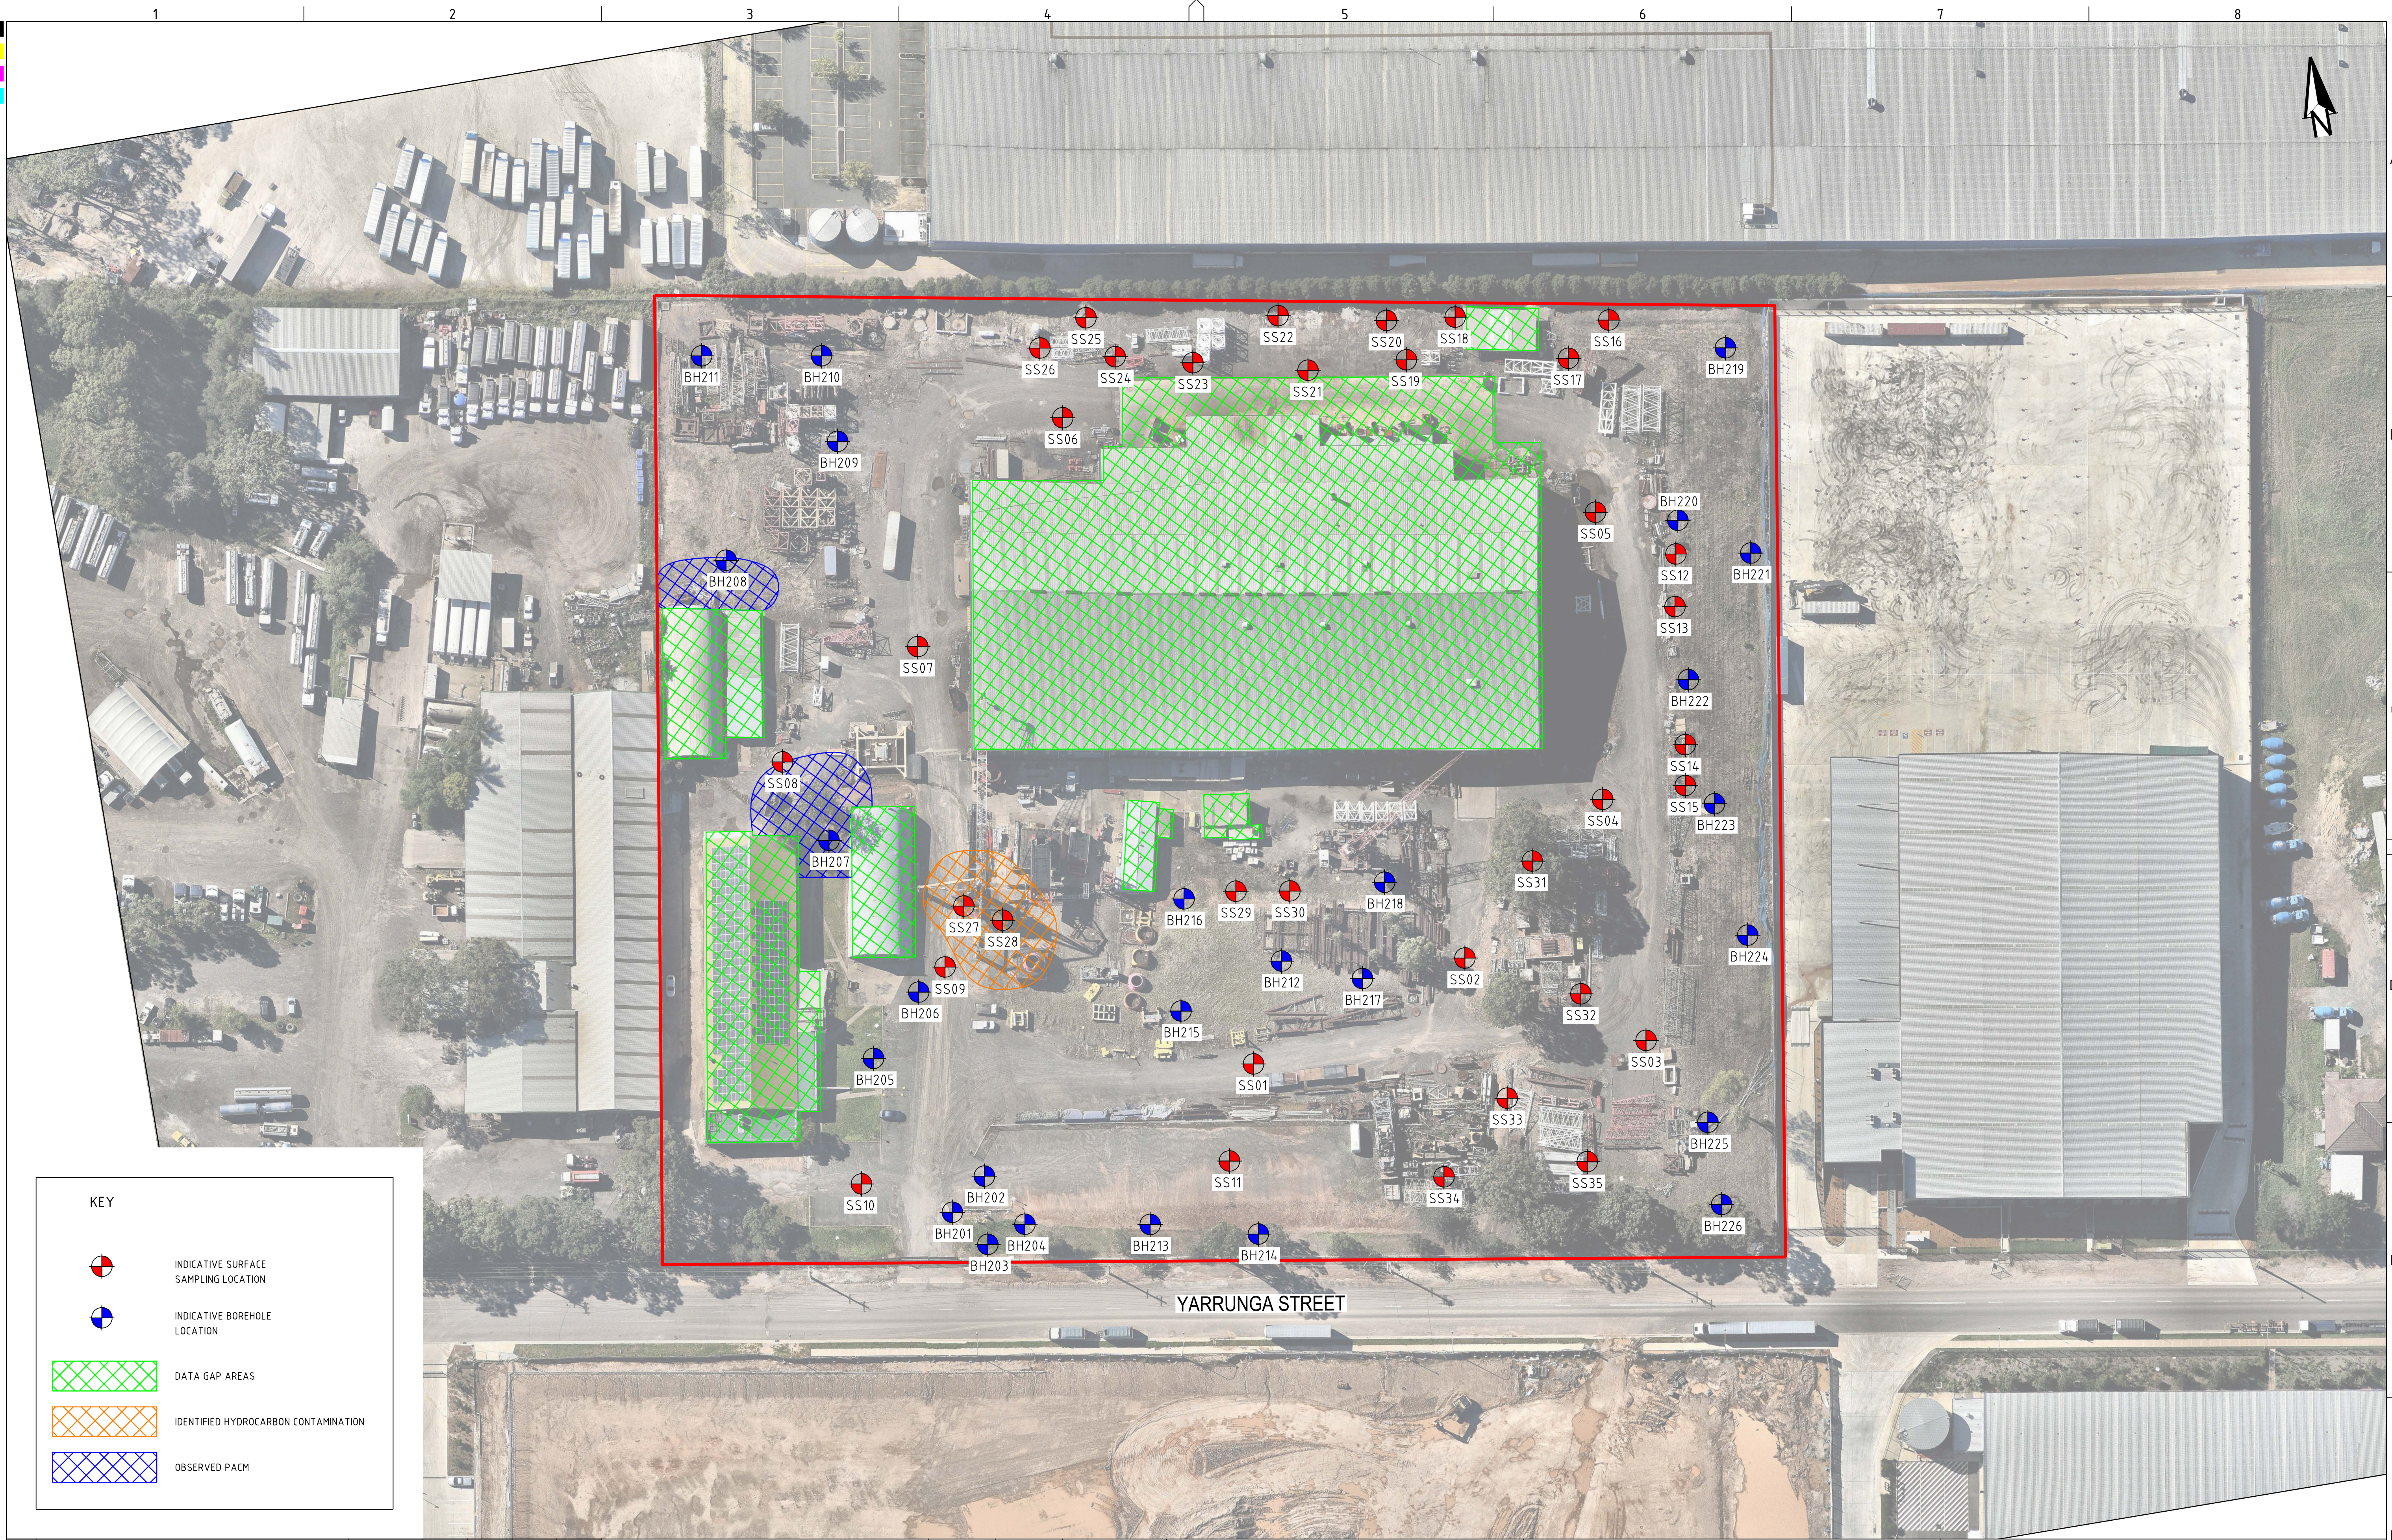
- There were little changes to the site from the PSI (MA, 2019) walkover findings.
- Potential asbestos containing material (PACM) was observed at the site surface, to the north of the administration buildings, which are considered to be asbestos containing for the purposes of this assessment.

Laboratory analytical results (Envirolab report 227977 and 227977-B) indicated TRH fraction C16-C34 exceeded adopted management limits (5,000 mg/kg) in samples SS27 (10,000 mg/kg) and SS28 (9,100 mg/kg). Samples were collected from near-surface soils beneath a crane, where hydrocarbon staining was observed. It is likely that elevated TRH identified is a result of oil leaks or spills from the crane and impact may be limited to near-surface soils. The depth of hydrocarbon impact is unknown at this stage.

INDICATIVE SURFACE SAMPLING LOCATION

OBSERVED PACM

Elevated TRH (fraction C16-C34) was identified in two sample locations (SS27 and SS28), where hydrocarbon soil staining was visible at the site surface. It is recommended that, following demolition, further investigations are undertaken in conjunction with data gap closure assessment to delineate the depth and lateral extent of TRH impact in these locations.
