STAGE I - PRELIMINARY SITE INVESTIGATION
18 RANDWICK CLOSE, CASULA, NEW SOUTH WALES
CES DOCUMENT REFERENCE: CES161003-HC-AC

STAGE I - PRELIMINARY SITE INVESTIGATION 18 RANDWICK CLOSE, CASULA, NEW SOUTH WALES PREPARED FOR HEYMANN COHEN PTY LTD

The site (18 Randwick Close, Casula) (Lot 104 in Deposited Plan (DP) 863214) covering an area of approximately 1.3 hectares, was purchased in 2015 by Besol Pty Ltd. The site was previously owned Ingham Processing Pty Ltd and used for the processing of poultry.

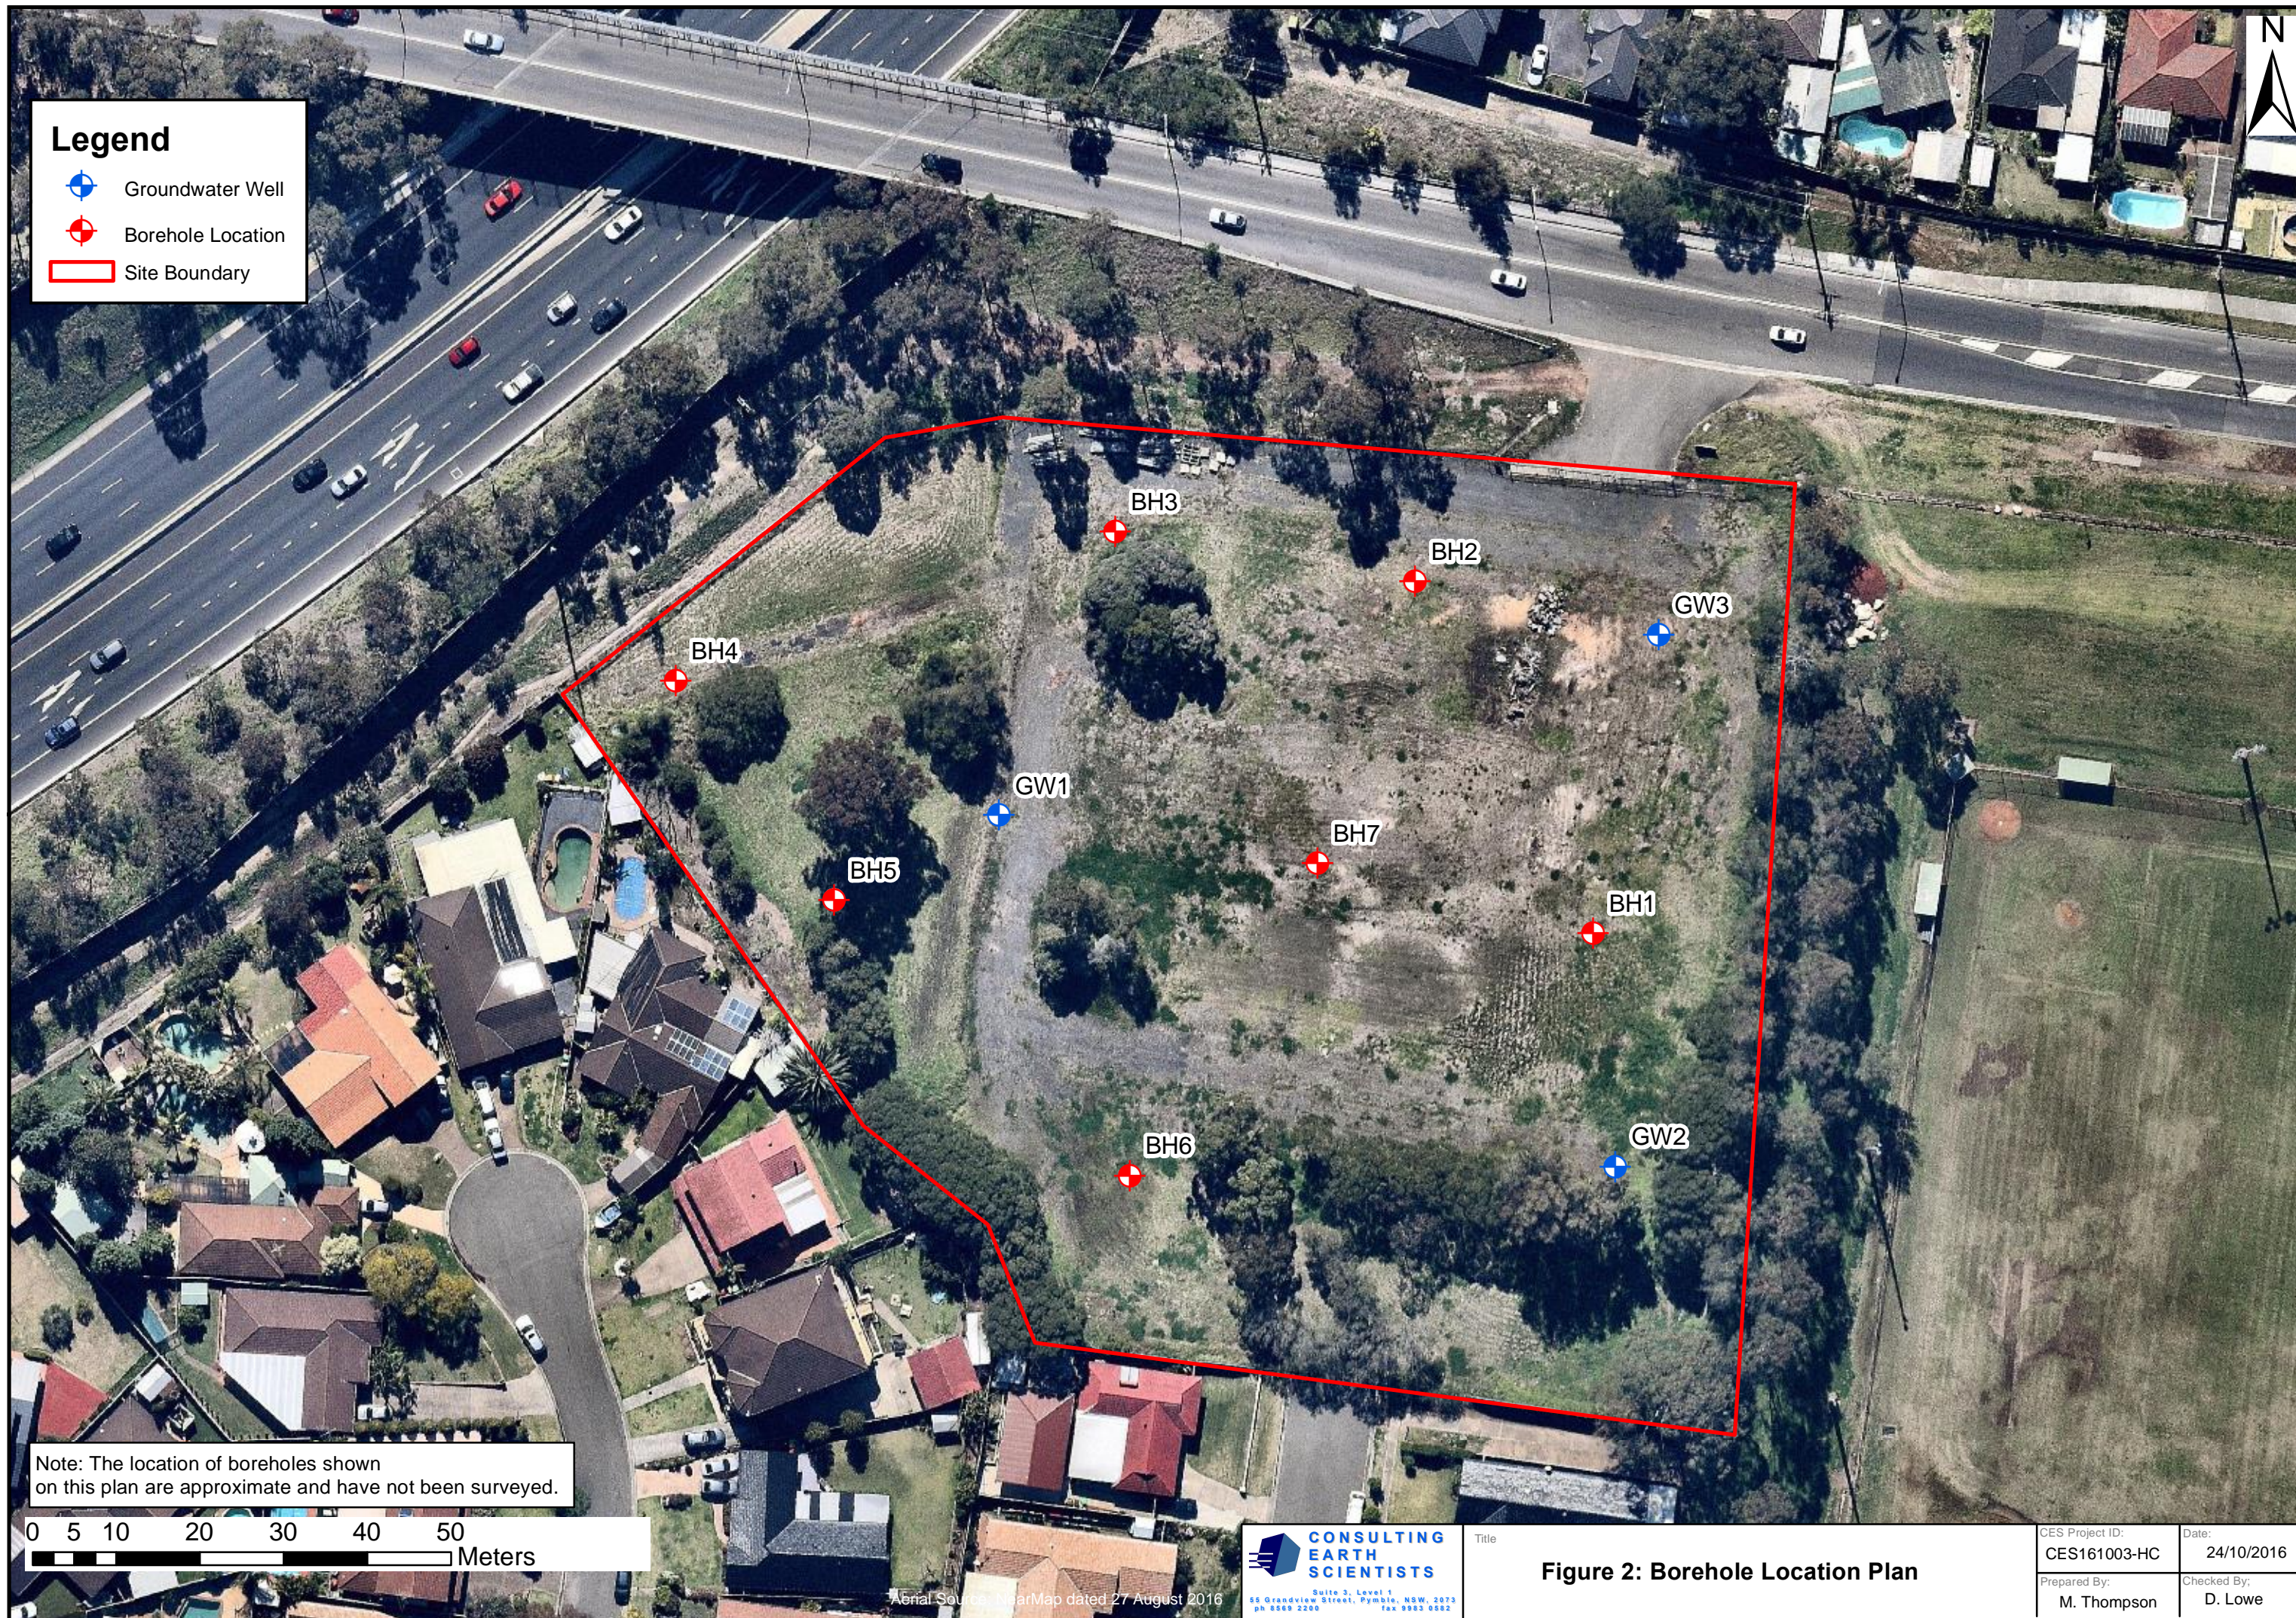
Site Boundary

Note: The location of boreholes shown on this plan are approximate and have not been surveyed.

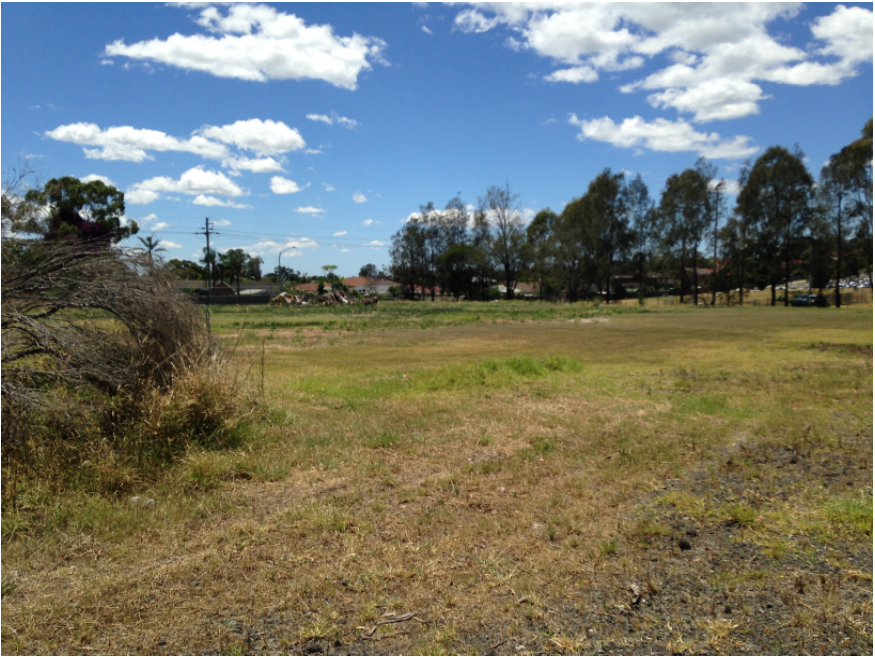
Photographic Log	
Client Name: Heymann-Cohen Pty Ltd		Site Location: 18 Randwick Close, Casula New South Wales	Project Number: CES161003-HC
Date: 24/11/16	Plate No: 4

Description: Photograph taken from the centre of the site looking towards the northeast. The foreground of the photograph shows a gravel / road base surface.			
Direction Photo Taken: Northeast

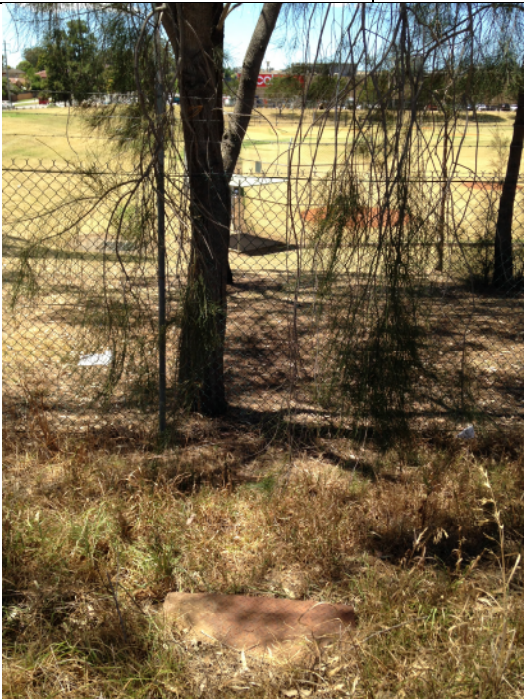
Photographic Log	
Client Name: Heymann-Cohen Pty Ltd		Site Location: 18 Randwick Close, Casula New South Wales	Project Number: CES161003-HC
Date: 24/11/16	Plate No: 5

Description: One of two metal road plate covered pits on the eastern boundary of the site. In the background is Daruk park and Casula Mall.			
Direction Photo Taken: East

A review of Dial-Before-You-Dig (DBYD) plans indicate the presence of two sewer property connection points along the eastern boundary in the north of the site which may serve as a preferential pathway of contaminant migration on the site. In addition, the site inspection conducted on the 24 November 2016 found evidence of PVC conduits within brick constructed pits in three locations along the eastern boundary of the site, two of which are covered with metal road plates (see Appendix A, Plate 5 and Plate 6 for photographs). It is unclear the purpose of these conduits and the extent of the pipeline, however it is a possibility that these conduits have connected to the sewer line during past uses at the site.

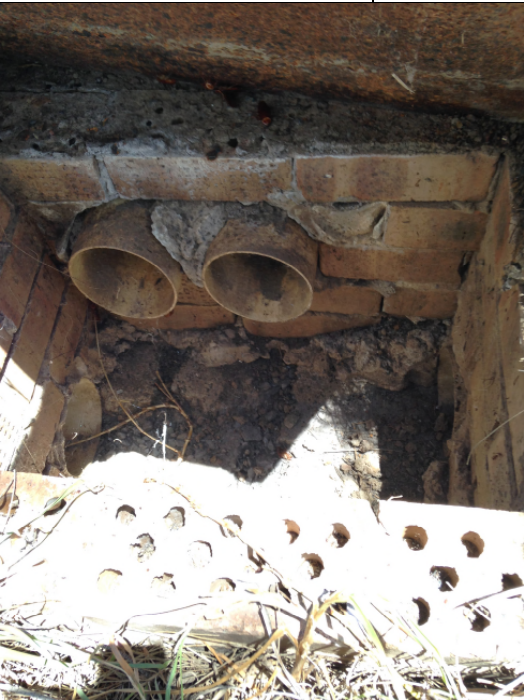
Photographic Log	
Client Name: Heymann-Cohen Pty Ltd		Site Location: 18 Randwick Close, Casula New South Wales	Project Number: CES161003-HC
Date: 24/11/16	Plate No: 6

Description: One of three brick constructed pits containing 150mm PVC conduit. Size of pit approximately 600mm x 600mm			
Direction Photo Taken: West

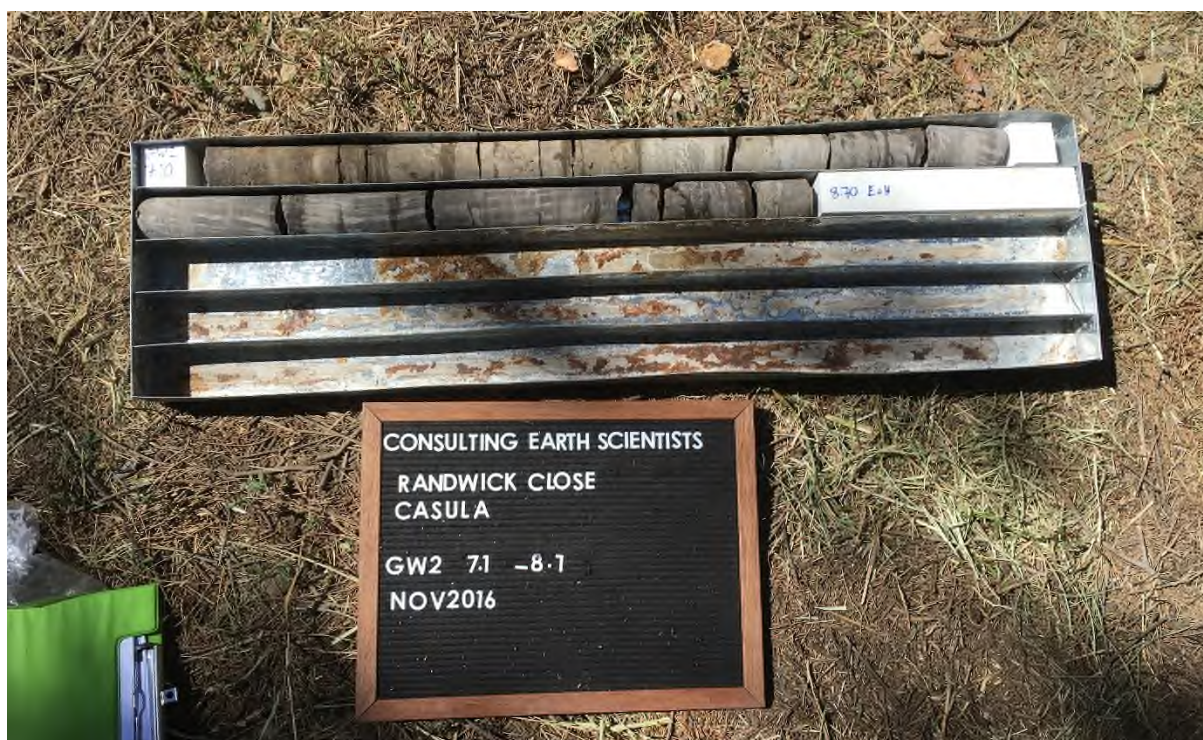
Project ID: CES161003-HC
Client: Heymann Cohen Pty Ltd
Project: SummitCare, Randwick Close
Location: Casula

Borehole cored from 7.1m, Refer to core log.						5
6	33											6
7	32											7
8	31											8
9	30											9
10	29											10
