ATTACHMENT C

**ADDITIONAL DOCUMENTS REFERENCED
IN ASSESSMENT REPORT**

Hazardous Materials Survey

Hazardous Materials Survey Cattle – Ward Oval, Cobar NSW

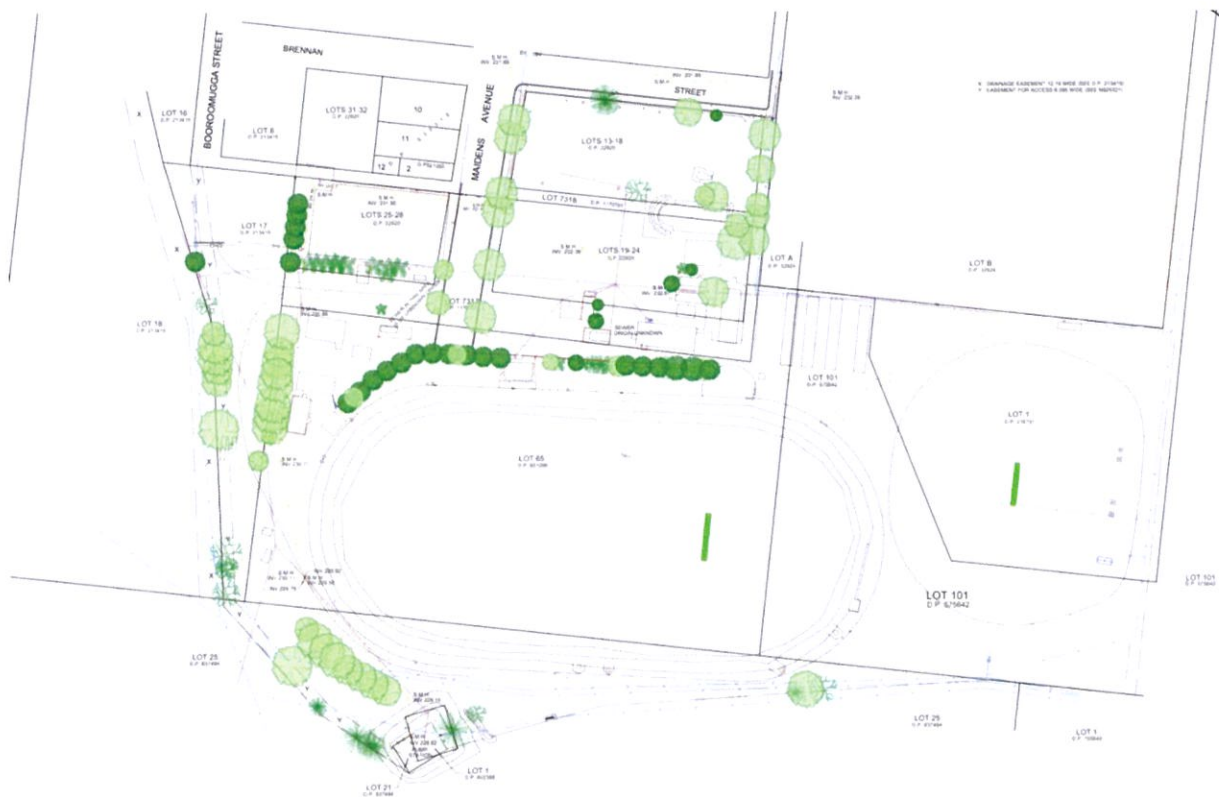
Figure 1: The lots comprising Ward Oval one of Cobar's premier sporting facilities.

The subject site is comprised of a number of allotments owned by either the Cobar Shire Council (Council) or the NSW State Government (Crown). These allotments are Lots 13-28 in D.P. 22820 and Lots 7317-7318 in D.P. 1170701 and Lot 1 in D.P. 216151 and Lot 17 in D.P. 213415 and Lot 65 in D.P. 651098 and Lot 1 in D.P. 602398 and Lot 21 in D.P. 837494 in Ward Oval, Cobar and shown in Figure 1.

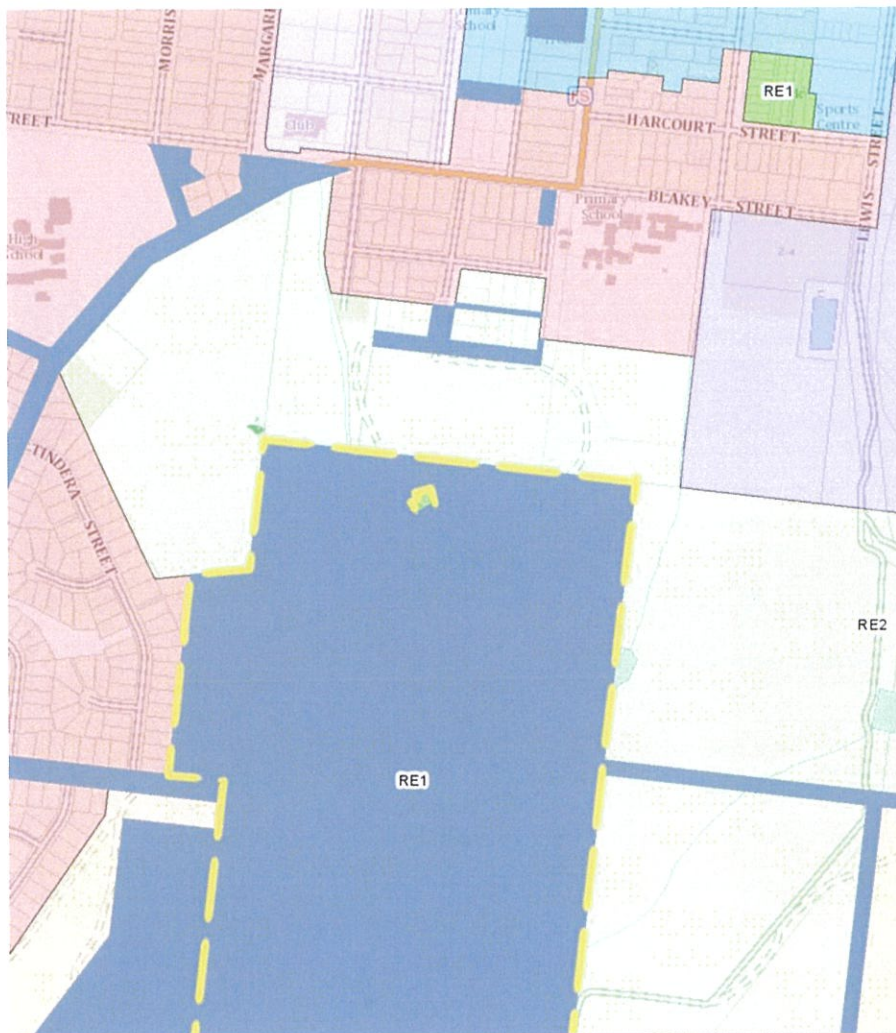
Figure 2: The areas shown in blue is identified as Crown land and principally relates to part of the site to the south and some roads near the entry to Ward Oval.

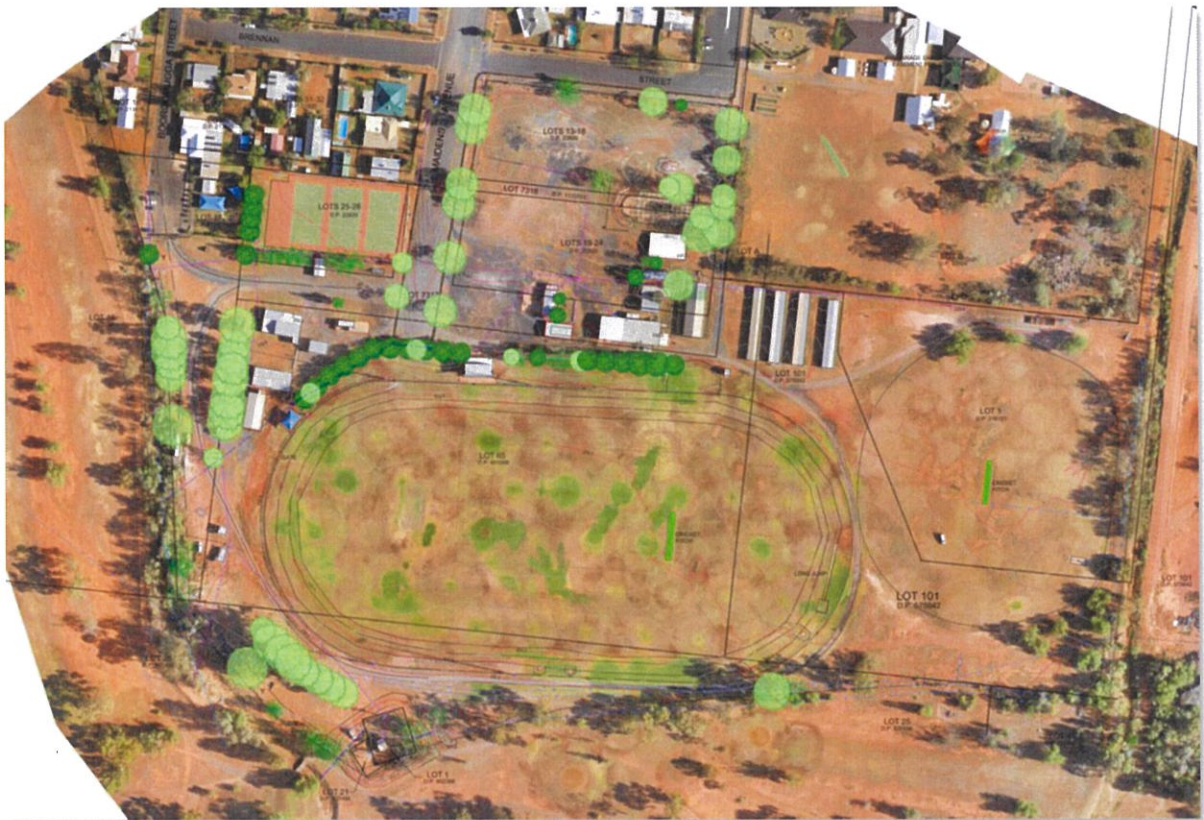
Figure 3: Ward Oval comprises of a number of facilities with a main multipurpose oval central to the site.

The Ward Oval grounds includes three grassed ovals (main Oval Number 1 includes a turf cricket pitch and lights and Oval Numbers 2 and 3 include synthetic cricket pitches), canteen and bar facilities, toilets and showers, changerooms, netball courts, dining rooms, main pavilion with office, grandstands, various stock yards and stables, and other pavilions.

Council has developed a Master Plan for Ward Oval which includes concept designs for a new multi-purpose centre, Early Learning precinct, upgrades to the oval including athletic facilities, additional lighting, improved show facilities and landscaping.

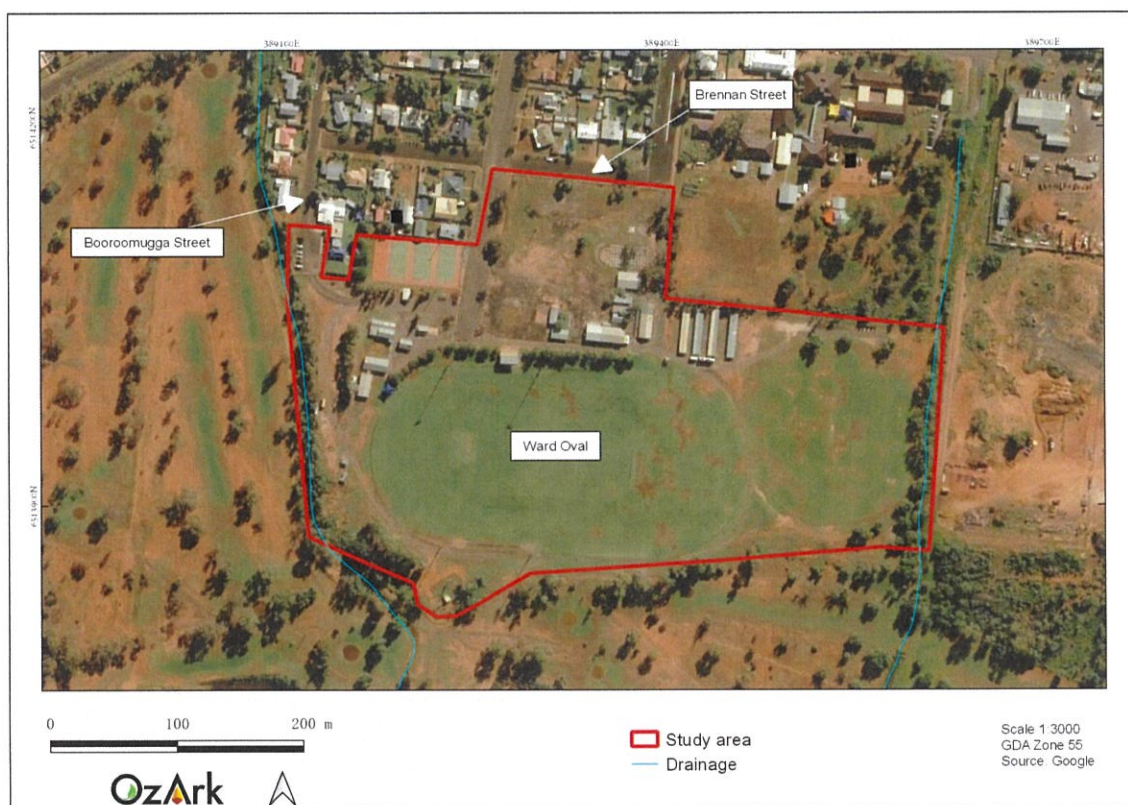
Figure 1-2: Aerial showing the study area.

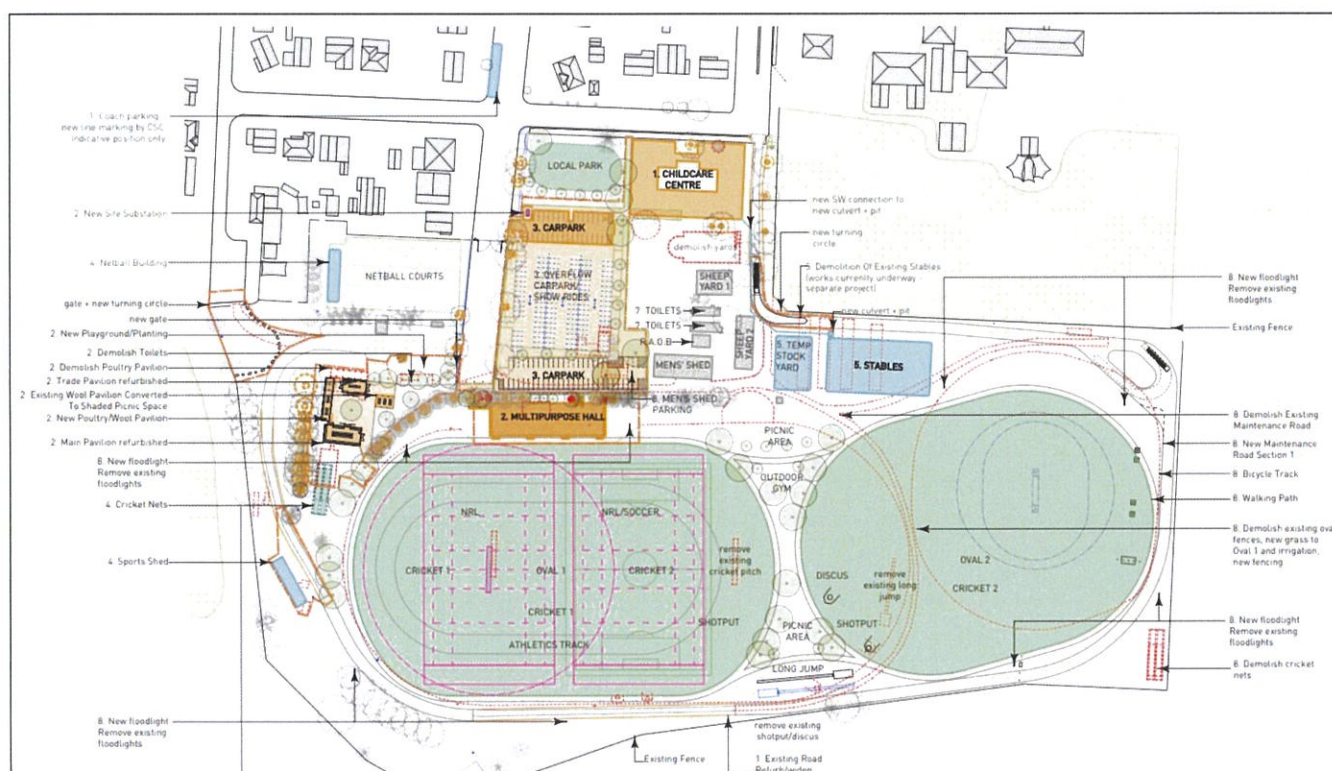
Figure 1-3: Master plan for proposed works.

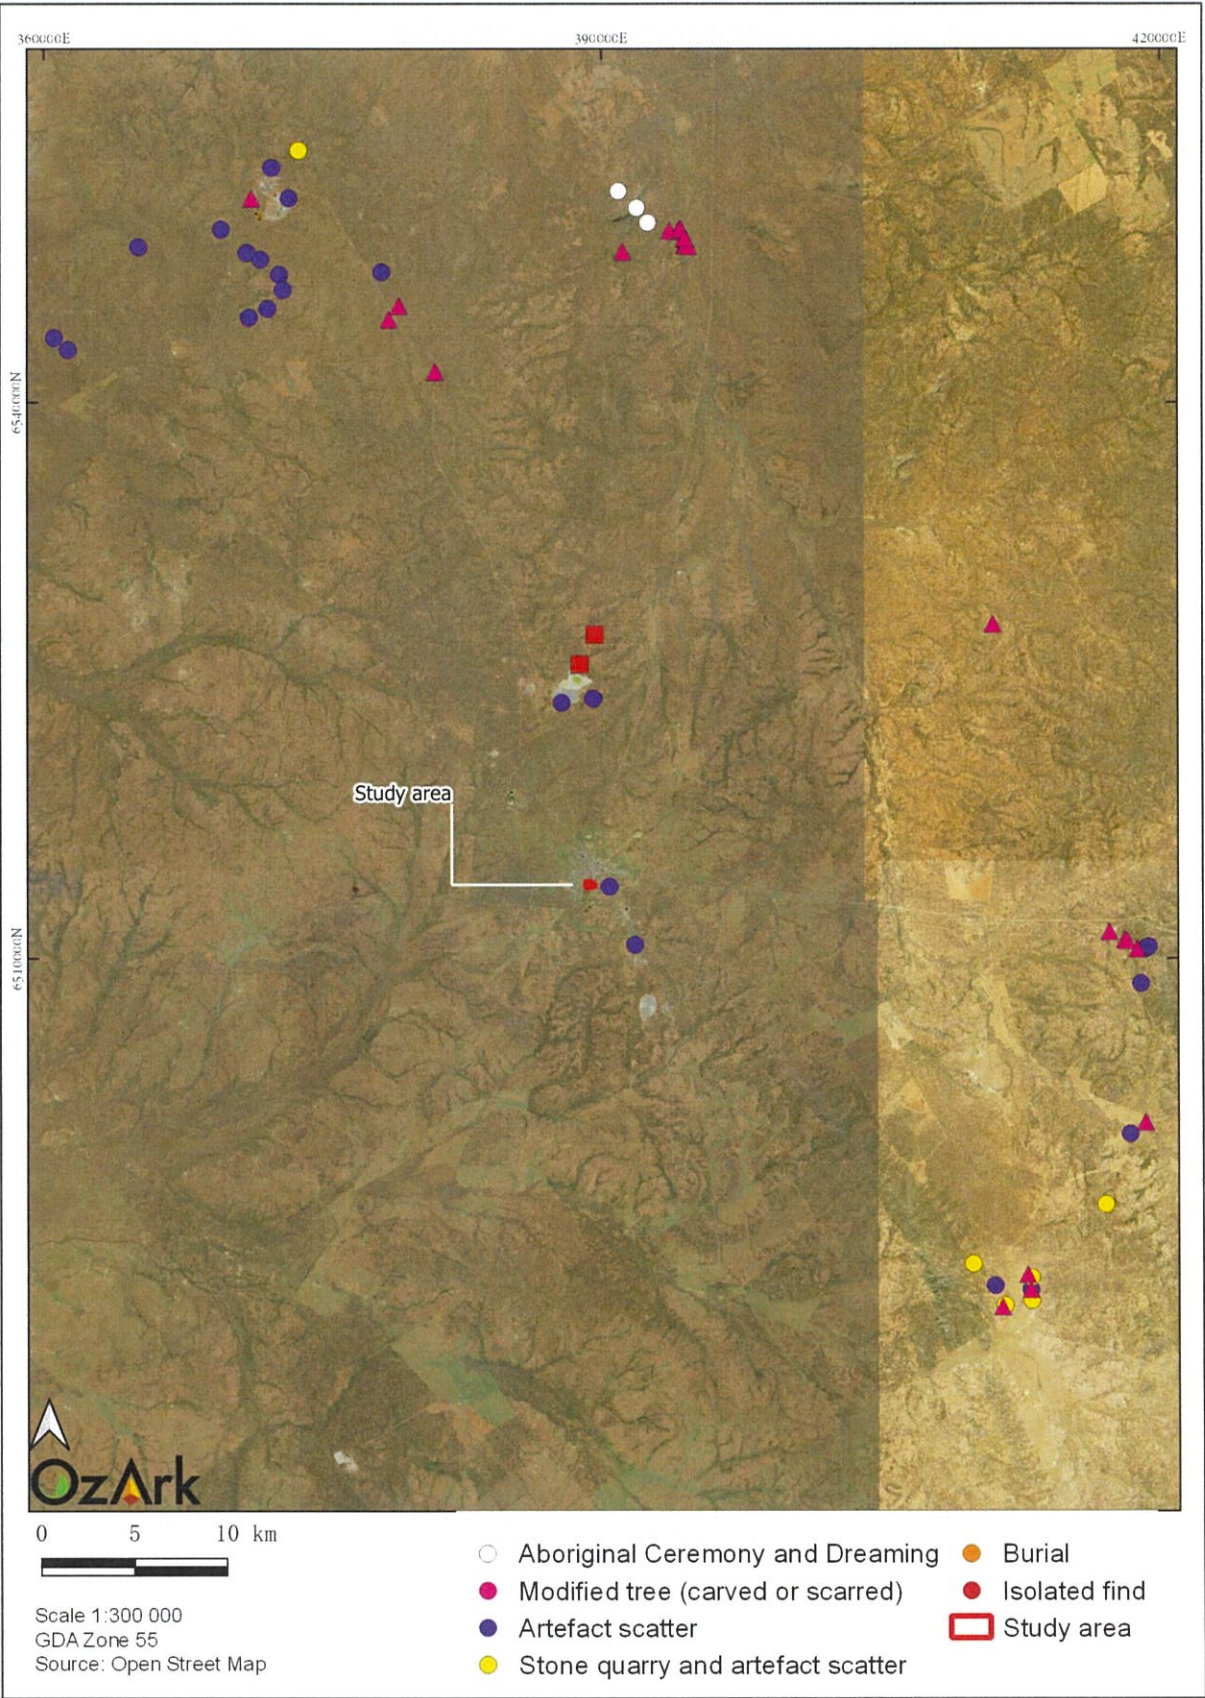
Figure 2-1: Previously recorded sites in relation to the study area.

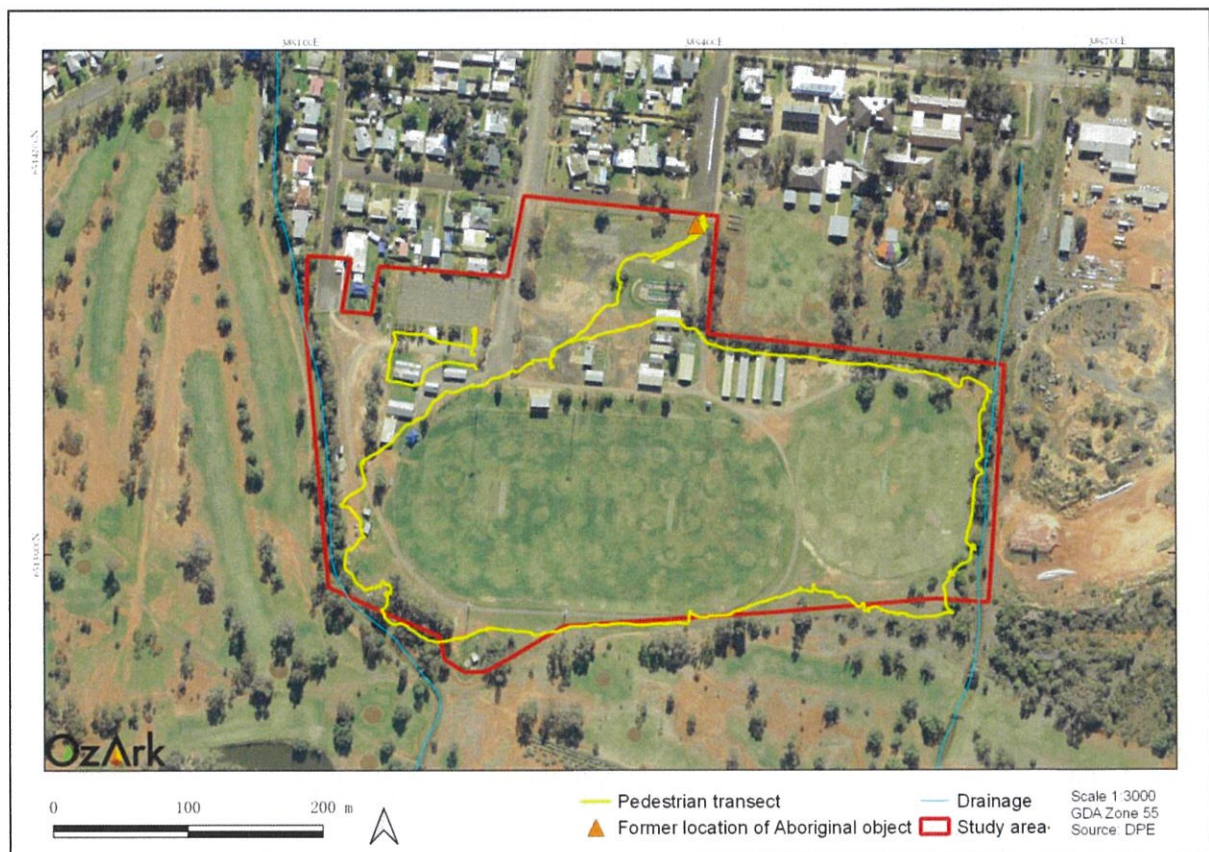
Figure 2-2: Survey coverage within the study area.

The location of the previously identified Aboriginal object (see **Section 1.2**) was revisited and no further objects were recorded (**Plate 1**). **Figure 2-2** shows the pedestrian coverage of the team during the visual inspection.

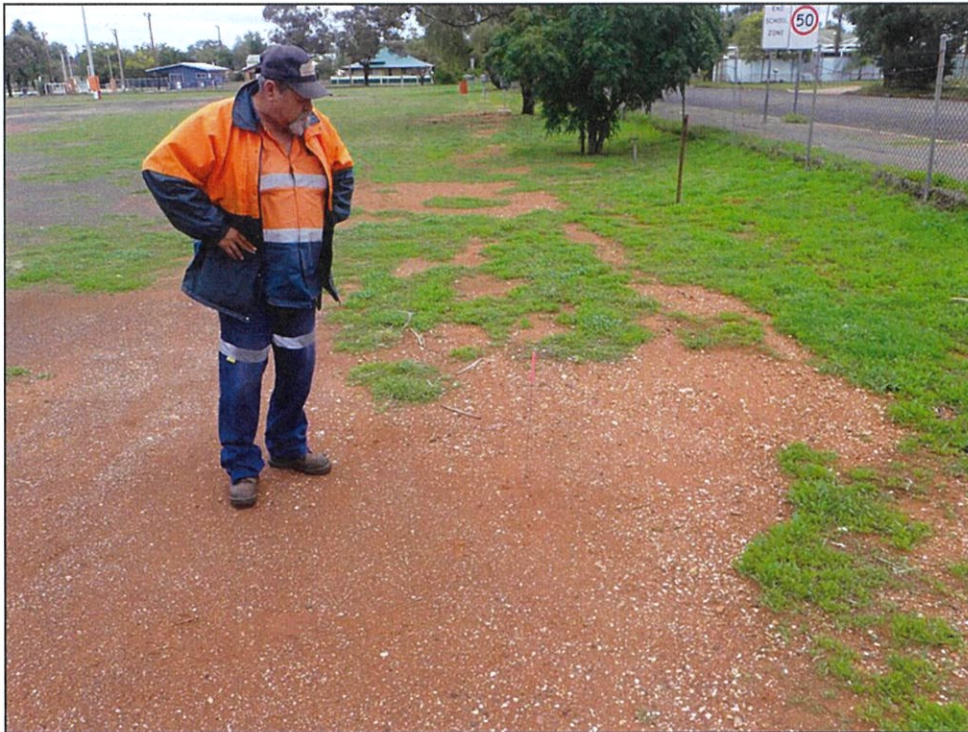
Plate 1: View west to the location of the previously recorded and removed Aboriginal object.

A site walkover for Aboriginal heritage was undertaken for the project by the Cobar Local Aboriginal Land Council (Cobar LALC) in April 2022. During the walkover, an isolated artefact was identified in the northern carpark area. The object was identified as a silcrete flake that was not in its original context and had likely been incidentally deposited at the site. The object was removed by the Cobar LALC site officer due to concerns that it would be damaged by vehicles.

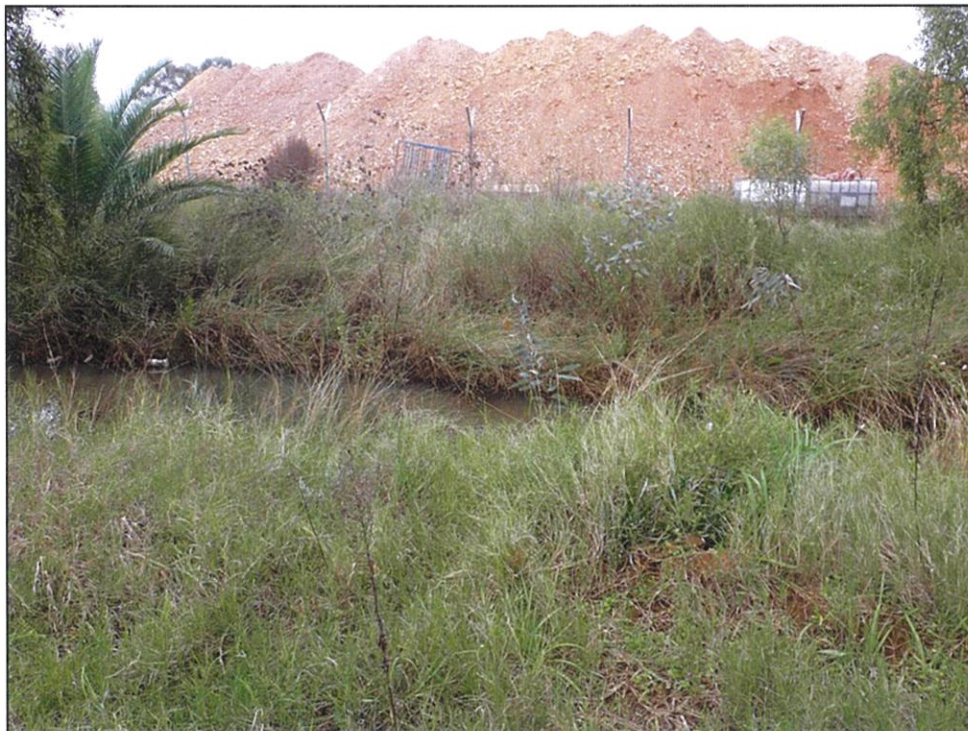
Plate 2: View east across the modified drainage line at the eastern boundary of the study area.

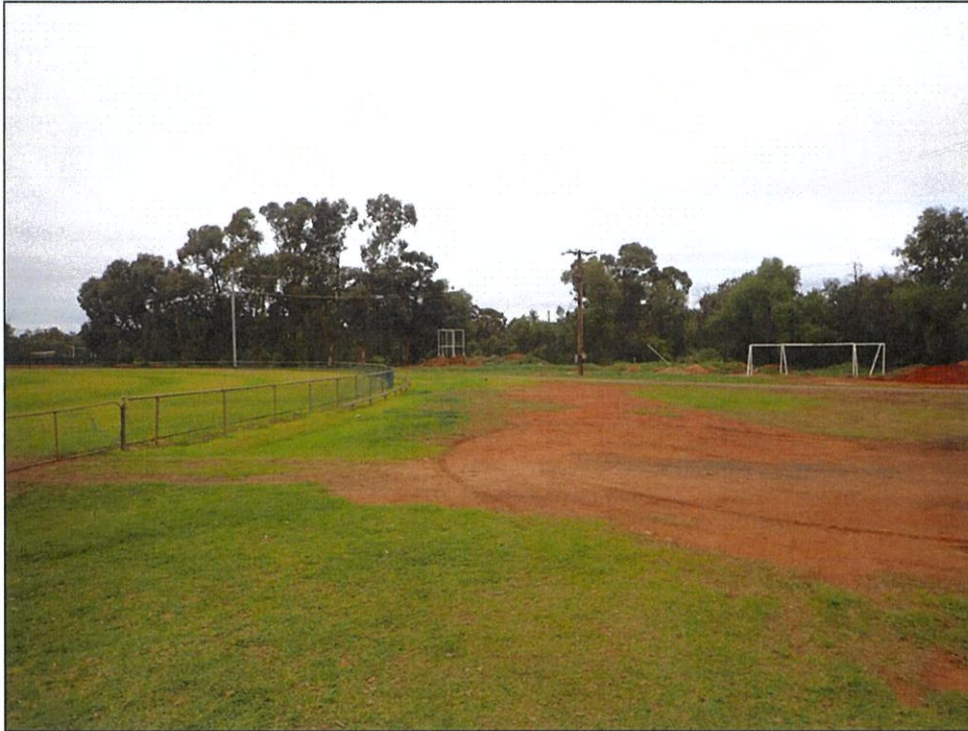
Plate 3: View south across the oval and landscaped surrounds showing spoil heaps in the background.

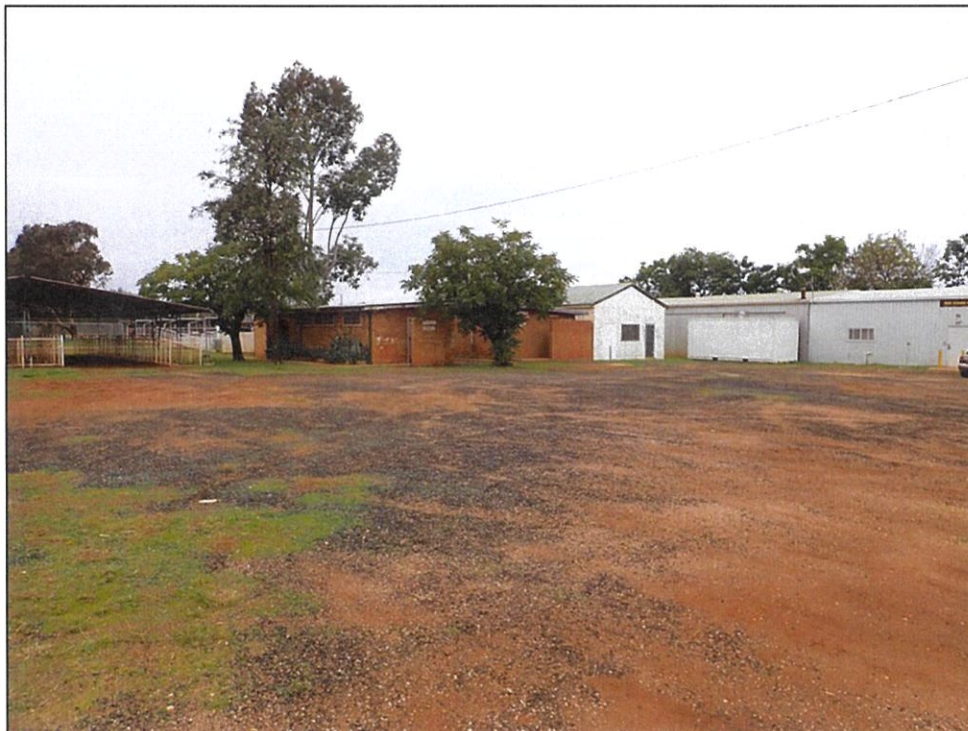
Plate 4: Example of sheds and stock infrastructure at the north of the study area.

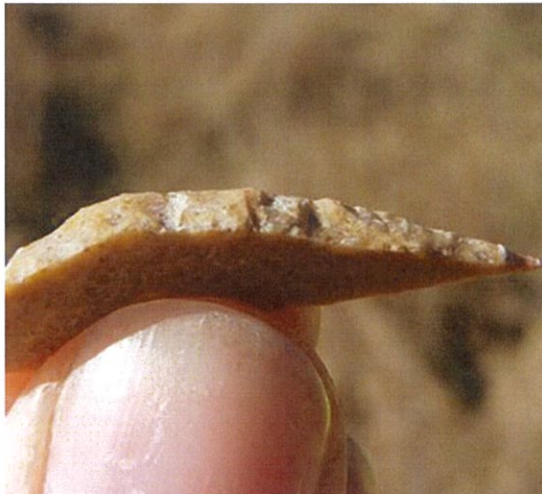
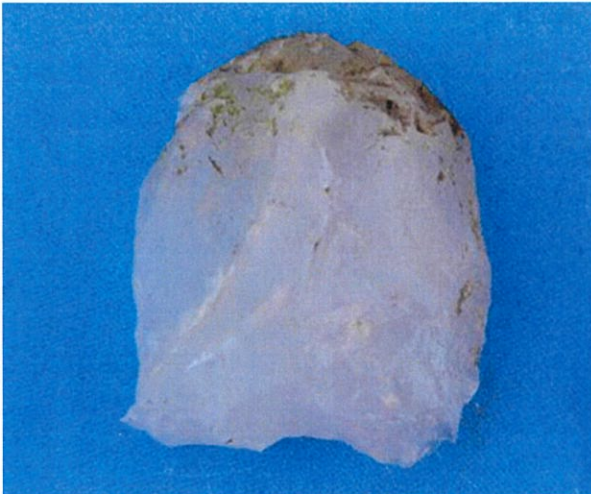
A retouched silcrete flake	A quartz flake

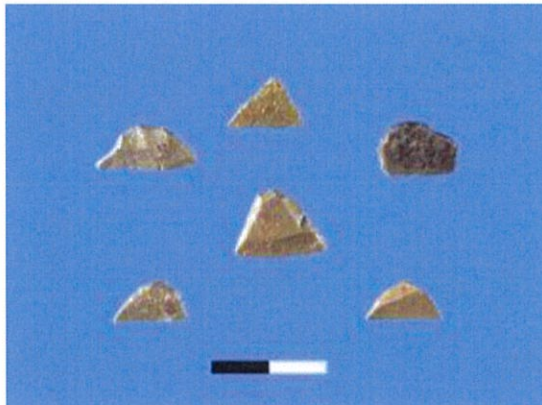
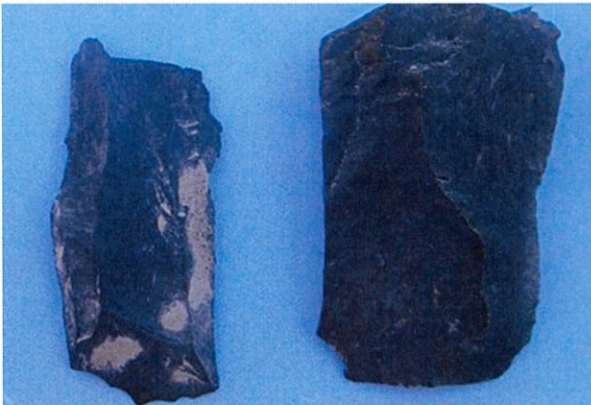
Microliths (scale = 1 cm)	Volcanic flakes

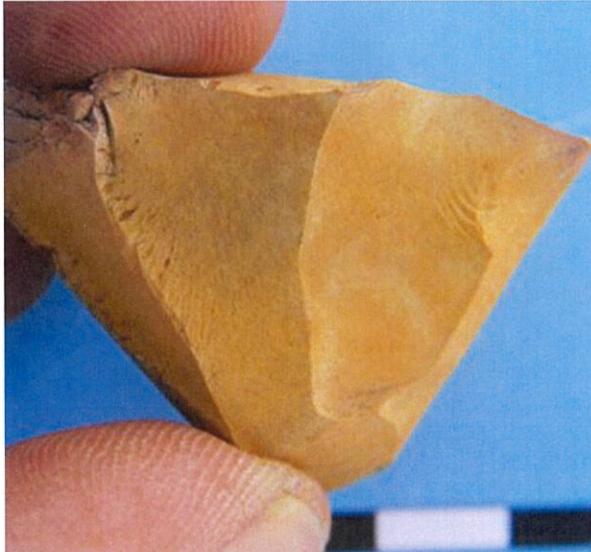
Flake characteristics (scale = 1 cm)	A mudstone/tuff core from which flakes have been removed

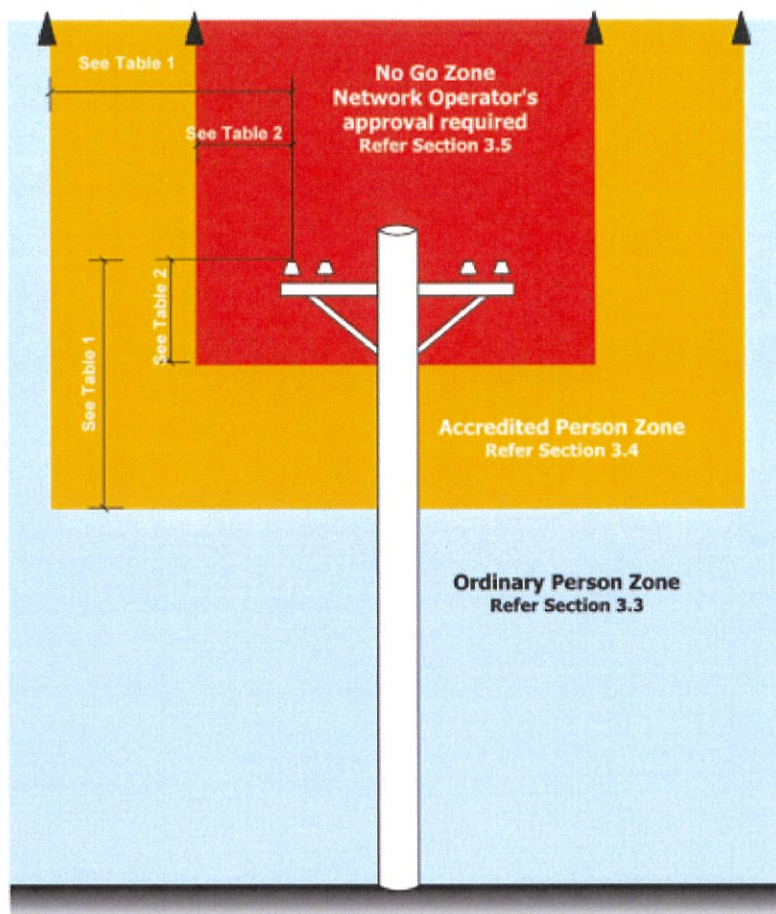
Figure 3 – Approach distances and work zones near overhead power lines

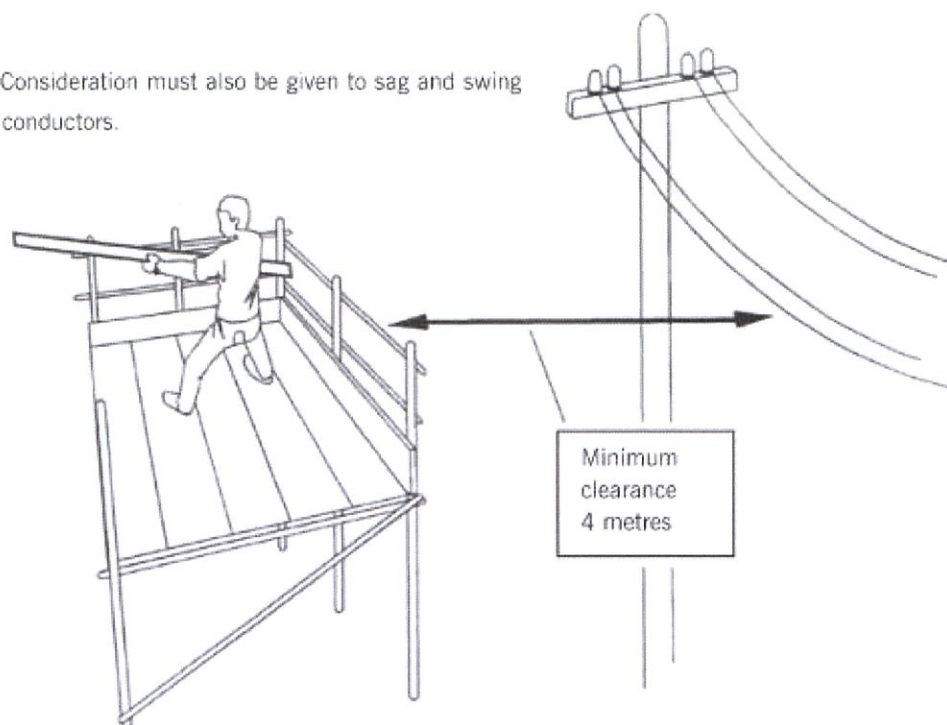
Note: End protection omitted for clarity

Figure 10 – A 4 metre approach distance applies in any direction where metallic scaffold is erected, used or dismantled near overhead power lines.

- (c) If there is the risk that the 4 metre approach distance cannot be maintained, the network operator must be contacted and a written risk assessment and safe work method statement including safe systems of work developed for the activities associated with the erection, use and dismantling of the scaffolding.

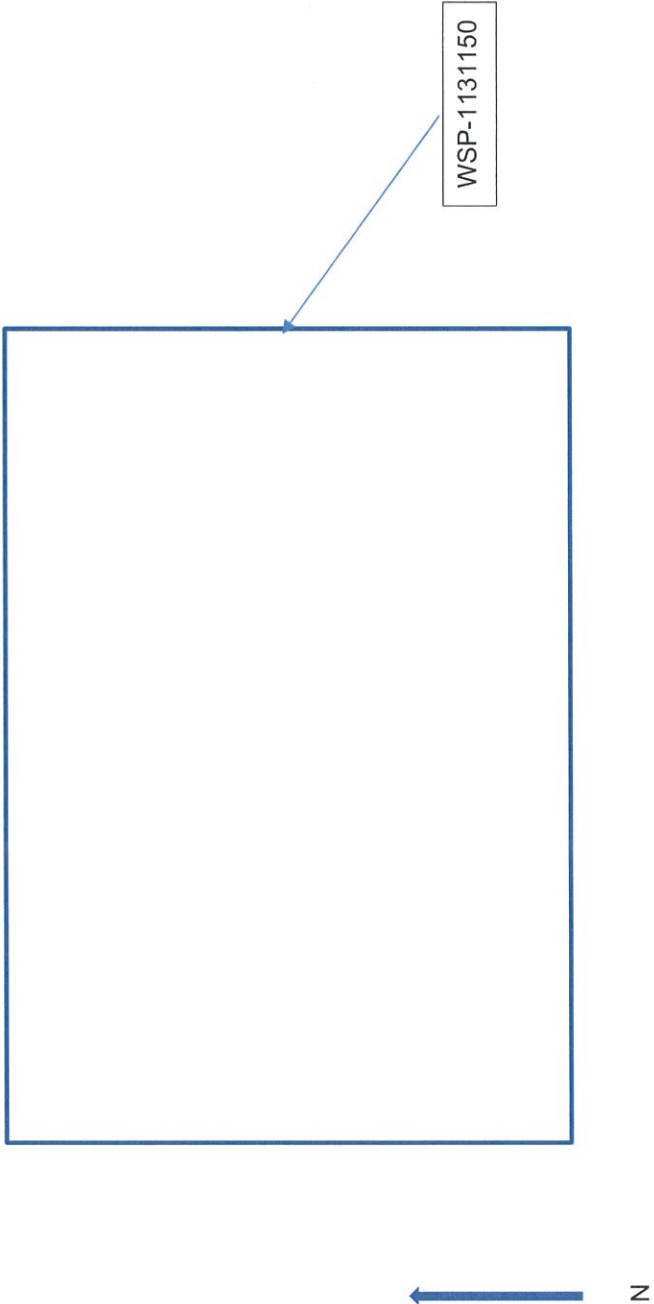
Figure 2: Floor Plan Showing Sampling Locations and Estimated Location of ACMs

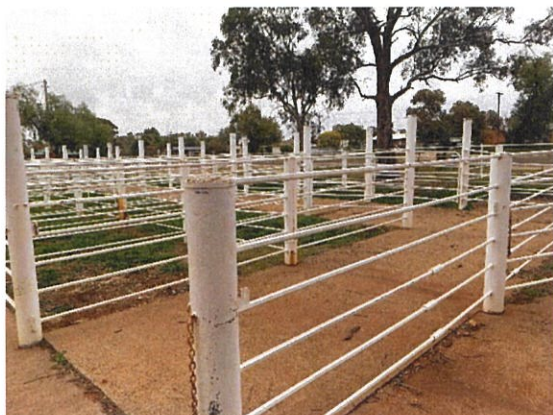
Photo 1: Metal structure white paint throughout, refer sample WSP-131150 - positive for lead paint

- The white paint to metal guard rails were in poor condition and peeled off throughout the building structure therefore was categorised as a Priority 2 – enclose, encapsulate or seal, reinspect periodically.
