REVIEW OF THE LAKE CARGELLIGO BUSH FIRE MANAGEMENT PLAN AND HV INSTALLATION SAFETY MANAGEMENT PLAN

PREPARED FOR GRAPHITE ENERGY PTY LTD

SUMMARY

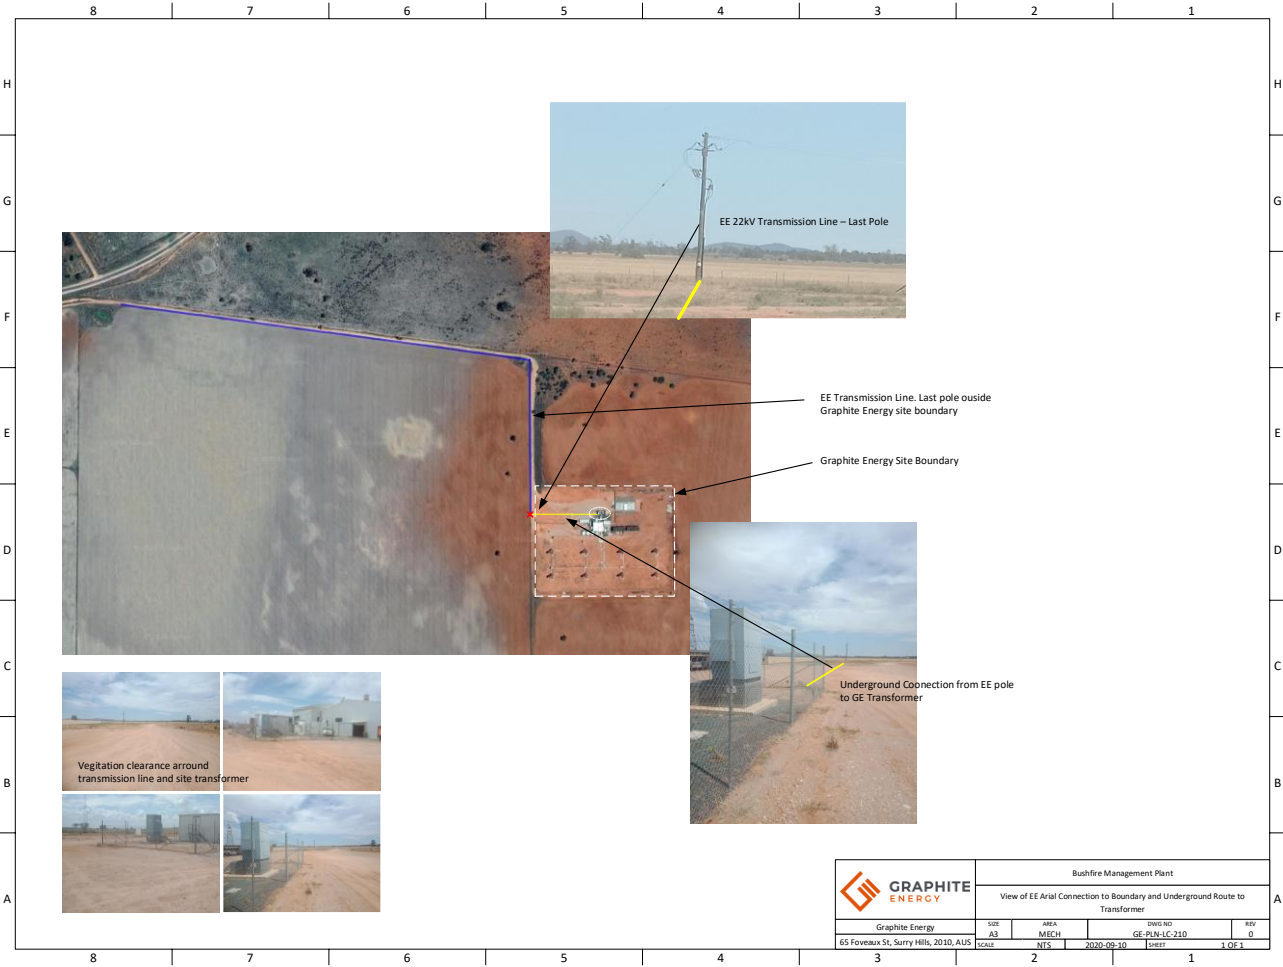
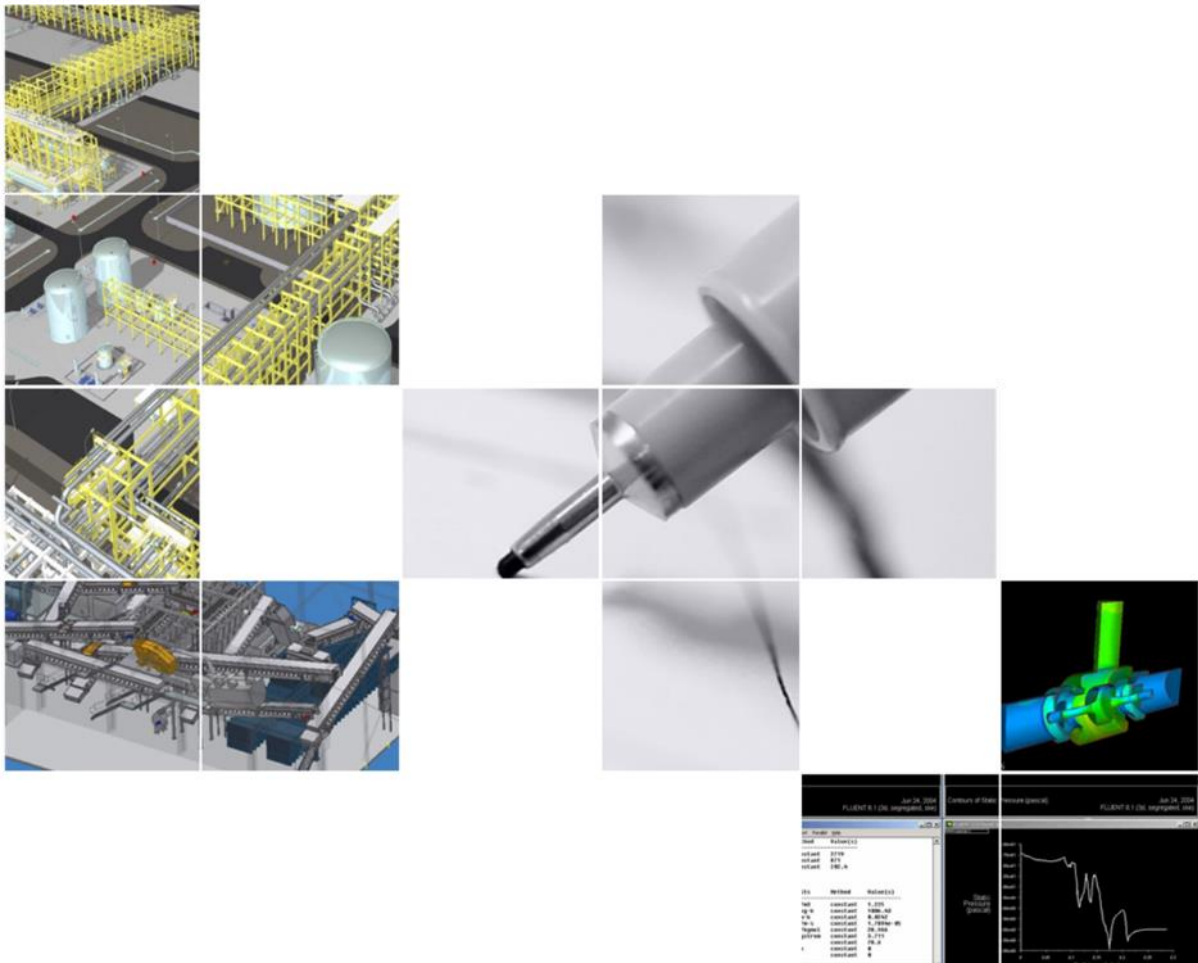
Appendix A Lake Cargelligo HV Connection and Distribution

The diagram below shows the 22kV connection to the boundary point outside the site and the underground connection from the site last pole to the GE substation and is an excerpt from the GE HV Bushfire Management Plan document. The diagram also displays an accurate representation of the vegetation in the vicinity of the GE HV installation

We note that the Graphite Energy Lake Cargelligo Facility does not have any aerial conductors or structures on its land or land under its control (Refer Appendix A). The connection for the Essential Energy supply is by underground trenching from the Essential Energy Pole to Plant Substation.
