LOT 1, DP 1268778

Preliminary Contamination Report

Job No.: B21829

The Treadstone Company

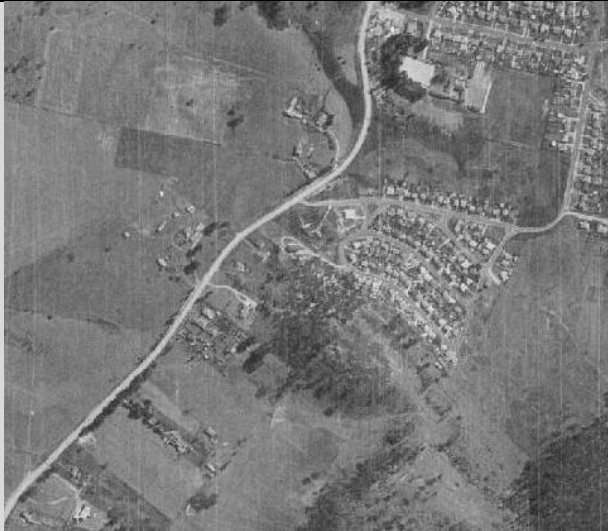
Date	Salient Features	Aerial Image Extract	
1965	No development identified on site. Several small outbuildings are present surrounding the site.

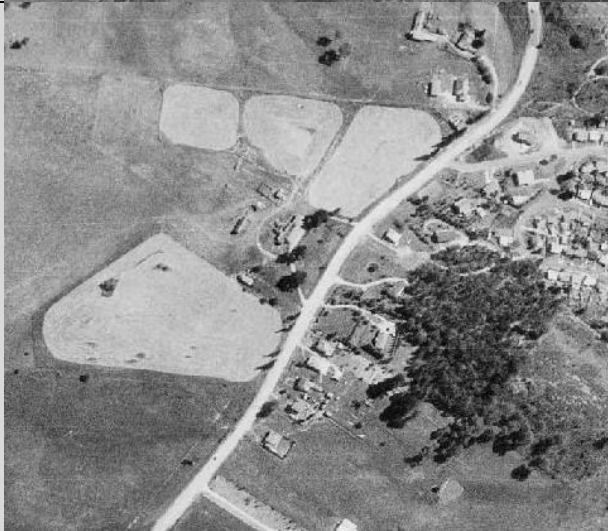
1974	Agricultural activity noted on site. Several outbuildings appear to be present.

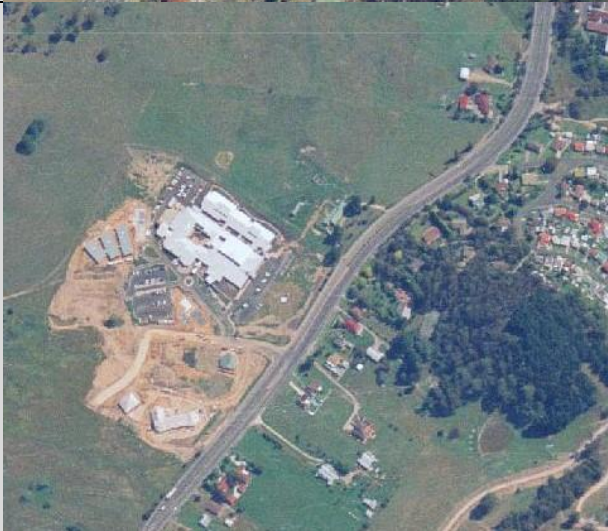
1998	Construction of the Lithgow Hospital on the southern borders of the site. A small pond is noted within the site.
