ACENERGY PTY LTD ON BEHALF OF GREENTECH SOLAR  
PROJECT NO 2 PTY LTD

## **Yoogali Solar Farm**

### PRELIMINARY SITE INVESTIGATION

Report No: P000223\_PCI\_001/R02

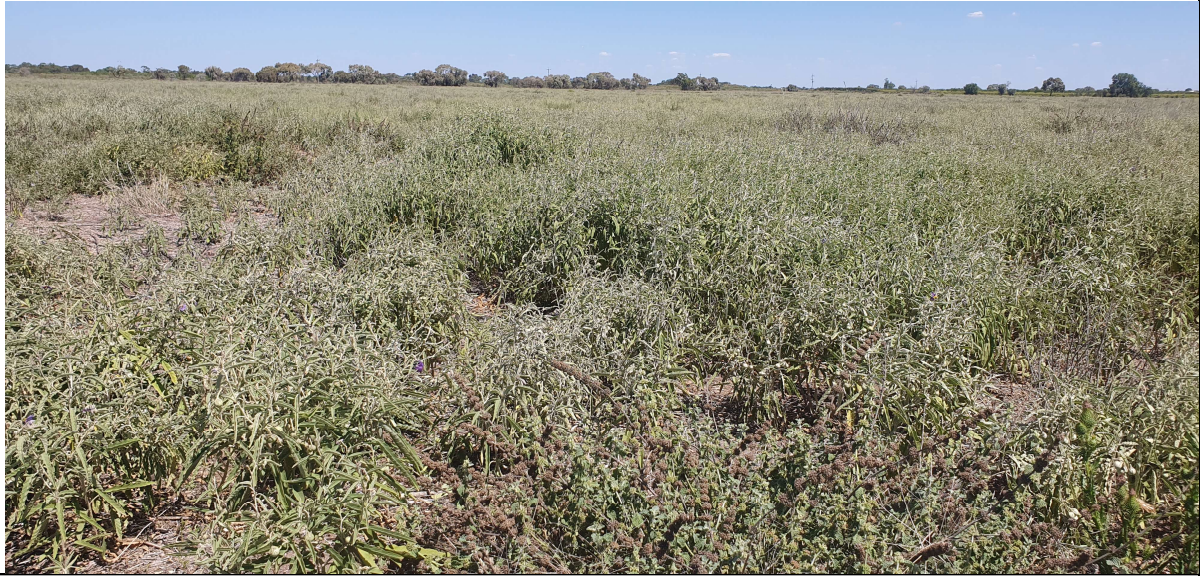
**Photo 1 – Site North-West, Southern Aspect**

No structures exist within the investigation area of the site. The site itself consists of groundcover vegetation (primarily grass), unsealed access paths, cleared areas and fences with gates.

Evidence of wastes having been disposed on the site by burial / landfilling was not identified at the site. The ground surface was observed to be generally even and no areas of potential subsidence were apparent.

Stressed vegetation, which may be indicative of soil and/or groundwater contamination, was not apparent at any locations during the site inspection.

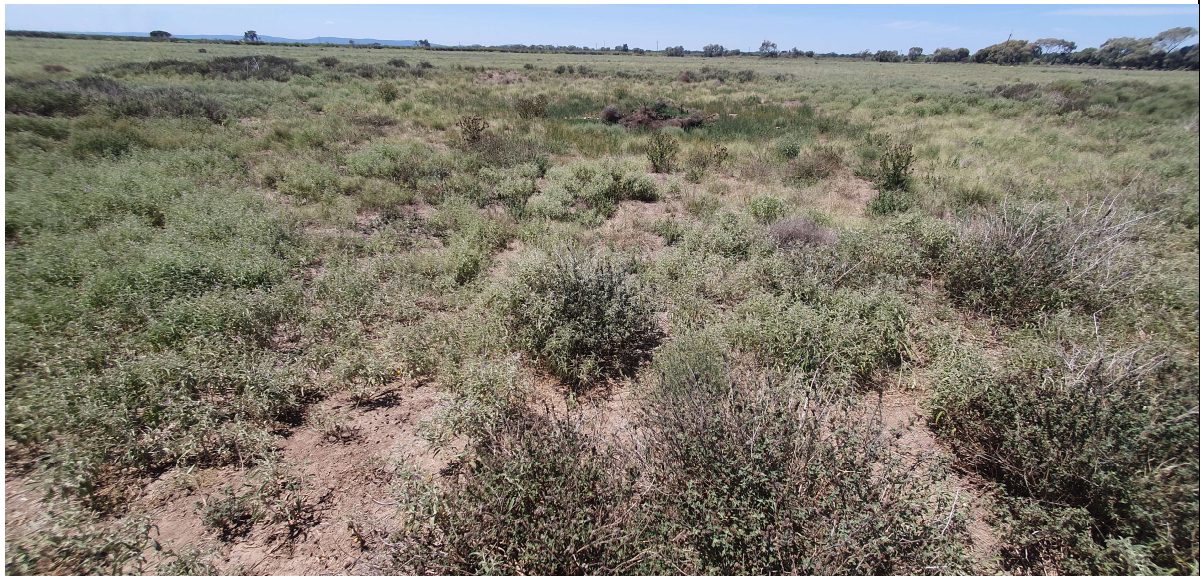
**Photo 6 – Farm Dam (Centrally Located)**

Defined drainage pathways exist at the site in the form of interconnected channels for irrigation purposes, and a farm dam also exists centrally on the site. Due to the landform, the majority of overland surface flow is presumed to be absorbed into the site. The catchment of surface water flow at the site may include off-site areas, including from roads and other properties.

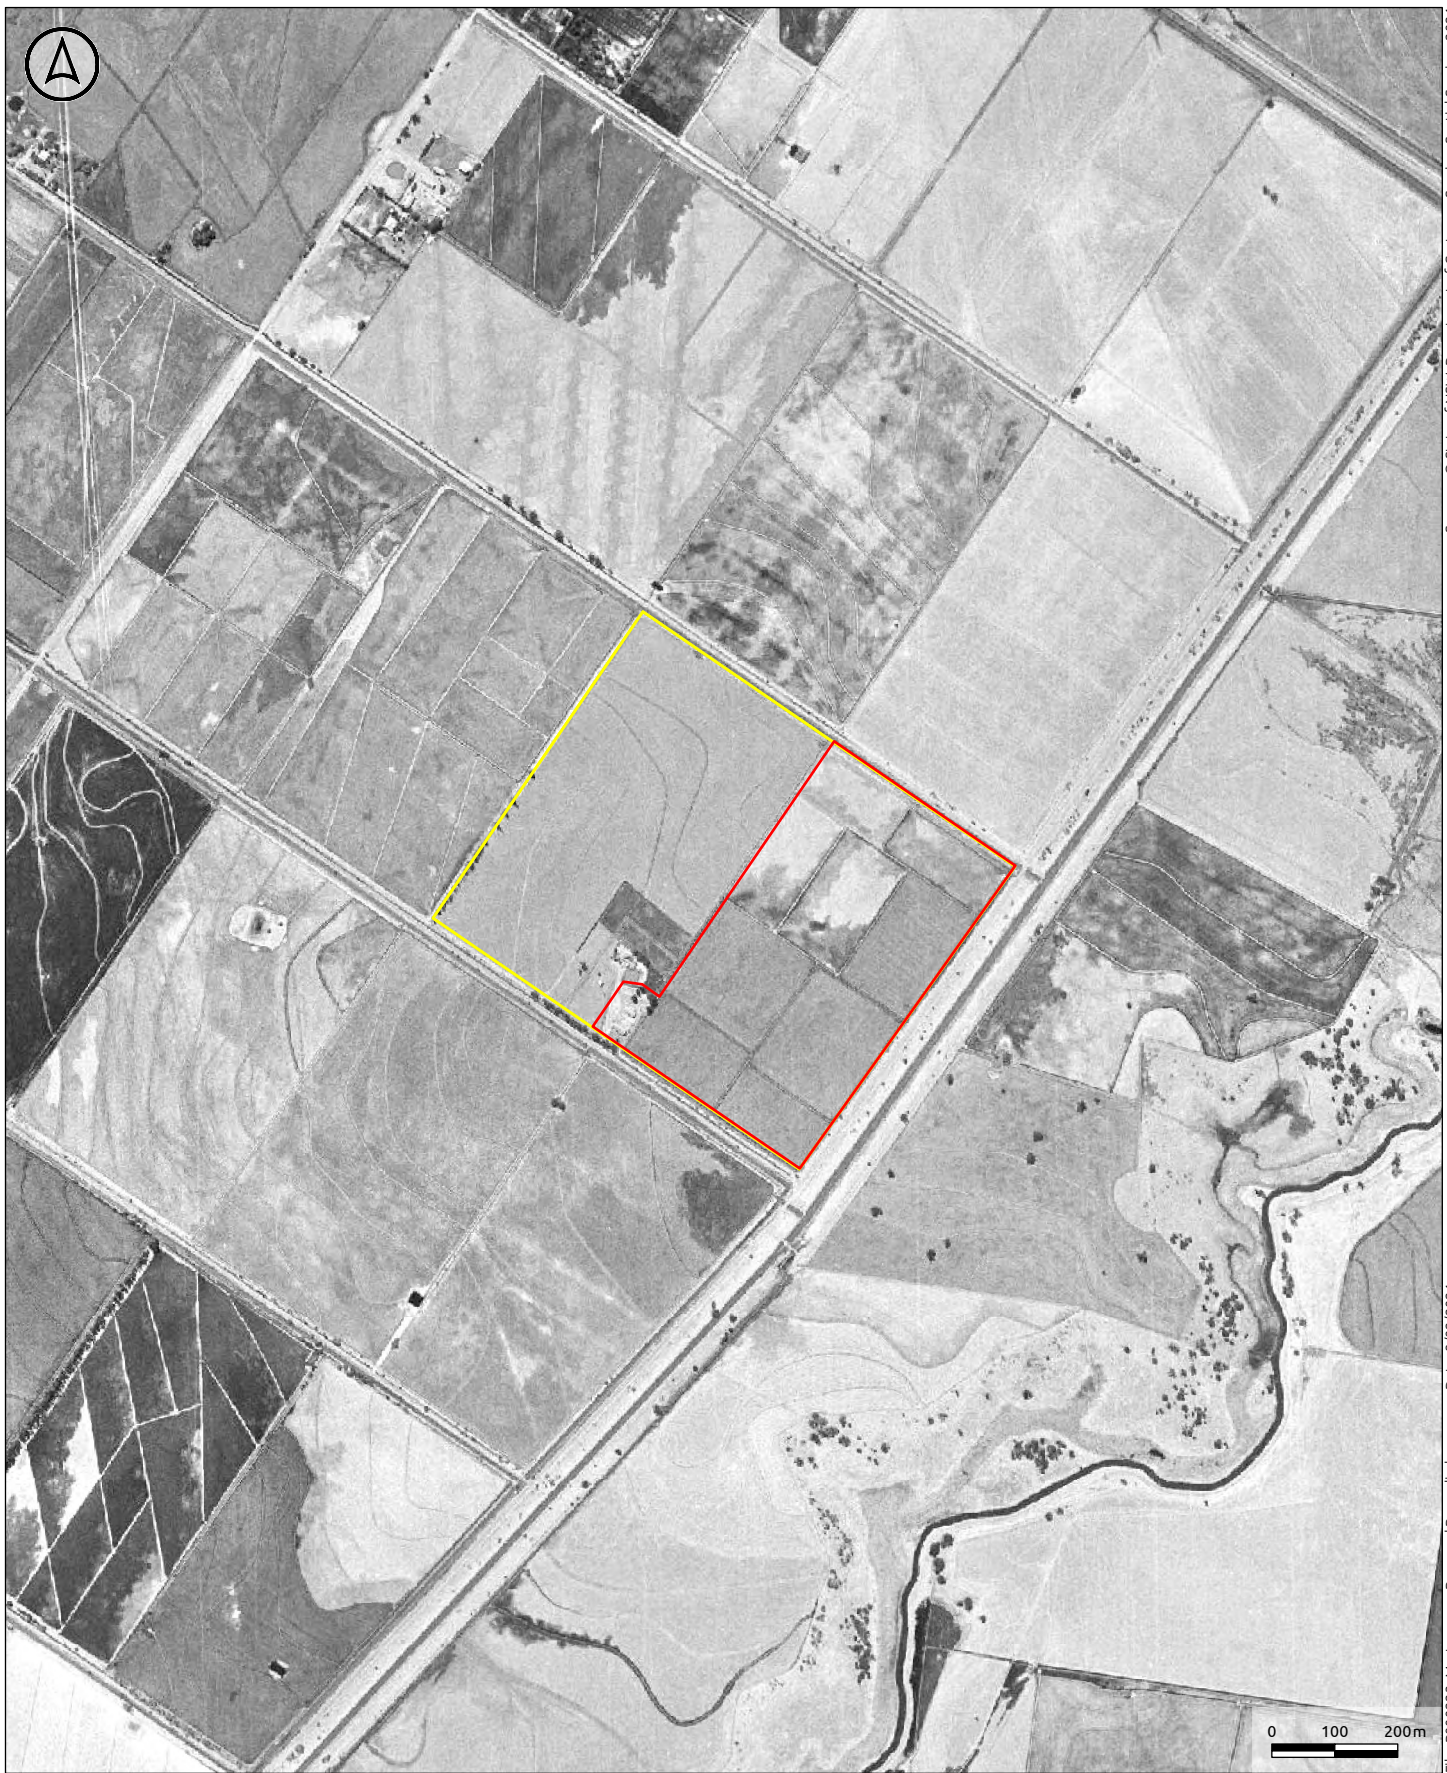
**ACENERGY PTY LTD**  
**Yoogali Solar Farm**  
**Historical Aerial Imagery 1958**

Date	Site Activity	Surrounding Land Use
1958	The site consists of a series of vacant paddocks. No structures or features of note are evident.	The area exists as rurally used land to the south-east of Griffith. Agricultural land uses (likely cropping) are present surrounding the site.  Cleared land is present to the south-west of the site.
1965	Features dividing site into paddocks are more defined. The remainder of the area encompassing the site is generally unchanged.	Some structures are present in the cleared area to the south-west of the site. Land uses of the remainder of the surrounding area do not appear to have been significantly altered.
1977	The layout of paddocks at the site has been altered, and contour banks are now present. The farm dam is present, and trees have been planted in east-west alignment with the dam. The remainder of the area encompassing the site is generally unchanged.	Land uses of the surrounding area do not appear to have been significantly altered.

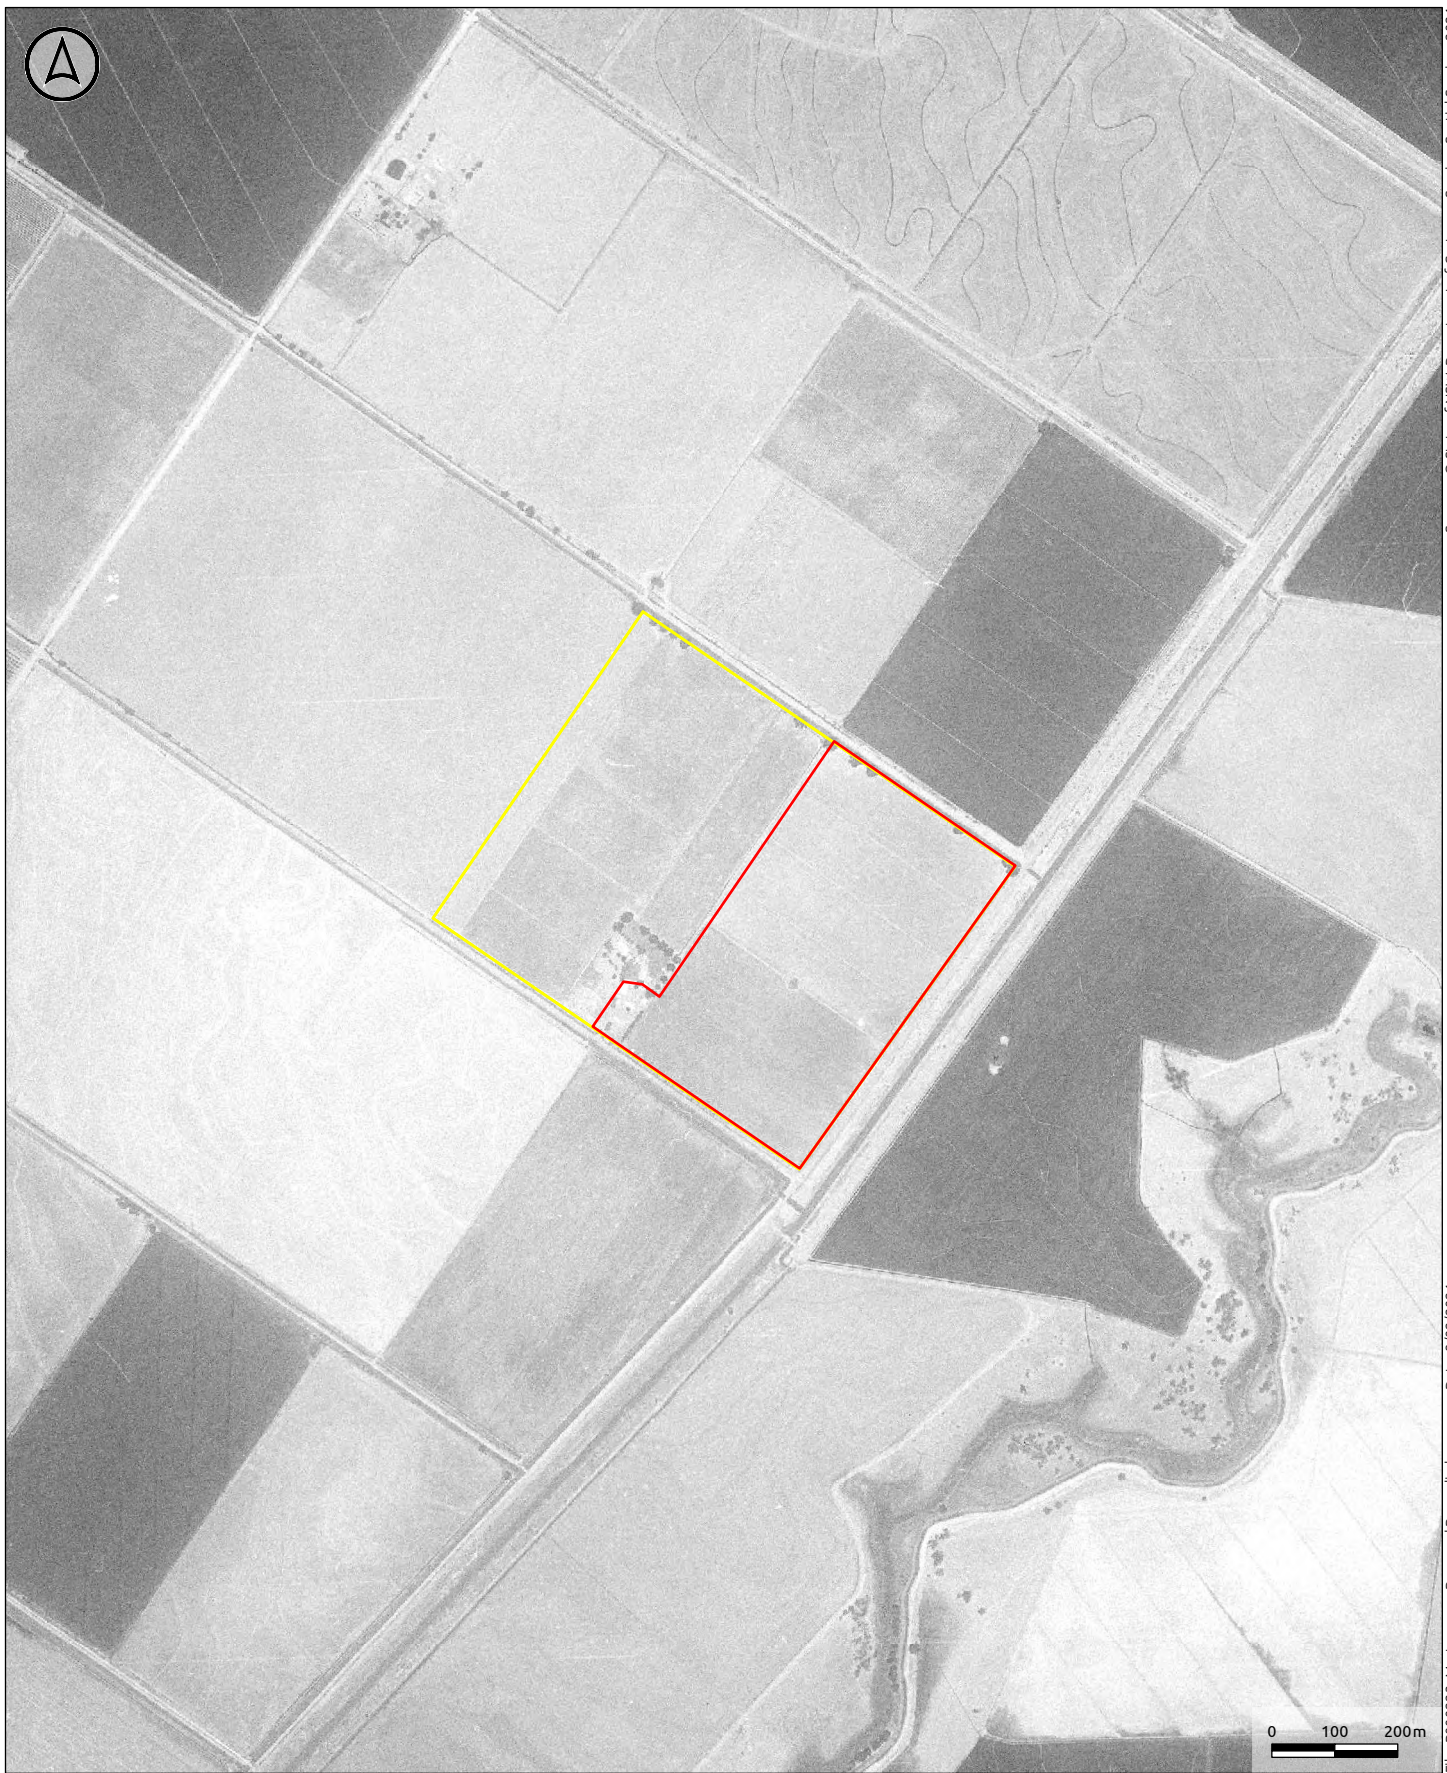
**ACENERGY PTY LTD**  
**Yoogali Solar Farm**  
**Historical Aerial Imagery 1988**

Date	Site Activity	Surrounding Land Use
1988	The contour banks and centrally-located trees have been removed. The remainder of the area encompassing the site is generally unchanged.	Land uses of the surrounding area do not appear to have been significantly altered.
1993	Cropping in the northern portion of the site is occurring. The remainder of the area encompassing the site is generally unchanged.	Land uses of the surrounding area do not appear to have been significantly altered.
1997	Cropping across the site is generally less intensive. The remainder of the area encompassing the site is generally unchanged.	Land uses of the surrounding area do not appear to have been significantly altered.
2015	The area encompassing the site is generally unchanged.	The area to the north of the site now appears to be used for vineyarding. Land uses of the remainder of the surrounding area do not appear to have been significantly altered.
