## **PRELIMINARY SITE INVESTIGATION (PSI) WITH TARGETED SAMPLING**

Proposed School  
Lot 1 Magpie Hollow Road, South Bowenfels NSW 2790

*4 November 2024*

Prepared for Dezin

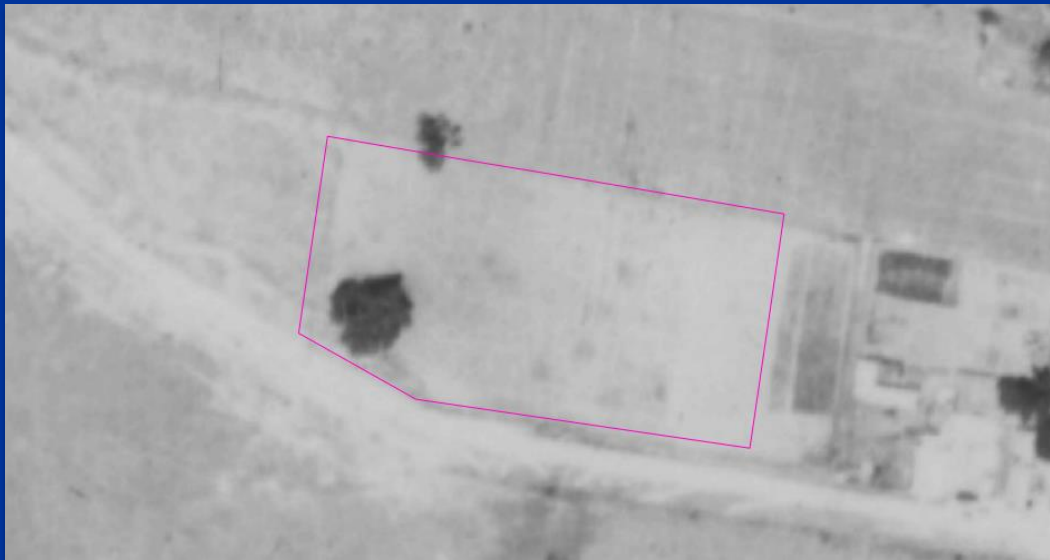
**1950 AERIAL PHOTOGRAPH**

No building structures can be seen on the site. Appears to be a minor amount of vegetation on site and some buildings on the eastern neighbouring side.

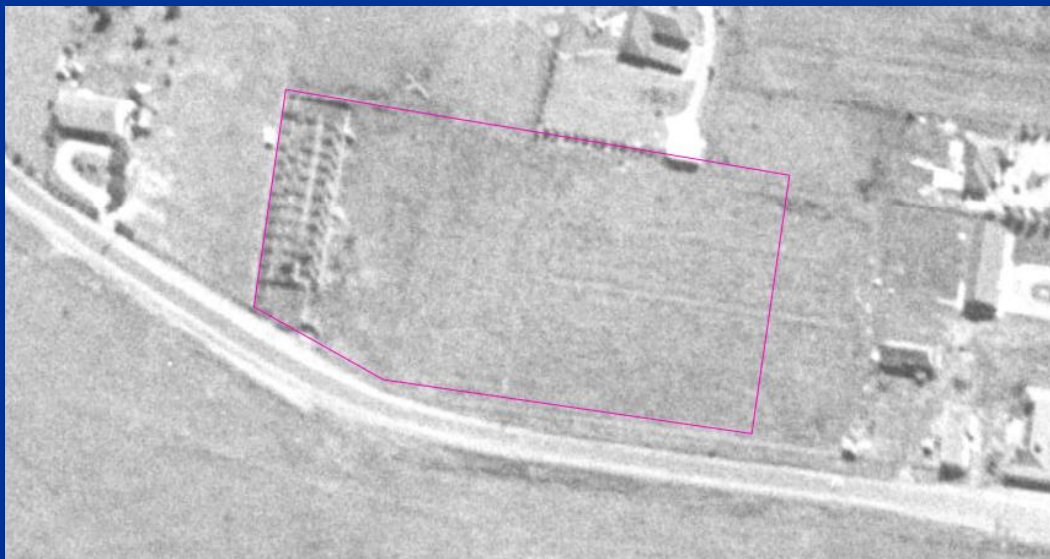
**1979 AERIAL PHOTOGRAPH**

Unclear what is on the western end of the site, it is suspected that it could potentially be a small orchard or stalls of some kind. More buildings have been constructed on the northern and western neighbouring sides.

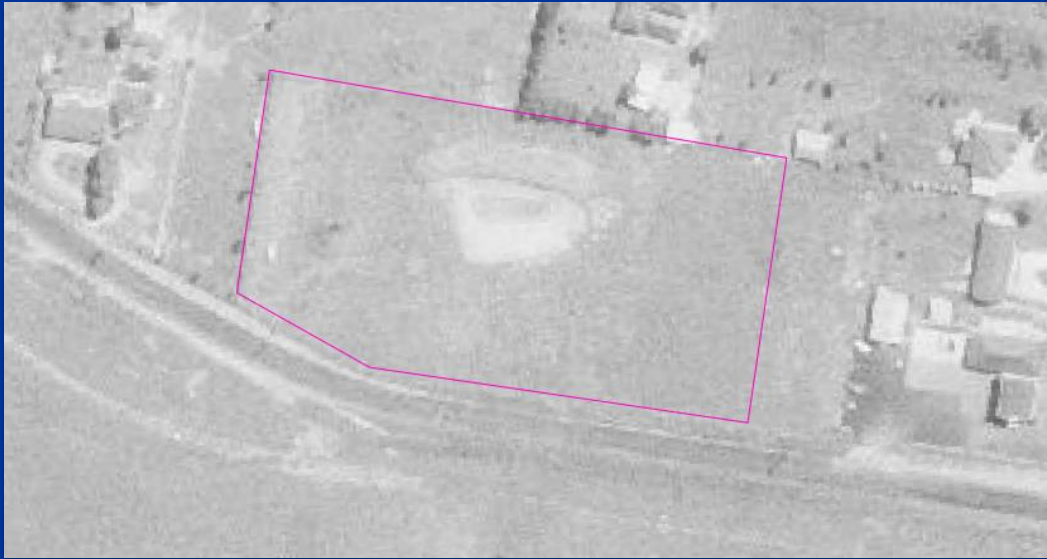
### 1984 AERIAL PHOTOGRAPH

A dam can be seen in the centre of the site, no other significant changes are noted.

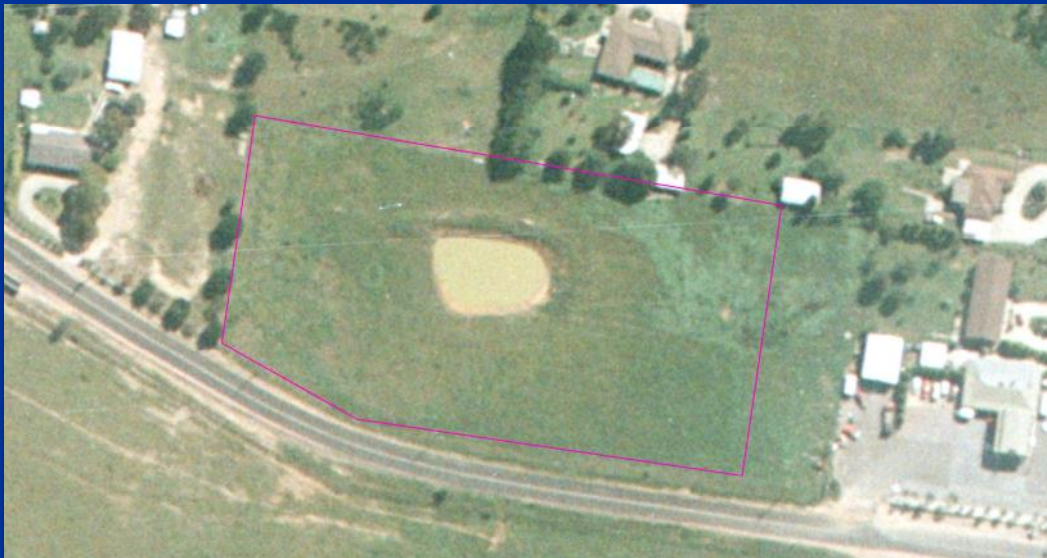
### 1990 AERIAL PHOTOGRAPH

No significant changes since previous aerial photo. Dam still present in centre of site.

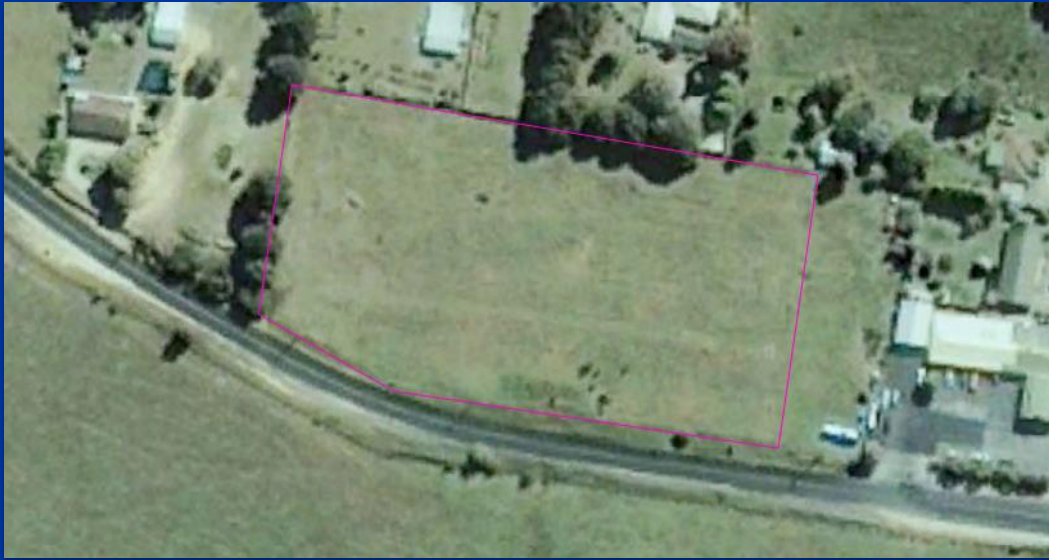
**2002 AERIAL PHOTOGRAPH**

Dam has now been backfilled, no other significant changes.

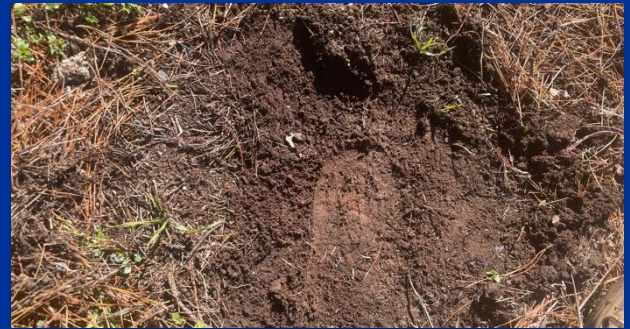
**Photo 4**

Exposed soil surface.

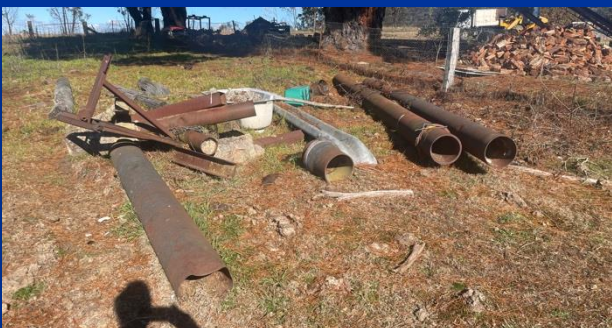
**Photo 5**

Residual fencing construction material along the western boundary of the site.
