# Site Contamination Investigation

**Client:** Bourke Aboriginal Corporation Health Service (BACHS)

**Site Address:** 88-96 Mitchell Street,  
Bourke, NSW 2840

**Our Reference:** 42571 ER01\_C

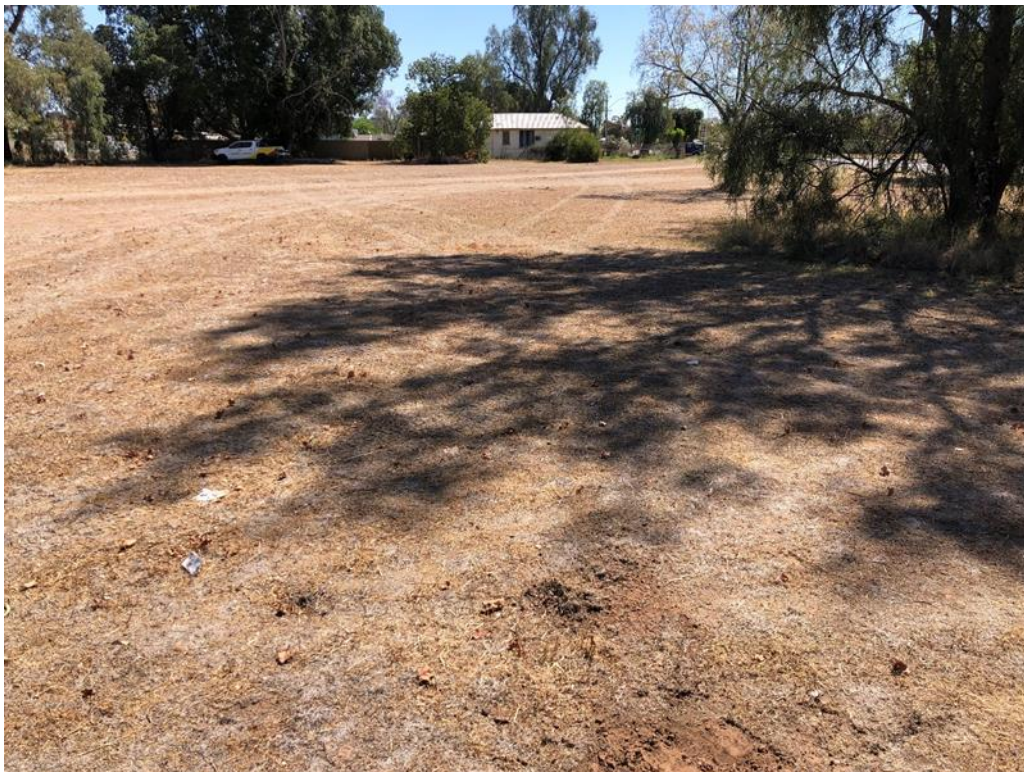
- The Subject Site is not fenced and access to the site is possible by vehicle and pedestrians. Both vehicle tracks and a footpath are evident (Figure 4.1).

Figure 4.1: View across the Subject Site looking west, vehicle and pedestrian tracks visible.

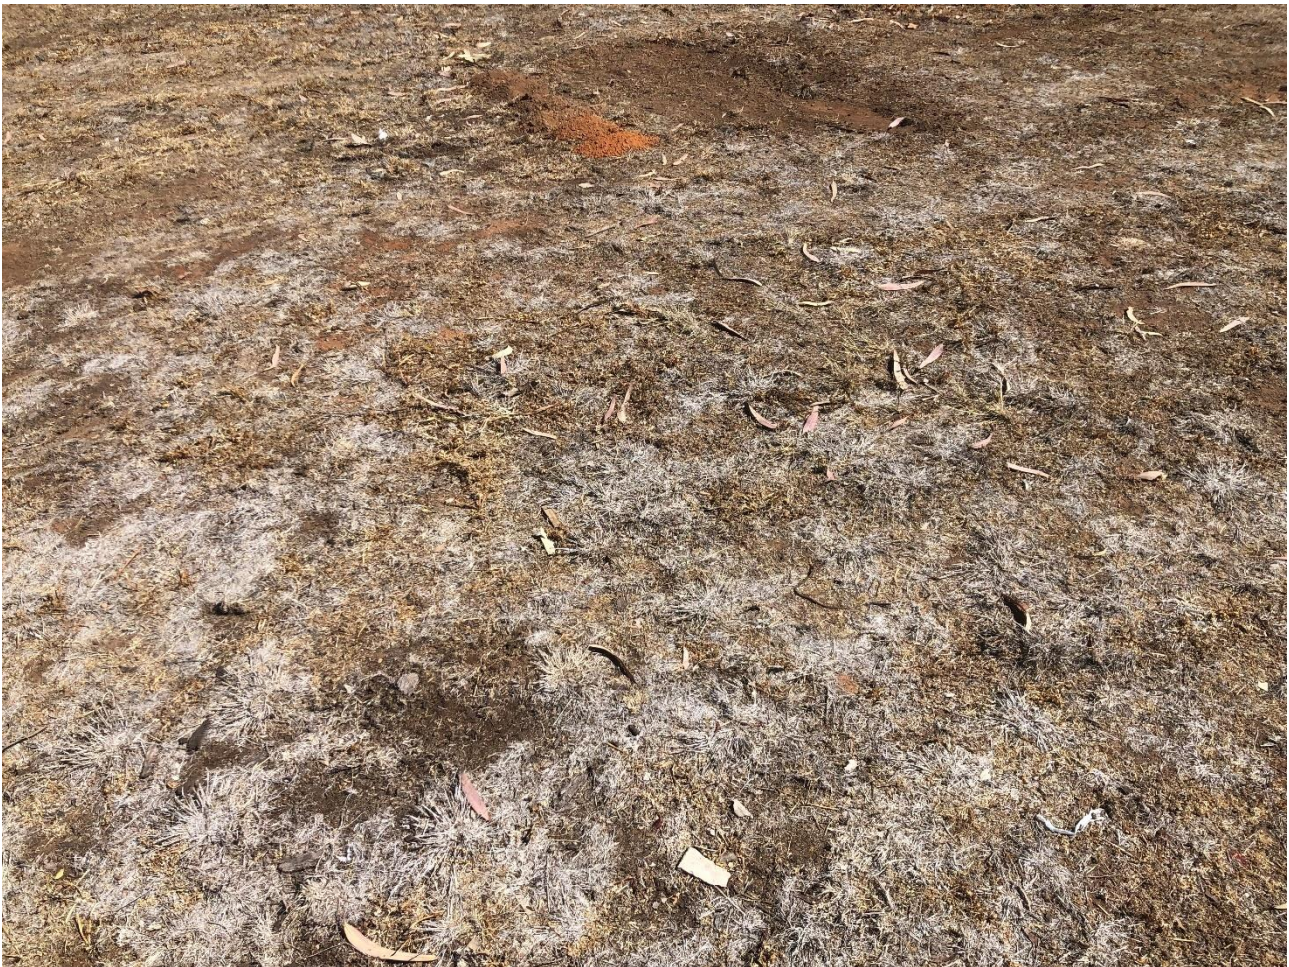
- At the time Barnson conducted the site inspection, most of the Subject Site was covered with maintained grass (very dry) with trees around the perimeter (Figure 4.2).
- No large-scale discoloration or staining visible of open ground or soil, and no obvious discoloration or irregularities in the occurrence of vegetation was observed during the site inspection.
- Fragments of fibre reinforced cement sheet was observed on the surface of the site (Figure 4.3). Fragments were also observed in the layer of soil just under the surface (approx.. 100mm to 200mm) upon excavations undertaken along the northern half of the site (Figure 4.5).
- Stockpiled sand as well as brick and concrete fragments observed under trees in the southwest corner of the site No other evidence of illegal waste disposal observed anywhere on site.

Figure 4.2: Dry grass cover on site..

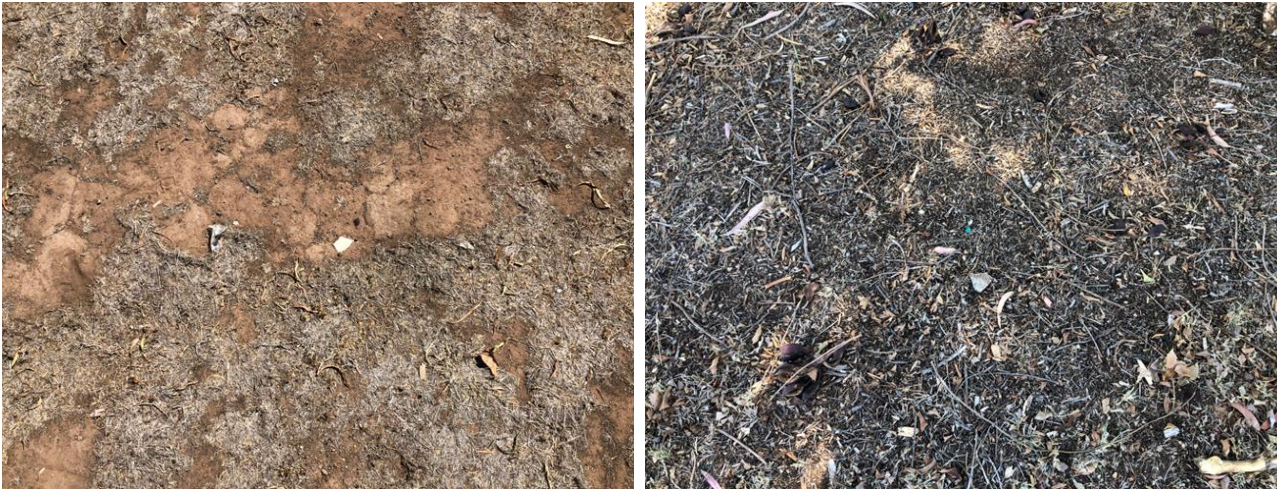
Figure 4.3: Fragments of fibre reinforced cement sheet.

The presence of asbestos containing material (ACM) as fragments on surface as well as in sub-surface soil was confirmed. The proposed development will require excavation of the site which will disturb the surface and buried fragments. Although broken, the bonded ACM fragments appear in reasonable condition and are not easily crumbled i.e. not fibrous asbestos. There is no evidence from the site history or direct observation during the site walkover that other fibrous asbestos materials (such as insulation or woven materials) are present on the site. Soil samples analysed for asbestos confirmed the presence of bonded ACM fragments only.

- The asbestos containing material (ACM) at the Subject Site, requires specialist attention during any removal or remedial action. It is recommended that during any removal of waste from this area, the ACM be removed and transported to a landfill, licensed to accept the waste, for disposal. The removal and disposal task can be undertaken by either a competent person or a licensed asbestos removalist.

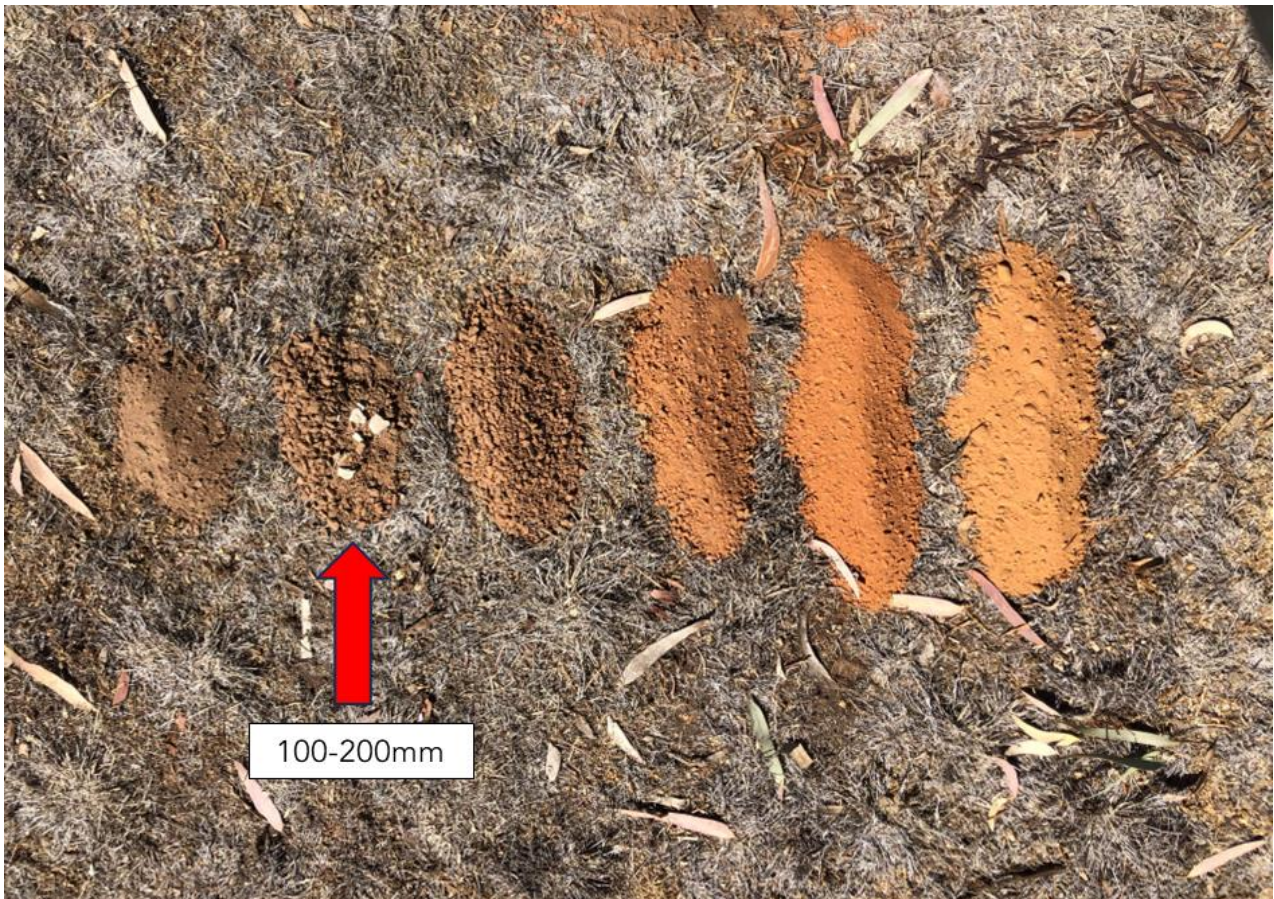
Figure 4.4: Fragments of fibre reinforced cement sheet in excavated soil.

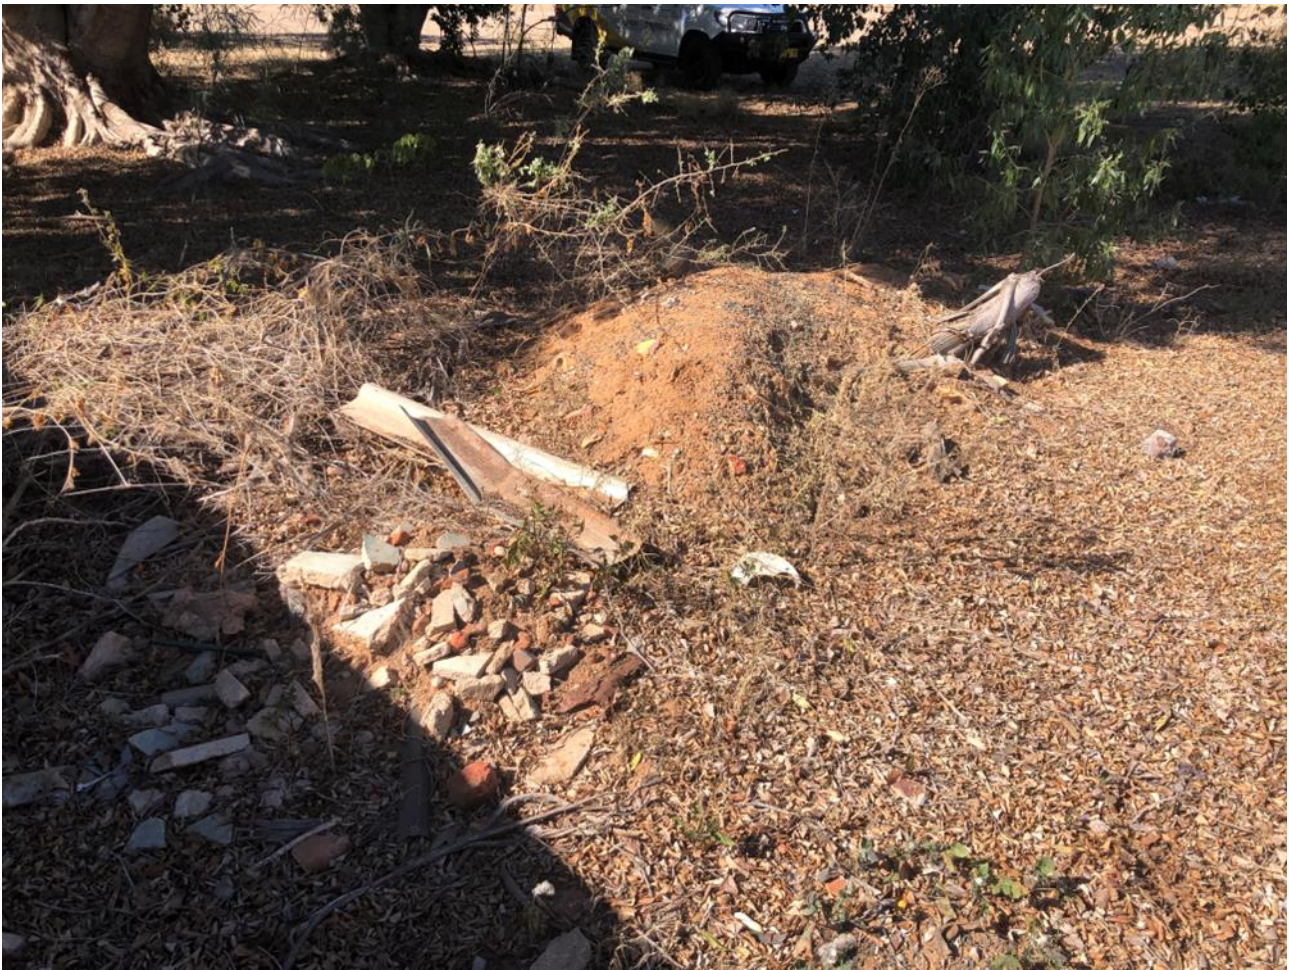
Figure 4.5: Sand and demolition waste.

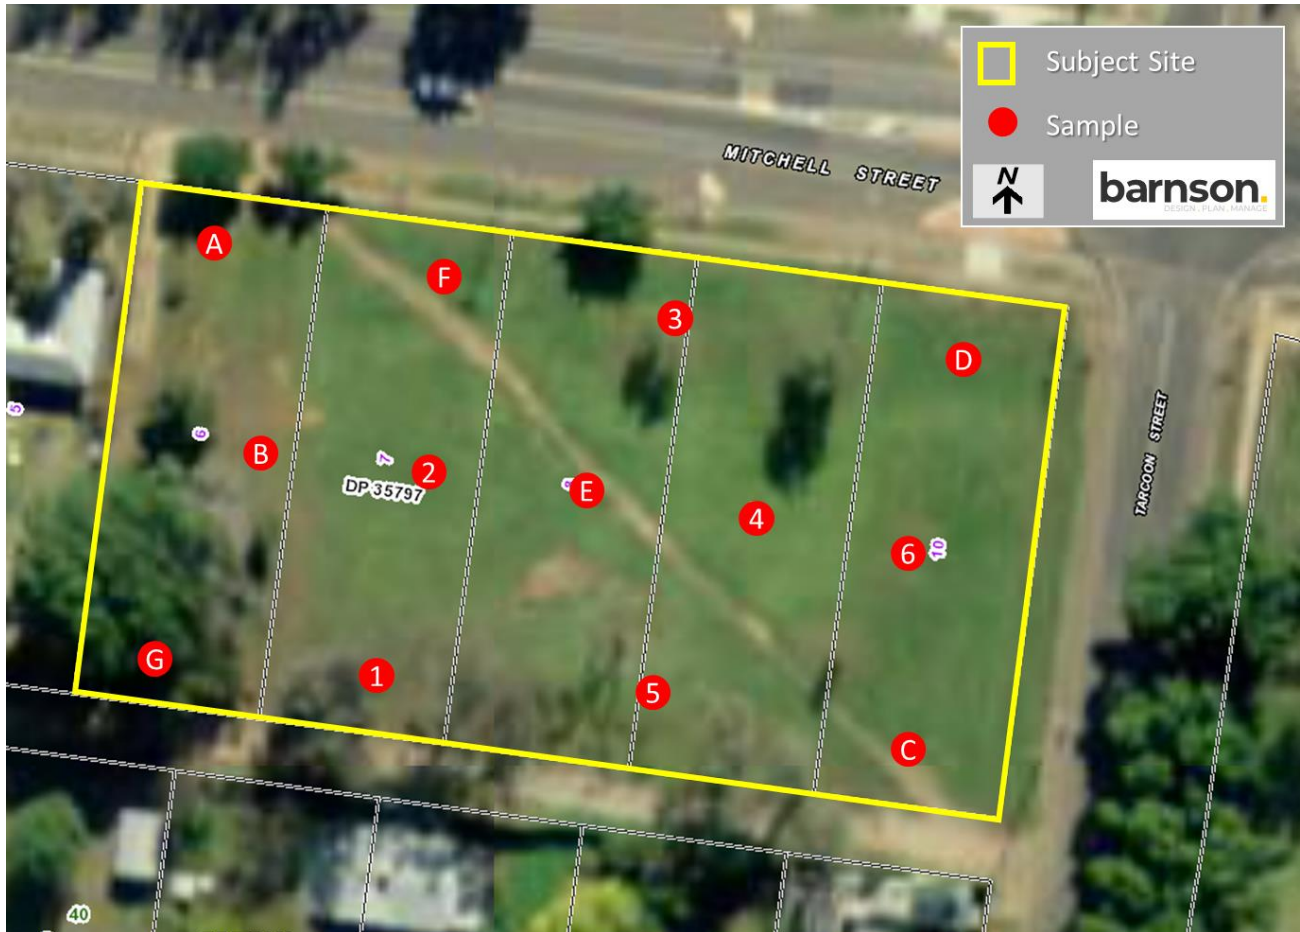
The pattern followed for the soil sampling can be described as a combination of Systematic and Judgement Sampling, where points are selected on a regular spaced grid with certain locations excavated to a greater depth based on the investigator's knowledge of the proposed land use and likely distribution of contaminants

Figure 4.6: Surface soil sample locations.
