# Remedial Action Plan

**Client:** Bourke Aboriginal Corporation Health Service (BACHS)

**Site Address:** 88-96 Mitchell Street,  
Bourke NSW 2840

**Our Reference:** 42571-ER02\_A

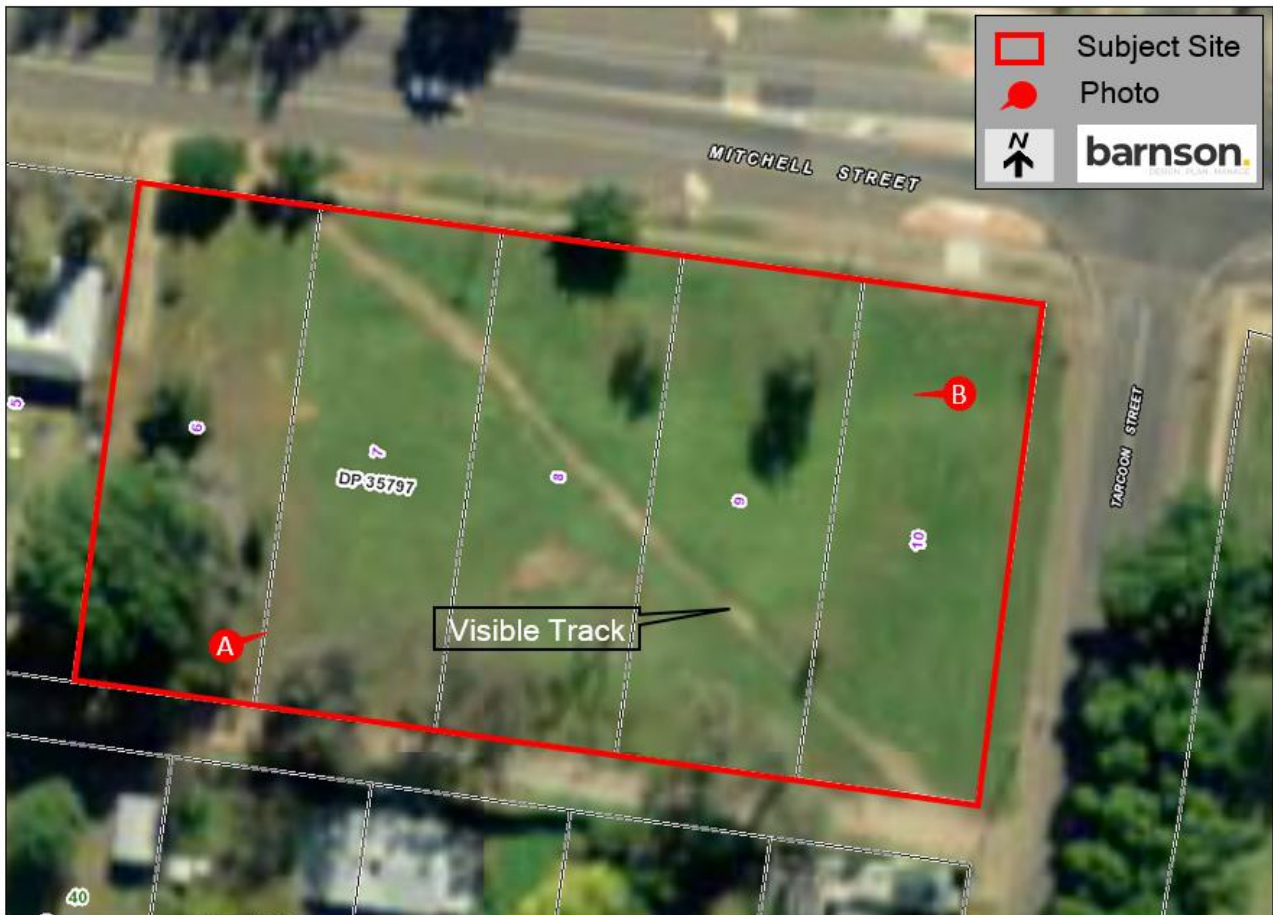
Figure 2.3: Aerial Photograph of the Site

**Figure 2.3** presents an overview of the subject site that is supplemented with photographs showing the different elements of the site (**Figure 2.4** and **Figure 2.5**). **Figure 2.3** includes markers indicating the vantage point and direction of the photographs.

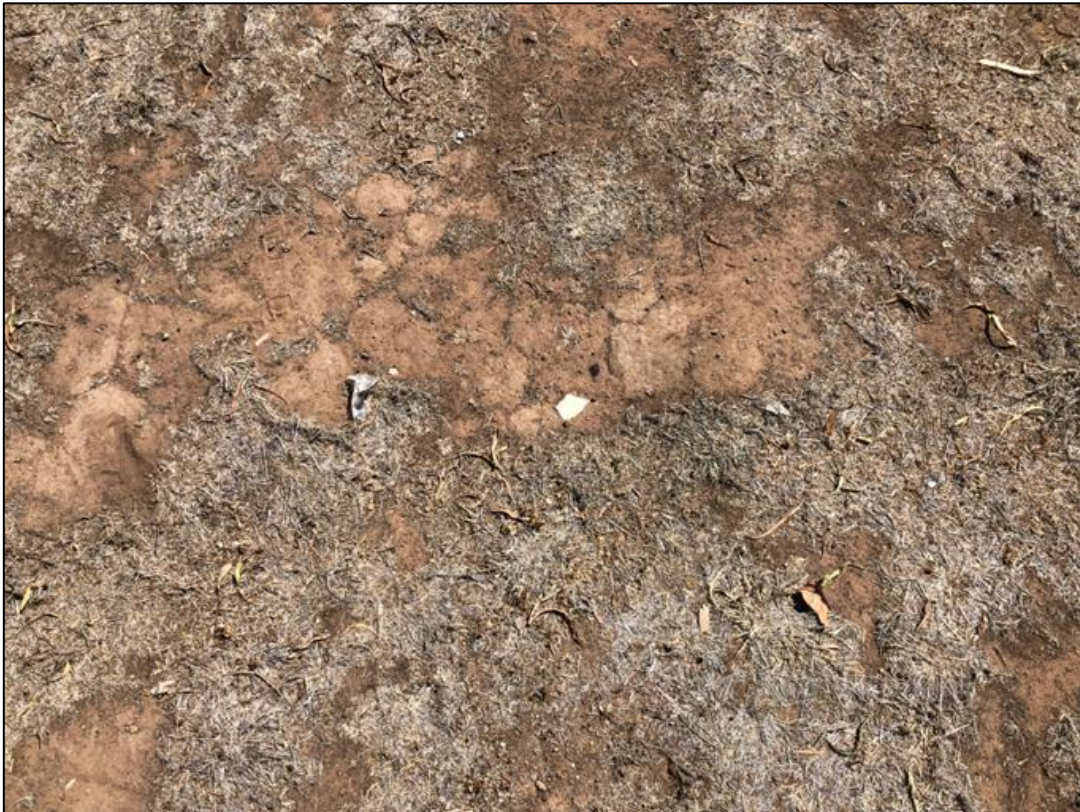
**Figure 4.1: Photograph of Cement Sheet Fragments Observed on the Site Surface**

The contamination located over Lots 6, 7, 8, 9, 10 DP35797, 88-96 Mitchell Street, Bourke NSW was confirmed by the previous Barnson Site Contamination Investigation (Barnson Pty Ltd, 2023). Asbestos containing material (ACM) was present over the surface of the subject site in the form of fragments of asbestos fibre reinforced cement sheeting. Asbestos contaminated soil was present in the sub-surface soil of the site. The source is expected to be imported fill which was identified up to a depth of 300mm or residue from buildings previously present on the site. The asbestos identified on the site was confirmed to be non-friable asbestos material. No evidence from the site history or direct observation during the site walkover that other fibrous asbestos materials are present on the site. Greater than 10m<sup>2</sup> of asbestos cement sheeting is estimated to be present on the site. **Figures 4.1, 4.2 and 4.3** present photographs of fragments of fibre cement sheeting observed during the site investigation.

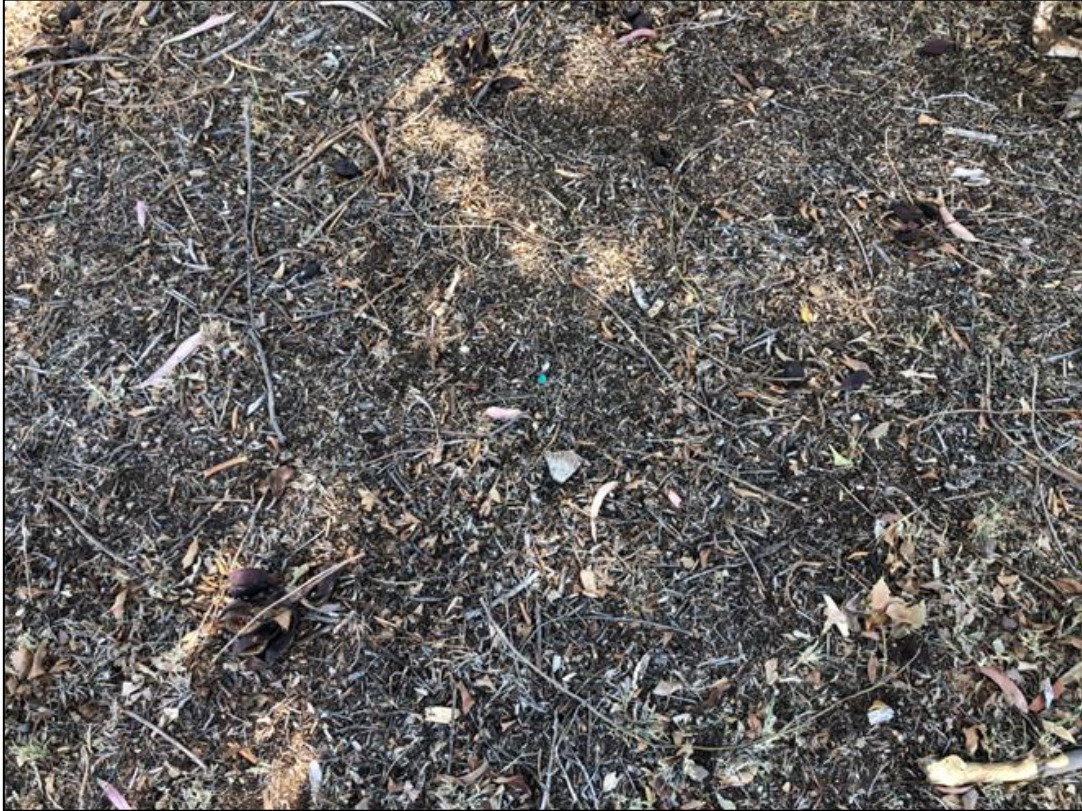
Figure 4.2: Photograph of Cement Sheet Fragments Observed on the Site Surface

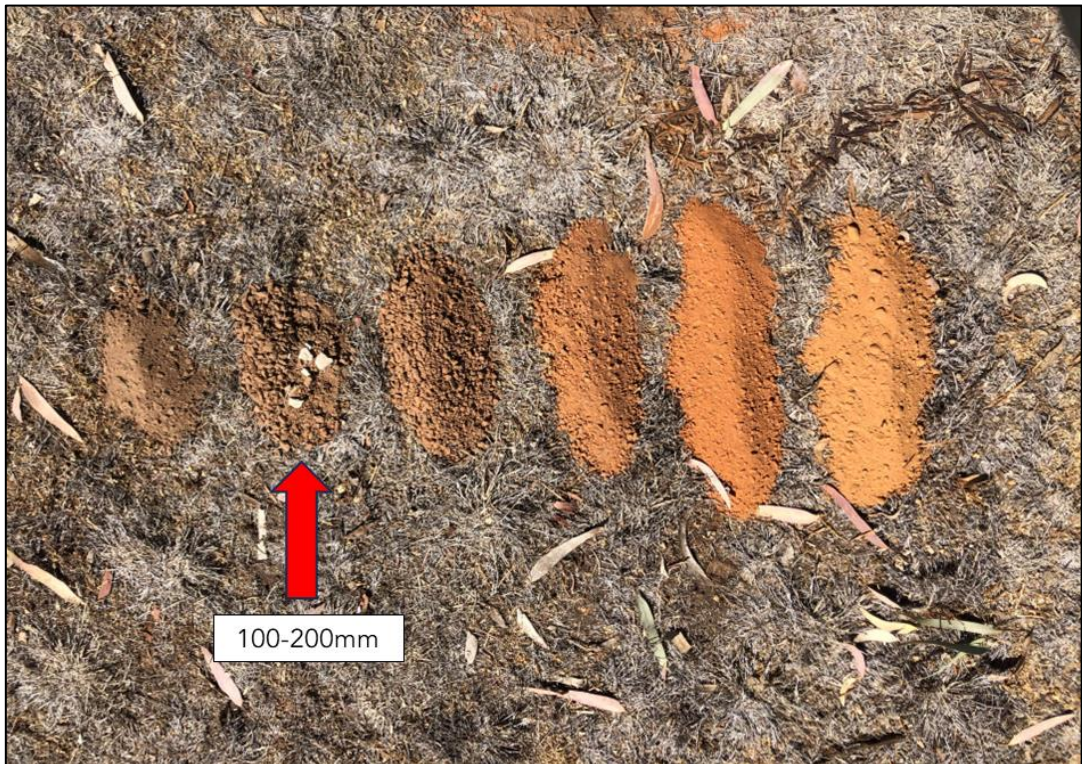
Figure 4.3: Photograph of Cement Sheet Fragments in Excavated Soil

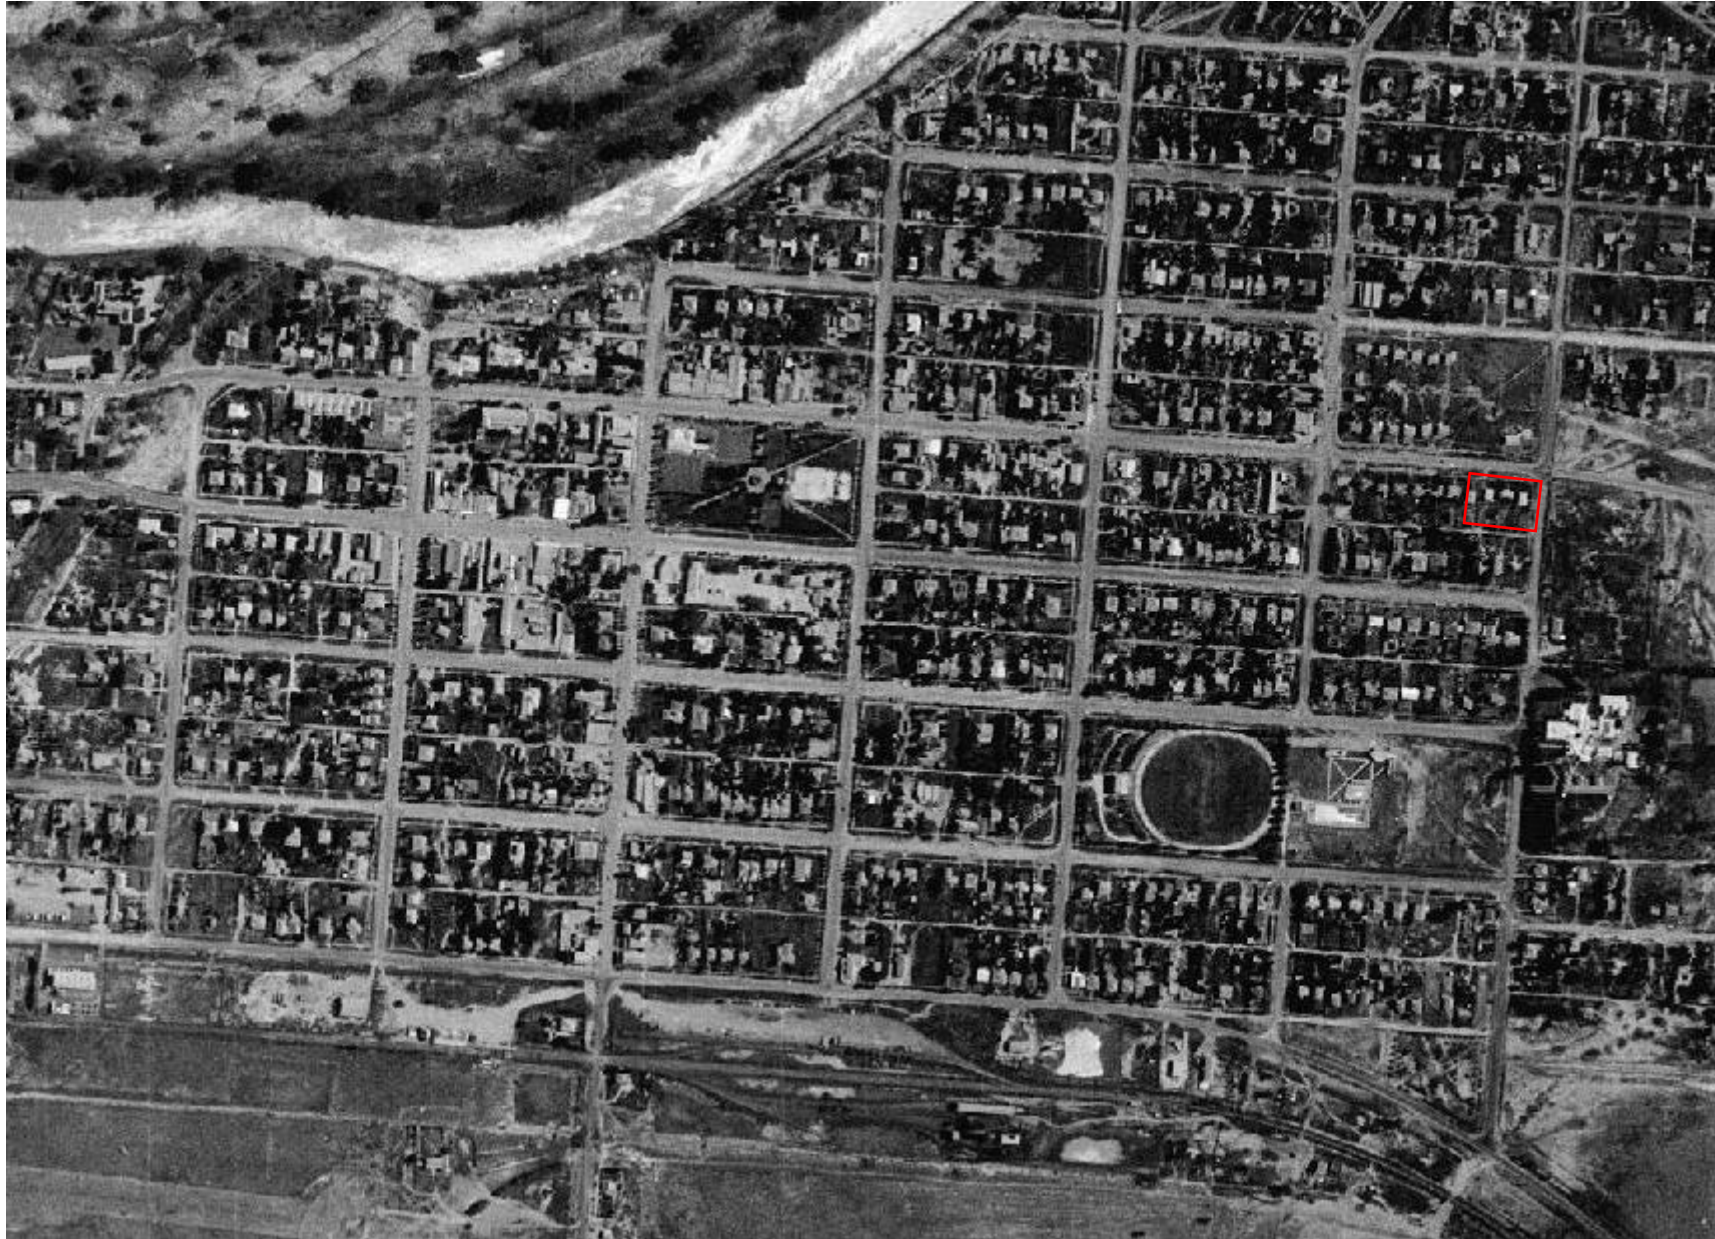
1963 – Houses onsite

- 1965 – Each of the five (5) lots are occupied by individual structures, most likely residential dwellings.
- 1979 – No change in previous fourteen (14) years.
- 1994 – No substantial changes to the site, however a new industrial development is evident adjoining the western side of the site.
- Sometime after 1994 – The aerial imagery depicts that all 5 dwelling structures and inter-lot fencing have been demolished and the site levelled.
- Present – The site remains unoccupied and is unfenced. Path used by pedestrians bisect the site diagonally from north-west to south-east.

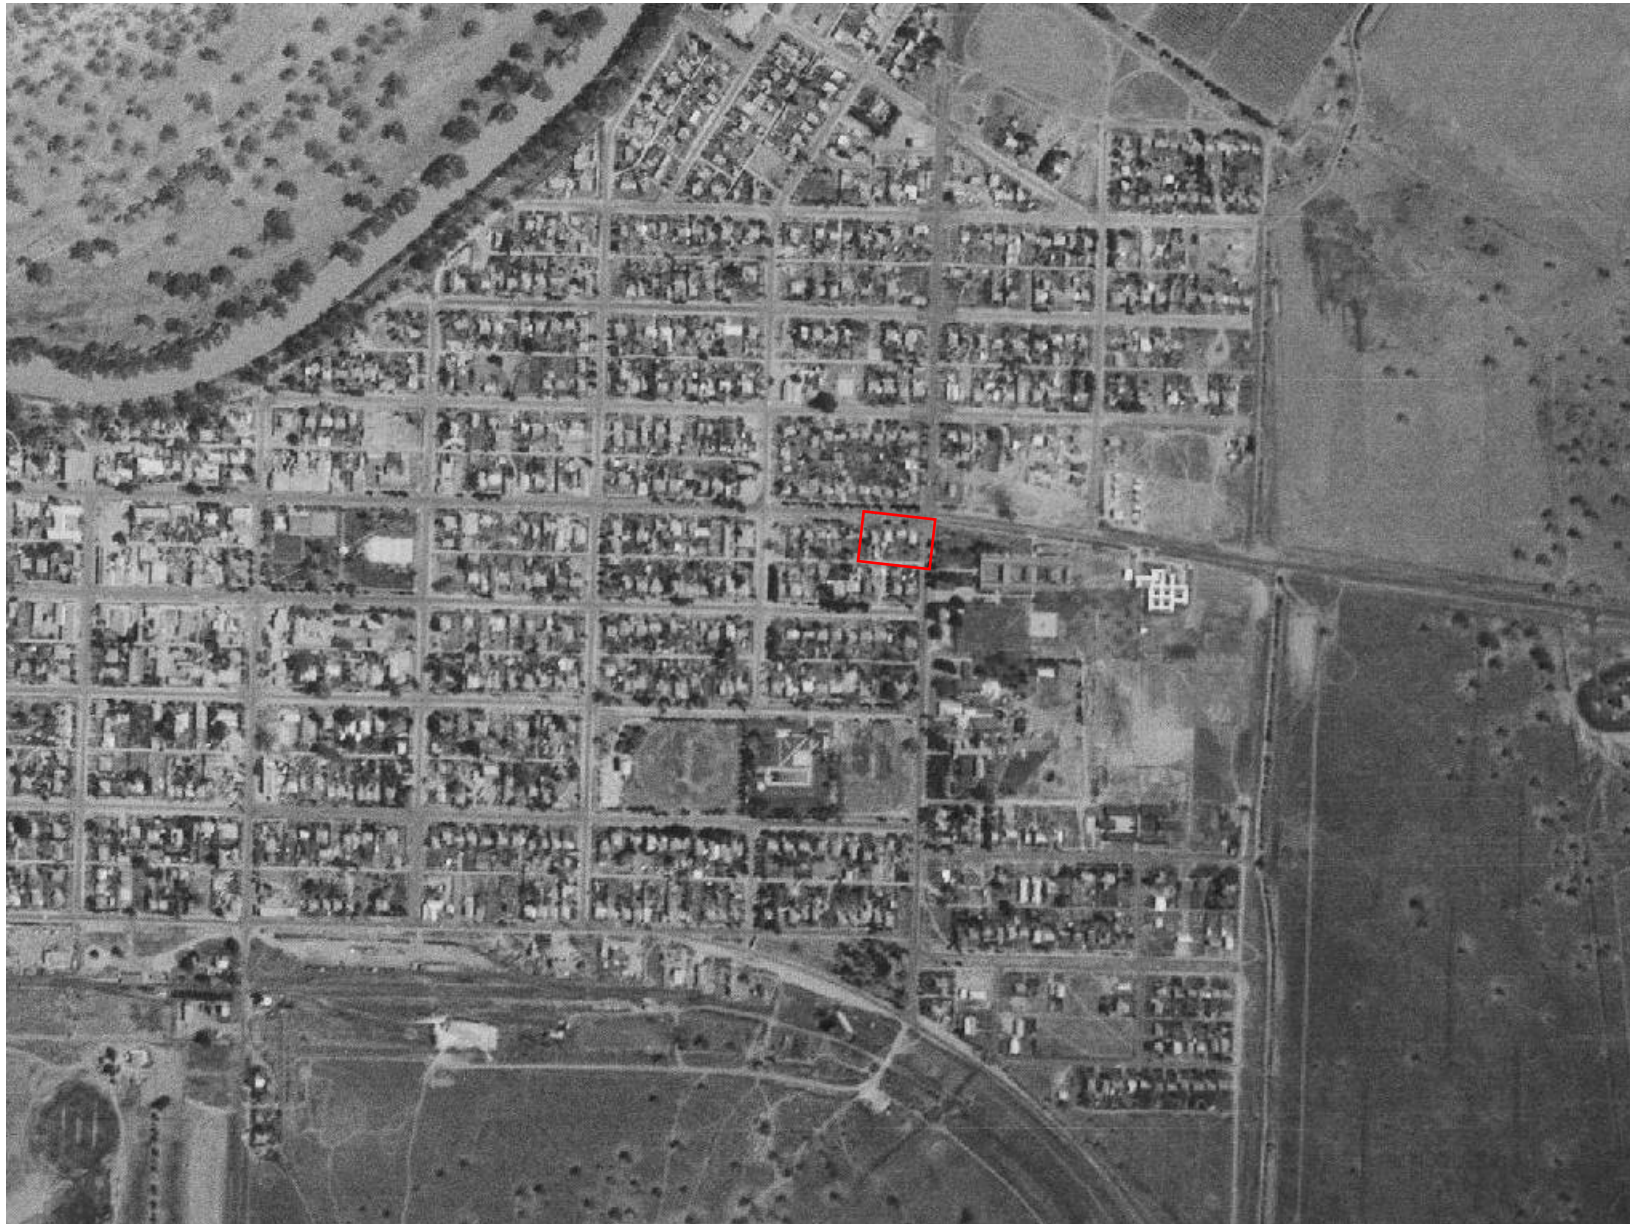
1979 – No Change

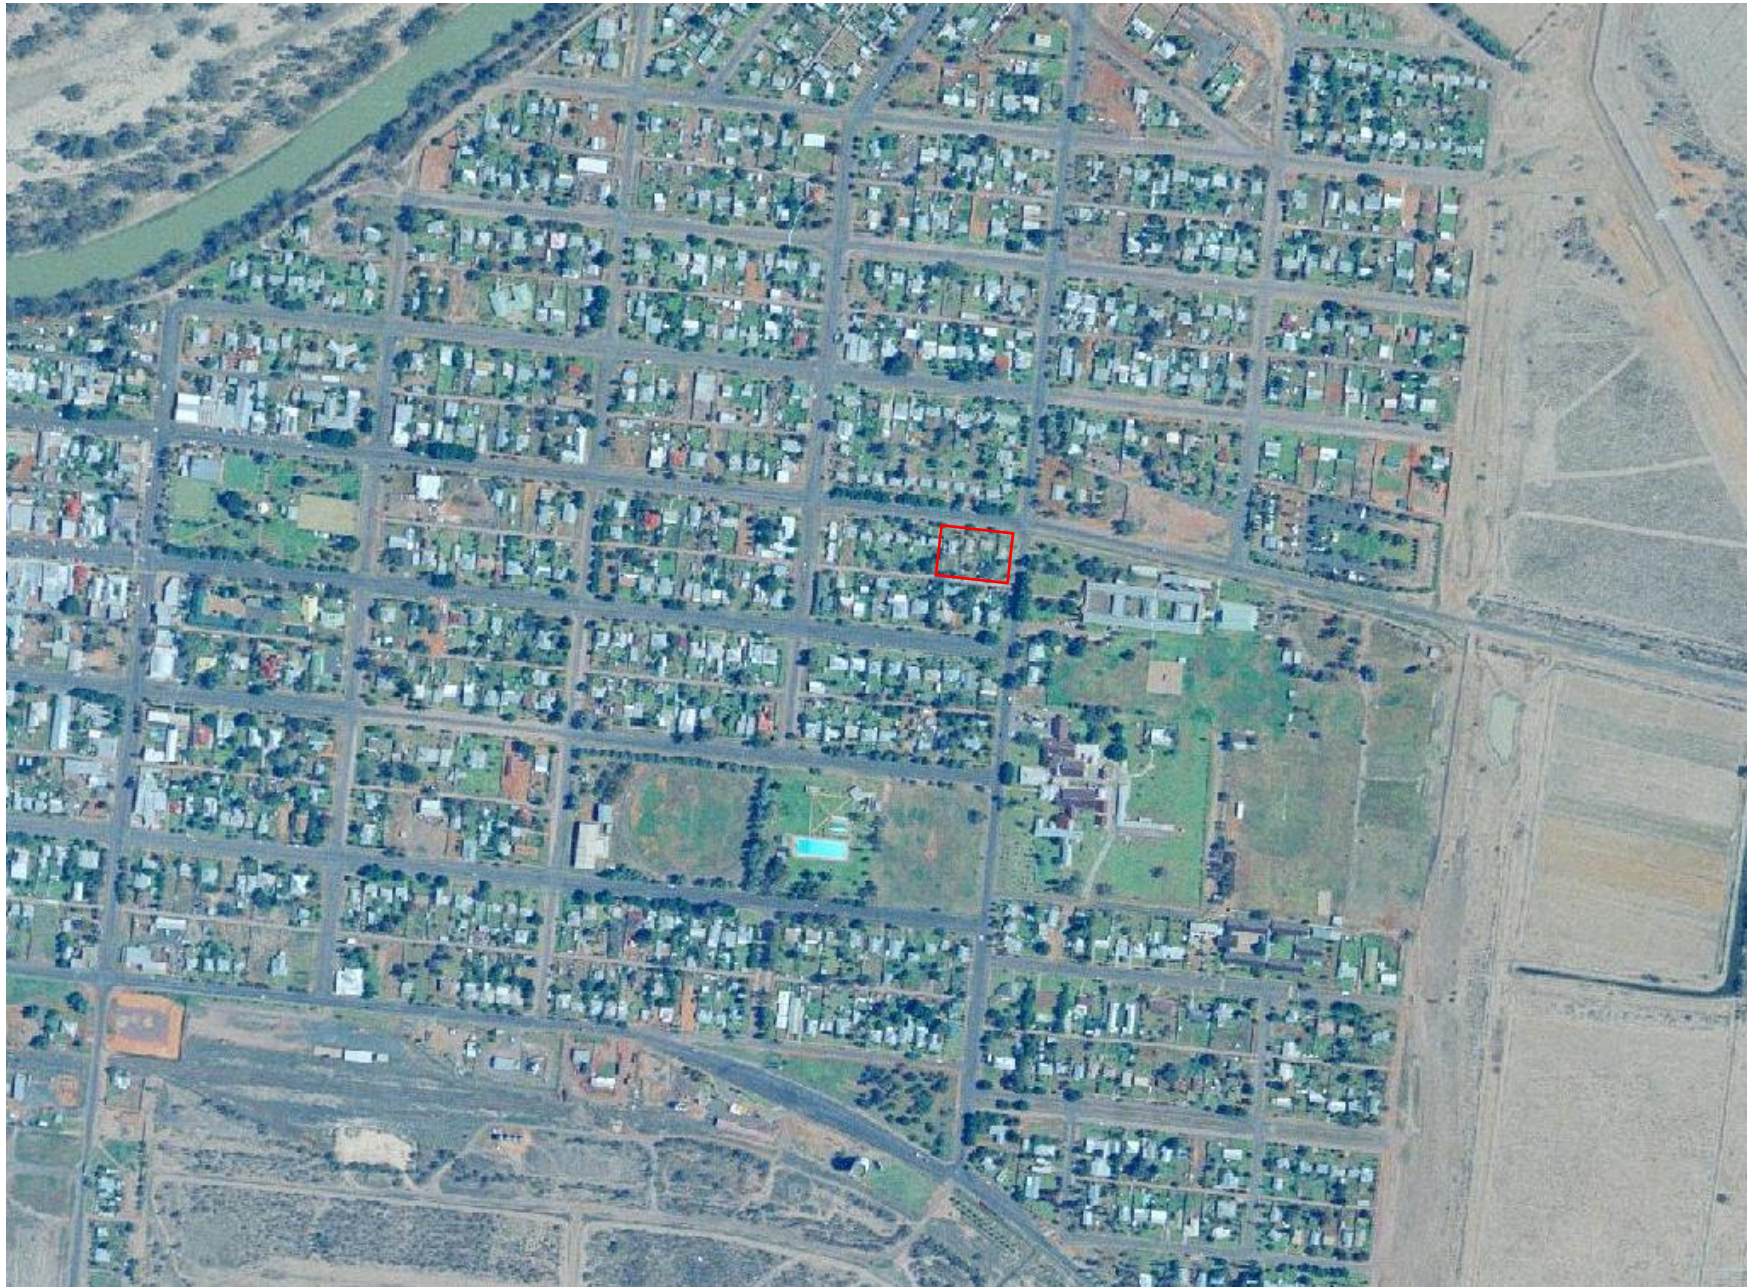
1994 – No Change

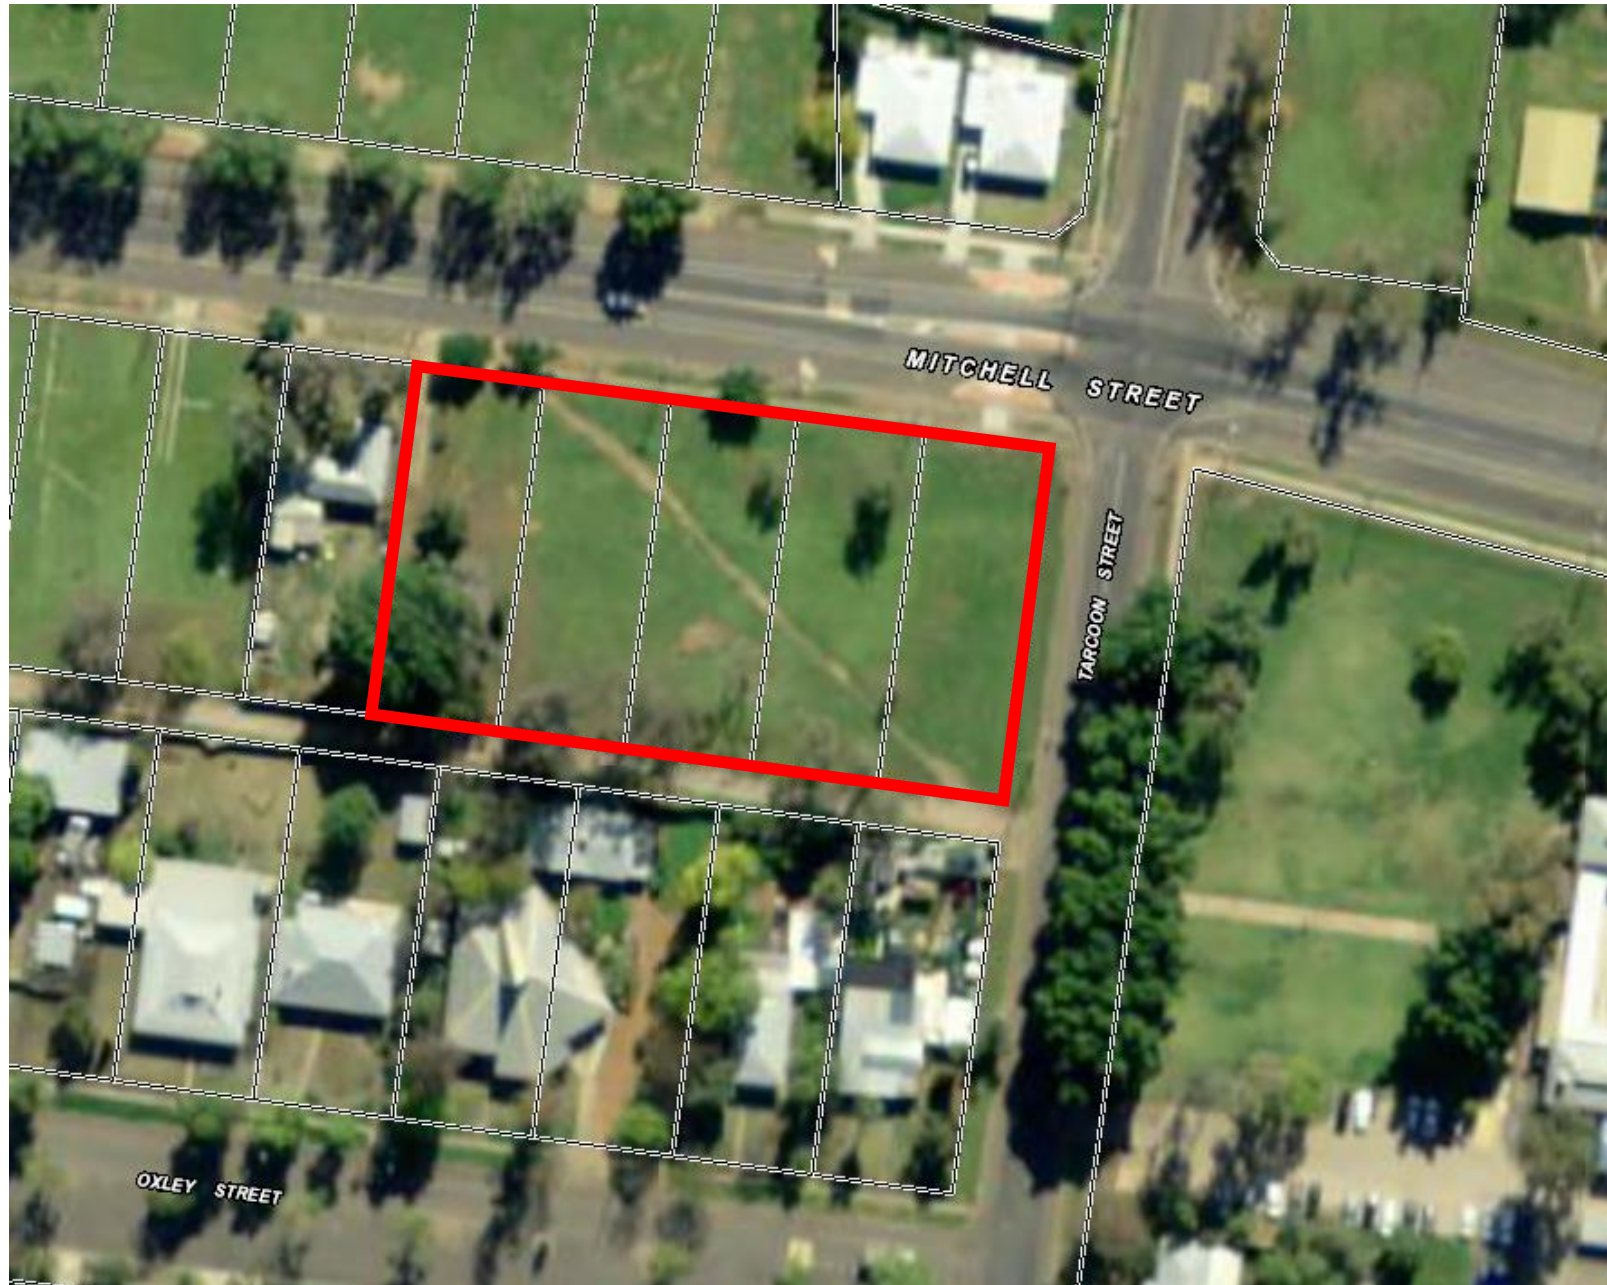
Sometime after 1994 – Demolished
