**LANDCOM**

**PROPOSED SUBDIVISION DEVELOPMENT (BPA 16642)  
REDMOND PLACE, ORANGE  
REPORT ON GEOTECHNICAL INVESTIGATION**

**REPORT 9812/1-AA-R3  
03 July 2025**

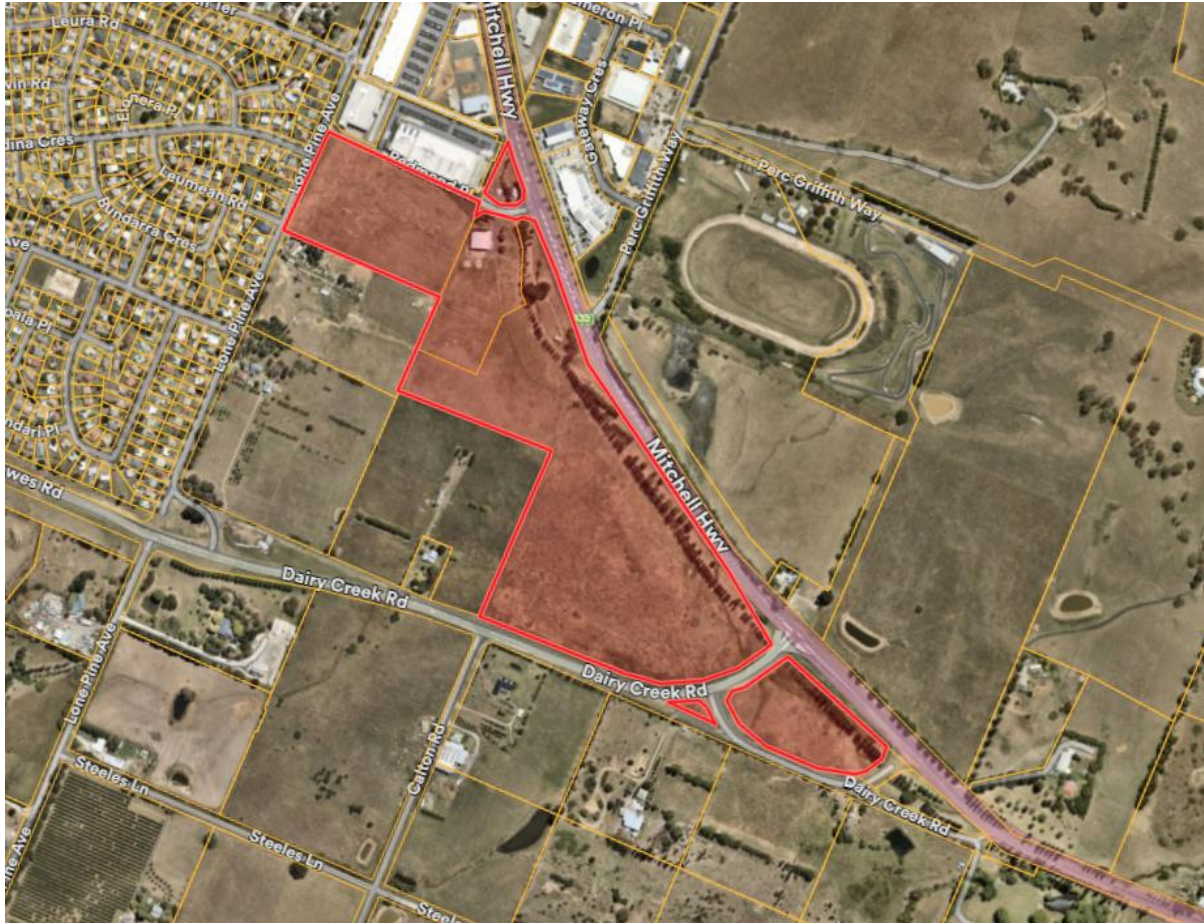
Figure 1: Locality of the Proposed Development

The site has been rezoned for residential purposes and the Master Plan will include approximately 330 dwellings across 264 lots for a diverse range of housing including single detached, medium density dwellings and low-rise apartment/s. The Master Plan will also include parks, a wetland and a sewer pump station. Figure 1 shows the locality of the proposed development.

This geotechnical investigation report aims to provide an assessment of the proposed development site (Figure 1), comprising Lot 1 in DP 153167, Lot 6 in DP1031236, and Lot 200 in DP1288388 located on the southern side of Redmond Place and Mitchell Highway. As Landcom progresses with the formulation of a concept masterplan, a geotechnical investigation is required to determine existing subsurface conditions and provide preliminary geotechnical recommendations for the design of the proposed development.
