**GEOTECHNICAL INVESTIGATION REPORT**

307 - 311 BEXLEY ROAD & 88 - 96  
NEW ILLAWARRA ROAD, BEXLEY NORTH NSW

PREPARED FOR TONY SOUEID  
REPORT ID: *E16016BN-R02F*

**Date:** 19<sup>th</sup> January 2017

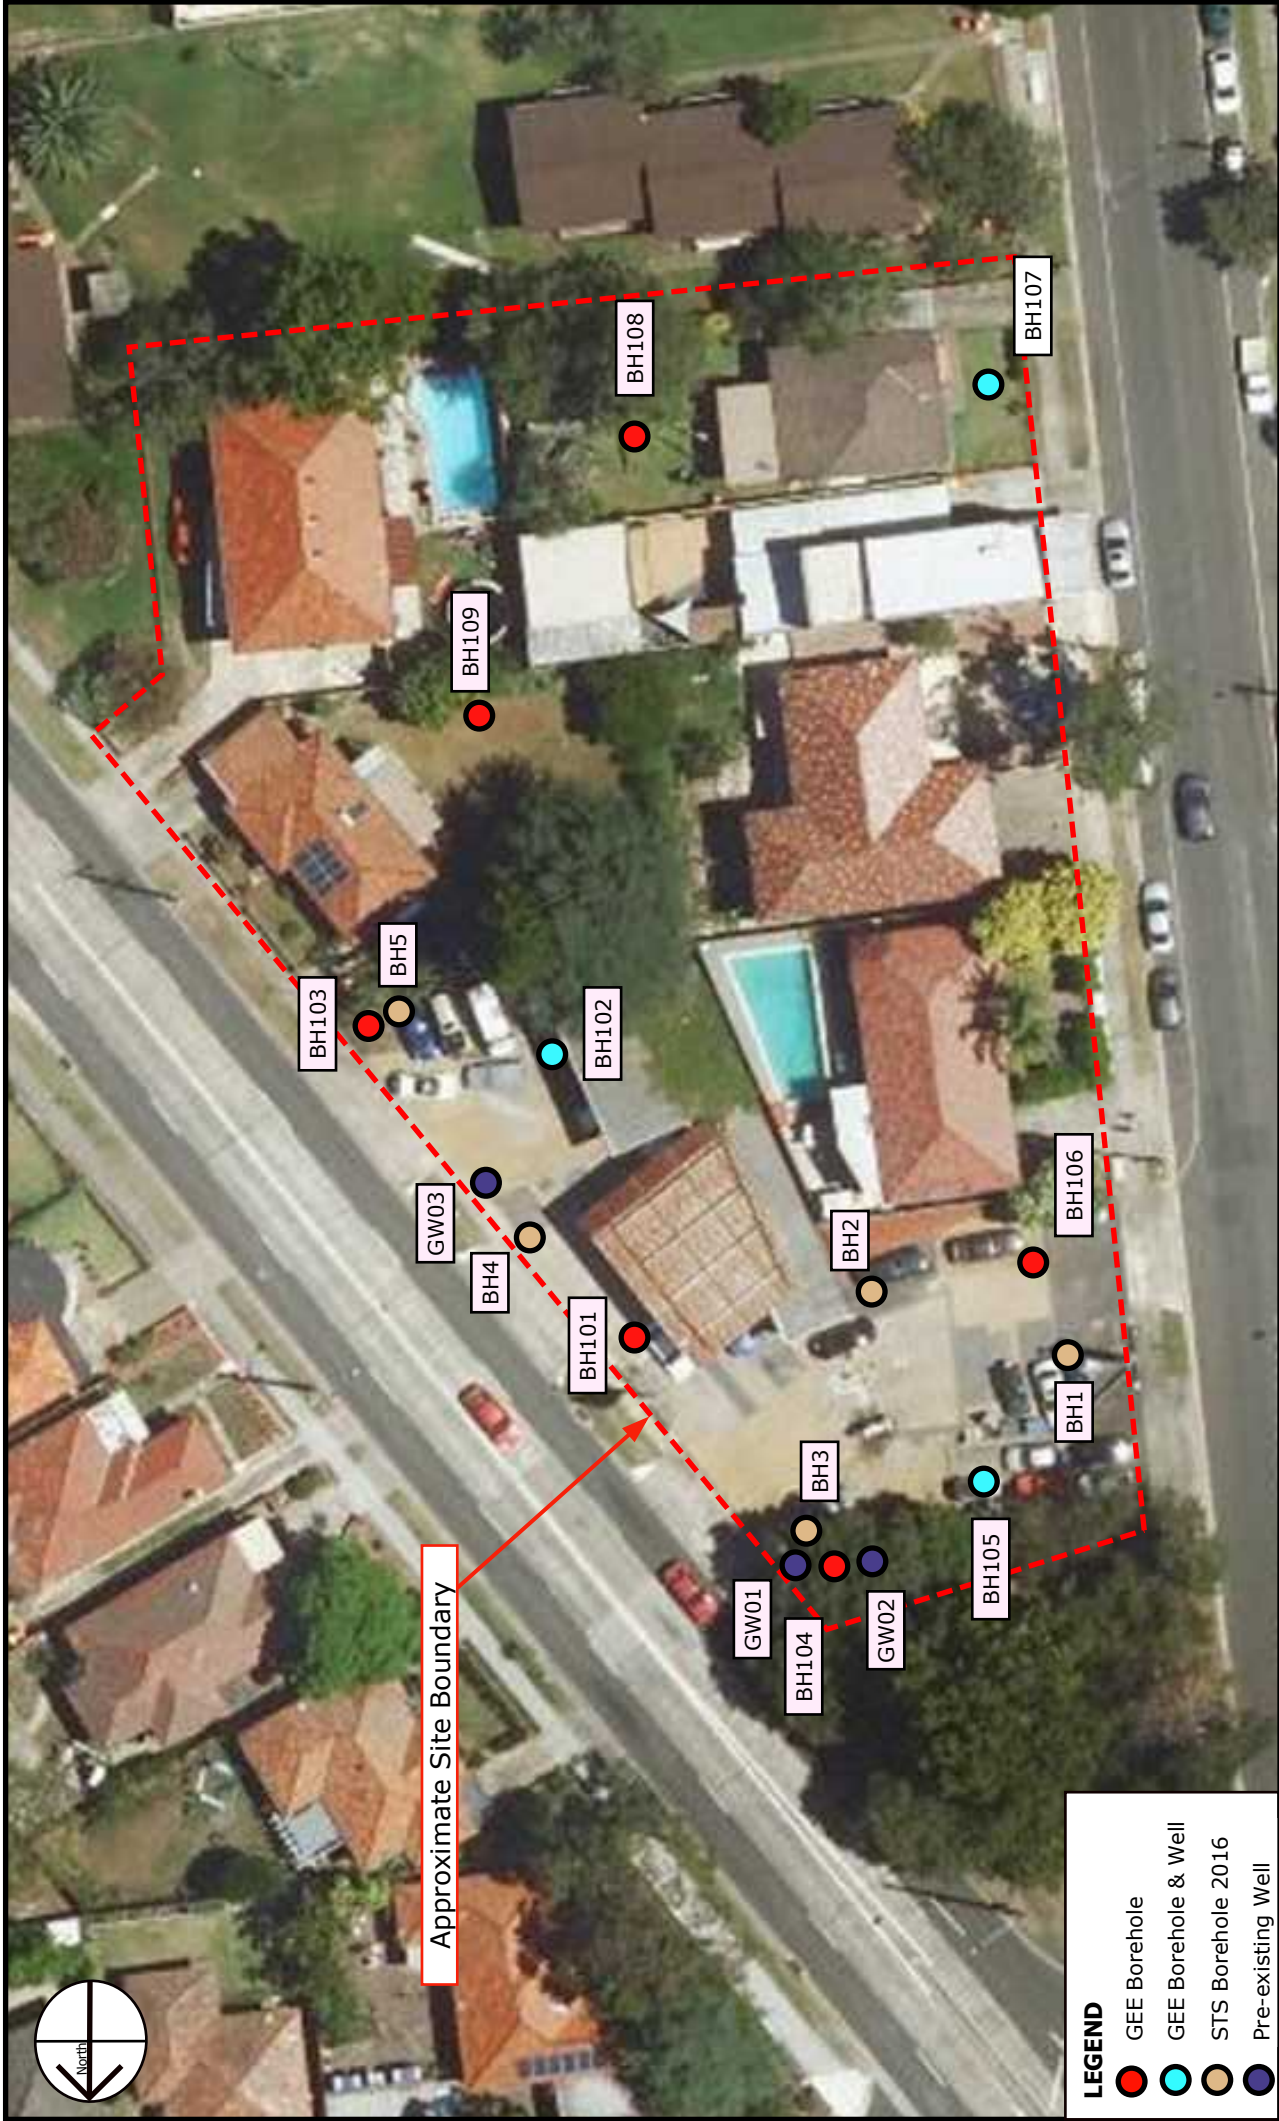
A summary of the subsurface conditions encountered is provided in Section 3.2, while a summary of the borehole information, including total depth, is provided in **Table 1** and their locations are shown on **Figure 2**. Also included in Table 2 and Figure 2 are details and location of the geotechnical bores completed by STS (reference 1). The borehole logs (including the previous STS bores) are provided in **Appendix B**.

Three groundwater monitoring wells were also observed across the Metro Service station forecourt and are likely from the former contamination assessment completed in 2011. As previously mentioned, GEE has not been provided with a copy of this report and for the purpose of this investigation they were labelled GW01 to GW03. Their approximate locations are shown on **Figure 2**.
