STAGE 1 AND STAGE 2 ENVIRONMENTAL SITE ASSESSMENT

307 - 311 BEXLEY ROAD & 88 - 96 NEW ILLAWARRA ROAD, BEXLEY NORTH NSW

PREPARED FOR TONY SOUEID REPORT ID: *E16016BN-R03F*

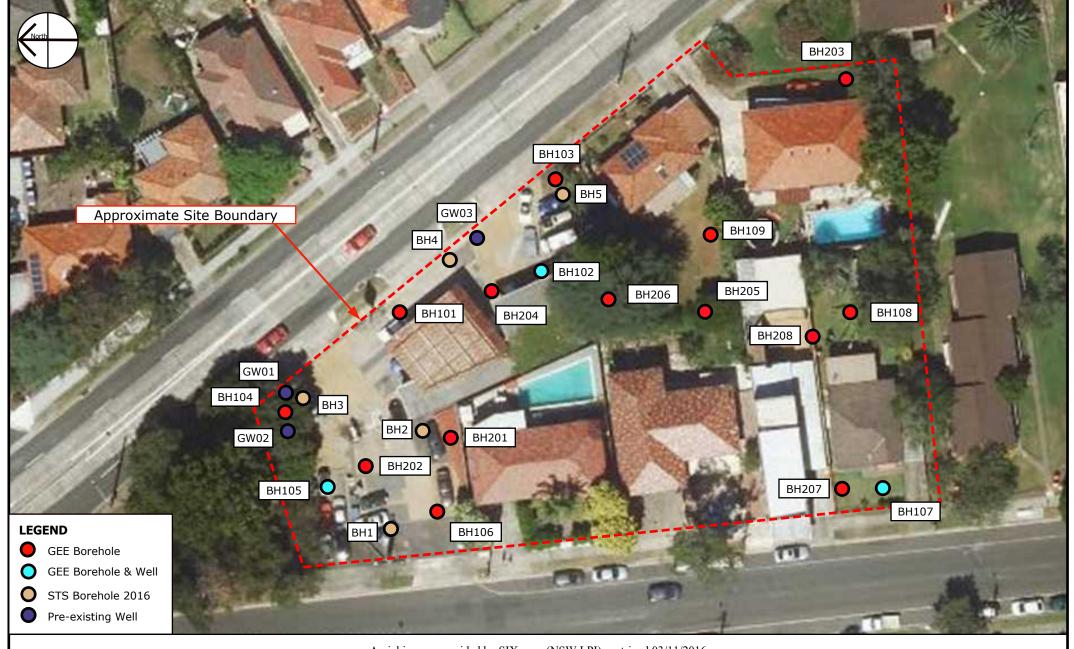
SCALE:
 N.T.S
 DATE:
 19 Jul 2017
 FIGURE No.
 2

Three groundwater monitoring wells were also observed across the Metro Service station forecourt and are likely from the former contamination assessment completed in 2011. As previously mentioned, GEE has not been provided with a copy of this report. Each of these wells were used to sample groundwater as part of this investigation and for the purpose of this investigation they were labelled GW01 to GW03. Their approximate locations are shown on **Figure 2**.
