# Conservation Management Plan

Simon and Brenda Tripp

Fernhill  
Mulgoa Road, Mulgoa NSW

July 2014  
(Endorsement edition 3  
submitted with IDA)

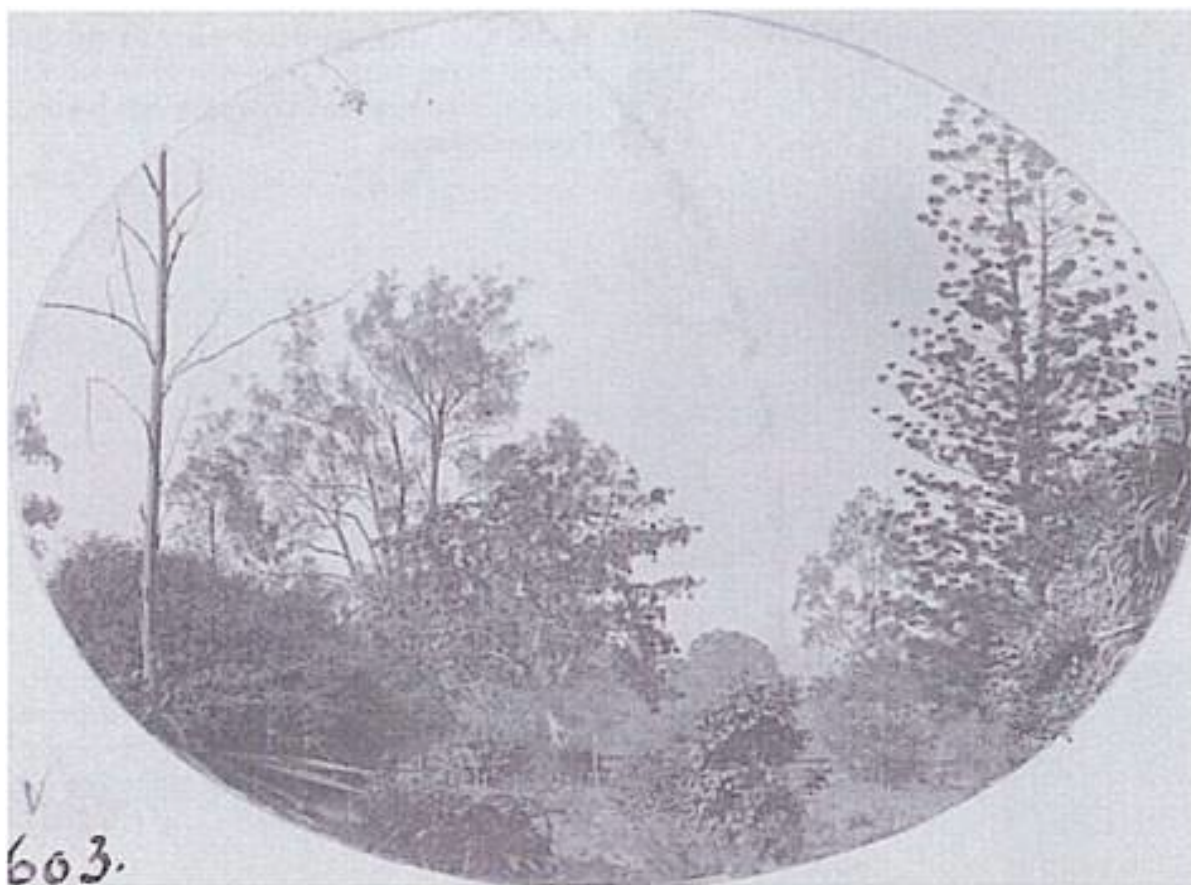
Figure 8: Fernhill landscape and stables, 1906 Source: Arthur Wigram Allen, Photographic Collection, Mitchell Library, Vol. 36, pp.39-40 PX\* D578

Figure 8 illustrates Fernhill's landscaping around the house in 1906, which shows predominantly native trees and a post and rail fence. The landscaper at this point had matured in this part of the estate and was quite dense. Figure 9 shows an enclosed room along the eastern skillion roof of the 1830s stables (since removed).

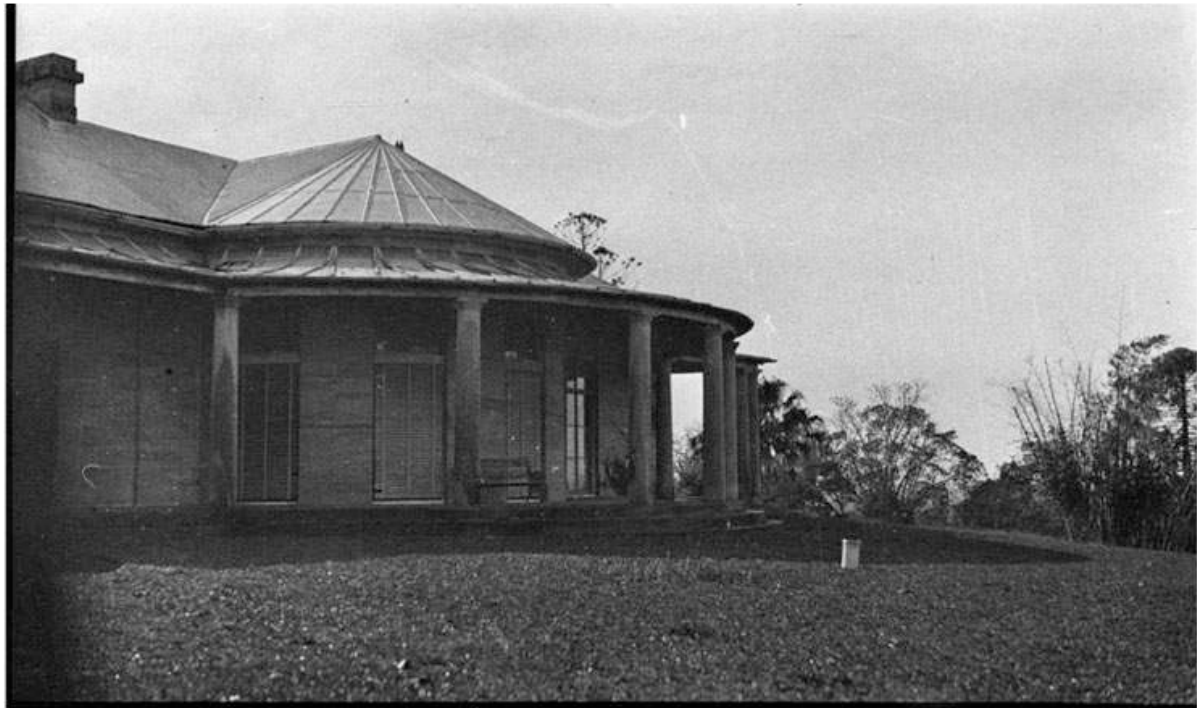
Figure 14: Fernhill, note the gravelled edge, the mature Hoop Pine above the house and the Bunya Pine to the right at this time. 1920 Source: Perier Collection, State Library of NSW

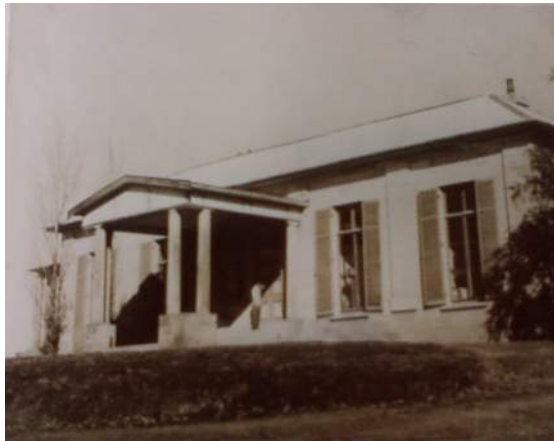
Figure 25: East elevation of house with porte-cochere

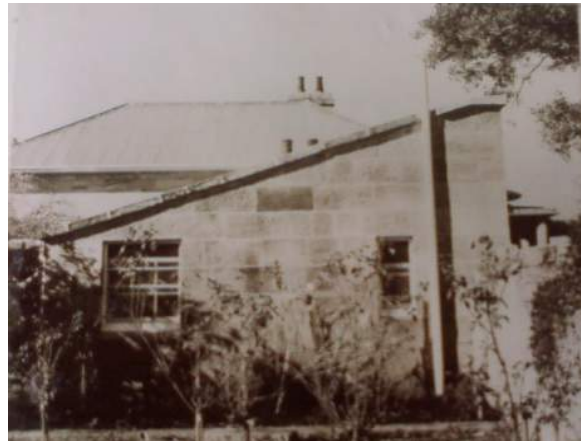
Figure 26: West elevation of the separate cess pit structure (now removed)

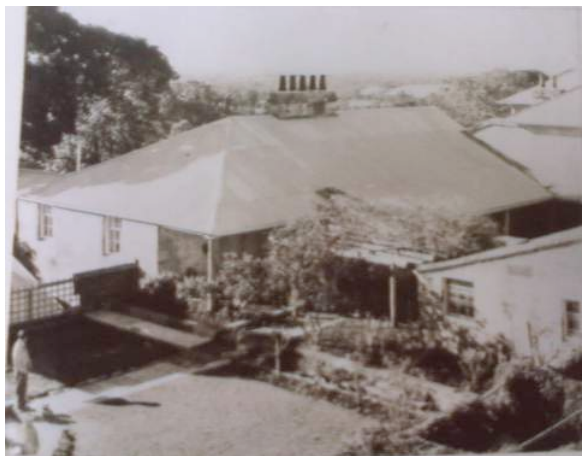
Figure 27: West elevation before extension to south wing

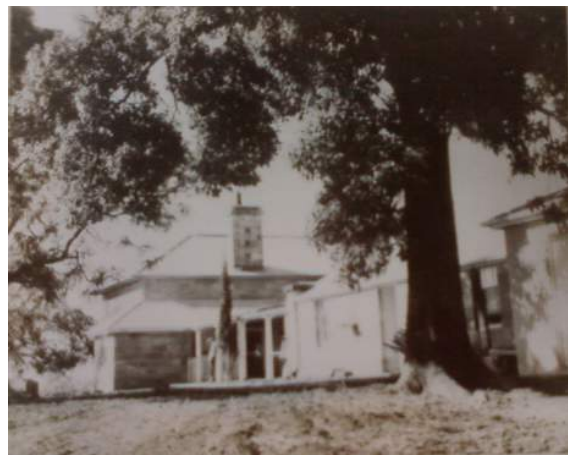
Figure 28: North elevation of house

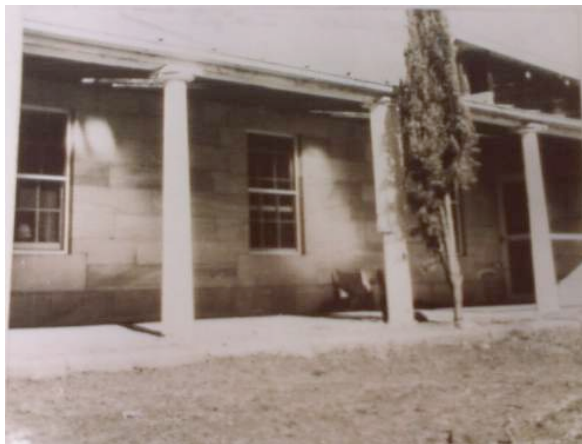
Figure 29: Verandah on north elevation

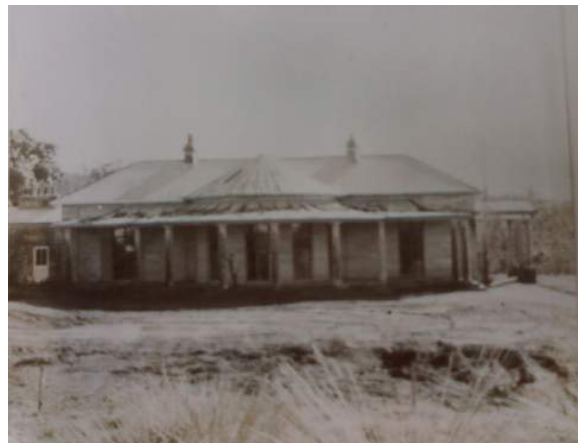
Figure 30: South elevation of house

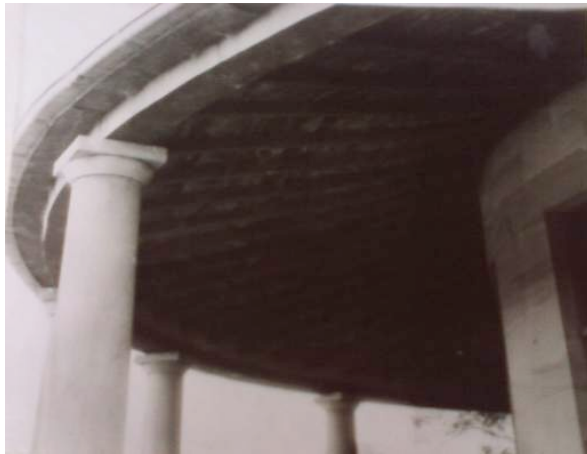
Figure 31: Detail of verandah on south elevation

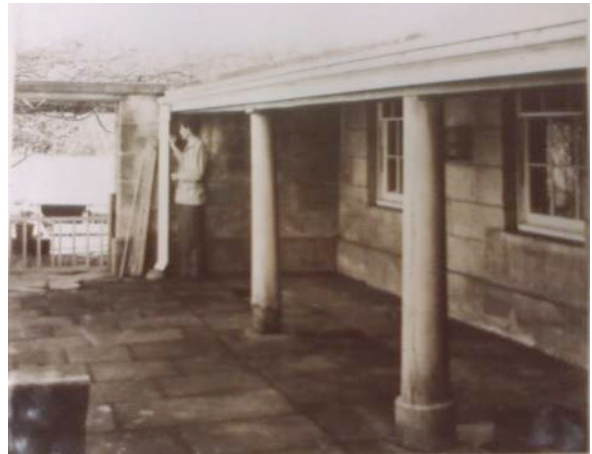
Figure 32: North side of internal courtyard

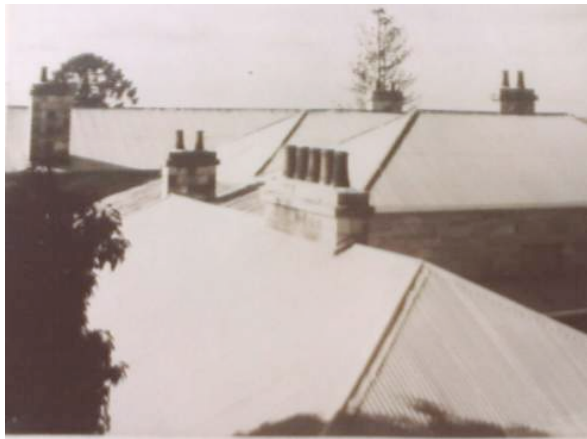
Figure 33: Galvanised iron roof, view from north-west

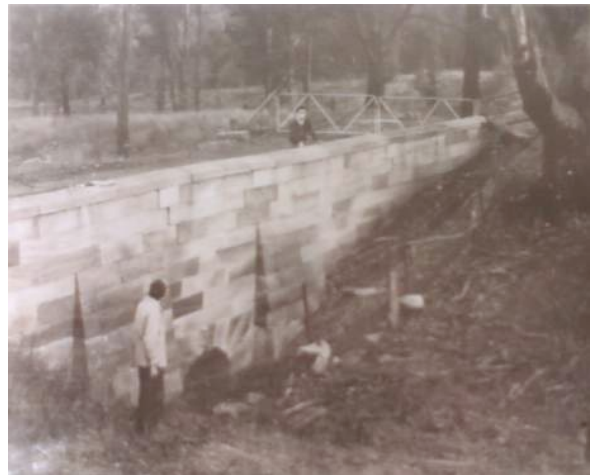
Figure 34: One of the two stone bridges

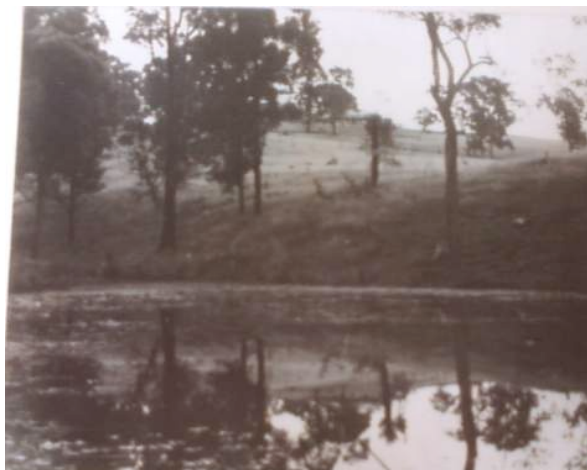
Figure 35: Reflecting pond along driveway showing house (prior to construction of retaining wall and planting of further vegetation in late 20<sup>th</sup> century)

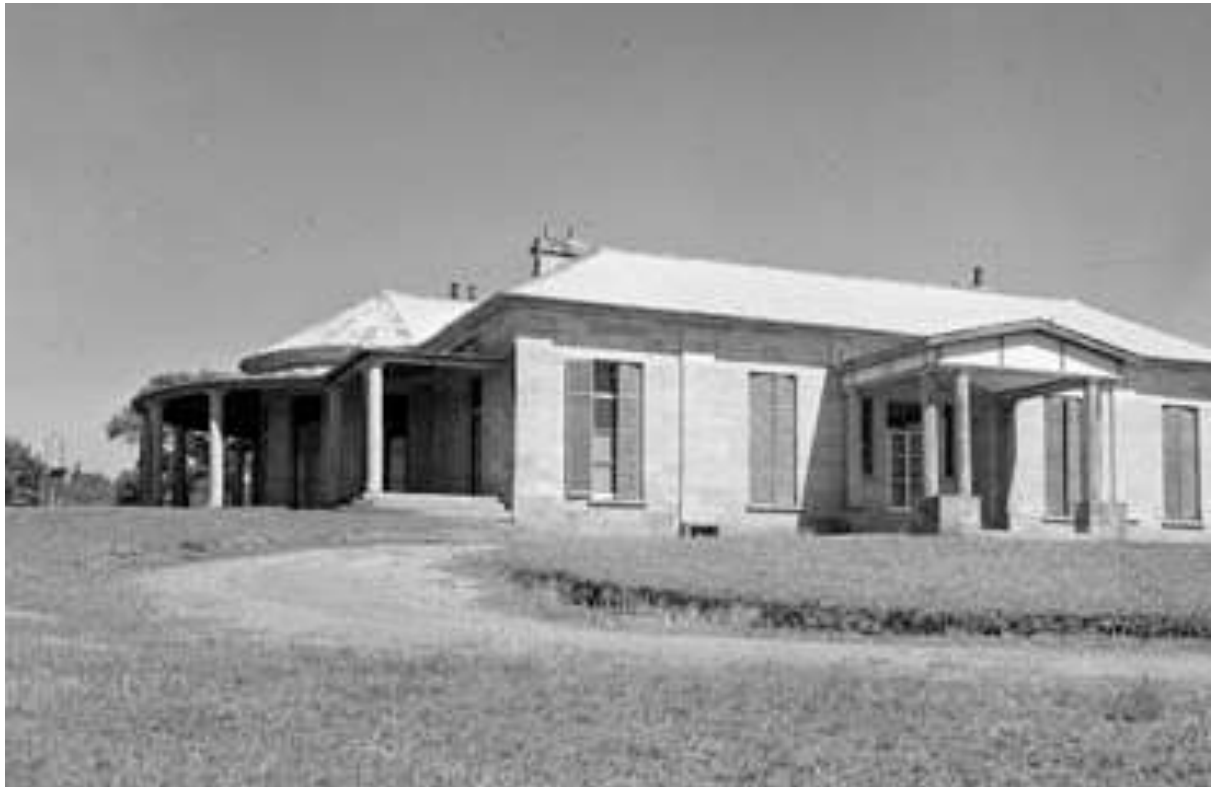
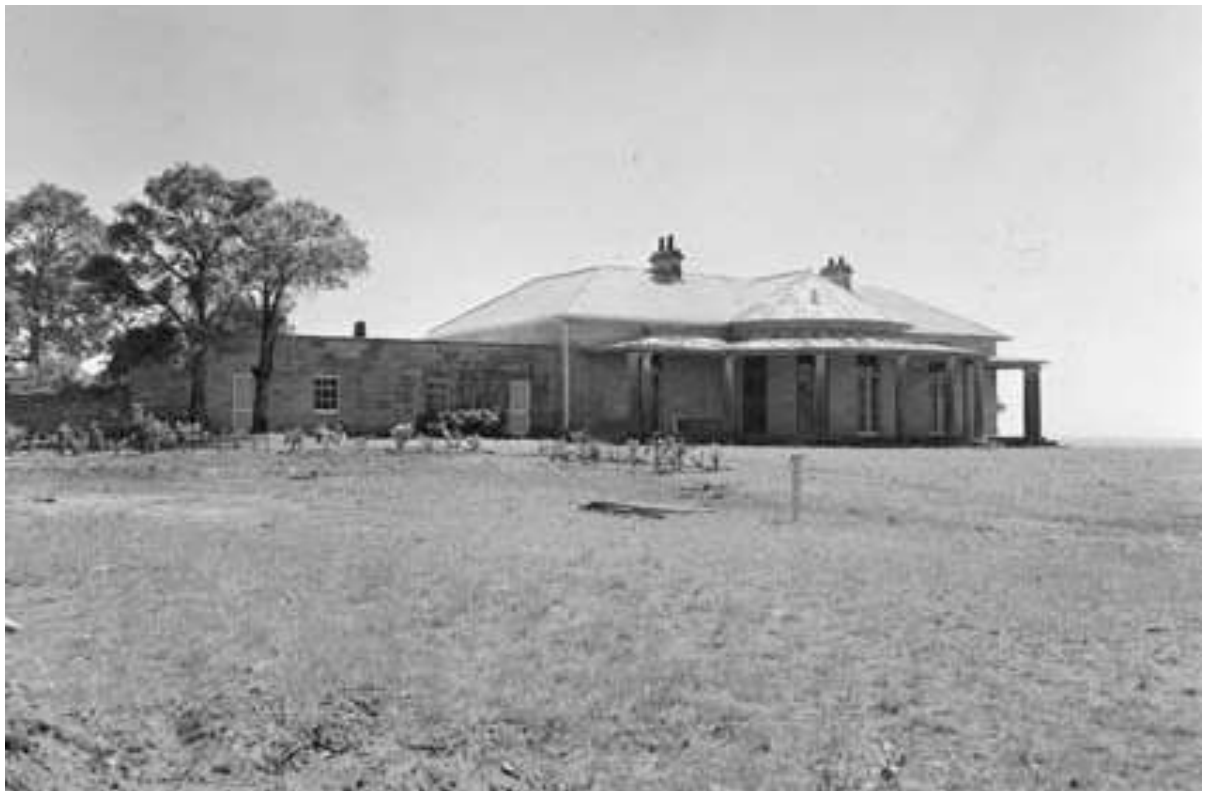
The Figures below shows several elevations of the house in 1961 with restoration work

clearly evident. Note the lack of planting, gardens or vegetation around the house.

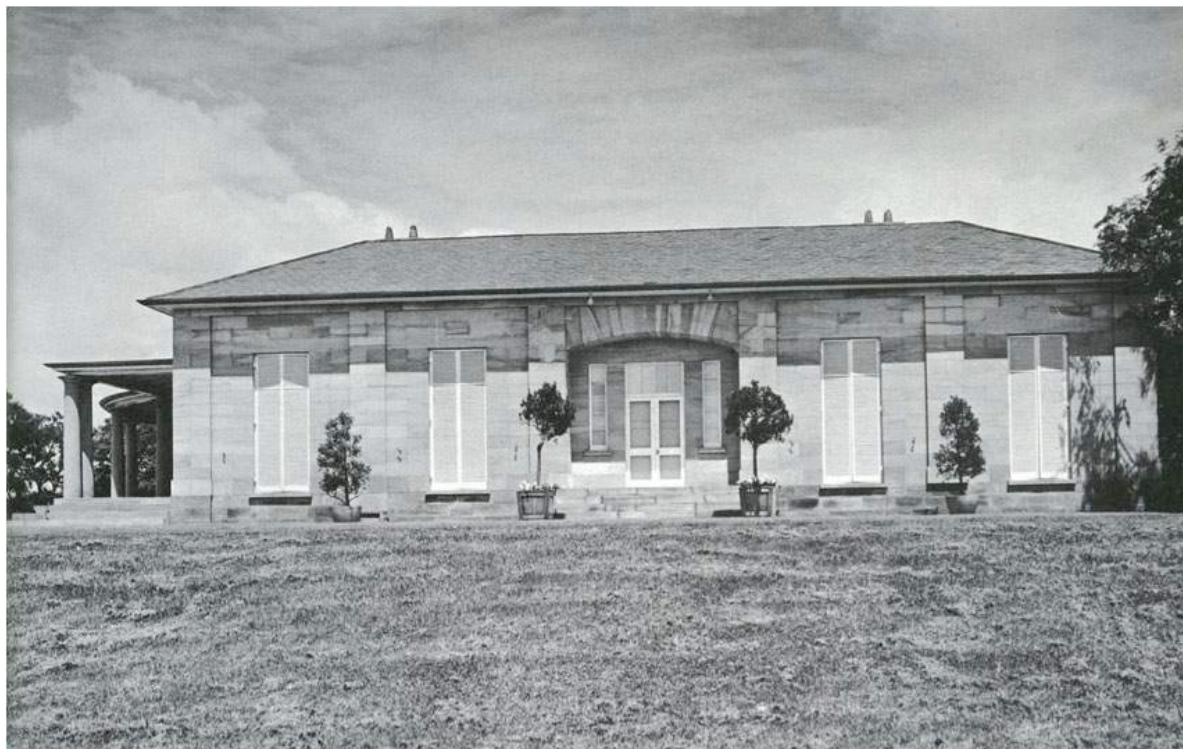
Figure 50: Fernhill, 1972. Eastern elevation of house. Note the circular driveway and porte-cochere have been removed; Source: Cox 1972:131

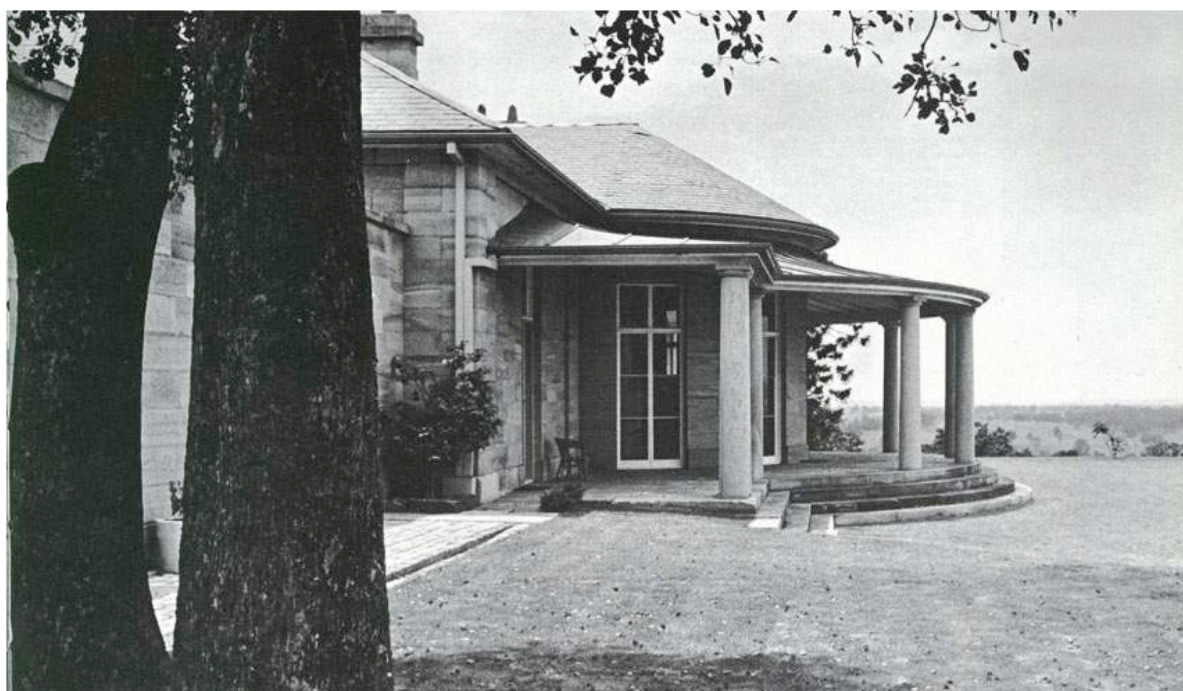
Figure 51: South elevation of house; Source: Cox 1972:133

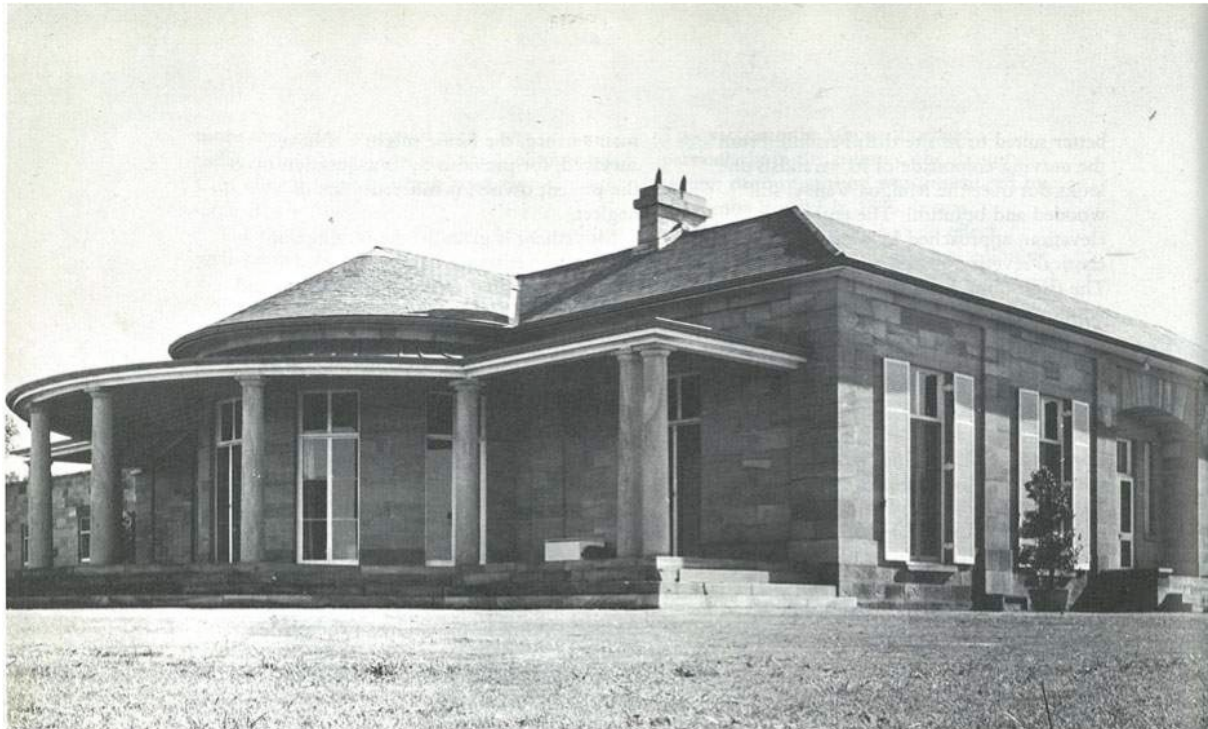
Figure 56: Fernhill, 1975 South Elevation of house showing the porte-cochere removed; Source: Roxburgh 1975:244

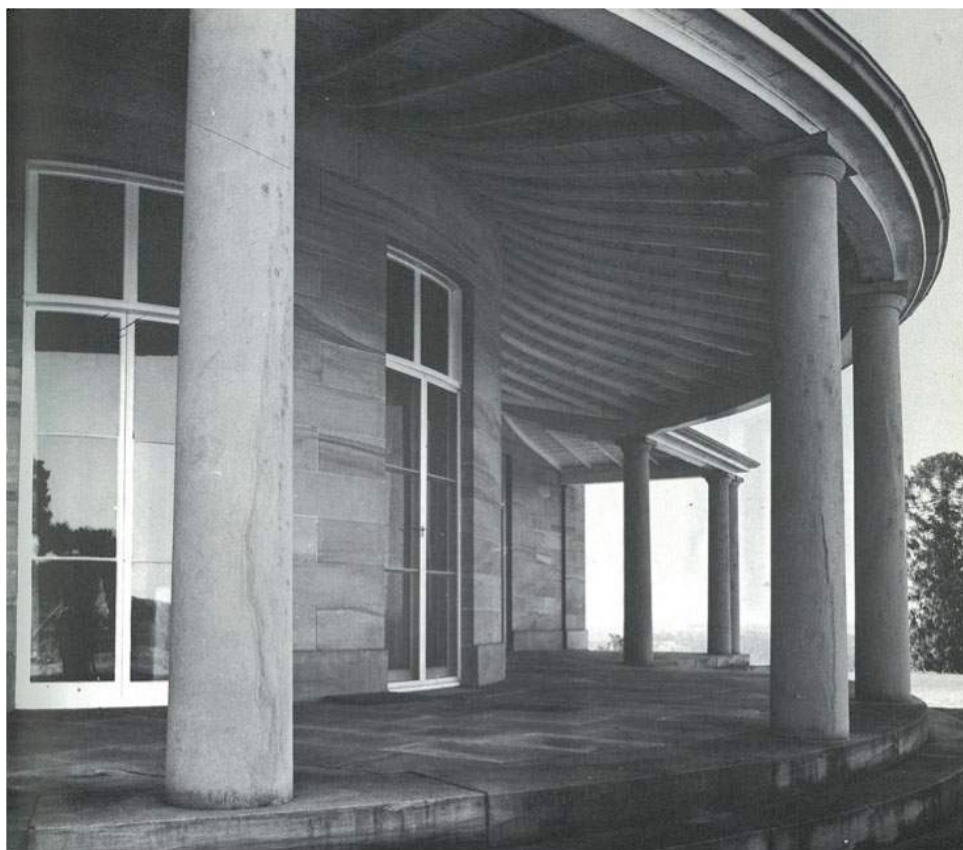
Figure 57: Detail of verandah on south elevation; [Source: Roxburgh 1975:247]

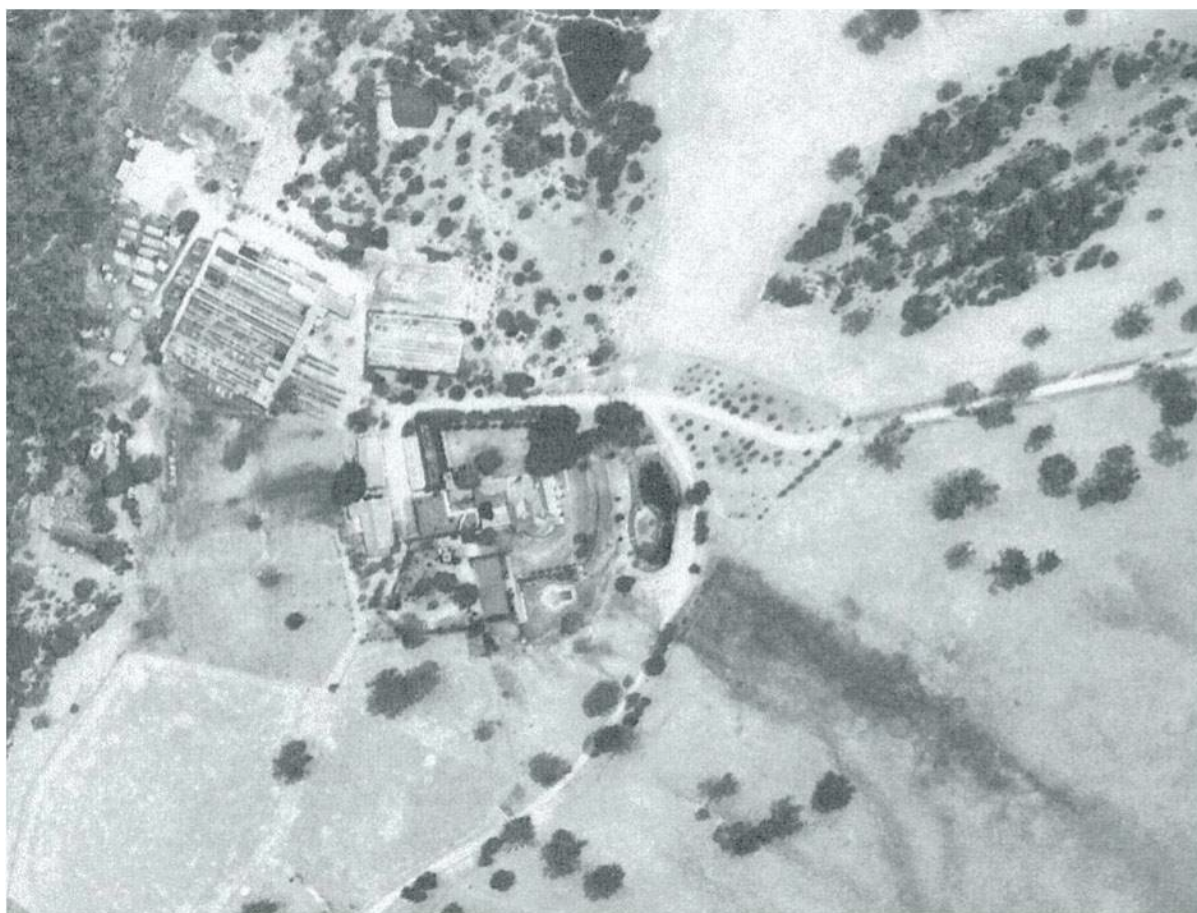
Figure 70: Aerial photograph of Fernhill Estate, 1979. Detail of garden area around house. Note the increase in larger trees particularly north of the house.

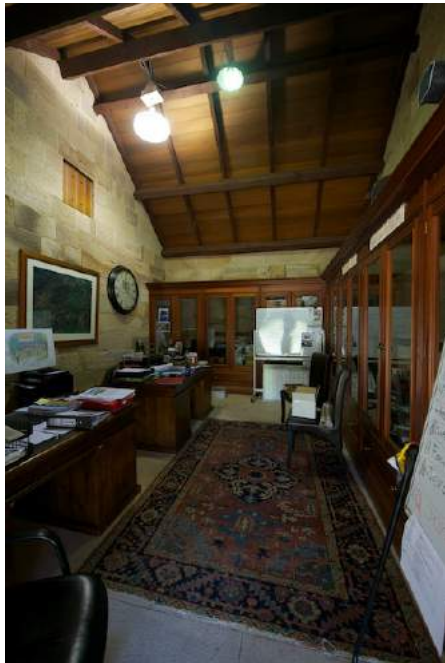
Figure 96: Joinery in central section of stables; new sandstone floor. Paul Davies 2013

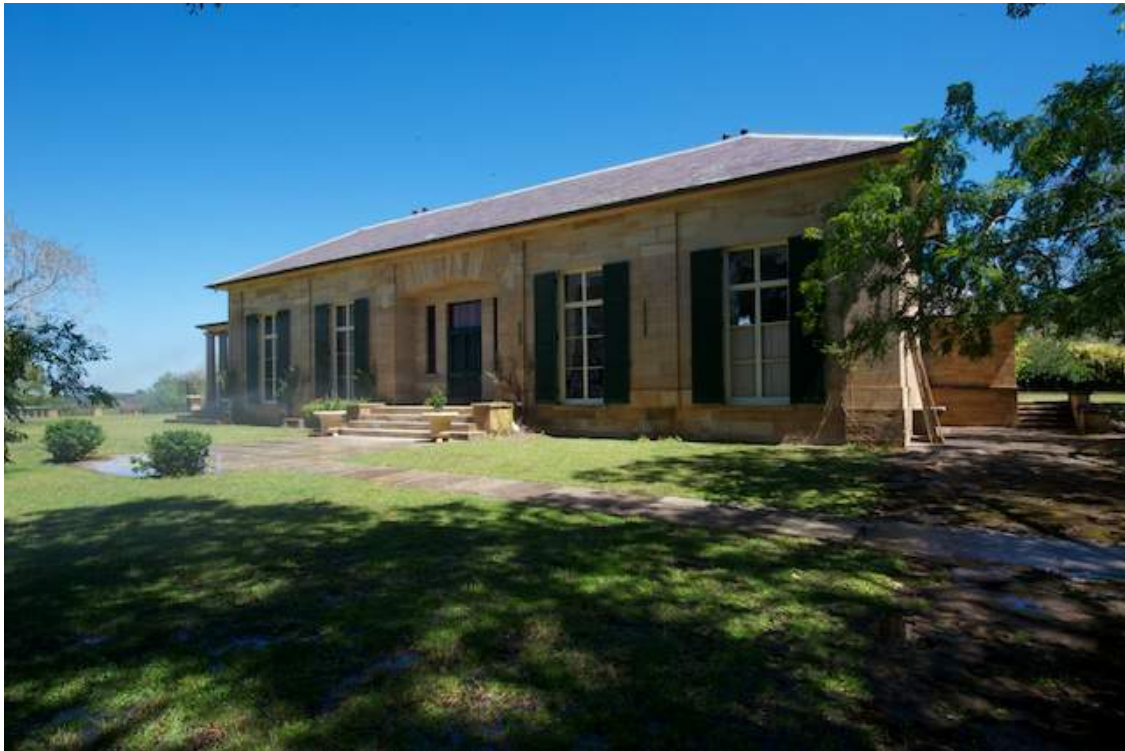
Figure 98: East elevation of the house; original entry to house where carriage loop was located; climbing rose growing on the façade. Paul Davies 2013.

The east elevation was built with a porte-cochere centred on the front entrance, that can be seen in historical photographs in Section 3.4, this was removed in the late 1950s. Historical sources note the porte-cochere was originally boarded timber and was later lined over in battened fibro-cement sheet (c. 1930s).<sup>158</sup> It was reportedly in very poor condition when removed by the Darlings.

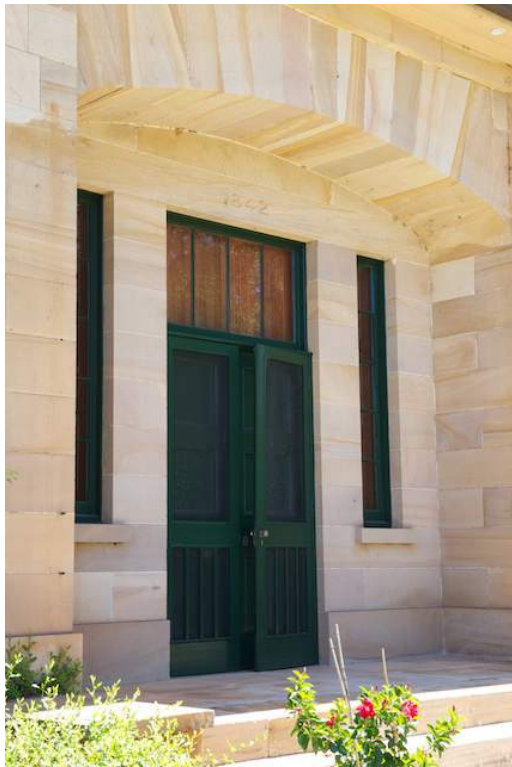
Figure 102: Date of construction above the door lintel, east elevation, 1842. Paul Davies 2013.

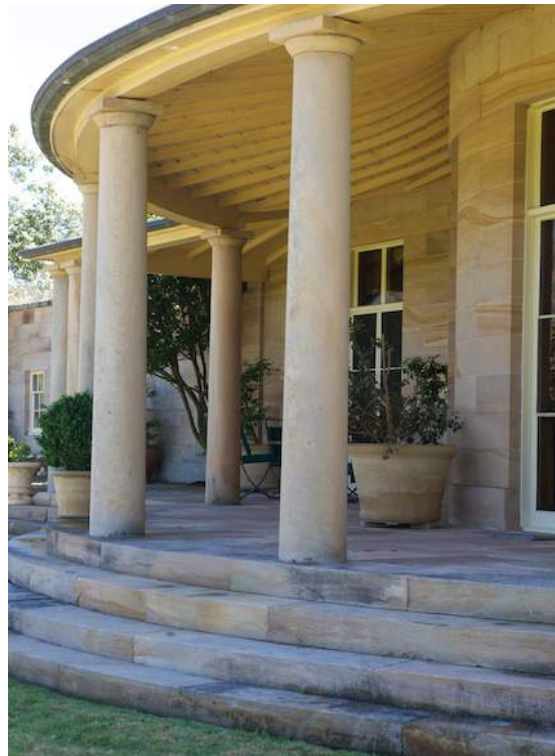
Figure 103: Detail of stone verandah. Paul Davies 2013.

The main walls are large block finely dressed sandstone. The eaves are relatively narrow. There are several stone chimneys with terracotta pots. Guttering and downpipes are in copper throughout all replaced in the 1980s work. The main columns on the southern verandah are single pieces of turned sandstone. Columns on the northern verandah and

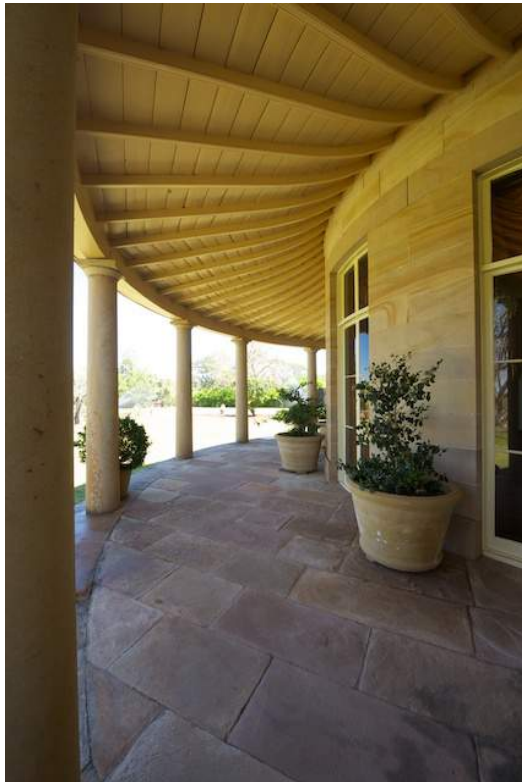
Figure 104: Detail of stone verandah. Paul Davies 2013

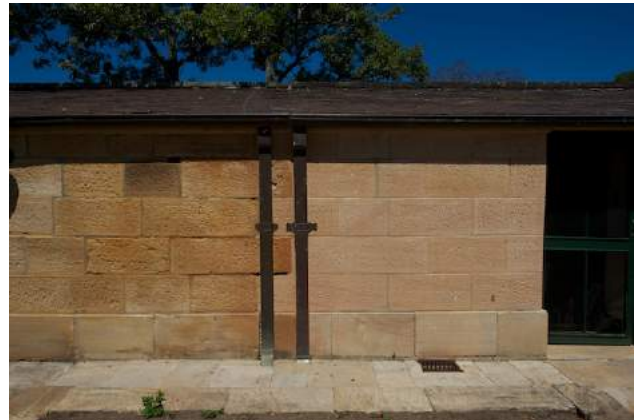
Figure 105: North elevation of laundry extension on south wing (1980s). Paul Davies 2013.

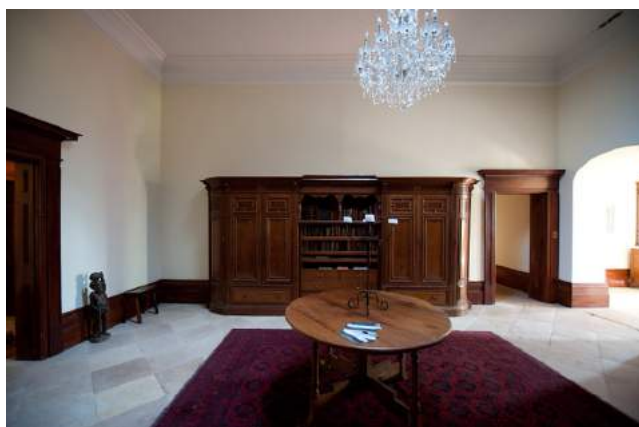
The main hall provides a formal entry from the main entry (G01) through to the ballroom (G04) and dinning room (G06). The sandstone flagging on the floor is laid diagonally to the walls. The walls were painted to give the effect of marble. The ceilings and cornices were altered by Darling in the early 1960s. The marble effect was added to the walls in the 1980s and has been more recently removed. This space is widely believed to have been the proposed location for the stairway to the upper floor (never constructed). There is a timber reconstructed ceiling frame and skylight over the entry hall, which was replaced by Darling.

Figure 107: Main Entry (G01), looking north. Paul Davies 2014

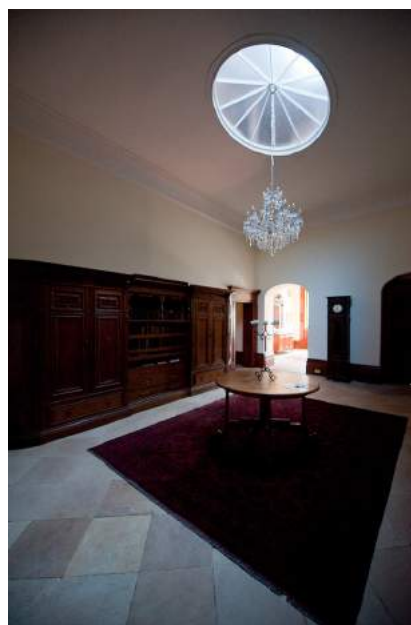
Figure 108: Hall (G02), looking east towards Main Entry (left) and door to Drawing Room. Paul Davies 2014 (right)

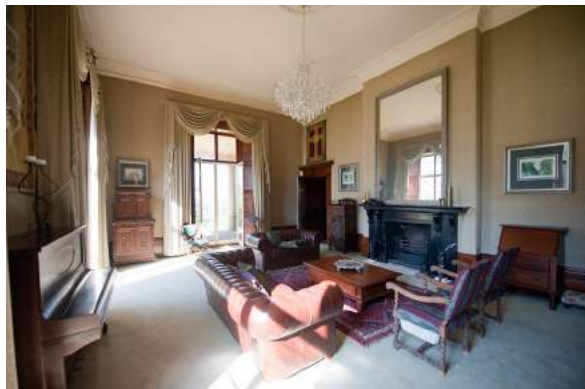
Figure 109: One of the windows on the east side of the room. Paul Davies 2014      Figure 110: Black marble chimneypiece on west side of the room. Paul Davies 2014

There are two high windows on the eastern wall that have internal and external shutters, an original or early design element said to protect the occupants. There is a double set of doors that access the southern verandah with internal and external shutters. This room was referred to as the Drawing Room on 1960s plans of the house.

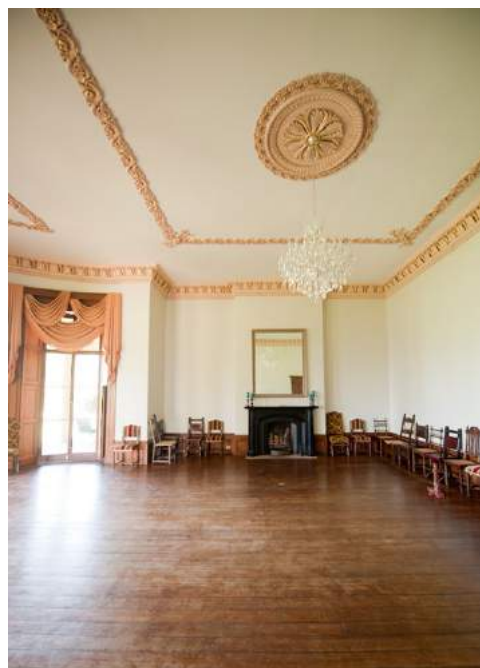
Figure 112: Gilding decoration on the ceiling. Paul Davies 2014

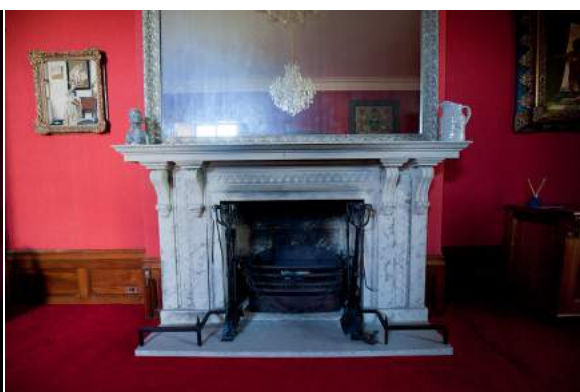
Figure 114: Grey marble chimneypiece. Paul Davies 2014.

The floor in the dining room is carpet and the walls are fabric like the other main rooms, however the curtains are a different contrasting pattern. The white marble chimneypiece is a new addition to the room with internal sandstone lining. The ceilings and cornices were altered by Darling and the finishes were installed by the Andersons. The cedar skirting boards are 53 cm high and unpainted (originally painted in most rooms with Andersons' taking back to finished timber). The doors have six panels with ornate panelling.

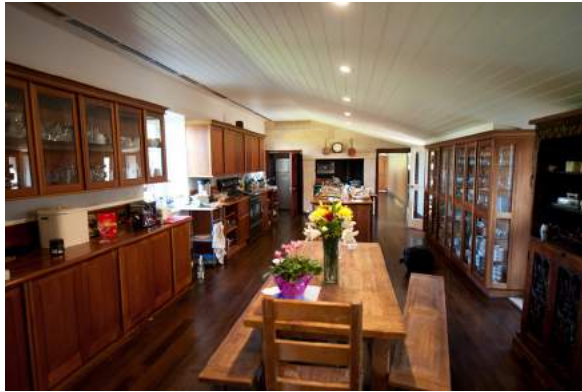
The kitchen was formerly three servants' rooms each accessed from the courtyard. In the early 1960s this area was converted to a kitchen. The interior of the kitchen had a new fit out in the early 1980s following extension of the south wing to the west for the new laundry, including new polished timber floorboards, new painted timber panelled ceiling, interior lined painted walls and new cupboard joinery.

Figure 115: Kitchen, looking west. Paul Davies 2014.

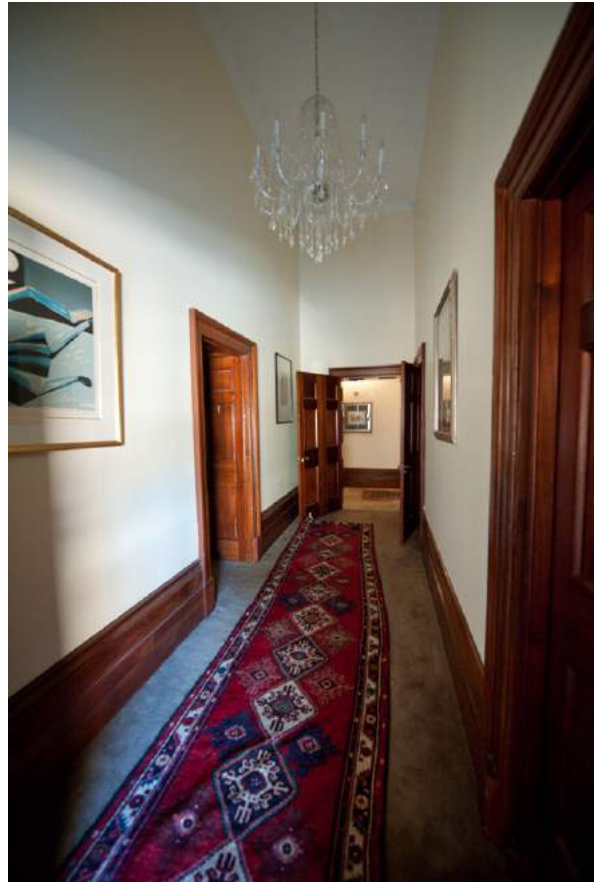
Figure 120: Hallway (G13), looking south towards entry hall (G02) with door to original master bedroom (far left). Paul Davies 2014.

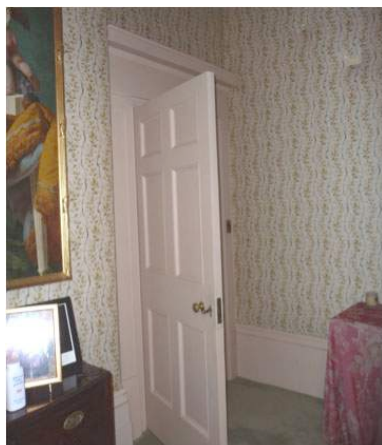
Figure 121: Door to en-suite from master bedroom, looking west; originally this part of the master bedroom was a separate room

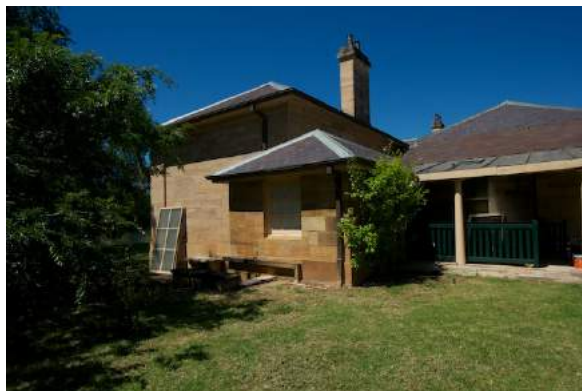
Figure 122: External view of en-suite extension (lower roof) on the north elevation of the house; the taller roof to the left is that of the master bedroom. Paul Davies 2014.

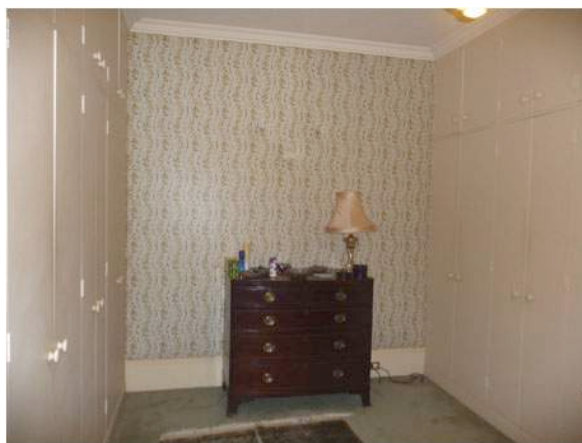
Figure 123: Former girl's bedroom with new built-in cupboards, looking south (G16)

The two bedrooms (G16 and G17) were shown as the girl's bedrooms and nurse's bedroom on the 1960 plan of the house. The girl's bedroom did not have a fireplace, however the nurse's bedroom did. The walls in G16 are covered with fabric, like the master bedroom. The walls in G17 are painted. All joinery is painted and both floors are carpeted. The stone chimneypiece in G17 could be a later addition or reused from another room in the house (Figure below).

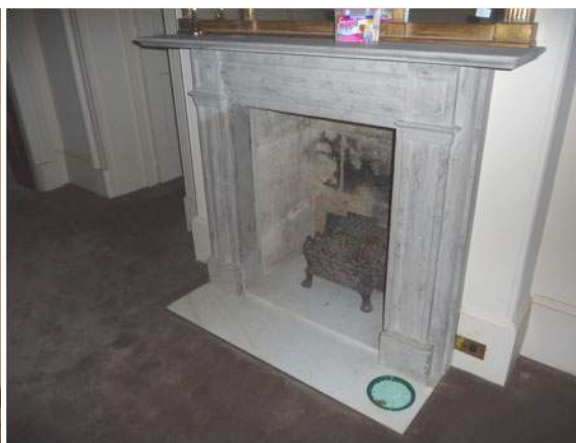
Figure 124: Chimneypiece in former nurse's bedroom, looking west (G17)

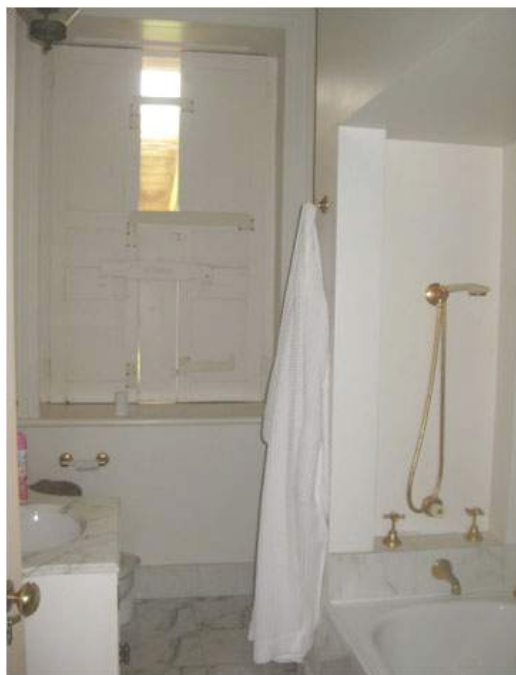
Figure 126: Bathroom (G23), looking north; originally part of bedroom with fireplace in location of bathtub

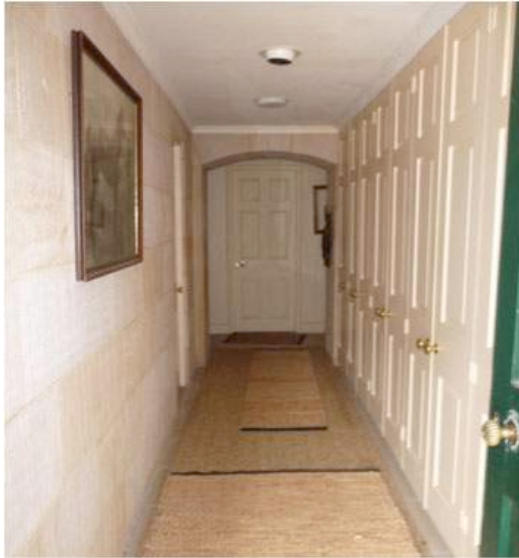
Figure 127: Hallway (G24), altered in the 1980s, looking north towards (G26) and door to bedroom (G27) Figure 128: Bedroom (G28)

These two rooms were originally the pantry and were refurbished in the 1980s to form two rooms: hallway (G24) and bathroom (G25). Changes include a new internal stone wall that now acts as the western wall of the hallway and a new door at the northern end to provide access to rooms further altered to become bedrooms and hallways. The pantry was formerly only accessed off the verandah of the internal courtyard.

The hallway (G26) was formed in the early 1980s when these rooms were further altered to become bedrooms and the stone stairs to the basement. Bedrooms (G27 and G28) both have painted walls and ceiling with a brass lighting fitting, they have sash windows (3 upper panes and 6 lower panes) with all painted window joinery, and a small painted timber skirting. The window to bedroom G28 was originally a door on the northern elevation, which was converted to a window with the 1980s changes. There are cracks on the wall of G28 near the window.

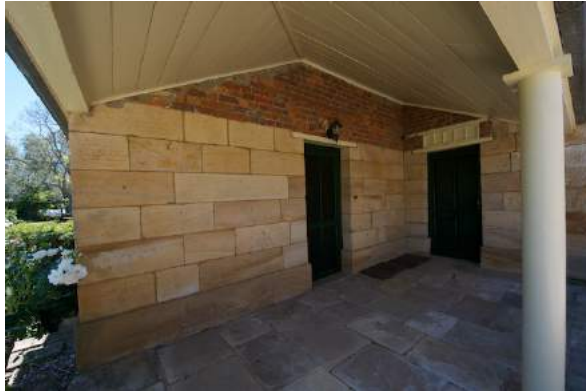
Figure 129: External door to bedroom (G31) with brick courses above sandstone wall to south and west wall under verandah. Paul Davies 2013.

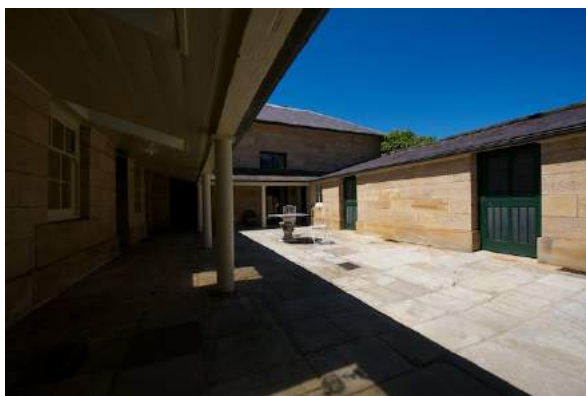
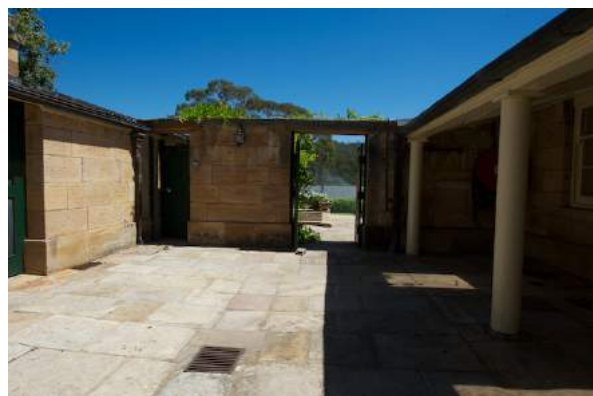
#### Internal courtyard

Figure 133: Internal courtyard, looking east towards dining room. Paul Davies 2013.

Figure 134: Internal courtyard, looking west. Paul Davies 2013.

The floor to the internal courtyard has always been sandstone flagging. There is a metal drainage grill in the centre of the yard and two along the wall of the south wing. The western side of the courtyard is screened by a high ashlar stone wall where there is a copper head and downpipe. The verandah skillion roof on the north wing has turned timber columns, which extends along the eastern side of the house to provide covered access to the south wing (current kitchen). The wooden columns are not original elements and are deteriorating at their bases.

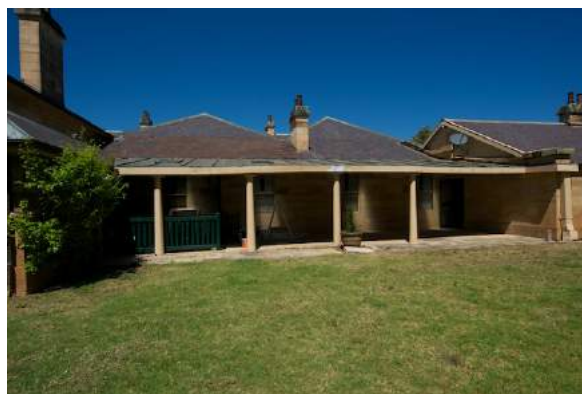
Figure 136: Verandah on northern elevation (G38), looking south towards basement stairs. Paul Davies 2013.

The northern verandah has sandstone flagging and timber columns. There are several skylights along the verandah roof. The western end of the verandah has been infilled with a concrete slab and stone paving over the former coal chute. An access hatch remains providing access to the area. In the basement a brick wall was constructed to separate the coal chute from the main basement area. There is damage to some of the verandah posts and pavement with consequential damage to the roof and structure.

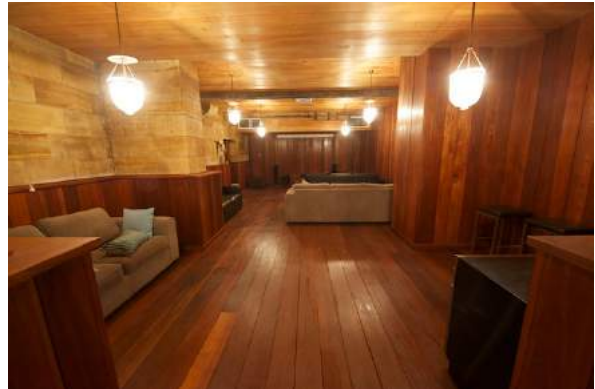
Figure 139: Basement Room B05, looking south. Paul Davies 2013.

These rooms are situated under the dinning room. They have timber floorboards and the ceiling is lined with cedar finished timber boarding. There are several timber beams running east/west across the ceilings in B05. Along the western wall of both rooms the sandstone blocks are fully clad with vertical hardwood boards, and along the eastern wall the sandstone blocks have a half height dado. There is no evidence in these rooms of salt attack or other water damage to the visible sandstone, however timber panels on the walls, floor and ceiling conceal the condition of the rest of the sandstone and should be further investigated. These rooms originally had a dirt floor prior to the 1980s alterations. The previous and current use of this basement room is unknown.

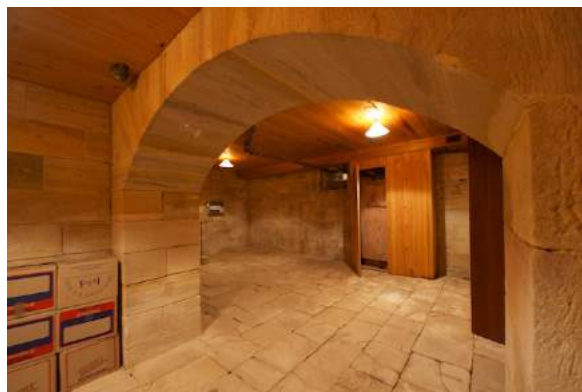
Figure 143: B09 looking south. Paul Davies 2013.

This room is accessed off B10, both of which were used as a kitchen cellar. Both rooms had sandstone flagging, which is substantially cracked and fretting due to water damage. The water damage should be investigated and urgent conservation works undertaken. The sandstone floor should not be replaced in B09 or B10 as it has in B02 – repairs should be undertaken in-situ and as sandstone flagging should only be replaced as a last resort if it poses a safety hazard and can not be suitably repaired. There is a large circular arch between these rooms as a decorative feature. There is evidence on the southern wall of B09 of water entering the ventilation shaft, which does not have a grill. The ceiling in B09 is lined with cedar finished timber boarding.

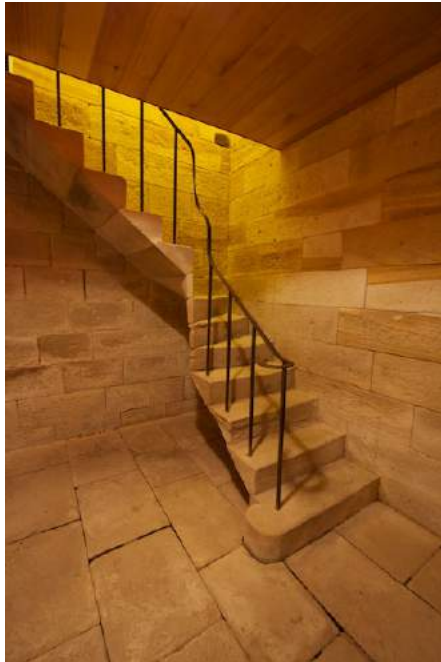
Figure 144: Stone stair from hallway to basement in north wing. Paul Davies 2013.

This room was originally the kitchen cellar when the kitchen was located in the north wing of the house. The curved cantilevered stone staircase in the basement was carved from the walls. The handrail and balustrade are original wrought iron. This room has sandstone walls and stone flagged floors. The ceiling is lined with cedar finished timber boarding. There are damp issues in this room, specifically on the northern wall and some of the stones on the floor are cracked. There is a bricked up vent on the western wall and another partly bricked up vent on the northern wall with intrusive pipes and a power-board. This vent may have been bricked up when the door to the northern wall of G28 was converted to a window in the 1980s. The causes of water damage in this room and B09 should be further investigated and urgent conservation works undertaken to ensure the long-term conservation of the original sandstone floor and wall. The condition of the ceiling is not known, but it should be investigated at the same time and on an annual basis.

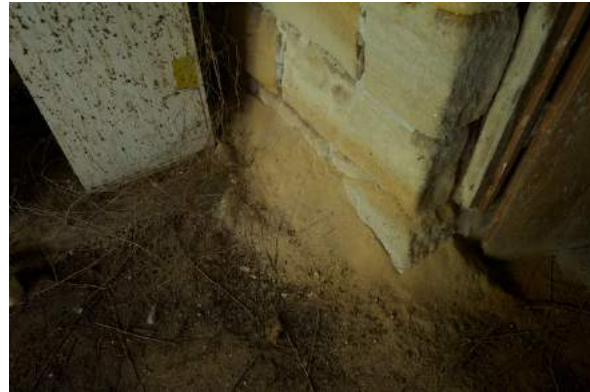
Figure 145: Door detail showing erosion from B10 in basement to B8. Paul Davies 2013.
