# Conservation Management Plan

Simon and Brenda Tripp

Fernhill  
Mulgoa Road, Mulgoa NSW

July 2014  
(Endorsement edition 3  
submitted with IDA)

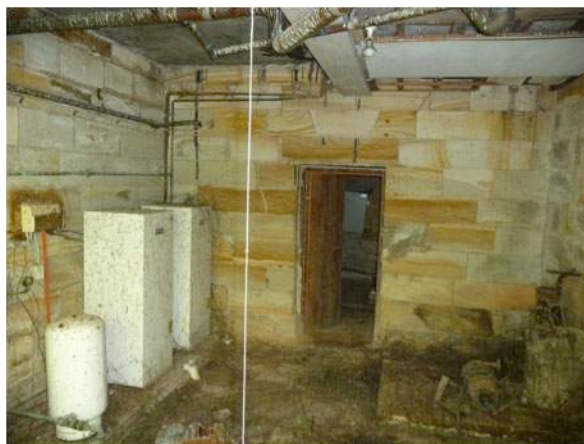
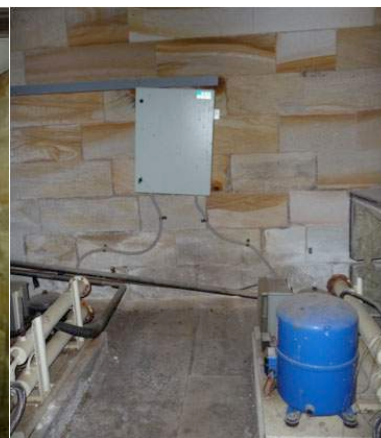
#### Basement Rooms (B11 and B12)

Figure 146: B12 open room accessed via external stairs off north wing

Figure 147: B11 accessed through B12.

These rooms are access via the external sandstone stairs on the western side of the north wing of the house. Both rooms are noted on the 1960 plan of the house as having sandstone flagging, however its original use is not known. These rooms are currently used for services to the house, to which there are intrusive elements in the walls, ceilings and concrete pads on the sandstone paving. The sandstone in this area is fretting and there is evidence of salt attack, which requires conservation works. Investigations are recommended in these rooms in relation to the water damage and potential intrusive services, and urgent conservation works should be undertaken.

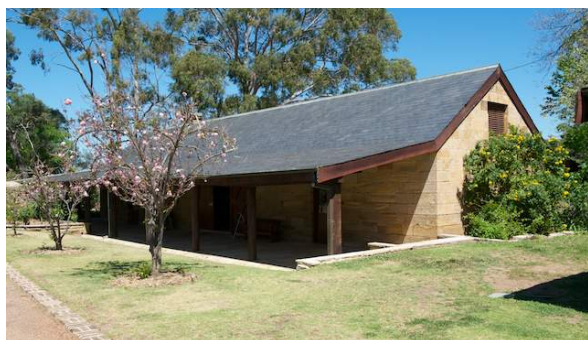
Figure 148: Entertainment Building, 1982. Paul Davies 2013.

The Entertainment Building was constructed north of the 1830s stables' building of a similar size. This building was constructed in 1982 (date on northern end) with sandstone walls, it replaced a smaller billiards room built by the Darlings.

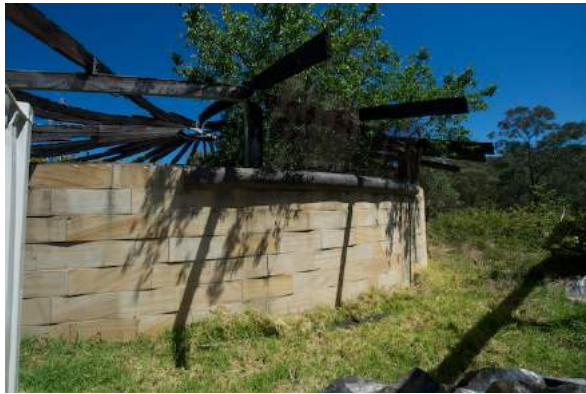
Figure 152: Ruin of workshop, c. early 1980s. Paul Davies 2013.

Located in landscape area 2 are several structures and ruins of former buildings. The ruins of the 1980s workshop building are located west of the house and were damaged by the 2000 bushfires. The structure is load bearing brick masonry walls with a concrete floor.

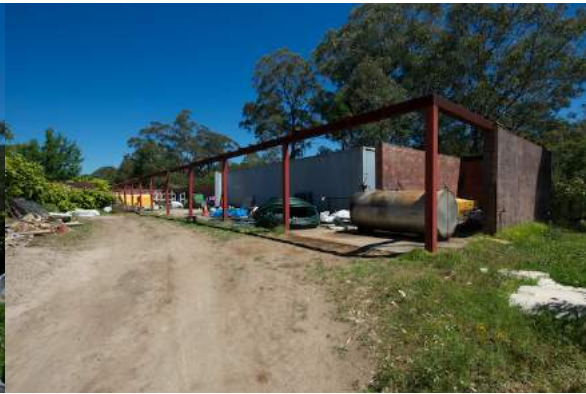
Figure 153: Long aviary (right) and workshop ruins (left), c. 1980s. Paul Davies 2013.

Two aviaries are located in landscape area 2, both constructed in the 1980s. The long aviary has a reinforced concrete floor, rendered brick walls and steel superstructure and is no longer used since it was damaged by the bushfire in 2000. The circular aviary, which was also damaged by the bushfire, has a reinforced concrete floor, dressed sandstone block walls and steel superstructure, and is currently being used.

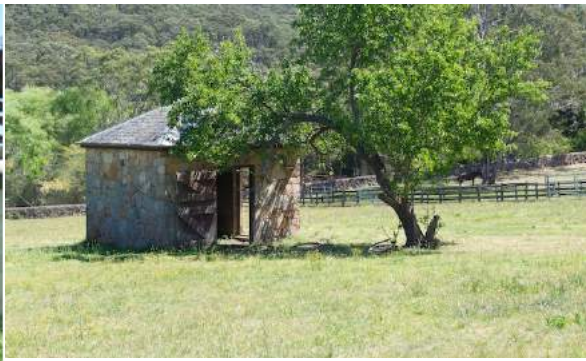
Figure 155: Sandstone loose rubble boxes in paddocks, c. 1980s. Paul Davies 2013

There are several sandstone rubble loose boxes in the paddocks west of the house in landscape area 2, which were all built in the 1980s. The roof of these structures is in slate.

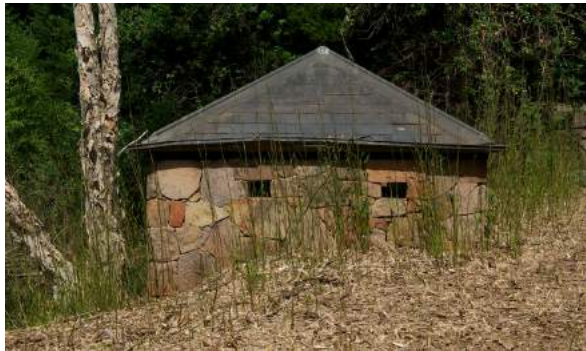
Figure 160: Pump house and retaining wall to dammed lake north of house, c.1980s. Paul Davies 2013. Figure 161: Stables complex, c. 1980s, looking east. Paul Davies 2014.

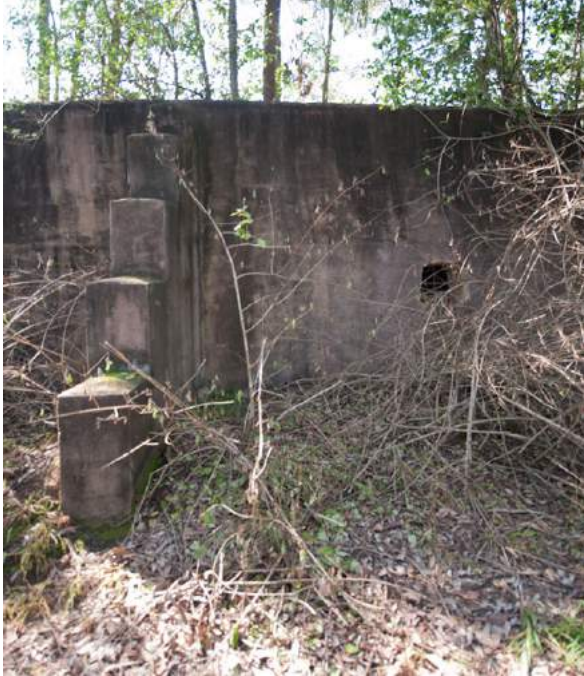
Figure 164: Retaining wall below aviary along access road, date unknown. Paul Davies 2014.

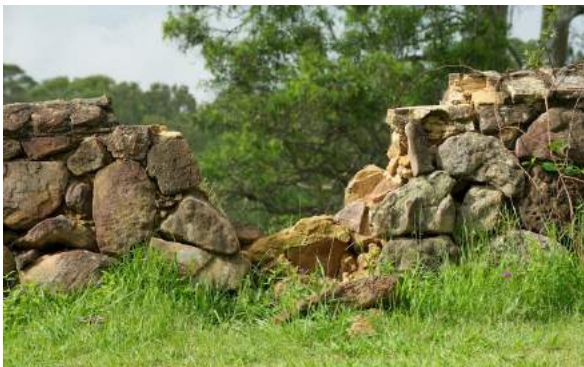
Figure 168: Stone wall along driveway, 1980s, looking south showing an area of recent damage (since repaired). Paul Davies 2013.

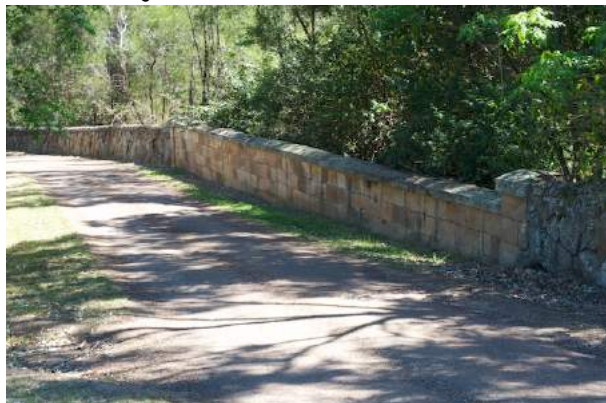
Figure 170: Southern bridge, looking south; Creeping fig (*Ficus pumila*) & Bougainvillea growing over sandstone bridge. Paul Davies 2014

There are two bridges that cross over a tributary creek from the southern driveway as it heads north towards the house. Stone bridges were original elements described by early visitors to the house along the carriage drive to the house. These bridges were partially rebuilt in the early 1960s.

In the early 1980s the eastern abutments of the two bridges were excavated and rebuilt and the western abutment of at least one bridge was rebuilt in reinforced concrete. Both bridges are constructed of sandstone blocks with drains underneath.<sup>180</sup>

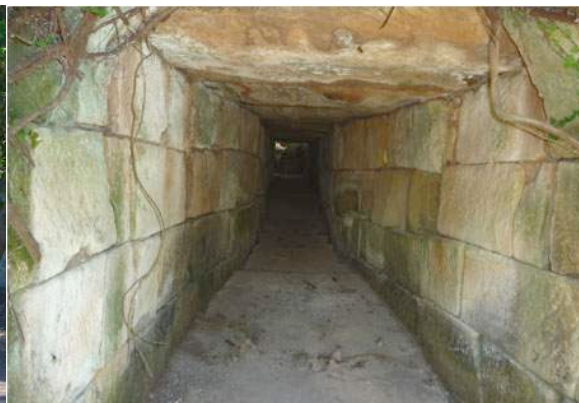
Figure 171: Sandstone drain under southern bridge. Paul Davies 2005.

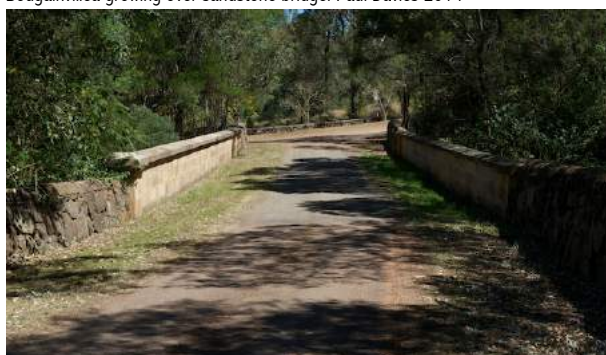
Figure 172: Northern Bridge approach, looking south towards second bridge around bend. Paul Davies 2014.

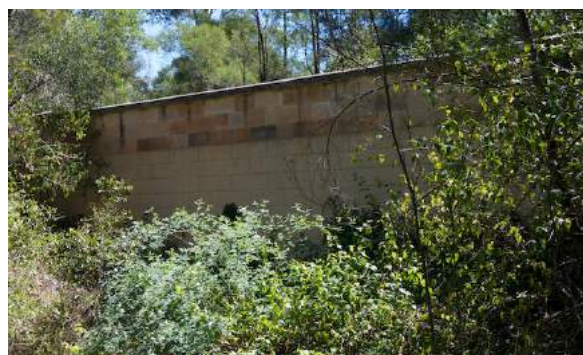
Figure 173: Eastern face of northern bridge, looking west. Paul Davies 2013.

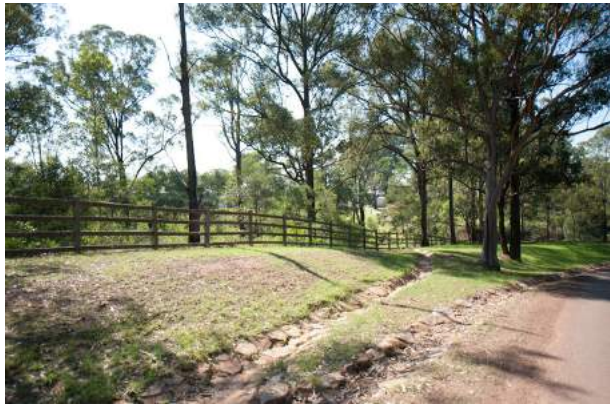
Figure 180: Stone drain along northern side of Southern Driveway in vicinity of original reflecting pond. Paul Davies 2014.

There is also a stone drain that runs along the northern edge of the southern driveway above the reflection pond. While its date of construction is unknown it is most likely to be part of the Anderson upgrade works of the site as the stonework is similar to the stone flanking walls.

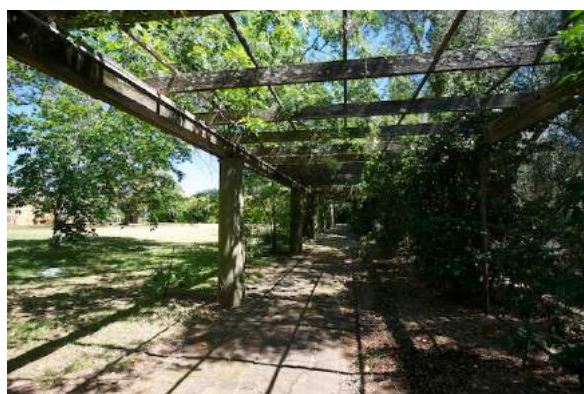
Figure 186: Pergola north of house, looking east. Paul Davies 2014.

The northern edge of the house garden is framed by a pergola with Doric order sandstone columns (reused from the demolished Union Club in Bligh Street Sydney) and a timber superstructure. The ends of the timbers were detailed by Sorensen with a design that was sympathetic to the Georgian architecture of the house. The pergola is covered with White Chinese Wisteria (*Wisteria sinensis* 'Alba'). The timber elements are now in deteriorated condition. It appears that Sorensen raised the level of the garden to create a level lawn to the north of the house. The rear of the pergola has a mid height retaining wall separating it from the driveway that extends to the rear of the house. The lawn between the retaining wall and the house is largely on fill.

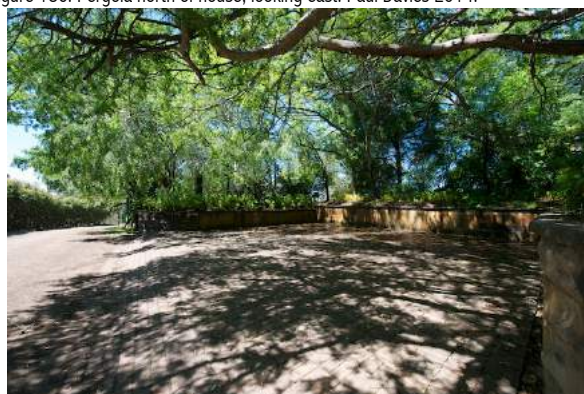
Figure 188: Car parking area with Chinese elm grove (*Ulmus parvifolia*), looking south-west. Paul Davies 2014.

East of the pergola is a paved car park and grove of Chinese elms (*Ulmus parvifolia*) that was laid out by Sorensen in the early 1970s. There is a large flight of paved stone stairs that lead from the car park to the northern area of the garden, the carpark is surrounded by a mid-height sandstone retaining wall. The stairs are the formal access to the eastern elevation and front door of the house. The car parking area, walls and stairs replaced the carriage loop that originally provided formal entrance to the house. Two lamp posts are situated either side of the stair and another set are located either side of the car park entrance. These works involved substantial changes to the land form in the area of the former carriage loop and driveway both excavating the area of the carpark and filling the front lawn area to create a more level platform adjacent to the house.

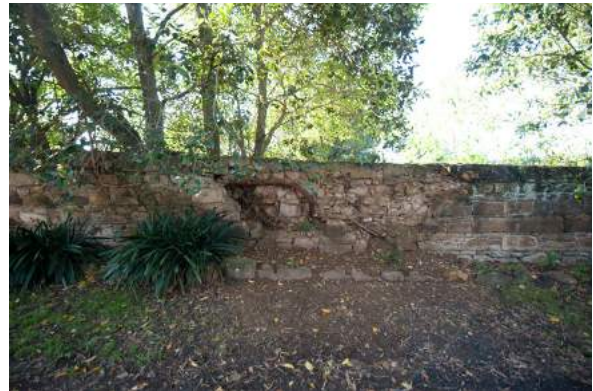
Figure 192: Wall along road south-west of house to car parking area showing damage to stonework. Paul Davies 2014.

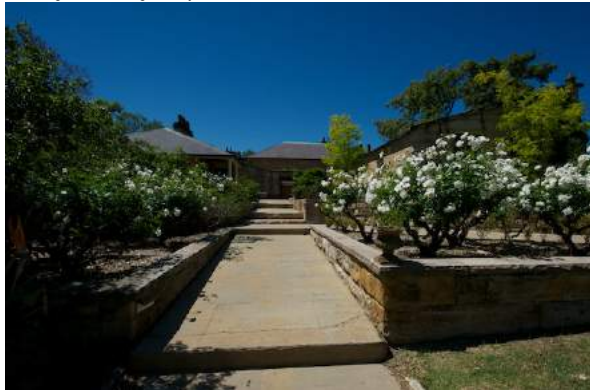
Figure 195: Garden, retaining walls and paved footpaths directly west of house, looking east, terracing designed by Sorensen with later plantings. Paul Davies 2014.

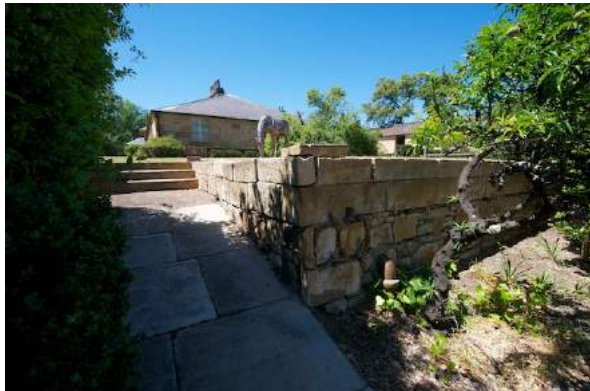
Figure 197: Sandstone steps from garage (left) to house, all designed by Sorensen in the 1970s. Paul Davies 2014.

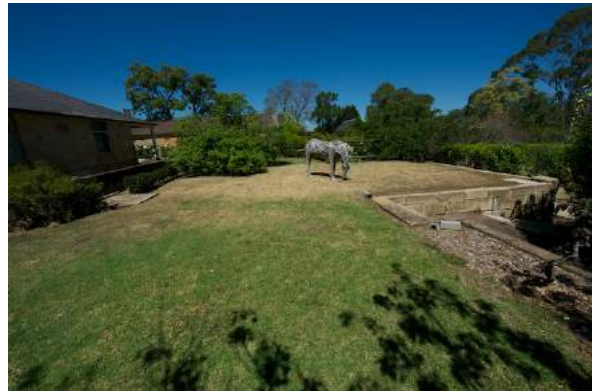
Figure 198: Location of water reservoir, contemporary with house, covered over and lined in 1980s, looking south-west towards 1980s gardener's shed located in car park south of laundry. Paul Davies 2014.

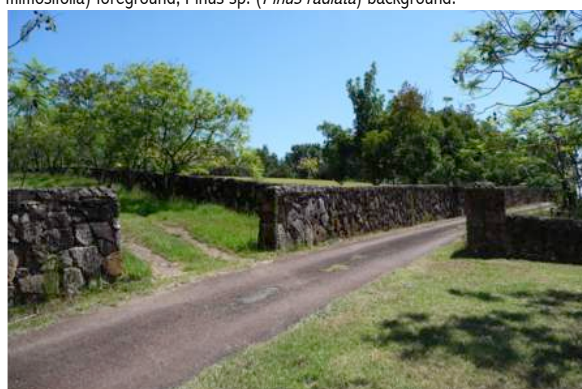
Figure 204: Perimeter stone wall around Sorensen's garden, added by current owner in early 1980s, looking north. Paul Davies 2014.

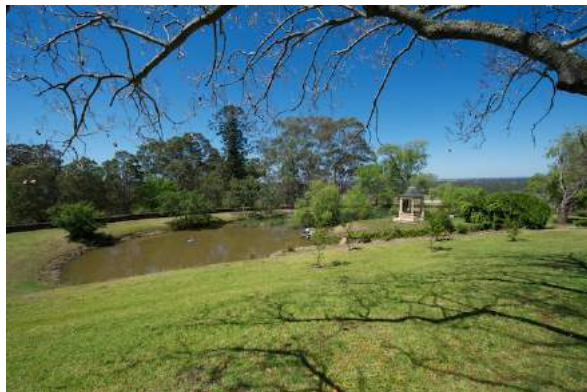
Figure 205: Looking east towards dammed lake, designed by Sorensen (1970s) with additional plantings by Andersons (1980s); Willow trees (*Salix babylonica*) & Jacaranda (*Jacaranda mimosifolia*) around lake. Paul Davies 2014.

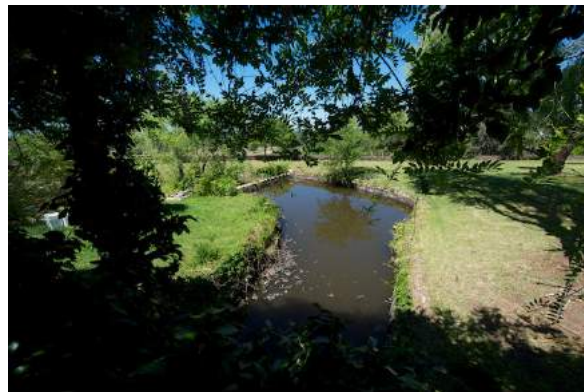
Figure 206: View from timber bridge to island, bridge replaced by Andersons (1980s) an earlier bridge designed by Sorensen (1970s). Paul Davies 2014.

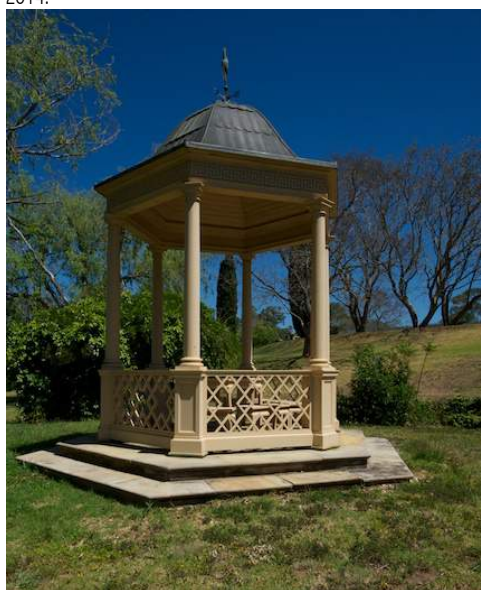
Figure 207: Summer house on island east of house, added by the Andersons (1990s); island was part of Sorensen's garden layout (1970s). Paul Davies 2014.

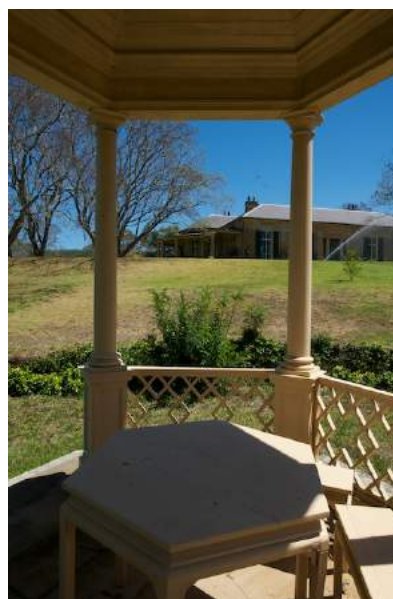
Figure 208: View to house from island, looking west, views to house from driveway are blocked by stone wall further to the east. Paul Davies 2014.

The establishment of the gardens since the 1970s and regrowth in former view corridors has caused loss of specific views overtime to the east to St Thomas Church, Cox's Cottage and parts of the Mulgoa Valley. Careful modification of the garden could be considered to recover views, to open the landscape setting and to remove some of the introduced elements that disrupt the open landscape form.

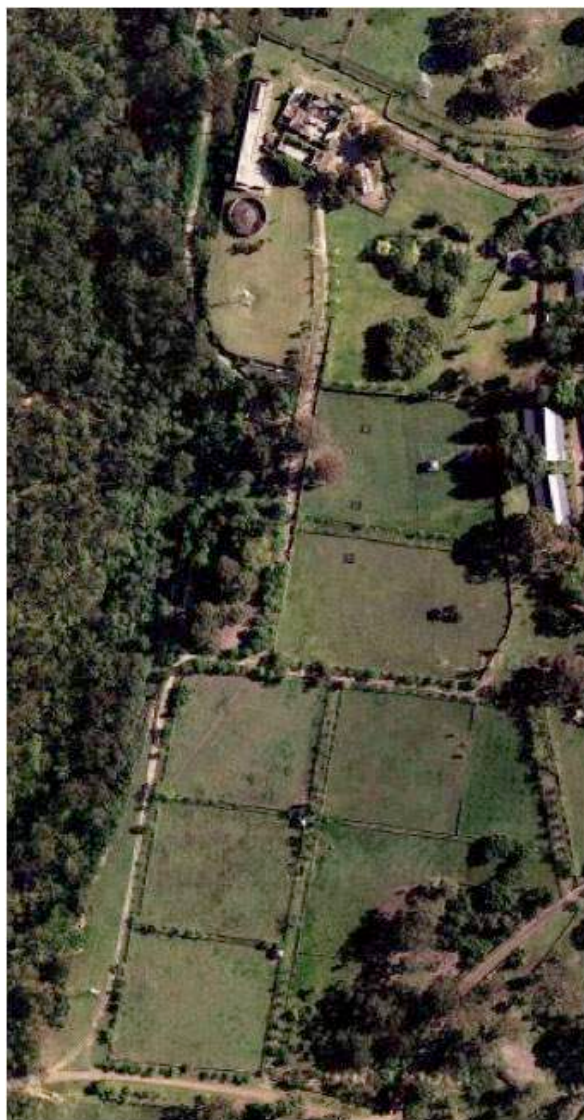
Figure 210: Landscape west of house garden; paddocks with timber fencing and some stone walls, erected in the 1980s with bird aviaries and workshops.

The items of heritage significance that remain in this area are the remains of the winery and the surrounding early land formations and the alignment of the north-south driveway. It appears that all other structures, retaining walls and many of the levels are late twentieth century and of little or no heritage significance.

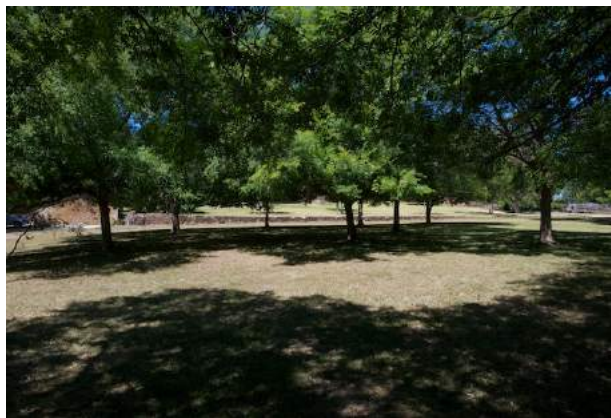
Figure 211: London Plane trees (*Platanus hybrida*) (foreground) and Stone Pine (*Pinus pinea*); looking north-west towards ruin of 1980s workshop building and aviaries. Paul Davies 2014.

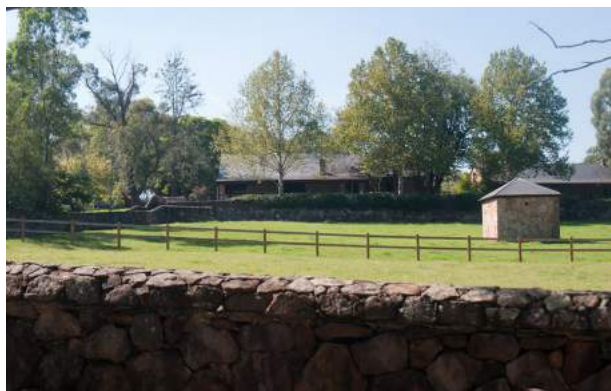
Figure 213: Paddocks and loose stone boxes west of house; looking towards location of winery ruins, aviary buildings and workshop building ruins. Paul Davies 2014..

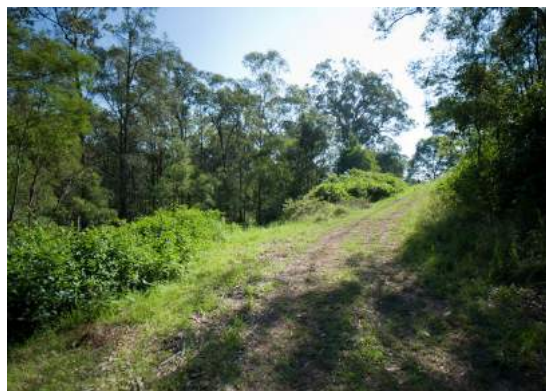
Figure 214: Lantana (*Lantana camara*) growing west of 1980s workshop ruin; in vicinity of quarries; currently 'class 5' weed under *Noxious Weed Act*. Paul Davies 2014

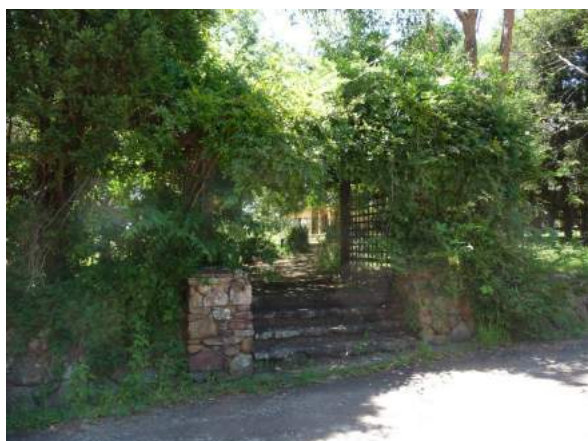
Figure 217: Sandstone stairs and arched timber trellis to Manager's Residence, 1980s, looking south-east. Photo taken 2010.

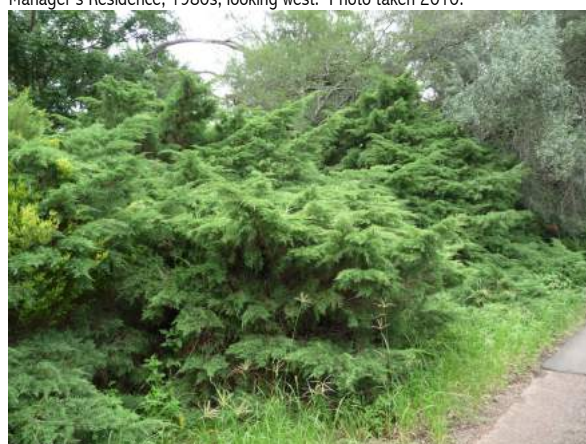
Figure 220: Conifer (*Juniperus sp.*) & Olive Tree (*Olea europaea*) in back-ground along driveway directly north of house, formalised by Sorensen in 1970s; plantings may be later additions. Photo taken 2010.

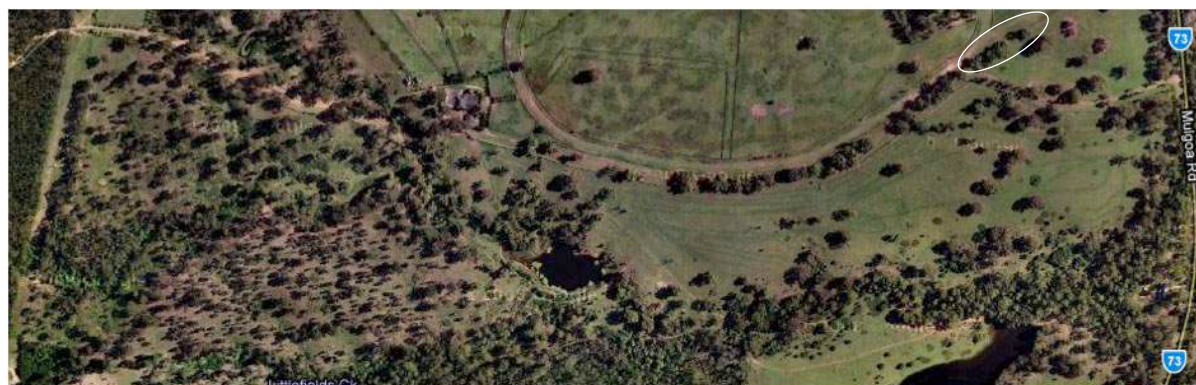
Figure 221: Native Apple (Angophora) trees that indicate original section of southern driveway (circled). Source: Google Maps 2010

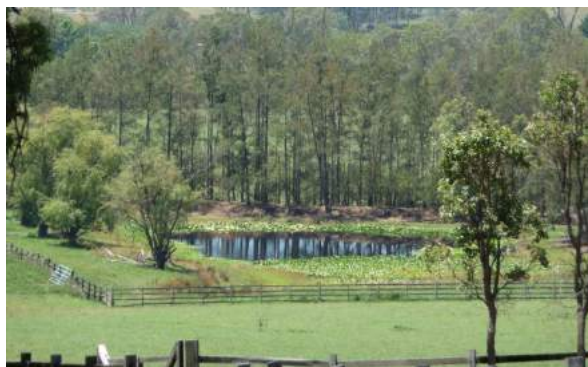
Figure 225: One of the dams directly north of the race-track with surrounding trees, c1980s. The grouping of casuarinas provides a solid visual screen in the landscape in contrast to the small clumps of scattered trees that previously existed. Paul Davies 2014.

The addition of the dams within this area and the dense planting around the edges of the water (items L3, L4 and L5) has also provided quite dense banks of planting when viewed from the front of the house and driveway. Consideration to removing or thinning areas of introduced planting should be given to recreate the smaller more random clumps of vegetation within the landscape.

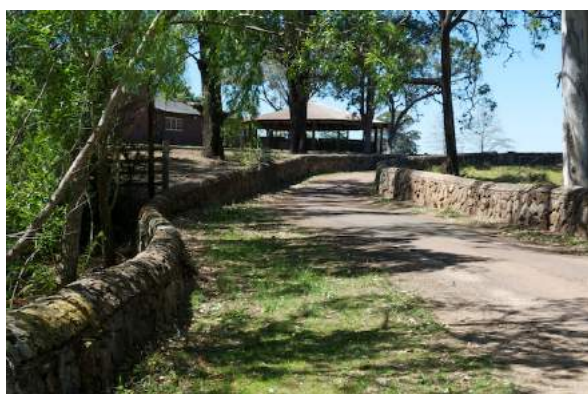
Figure 229: Trees are Broad-leaved Apple (*Angophora subvelutina*); stone and concrete fence added in the 1980s. Originally there were no stone fences in this location. Paul Davies 2014.

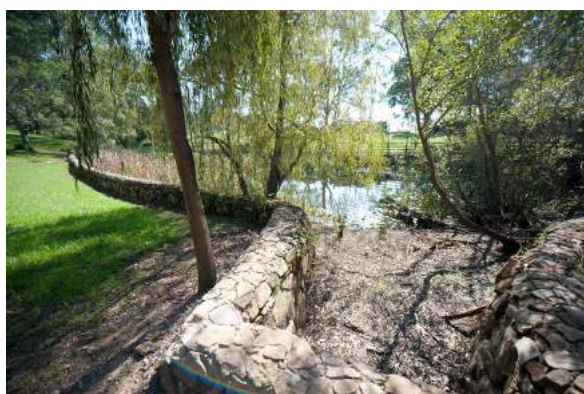
Figure 230: Reflecting pond, part of the original design of the property, 1840s; vegetation on pond and in vicinity, stone retaining wall and timber fence have altered the significance of this element and views to the house since the 1980s. Paul Davies 2014.

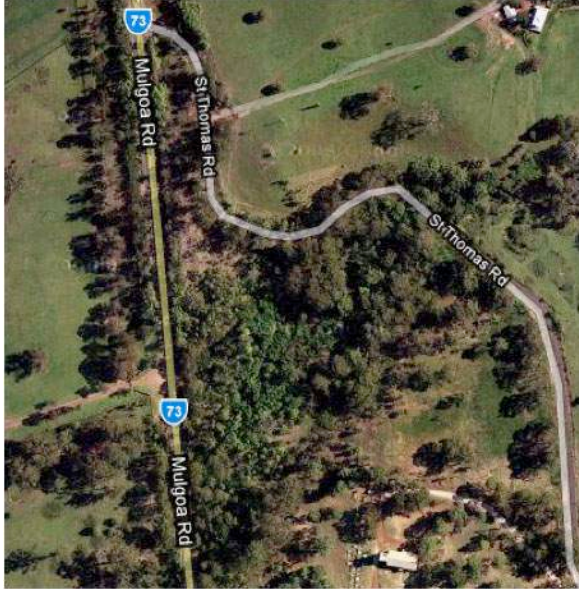
Figure 239: St Thomas' Church is at the bottom of the above aerial photograph, and Fernhill's current southern driveway entrance is on the bottom left. The original drive extended approximately from the end of the driveway extending east from St Thomas Road; Source: Google Maps 2010.

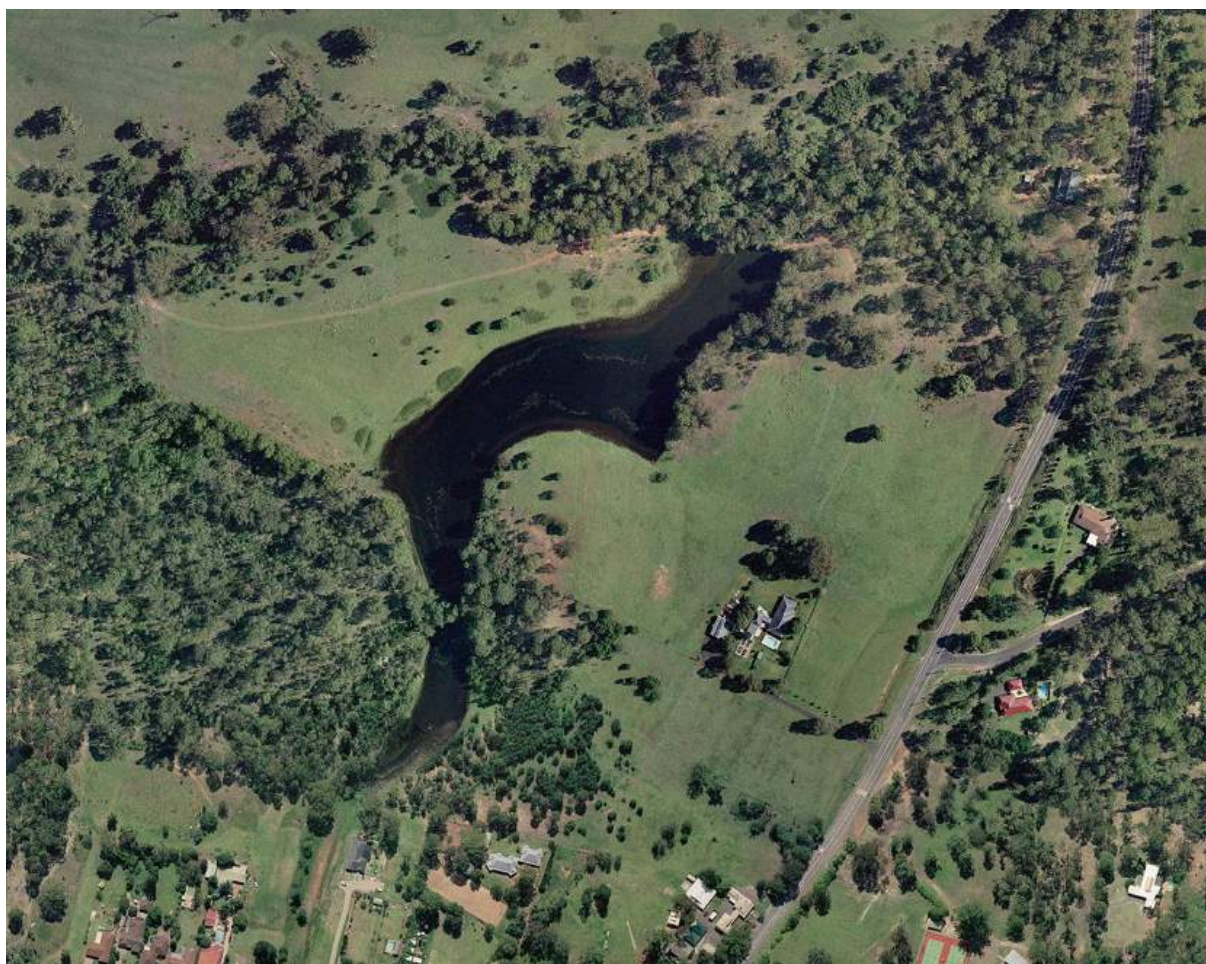
Figure 241: The southern lots around the 1960s dam. Six Viewer 2013.

The aerial photograph of 1947 shows this area as substantially cleared grazing land with some tree cover near Littlefields Creek, a chain of ponds forming a tributary of this creek, and a number of small paddocks under cultivation. A cottage is shown at the south-east corner of property with frontage to Mulgoa Road. The Heritage Study of Penrith (1987) identifies this property as Woodlands (item no. MV-5), attributed to c1870, and possibly was

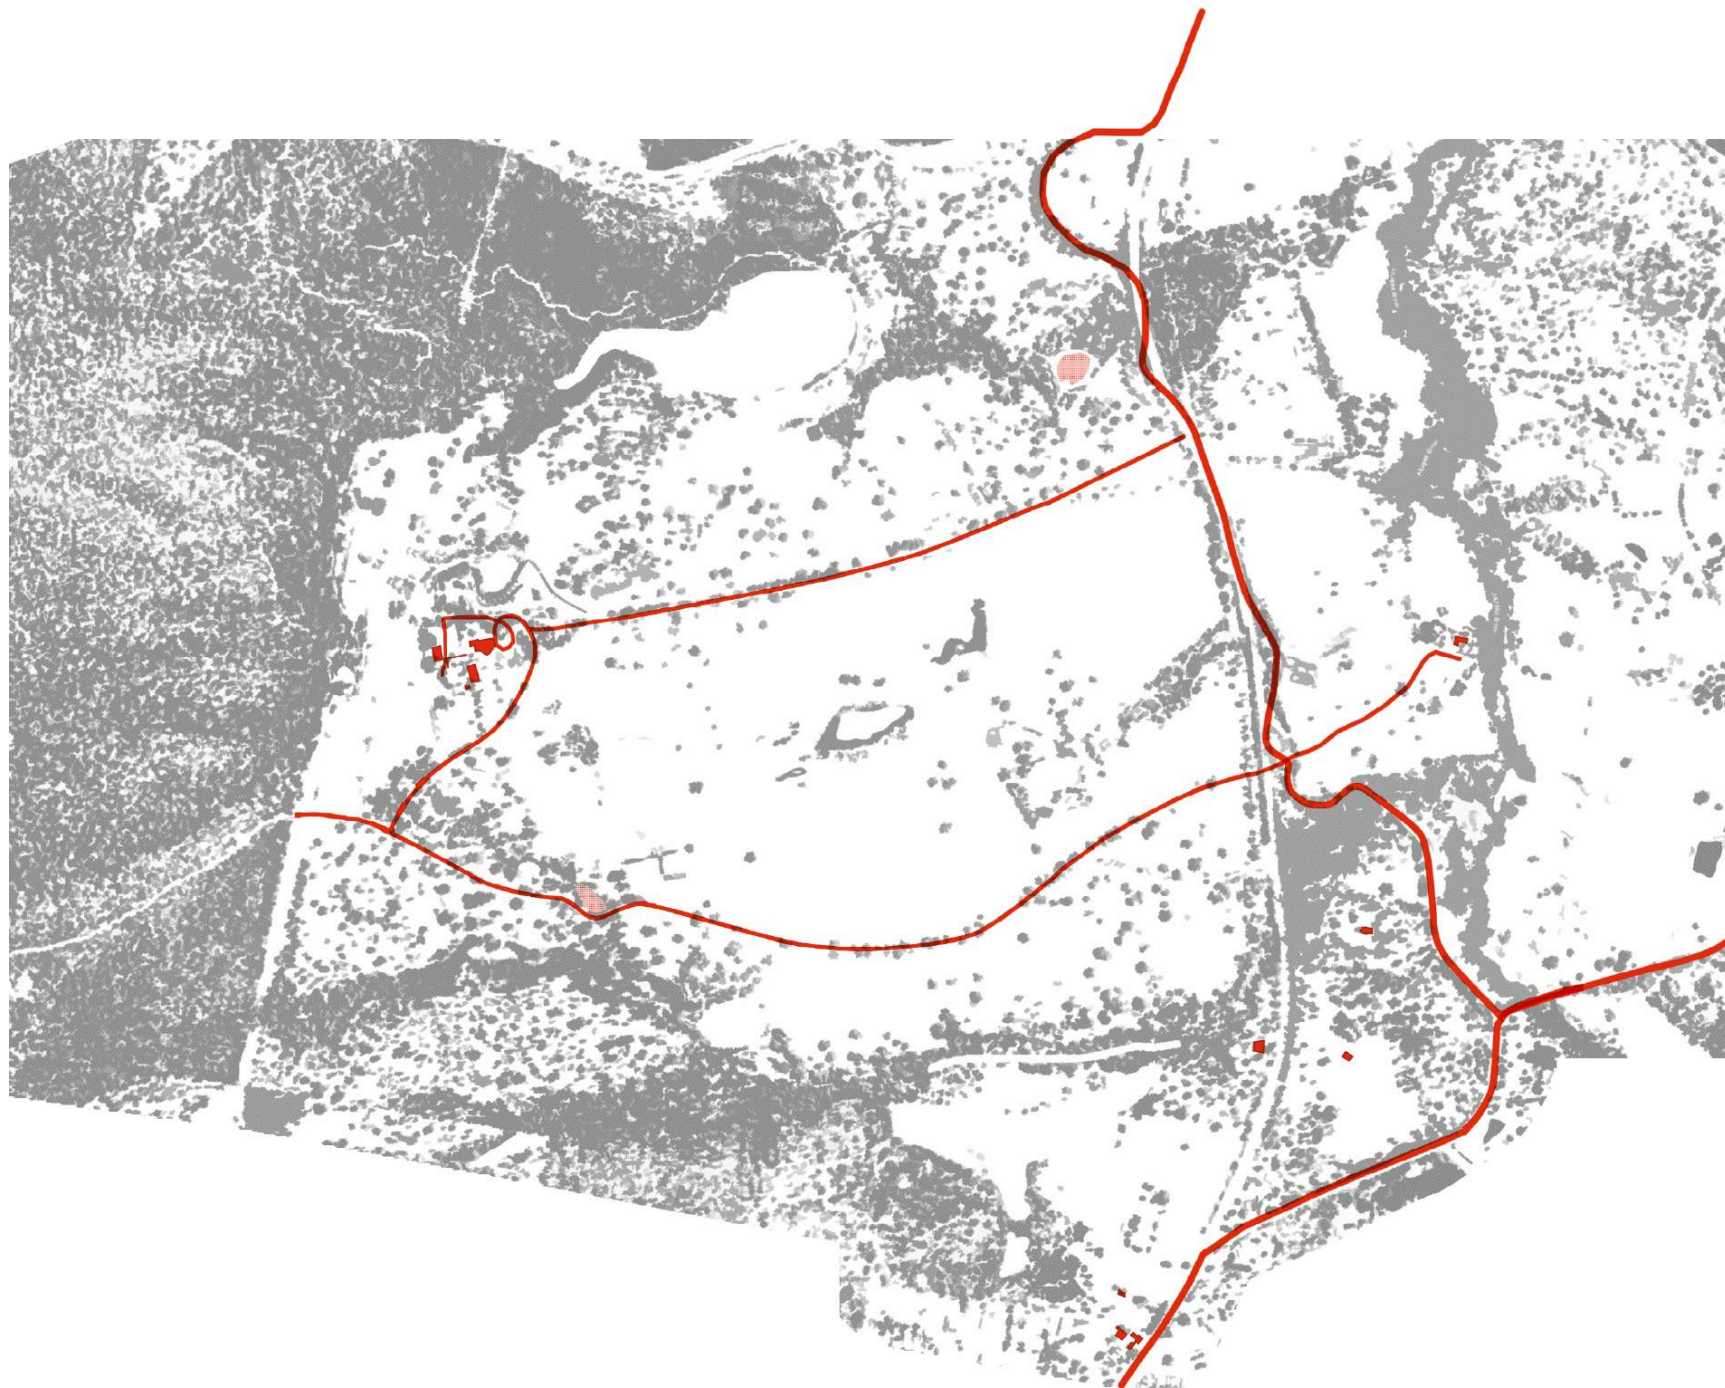
Figure 245: 1947 Features overlaid on current aerial photograph.

Figure 245 shows the 1947 features overlaid on the current aerial photograph. This illustrates the landscape changes that have taken place, particularly the realignment of Mulgoa Road and the increase in vegetation cover on the site.

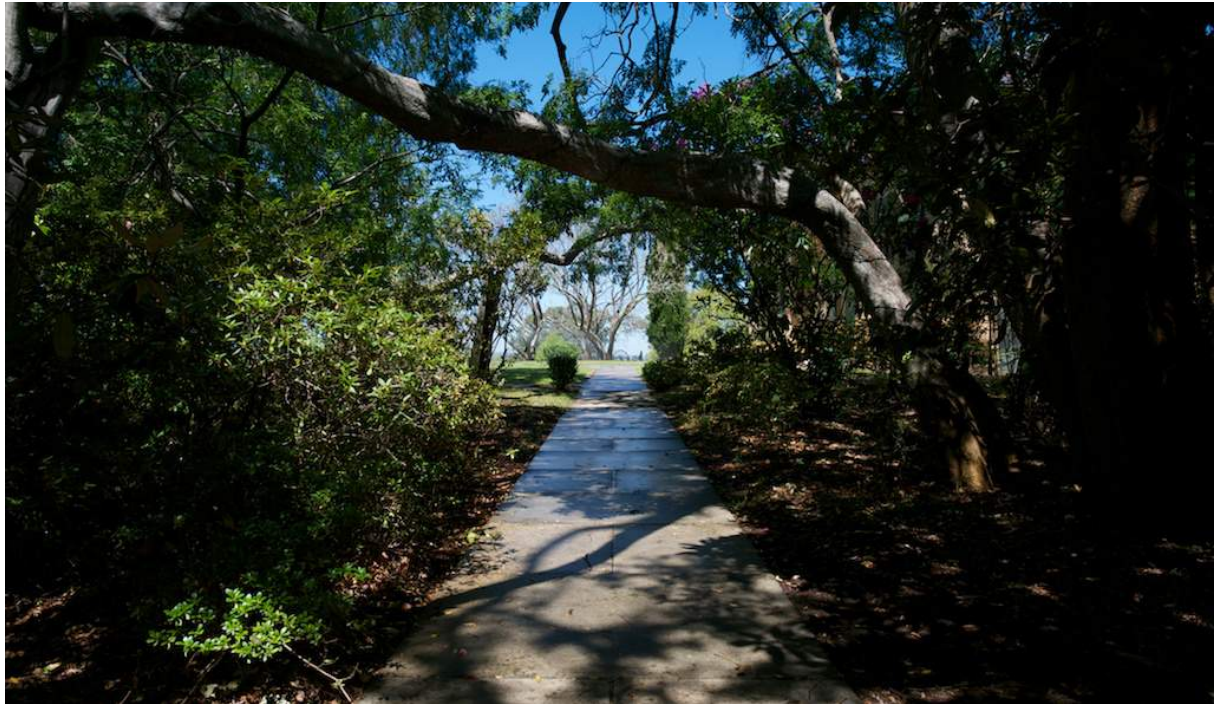
Figure 254: The view along the entry path above the carpark to the front of the house. The Sorensen landscape treatment has provided an enclosed and contained entry with the house only revealed once the visitor reaches the lawn directly in front of the house. Paul Davies 2014.

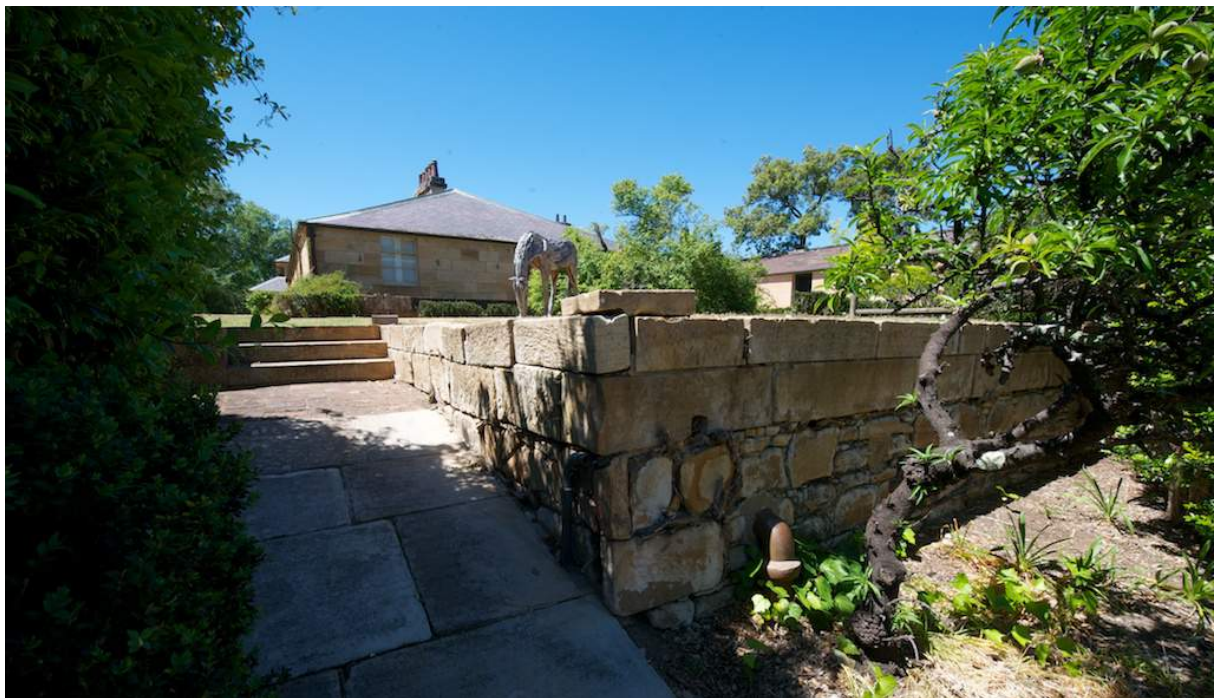
Figure 255: The entry path arriving from the rear of the property. Sorensen created a series of platforms with gardens and the entry path stepping around the gardens to the central rear courtyard. Earlier this area was not landscaped. Paul Davies 2014.

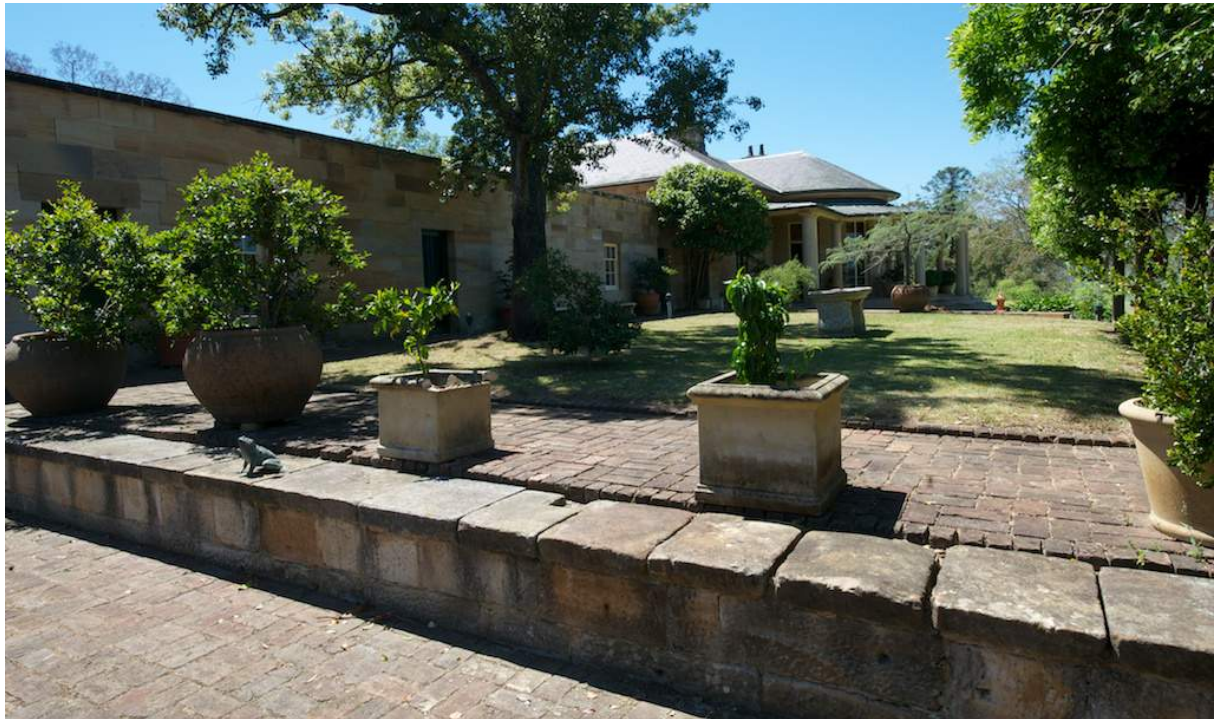
Figure 256: The entry point at the end of the driveway adjacent to the house service wing where limited parking is available. This view provides vista to the main frontage of the verandah. The level changes and landscaping is a combination of Sorensen and later Anderson works. Paul Davies 2014.

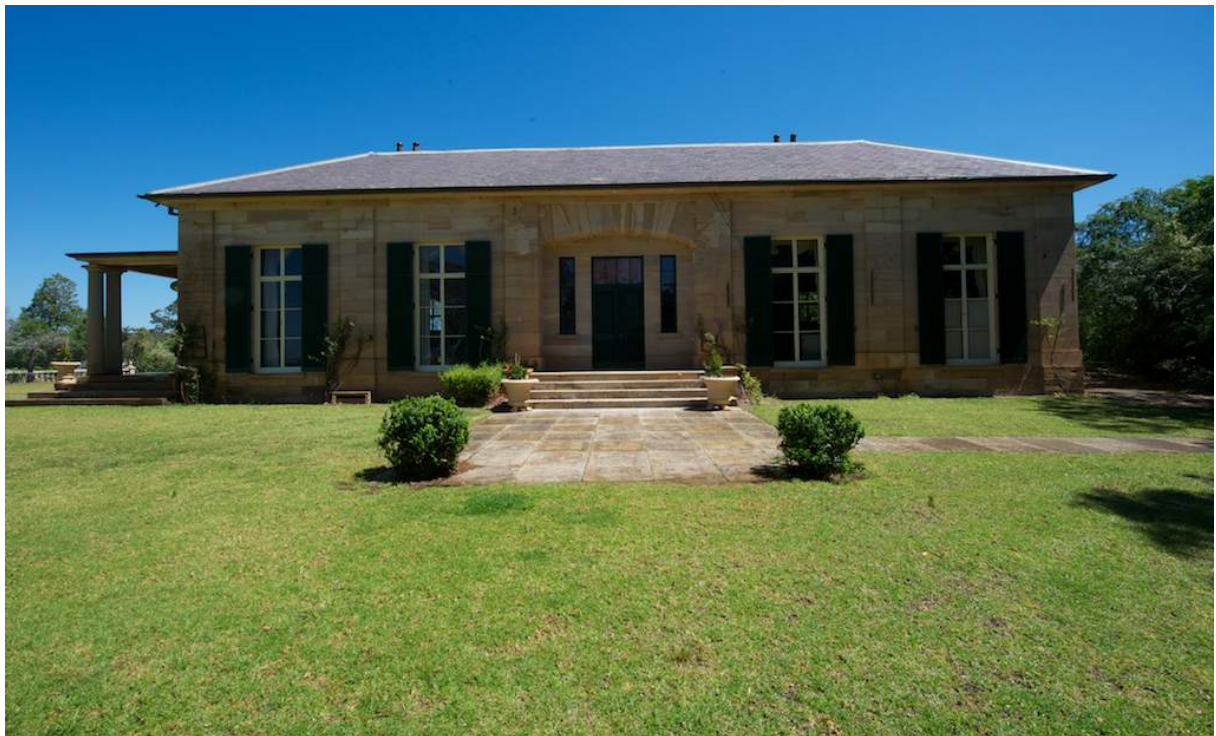
Figure 257: The main frontage of the house with the entry path entering from the right of the photo and a levelled lawn in the foreground. Originally the house had a porte-cochere in this location, sloping ground and a circular driveway. Paul Davies 2014.

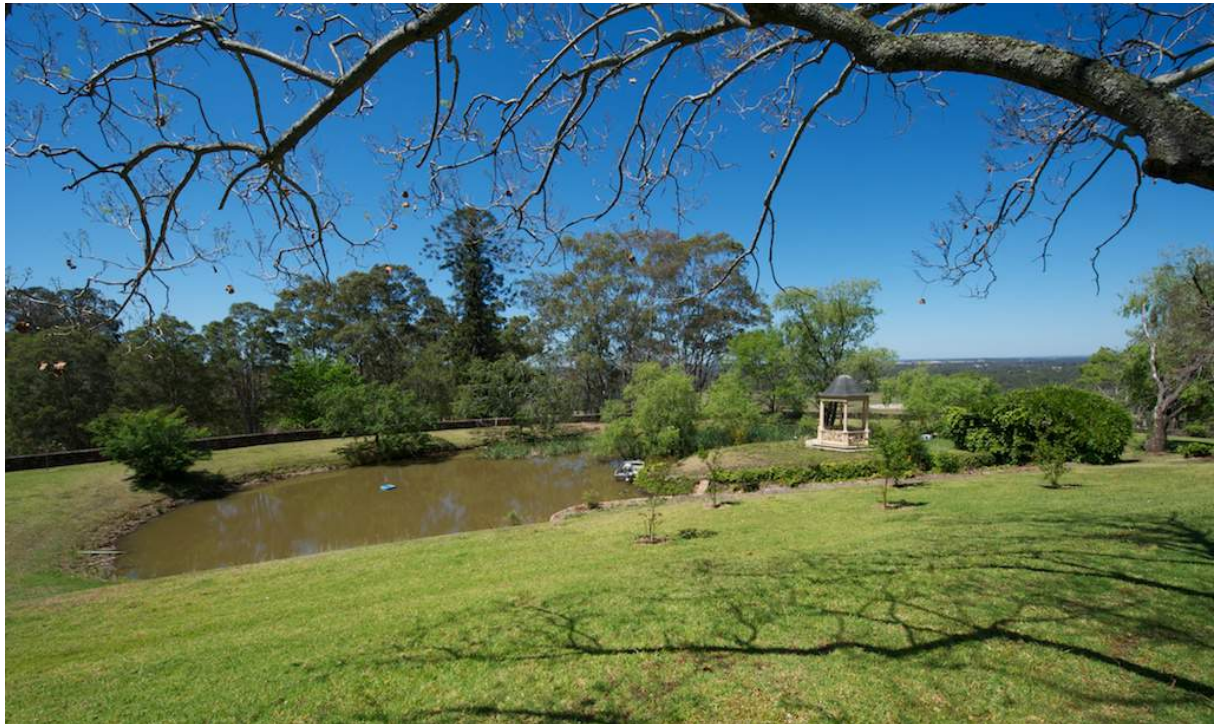
Figure 258: The current view or outlook taken from the front of the house on the lawn near the edge of the grassed embankment. This is the first point at which an overview is available from the main frontage. The level changes and intense planting has created an enclosed viewscape with glimpses to distant hills. The intermediate landscape is not visible from the house or main garden areas immediately adjacent to the house, however the outlook is broad, despite the tree cover. Paul Davies 2014.

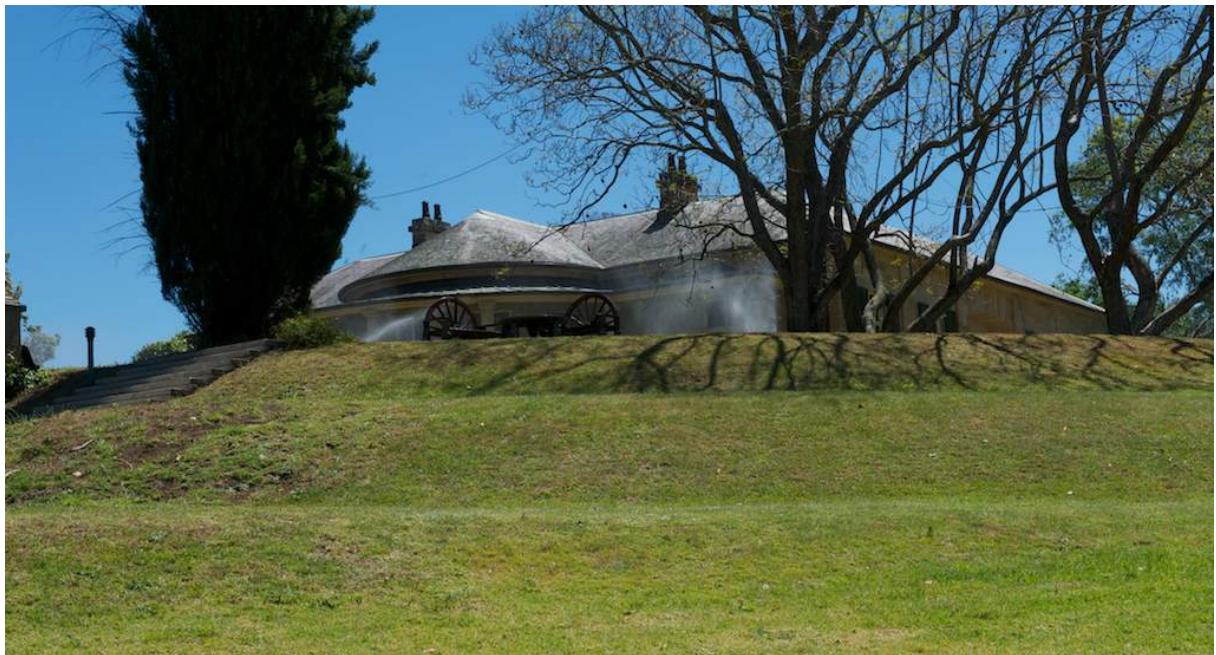
Figure 259: An interesting view back to the house from the middle of the lower lawn area. The levelling of the lawn around the house to create platforms has removed most of the view of the house from the lower garden and from the entry driveway. Paul Davies 2014.

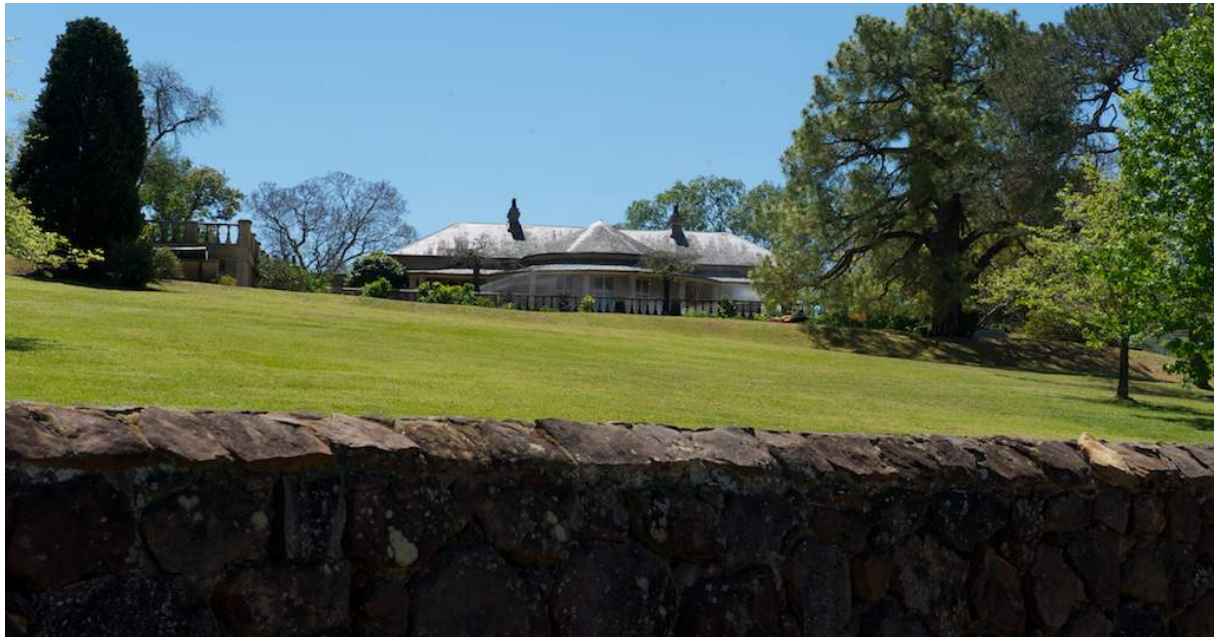
Figure 262: The only clear view of the house available from the entry driveway on approach to the house. The colonial landform can be seen immediately behind the fence in the sloped lawn that is then interrupted by the grassed embankment and the balustrading around the pool area. As the visitor moves further along the driveway views of the house are removed by the level changes and the stone fence. Paul Davies 2014.
