# Conservation Management Plan

Simon and Brenda Tripp

Fernhill  
Mulgoa Road, Mulgoa NSW

July 2014  
(Endorsement edition 3  
submitted with IDA)

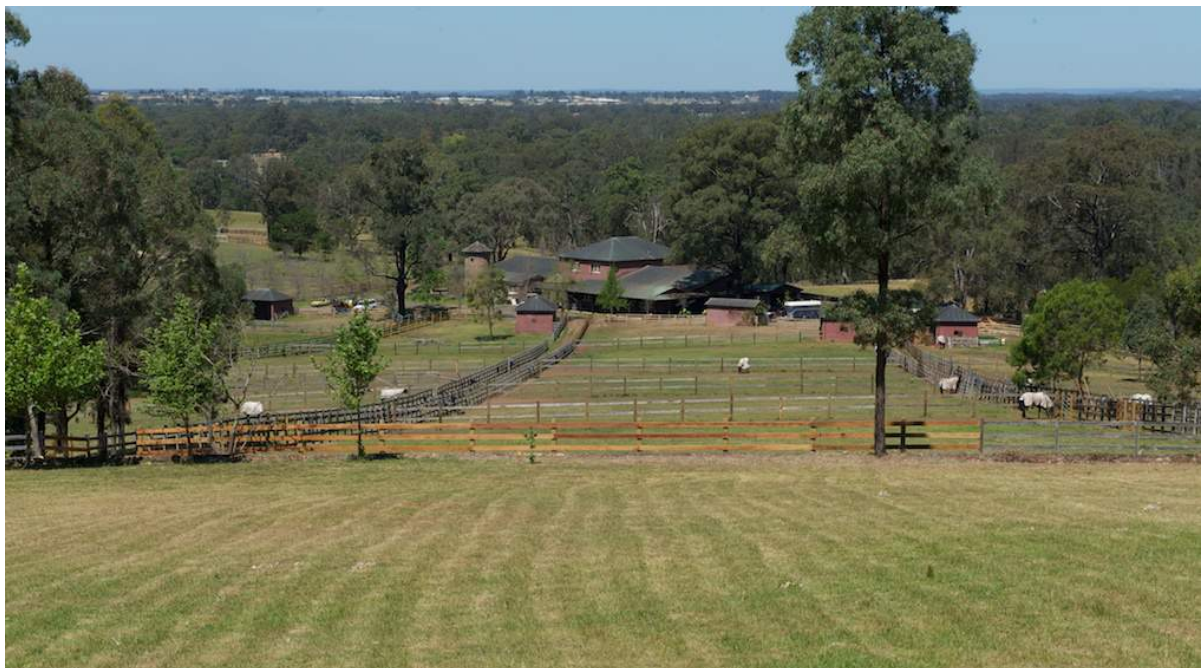
Figure 263: A view from the lower garden/lawn area across the stone fence and entry drive to the stables complex. The reflecting pond is on the far right of this photo behind a stand of trees. Views in this direction are largely terminated by the tree growth along Littlefields Creek. A glimpse of the eastern precinct grasslands around the lake can be seen in the upper left of the photo. As a colonial property this was a more open vista with views possible to the church beyond (to the left of this photo). Paul Davies 2014.

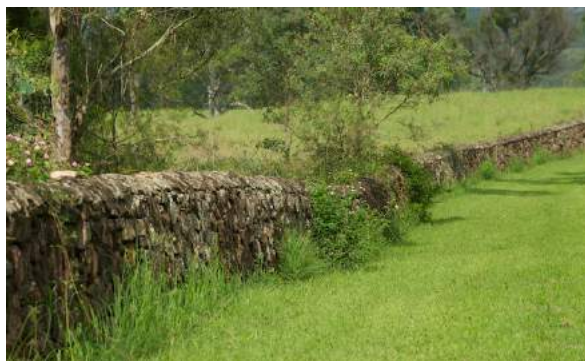
Figure 274: View near entry of flanking stone wall that follows the main drive for most of its length. These walls were added by the Andersons. Paul Davies 2013.

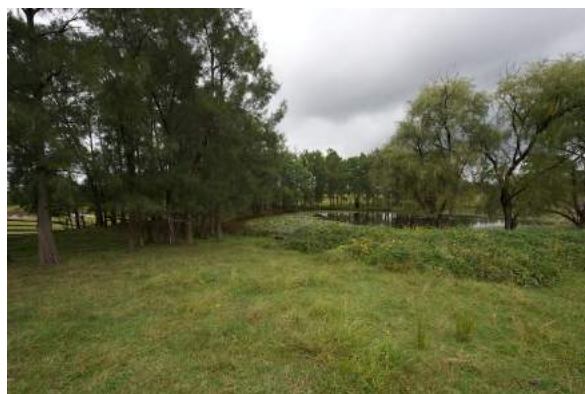
Figure 278: A detail of one of the central dam areas surrounded by casuarinas and willows. As noted in the discussion these plantings are quite recent and thinning or selected removal can open up longer vistas through the property. Paul Davies 2013.

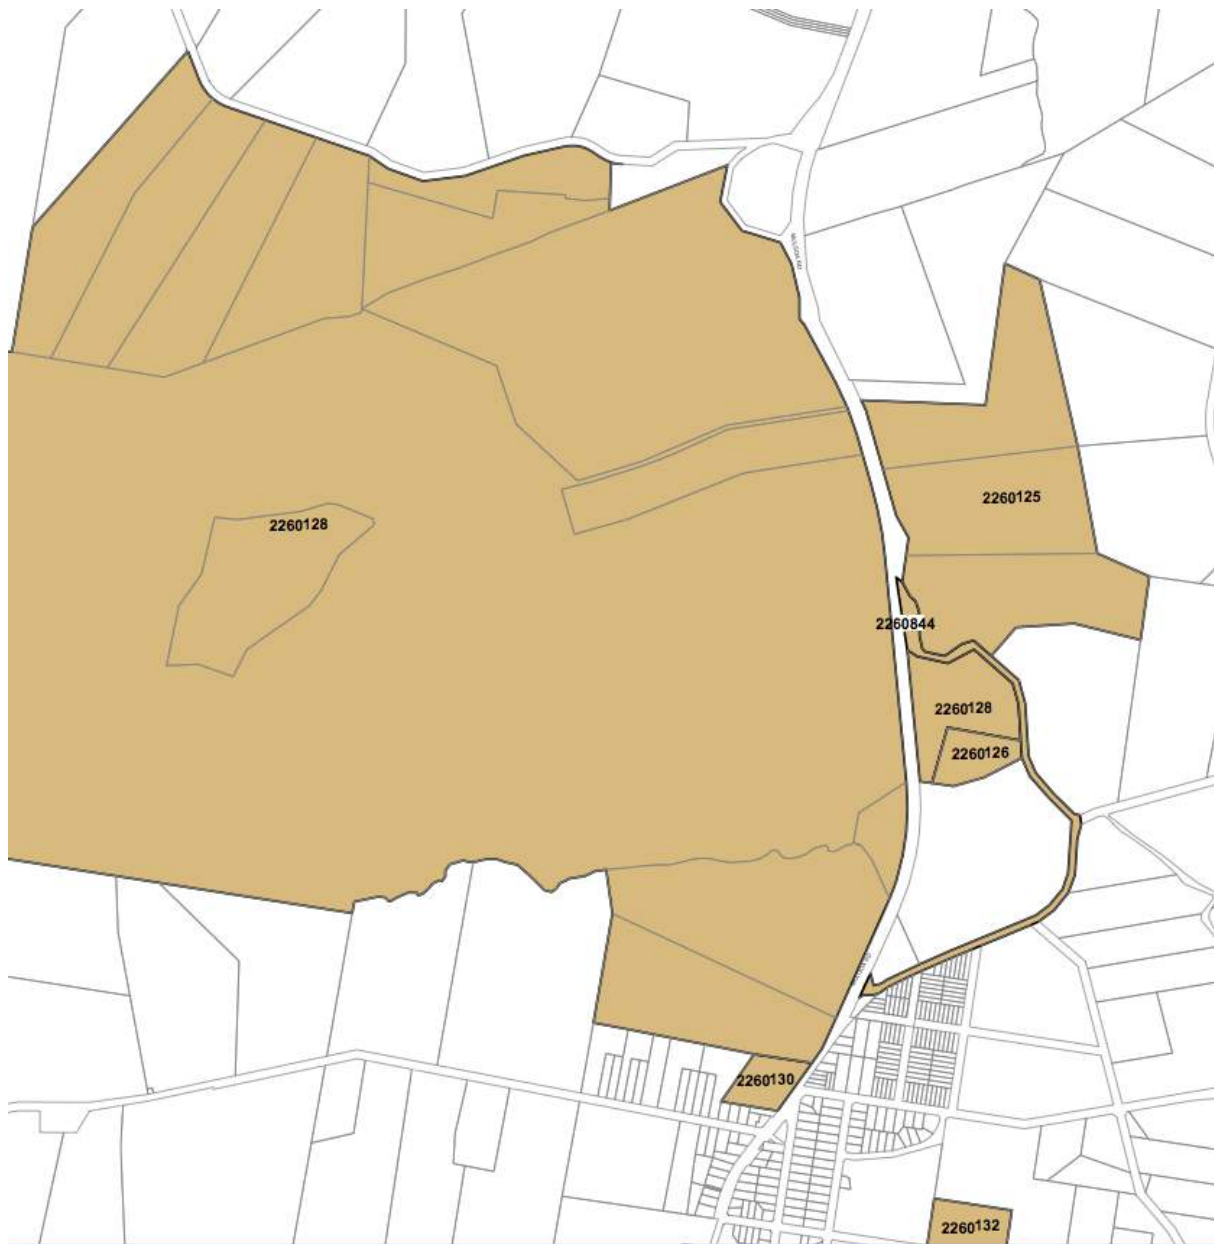
Figure 291: Extract: Penrith LEP 2010 Heritage Map 007, showing part of the Fernhill site at left (coloured, Heritage Item No. 2260128). This also shows the locations of adjacent heritage items, numbered (see Table for detail).

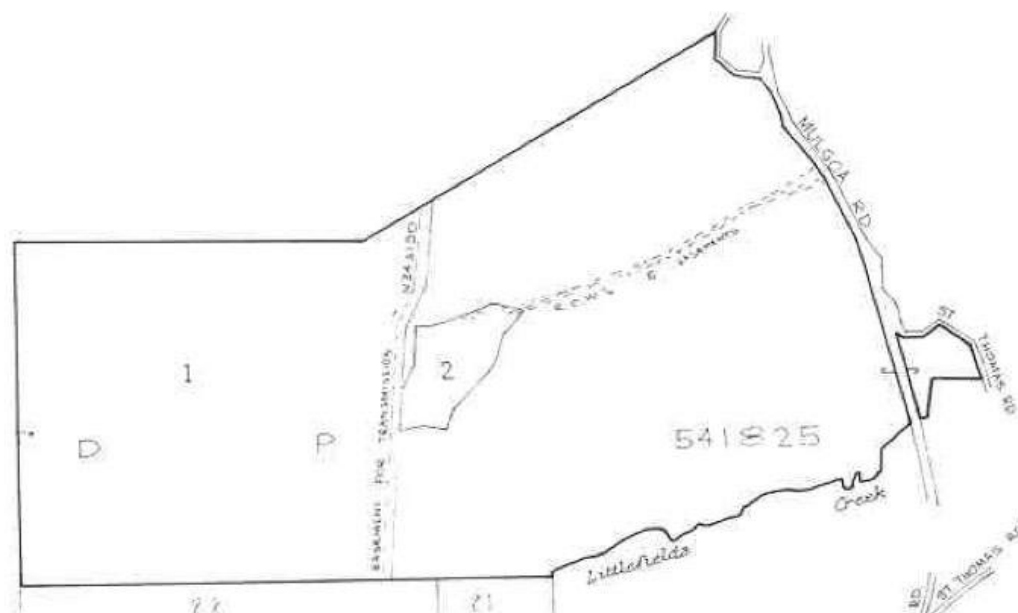
Figure 293: SHR map of the gazetted listing for Fernhill.

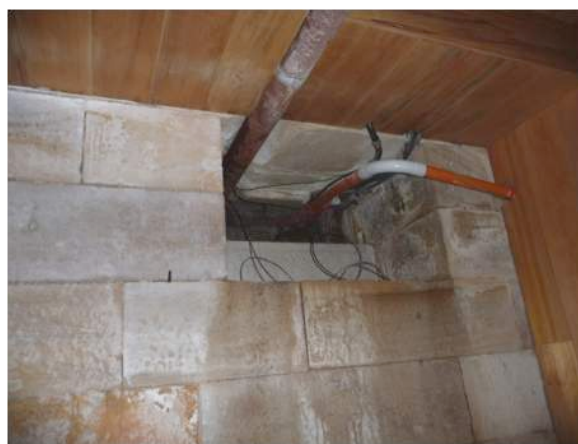
Figure 297: Partly bricked up vent and intrusive services on northern wall in Basement room B10; also shows evidence of salt attack and spalling on the original sandstone walls

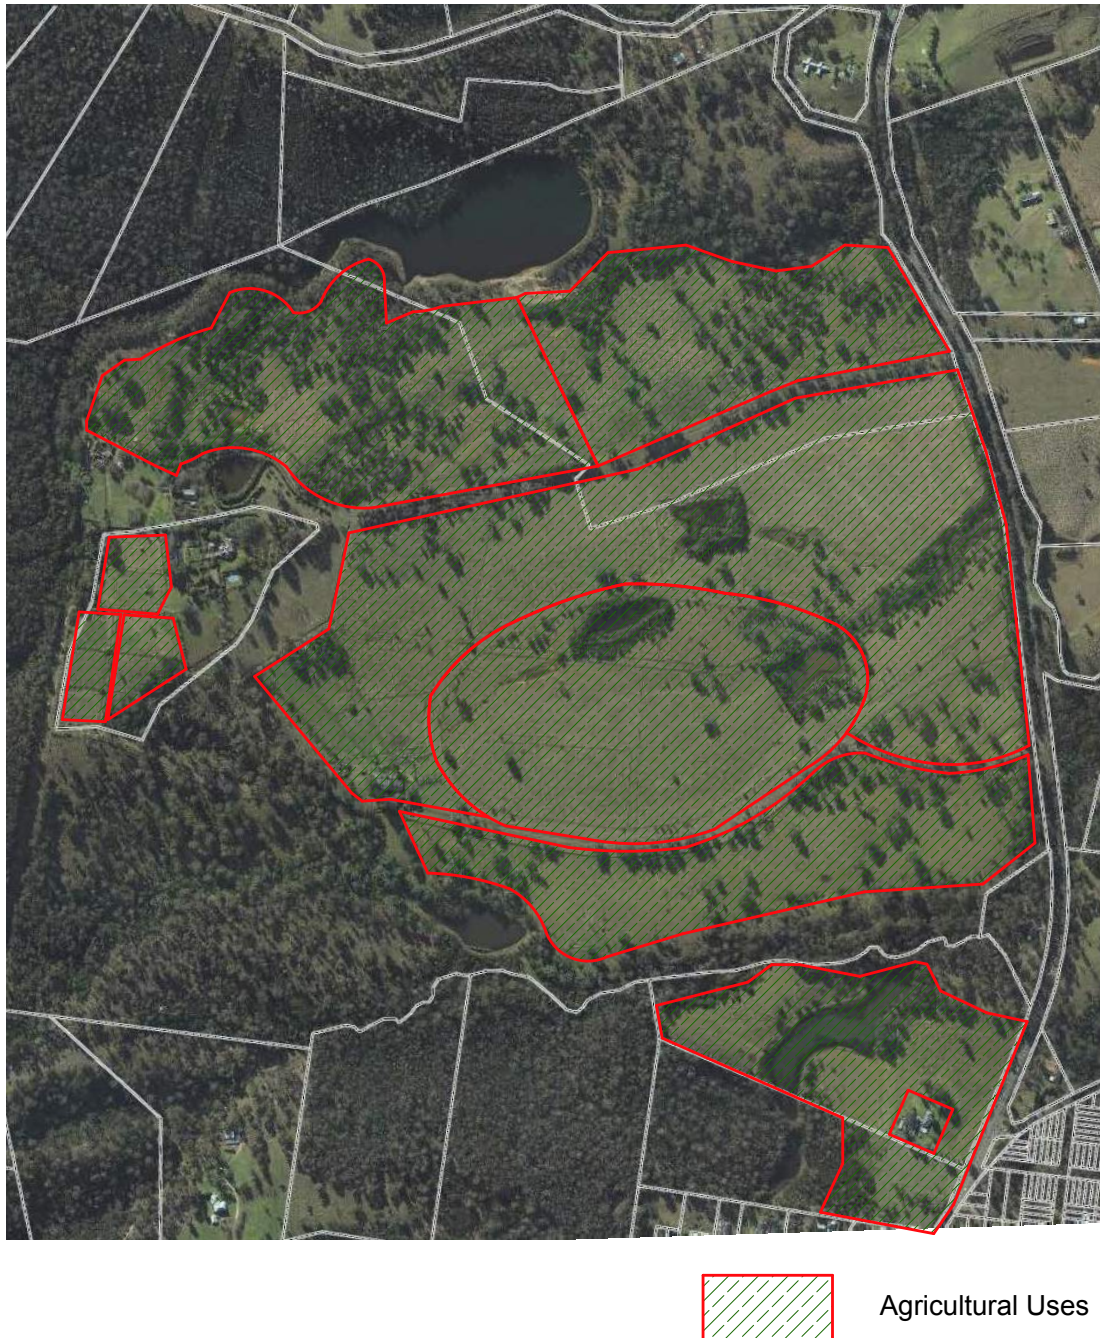
Figure 298: Site plan showing areas of the site that could be used for farm activities apart from specific uses noted below. Paul Davies Pty Ltd 2013

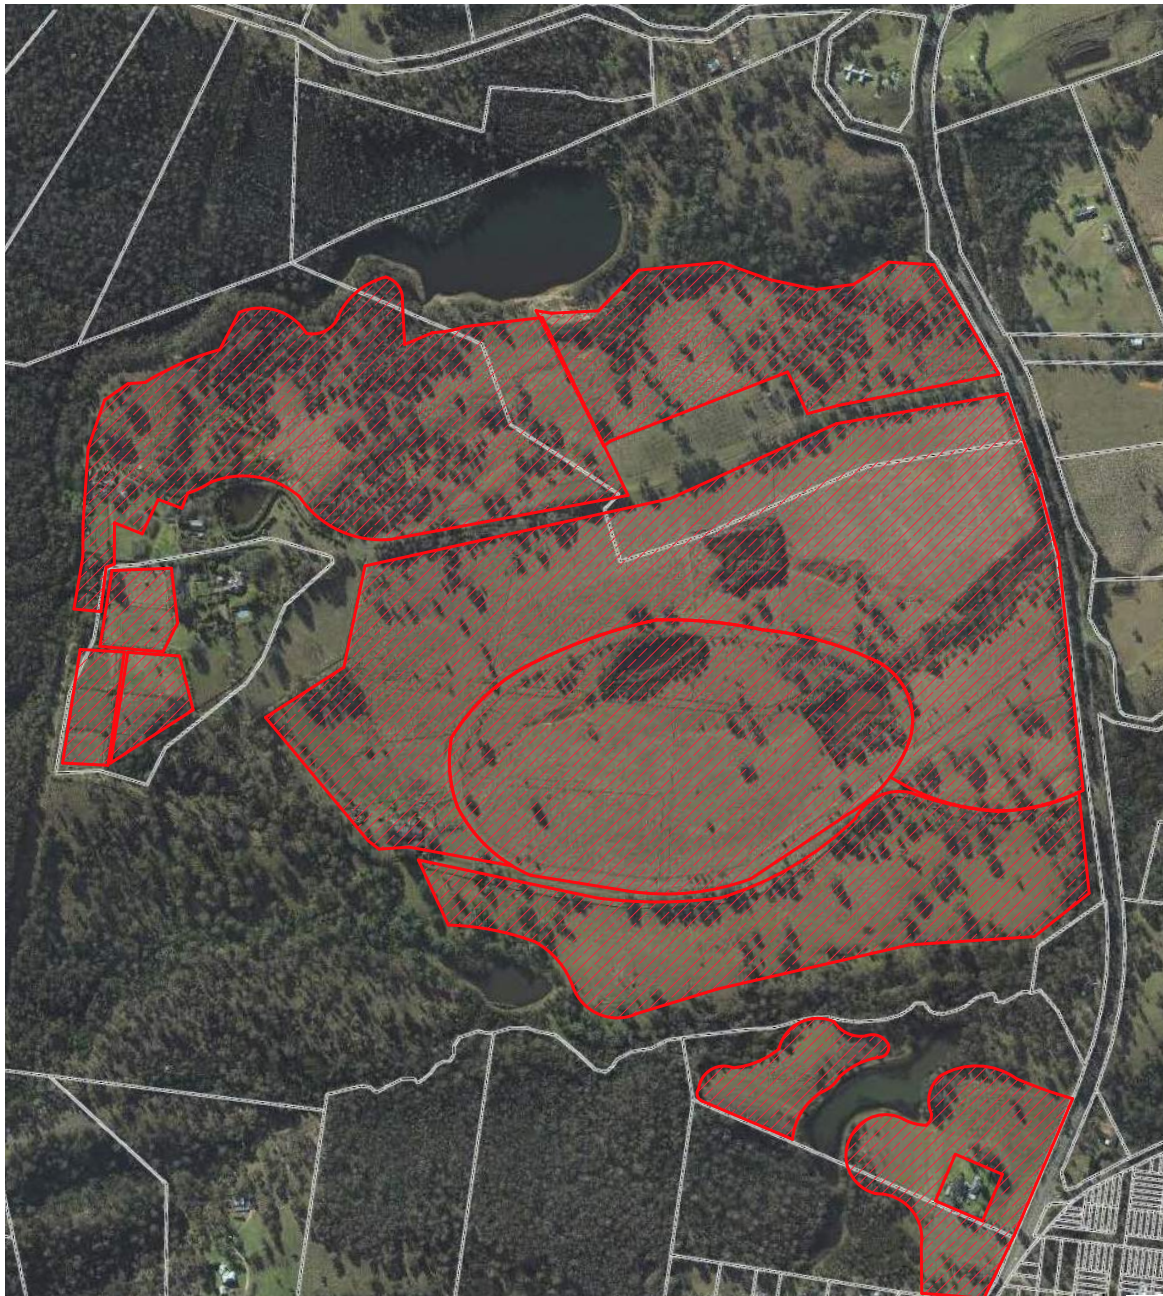
Figure 299: Detailed site plan showing areas of the site that could be used for equestrian activities. Paul Davies Pty Ltd 2013.

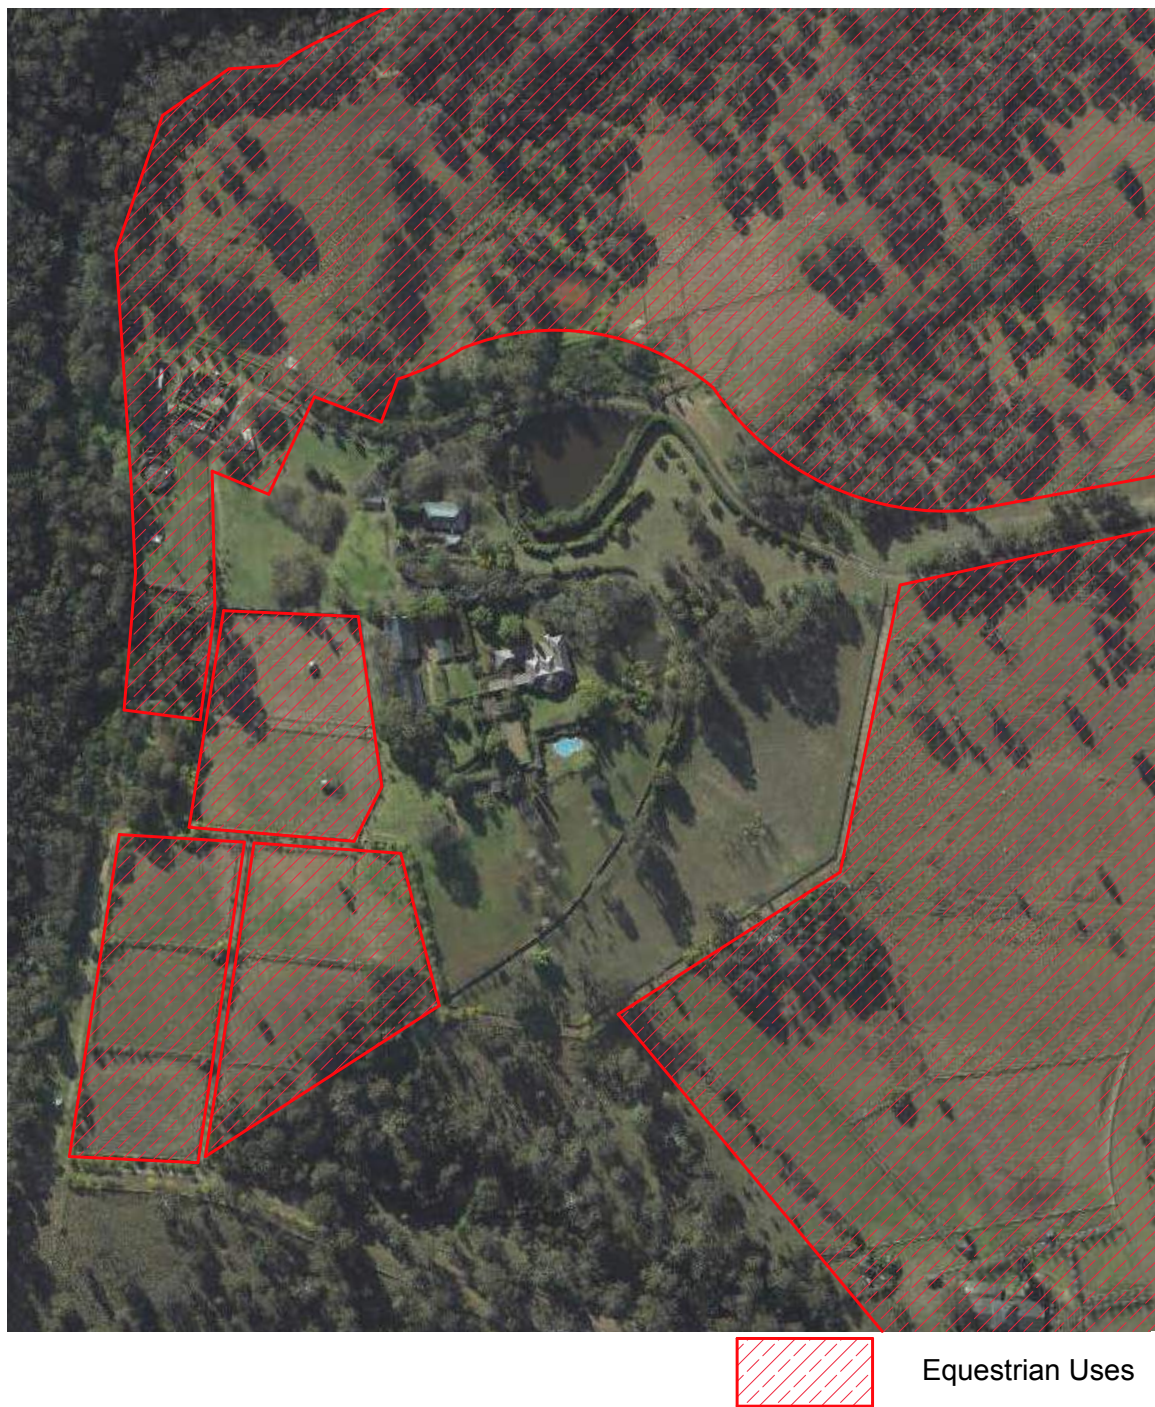
Figure 300: Site plan showing areas of the site that could be used for equestrian activities. Paul Davies Pty Ltd 2013.

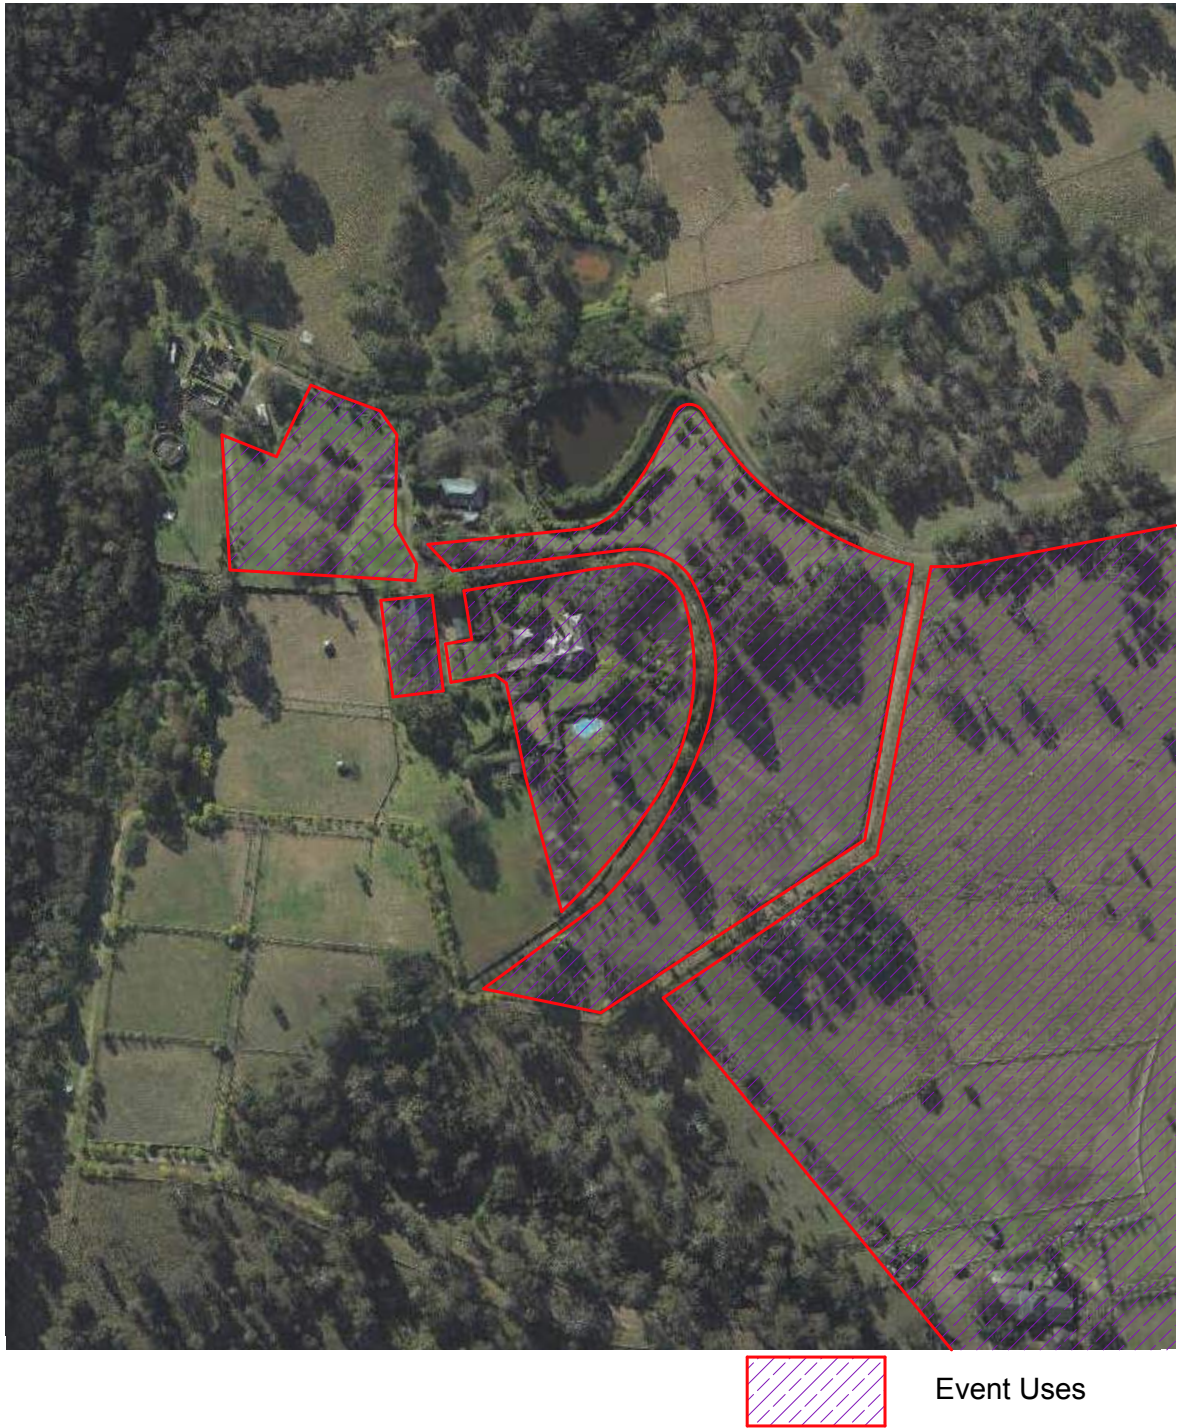
Figure 301: Site plan showing areas of the site that could be used for events activities. Paul Davies Pty Ltd 2013.

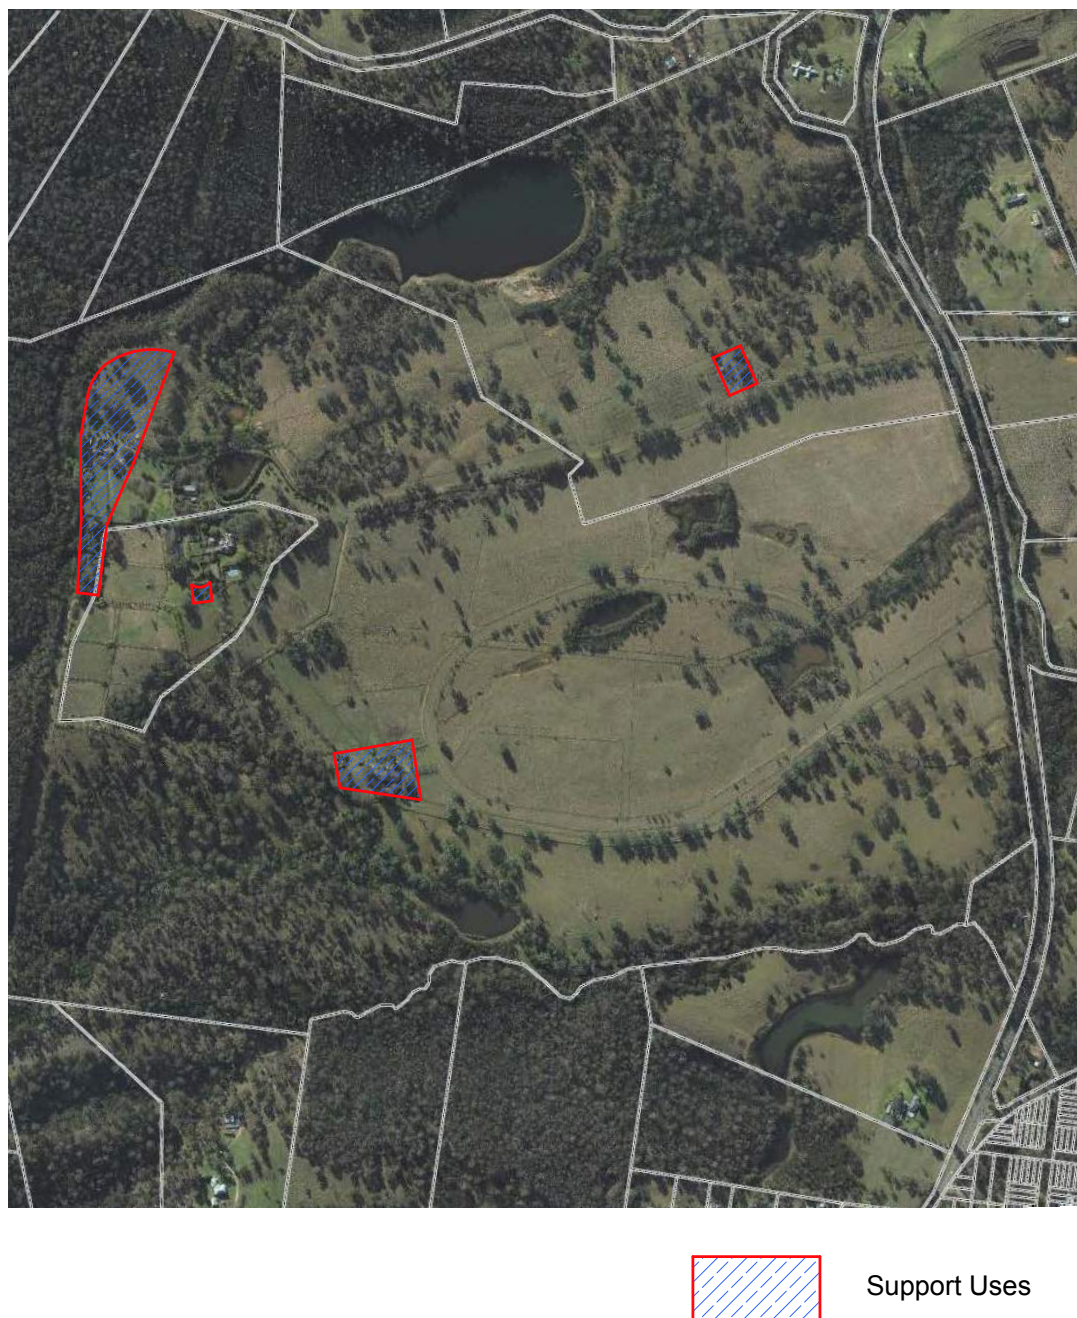
Figure 303: Site plan showing areas of the site that could be used for support activities. Paul Davies Pty Ltd 2013.

The Fernhill site is expansive and can accommodate support uses related to other uses. The establishment of support uses such. could be integrated into the site in locations that are outside the core heritage areas and which would have little or no impact on the character and heritage values of the place.

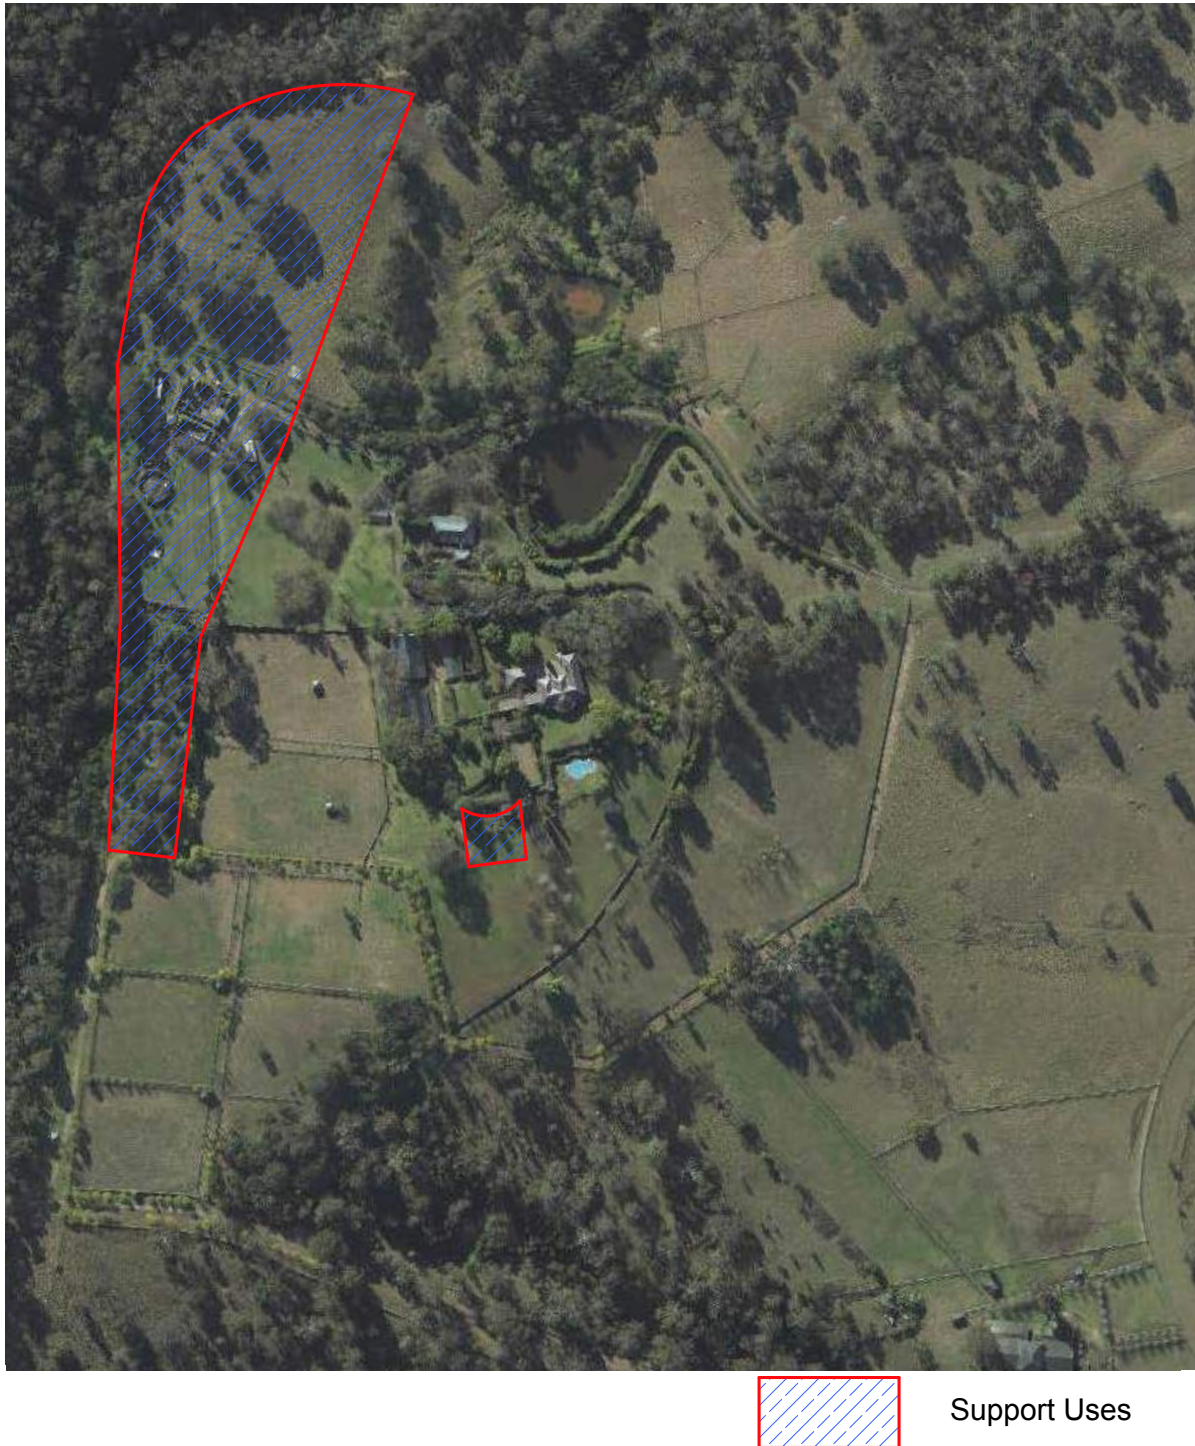
Figure 304: Site plan showing areas of the site that could be used for support activities. Paul Davies Pty Ltd 2013.

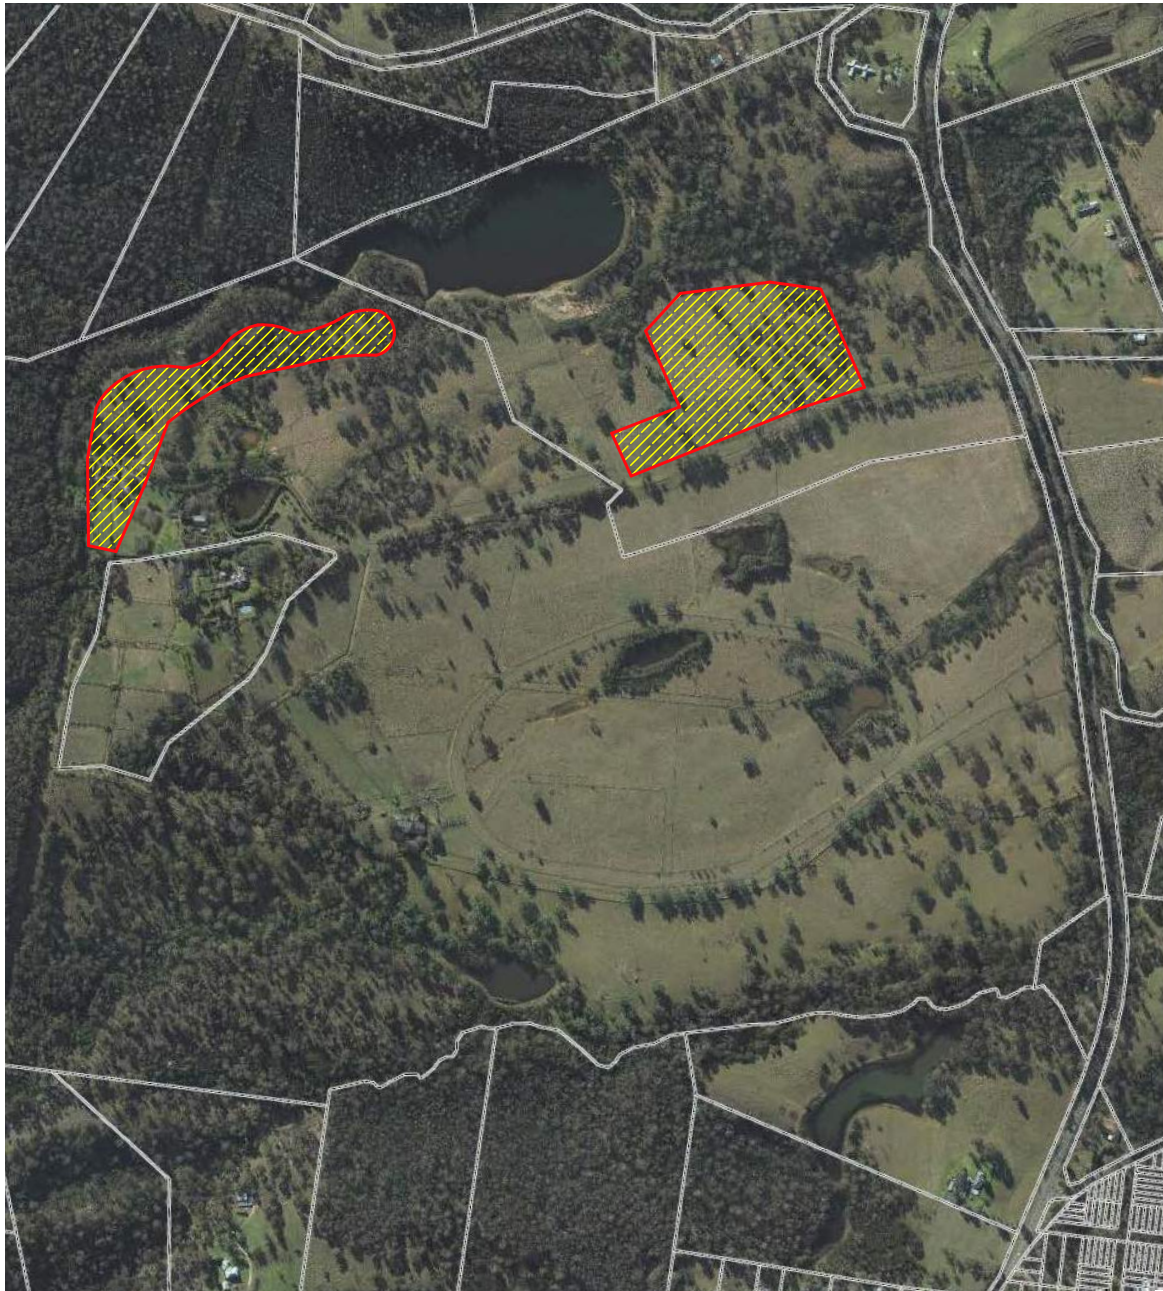
Figure 305: Site plan showing areas of the site that could be used for support activities. Paul Davies Pty Ltd 2013.

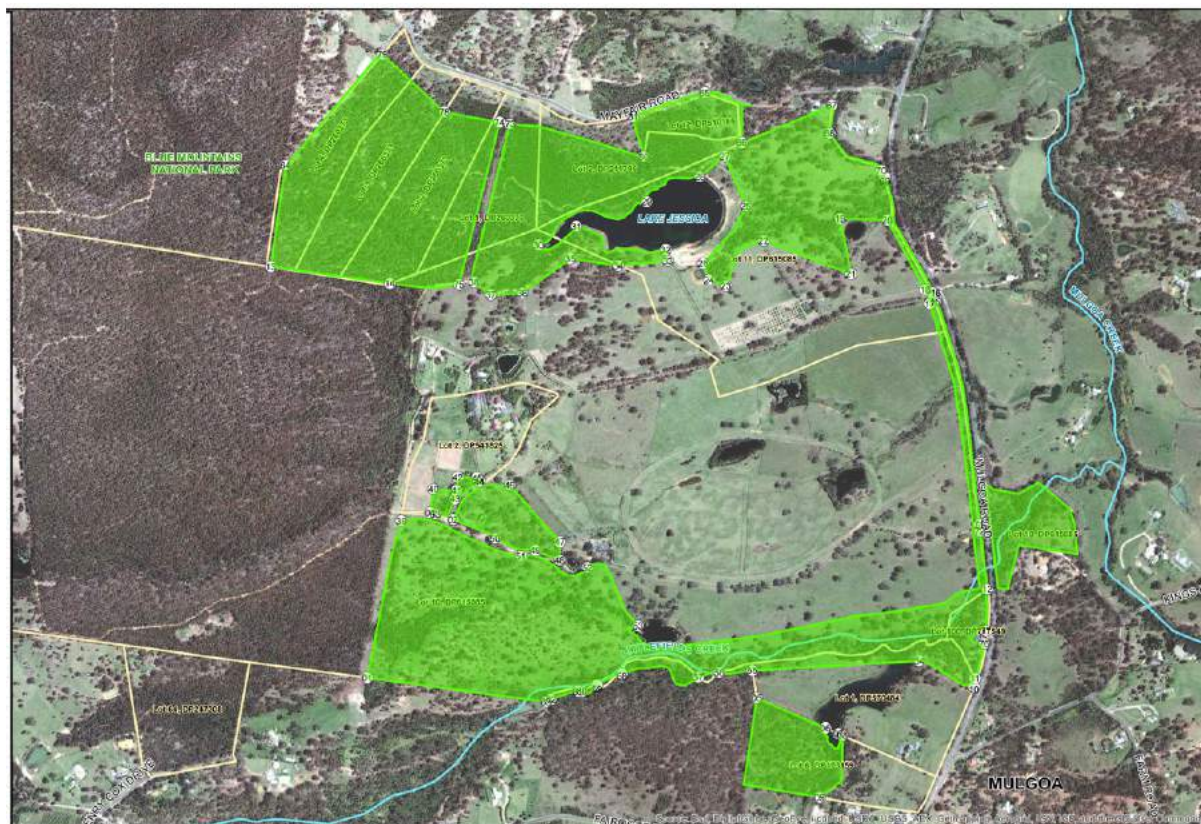
Figure 306: BioBanking areas on the eastern part of the Fernhill Estate. The areas shaded green are the areas that are currently subject to BioBanking agreements. The shading is an overlay of a GHD Plan marking the boundaries of BioBanking areas 2013.

Decisions related to BioBanking and natural vegetation management need to be made within the context of the historic values of the Fernhill Estate.

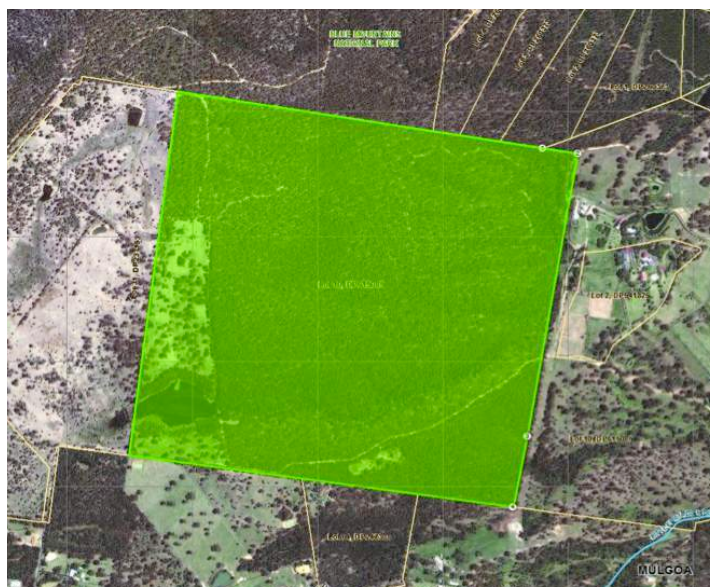
Figure 307: BioBanking areas on the central part of the Fernhill Estate. The areas shaded green are the areas that are currently subject to BioBanking agreements. The shading is an overlay of a GHD Plan marking the boundaries of BioBanking areas 2013.

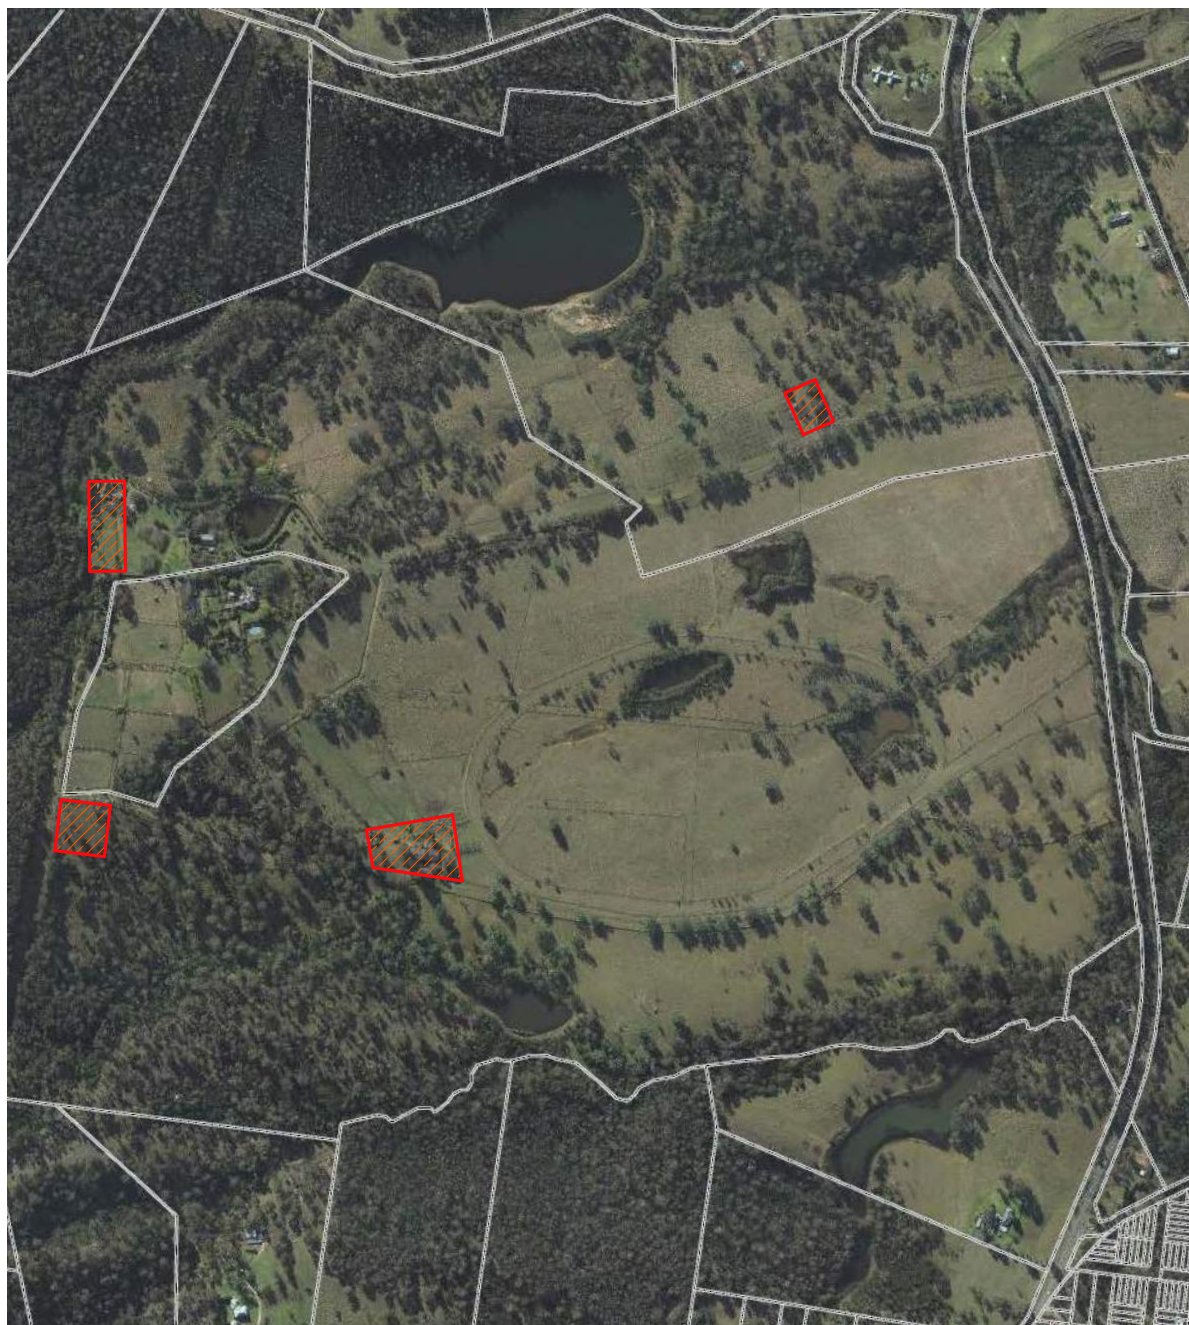
Figure 308: Site plan showing areas of the site that could be used for service activities. Paul Davies Pty Ltd 2013.

and materials. There are several locations on the site where this presently occurs and provision should be made in future development to provide for servicing and storage requirements so that these elements do not impact on core areas, views or vistas.

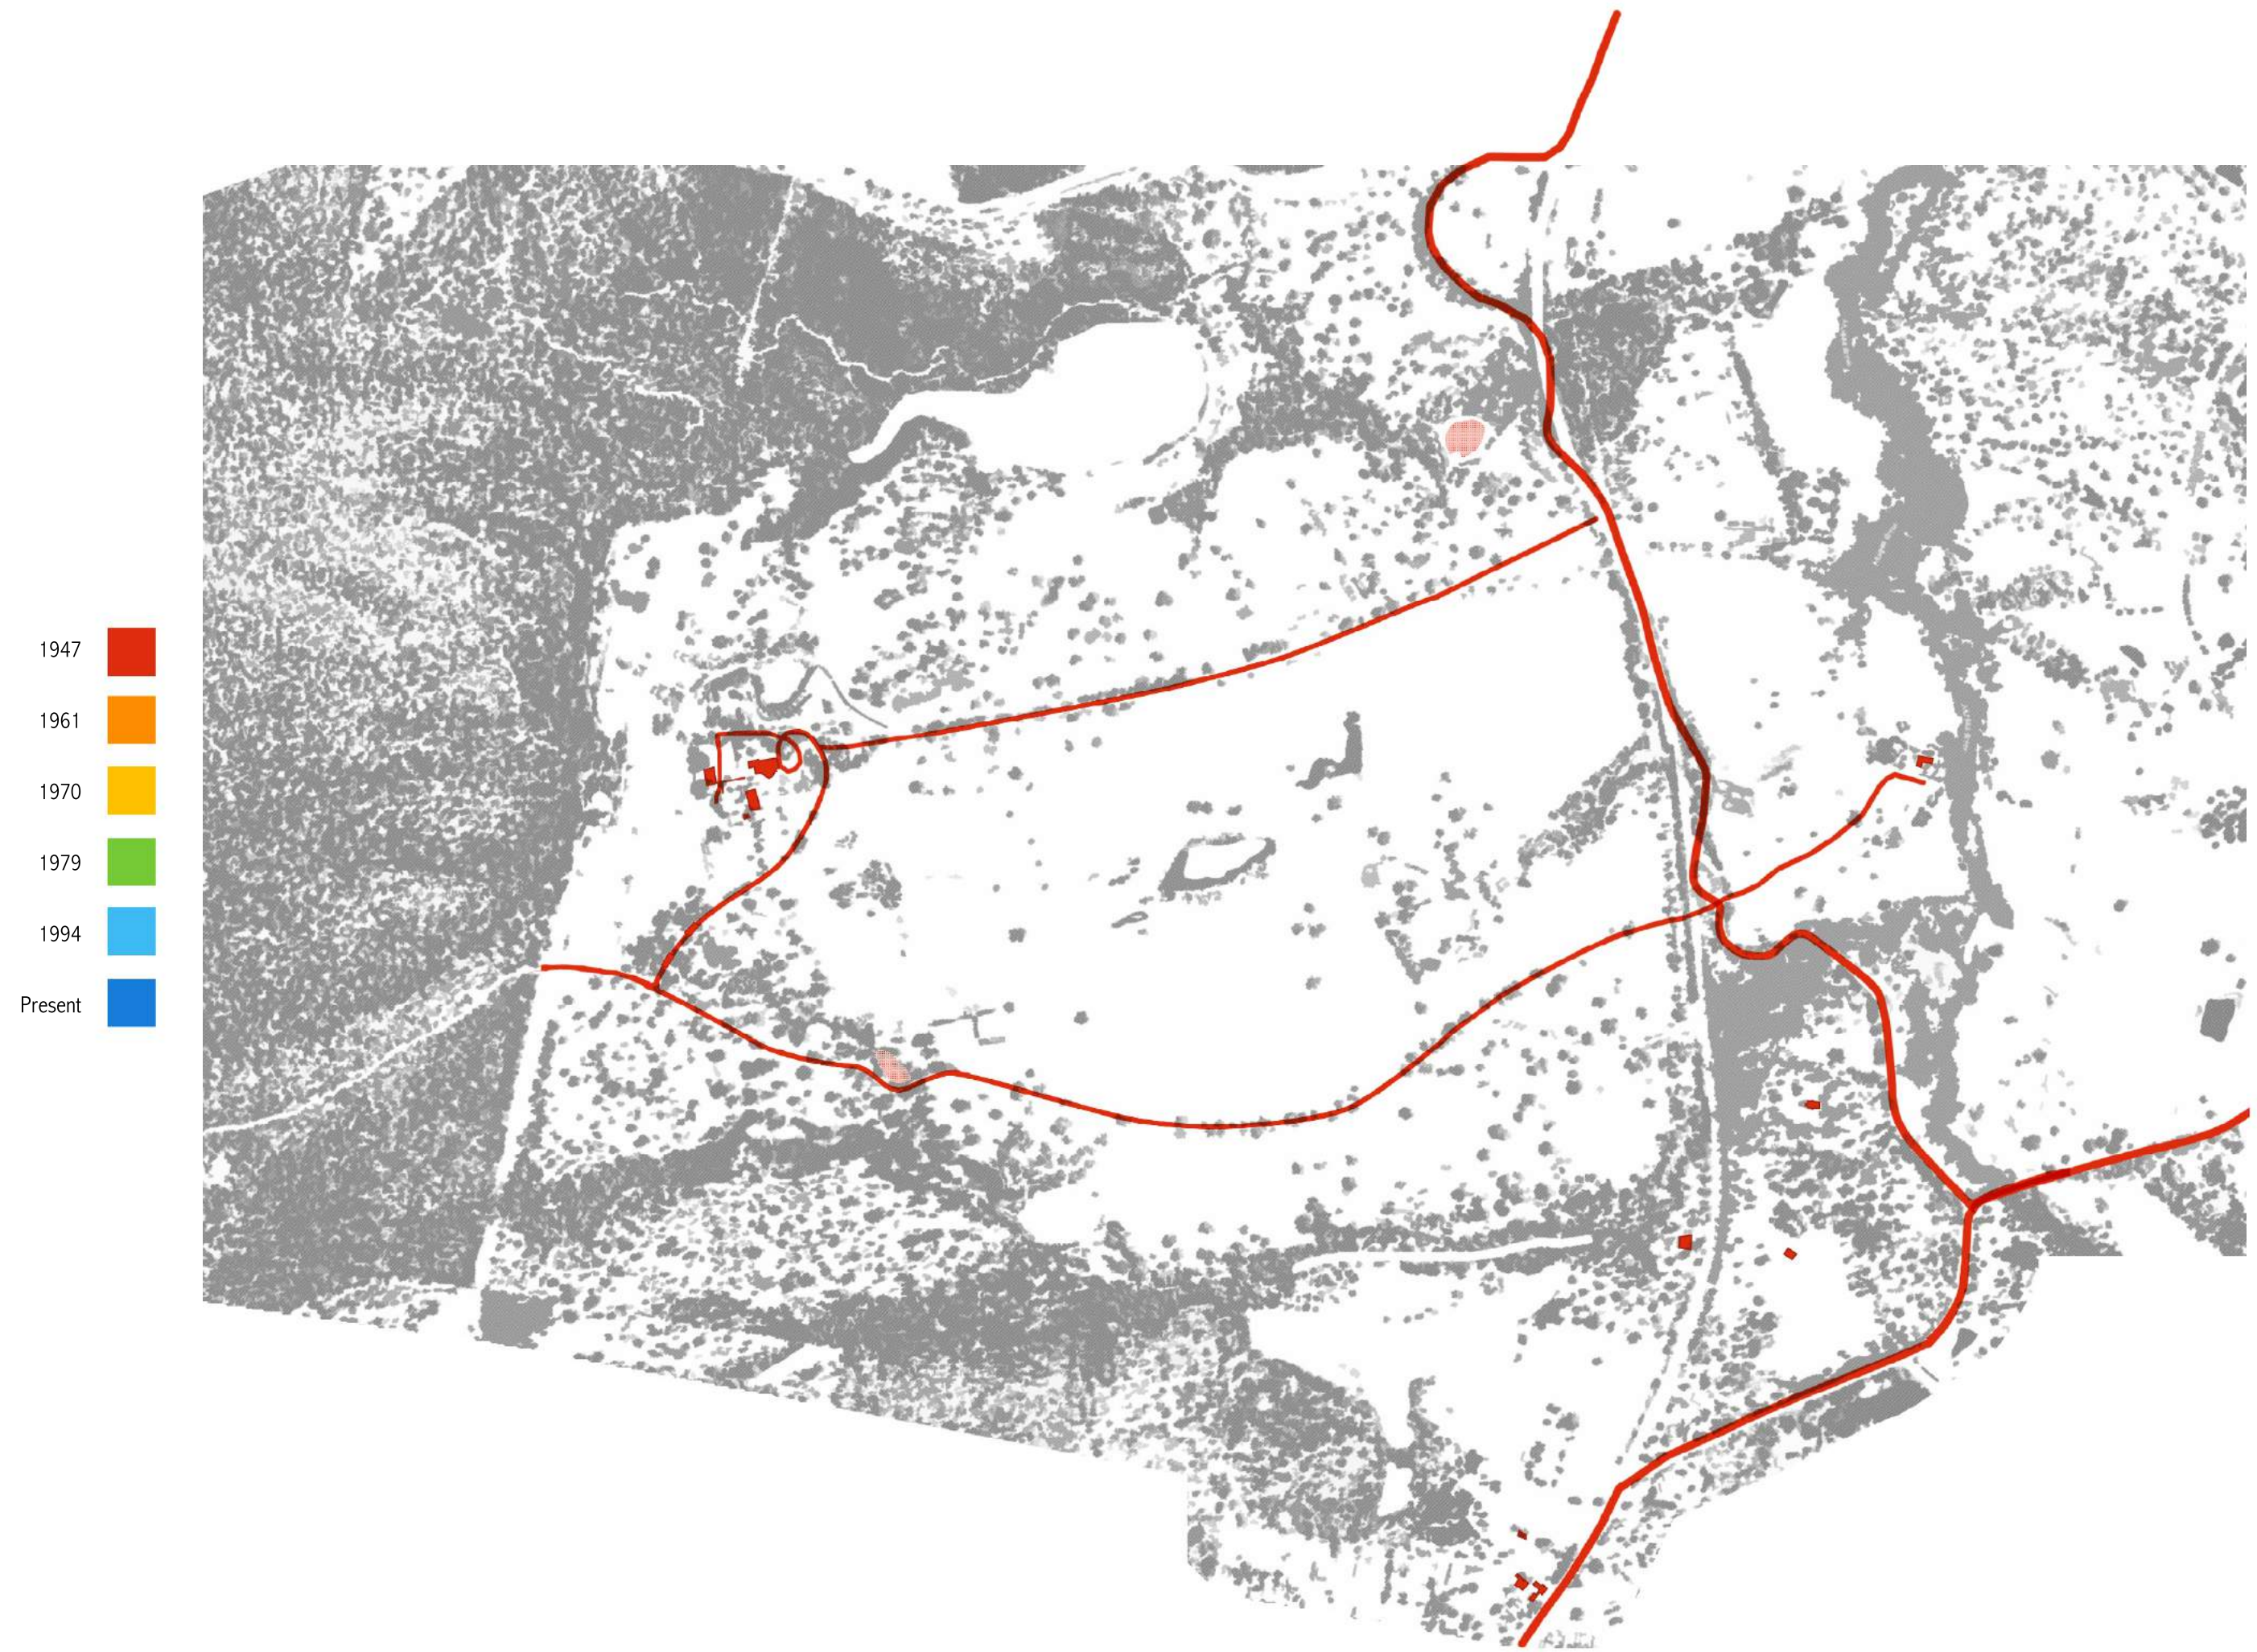
Figure 245: 1947 Features overlaid on current aerial photograph.

Figure 245 shows the 1947 features overlaid on the current aerial photograph. This illustrates the landscape changes that have taken place, particularly the realignment of Mulgoa Road and the increase in vegetation cover on the site.
