# **Preliminary Site Investigation**

524-542 Pacific Highway, St. Leonards, NSW

EI Report No.: E23213 AA  
Date: 7 December 2016

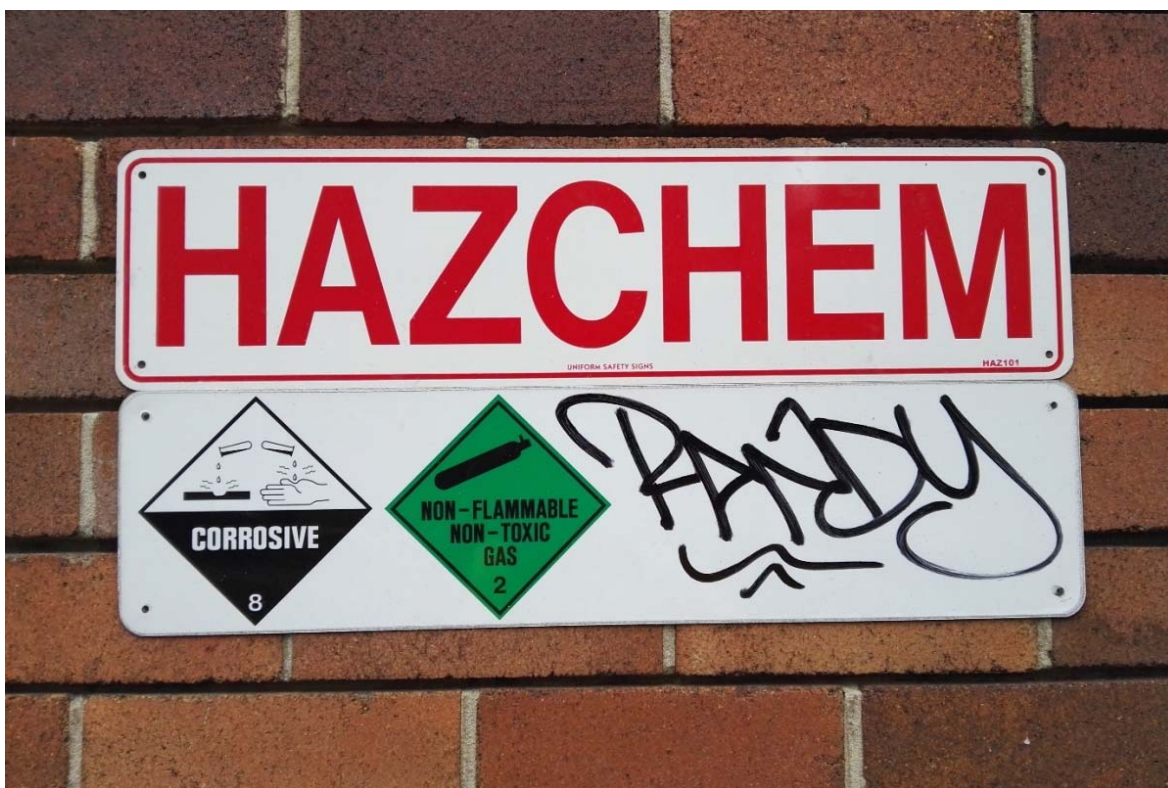
Photograph 5: Warning labels on the telecommunications exchange building

- Warning labels for corrosive materials and non-flammable non-toxic gas were present near doors in the telecommunications exchange (**Photo 5**).
- A number of service pipes (both active and decommissioned) were present within the telecommunications exchange compound. Possible decommissioned pumps were also noted (**Photo 6**).

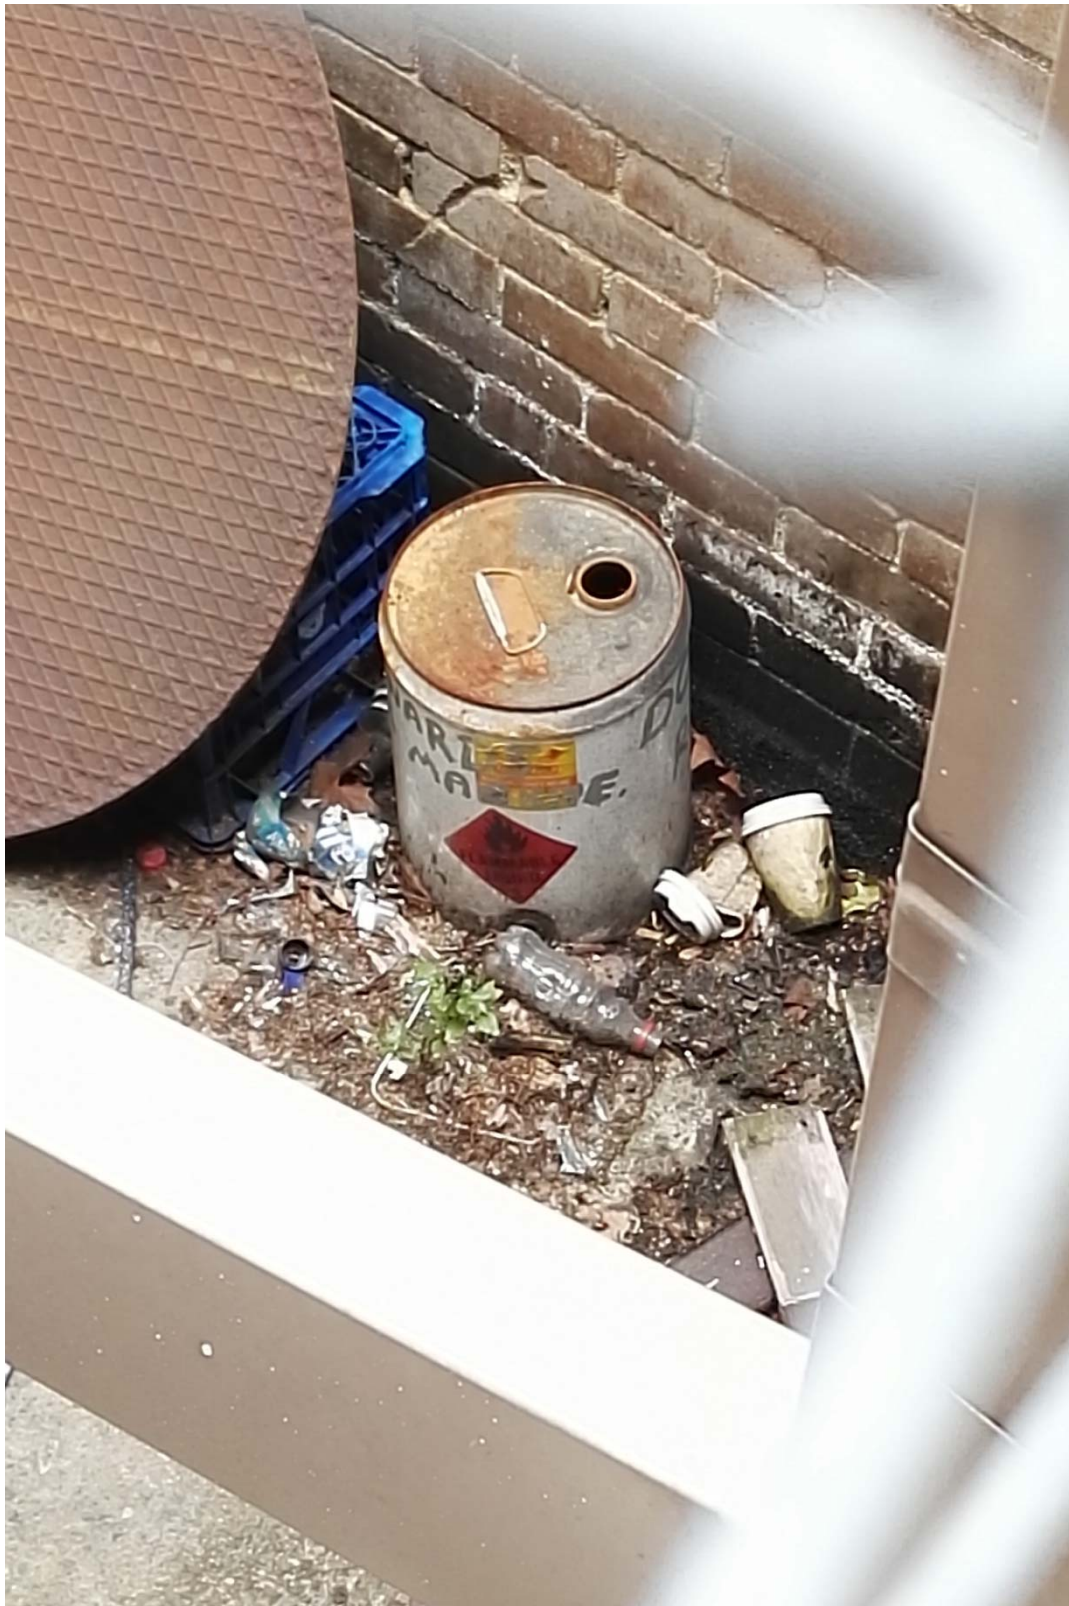
**Photograph 7:** Barrel with flammable liquid warning label within the secure compound

- No suspicious odours were observed in any part of the site;
- A metal barrel with a flammable liquid warning label was present within the telecommunications exchange compound (**Photo 7**). It was not possible to confirm its contents due to restricted access.

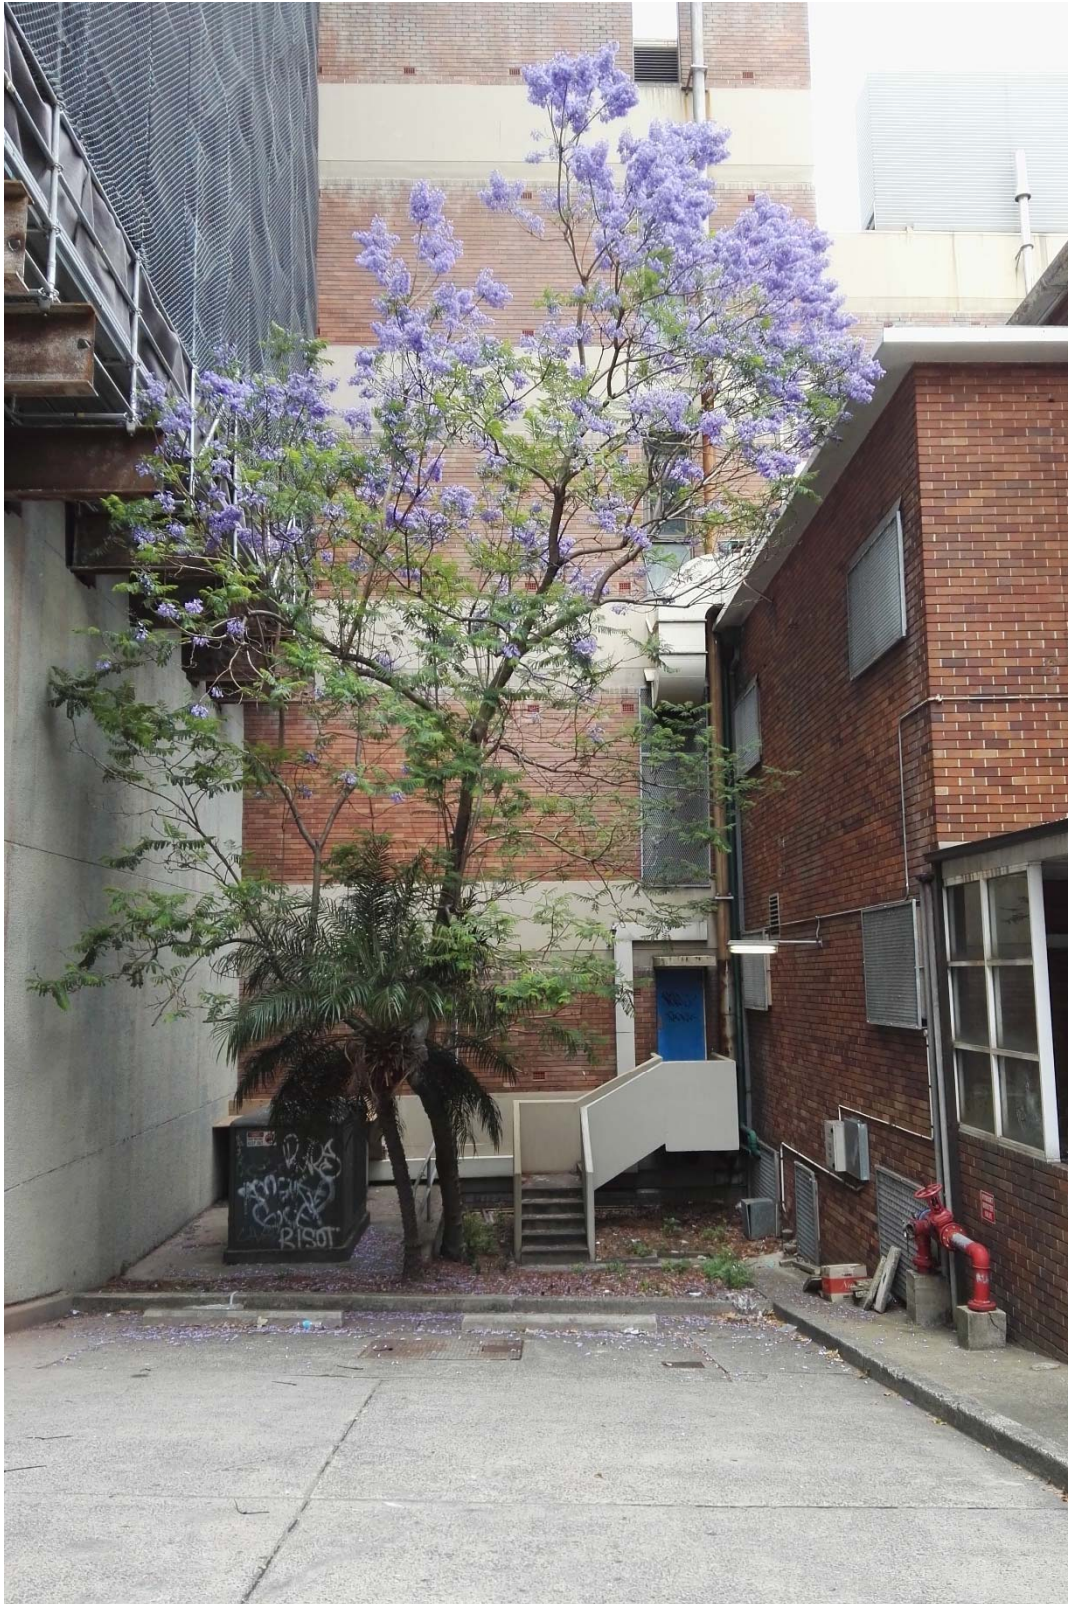
**Photograph 8:** Concrete parking, landscaping, and trees in the easy of the site area

- A small area in the west of the site was under soft cover as landscaping. The trees in this area looked to be in good condition (**Photo 8**), however bare soil patches were present;

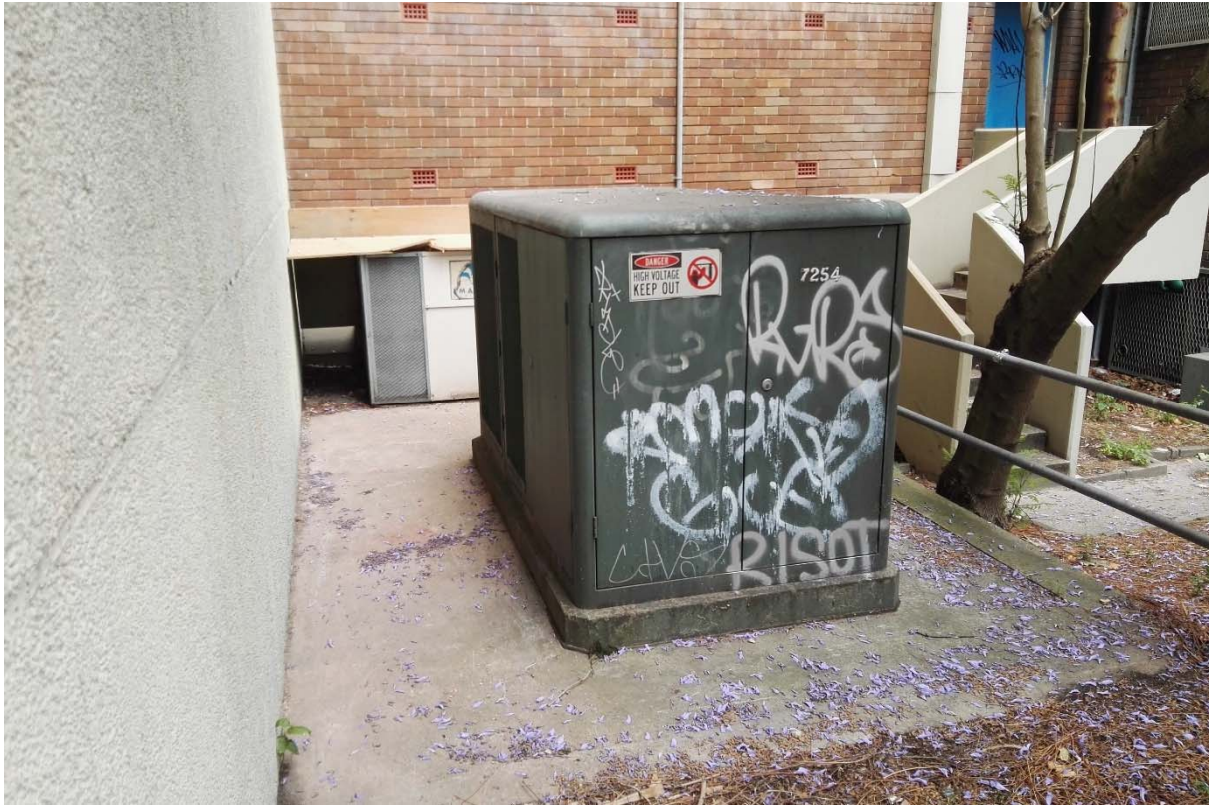
**Photograph 9:** Substation in the east of the site area

- No evidence indicative of underground petroleum storage systems (UPSS) was observed on any parts of the site.
- A substation was present in the eastern area of the site (**Photo 9**).
