**Preliminary Environmental Review  
14-16 & 18-20 Orion Road, Lane Cove West**

# **Preliminary Environmental Review**

## **14-16 & 18-20 Orion Road, Lane Cove West**

Prepared for  
Develco Pty Ltd

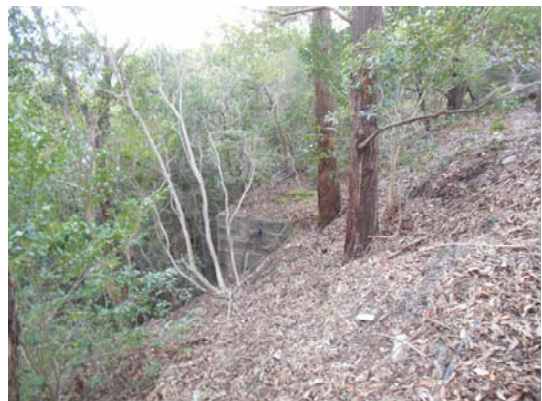
- Drain structures were observed on the western portion of the site in the vicinity of the childcare centre playground area.
- A portion of a square shaped sandstone brick structure was observed to the north of the access road near Orion Road. A black pipe was observed on its western face. The function of this structure could not be determined during the site walkover.

Photograph 4: View of sandstone brick square-shaped structure and associated pipe located to the north of the access road at 18-20 Orion Road (June 2015)

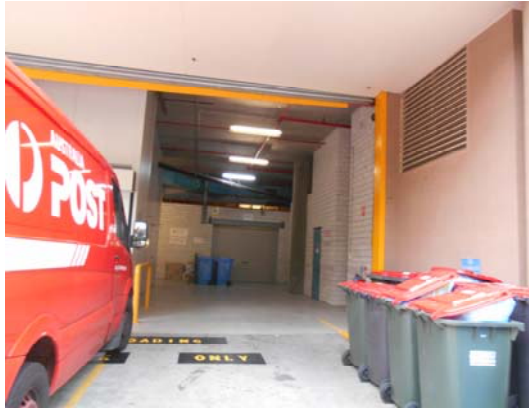
- A loading dock and waste management area is located at ground level on the southern end of the building.
- A small area with brick ground surface with chairs and a table is present to the east of the building.

Photograph 7: View of loading dock and waste facility located at the southern end of the multilevel building, 18-20 Orion Road (June 2015)

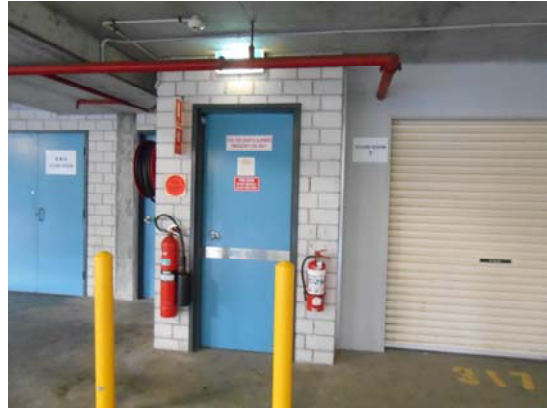
- Small storage rooms are present in the carpark area and underneath the building footprint. It was indicated that some of these storage areas are used by the tenants. Coffey was given access to those used by the building management. The inspected rooms were used for storage of maps, paper boxes, light bulb and cleaning substances (Level A1), control boxes and general building maintenance items (Level A2) or paint containers (Level A3). No evidence of significant contamination such as spills or stains was observed within the underground car park areas.

Photograph 8: Storage rooms located in carpark are underneath the building footprint on 18-20 Orion Road (June 2015)

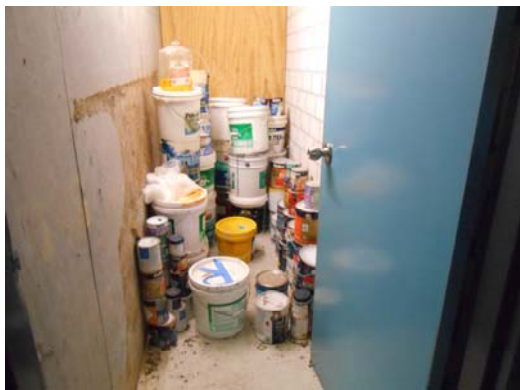
Photograph 9: Paint room located in carpark area underneath the building footprint on 18-20 Orion Road (June 2015)

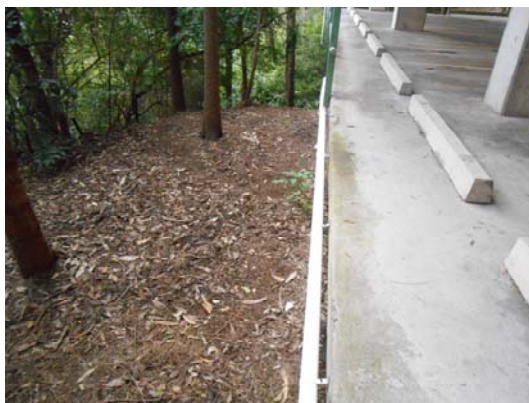
- An electric substation is present to the south of the Childcare Centre playground.
- PVC pipes were observed running west-east along the northern edge of the car park. Coffey was informed that these pipes are part of the stormwater and planted pot runoff system.

Photograph 11: PVC pipe running west-east along the northern edge of the carpark, 18-20 Orion Road (June 2015)

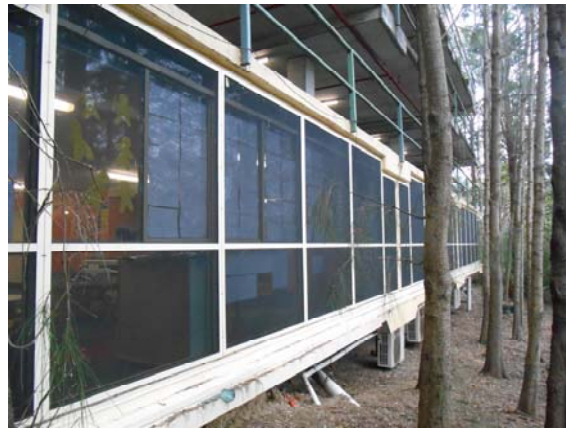
- A childcare centre facility is located at the western end of the car park with additional playground to the west. The childcare centre has a car parking area to the west. This car park is accessible via Sirius Road. Air conditioning units are located underneath the childcare centre.

Photograph 14: North-western end of the carpark showing air conditioning units underneath the Childcare Centre, 18-20 Orion Road (June 2015)

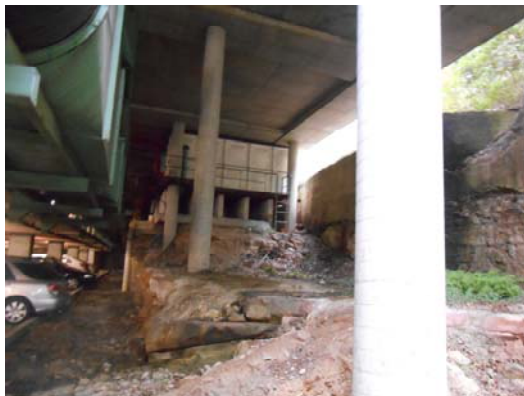
Photograph 15: view of the squared-shaped water tank located underneath the building footprint (right) and the carpark exhaust pipe system (left), 18-20 Orion Road (June 2015)

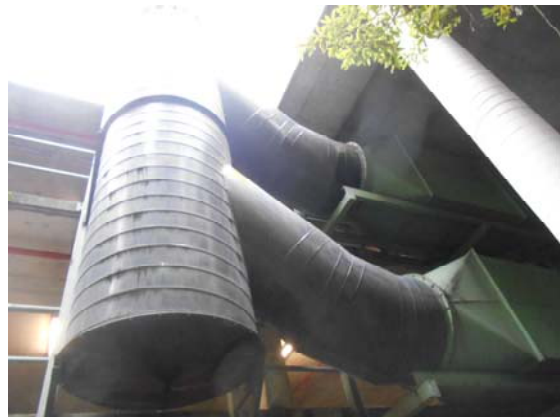
Photograph 16: View of the end pipe part of the carpark exhaust pipe system, on 18-20 Orion Road (June 2015)

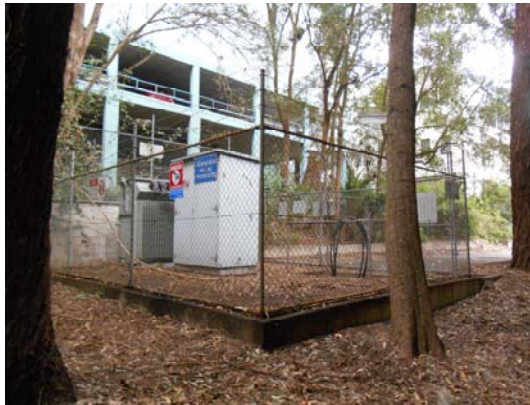
Photograph 17: Electric Substation located on the south-western portion of 18-20 Orion Road (June 2015)

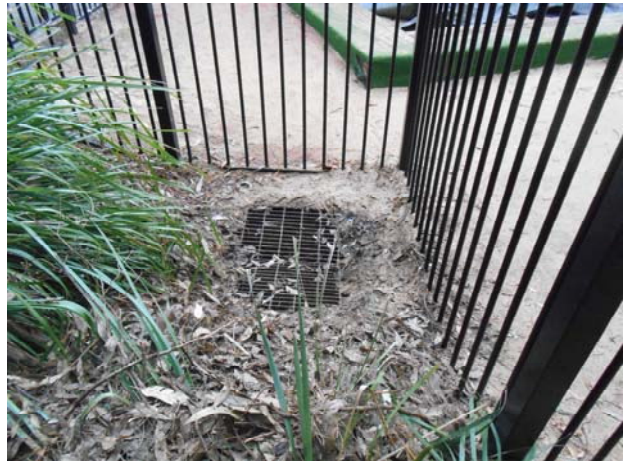
Photograph 18: View of stormwater/drain system at the vicinity of the Childcare Centre, 18-20 Orion Road (June 2015)

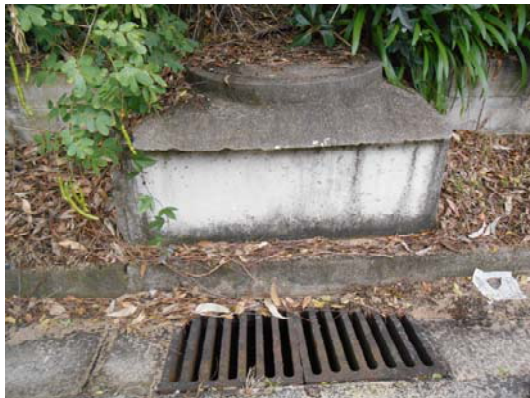
Photograph 19: View of stormwater/drain system structures observed at the vicinity of the Childcare Centre, 18-20 Orion Road (June 2015)

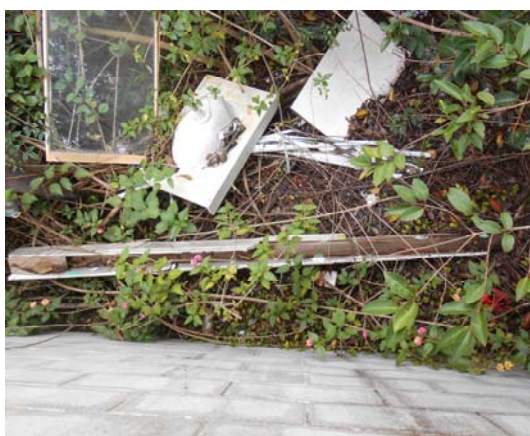
- Anthropogenic waste including demolition materials (including wood, toilet basins, plasterboards and plastic) was visible from the ground level and downslope on the bush strip at the western end of the site.

Photograph 21: view of waste dumped on the bush strip at the western end of the northern boundary, 18-20 Orion Road (June 2015)

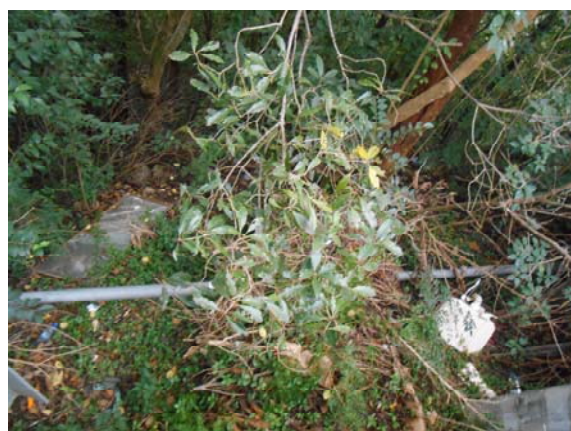
Photograph 22: view of dumped on the bush strip at the western end of the northern boundary, 18-20 Orion Road (June 2015)

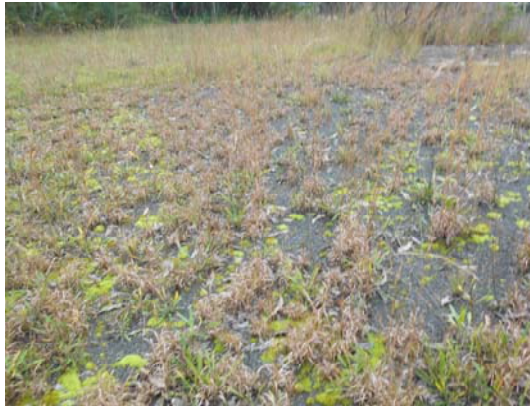
Photograph 25: View of bitumen gravel on surface at the southern portion of 14-16 Orion Road (June 2015)

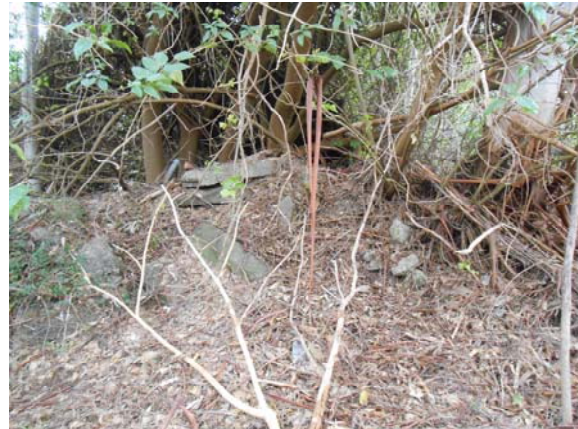
- Asbestos in the form of bundles of fibres was detected in 10 samples of fill material collected from 14-16 Orion Road. Four samples were located within the fill mound while the other six samples were located in fill material in other parts of this property at a range of depths. It was considered that the asbestos detections would likely be associated with fill imported onto the site with possible contributions from the demolition of the former structure noted above. No asbestos contamination materials were identified in samples collected from 18-20 Orion Road.
- Concentrations of nickel, zinc, TPH C15-C28 and Benzo(a)pyrene were reported at concentrations exceeding the adopted ecological investigation levels.

Photograph 26: View of fragments of concrete observed at the fill mound located at the central part of 14-16 Orion Road (June 2015)

It is recommended that a Remedial Action Plan (RAP) is developed to mitigate the potential risks associated with asbestos impacted fill. It is recommended that the RAP is developed to manage potential ecological risks associated with heavy metals and Benzo(a)pyrene in soils. The RAP should be developed in consideration of the data gaps identified herein and present a strategy to identify and manage unexpected finds of contamination during the future redevelopment site.

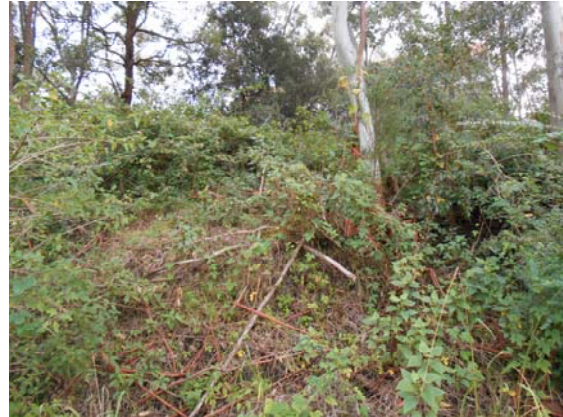
Photograph 30: View of weed over fill mound at 14-16 Orion Road (June 2015)

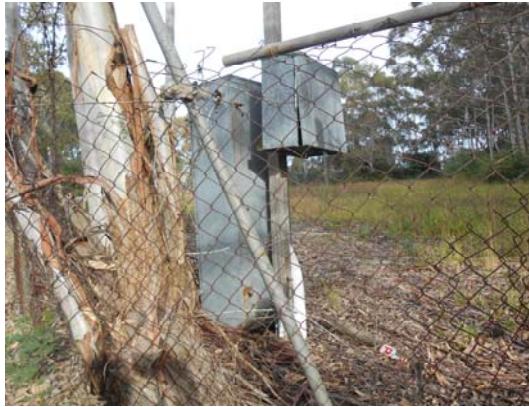
Photograph 31: View of redundant electricity post on the southern boundary of 14-16 Orion Road (June 2015)

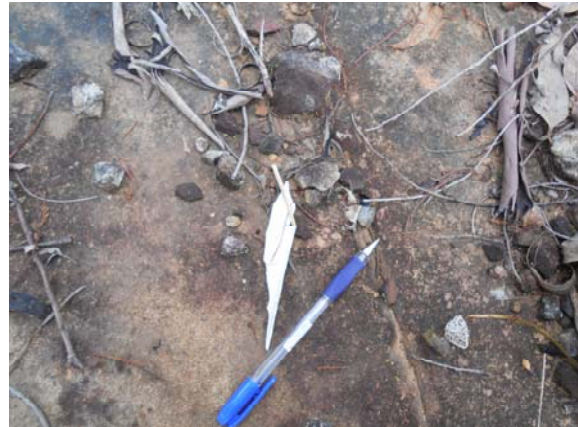
- This lot is approximately square in shape. It is bounded by Orion Road along the east and southern boundary, by 18-20 Orion Road to the north and commercial built area to the west.
- This portion of the site is vacant land with overgrown vegetation including mature trees, weeds and grasses.
- Bitumen gravel with sparse grass was observed across the southern section.
- Minor fragments of anthropogenic waste were observed across the surface of this portion of the site, including fragments of plastic pipe, paper, glass and metal.
- No evidence of significant contamination, such as oily stains, odours or materials suspected to contain asbestos, was observed on the ground surface.

Photograph 32: View of pvc fragment observed on ground surface at 14-16 Orion Road (June 2015)
