**PRELIMINARY DESKTOP ENVIRONMENTAL SITE
ASSESSMENT**

**PLANNING PROPOSAL - PROPOSED RESIDENTIAL
DEVELOPMENT**

**3-31 WALTER STREET AND 462 WILLOUGHBY ROAD,
WILLOUGHBY, NSW**

REF: E30088KPrptRev1

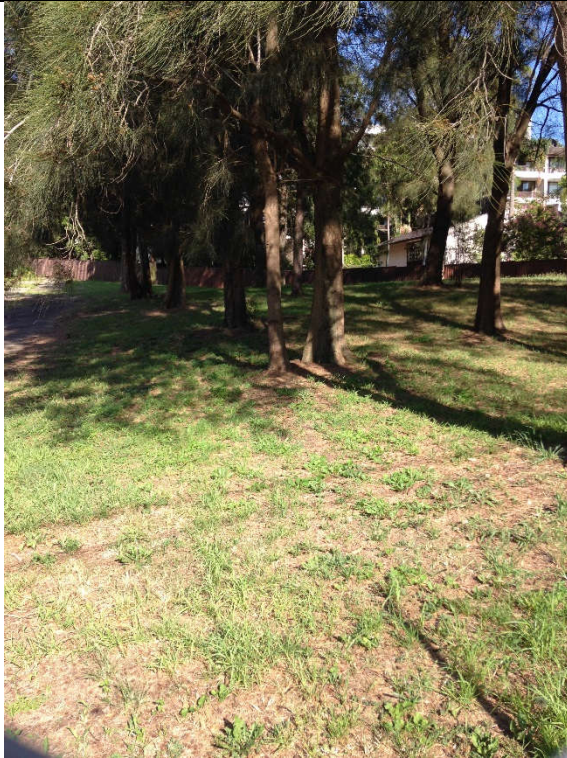
Sandy fill was observed at the ground surface in the eastern section of the 462 Willoughby Road property. This area of the site also included a raised mound which was likely to be fill considering the local topographic features. Fill was considered likely to be present behind raised garden beds and retaining walls at the front of a number of individual properties.

462 Willoughby Rd (facing north-west), showing suspected Fill mound

- A preliminary intrusive investigation should be undertaken to make an assessment of the soil and groundwater contamination conditions. Although the investigation should be designed to assess the broader site conditions, a higher density of sampling and more detailed investigation is recommended in the eastern site areas;

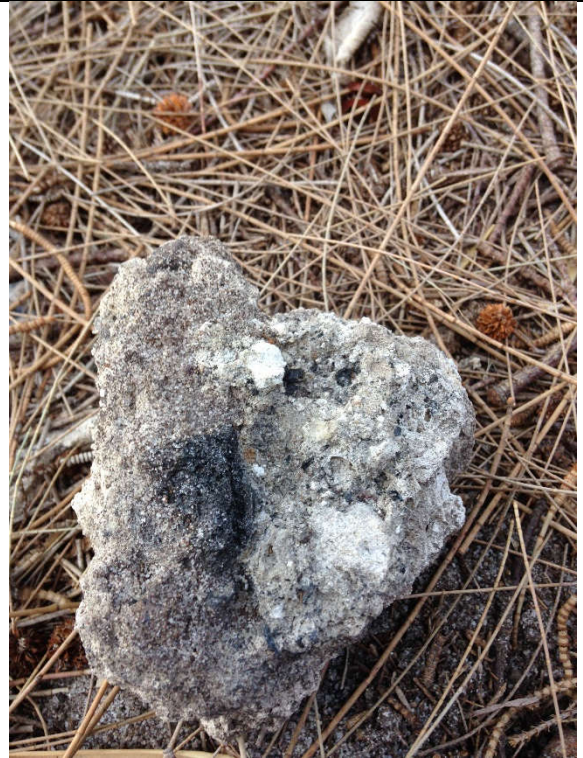
A slag cobble (including metallurgic furnace slag) was observed at the ground surface in the eastern section of the 462 Willoughby Road property (see Figure 2). Pieces of ash were also observed in several garden beds at the front of some adjoining properties along Walter Street. There were no other obvious indicators of contamination observed during the inspection.

Slag cobble at surface at eastern end of 462 Willoughby Rd

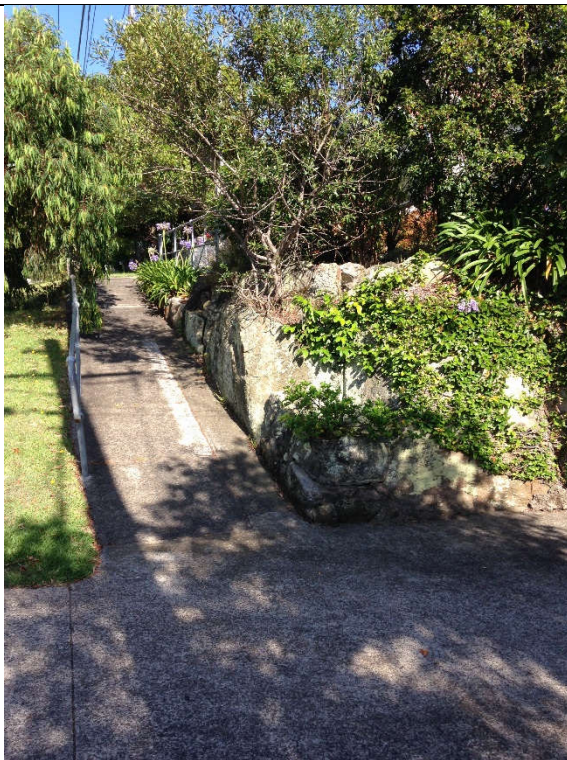
Sandstone outcropping was observed at the front of several Walter Street properties (see Figure 2) during the site inspection.

Sandstone outcropping along 7 Walter Street property frontage
