Report on  
Preliminary Site Investigation (Contamination)

Proposed Unit Development  
3 Ellis Street, Chatswood

Prepared for  
MPG AU Pty Ltd

Project 91234.00  
December 2017

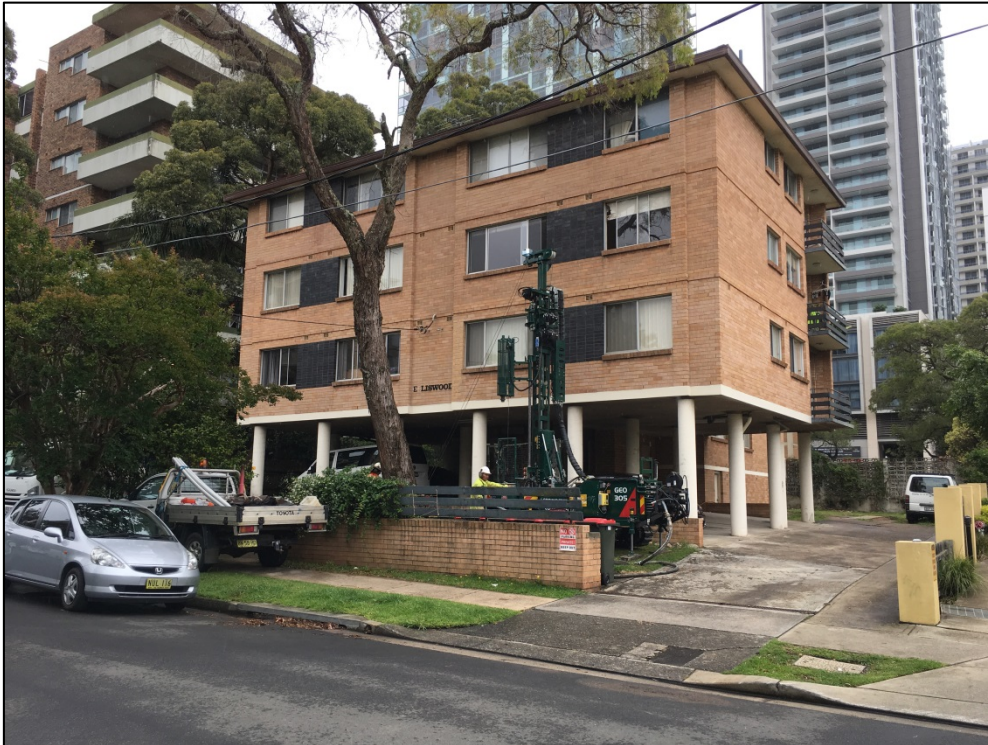
The site is currently occupied by a three storey residential unit development with undercroft carparking (refer Figure 1).

**Figure 1: View of existing development on site from Ellis Street (looking north)**

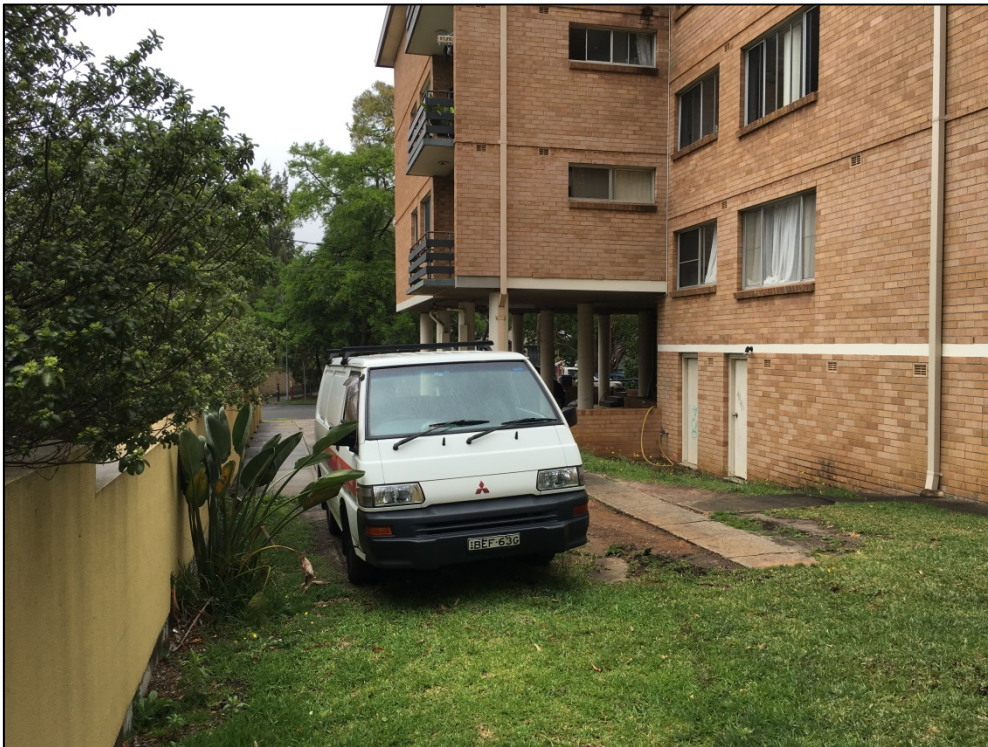
**Figure 2: View looking to the south from eastern side of building**

The building is surrounded by a combination of concrete pavements and grassed areas (refer Figure 2 to Figure 4).

Surface soils were observed to comprise sandy silt. Minor anthropogenics, such as brick fragments were observed near the edges of the existing concrete pavements.

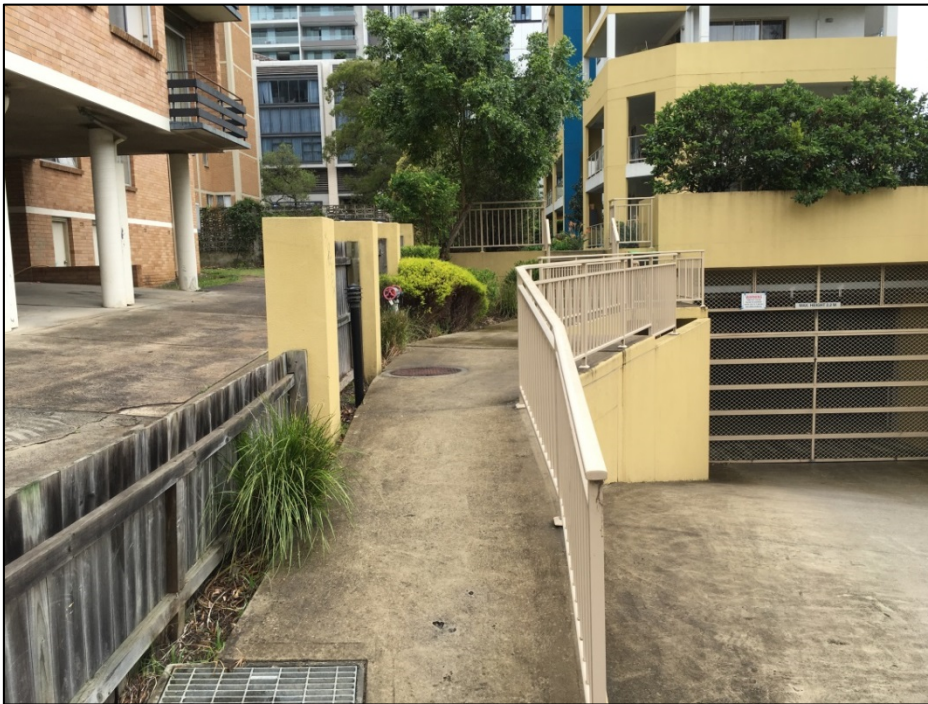
**Figure 3: View along eastern boundary (looking north)**

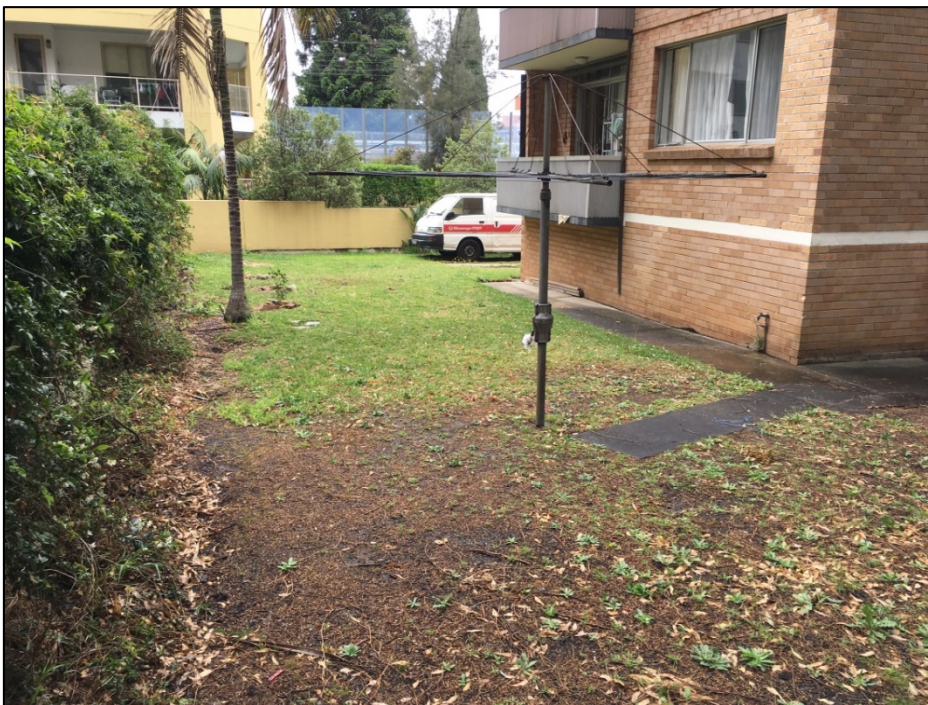
**Figure 4: View of area at the back of the site (looking east)**

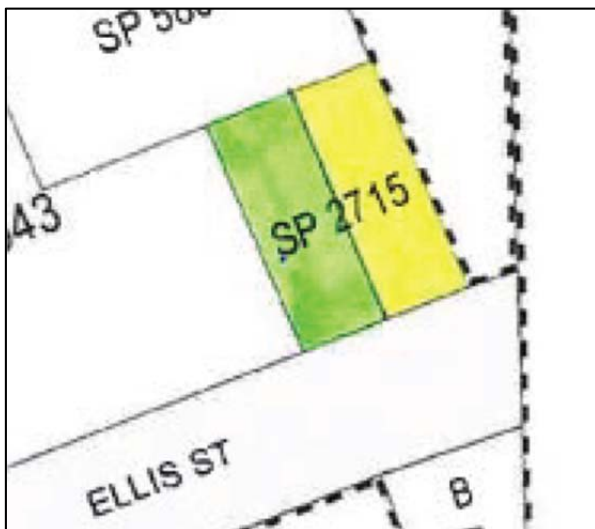
Figure 5: Key to historic title search

A historic title deeds search was carried out by Scott Ashwood Pty Ltd, the results of which are provided in Appendix B and summarised in Table 1 below. The results of the search indicated that different parts of the site have a different ownership history (refer Figure 5).

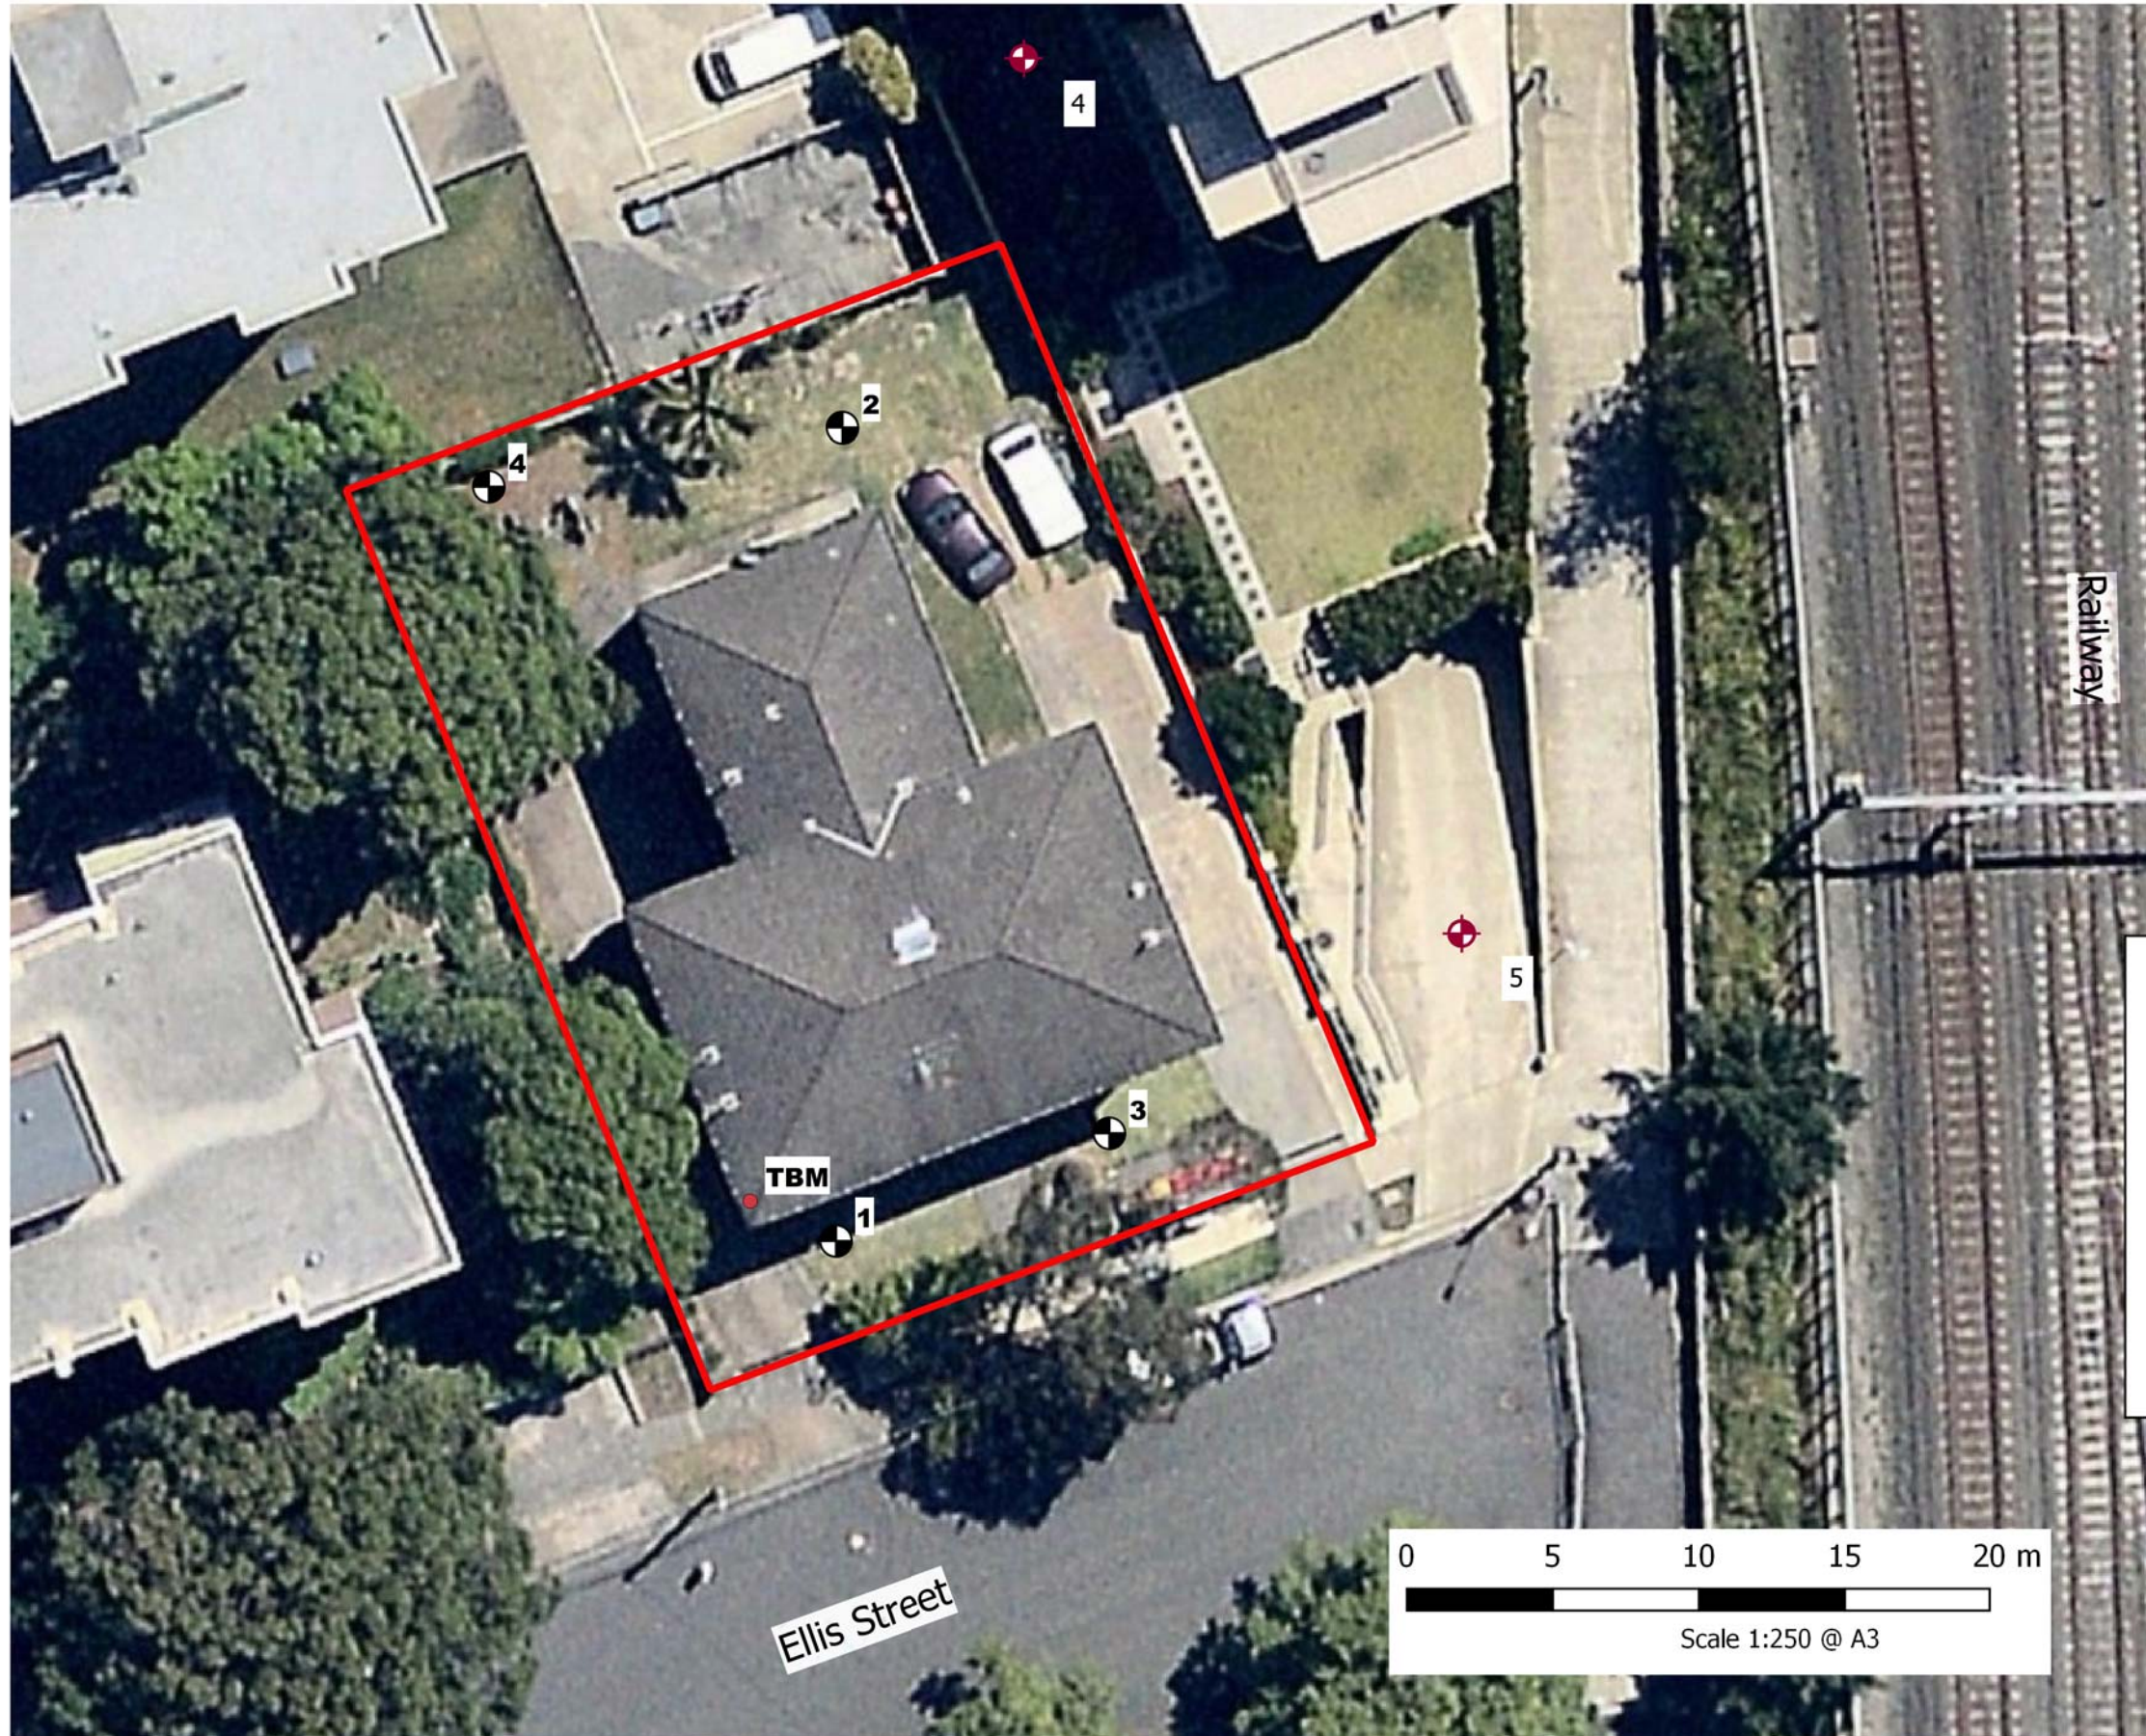
Drawing 1 – Test Location Plan

The field work comprised the drilling of four boreholes (Bores 1 to 4) within accessible locations to assess general site conditions using a combination of track mounted rig and hand tools, as summarised in Table 3 below.
