Report on  
Phase 1 Contamination Assessment  
with Limited Sampling

27 Mitchell Street  
Croydon Park

Project 73112.01  
January 2018

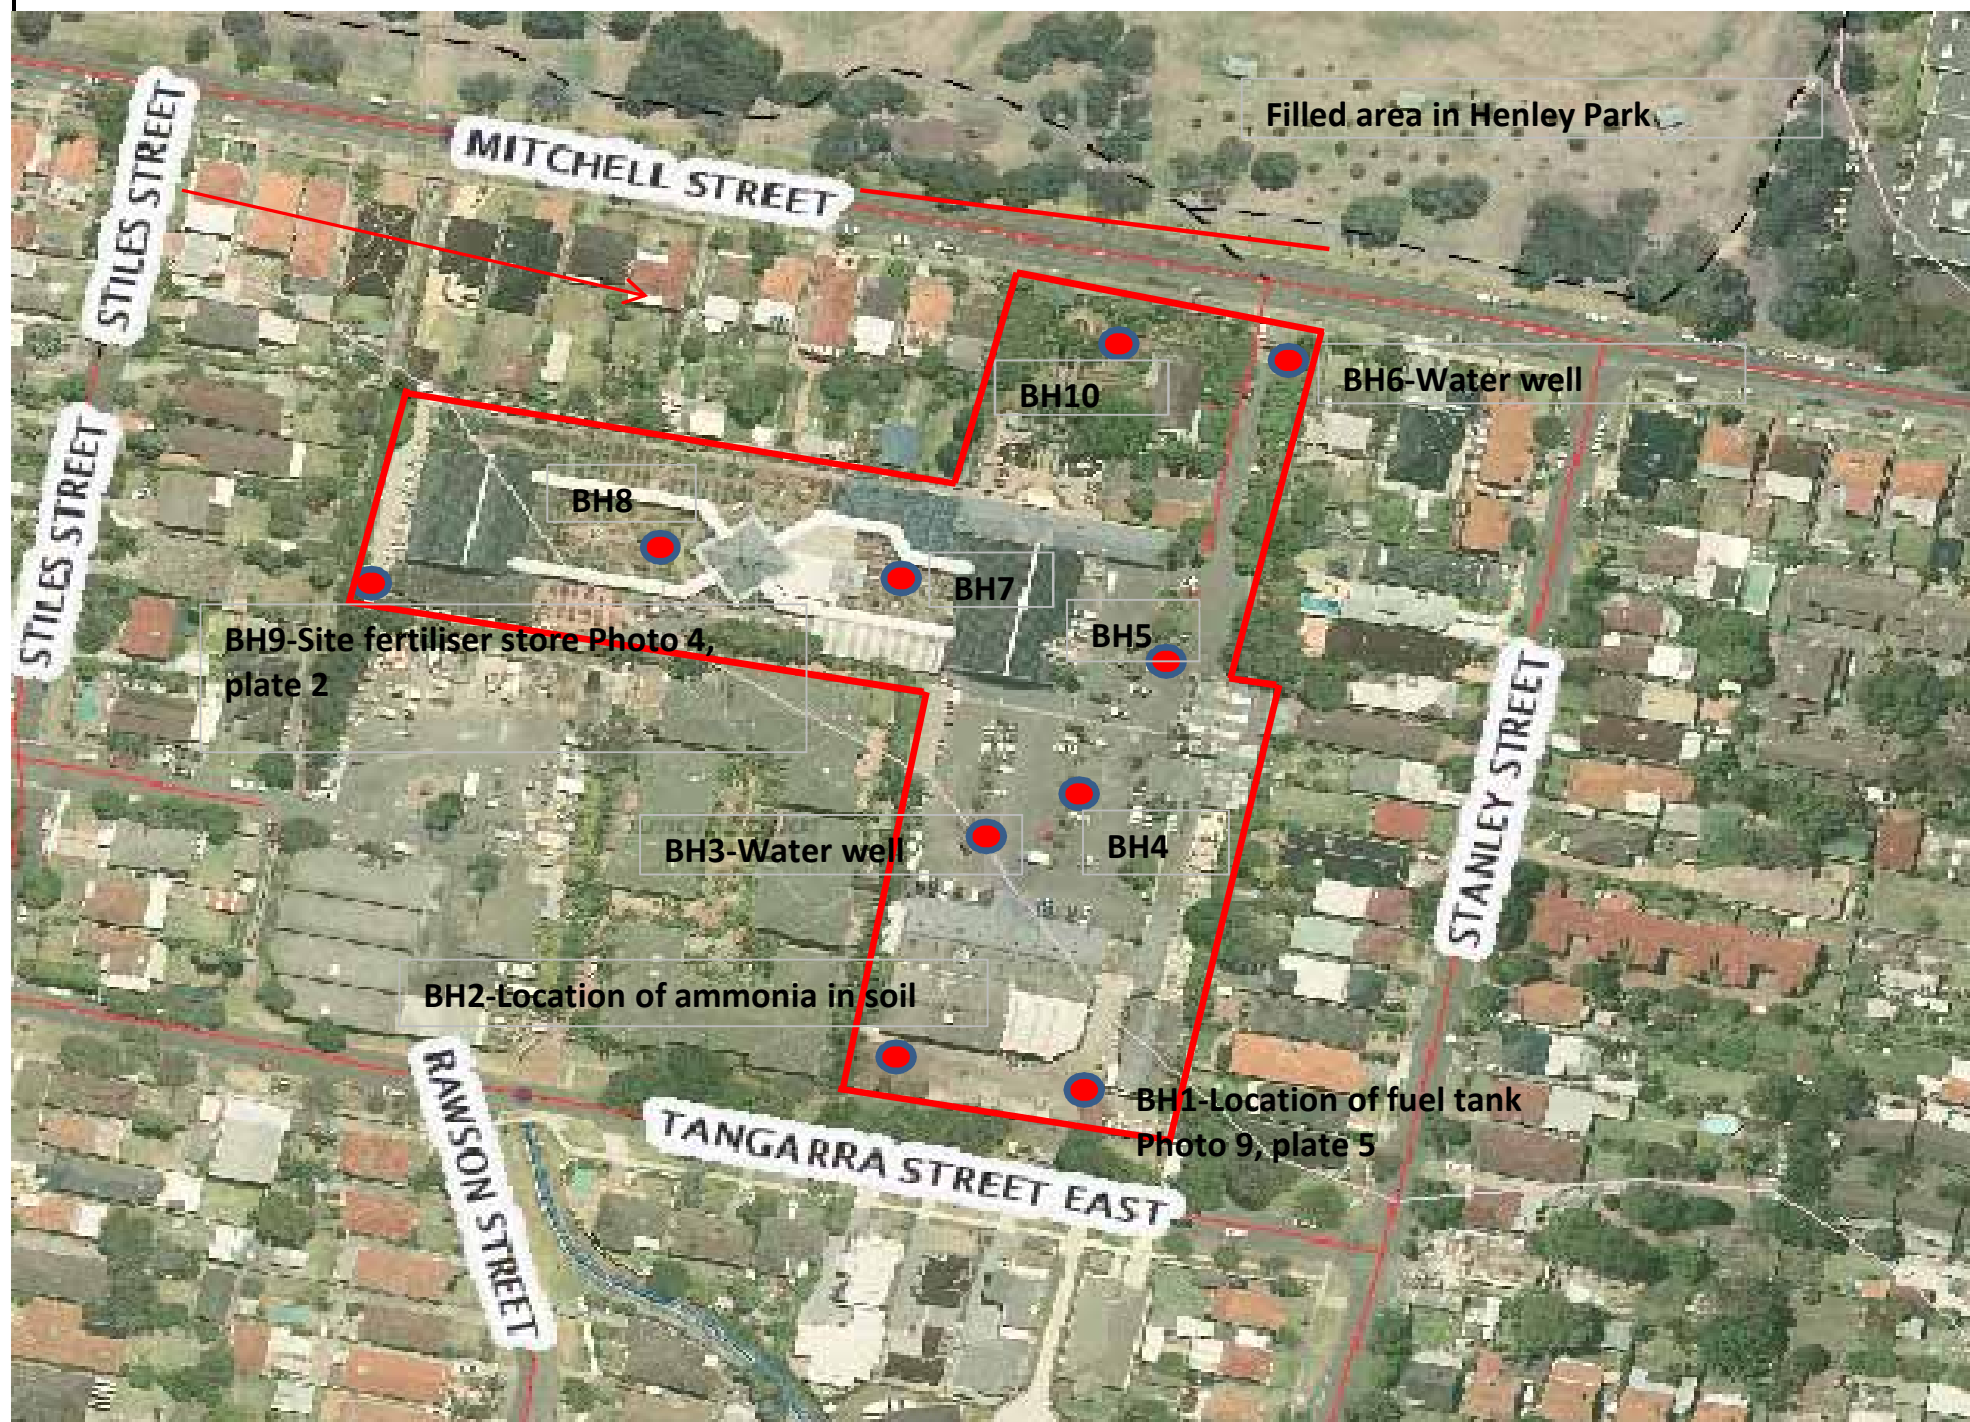
<b>Douglas Partners</b> <small>Geotechnics   Environment   Groundwater</small>	CLIENT: Flower Power	Borehole Locations and Site Features	PROJECT No: 73112.00
	Location Sydney		PLATE No: A1
	DATE: Aug 2012		REVISION: A

<b>Bore Location</b>	<b>Rationale</b>
1	Near above-ground fuel tank with cracked bund and some minor staining.
2	To provide for site coverage.
3	In or in the vicinity of the old Adhesive Pty Ltd premises (soil bore and ground water well).
4	To provide for site coverage/ in the vicinity of the Adhesive Pty Ltd premises.
5	To provide for site coverage.
6	Up gradient Groundwater well location-Potential off site contamination from the filled land opposite in Henley Park.
7	To provide for site coverage.
8	To provide for site coverage.
9	Targeting potential contamination related the storage of pesticides and fertilisers in shed.
10	To provide for site coverage.

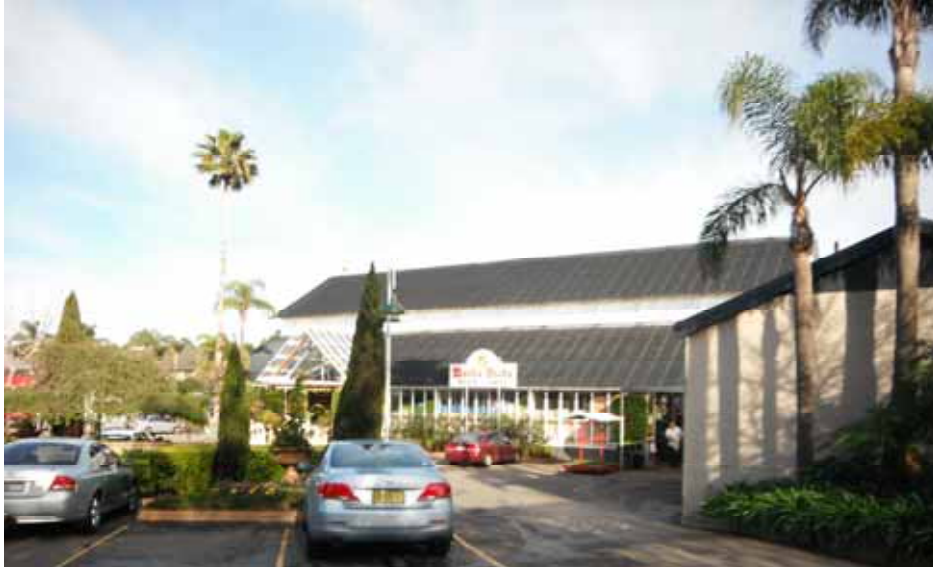
Photo 1 – Flower Power front elevation

The main building of the garden centre and café sits roughly in the middle of the site and is built mainly of steel and glass covering an approximate area of 1050 m<sup>2</sup> (photo 1, plate 1). To the west of this building is an outside retail area where the plants and materials are stored covering 4500 m<sup>2</sup> (photo 3, plate 2). To the west of this section lies a further retail building twinned with the main building of similar size and design and, running between the two buildings, are covered walkways (photo 3, plate 2). The outside storage area is generally filled with plants, however, on the southern edge of this area there is an access way and storage area. This storage area is mainly used for holding pallets of plant pots and other garden items though this is apparently not the normal area for this as Sydney Water works, currently being undertaken at the site, affected the day to day operation of the site. The access way continues all the way along the south of the area and goes behind the most westerly of the buildings tracing the western boundary. On this western boundary there is a small steel shed (photo 4, plate 3) which houses the fertilisers and pesticides used on site. To the north of the main building and café is an outdoor dining area, an aviary, and an unoccupied house (photo 5, plate 3).

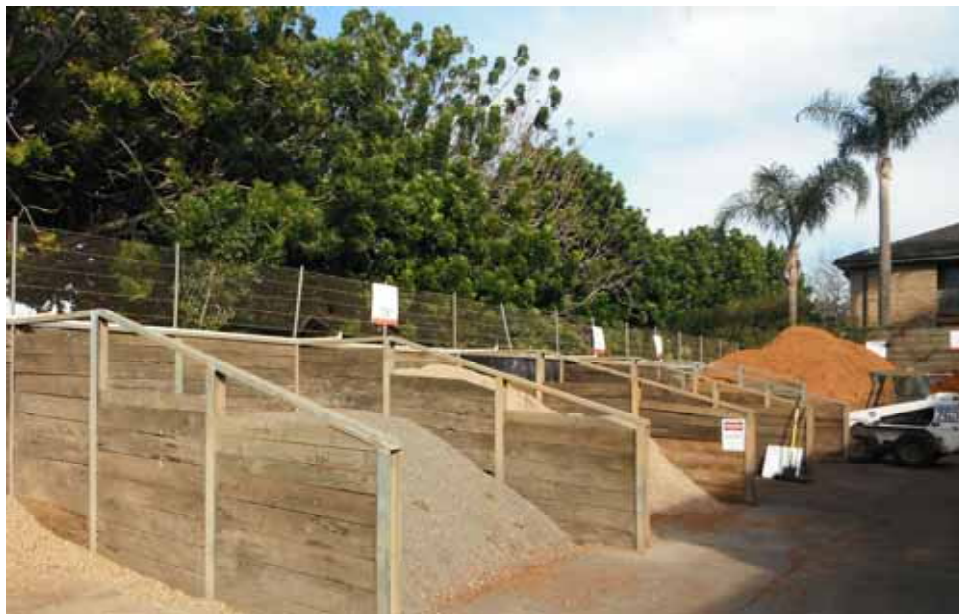
Photo 2 – Storage bays

To the west of above-ground tank are the various storage bays used by the hardware store (photo 2 plate 1). There are 14 bays, the majority of which contain sand or gravel, though the most westerly contained compost and wood chips. Along this area is a stormwater drainage system possibly linked to off-site stormwater drains.

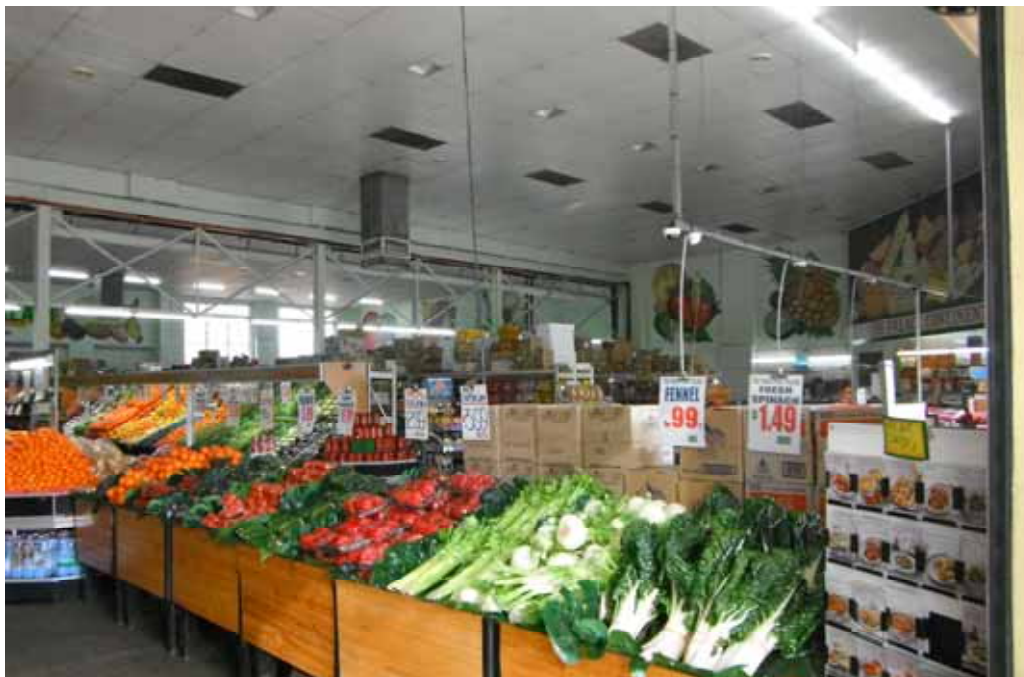
Photo 6 – Fruit and vegetable shop

The car park and access from Mitchell Street runs from the north to the south along the eastern edge of the site down to the fruit and vegetable shop covering an area of roughly 5250 m<sup>2</sup> (photo 6, plate 3). This area is mainly covered with asphalt though at the entrance to the site some of the parking spaces are graveled to either side of the access road. Being paved with asphalt there were no obvious signs of contamination encountered on the site visit. Refuse bins used for storing waste are located in the south west corner of the car park.

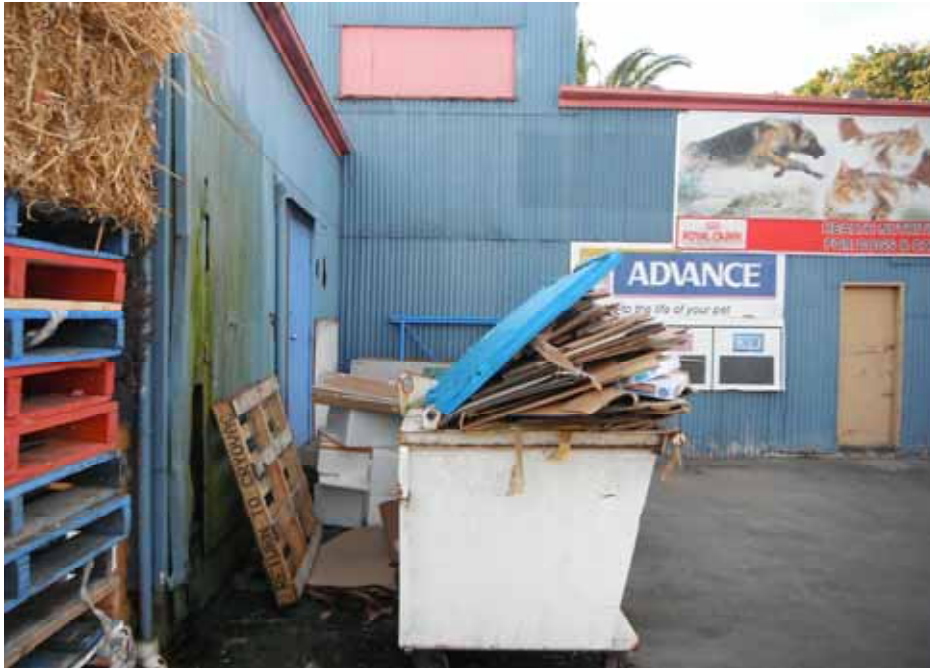
Photo 7– Pet shop bins

The pet shop (300 m<sup>2</sup>) is constructed of corrugated iron sheeting and block work. A refuse dumpster was located next to the building (photo 7, plate 4). This building was constructed after 1991 and, therefore, the potential for asbestos should be minimal.

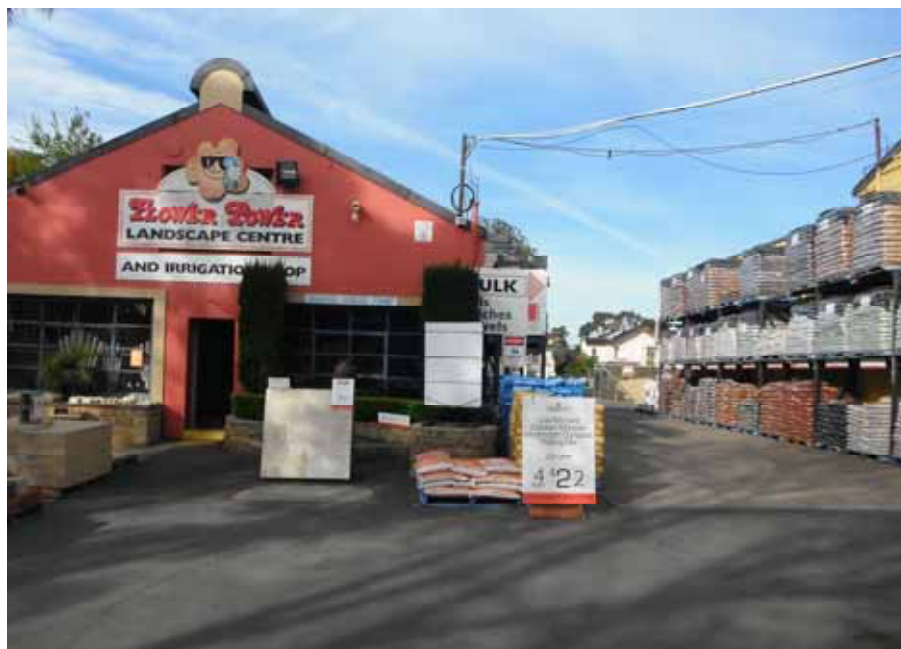
Photo 8 – Hardware and water garden shop

On the eastern boundary opposite the fruit and vegetable shop lies Flower Powers hardware and water garden premises (photo 8, plate 4). This is a rendered structure covering 220 m<sup>2</sup> with external racking for storage. These storage racks are filled with various pallets containing bags of stone, compost, cements and sands (photo 8, plate 4). To the front of the building in the car park area are various garden ornaments. Though the building itself shows no obvious signs of contamination the area used to the rear of the building contained a raised diesel fuel tank, approximately 2 m off of the ground (photo 9, plate 5). This fuel tank is bunded; however the bunding shows some distress with visible cracks in its structure and staining (photo 10, plate 5). The bund is also unlined and made of bricks and mortar (photo 11, plate 6) which over time will potentially leak. Within the bund is chipped wood so the base was not visible though it is assumed the concrete floor extends beneath this structure. It is presumed that the wood chips are used to soak up spillage. In front of this tank (at the time of inspection) was a pallet of chlorine containers.

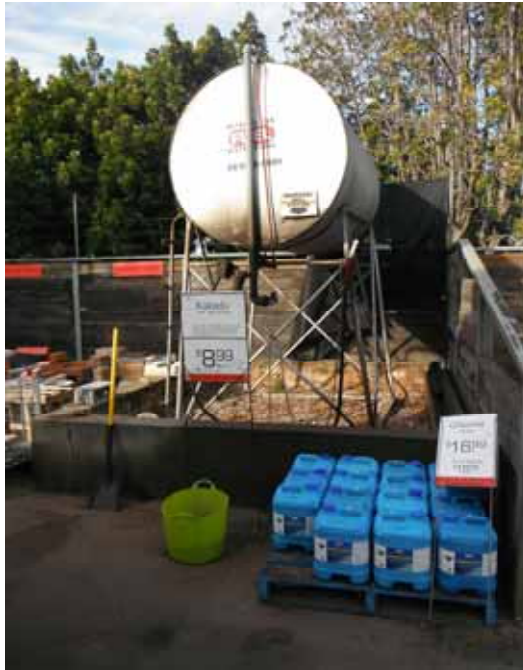
Photo 9– Fuel tank and chlorine pallet

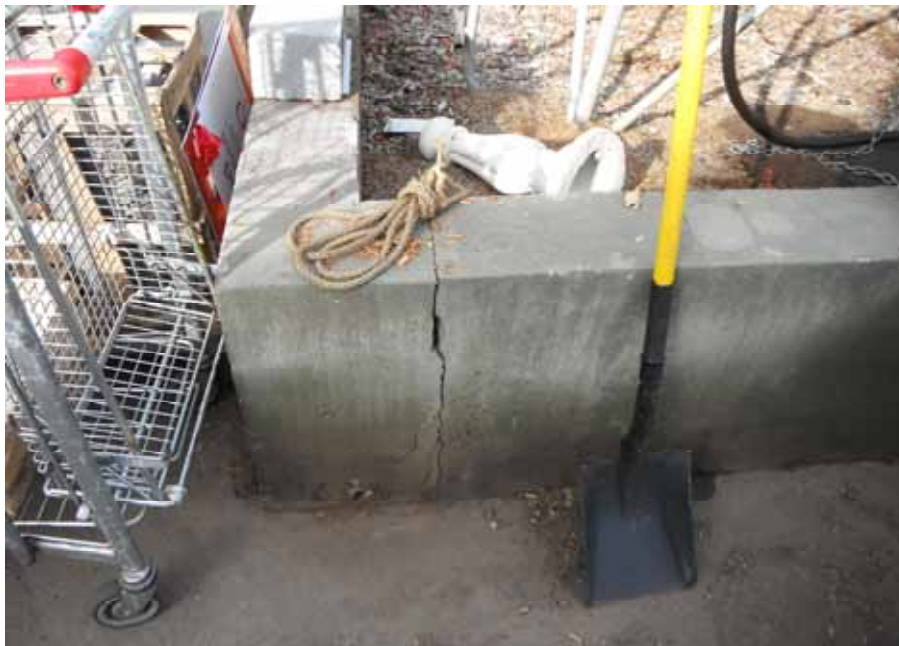
Photo 10 – Cracks in fuel tank bund

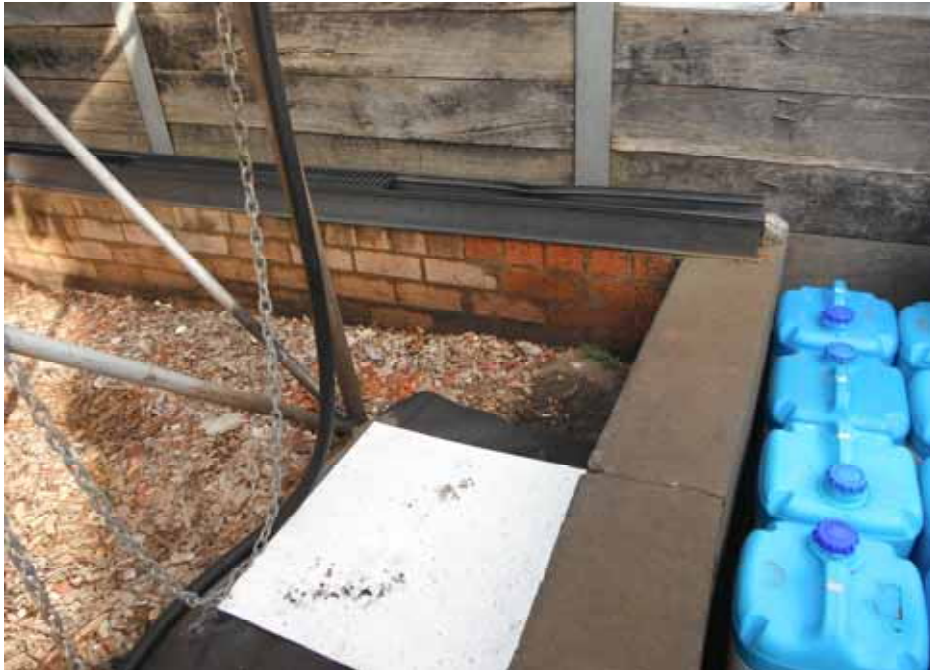
Photo 11– Brick lining of bund and further cracks

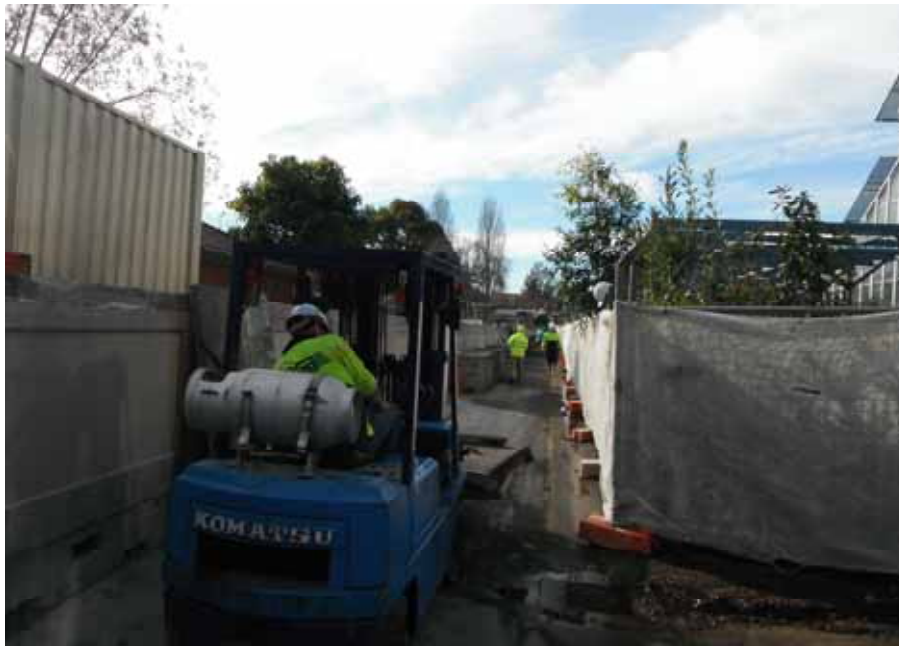
During the site visit it was noted that Sydney Water was undertaking an upgrade (photo 12, plate 6) to a surface sewer line aligned east to west (orientation, not flow direction). The contractor for Sydney Water demanded no restriction to their access to the site on the days of DP's drilling which limited DP's ability to drill as proposed and consequently hand augers were used for four of the 10 bore locations as a result of this.

Photo 12 – Sydney Water site

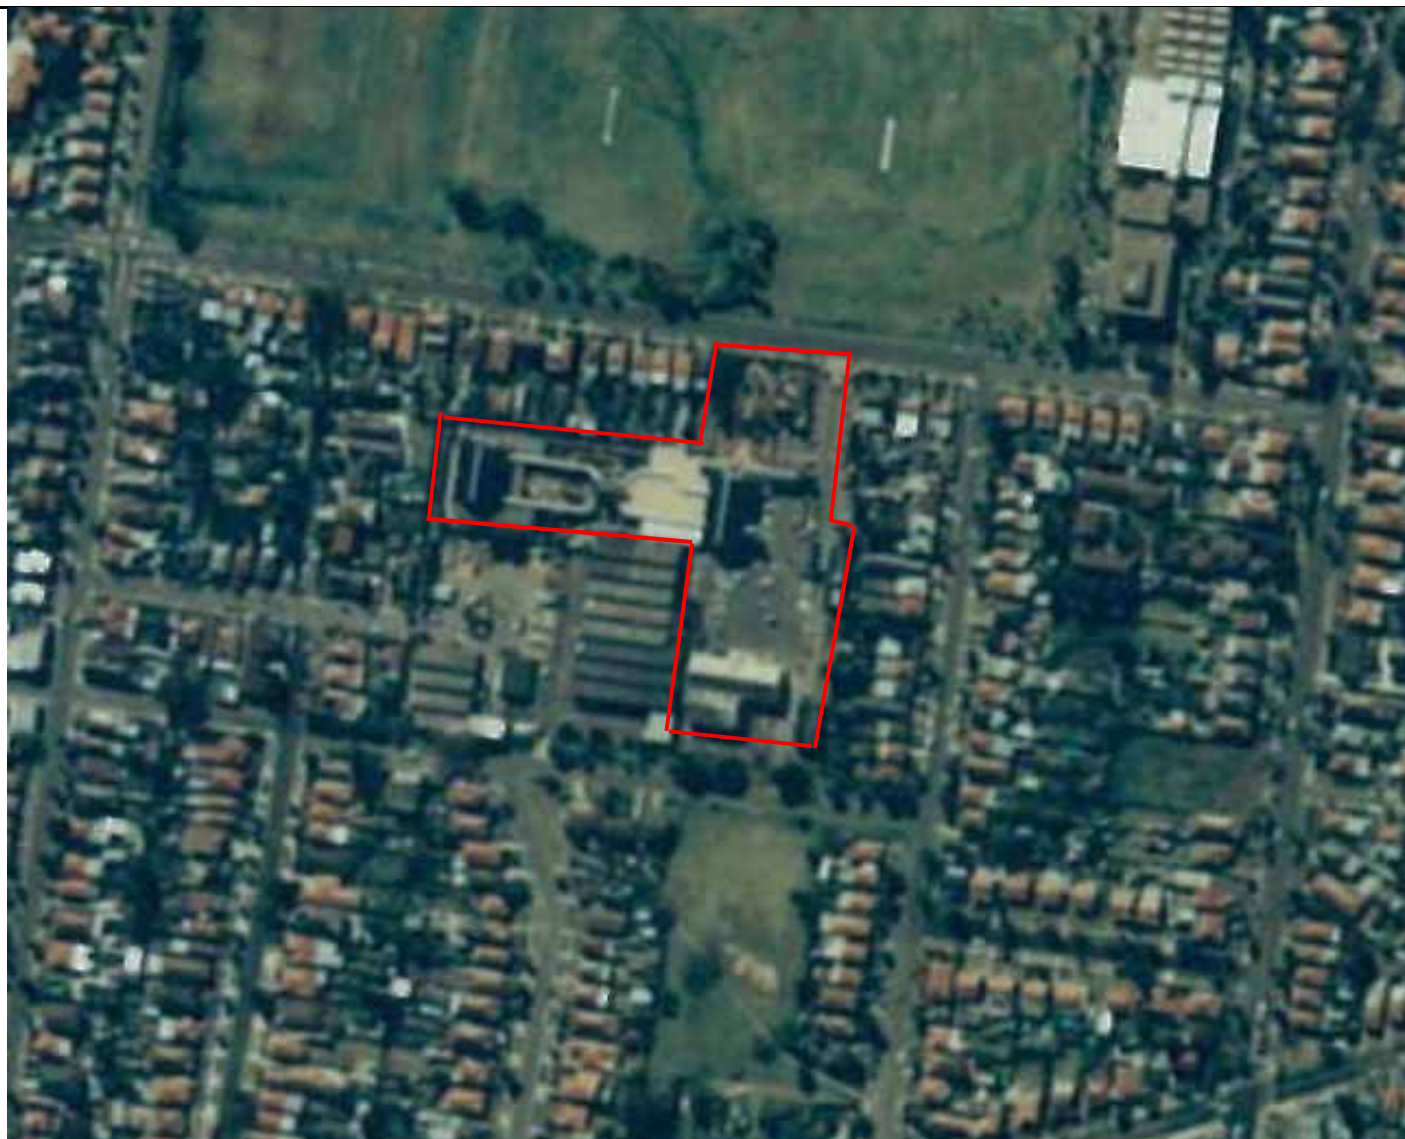
PROJECT No:	73112.00
PLATE No:	D5
REVISION:	A

<b>1991 Aerial Photograph</b>
<b>Phase 1 Contamination Assessment</b>
<b>27 Mitchell St, Croydon Park</b>
