Report on  
Preliminary Site Investigation for Contaminated Land

Proposed Senior Living Development  
21 Boardman Road South, Bowral

Prepared for  
KRB Property Holdings Pty Ltd

Project 89492.00  
February 2019

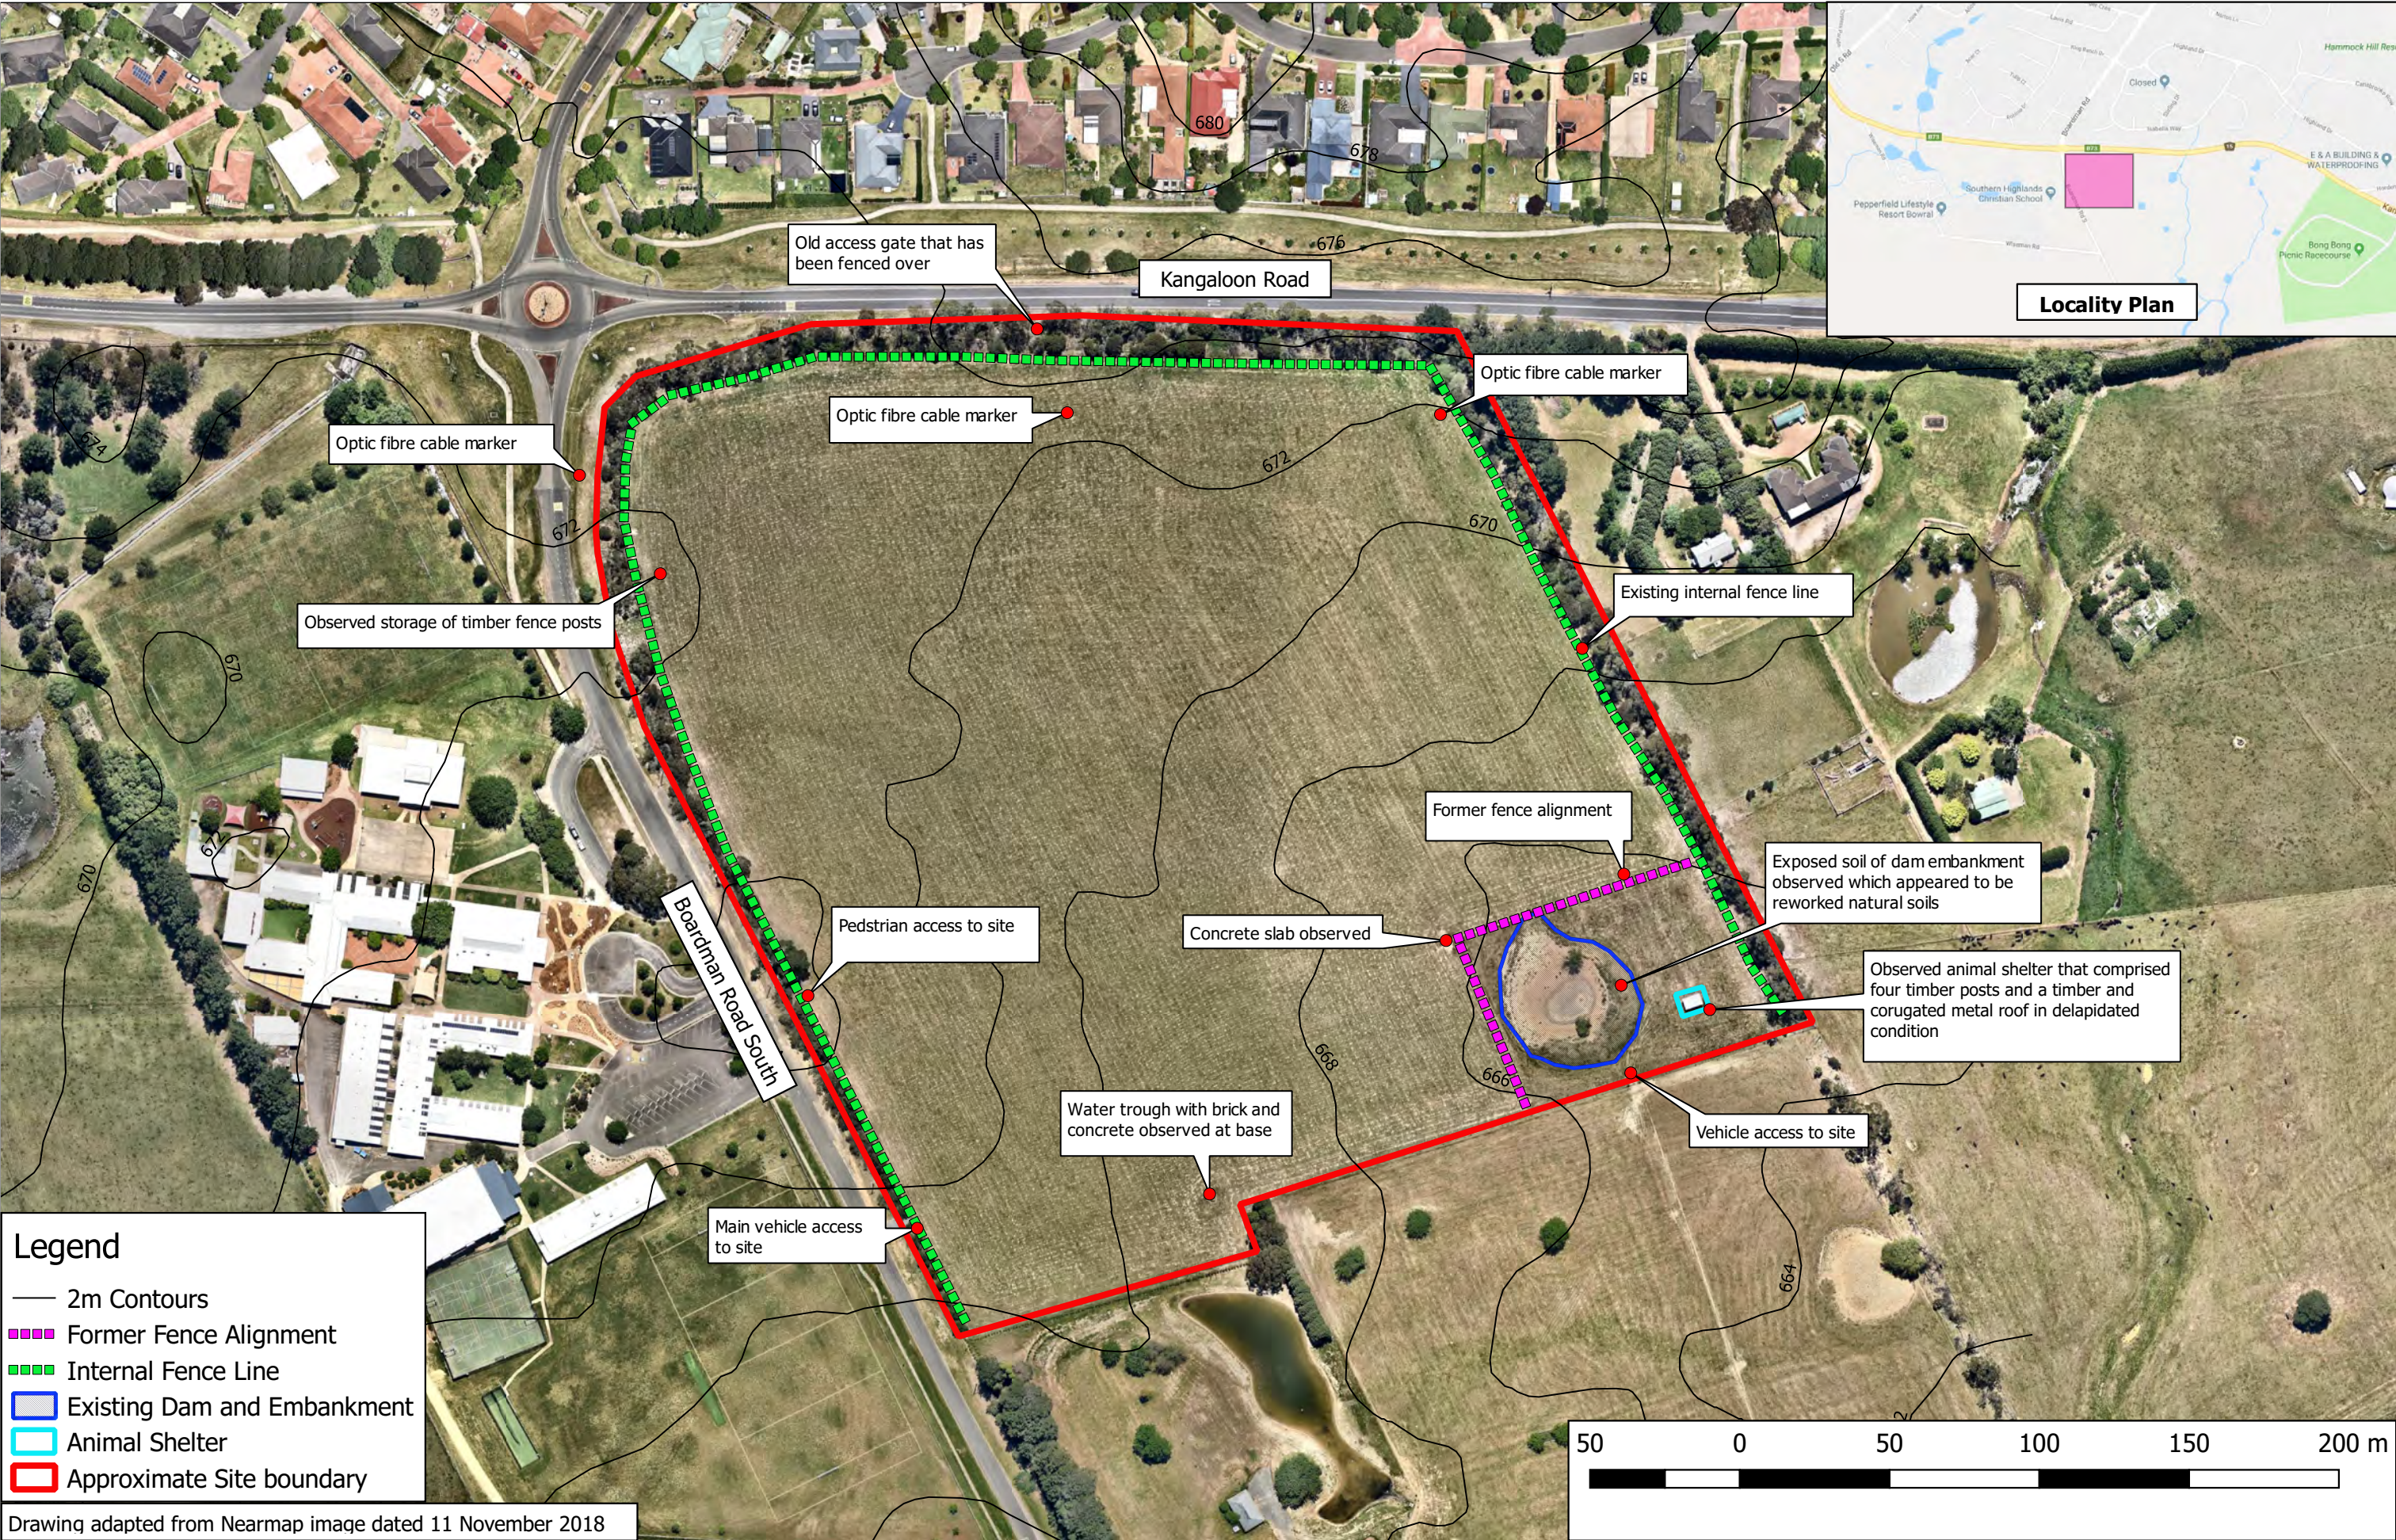
Drawing 1

Drawing adapted from Nearmap image dated 11 November 2018

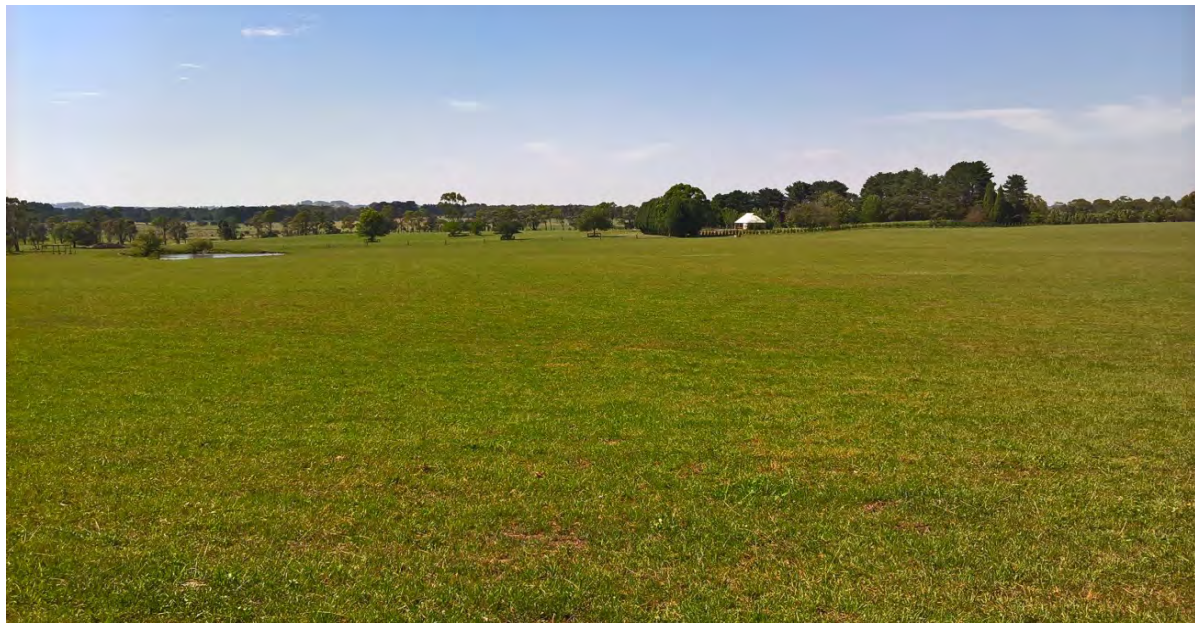
Photo 1: View from northern boundary of site looking south.

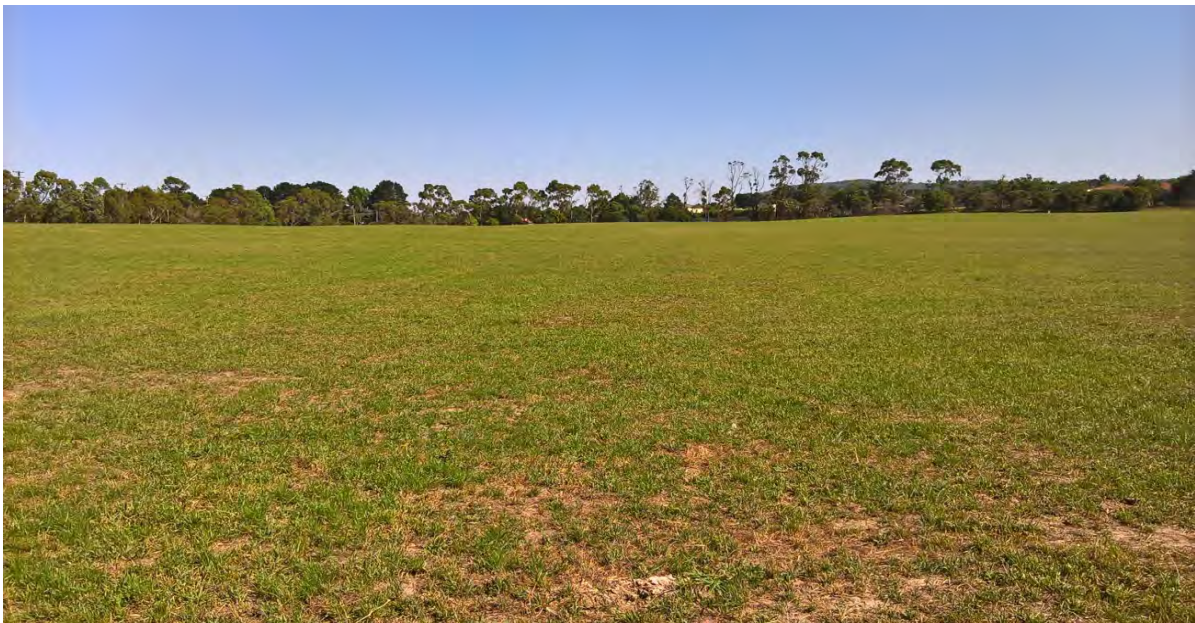
Photo 2: View from southern boundary of site looking north

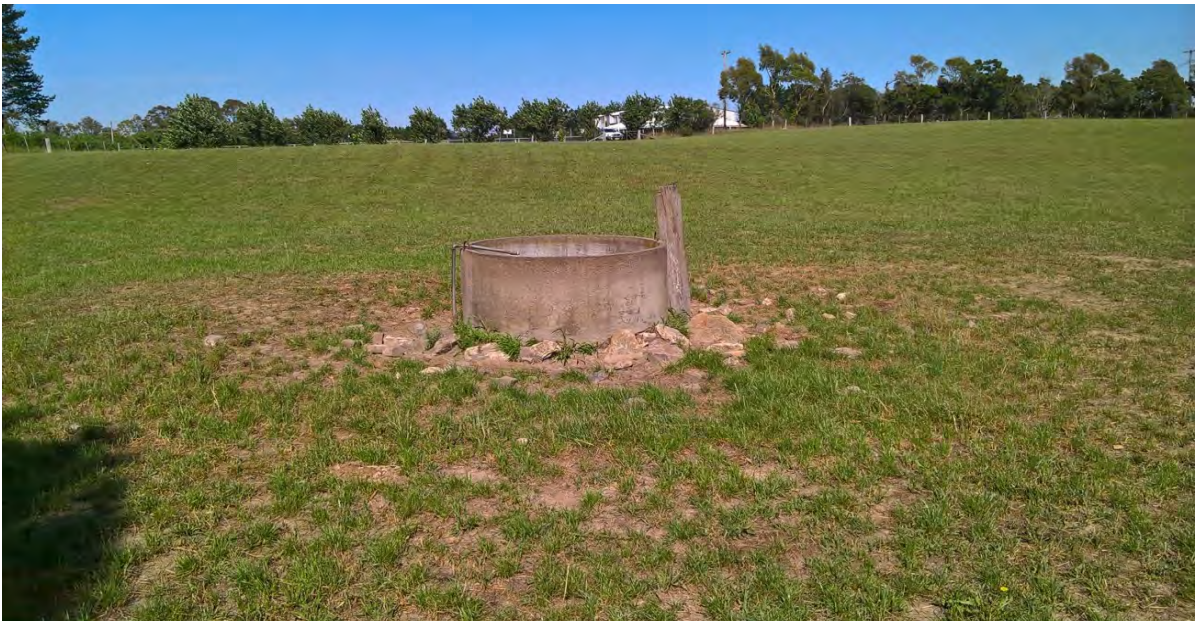
- Bricks and cobble sized pieces of concrete were observed immediately surrounding the base of the water trough in the southern-central portion of the site. Approximately 1 – 2 m from the water trough, the site surface was observed to be free of brick and or concrete;

A concrete slab was also observed in the south eastern portion of the site, to the north west of the dam. This location is evident in the historical aerial photographs, however, the nature of the feature is unclear. This is considered to most likely be a similar grazing land use feature such as a water or feeding trough or animal shelter. Minor amounts of brick and concrete were also observed at the base of the water trough in the south western portion of the site.

Photo 3: View of water trough with brick and concrete at the base observed in the southern central portion of the site.

It is further recommended that the bricks and concrete in the southern portion of the site associated to the grazing land use features, be appropriately classified and disposed of to an appropriate licensed waste facility.

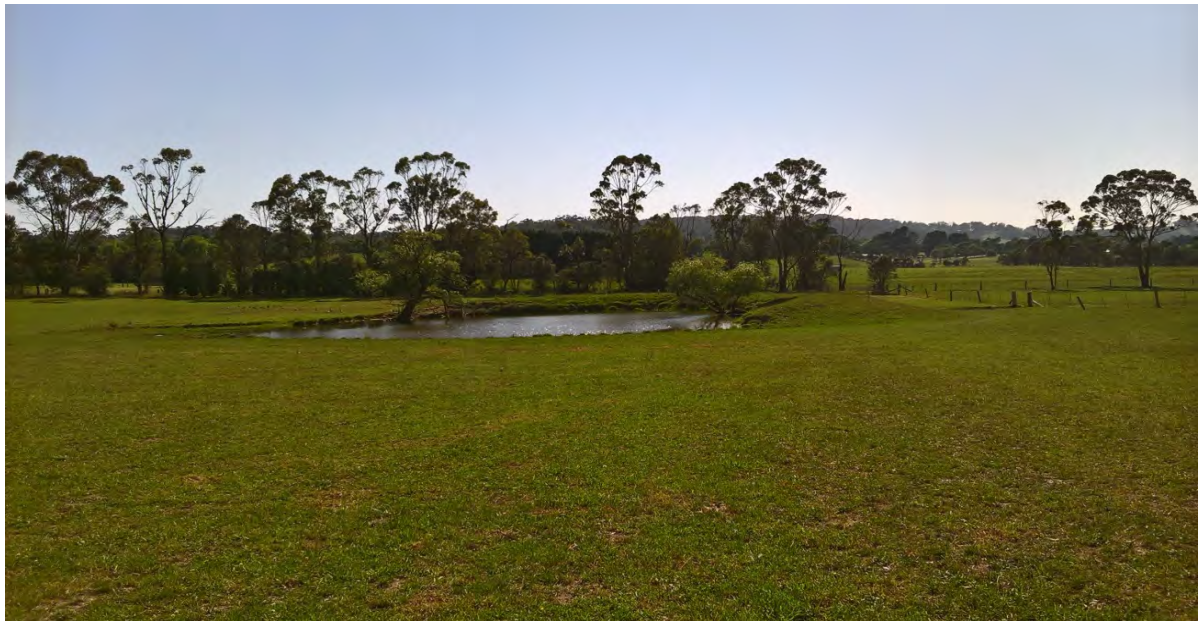
Photo 5: View of dam and dam embankment.

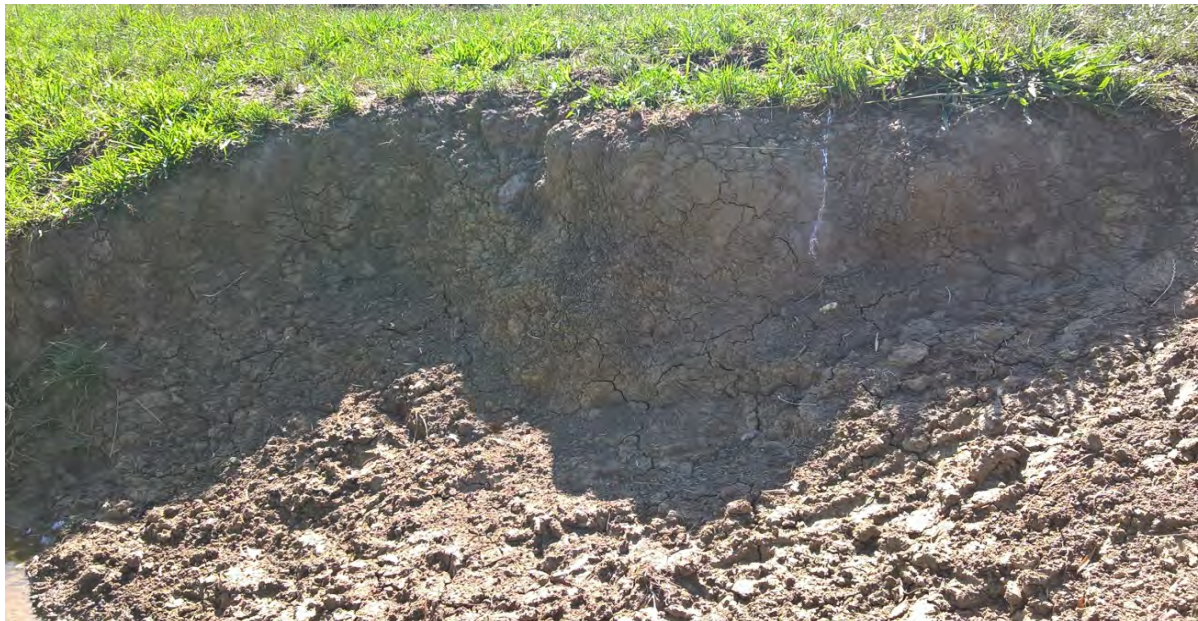
- Exposed soils in the dam embankment were observed to comprise disturbed natural soils;
- The animal shelter in the south eastern portion of the site was observed to comprise four timber posts and a timber and corrugated metal roof and to be in a dilapidated condition. The ground surface within the footprint of the animal shelter was observed to be covered with long grass and marginally lower than the surrounding ground surface.

Uncontrolled filling was observed in the dam embankment. However, the fill was observed to comprise reworked natural soils only, and is therefore not considered to present a potential source of contamination.

Photo 6: View of exposed soils in dam embankment.

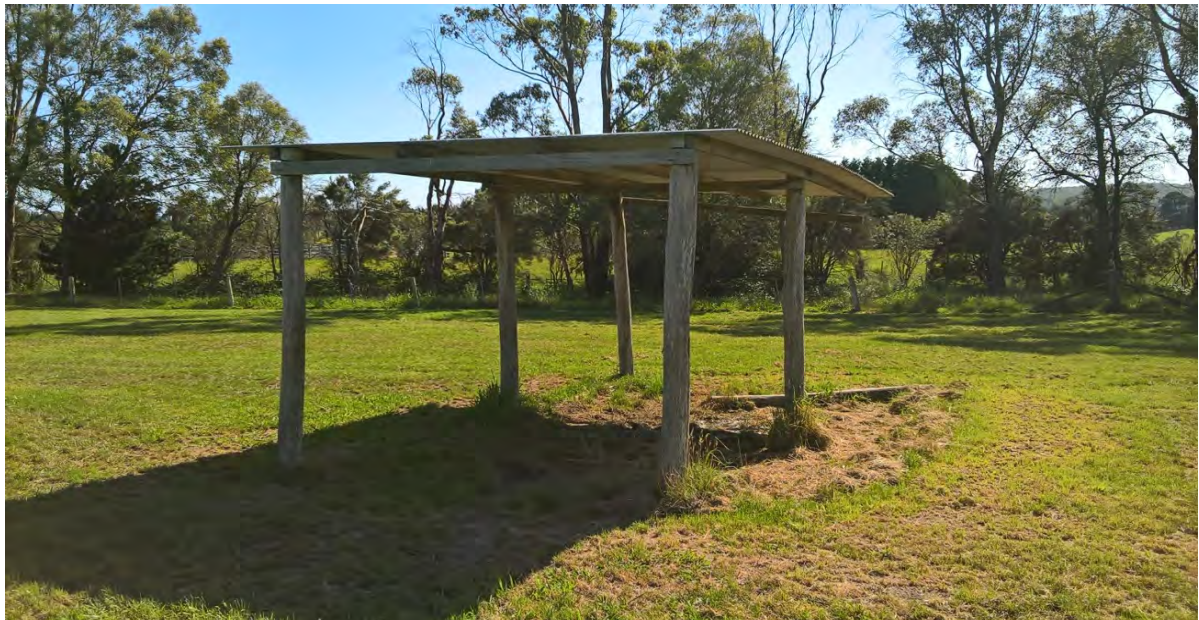
An animal shelter in the south eastern portion of the site was observed to be in a dilapidated condition. As such, degradation of the animal shelter including the degradation of potential weather proof treatments to the corrugated iron roof and timber posts are considered to present a potential contamination source.

Photo 7: View of former animal shelter

As such, it is recommended that intrusive sampling be undertaken in the area of the animal shelter to assess the contamination status of the site associated with this structure.

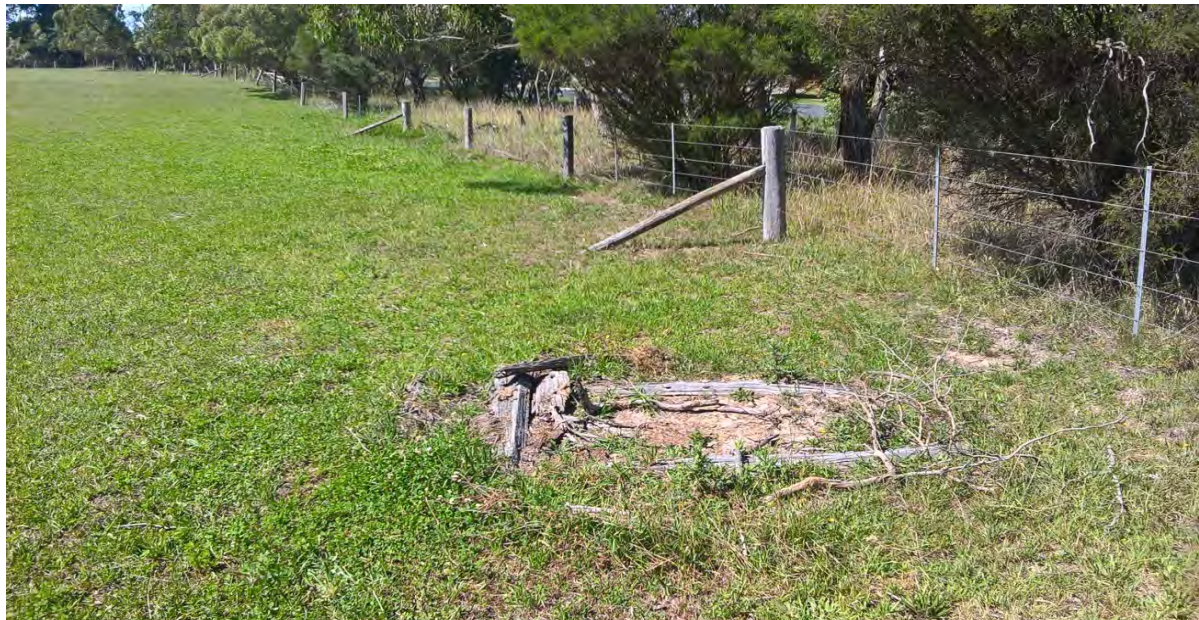
- A former timber fence post storage area was observed in the north western portion of the site; and
- No obvious asbestos, soil staining or vegetation dieback was observed on the site surface during the site walkover.

Photo 8: View of former timber post storage area observed in north western portion of the site.

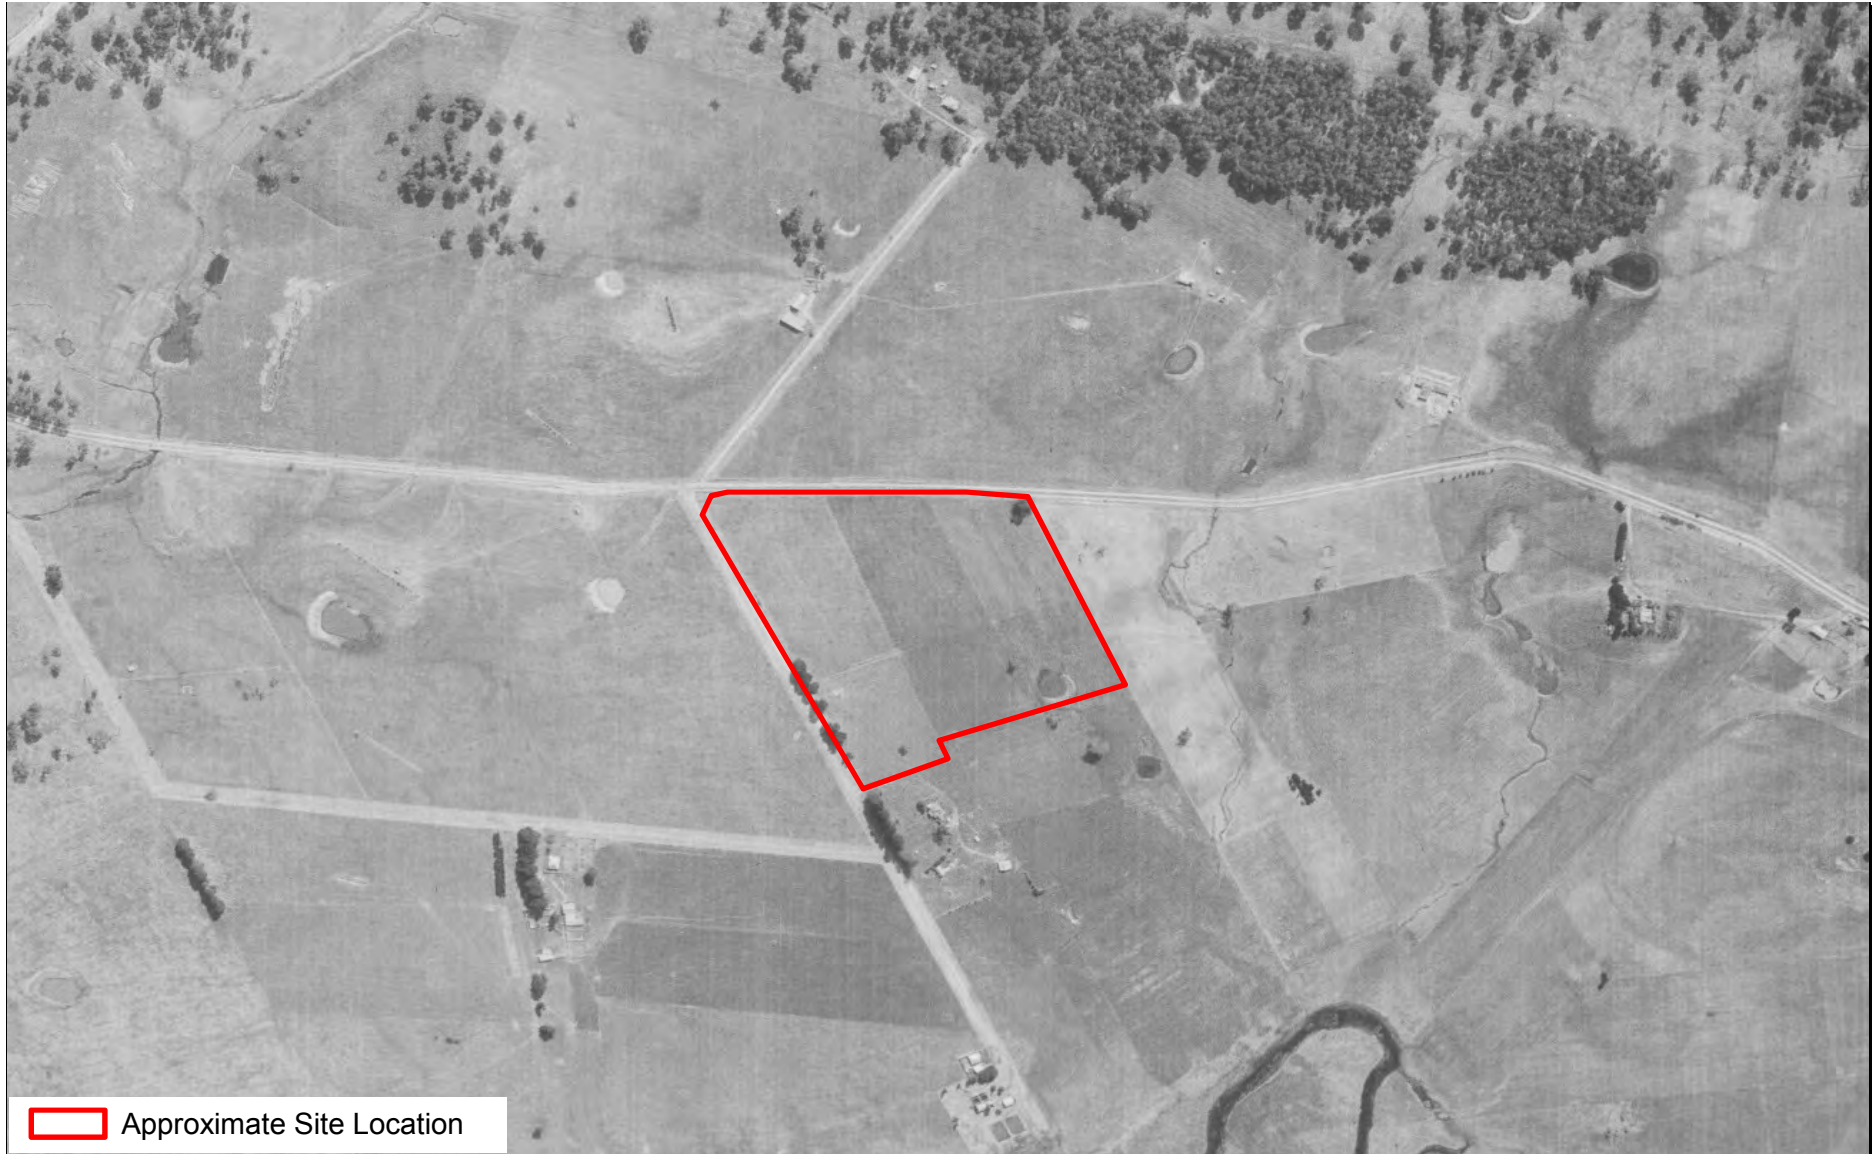
| <b>Douglas Partners</b><br>Geotechnics Environment Groundwater | Project No. | 89492.00 | Historical Aerial Photograph - 1963 | Drawing No. 2 |

**1963:** The site appears to be undeveloped and vacant with a small row of trees along the south western boundary, some trees in the north eastern corner and a dam located in the south eastern corner of the site. Two small dark spots are visible in the south western and south eastern portions of the site, however, it is unclear as to what the observed features may be. Potential fence lines are visible through the central portion of the site, which may suggest evidence of agricultural work taking place on the site. The surrounding land use of the site appears to be for rural / residential / agricultural purposes with the majority of the surrounding land being vacant. The land adjacent to the south western portion of the site appears to have been developed with a driveway and three buildings evident.

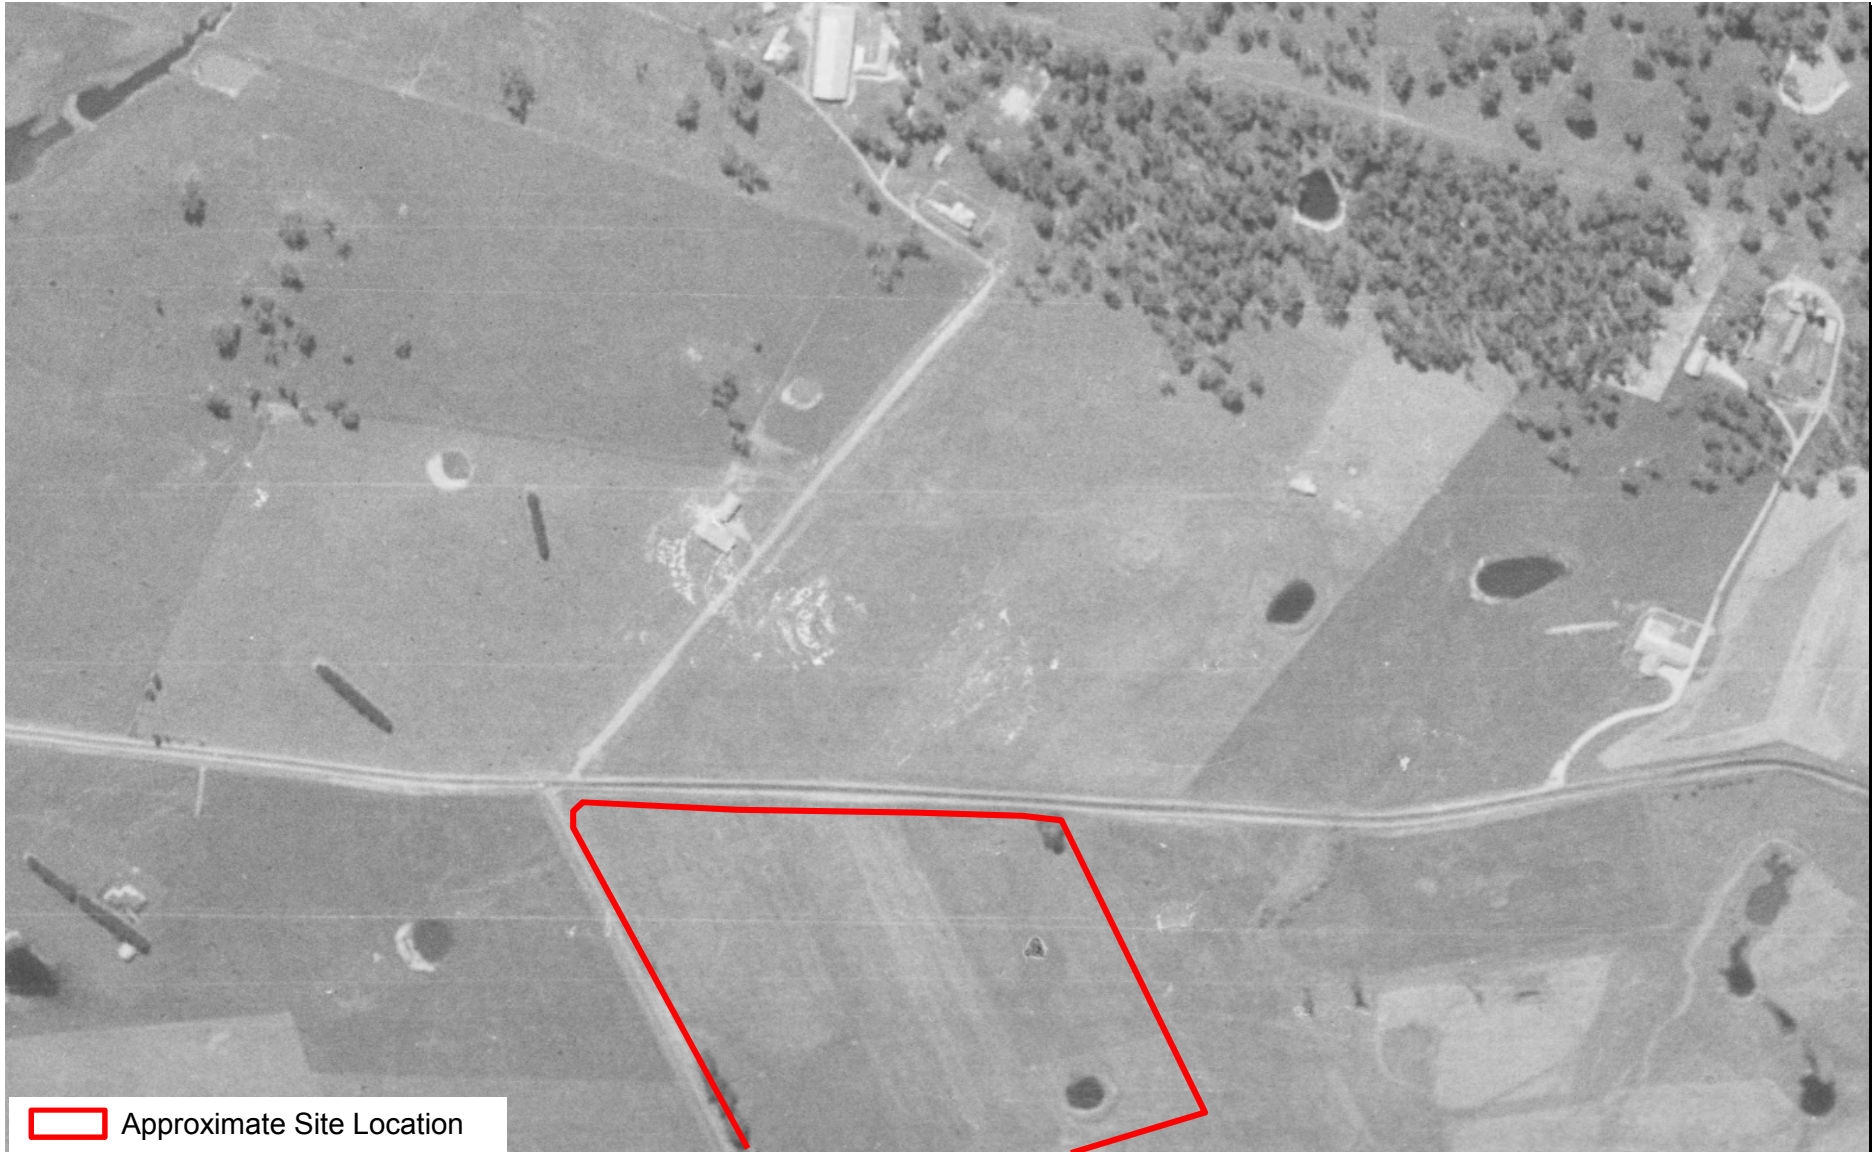
| <b>Douglas Partners</b><br>Geotechnics Environment Groundwater | Project No. | 89492.00 | Historical Aerial Photograph - 1972 | Drawing No. 3 |

**1972:** The site is only partially shown in this photograph with a portion of the southern boundary missing. The site and surrounding land use appears relatively unchanged. A circular spot is visible in the central eastern portion of the site, however, it is unclear as to what the observed feature may be. The “dark spots” observed in the 1963 photograph are no longer evident in this image.

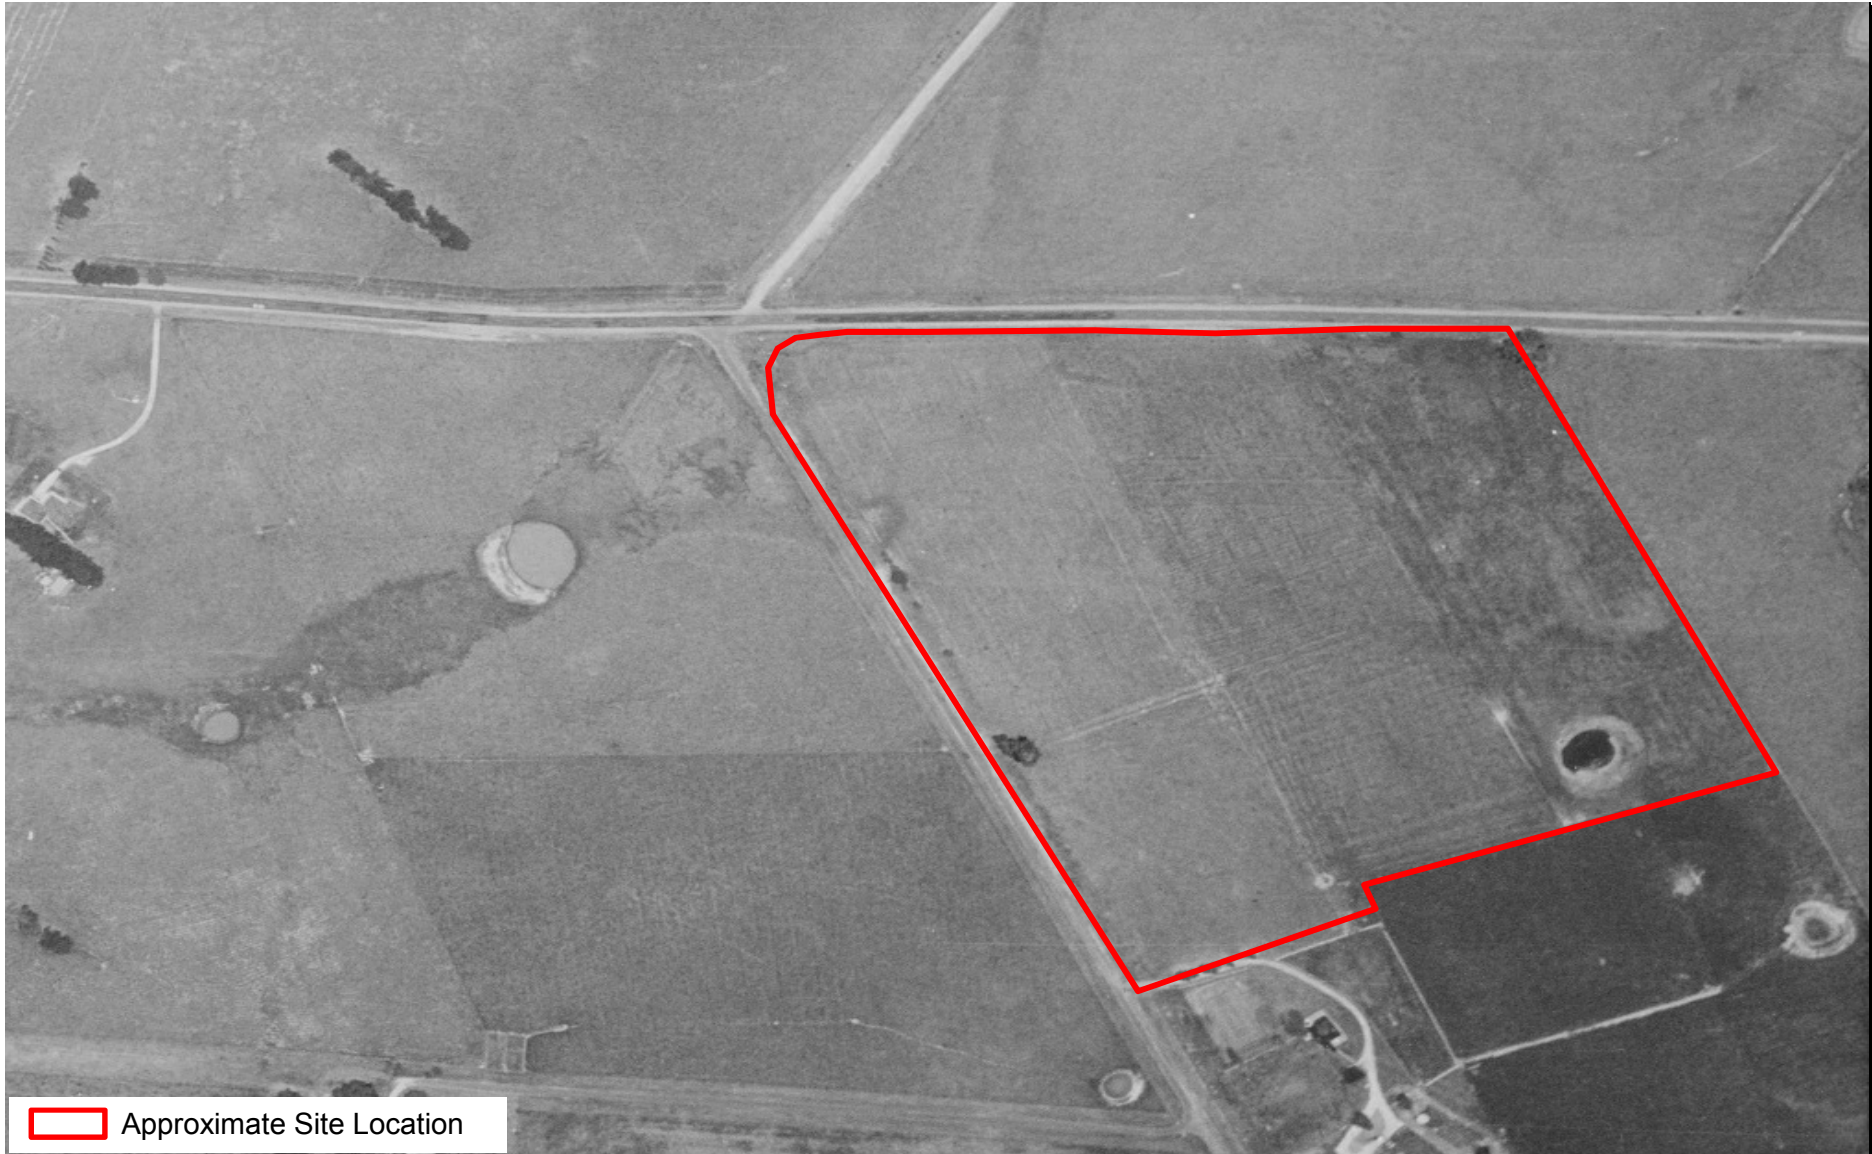
| <b>Douglas Partners</b><br><small>Geotechnics Environment Groundwater</small> | Project No. | 89492.00 | Historical Aerial Photograph - 1982 | Drawing No. 4 |

**1982:** The site and surrounding land use appear relatively unchanged. Two light coloured spots are now visible in the south eastern and southern central portion of the site. The light coloured spot in the south eastern portion of the site is in a similar location to one of the “dark spots” observed in the 1963 photograph.
