## **STAGE 1 PRELIMINARY SITE INVESTIGATION (PSI)**

**105 COOBY ROAD  
LOT 240 DP 828854  
TULLIMBAR, NSW, 2527**

Prepared For: **INDESCO**  
Project Number: **ENRS1187**  
Date: **7<sup>th</sup> December 2018**

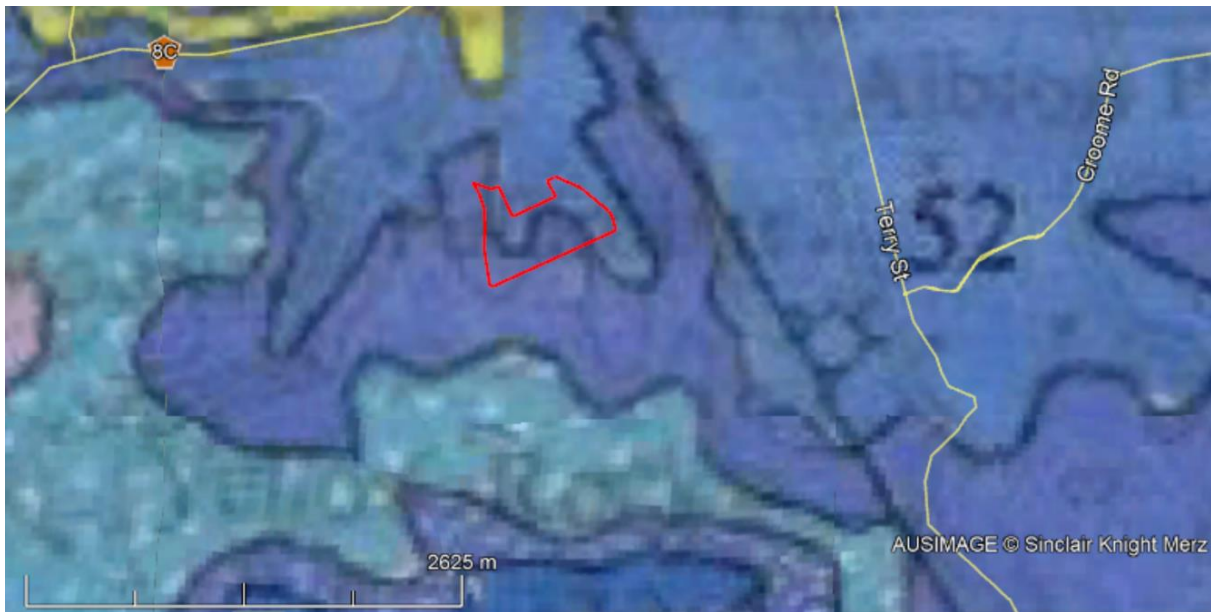
**Figure 2: Geology Map**

Review of the Site's geological setting was conducted with reference to the Wollongong 1:100,000 geological series sheet. The Site is located near the boundary of the Illawarra Coal (Pi) and Berry Formation (Psb) (Undifferentiated). Both formations are characterised by siltstones, shales and sandstones. The Illawarra Coal Measures also include tuff, chert, coal and torbanite seams. In general, Shales within the Sydney Basin are characterised by low groundwater yields and moderate to high salinity.

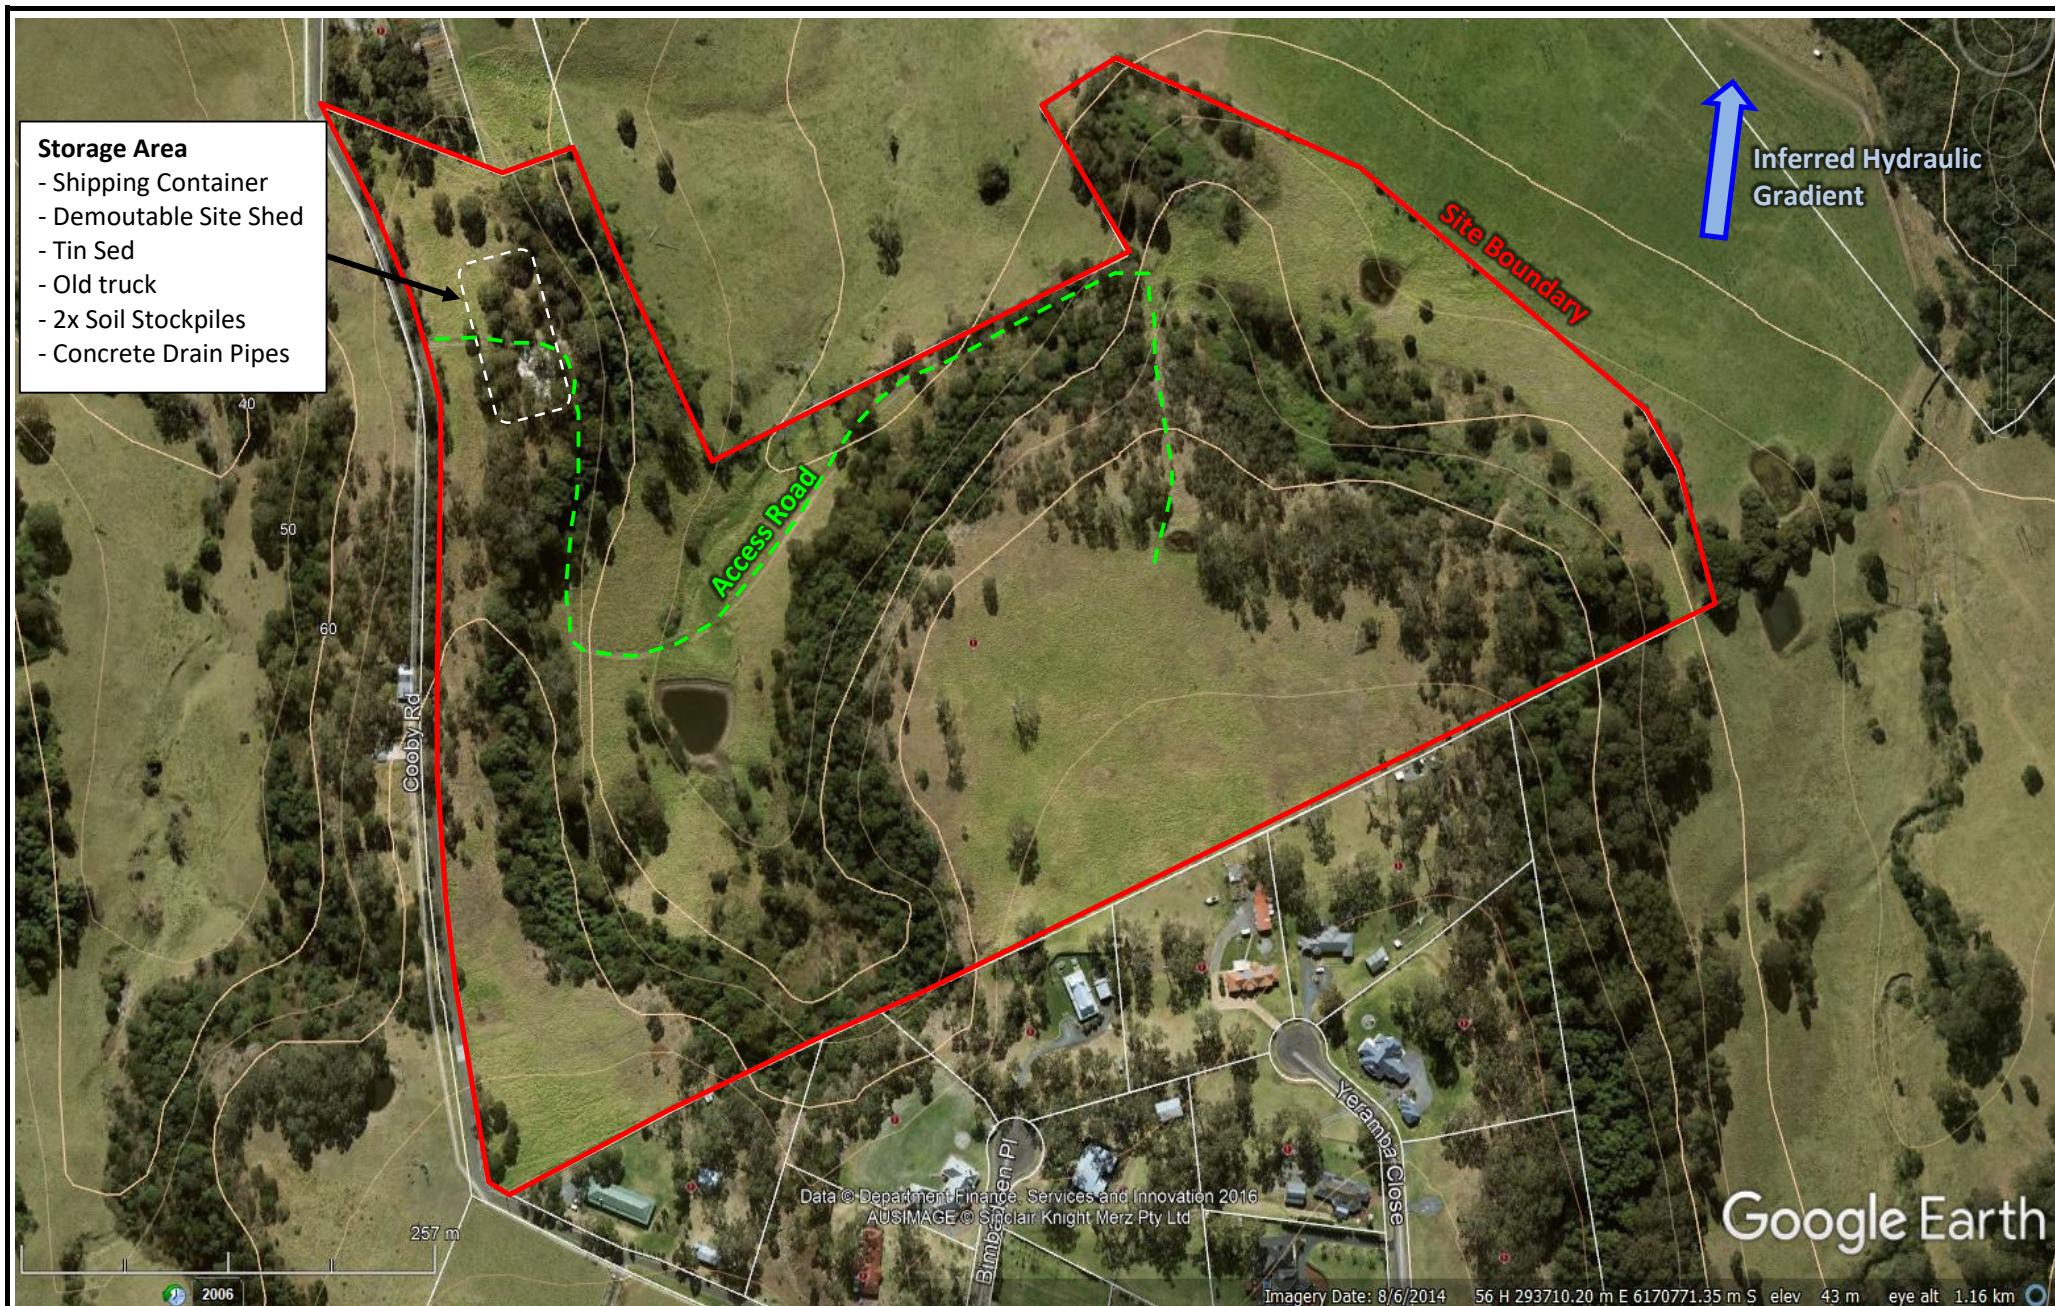
**Figure 6 Site Plan**

A review of the Site topography was conducted with reference to the current series topographic map sheet, refer to **Figure 6**. The following points summarise the key observations:

- In general, the regional gradient gently dips to the north;
- A large relatively level area is located in the middle of the Site surrounded by moderate slopes;
- A small gully and drainage line is located over the western portion of the Site which is expected to capture the majority of surface runoff; and
- No stormwater drainage systems were observed at the Site.

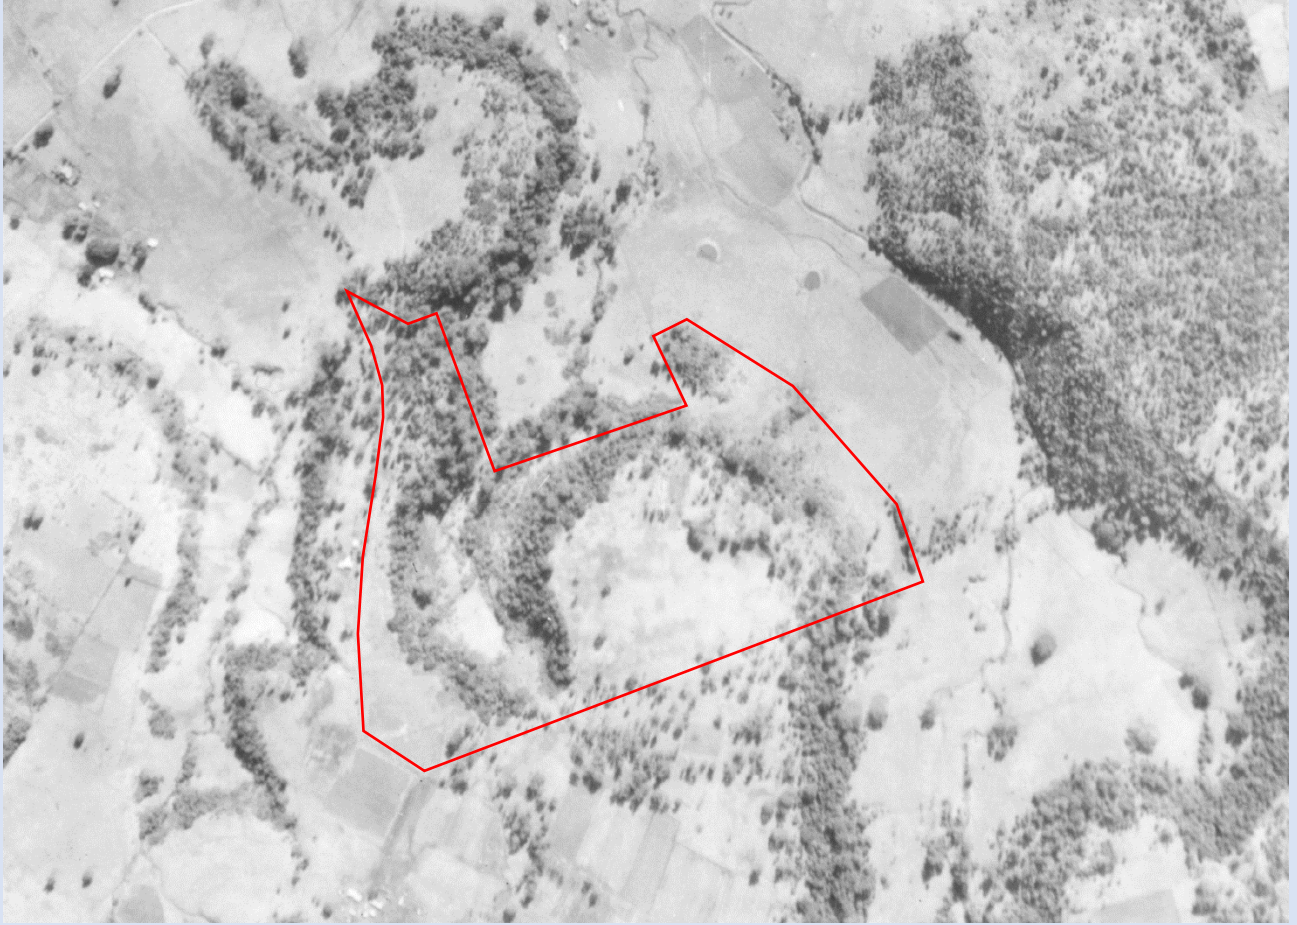
1949 – Mixed cleared rural land and bushland. No structures on the Site.

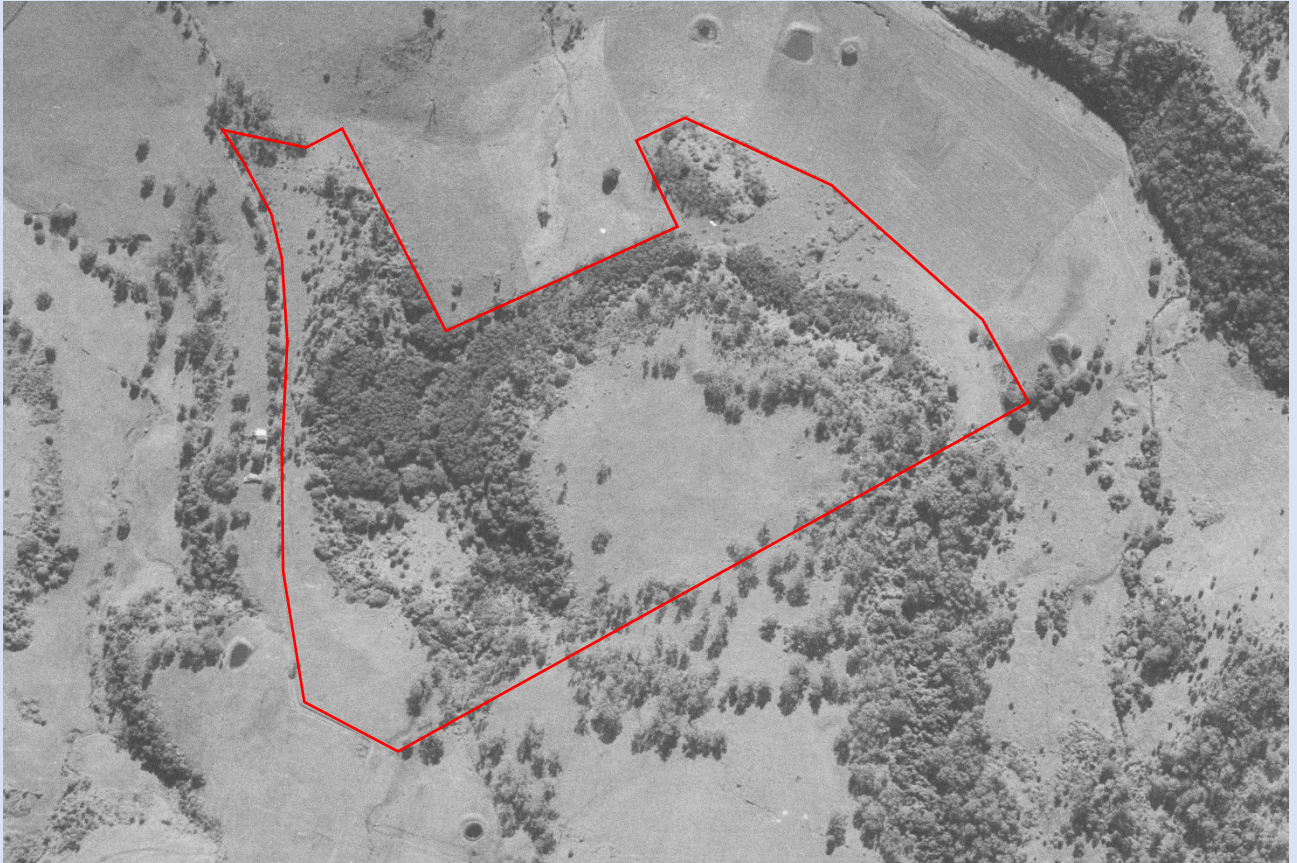
1984 – Mixed cleared rural land and bushland. No structures on the Site. No significant changes since 1949.

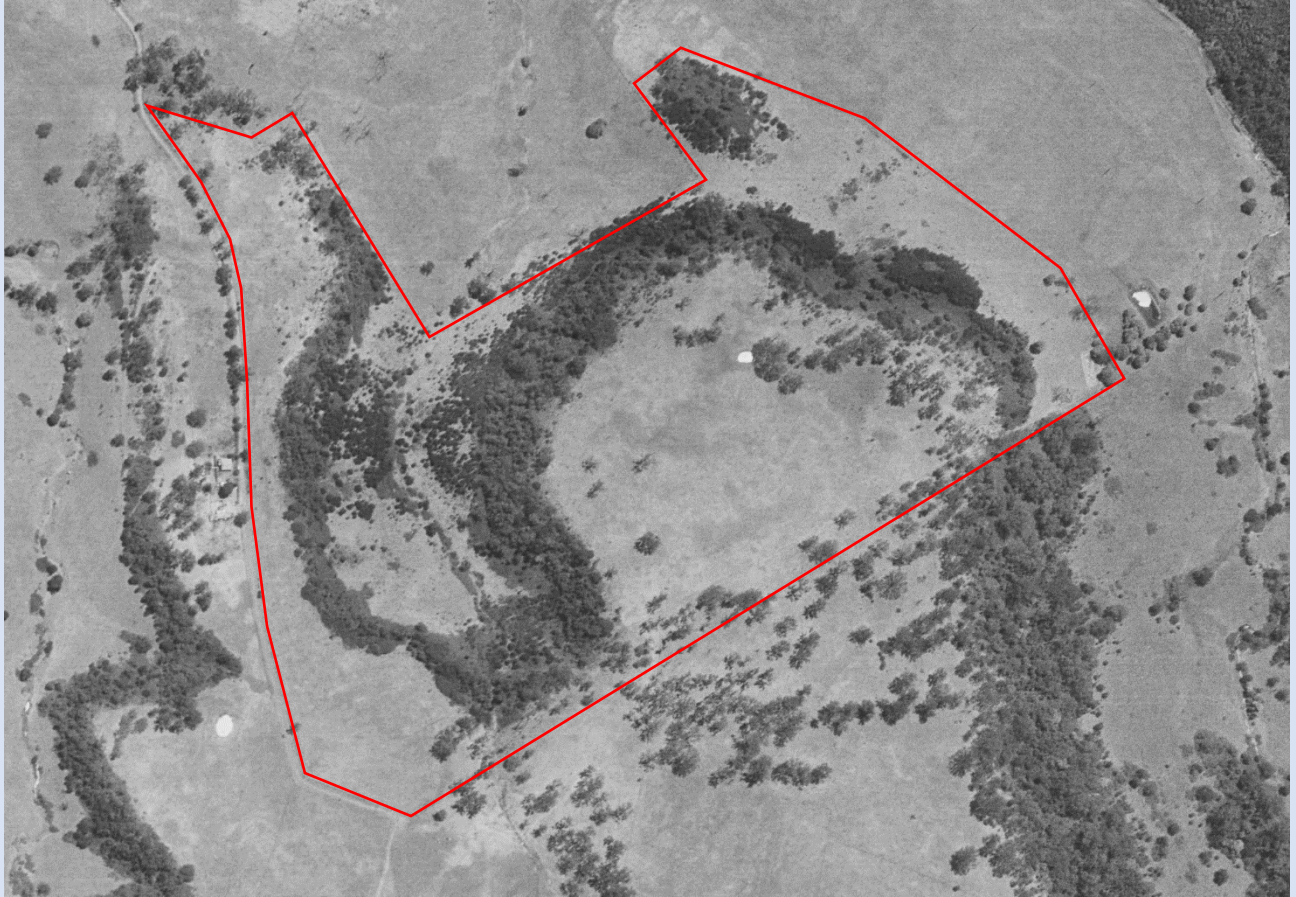
**1994— Mixed rural land and bushland. No structures on the Site. No significant change since 1984.**

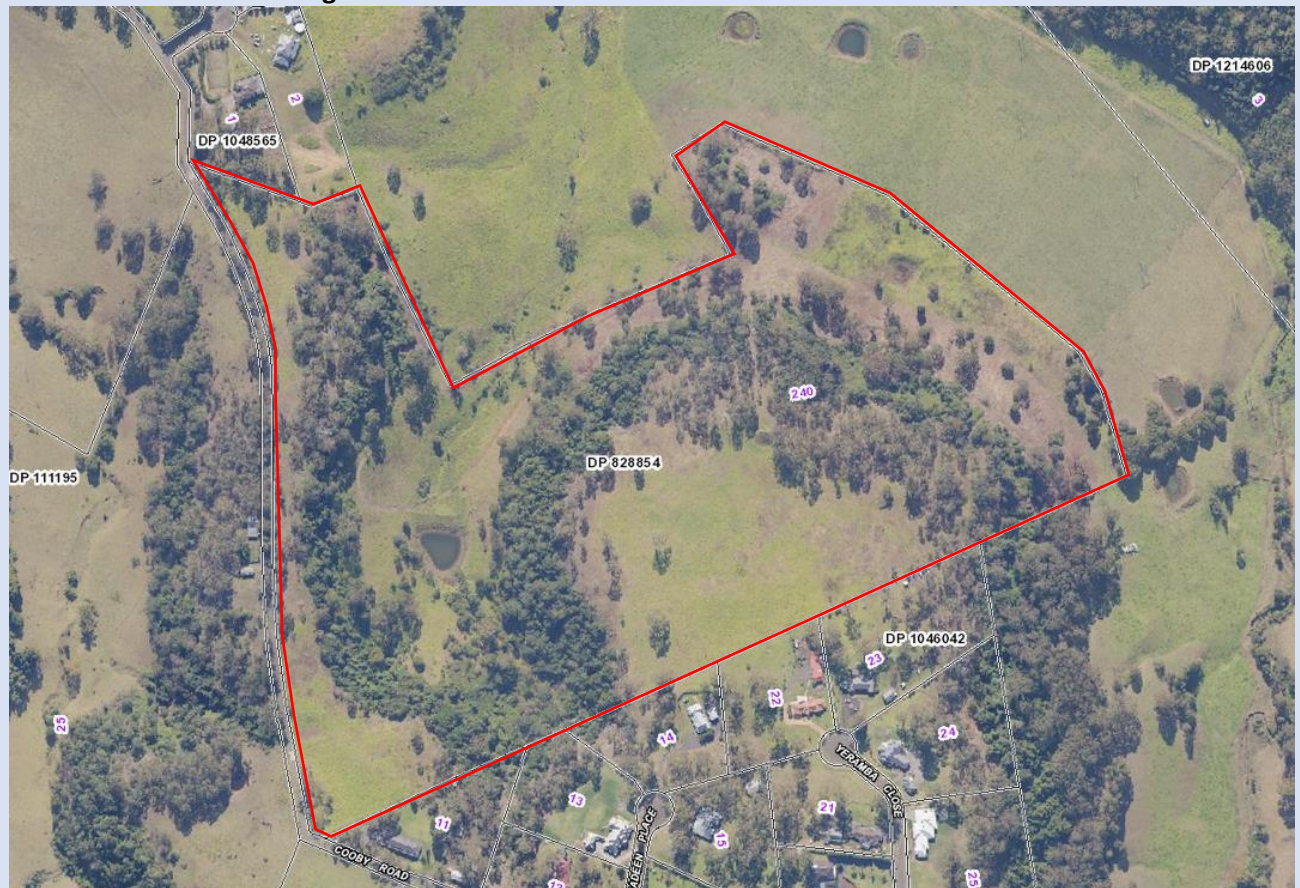
**2014—Mixed rural land and bushland. No structures on the Site. No significant change at the Site since 1994. Residential dwellings were located on the southern and northern boundaries.**

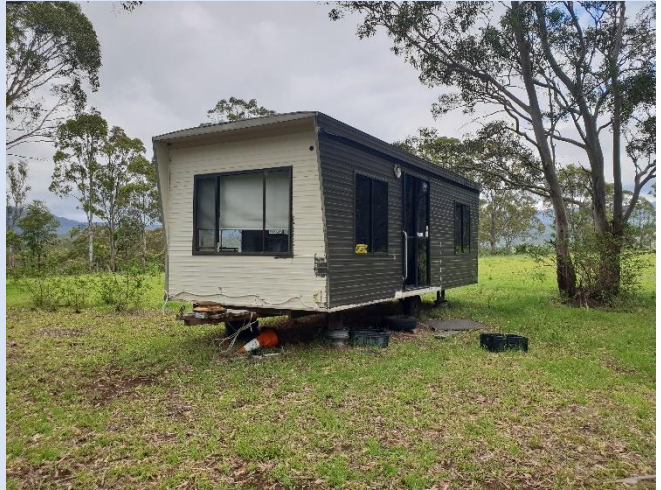
A demountable building and small corrugated iron shed were located adjacent the entry of the Site. Both structures were empty. A preliminary inspection did not identify any hazardous materials.

**Photograph 2: Demoubtale site shed**

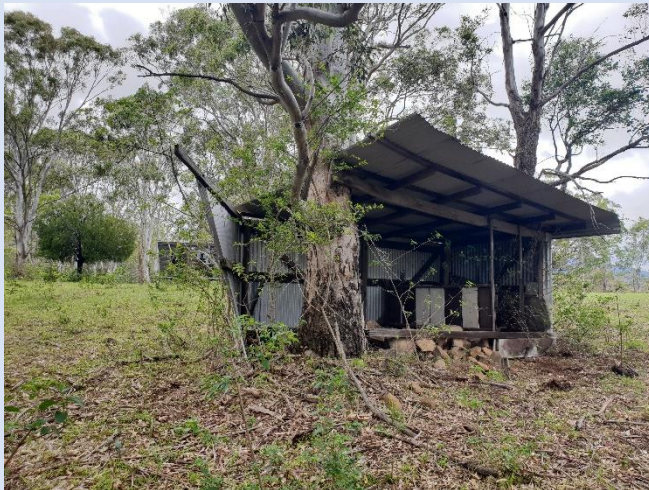
**Photograph 3: Corugated iron shed – no longer in use**

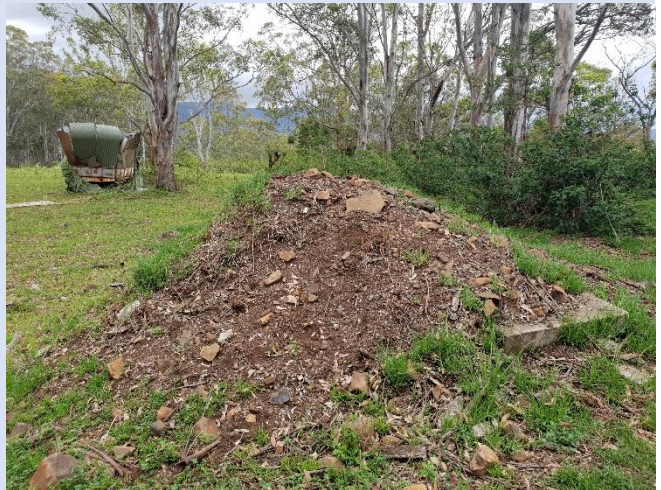
A visual inspection across the Site and specifically the storage area adjacent the Site entry did not detect any visual or olfactory evidence of contamination including but not limited to asbestos containing materials (ACM) and hydrocarbon products. Two (2) soil/gravel stockpiles approximately ~5 m<sup>3</sup> each were observed within the storage area. The inspection did not include any intrusive investigations of the stockpiles. The surface of the stockpiles as observed comprised of soil and gravel material with some cement fragments. No ACM was observed on these stockpiles.

Given the documented Site history for rural land use and observed Site conditions there is 'low' potential for the presence of significant ground contamination at the Site. No areas of Fill were observed across the Site. The two (2) stockpiles (~5 m<sup>3</sup> each) located within the storage area comprised of soil, gravel and minor concrete fragments. No visual or olfactory evidence of contamination was observed on the surface of this material.

**Photograph 4: 2x Soil Stockpiles – soil, gravel, concrete**

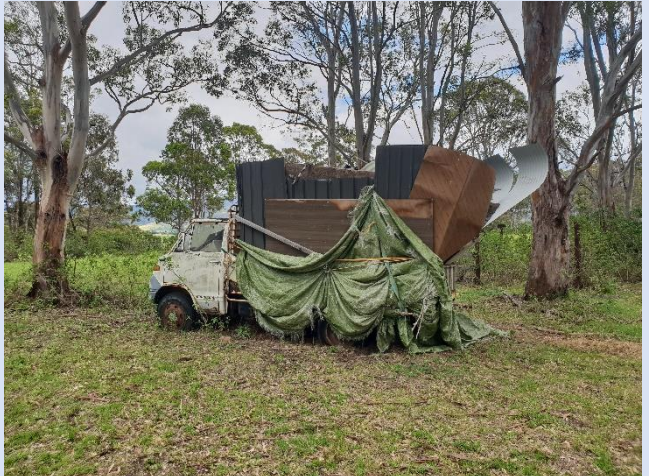
**Photograph 4: Old Truck filled with plastic sheeting**

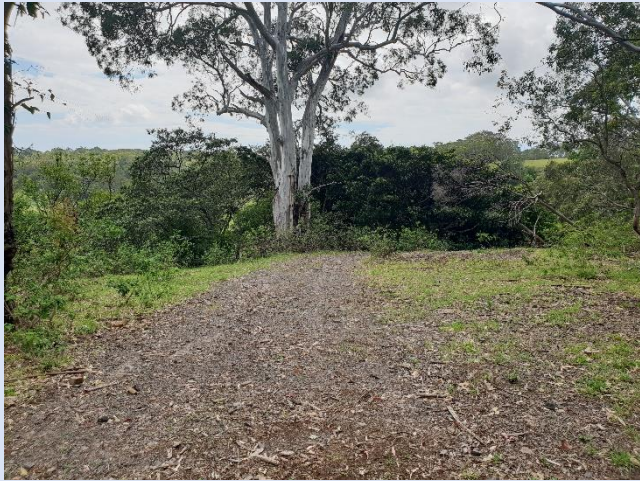
The property comprises of bushland and open paddock areas. The access track through the property was comprised of gravel and soil. No sealed surfaces were present at the Site. No oil or surface stains were noted to indicate a history of spills or chemical contamination.

**Photograph 4: Access road condition**

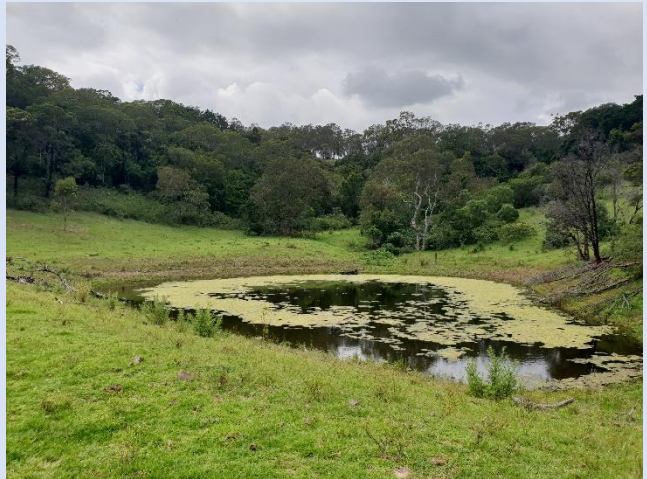
**Photograph 4: Dam within maine drainage line/gully**

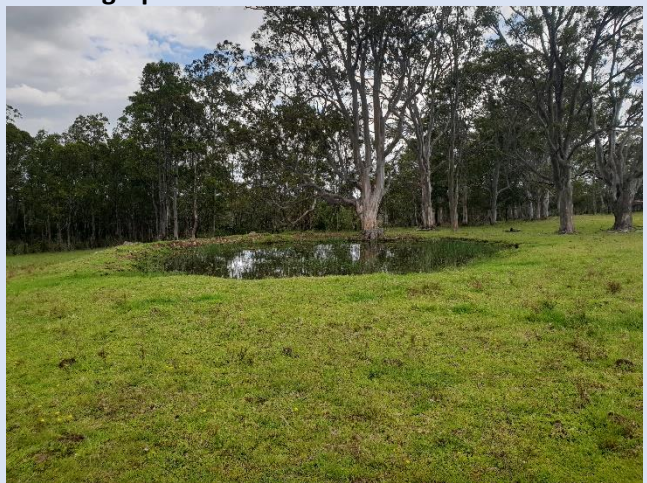
**Photograph 4: Dam within the middle of the Site**
