Preliminary (Desktop) Acid Sulfate Soil Assessment

Proposed Rezoning

Western Portion of Lot 44 DP1274452, South West Rocks

Report No. RGS20970.2-AH

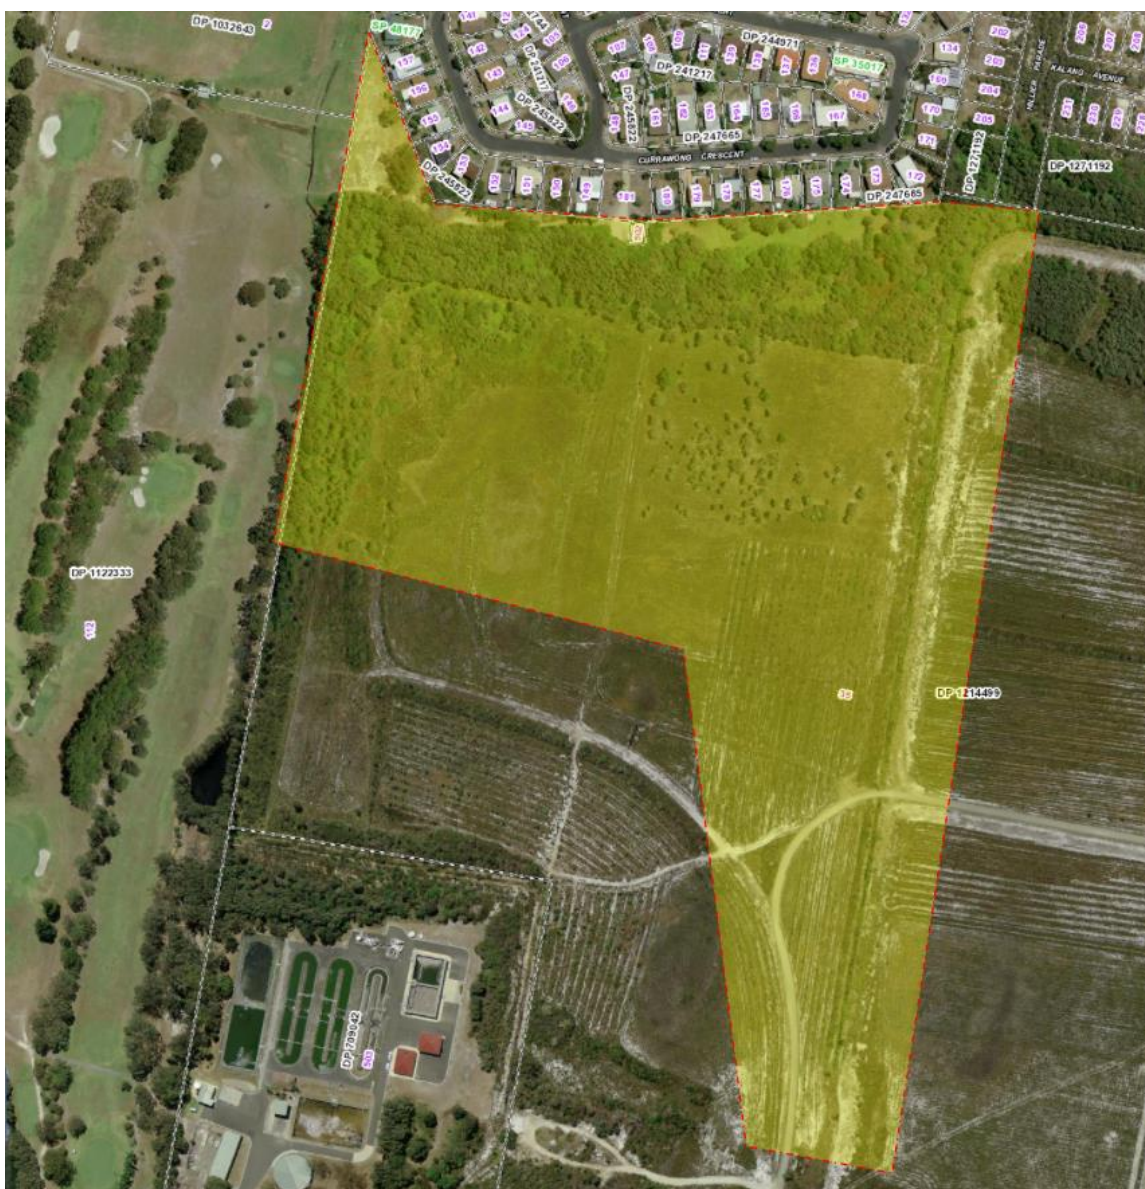
A satellite image that shows the location of the site and the site setting is reproduced in Plate 1.

The site is vegetated with thick bushes and trees along the northern boundary and northwest corner. The remainder of the site appears to have been previously cleared with some vegetation regrowth occurring. Several access tracks cross the site. An open drain is present near the eastern boundary.

Surface elevations are approximately 5m AHD along the northern boundary of the site and approximately 3m AHD in the south-east corner.
