Preliminary (Desktop) Site Contamination Assessment

Proposed Residential Rezoning

Eastern Portion of Lot 44 DP1274452, South West Rocks

Report No. RGS20970.4-AC

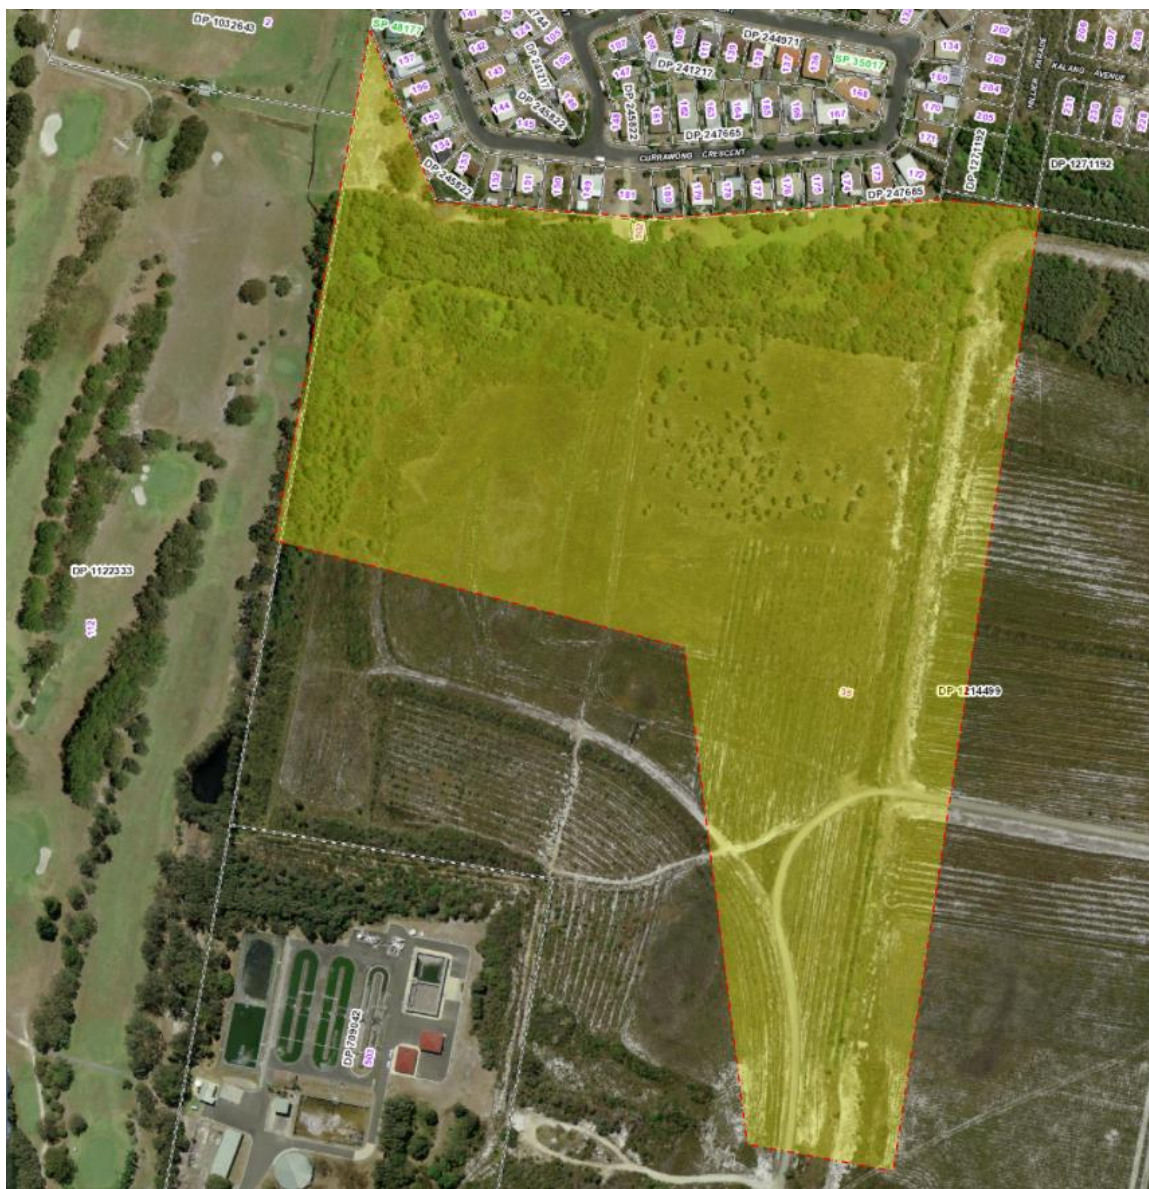
Plate 1: Satellite image dated 2012 obtained from the NSW Government 'Six Maps' website that illustrates the site location and setting. The approximate site boundaries of the subject portion of Lot 44 DP1274452 are outlined in red.

The site is vegetated with thick bushes and trees along the northern boundary and northwest corner. The remainder of the site appears to have been previously cleared with some vegetation regrowth occurring. Several access tracks cross the site. An open drain is present near the eastern boundary.

The site is bordered by a golf course to the west, residential subdivision to the north and undeveloped land to the south and east. To the north east of the site, a residential subdivision has been recently constructed where a historical fuel storage facility was previously located. The Council sewerage treatment plant (STP) is located approximately 150m to the south of the site.

Surface elevations range from approximately 8m AHD along the northern boundary where contours indicate the houses to the south of Currawong Crescent are constructed on a raised fill embankment that extends into the subject site. Surface elevations at the toe of the inferred fill batter are approximately 5m AHD along the northern boundary of the site and approximately 3m AHD in the south-east corner.

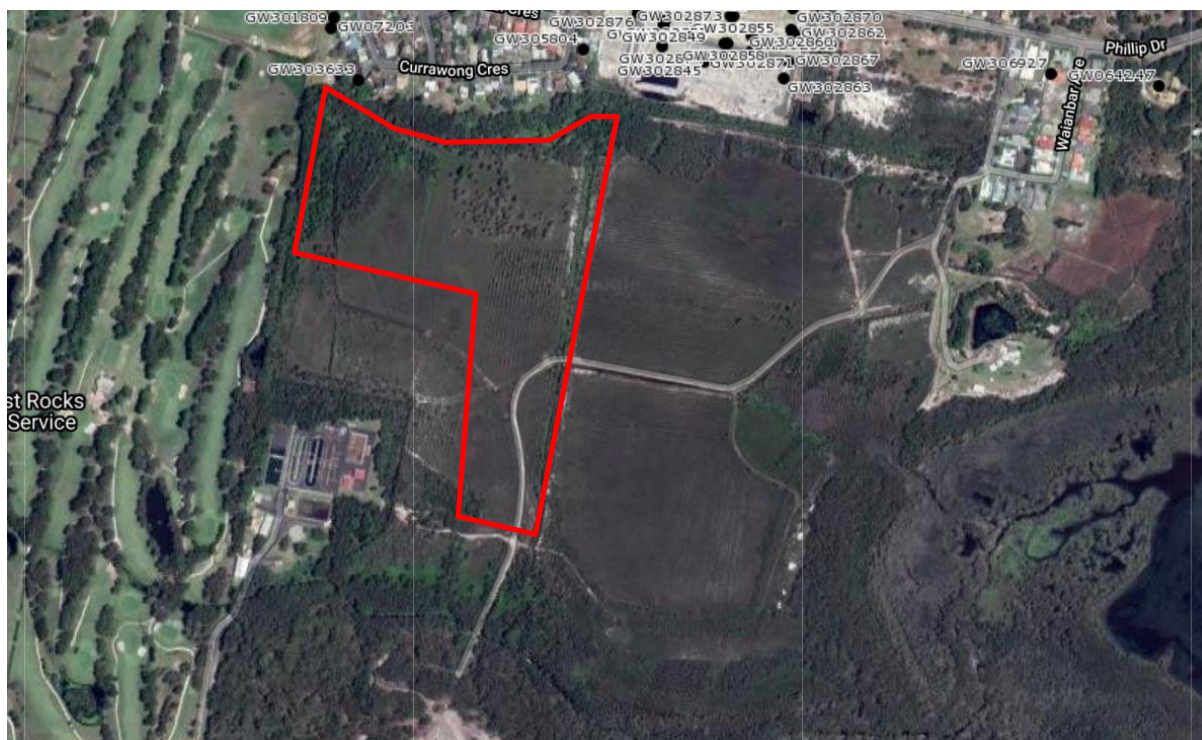
Plate 2: Licensed groundwater well locations. Approximate site boundary of partial Lot 44 DP1274452 is shown in red.

A groundwater bore search on the Water NSW website indicates that there is a large number of licensed groundwater bores within 200 m of the site boundary as shown in Plate 2, however there are no registered boreholes within the site boundary.

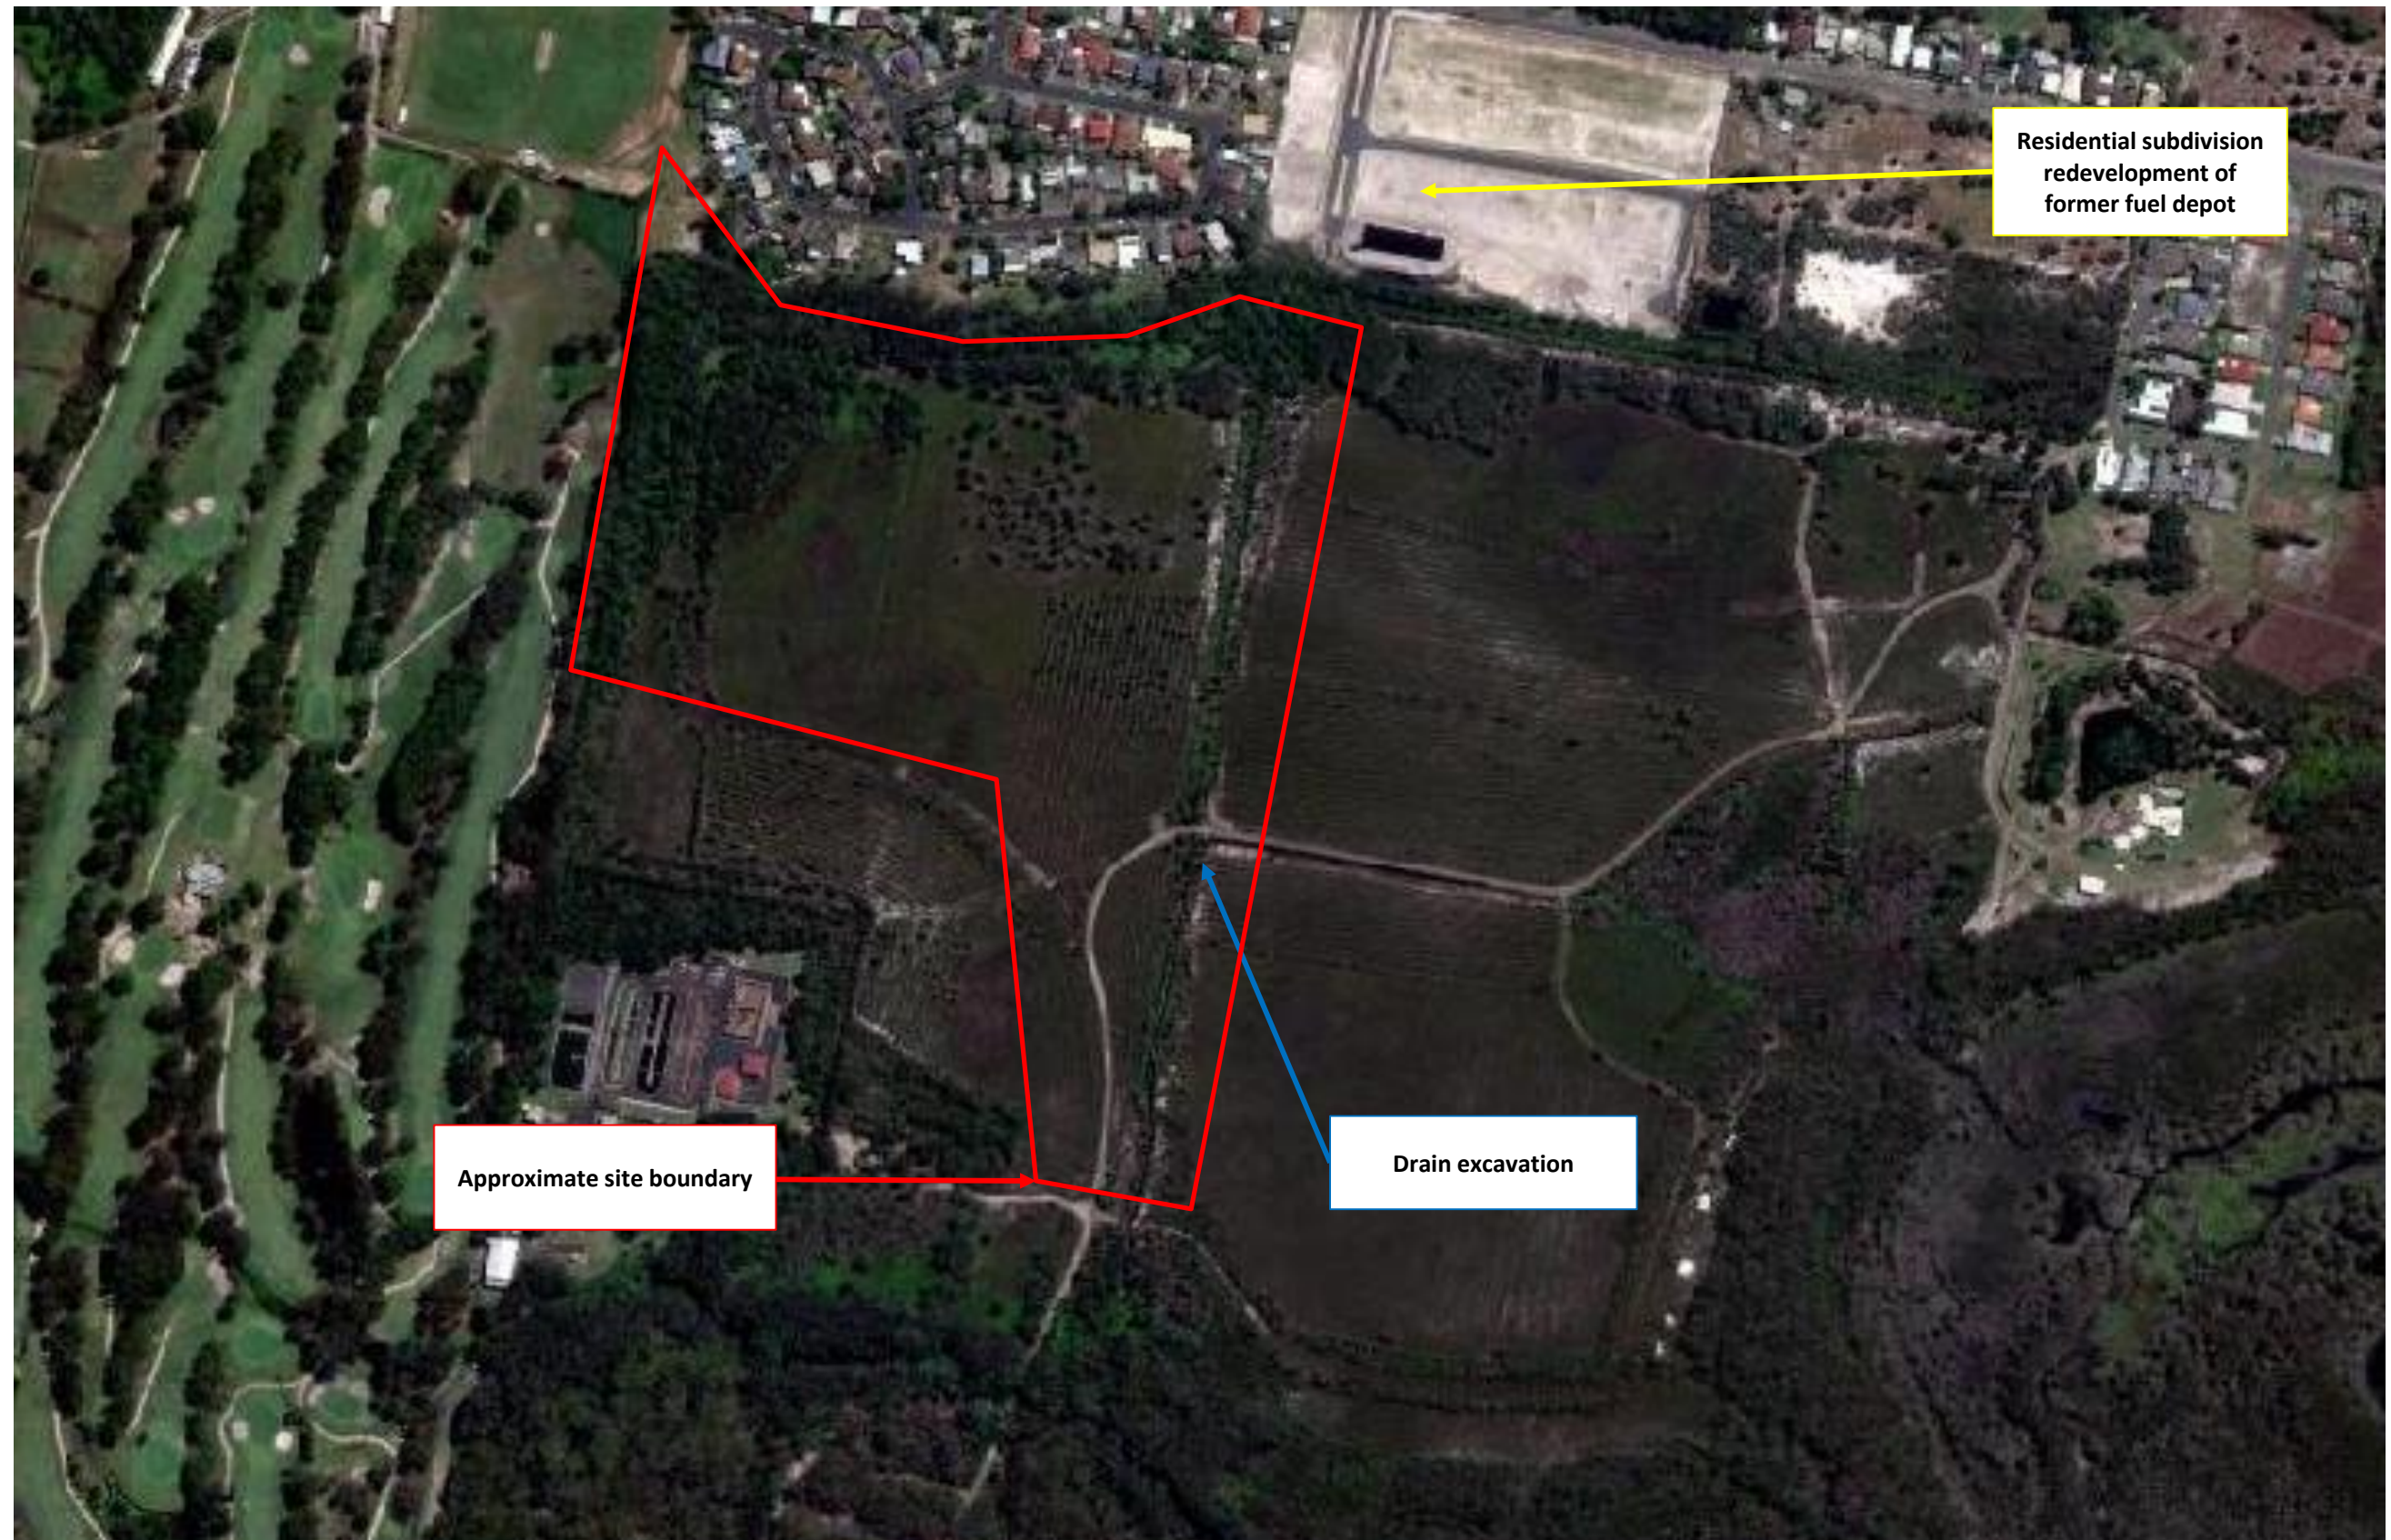
| | Title: | HISTORICAL IMAGERY 2020 | Date: | 19-Dec-21 |

| Year | Site (Lot 44 DP1274452) | Surrounding Land |
|---|---|---|
| August 2020 | From 2010 to present there are no significant changes observed. | The former fuel terminal is being redeveloped as a residential subdivision. |
