STAGE 1 PRELIMINARY SITE INVESTIGATION (PSI)

MEADOW VIEWS

Lot 2 / DP651377 & Lot A / DP382471

Prepared For: **INDESCO**
Project Number: **ENRS1486**
Date: **August 2020**

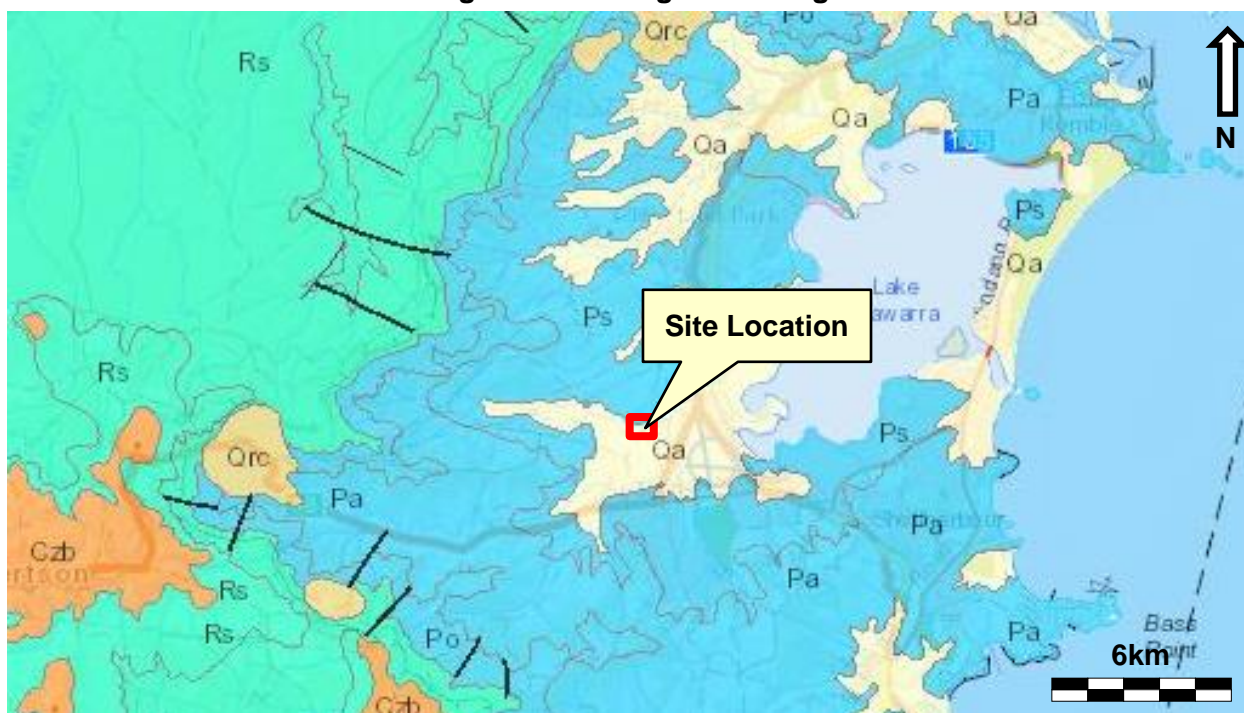
Figure 4: Geological Setting

Review of the Site's geological setting was conducted with reference to the Geoscience Australia Australian and Region Surface Geology map (1:1000000 scale) as in **Figure 4**. The Site was mapped within the floodplains of Marshall Mount Creek and Macquarie Rivulet, primarily situated on a large deposit of Quaternary Alluvium (Qa, sand and clay deposits). The northern boundary of the Site is underlain by Permian sedimentary (Ps) and low-grade metamorphic rocks which are part of the Shoalhaven Group and known as the Berry Formation.

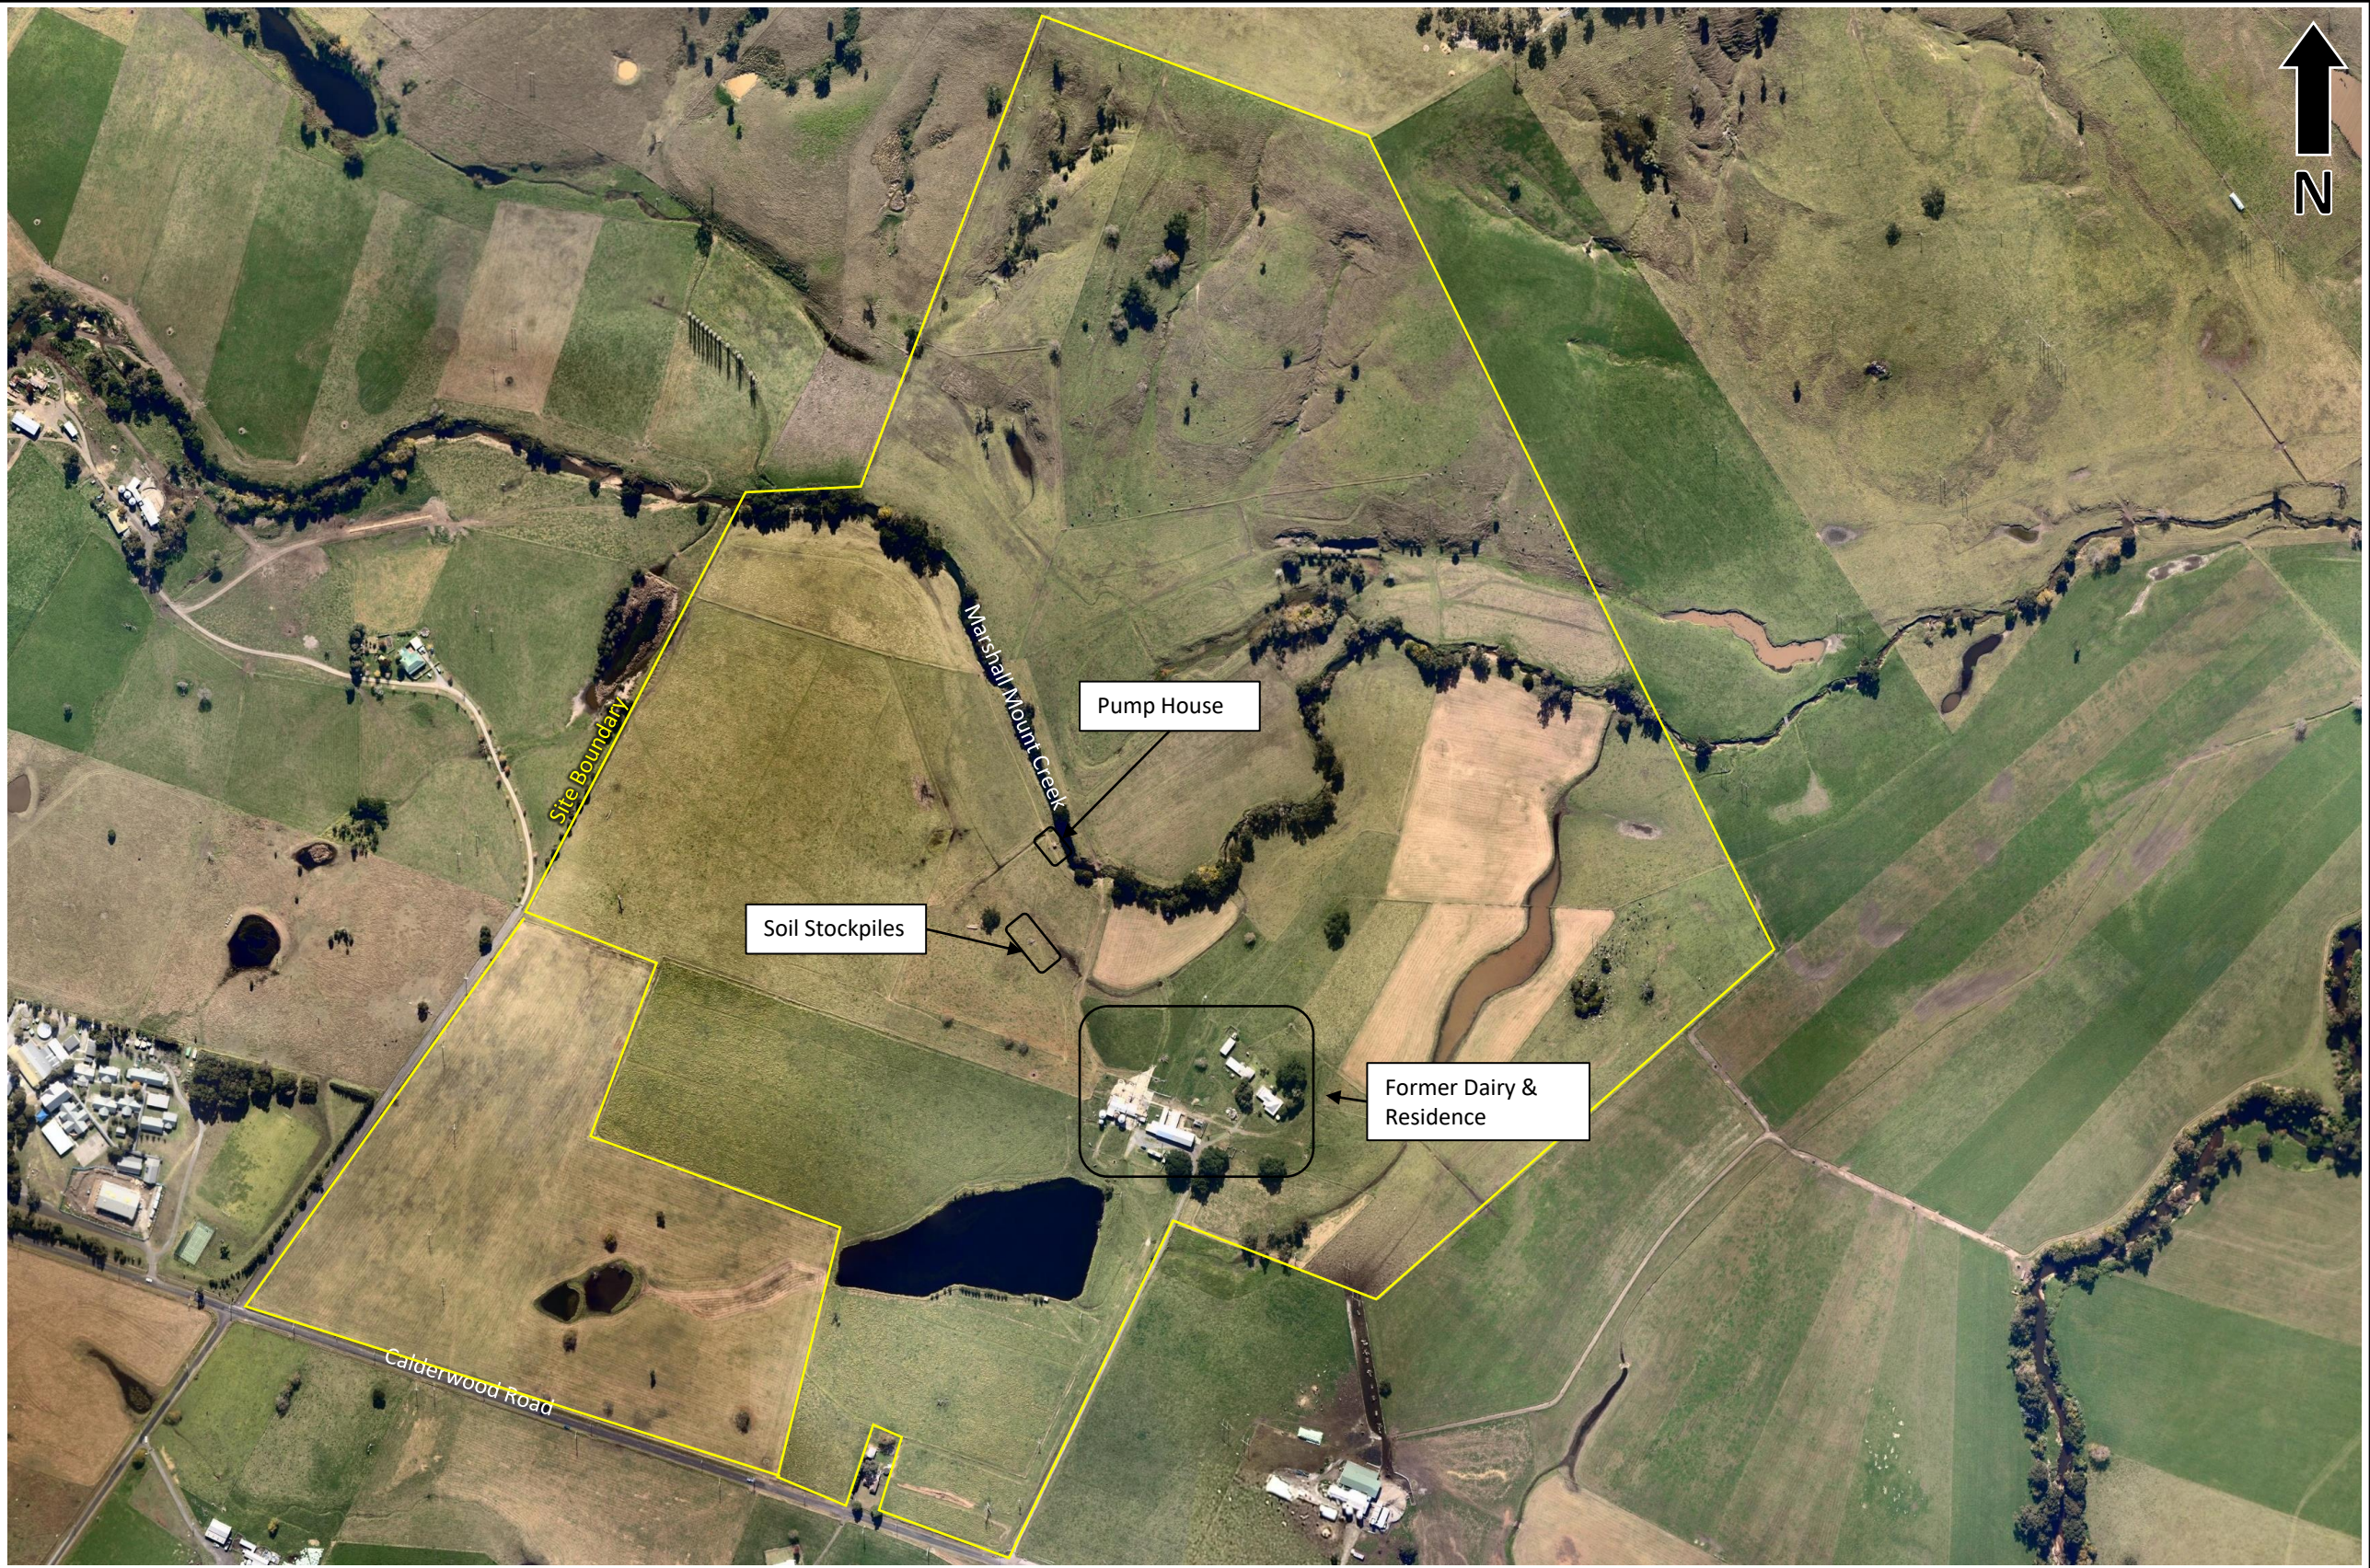
Client:	INDESCO	Drawn:	MT / TB	Figure:	7
Project:	ENRS1486	Source:	Nearmap	Date:	As reported
Location:	Lot/DP 2/651377 & A/DP382471, Calderwood, NSW	Scale:	NTS	Title:	Site Plan & Layout
		Status:	Rev 1

The following points outline the site activities and layout identified at the time of this investigation. A site layout plan is provided in **Figure 7**.

The Site is located on the northern side of Calderwood Road, approximately 2.5km west of Albion Park, as shown in **Figure 1**. A detailed Site plan is provided in **Figure 7** attached. The key features required to identify the Site are summarised in **Table 1** below.

A review of historical aerial imagery found changes in buildings and structures on the Site since circa 1970. Additional buildings were considered to be associated with the expansion of the dairy. No buildings were observed to be removed from the Site through the review of the historical aerials. The residential dwelling has remained consistent since the 1963 imagery. A Site plan with building locations is provided within **Figure 7** attached.

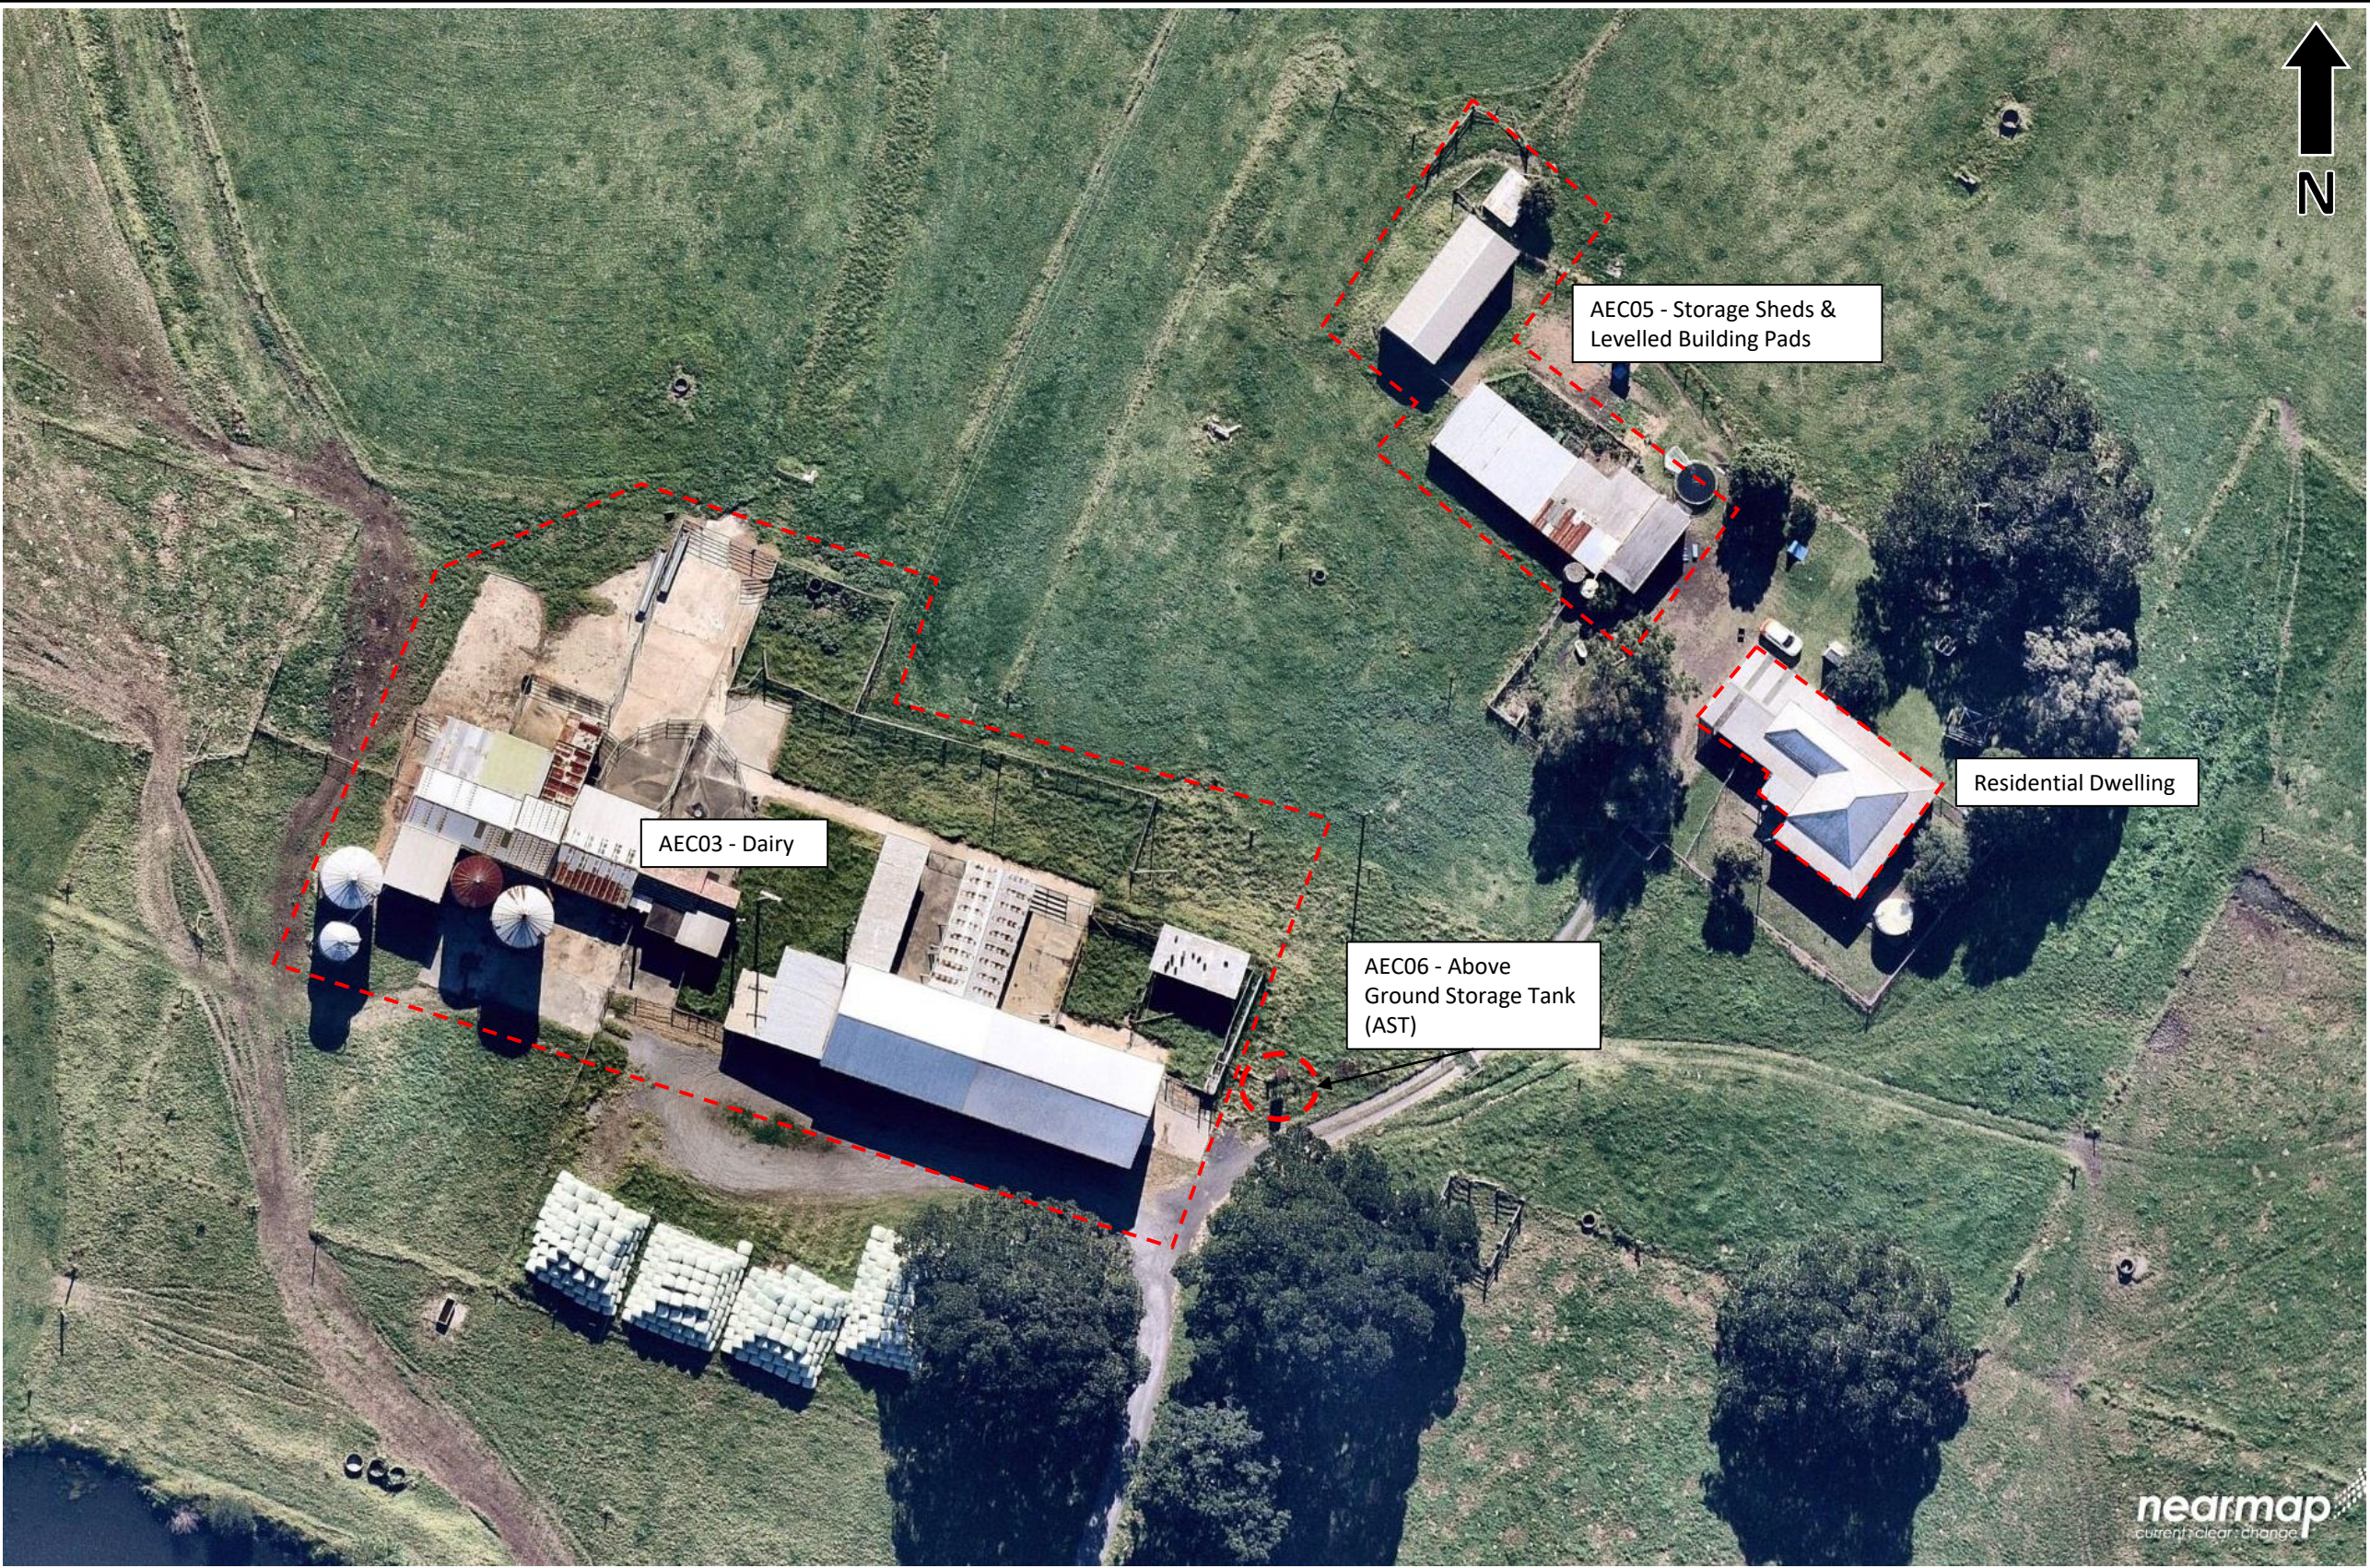
- AEC04: Pumphouse. Storage of old oil drums;
 - AEC05: Levelled Building Pads. Uncontrolled fill used beneath some of the buildings;
 - AEC06: Above Ground Storage Tank (AST). Leaks and spills directly adjacent and below the AST may have caused shallow soil contamination;

Based on Site description documented in **Section 2.0**, Site history documented in **Section 3.0** and current land use, the identified Areas of Environmental Concern (AECs) are outlined in **Table 5** below. AECs locations are provided in **Figure 8**, **Figure 9** and **Figure 10**.

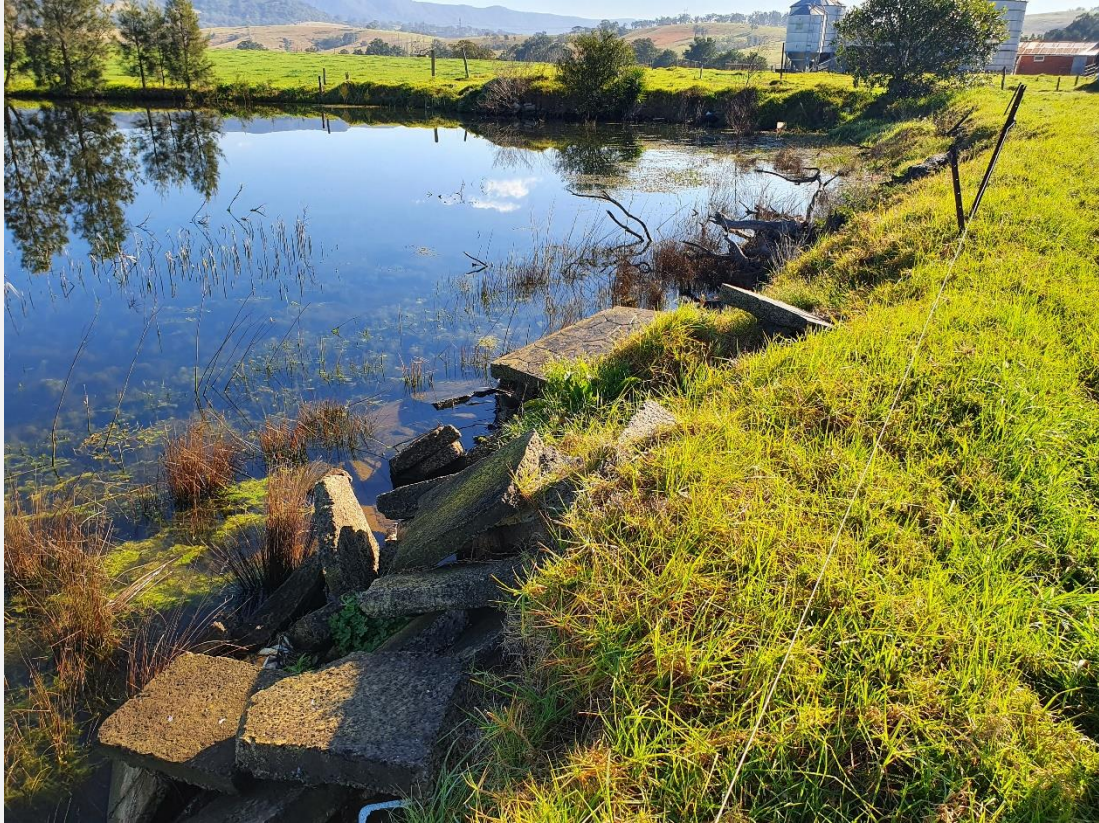
- The Areas of Environmental Concern (AECs) identified during this investigation are summarised below:
 - AEC01: Storage Dam Wall. The majority of material within the dam wall is expected to be natural, excavated from the centre of the dam during its construction. However, localised piles of crushed concrete were observed within small portions of the wall. It is considered that there may be a risk of further unknown building materials;

Dam Wall

- Conduct a Detailed Site Investigation (DSI) to assess the Areas of Environmental (AECs) identified within this PSI. The DSI should be conducted by a suitably licenced environmental professional in accordance with the NSW EPA Guidelines for Consultants Reporting on Contaminated Sites (OEHS,2020) in support of a future Development Application;
- Prior to the demolition of Site infrastructure, conduct a Hazardous Materials Survey (HAZMAT). The HAZMAT should be conducted by a suitably licenced environmental consultant holding a current asbestos assessor's licence;

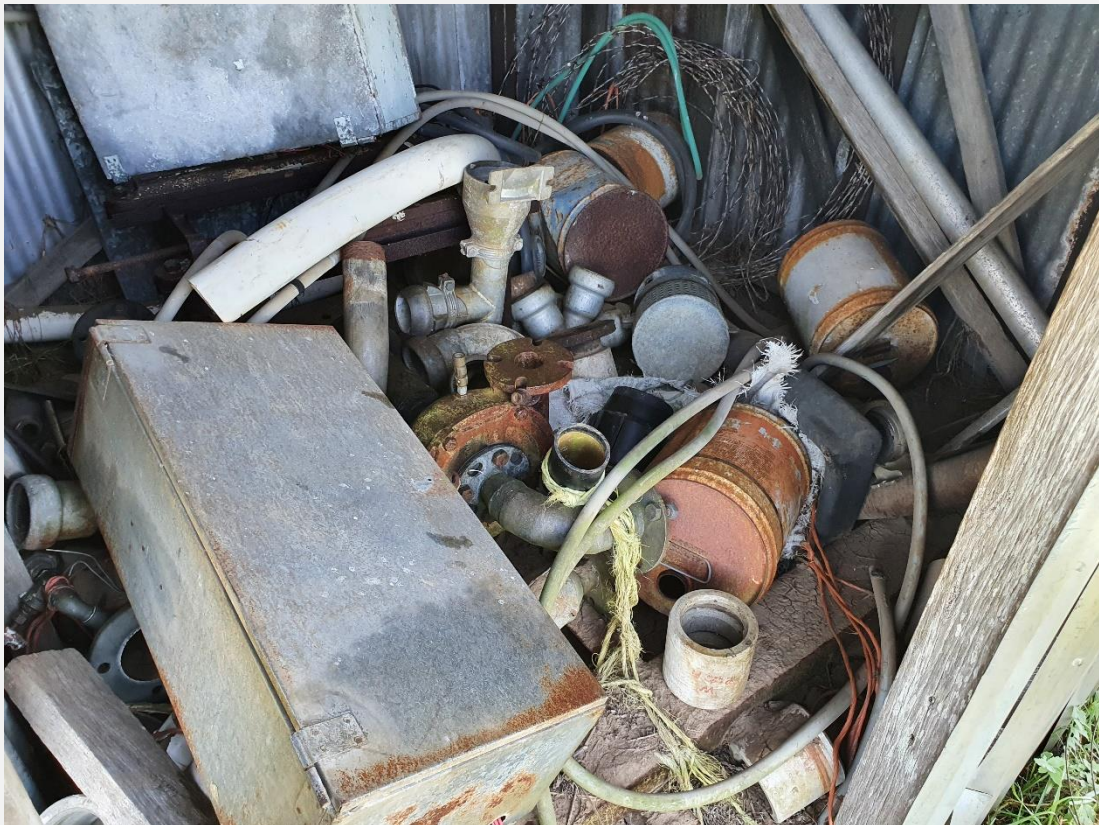
Small stockpiles of construction debris were located within the farming pastureland approximately 180m north-west of the dairy yards. One (1) corrugated iron pumphouse was also observed within this area, adjacent to Marshall Mount Creek. Discarded fuel storage drums and electrical boxes were observed in the pumphouse.

Pump House

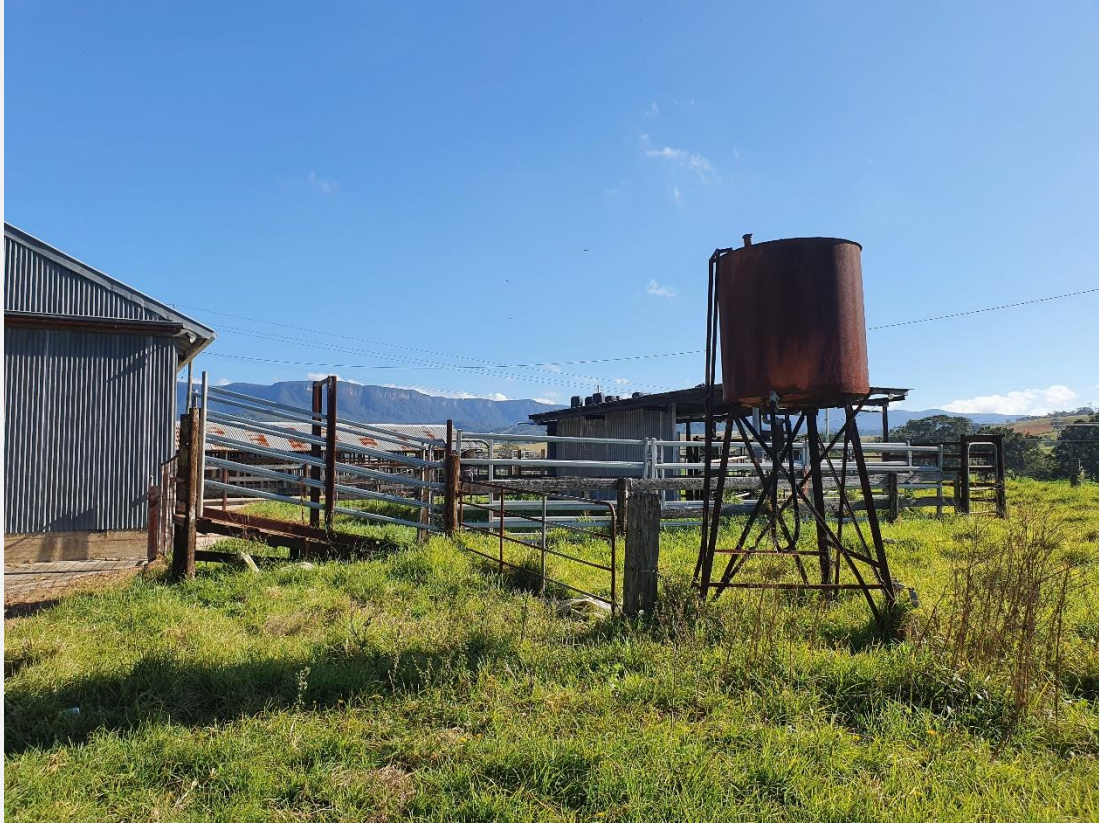
The Site inspections conducted by ENRS on the **24th of July 2020** identified an Above Ground Storage Tank (AST) adjacent the dairy area. The AST was observed in a non-functioning condition. The AST was assumed to be used for the re-fuelling of farming machinery. The site walkover did not identify any evidence of Underground Storage Tanks (USTs) at the Site.

An above ground storage tank was located adjacent the eastern entrance of the dairy. It did not show evidence of current use. The base area of the AST was covered in grass with no evidence of surface staining or spills visible.

Above Ground Storage Tank (AST)

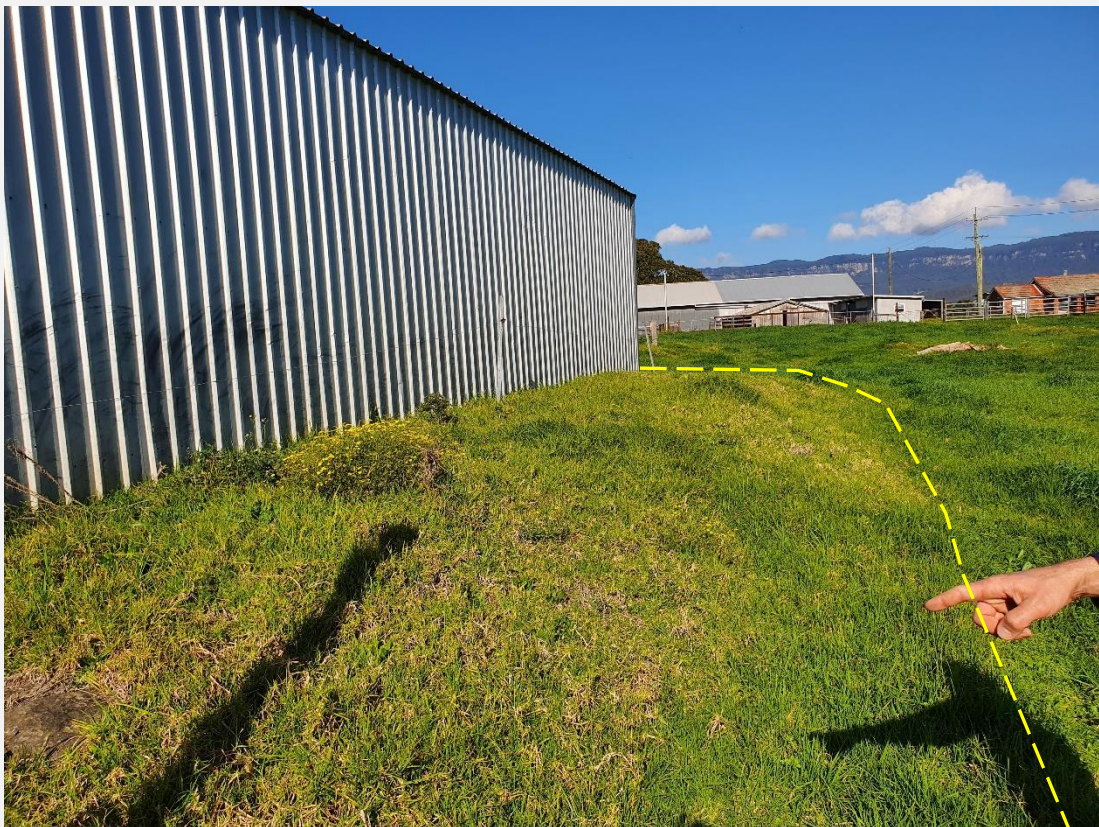
Levelled Building Pad

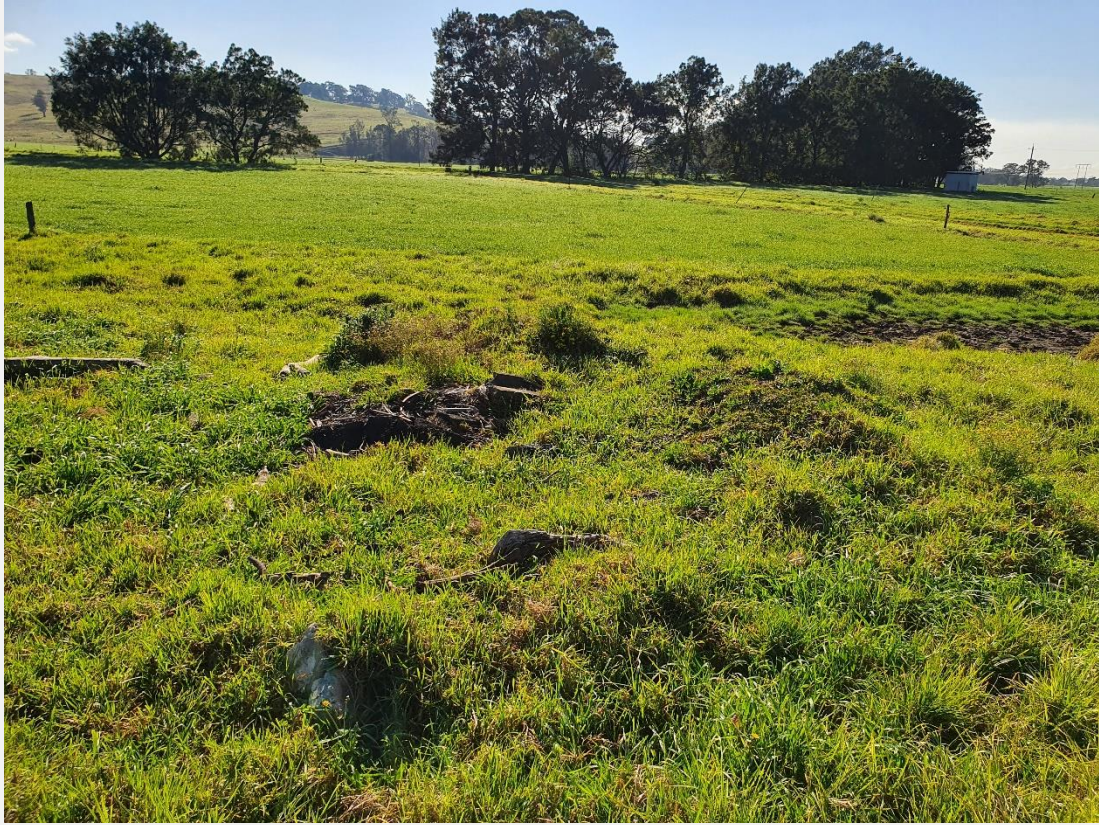
Soil Stockpiles

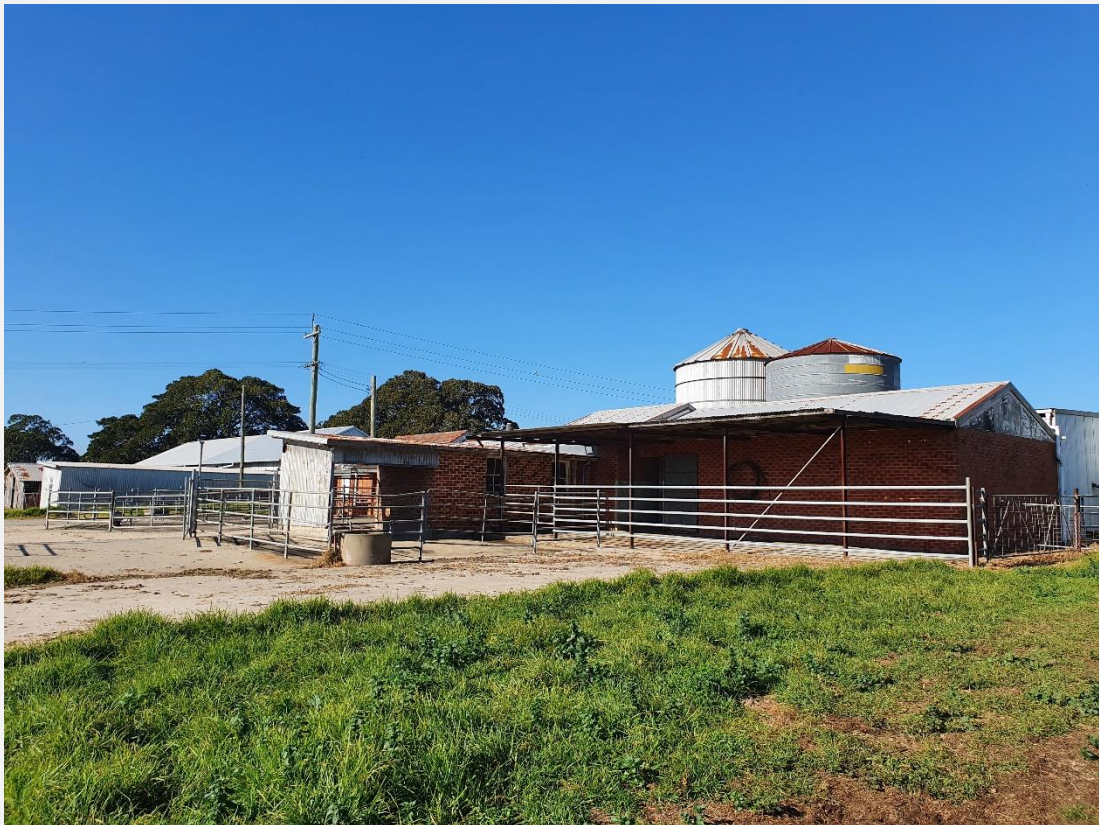
The dairy infrastructure adjacent to the house consisted of multiple large areas of sealed concrete, sheds and fencing for dairy farming practices. Storage silos and dairy milking areas were also present. Dairy buildings were generally clad in corrugated iron. However, timber and other materials were also observed. Storage of farming machinery, dairy production machinery and chemicals associated with machinery and farming practices were found in the storage barns.

Dairy

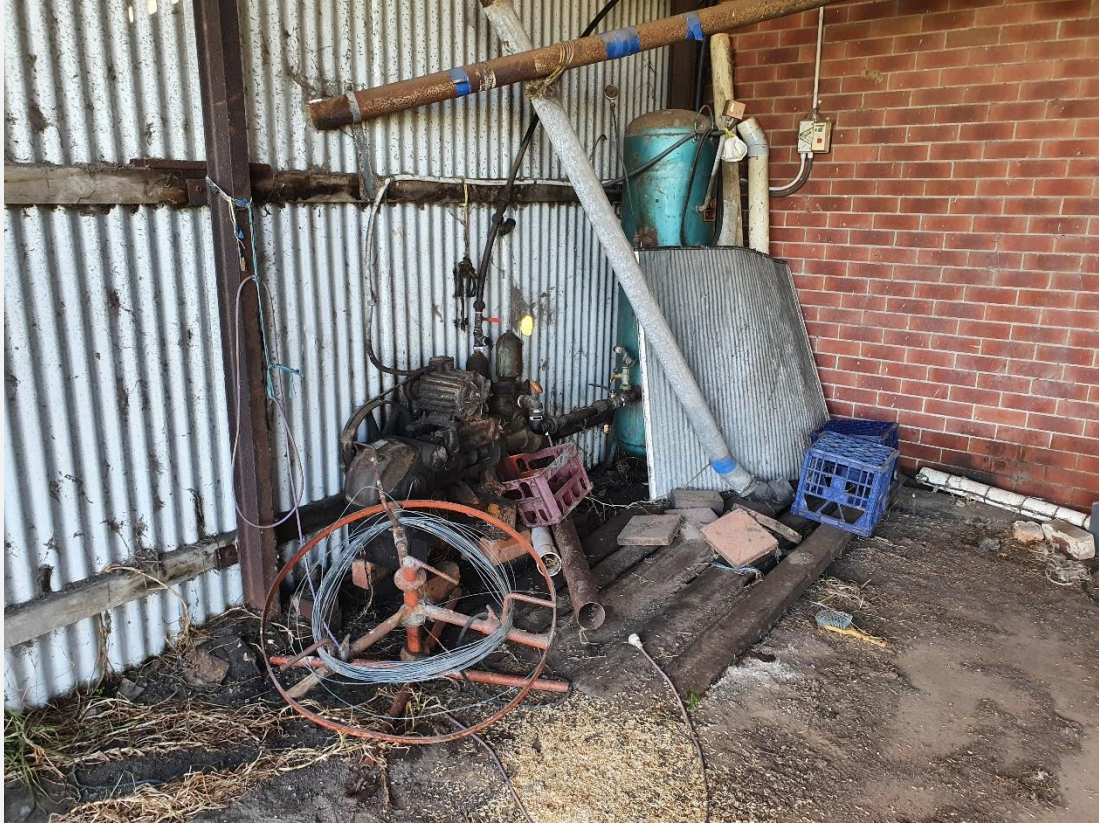
Dairy – Pump with surface oil spills

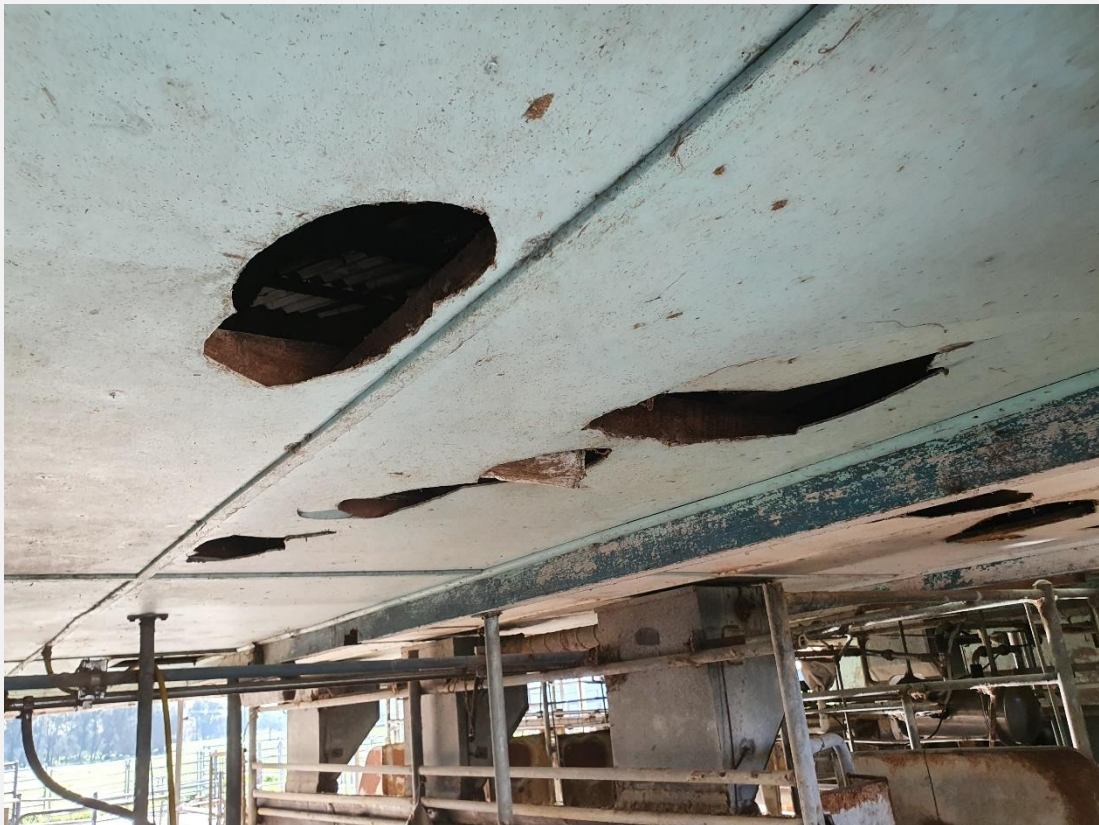
This investigation did not comprise of a detailed Hazardous Materials Survey (HAZMAT). The site inspection included preliminary visual investigation for asbestos containing materials (ACM). The dairy yard buildings and storage barns were observed to contain fibro sheeting within internal areas. Given the ages of the buildings, the fibro sheeting was presumed to contain asbestos materials. The residential dwelling residence was not accessible at the time of the inspection.

Dairy – Suspected ACM

- Prior to the demolition of Site infrastructure, conduct a Hazardous Materials Survey (HAZMAT). The HAZMAT should be conducted by a suitably licenced environmental consultant holding a current asbestos assessor's licence;

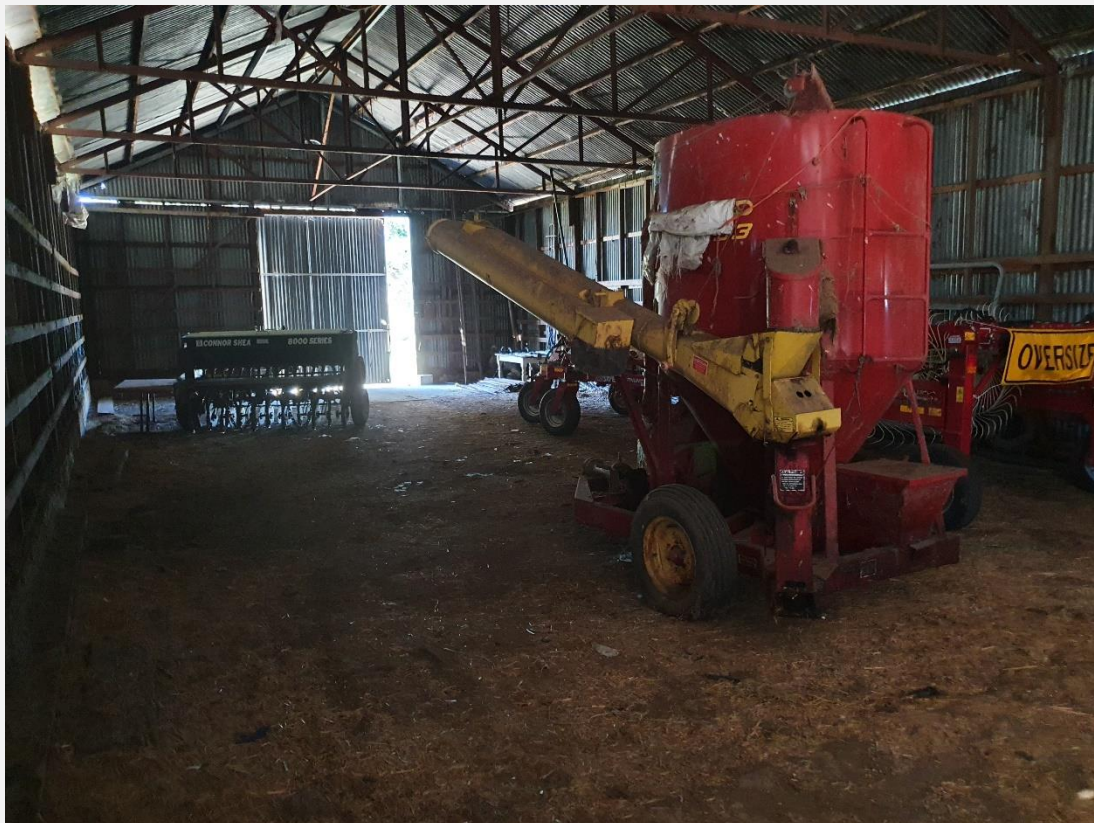
Dairy – unsealed storage area

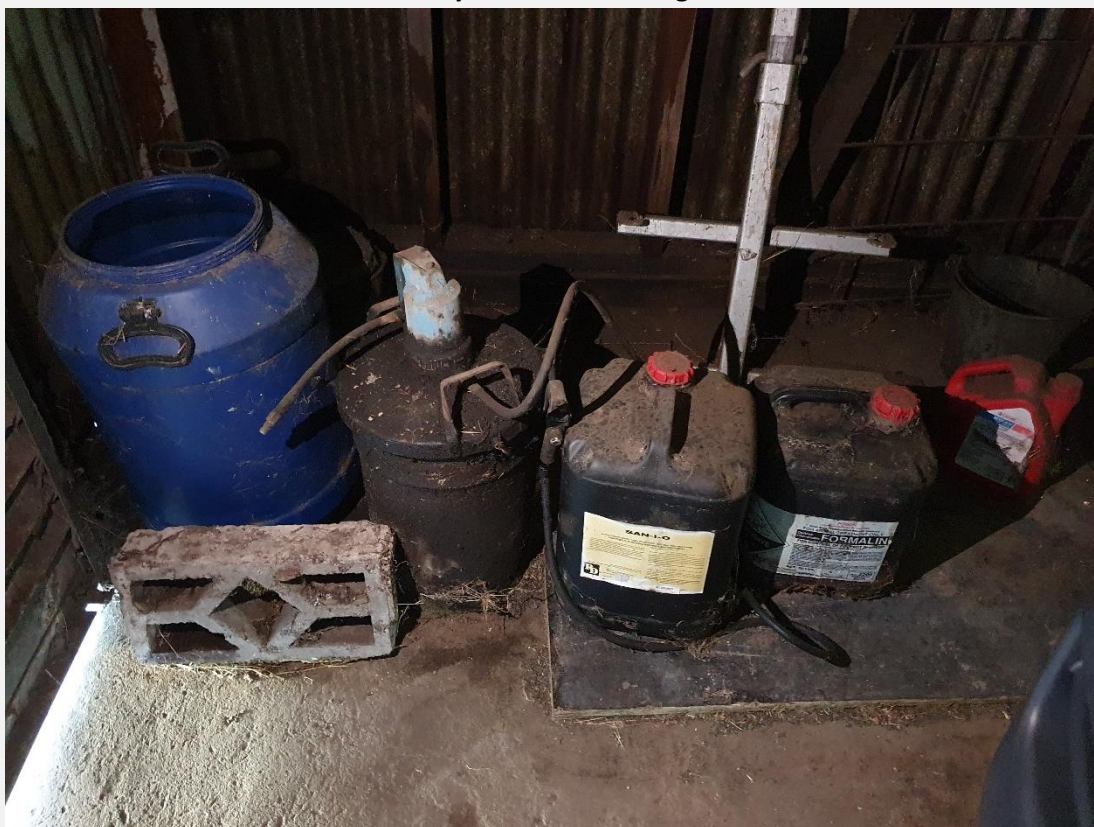
Storage of chemicals and machinery associated with dairy farming was evident within and around the dairy buildings. Adjacent to dairy yards, an above ground fuel storage tank was observed. An effluent trap and septic tank for the dairy yard were located on the north side of the dairy. Dairy yards and storage barns contained construction material which were presumed to be ACM.

Dairy – Chemical storage

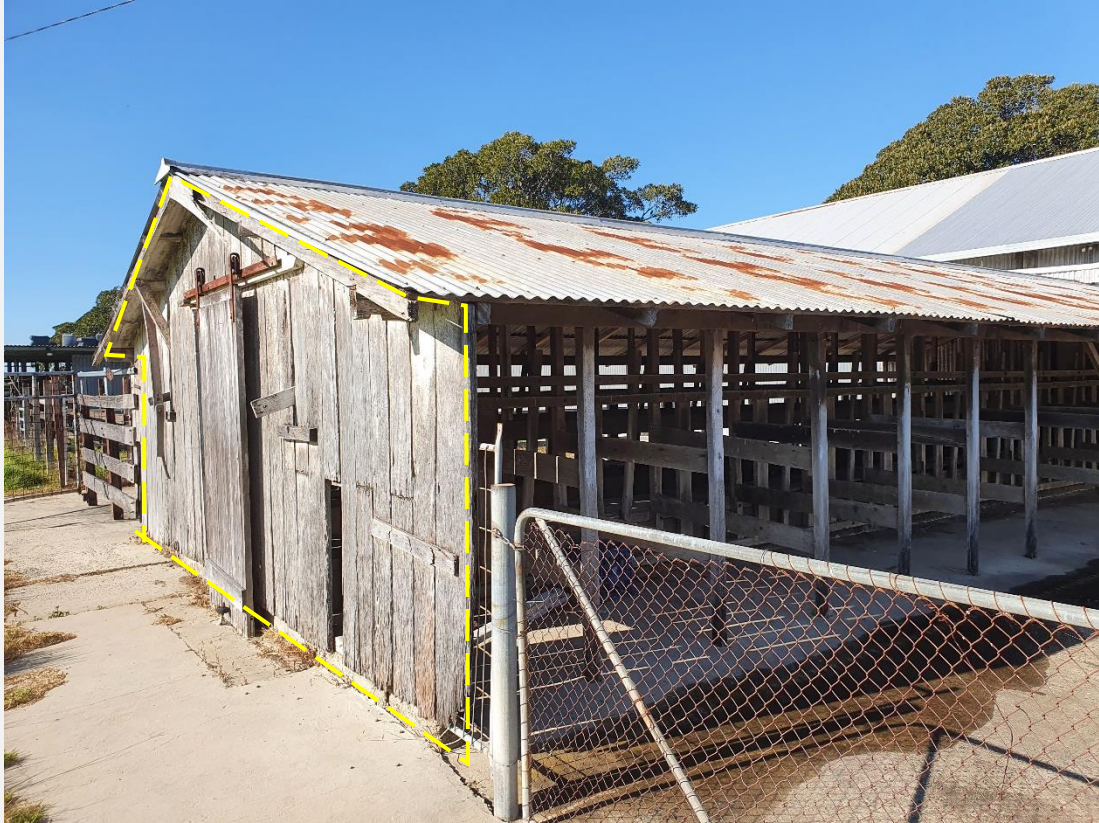
Lead within domestic paints was restricted circa 1969 (AS/NZS 4361.2:2017). Given that some permanent buildings or structures were present at the Site prior to this time, it is assumed that heavy metal-based paints may be present within site infrastructure. Flaky paint was observed on external structures of the dairy.

Dairy – Flaking Paint

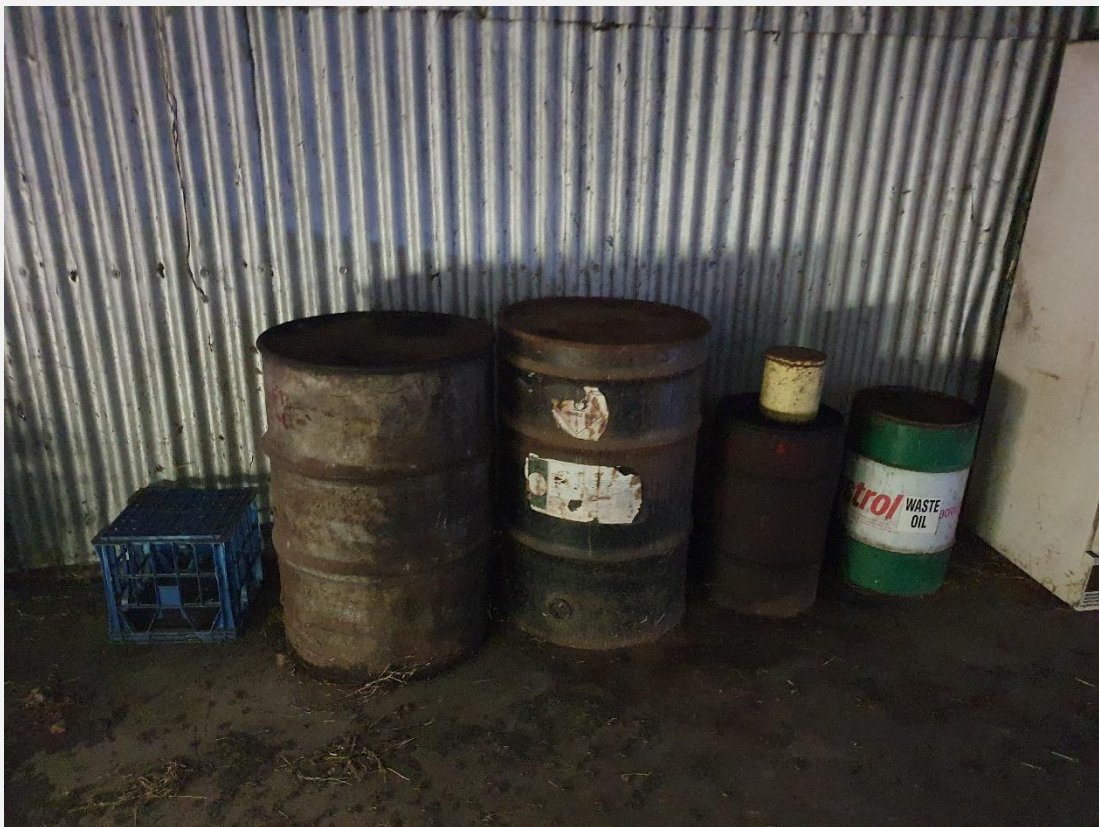
Diary - Chemical & Oil Storage
