## Geotechnical Investigation

The Hills Bowling Club, Baulkham Hills

Report No: E24782.G03

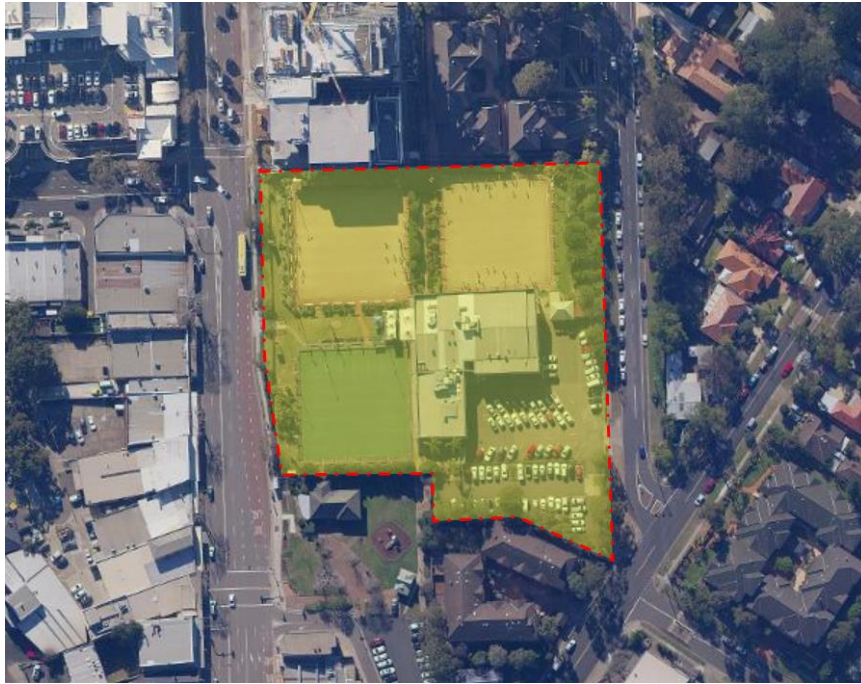
**Plate 1:** Aerial photograph of the site (source: SIX Maps, accessed 27/8/20)

| Information | Detail |
|---|---|
| Brief Site Description | <p>At the time of our investigation, the site was occupied by The Hills Club, consisting of a two storey concrete, brick and metal clubhouse located in the central portion of the site. Surrounding the clubhouse were three bowling greens located in the northern and eastern portions of the site, with an asphalt paved carpark to the south east of the clubhouse.</p> <p>Various retaining walls were observed across the site, retaining garden areas and pathways. A mortared brick retaining wall of up to 3.00m height in good condition was observed in the southern portion of the site retaining a carpark area.</p> <p>Between the two northern bowling greens was a stepped garden area, retained with several timber and mortared sandstone retaining walls of approximately 1.00m to 2.00m in height. The north western bowling green is approximately 4.90m higher than the north eastern bowling green.</p> <p>Along the eastern boundary of site was a mortared brick retaining wall of approximately 1.00 to 2.00m in height, with a vegetated earth embankment of up to approximately 4.00m in height above.</p> |

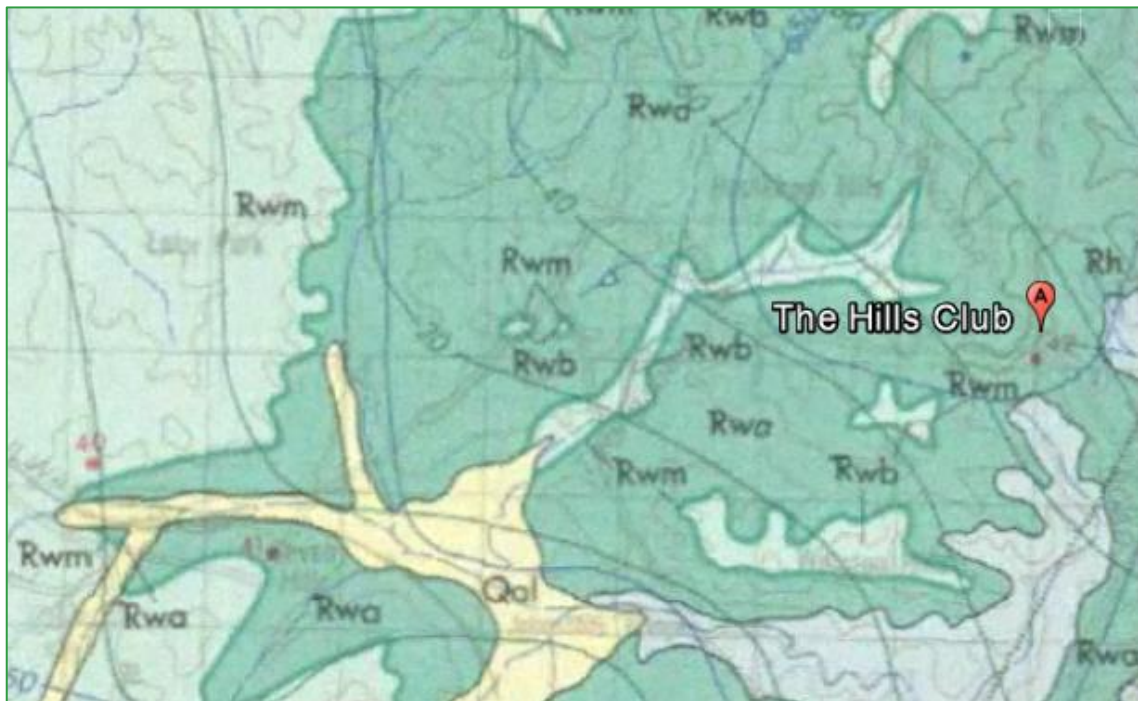
**Plate 2:** Excerpt of geological map showing location of site.

| Attribute | Description |
|---|---|
| <b>Regional Geology</b> | Information on regional sub-surface conditions, referenced from the Department of Mineral Resources Geological Map Penrith 1:100,000 Geological Series Sheet 9030 (DMR 1991) indicates the site to be underlain by Ashfield Shale (Rwa), which consists of black to dark grey shale and laminite. |

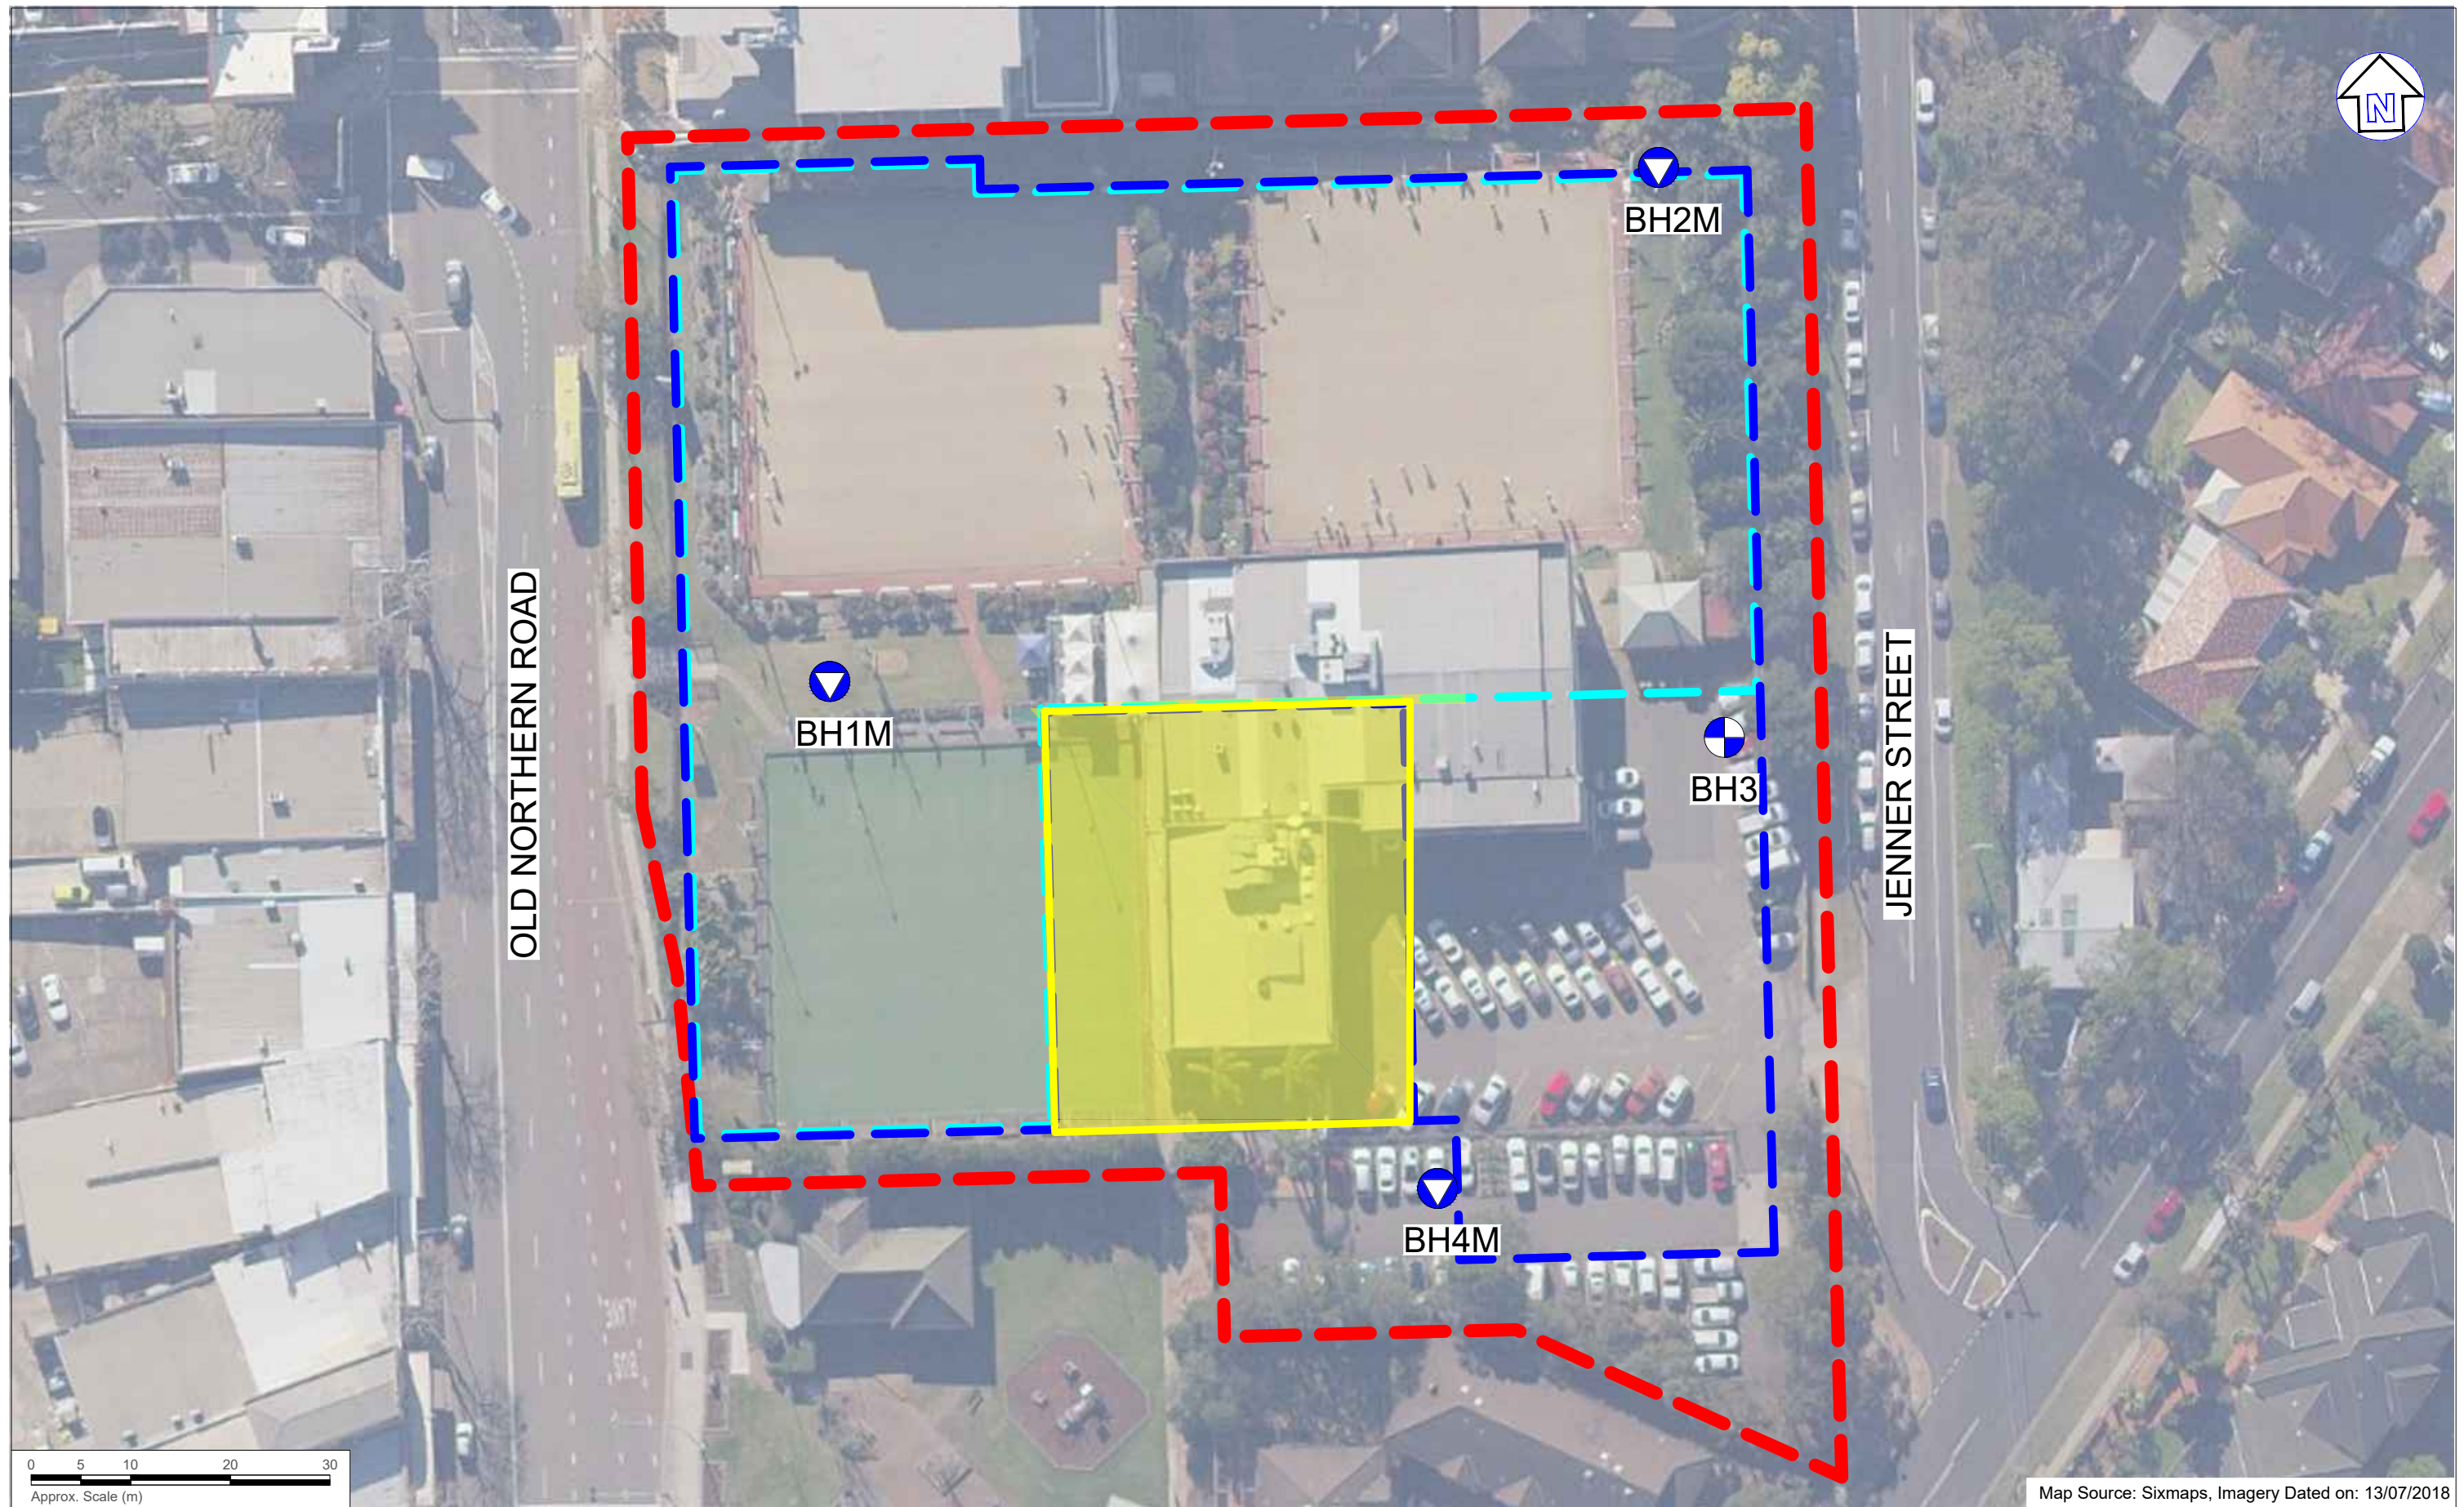
Figure 2      Borehole Location Plan

- Approximate site boundary
- Approximate basement 2 boundary
- Approximate basement 3 boundary
- Approximate undercover bowling green boundary
- Approximate borehole location
- Approximate borehole/monitoring well location

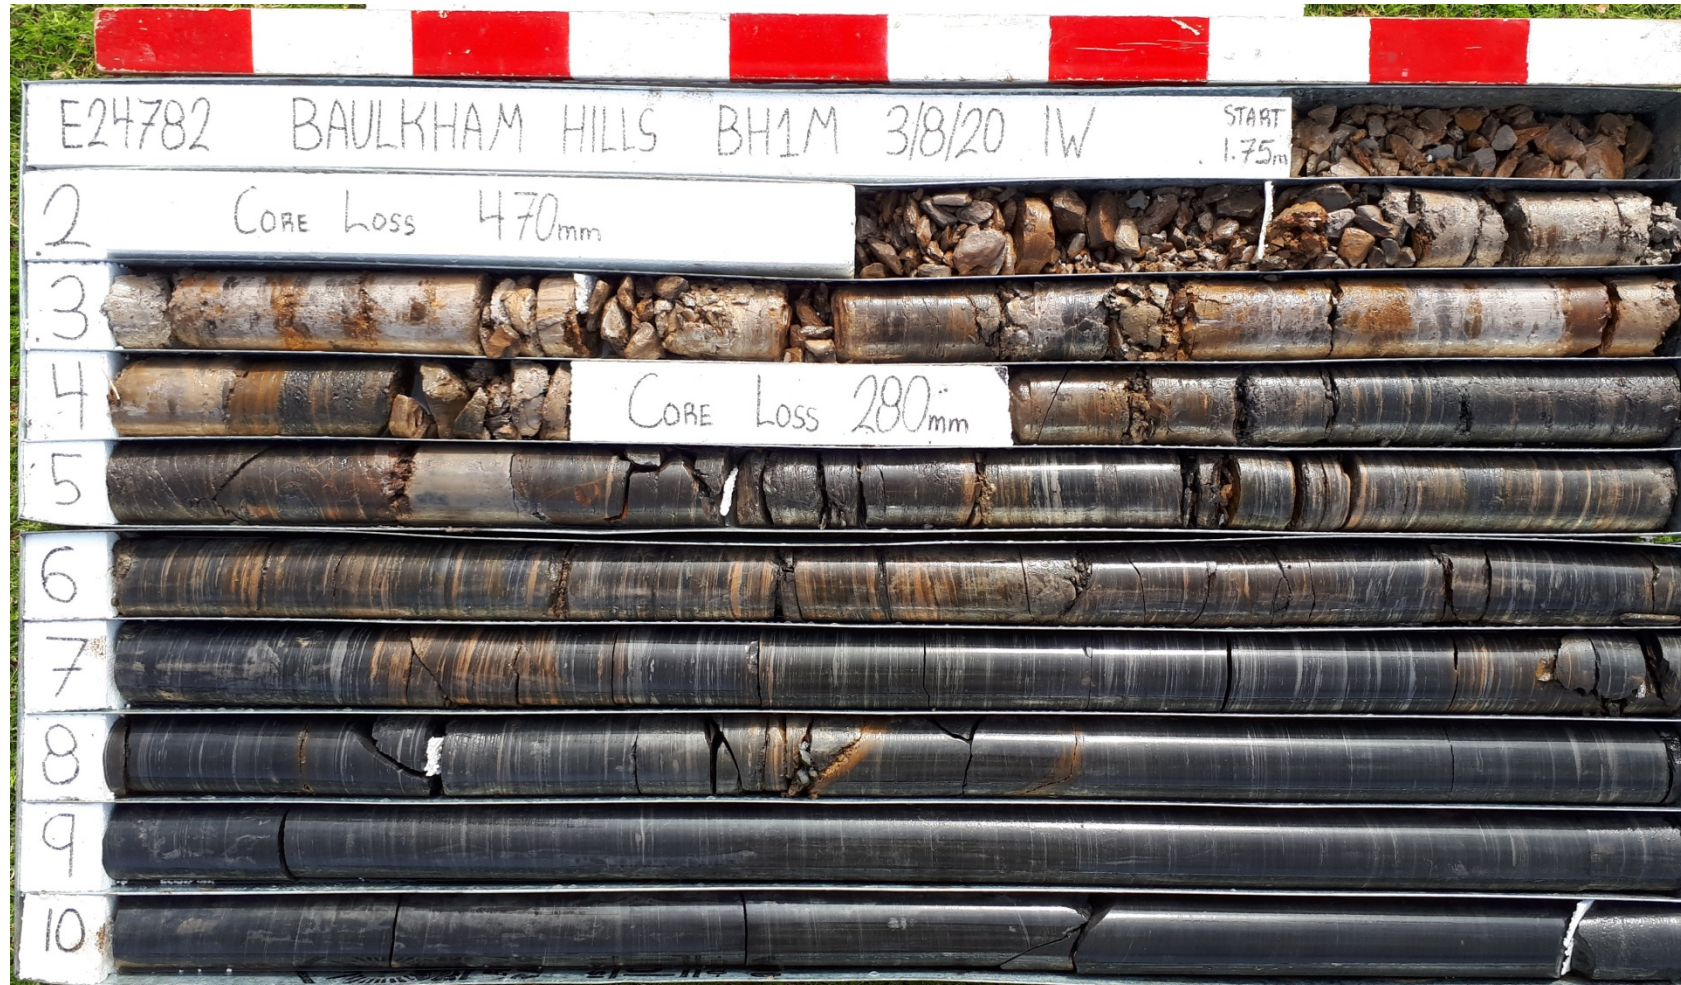
# CORE PHOTOGRAPH OF BOREHOLE: BH1M

| <b>Project</b> | Proposed Development | <b>Depth Range</b> | 11.0m to 17.21m BEGL | |

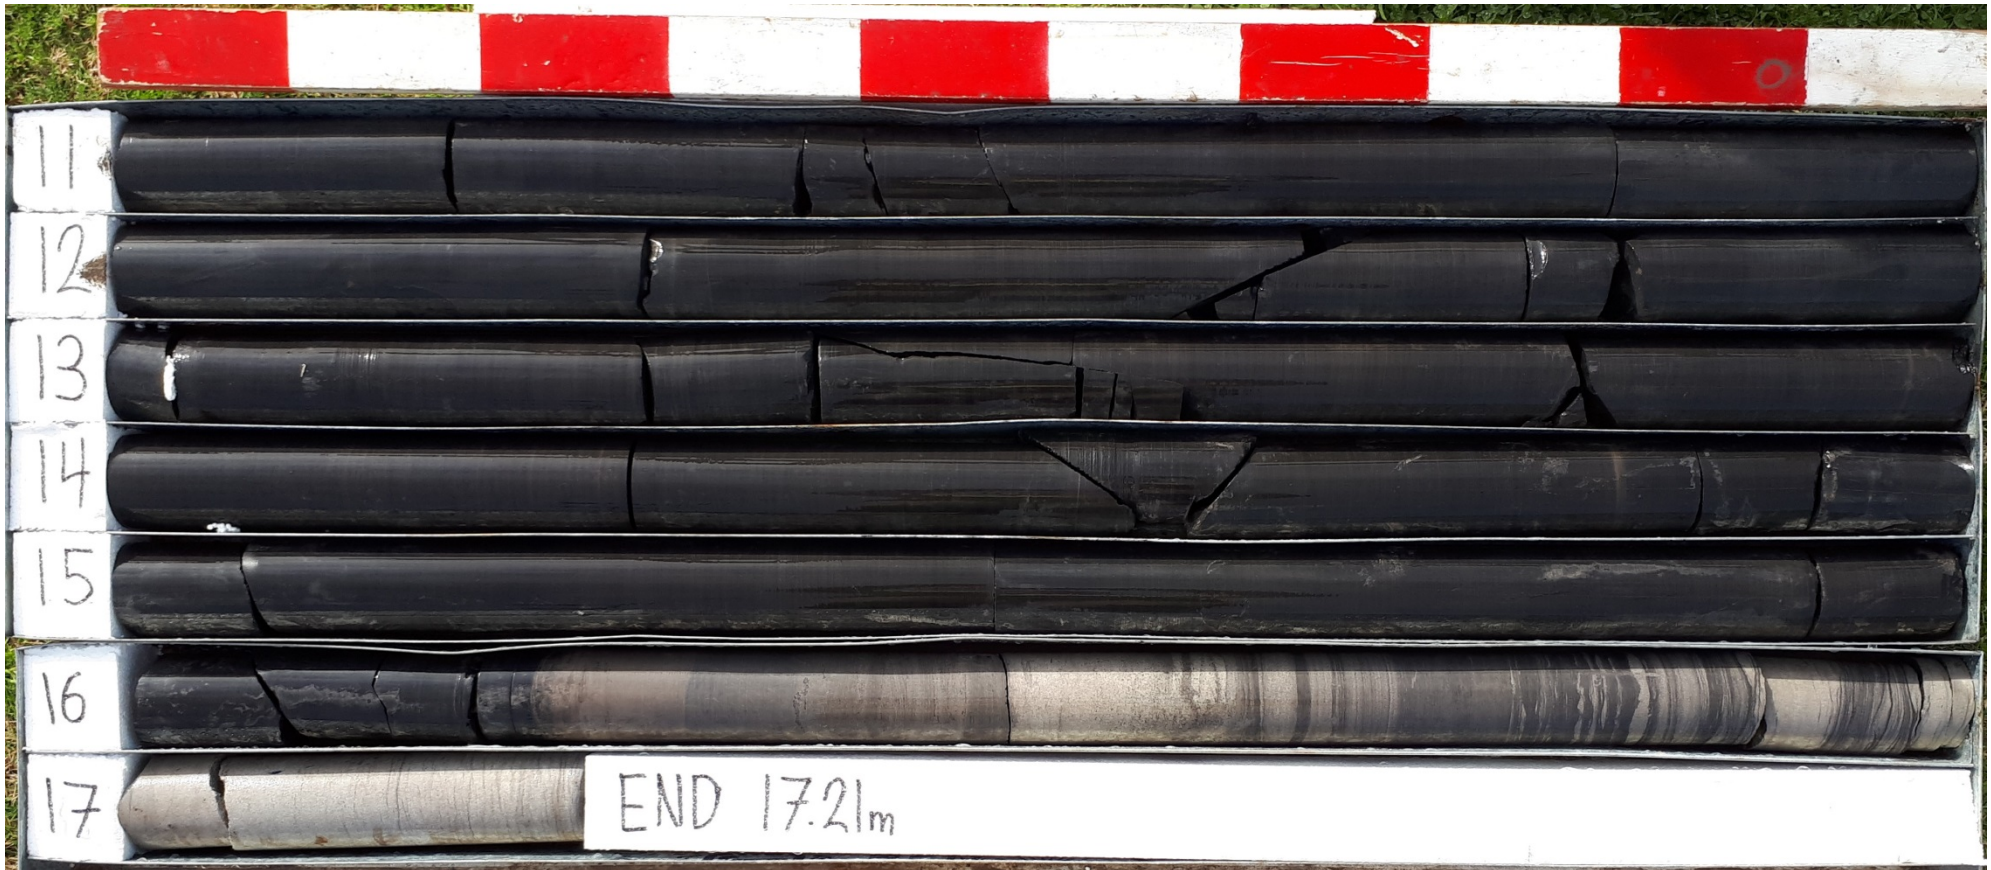
| <b>Job No.</b> | E24782.G03 | <b>Logged</b> | IW | <b>Date</b> 03 / 08 / 2020 |
| <b>Client</b> | Arden Property Group Pty Ltd | <b>Box</b> | 2-4 of 4 | <b>Date</b> 01 / 09 / 2020 |

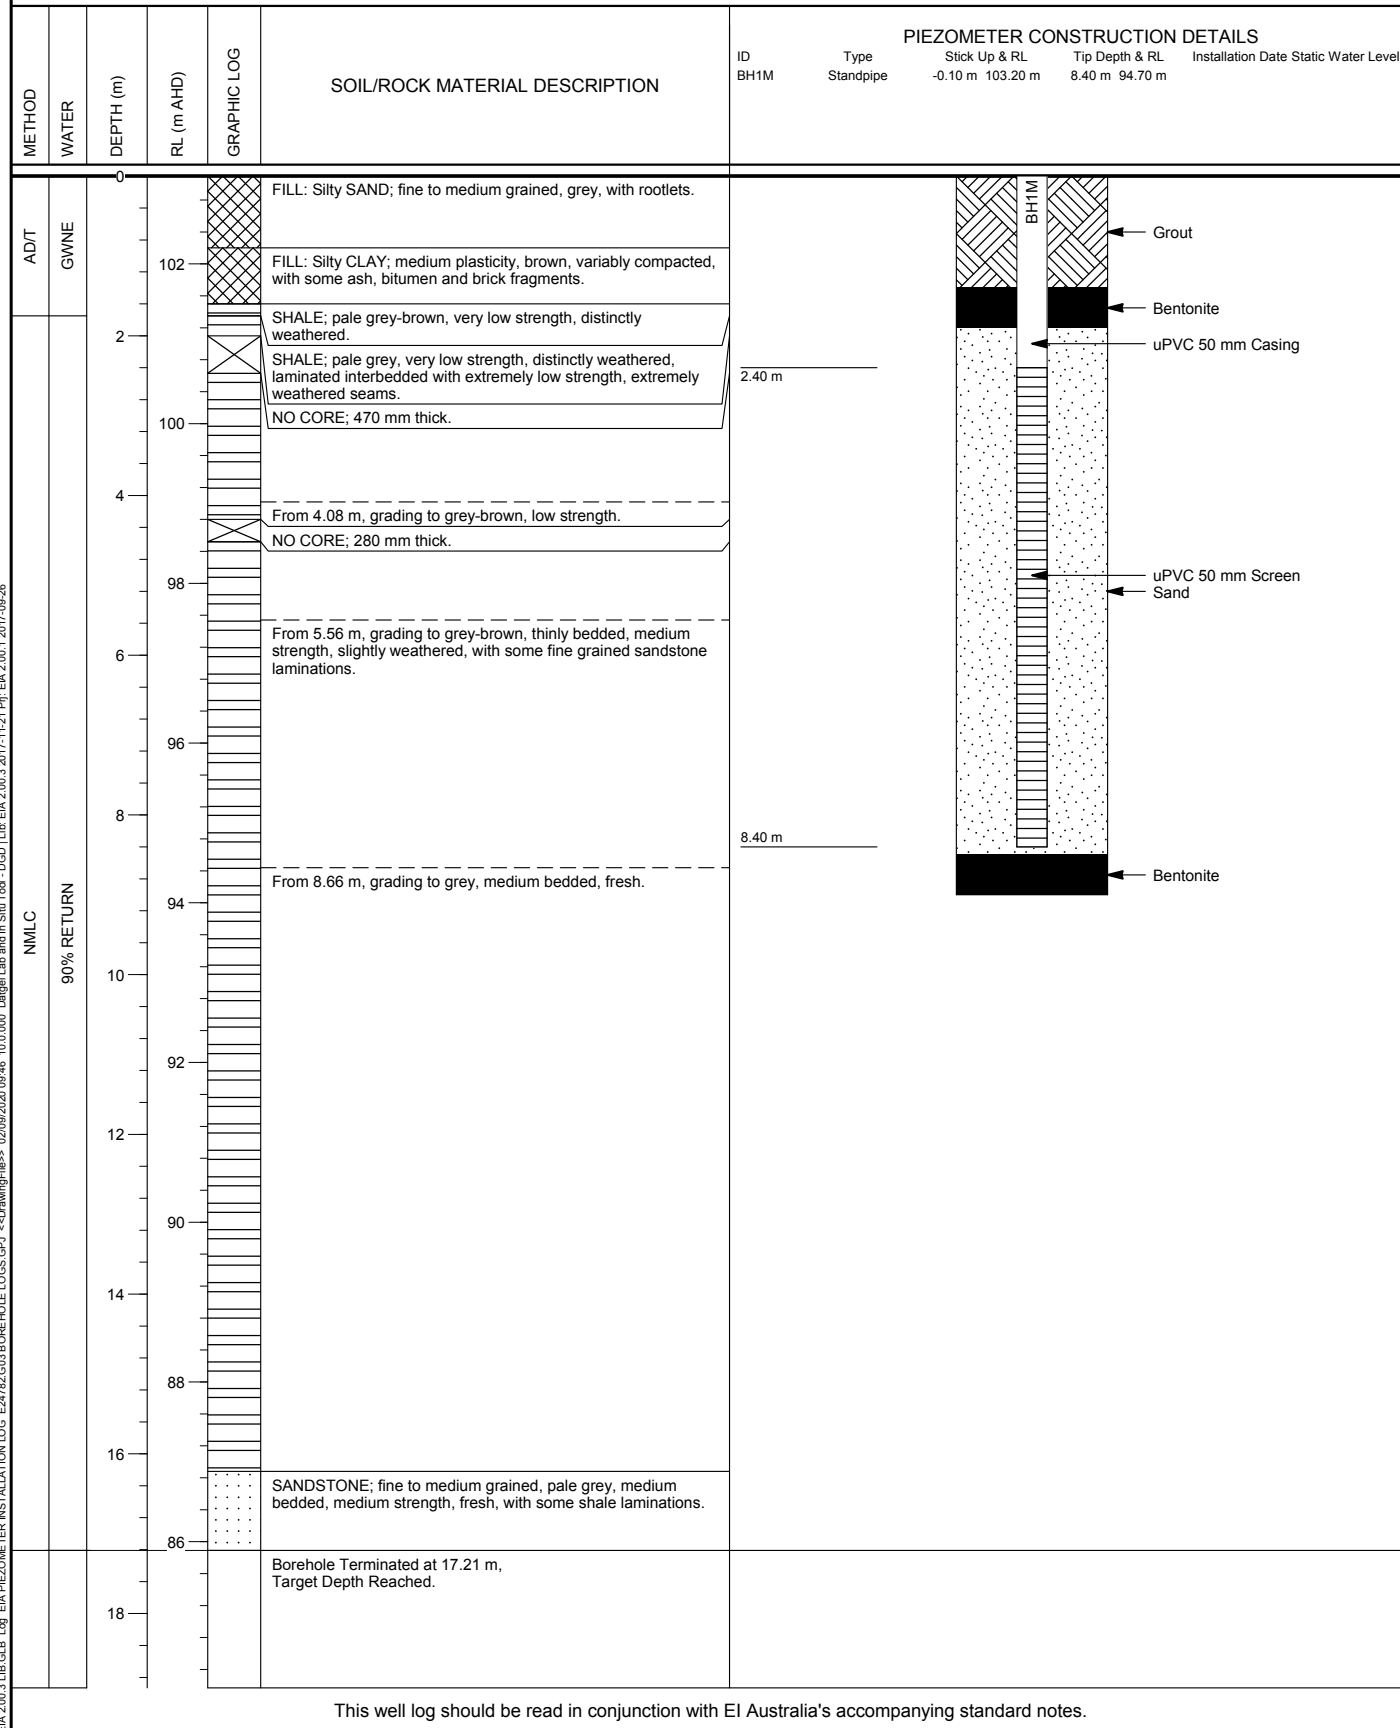
MW NO. BH1M

# MONITORING WELL LOG

| <b>Drilling Contactor</b> | Geosense Drilling | <b>Surface RL</b> | ≈103.10 m AHD |
| <b>Drill Rig</b> | Hanjin DB8 | <b>Inclination</b> | -90° |

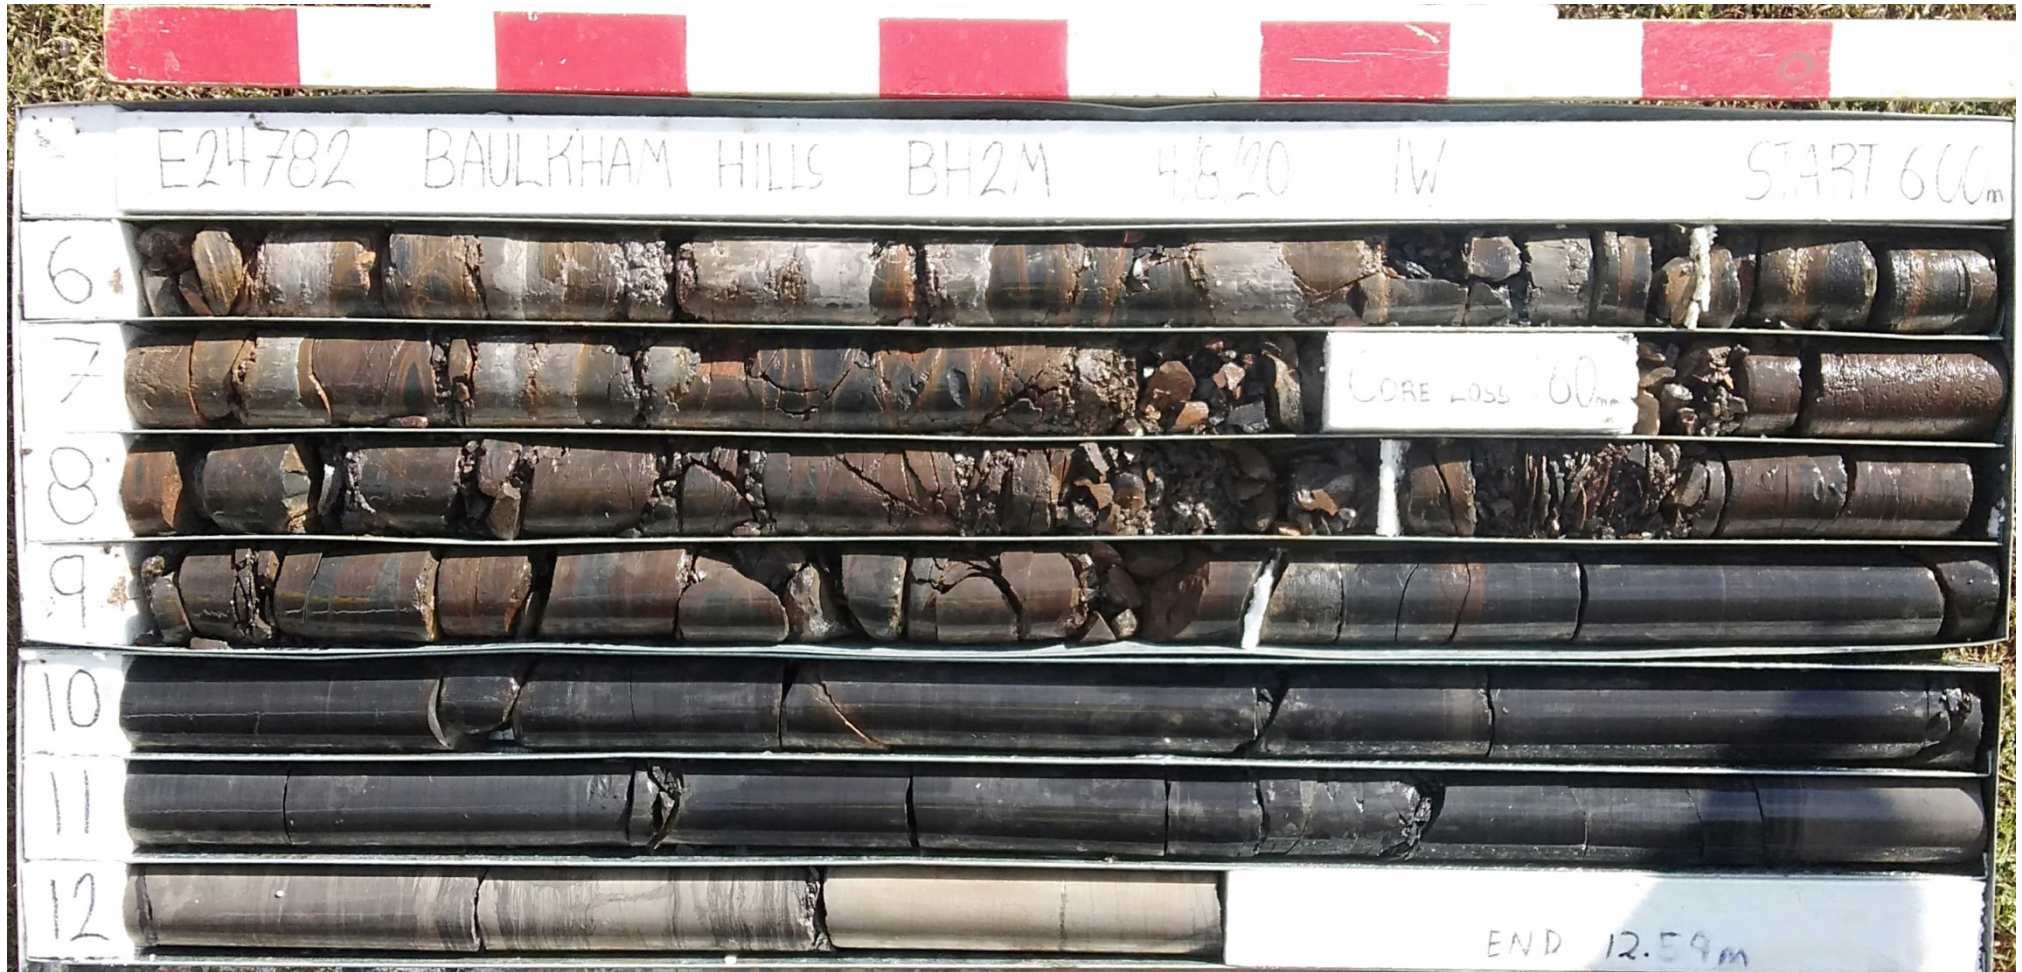
| <b>Client</b> | Arden Property Group Pty Ltd | <b>Box</b> | 1-2 of 2 | <b>Checked</b> | SR |

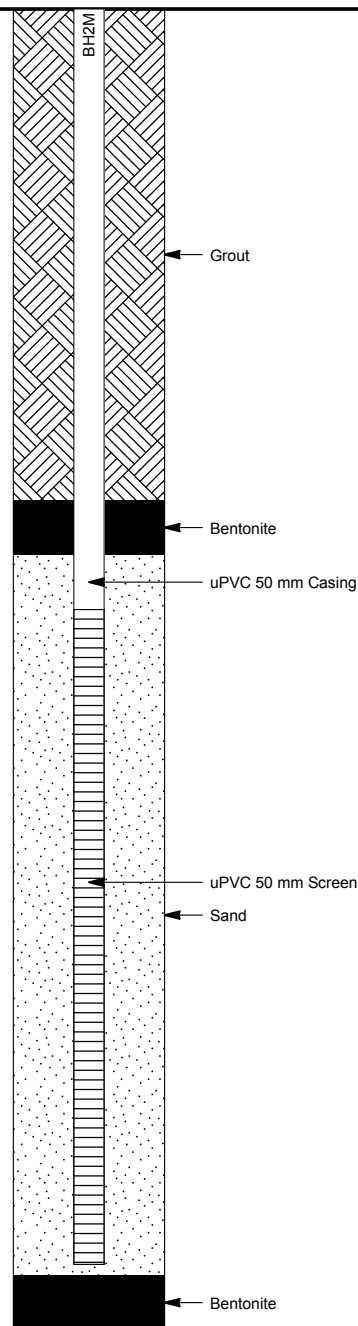
MW NO. BH2M

# MONITORING WELL LOG

| METHOD | WATER | DEPTH (m) | RL (m AHD) | GRAPHIC LOG | SOIL/ROCK MATERIAL DESCRIPTION |
|---|---|---|---|---|---|
| | | 86 | | | SANDSTONE; fine grained, pale grey, 10 % carbonaceous laminations at 0 to 10°. |
| | | | | | Borehole Terminated at 12.59 m, Target Depth Reached. |

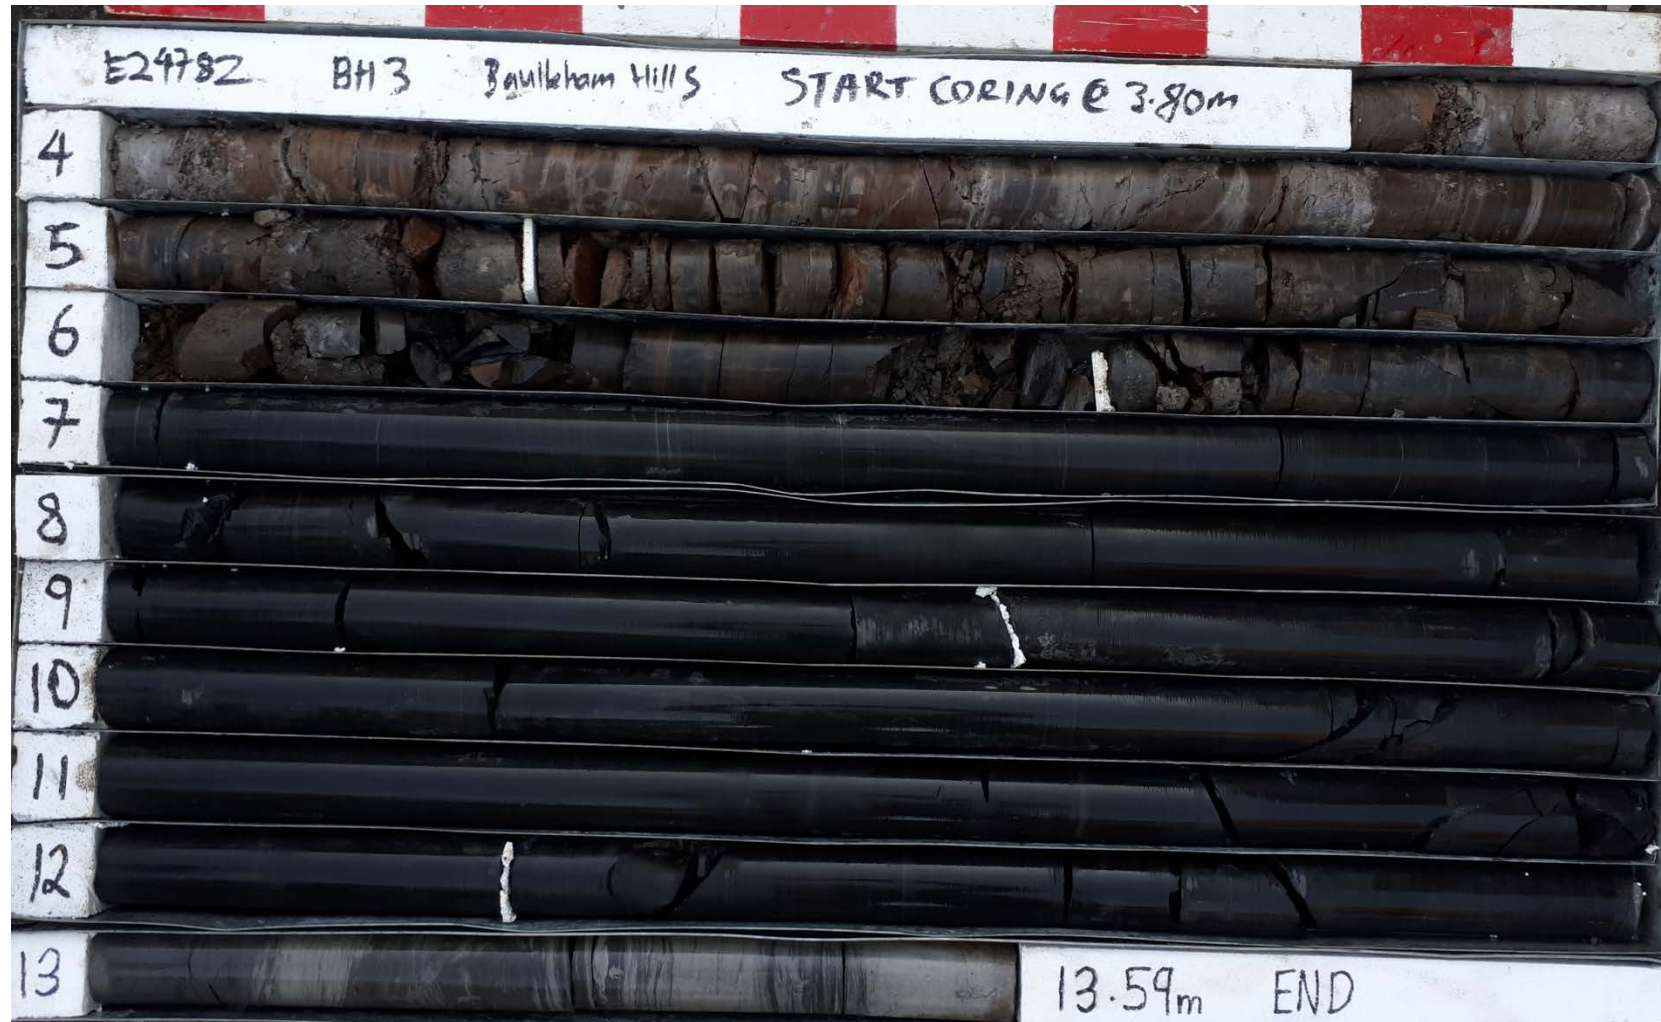
| <b>Job No.</b> | E24782.G03 | <b>Logged</b> | RS/IW | <b>Date</b> 05 / 08 / 2020 |
| <b>Client</b> | Arden Property Group Pty Ltd | <b>Box</b> | 1-3 of 3 | <b>Checked</b> SR <b>Date</b> 01 / 09 / 2020 |

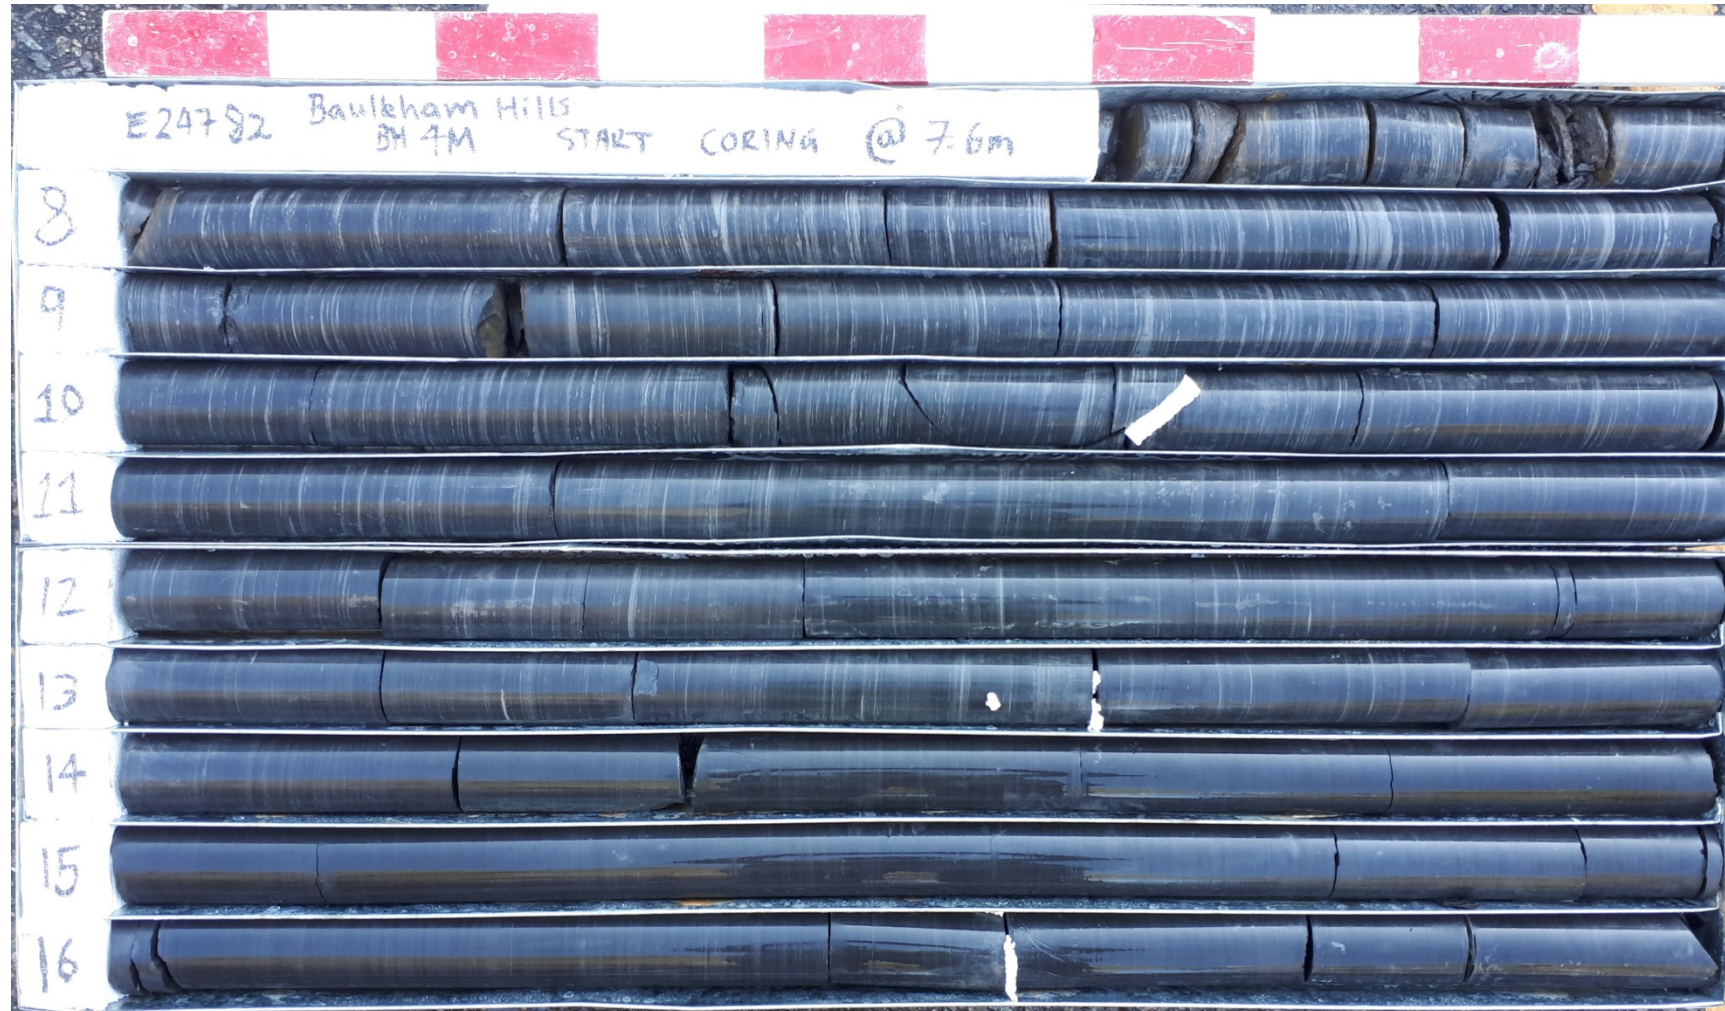
# CORE PHOTOGRAPH OF BOREHOLE: BH4M

| <b>Project</b> | Proposed Development | <b>Depth Range</b> | 17.0m to 19.04m BEGL | |

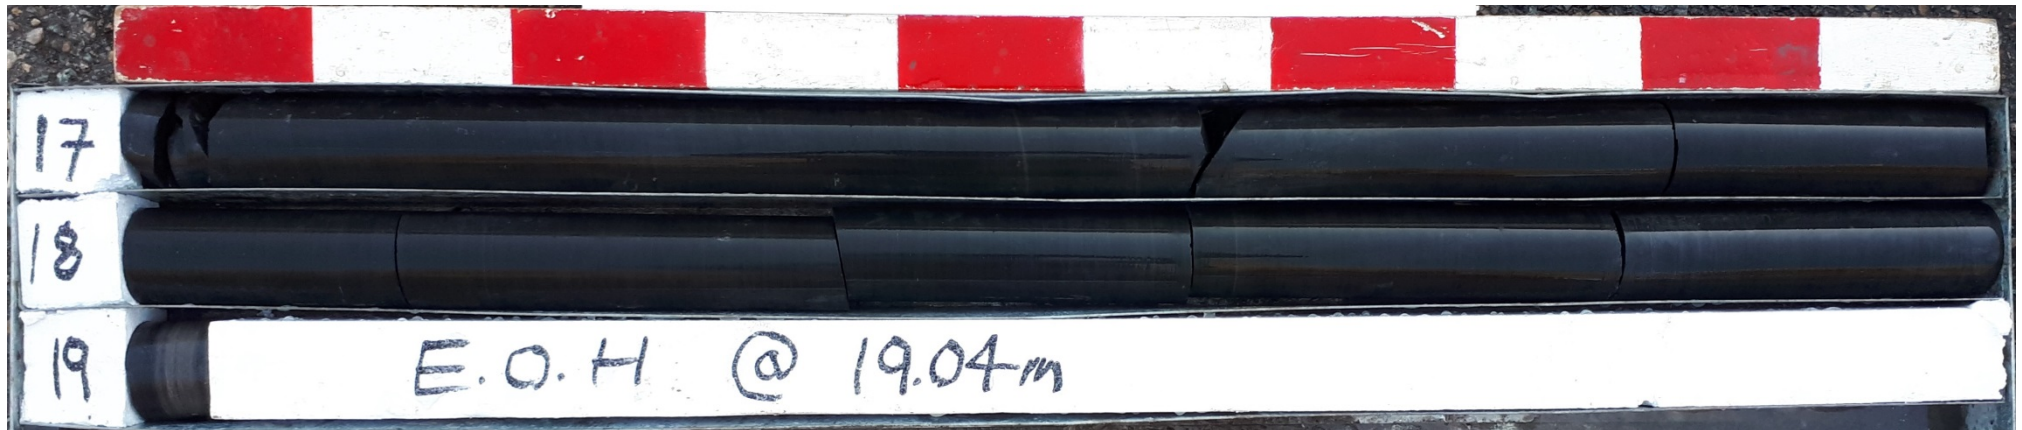
**BH NO. BH4M**

# BOREHOLE LOG

| <b>Job No.</b> | E24782.G03 | <b>Logged</b> | RS | <b>Date</b> 04 / 08 / 2020 |
| <b>Client</b> | Arden Property Group Pty Ltd | <b>Box</b> | 3 of 3 | <b>Checked</b> SR <b>Date</b> 01 / 09 / 2020 |

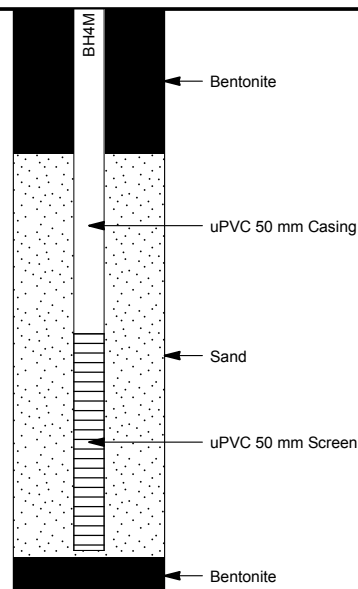
**MW NO. BH4M**

# MONITORING WELL LOG

| METHOD | WATER | DEPTH (m) | RL (m AHD) | GRAPHIC LOG | SOIL/ROCK MATERIAL DESCRIPTION |
|---|---|---|---|---|---|
| | | 18 | 86 | | |
| | | 20 | 84 | | Borehole Terminated at 19.04 m, Target Depth Reached. |
