Remediation Action Plan

Site B  
Castle Towers Expansion Project – P11 Scheme  
Castle Street, Castle Hill

Prepared for  
QIC Limited

Project 84335.03  
February 2019

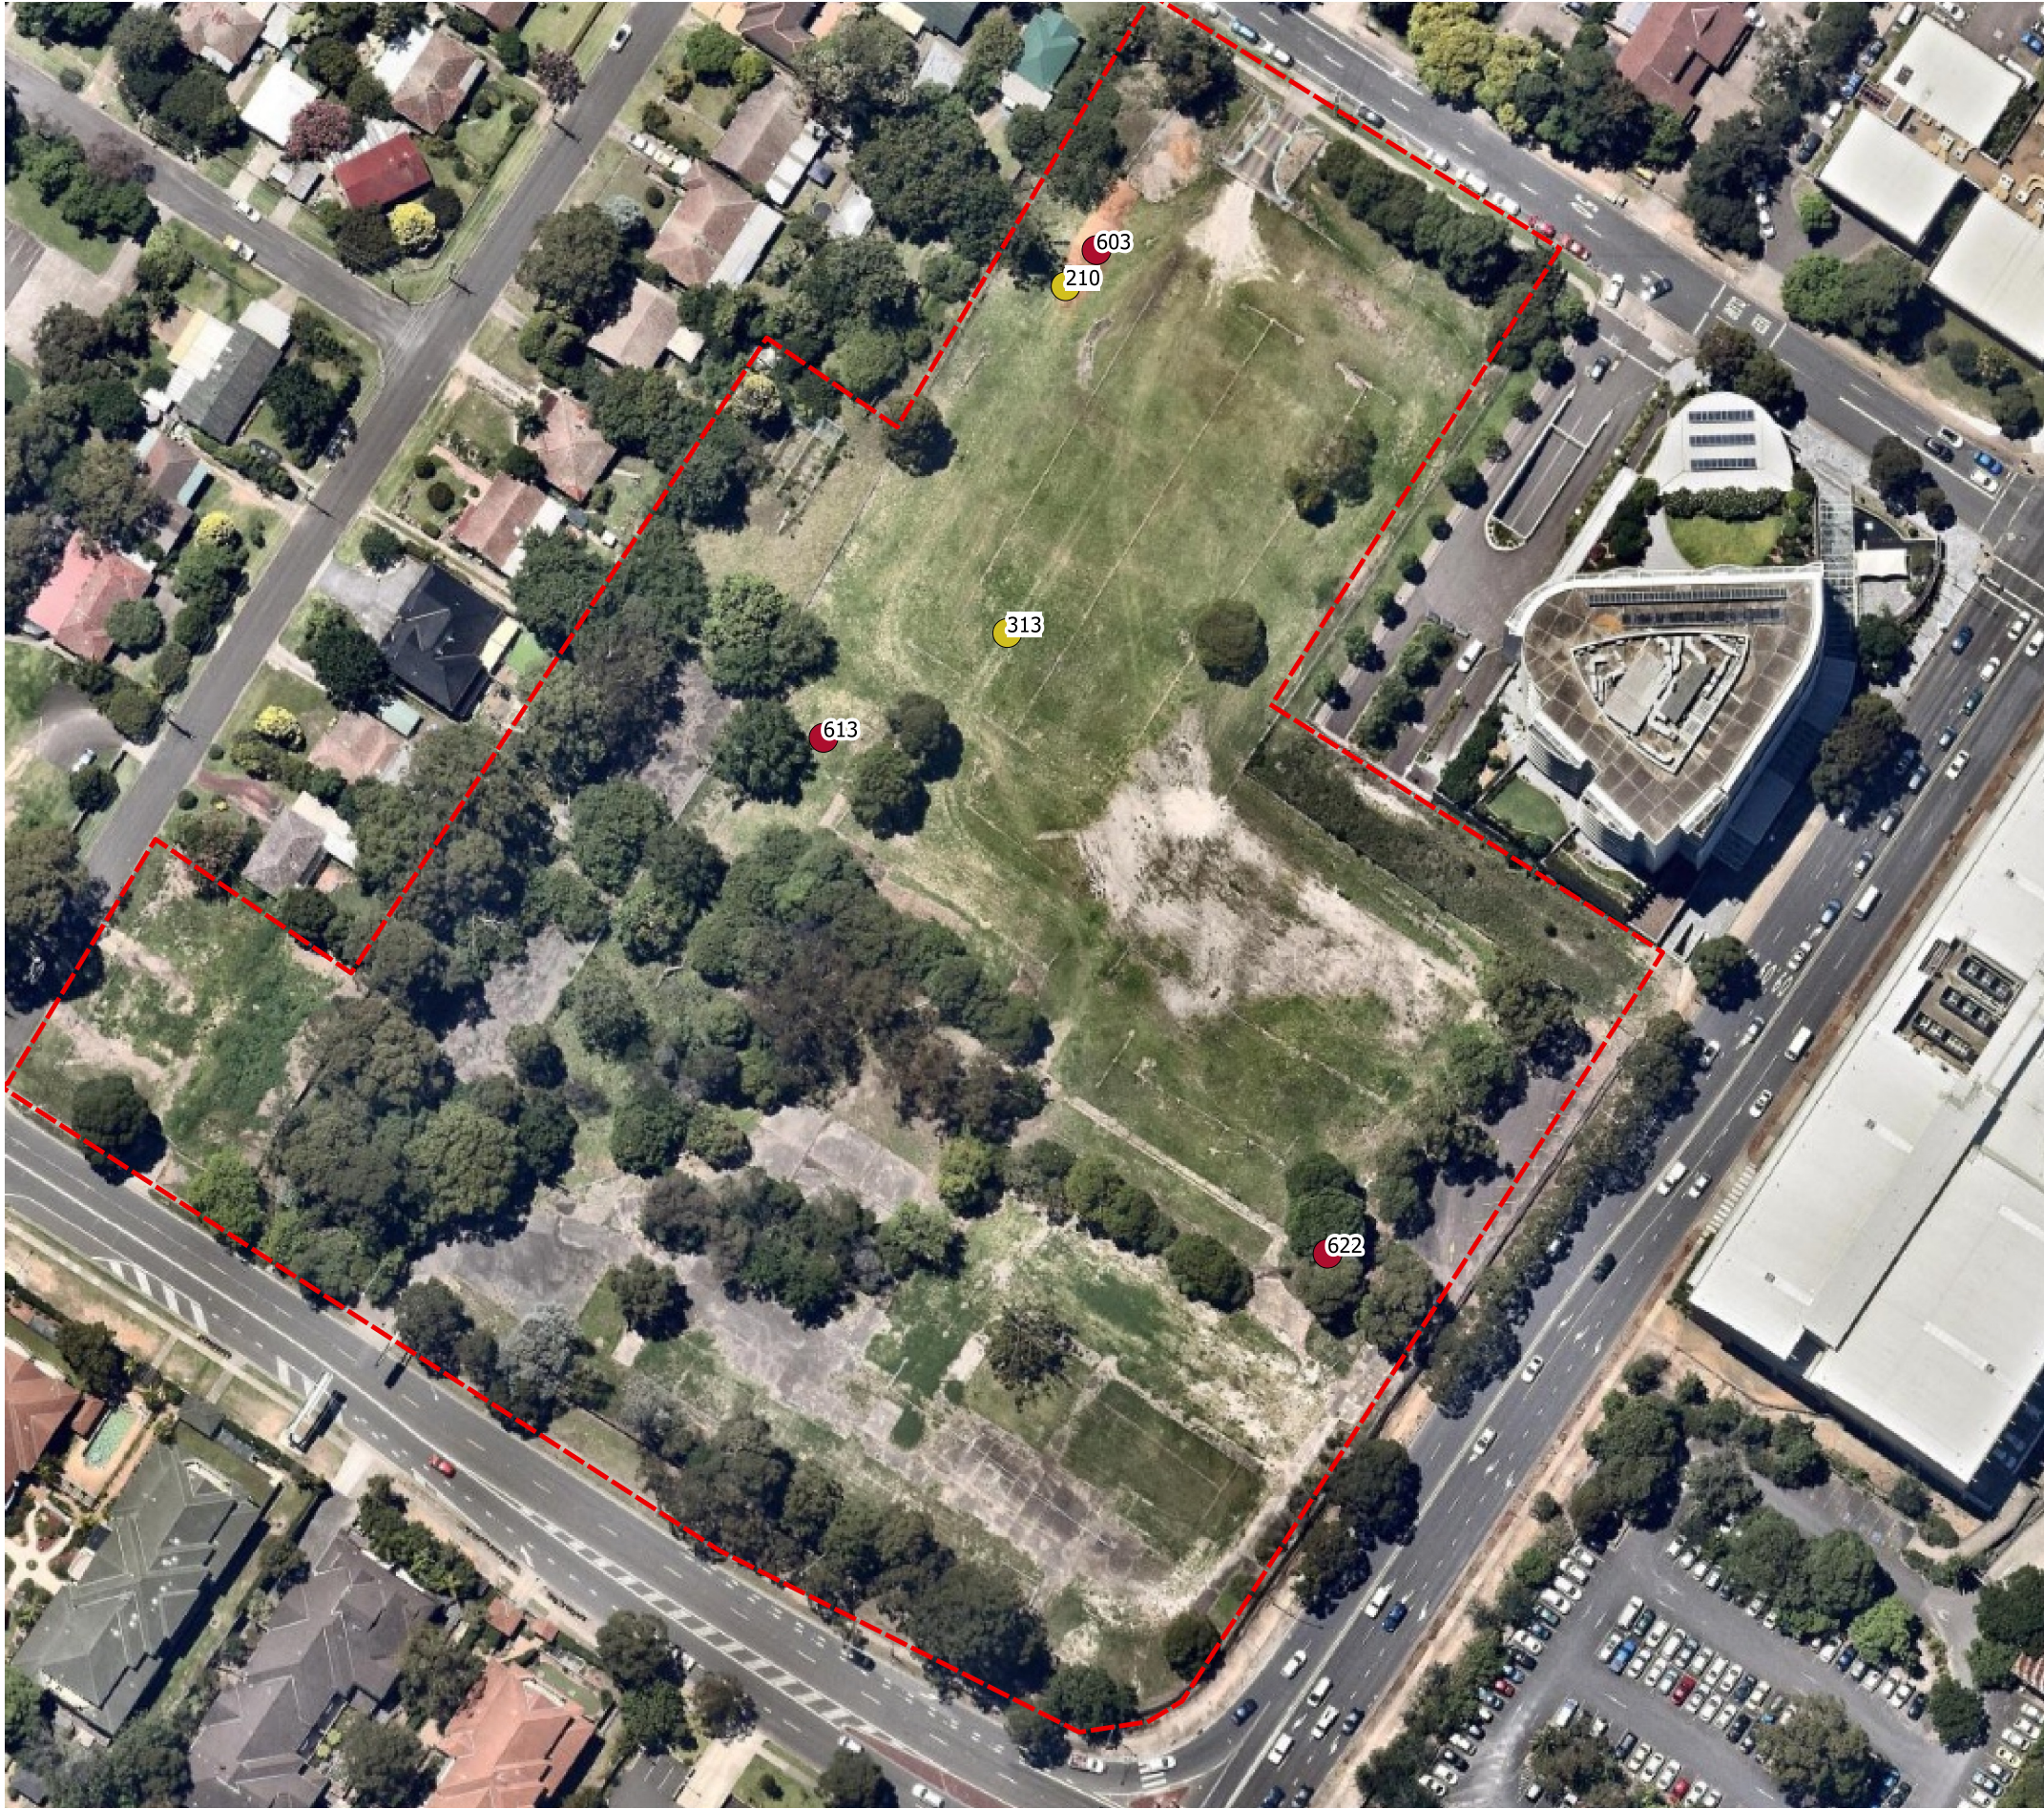
- Legend
- Possible asbestos hotspot
  - Asbestos hot spots
  - Site B Boundary

which the ACM fragments were observed, it is likely that the filling in this portion of the site is generally contaminated with the asbestos. It is noted that no fibres were detected in any of the soil samples. Furthermore, no fibres were detected in the residual soils underlying the filling. These locations (TP210 and TP313) are shown on Drawing 2 – hotspot locations in Appendix A.
