Report on
Geotechnical Desktop Review

Site B Development
Showground Road and Pennant Street, Castle Hill

Prepared for
QIC Ltd

Project 84335.16
July 2022

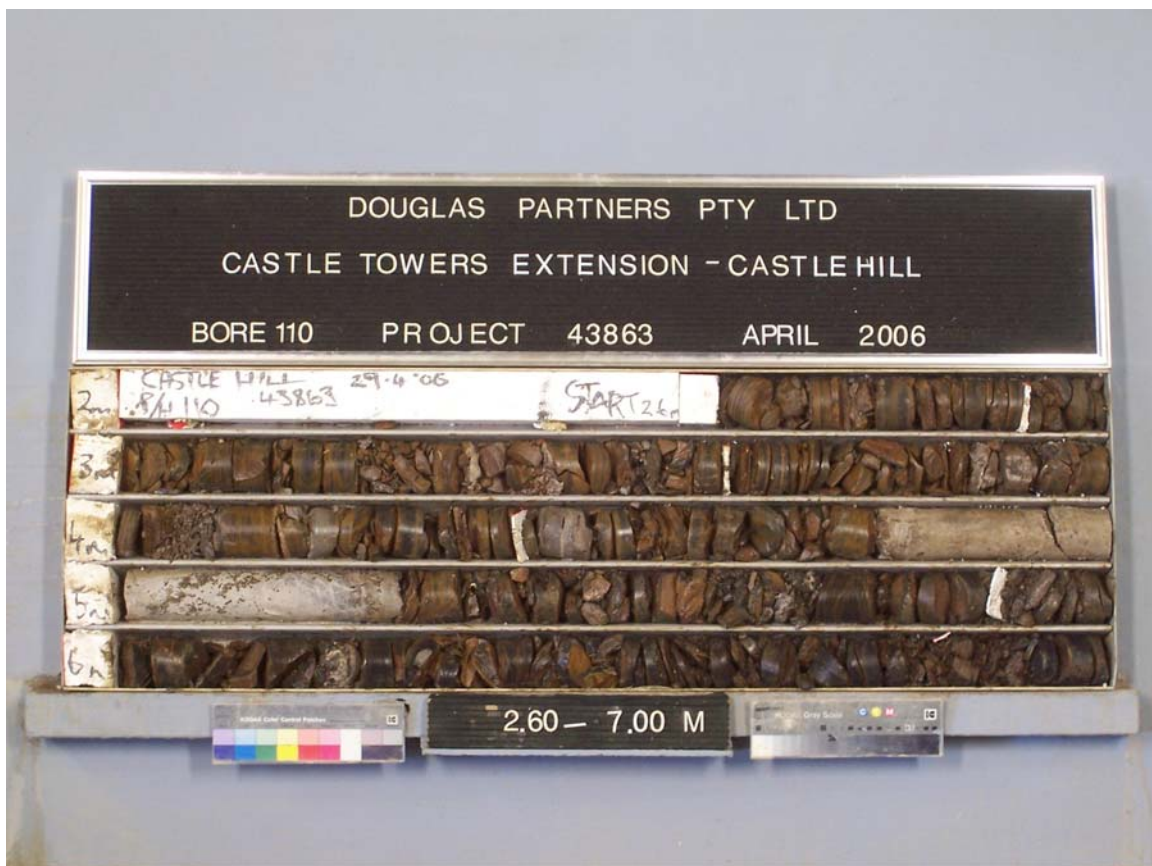
DOUGLAS PARTNERS PTY LTD
CASTLE TOWERS EXTENSION - CASTLE HILL
BORE 110 PROJECT 43863 APRIL 2006

2m CASTLE HILL 29-4-06
8/110 43863 START 26m
3m
4m
5m
6m

2.60 - 7.00 M

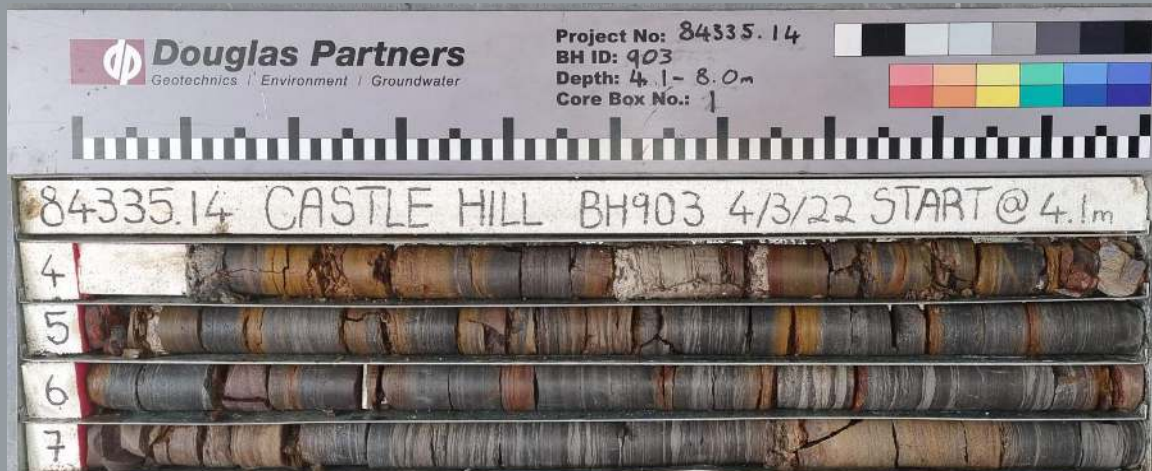
BORE: 903

4.1 - 8.0 m
