Kiama West Masterplan: Historical Heritage Constraints Assessment

FINAL REPORT

Prepared for Traders in Purple

26 January 2023

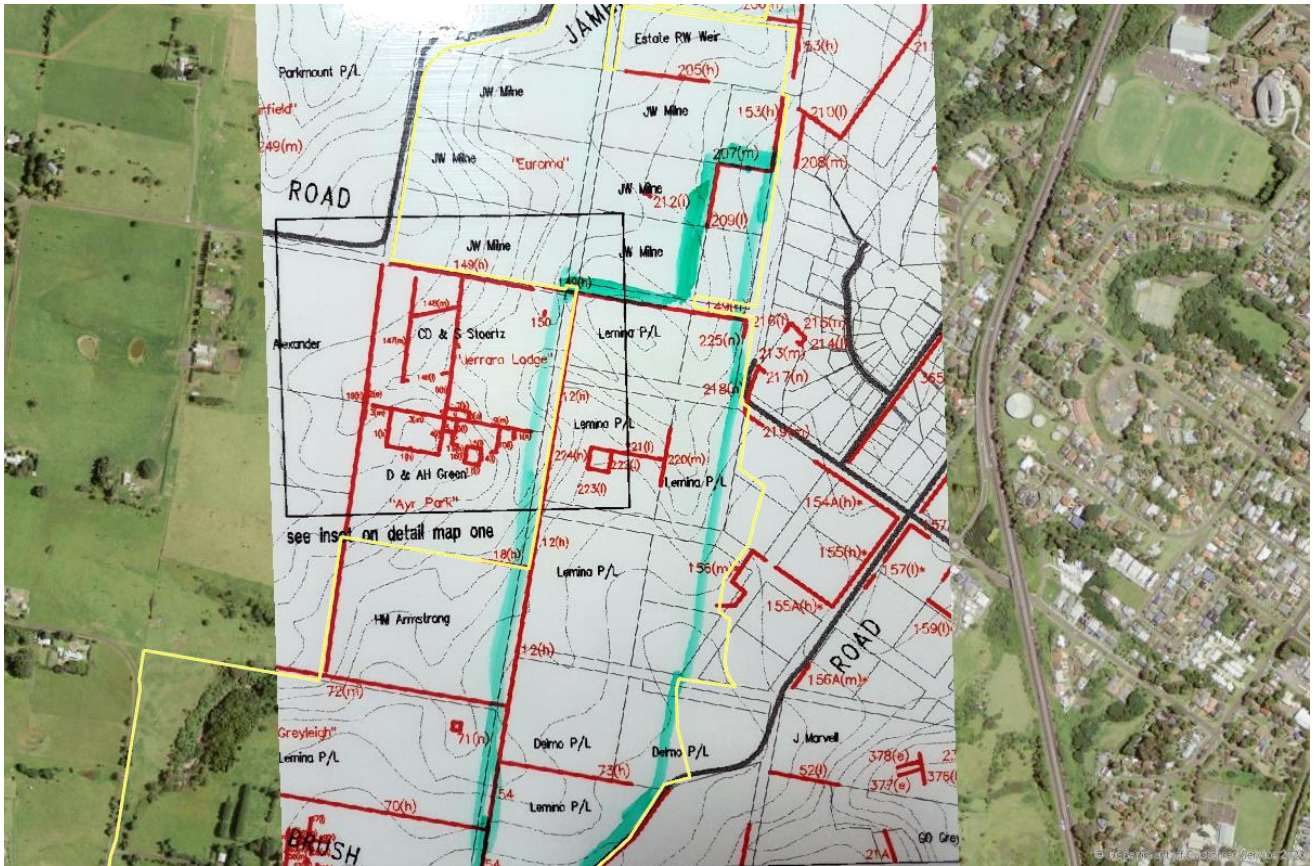
Photo 3 Dry stone walls mapped by Kiama Council within part of the study area, which is outlined in yellow (Source: Kiama Council, 2018)

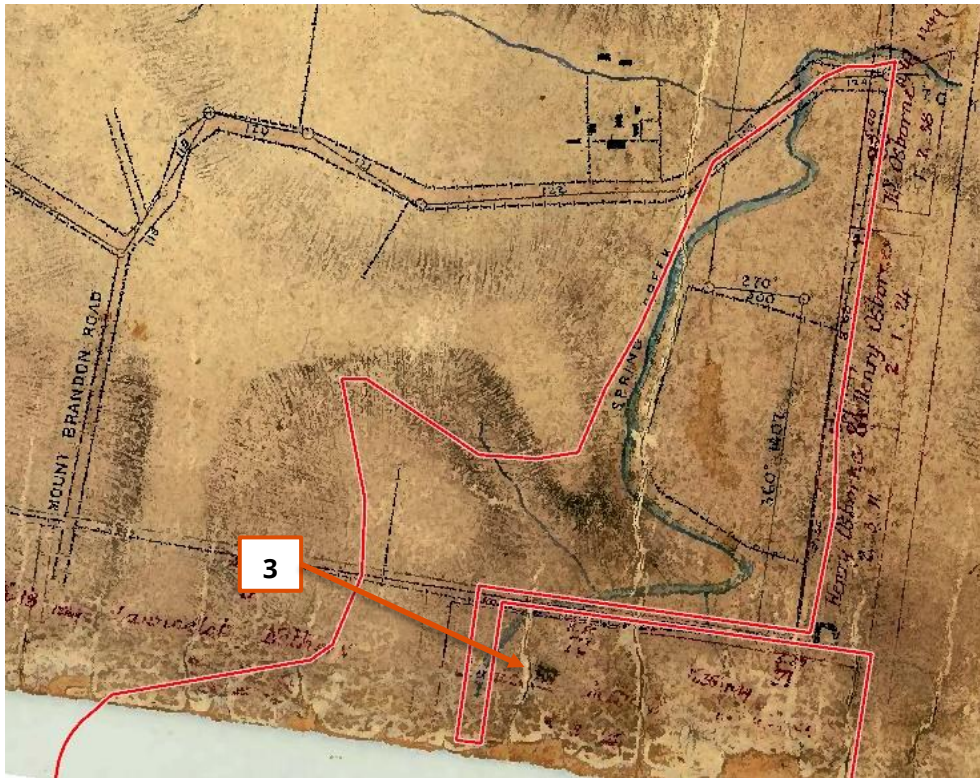
Photo 10 1871 Crown plan for the resurvey of three large properties including Portion 16, showing a possible structure [3], roads and fence lines (does not state whether they are stone walls), with the study area outlined in orange (Source: NSW Land Registry Services, Crown plan C176.2041)

Two plans from the 1870s provide some detail on the development that has occurred in the northern portion of the study area. An 1871 Crown plan for the resurvey of three large estates including Robb's Portion 16 shows a series of fence lines within Portion 16 and along Jamberoo Road (Photo 10). It is not specified whether these fence lines are stone walls. A potential structure [3] is also present in Portion 178.⁸² In 1879, the South Coast Road was deviated south; this deviation forms the boundary of the most northern portion of the study area (now Jamberoo Road).⁸³ The Crown plan for this deviation is annotated with notes recording that the northern portion of the study area is part of G. Woods' property, which is separated from James Robb's Portion 16 by the original alignment of the South Coast Road. The name Pike is also noted above Woods' name, suggesting that Pike, already an owner of several portions in the study area, may have owned the property and was leasing to Woods. A stone wall [4] is recorded along an unnamed road which runs along the northern boundary of Portion 179 and 178 and along the part of the northern boundary of Portion 76. This plan also recorded a second stone wall [5] running along the western boundaries of Portion 76, 75 and extending into Portion 74, adjacent to which is the current Jerrara Road.

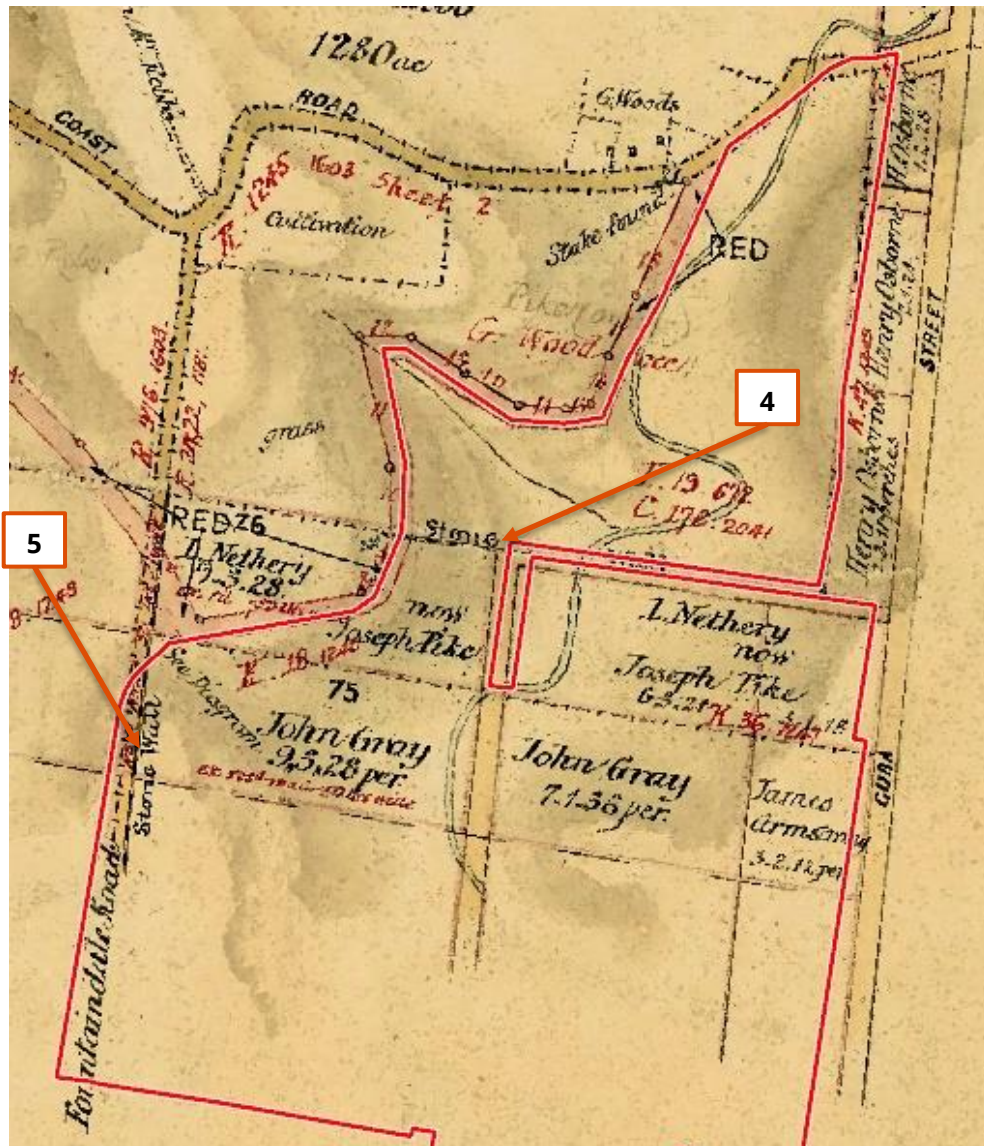
Photo 11 1879 Crown plan for the deviation of the South Coast Road, showing property owners or occupants and two stone walls [4] [5], with the study area outlined in orange (Source: NSW Land Registry Services, Crown plan R1245c.1603)

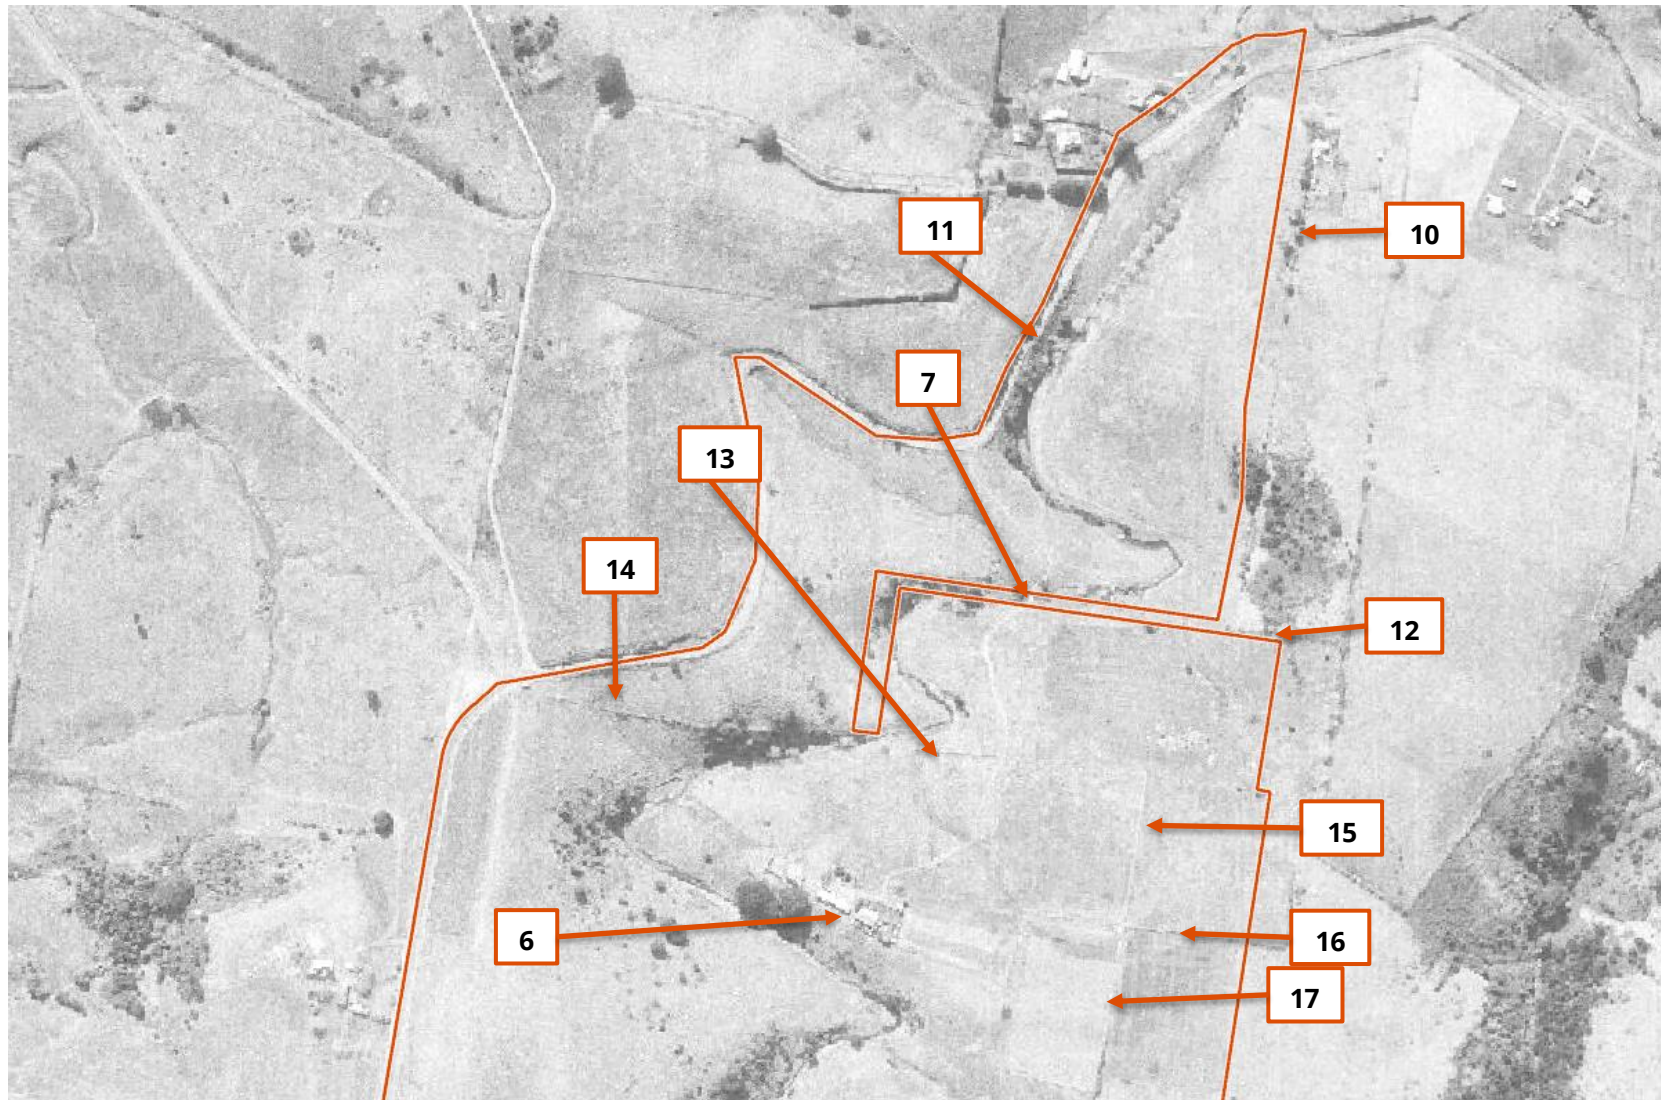
Photo 15 1963 aerial photograph of the northern portion of the study area, which is outlined in orange, showing dry stone walls [10] [11] [12] [13] [14] [15] [16] [17], the homestead complex [6] and the bridge spanning Spring Creek [7] (Source: NSW Spatial Services 2022)

Aerial imagery dating to 1963 shows a number of developments and features within the study area (Photo 15, Photo 16, Photo 17). In the northern portion there is a homestead complex [6] with potentially nine structures adjacent to Spring Creek with a track leading to Jamberoo Road. A bridge [7] associated with this track cross Spring Creek. In the southern portion of the study area is a second homestead complex [8] north of Old Saddleback Road/Long Brush Road [9] with potentially 15 structures. A high number of dry stone walls are also visible [10] [11] [12] [13] [14] [15] [16] [17] [18] [19] [20] [21] [22] [23] [24] [25] [26] [27] [28] [29] [30] [31] [32] [33] [34] [35] [36] [37] [38] [39] [40] [41] [42] [43] [44] [45] [46] [47] [48]. It should be noted that due to the quality of aerial imagery there may be dry stone walls or other structures which are not visible. This may also be compounded by the presence of seasonal or dry vegetation.

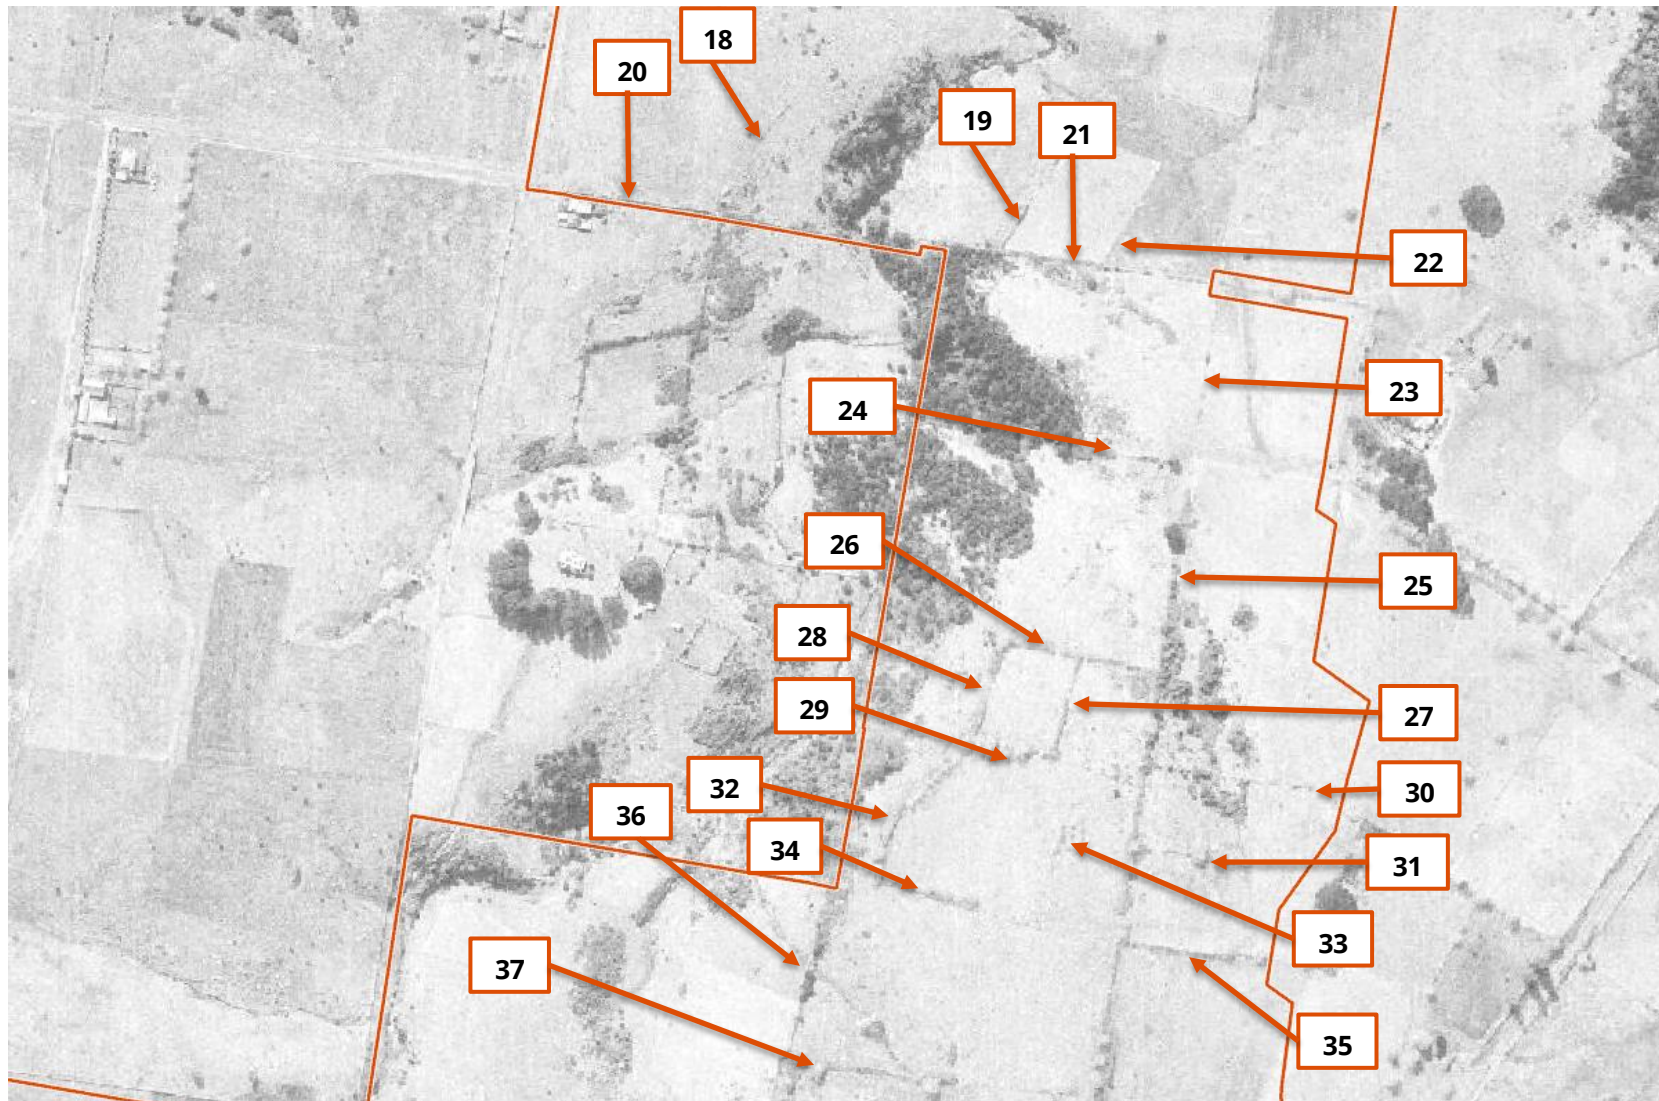
Photo 16 1963 aerial photograph of the central portion of the study area, outlined in orange, showing paddocks separated by dry stone walls [18] [19] [20] [21] [22] [23] [24] [25] [26] [27] [28] [29] [30] [31] [32] [33] [34] [35] [36] [37] (Source: NSW Spatial Services 2022)

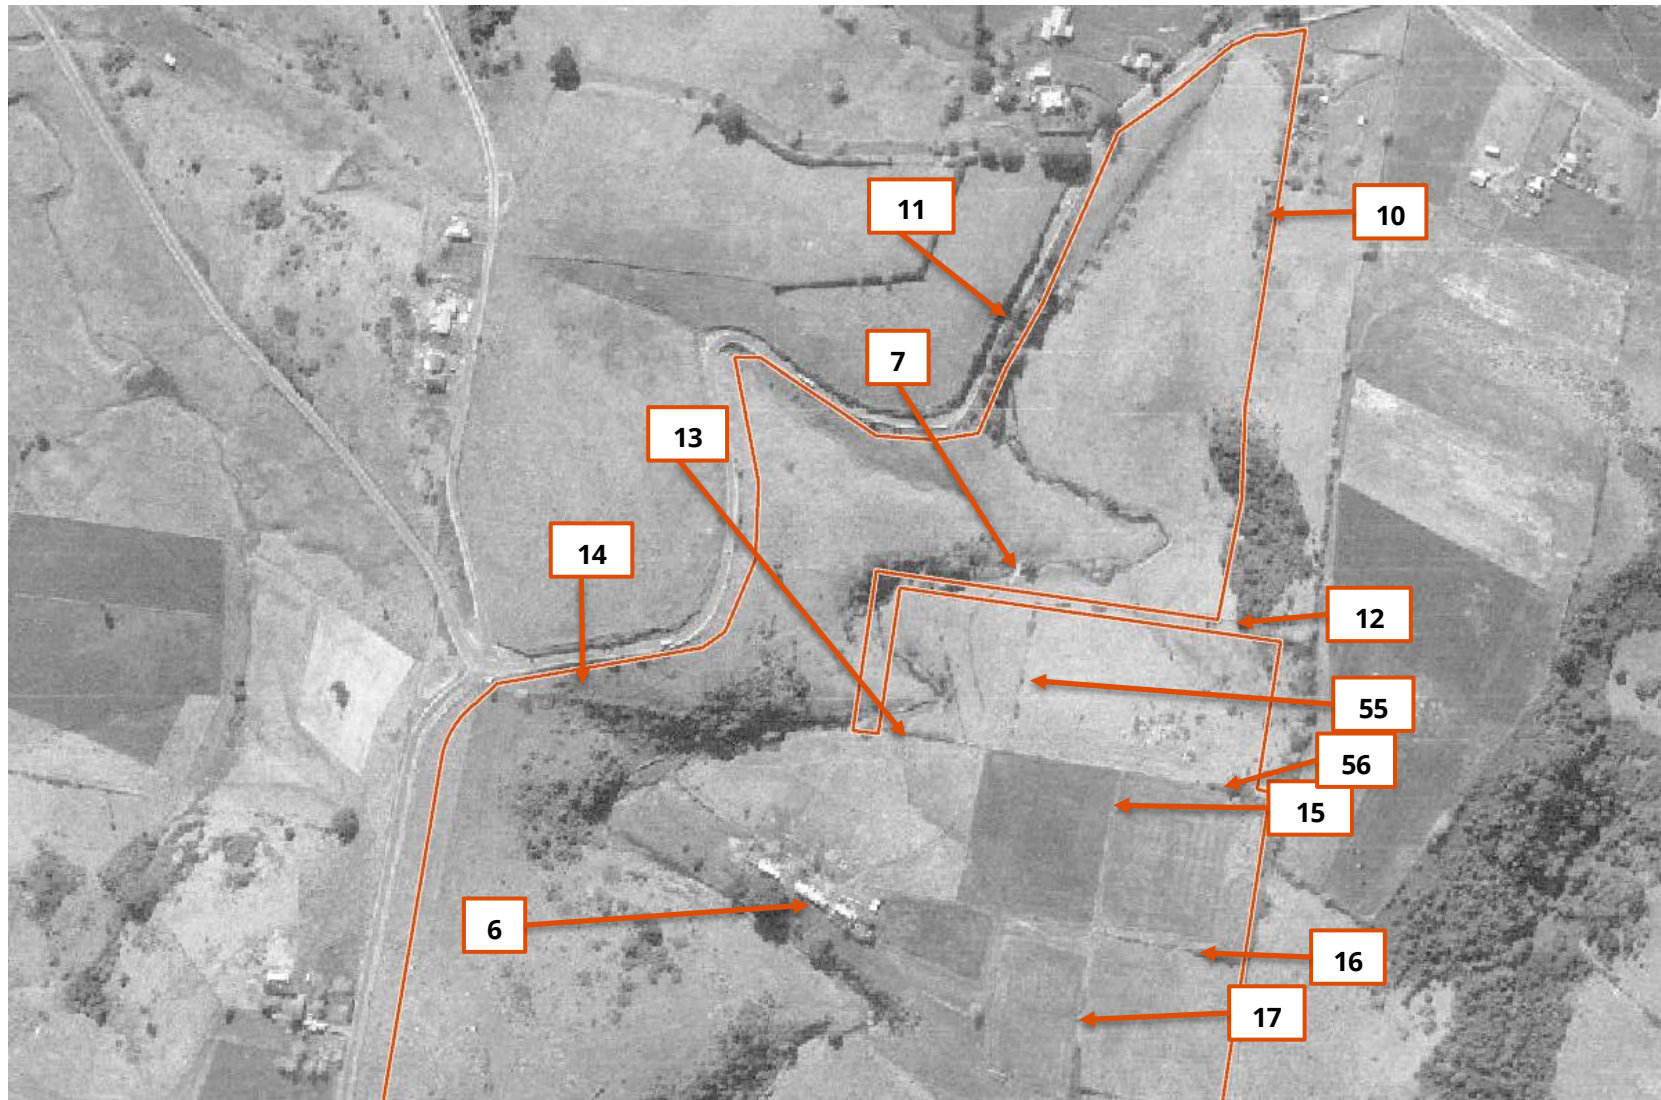
Photo 19 1979 aerial photograph of the northern portion of the study area, outlined in orange, showing two newly visible dry stone walls [55] [56] (Source: NSW Spatial Services 2022)

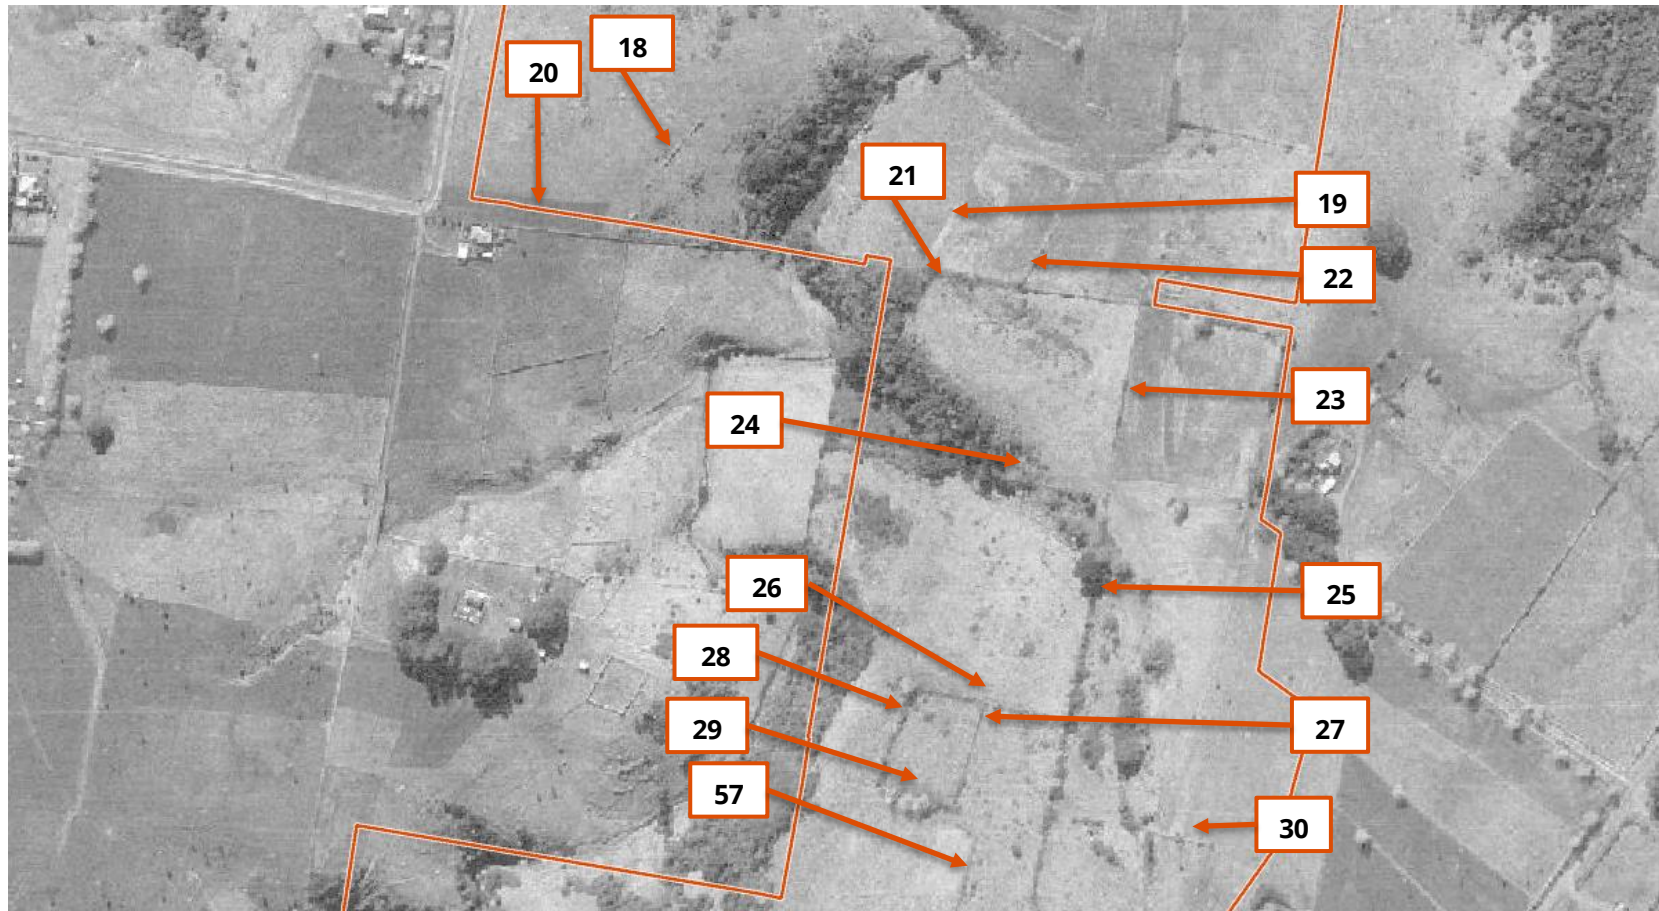
Photo 20 1979 aerial photograph of the central portion of the study area, outlined in orange, showing one newly visible dry stone wall [57], but with one dry stone wall missing [32] (Source: NSW Spatial Services 2022)

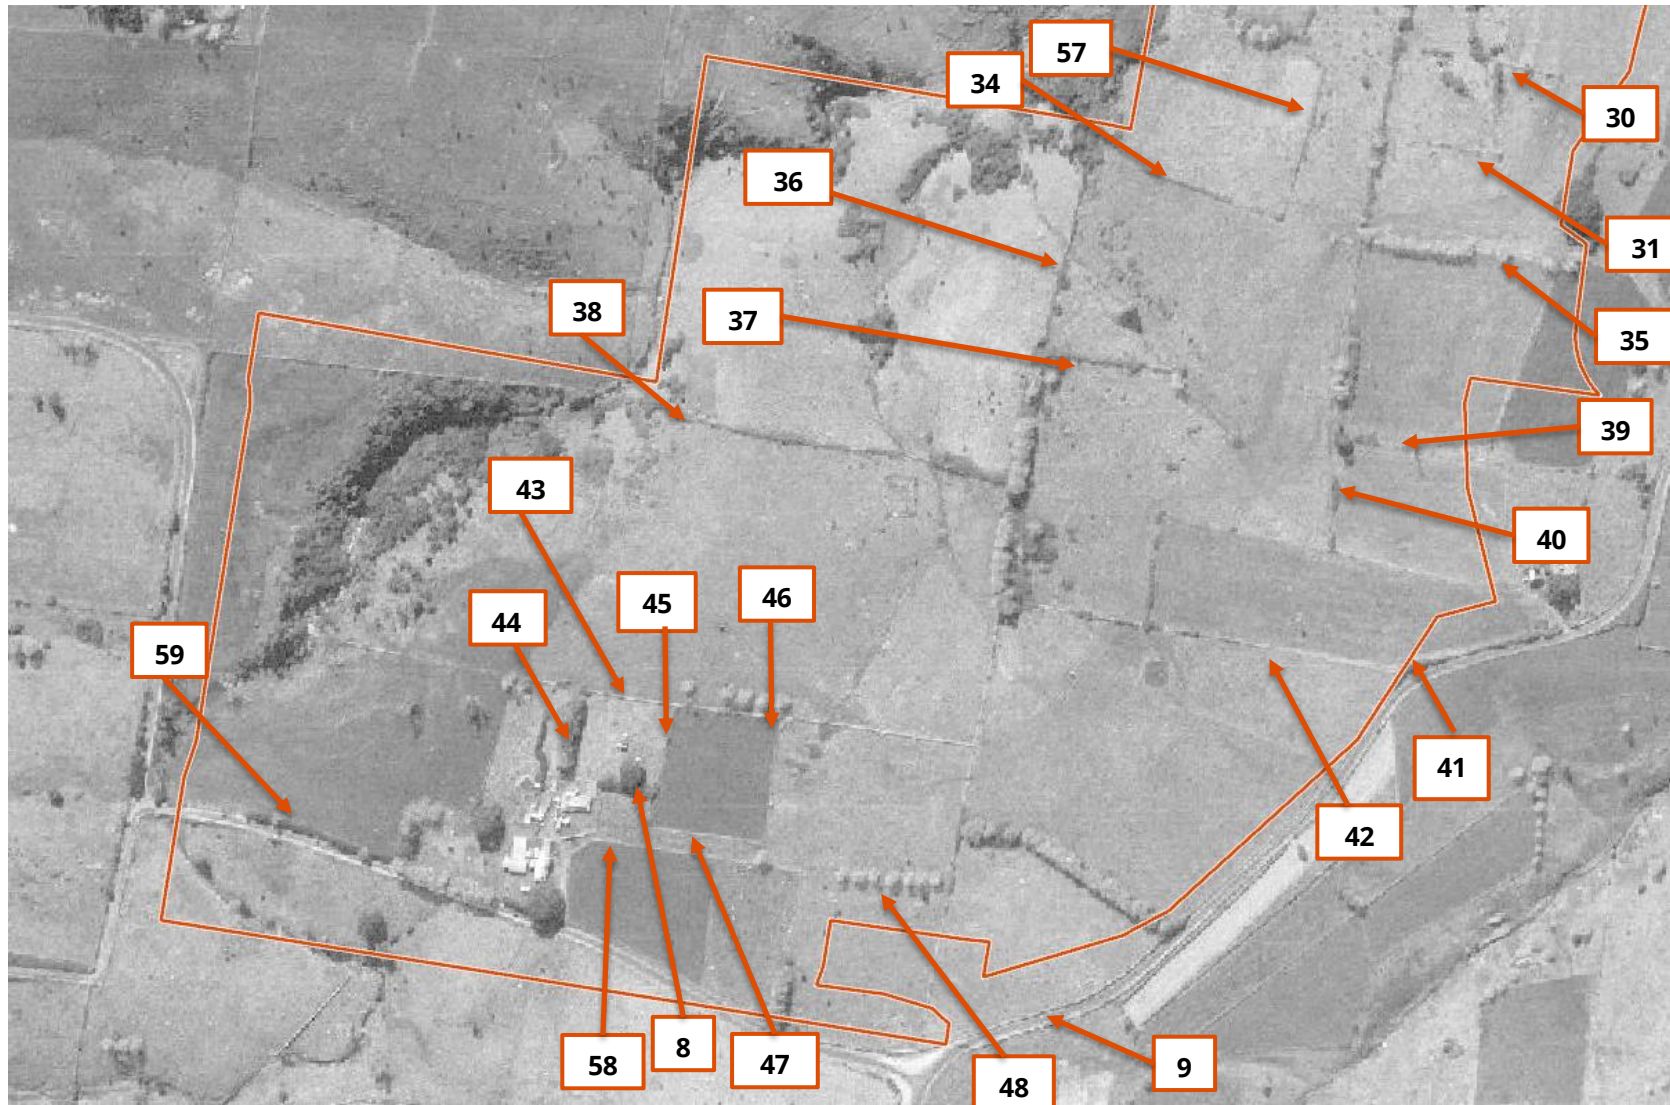
Photo 21 1979 aerial photograph of the southern portion of the study area, outlined in orange, showing two newly visible dry stone walls [58] [59] (Source: NSW Spatial Services 2022)

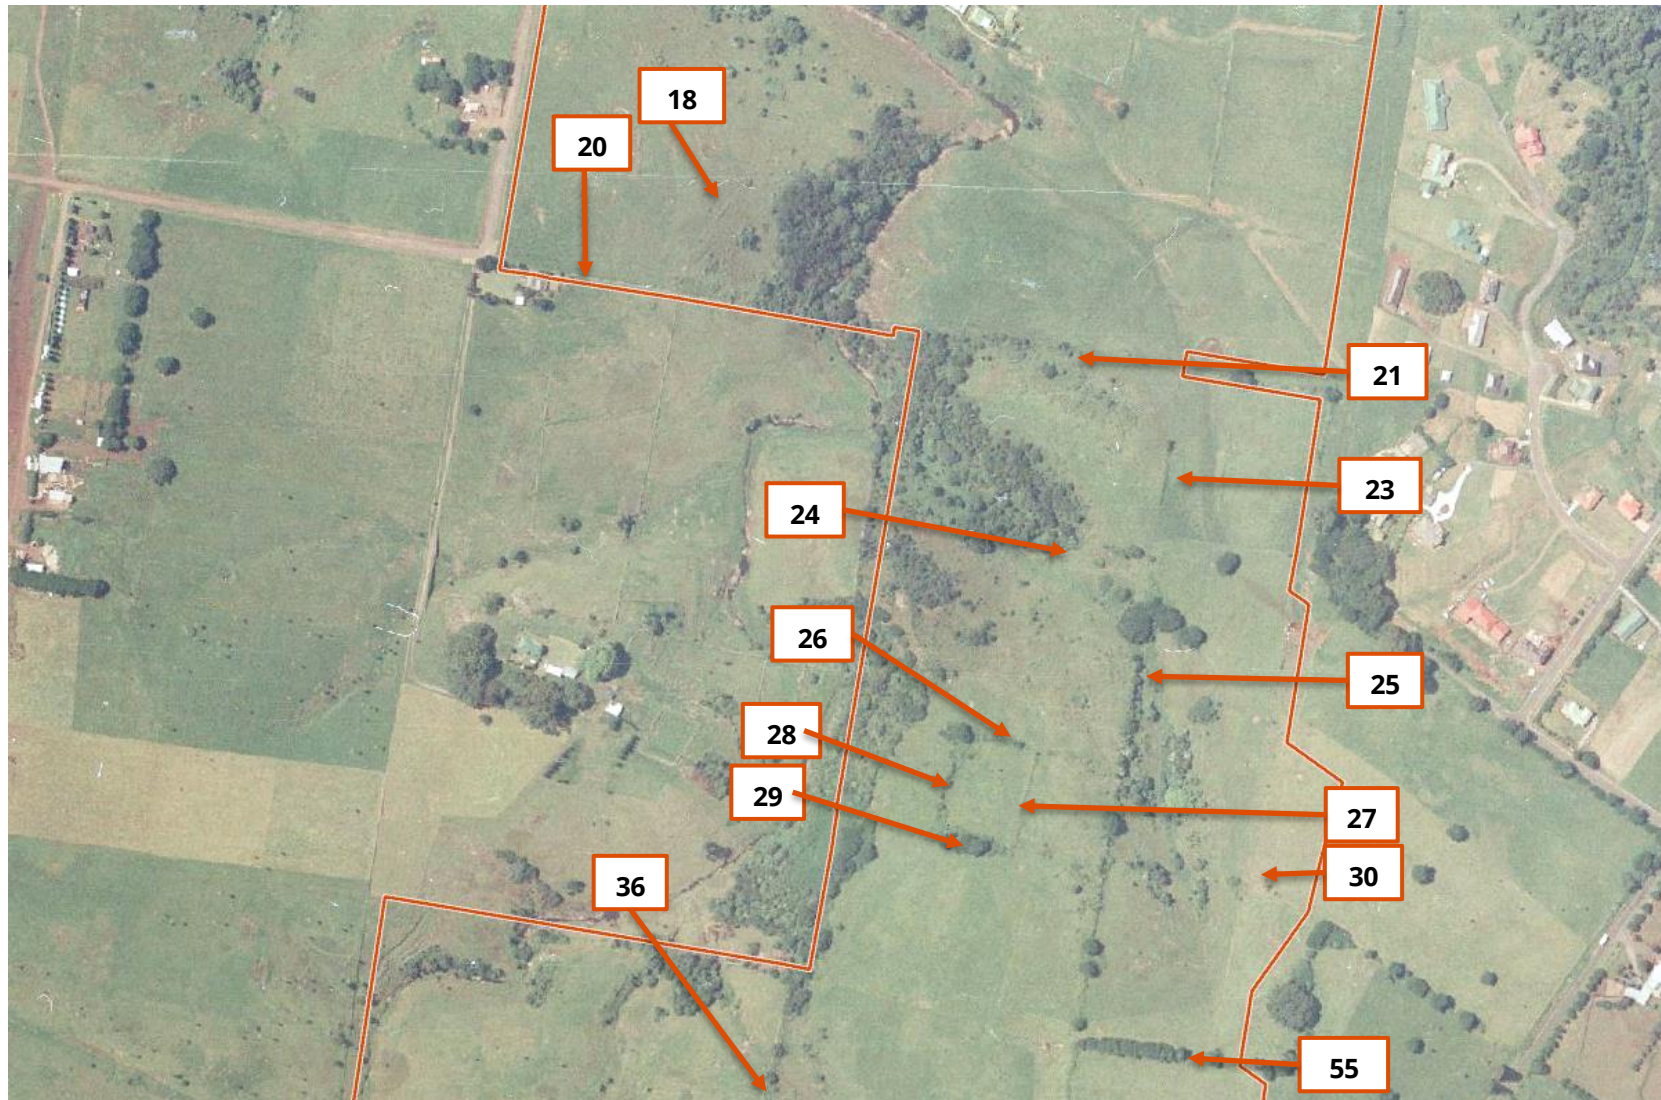
Photo 24 1993 aerial photograph of the central portion of the study area, outlined in orange, showing previously identified dry stone walls (Source: NSW Spatial Services 2022)

Aerial imagery dating to 1993 shows further minor changes within the study area (Photo 23, Photo 20, Photo 21) when compared with the imagery from 1979. Far fewer dry stone walls are clearly visible. There appears to be some additional buildings within both the northern homestead complex [6] and the southern homestead complex [8], while a new homestead is present in the south-east [60].

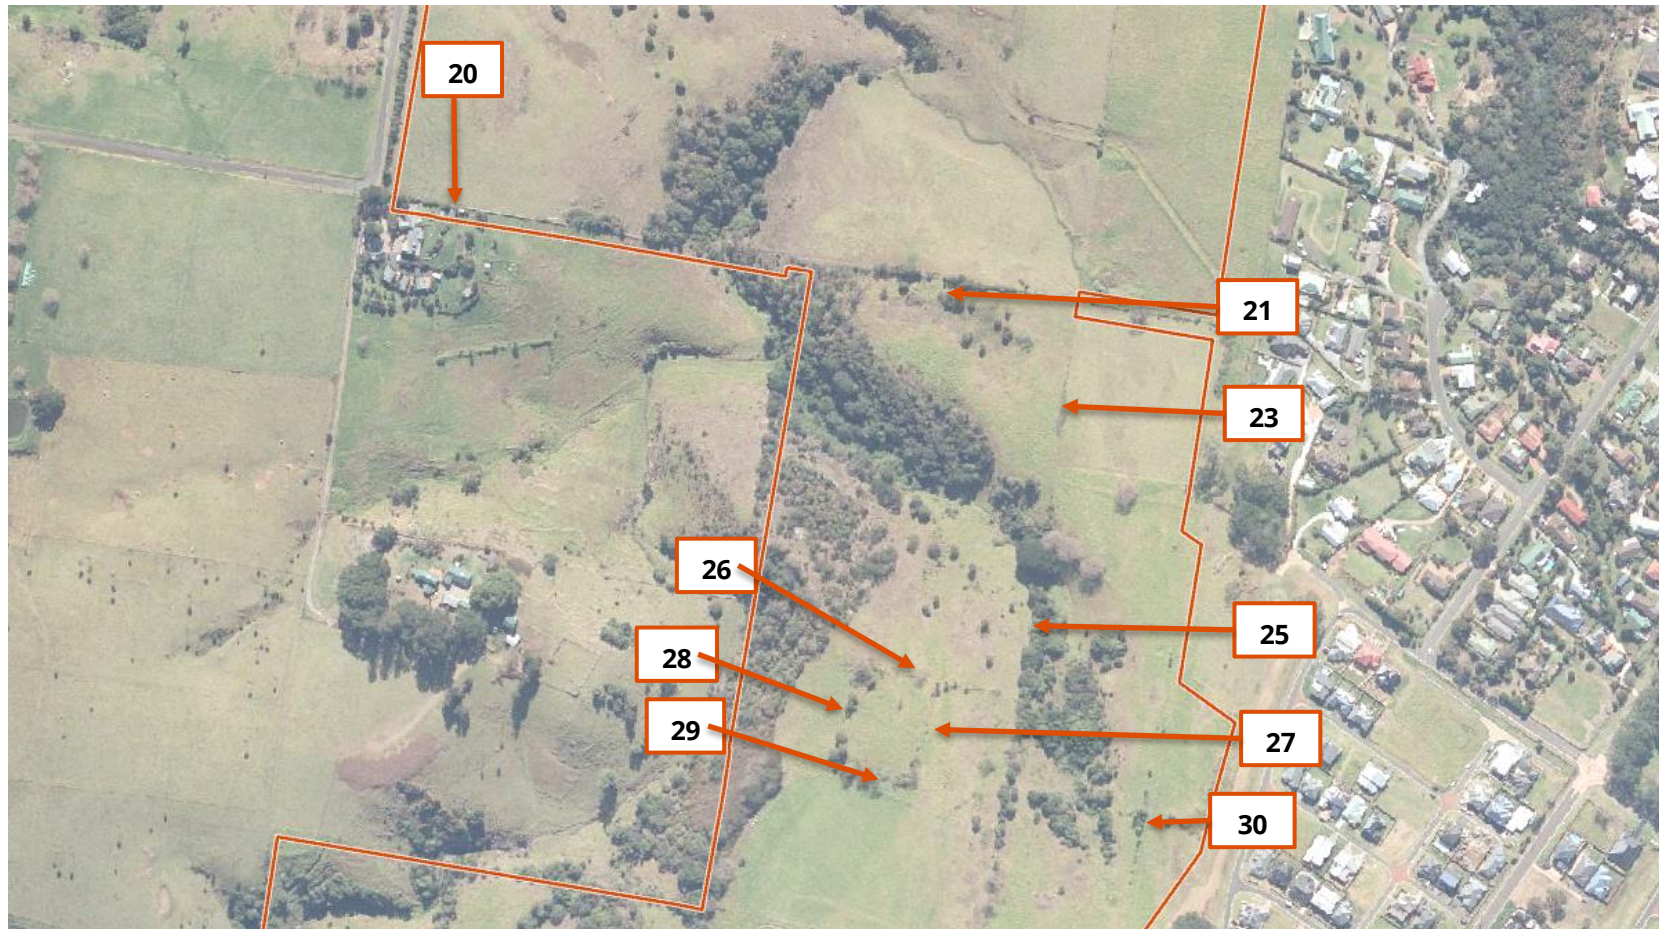
Photo 30 2006 aerial photograph of the central portion of the study area, outlined in orange, showing previously identified dry stone walls (Source: NSW Spatial Services 2022)

Aerial imagery dating to 2006 shows some changes within the study area (Photo 29, Photo 30, Photo 31) when compared with the imagery from 1993. Both the northern and southern homestead complexes [6] [8] have more formalised spaces, with lines of tree plantings having been established in both locations, with further changes to the configuration and number of structures. Fewer dry-stone walls are clearly visible, and a dry stone wall is newly visible on the southern boundary of Jamberoo Road [62].

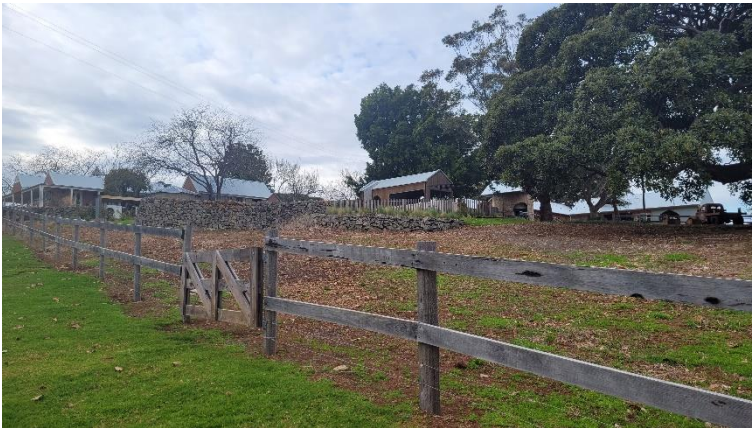
Photo 36 View of the Greyleigh homestead in the southern portion of the study area, facing east

There are three homestead areas within the study area: one in the northern portion east of Spring Creek; a second in the southern portion north of Long Brush Road (Greyleigh); and a third north of Old Saddleback Road. The northern homestead has been in operation since at least the 1960s, but likely earlier; it was not possible to access this location. Greyleigh has been a working dairy farm since its establishment by the Grey family in the second half of the 19th century, is currently also operating as a guest house and works appear to

be underway for preparation of the site as a wedding venue (Photo 36). The third homestead on Old Saddleback Road was also inaccessible.

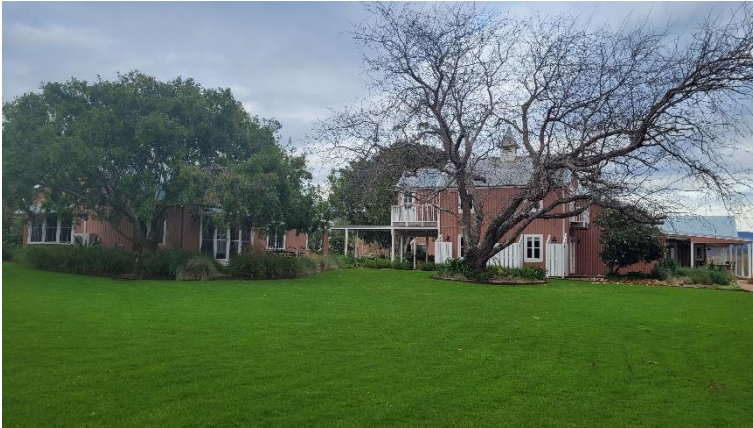
Photo 38 View of the Greyleigh homestead complex showing residential or commercial buildings and landscaped gardens

The homestead complex for Greyleigh within the southern portion of the study area was accessible and inspected. The Greyleigh homestead complex contains a range of built fabric, including but not limited to: structures for domestic, commercial (guest house accommodation, events), and agricultural use in a range of fabric including timber, corrugated iron, brick and concrete; driveways, footpaths and parking areas; storage and stockpiling areas; landscaped and garden areas; and dry stone walls and other fence lines of timber and wire (Photo 36, Photo 37, Photo 38, Photo 39, Photo 40, Photo 41, Photo 42). The northern homestead complex was not accessible but was observed from a distance. The northern homestead complex appears to contain residential and agricultural structures, a cleared yard area, sealed and unsealed roads and fence lines (Photo 43). The south-eastern homestead complex could not be accessed and was not inspected. Observations could not be made of the structures within the south-eastern homestead complex due to the presence of vegetation blocking views of this site.

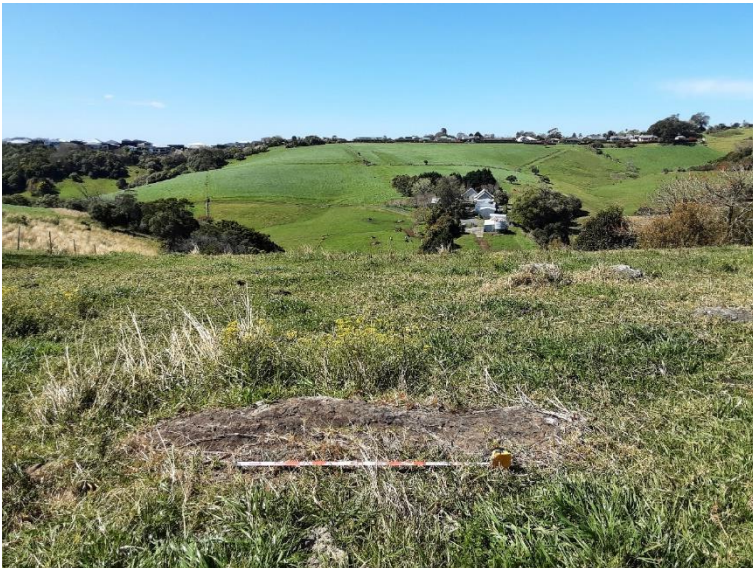
Photo 43 East-facing view of the northern homestead complex

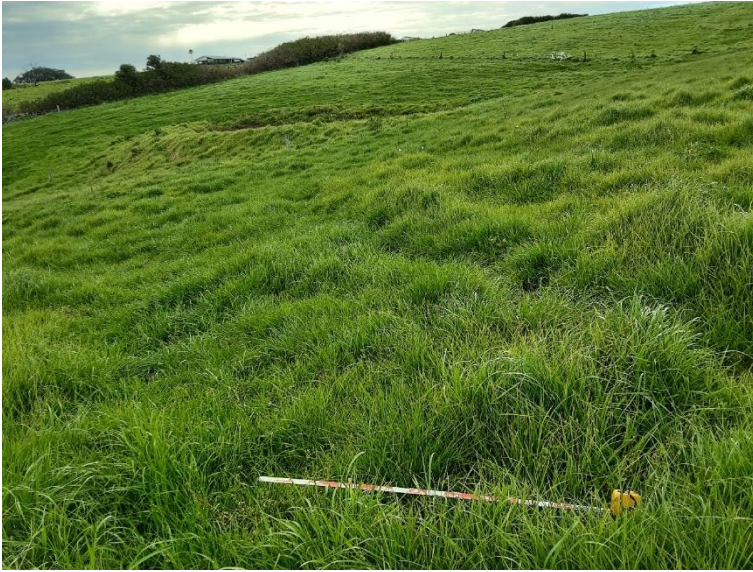
Photo 44 North-east facing view of an earthen dam located on one of the tributaries of Springs Creek in south-eastern portion of the study area

The following features have been identified as landscape features within the study area associated with the functioning of the land as dairy farms under several owners. The study area features dams with earthen banks and concrete walls, timber post and wire fences, metal and timber gates, electrical fences, a concrete tank and a concrete and stone/rubble bridge with a culvert within the study area (Photo 44, Photo 45, Photo 46, Photo 47, Photo 48).

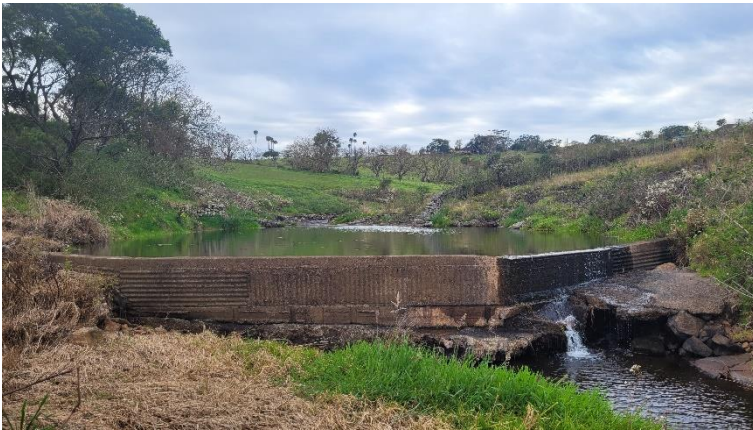
Photo 45 South-east facing view of a concrete dam contained within Springs Creek in the far southern portion of the study area

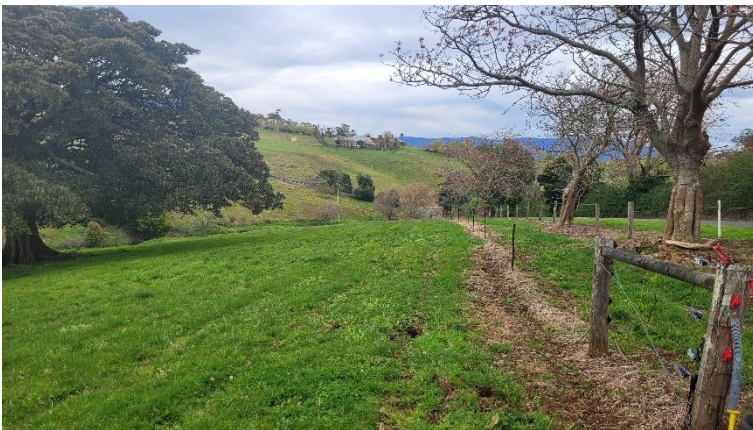
Photo 46 South-west facing view of post and wire fences in the southern portion of the study area

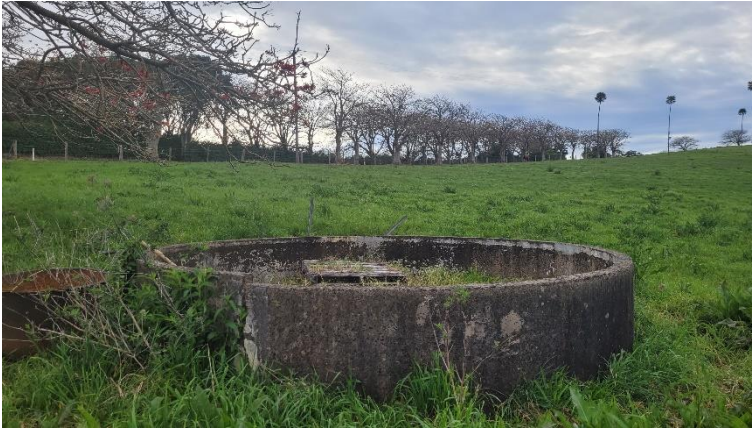
Photo 47 North-east facing view of a concrete tank in the far southern portion of the study area

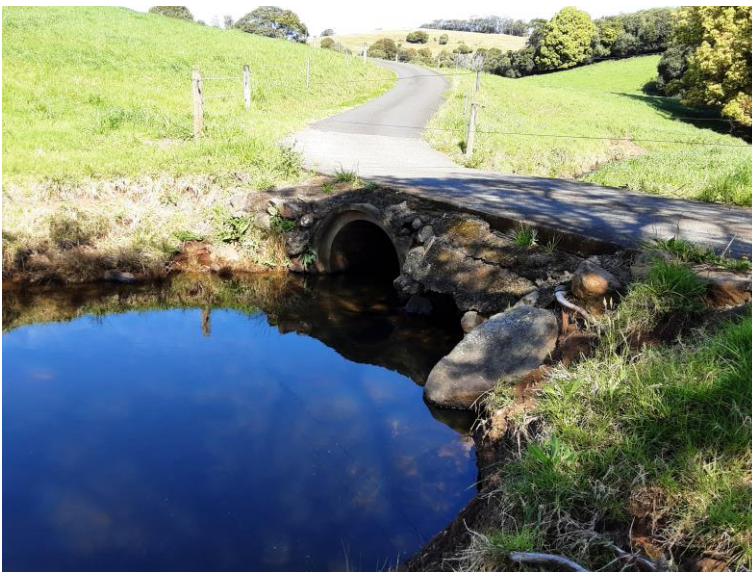
Photo 48 South facing view of a bridge and culvert over Spring Creek on the driveway to the northern homestead complex

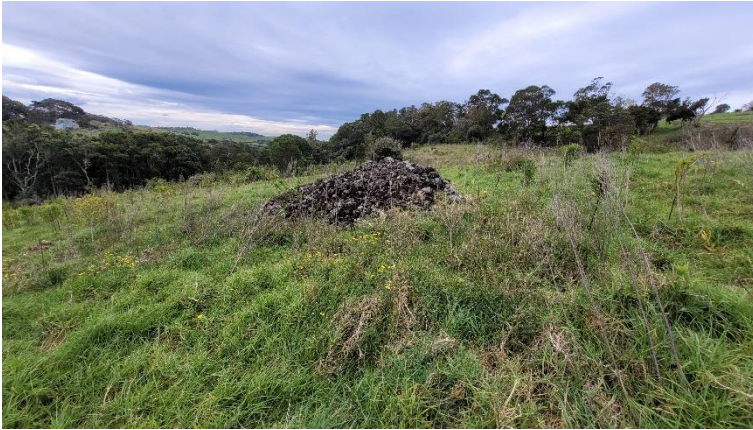
Photo 49 North-west facing view of pile of stones in the central portion of the study area

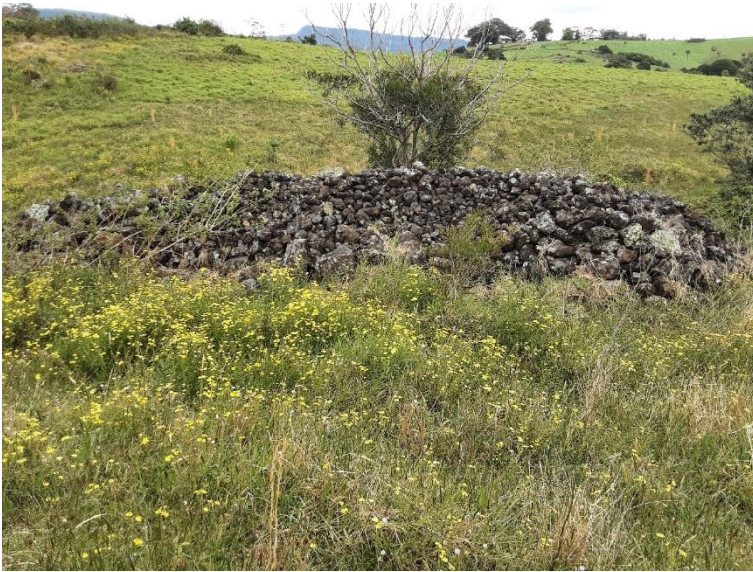
Photo 50 West facing view of the southern pile of stones in the central portion of the study area

A total of 20 dry stone walls located and inspected. Three additional walls were also identified, as were some associated features. Three piles of stones were also observed in the southern central portion of the study area, approximately 132 metres apart (Photo 49, Photo 50). These may be associated with the clearing and cultivation of the paddocks for agriculture and grazing, whereby stones were removed from the surface and topsoils and piled on the edges of fields and paddocks. These piles of stones were utilised for the dry stone walls from the mid-19th century onwards. Alternatively they may be the result of a dismantled dry stone wall.

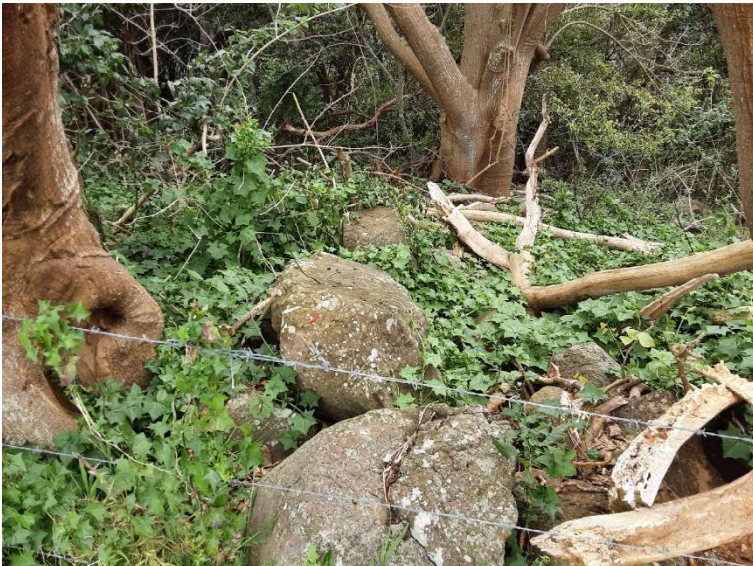
Photo 51 West facing view of the southern pile of stones in the central portion of the study area
