Kiama West Masterplan: Historical Heritage Constraints Assessment

FINAL REPORT

Prepared for Traders in Purple

26 January 2023

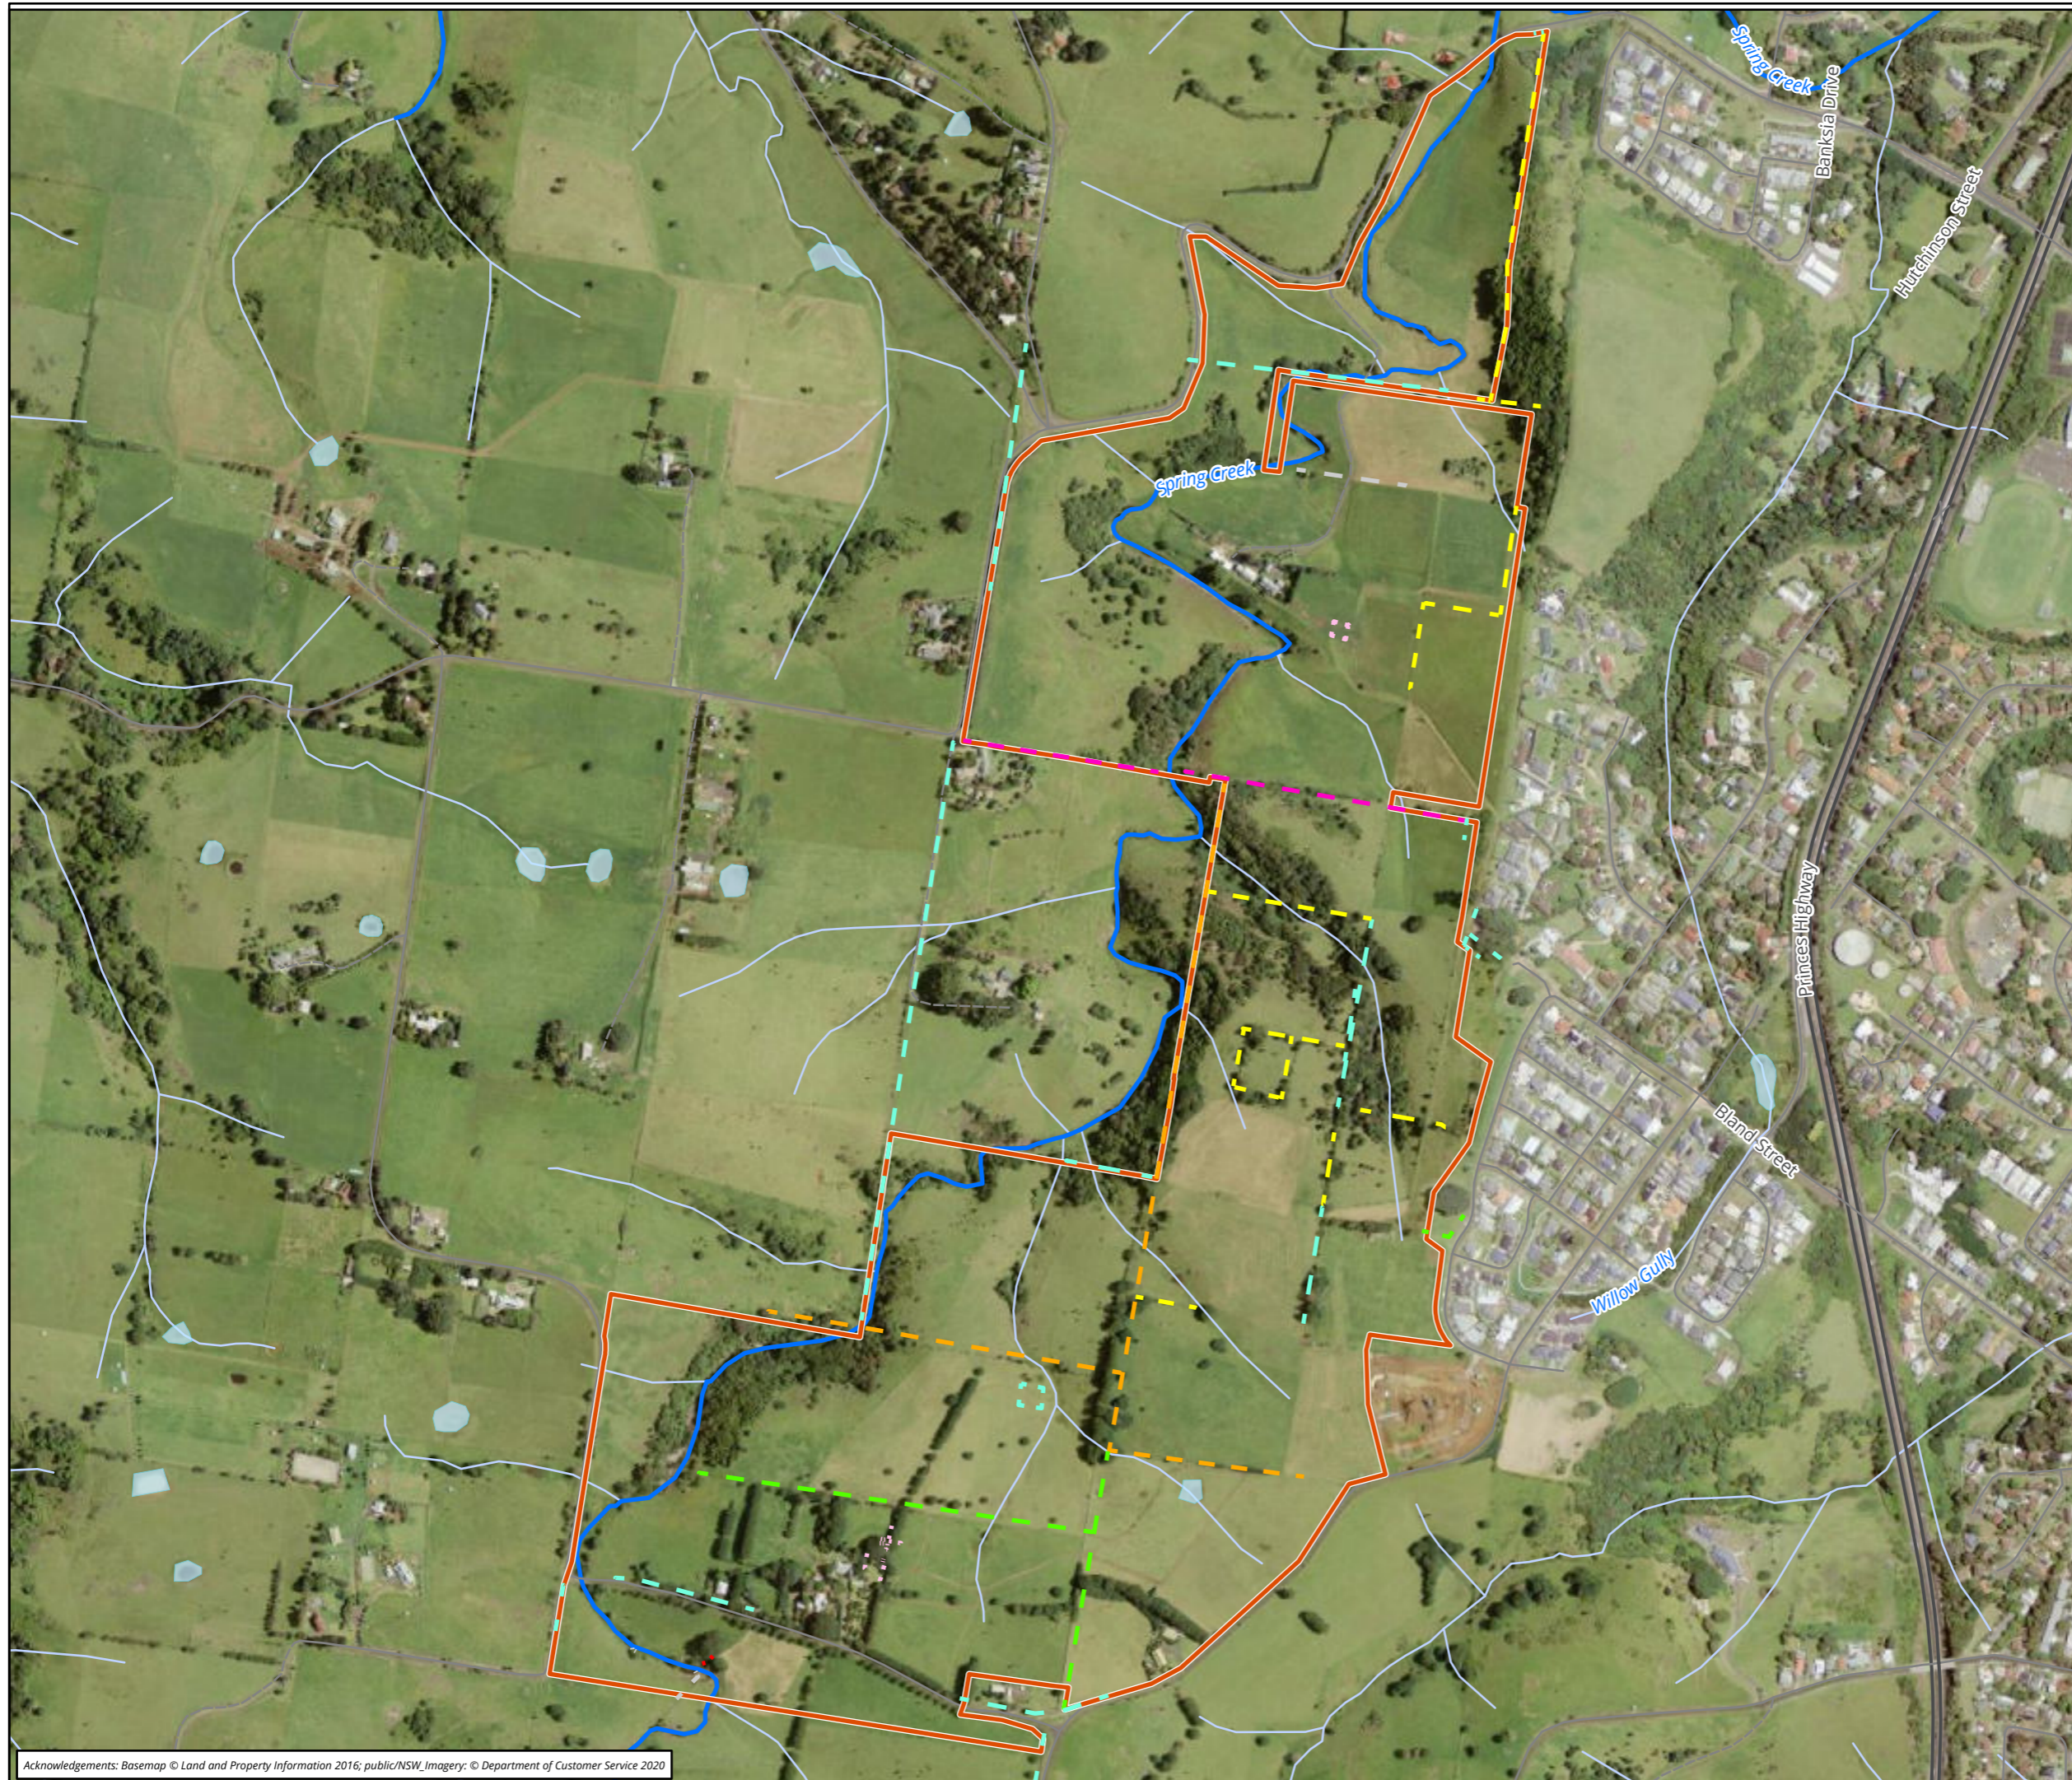
Figure 4 Overview - Locations of dry stone walls investigated during the physical inspection

- Legend**
- Study area
 - Condition of dry stone walls**
 - Good
 - Good to average
 - Average
 - Average to poor
 - Poor
 - No longer extant
 - Unknown; no longer extant
 - Unknown

Length of walls are as per Kiama Municipal Council and historical records, except Biosis DSW007, Biosis DSW008 and Biosis DSW012 which were first identified in the field

Biosis reference no.	Identification source	Biosis condition observations
Biosis DSW001	DP 1148007	Poor
Biosis DSW002	DP 1003719	Overgrown with vegetation
Biosis DSW003	DP 1042908	Poor
Biosis DSW003.1	DP 1042908	Not inspected.
Biosis DSW004	DP 1042908	Poor
Biosis DSW005	DP 1042908, DP 882774	Poor
Biosis DSW006	DP 1176643	Poor
Biosis DSW006.1	DP 1176643	Not identified.
Biosis DSW007	During physical inspection	Good to average
Biosis DSW008	During physical inspection	Average

Biosis reference no.	Identification source	Biosis condition observations
Biosis DSW009	R31905.1603	Overgrown with vegetation
Biosis DSW009.1	R31905.1603	Not accessible
Biosis DSW009.2	R31905.1603	Not accessible
Biosis DSW010	DP 1042908	Not accessible
Biosis DSW011	R1245c.1603	Not visible, possibly no longer extant
Biosis DSW011.1	R1245c.1603	Not identified.
Biosis DSW012	During physical inspection	Good to average

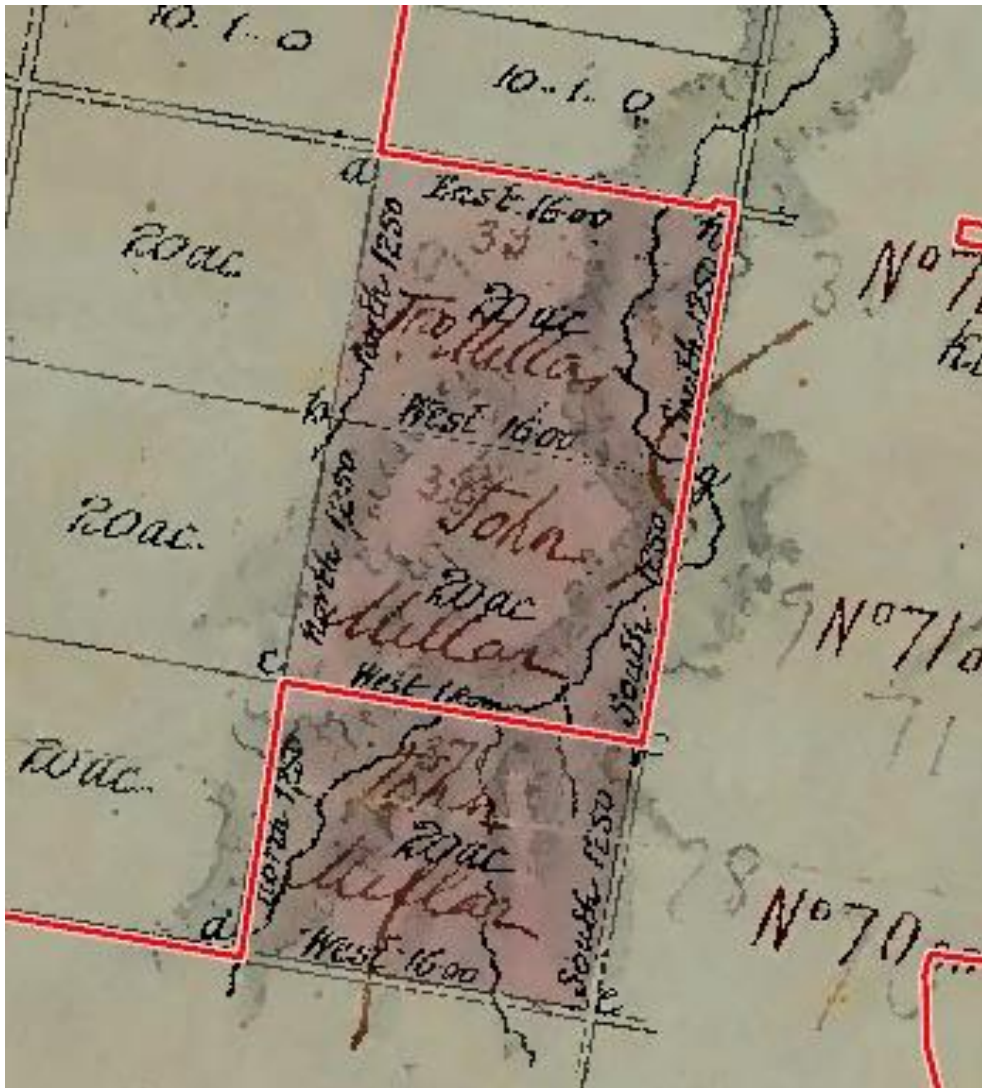
Photo 53 1851 Crown plan for three portions of land, featuring Portion 70, with the study area outlined in orange (Source: NSW Land Registry Services, Crown plan K23.1249)

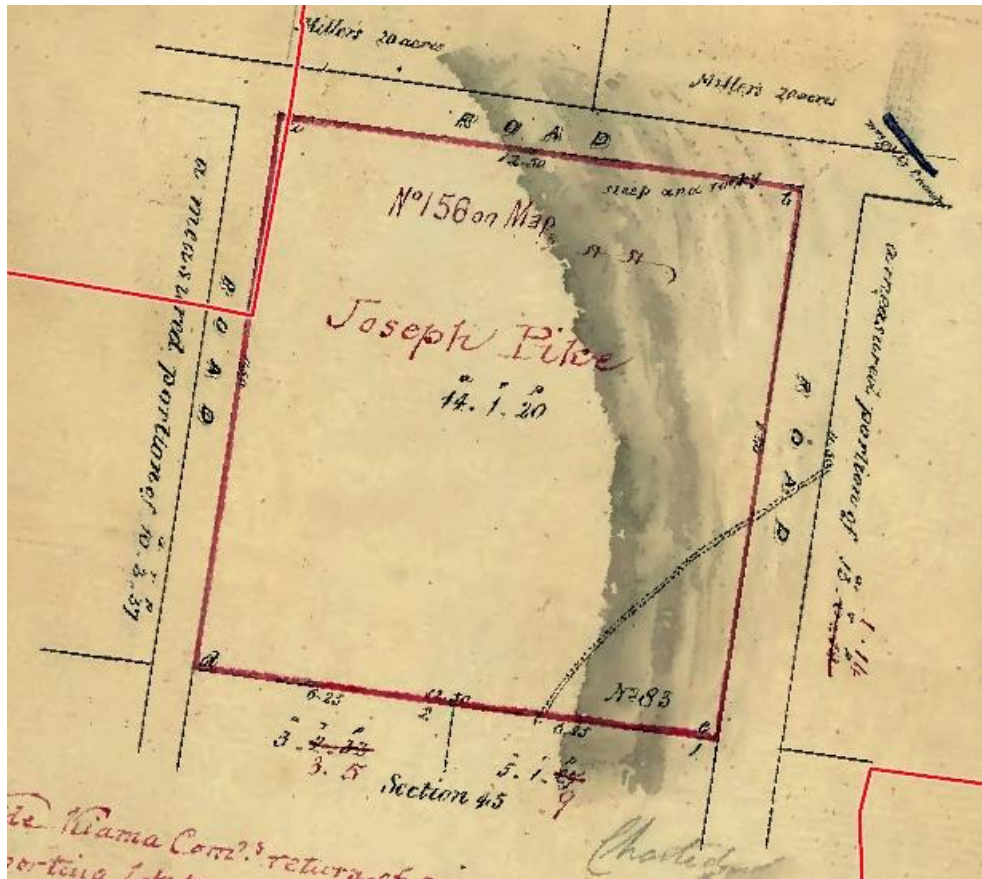
Photo 55 1854 Crown plan of suburban allotment 83, featuring Portion 156, with the study area outlined in orange (Source: NSW Land Registry Services, Crown plan K33.1249)

The Crown plans for the study area record descriptions of the land within the study area, with notes such as thick bushland, stony ground, good soils suitable for agriculture and good supplies of water either from creeklines or sinking wells (Photo 8, Photo 55, Photo 9, Photo 56, Photo 57, Photo 58). An old saw pit [1] and an associated track through portions 188, 189, 156, 178 Town Section 45 is recorded on several of the 1854

Crown plans (Photo 8, Photo 55, Photo 56, Photo 58).⁶⁵ The alignment [2] for what would become Old Saddleback Road/Long Brush Road is also recorded (Photo 9).⁶⁶

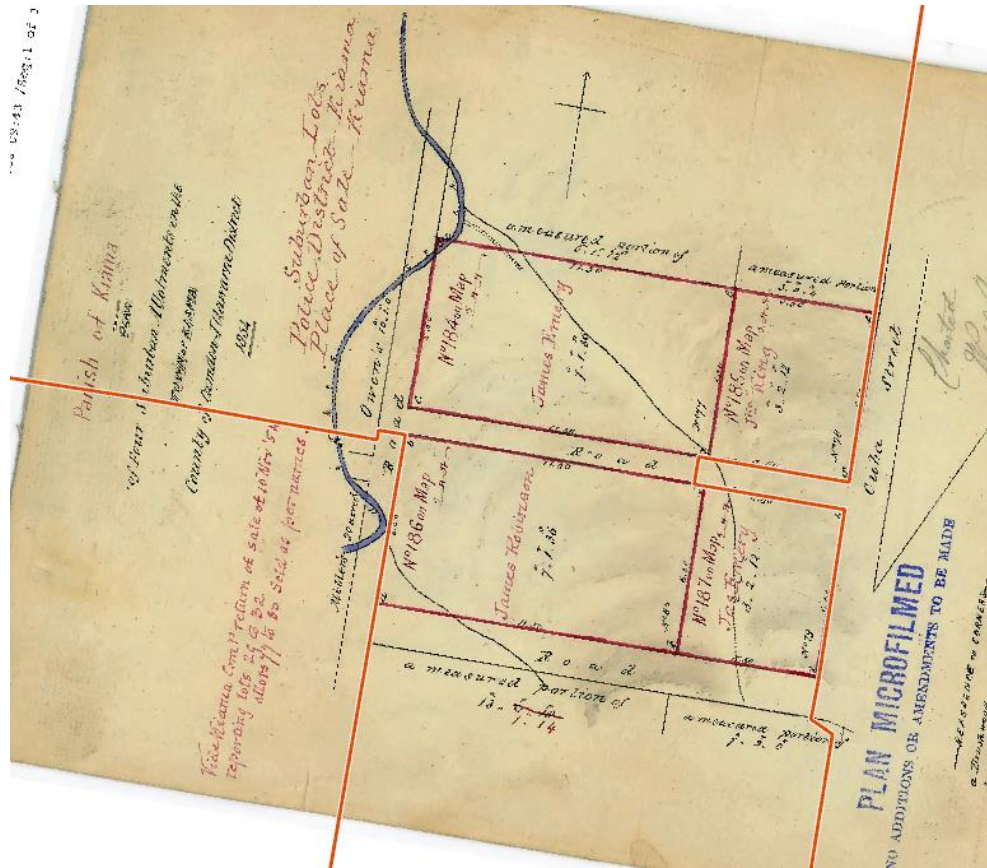
Photo 57 1854 Crown plan of four suburban allotments, featuring portions 184-187, with the study area outlined in orange (Source: NSW Land Registry Services, Crown plan K35.1249)

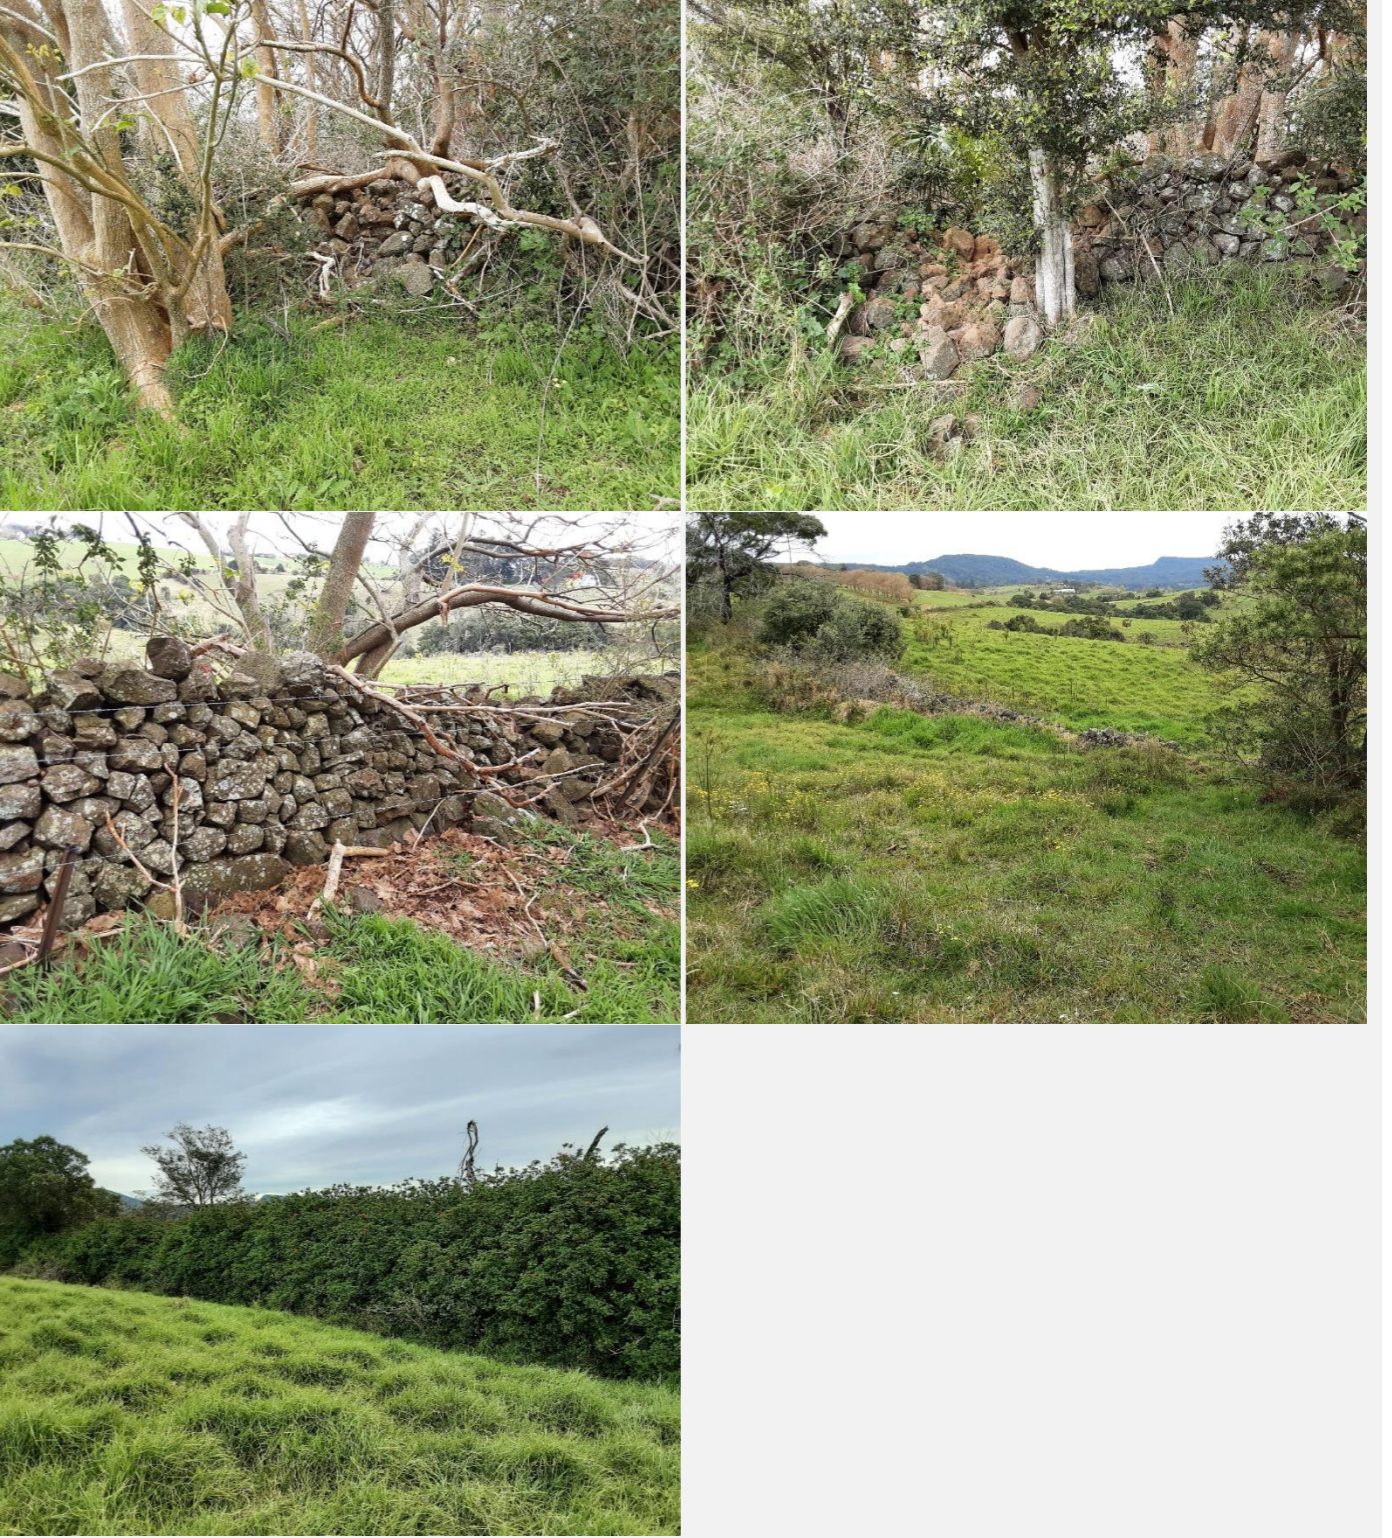
Kiama Dry Stone Walls Inventory No.	Description and condition	
	Kiama Heritage Inventory sheet – technical values	Current Biosis observations
18	<ul style="list-style-type: none"> Standard ‘double dyke’ model used. Large blocks standard throughout walls Excellent interlocking on steepest slopes Coping layer has been predominantly removed. Intactness: 75% 	Inaccessible due to dense vegetation.
19	Inventory sheet unavailable.	Not located during physical inspection.
54	<ul style="list-style-type: none"> Very good height to base course relationship. Irregular foundation stones, whatever was present was utilised. Face stones have a high engagement for interlocking, but here is no consistency in the wall. Very large coping stones, regular and well bound. Intactness: 100% 	<ul style="list-style-type: none"> Good condition Largely complete in locations inspected. Likely to be maintained.

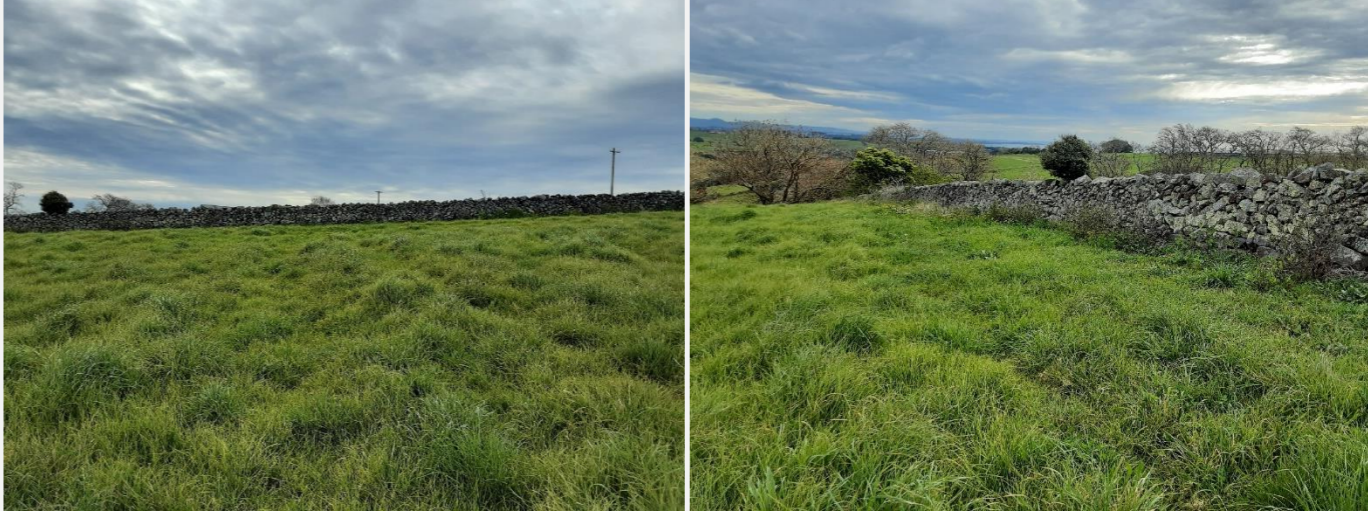
55	Inventory sheet unavailable.	Not identified in the field; likely dismantled and stone used elsewhere in Greyleigh homestead.

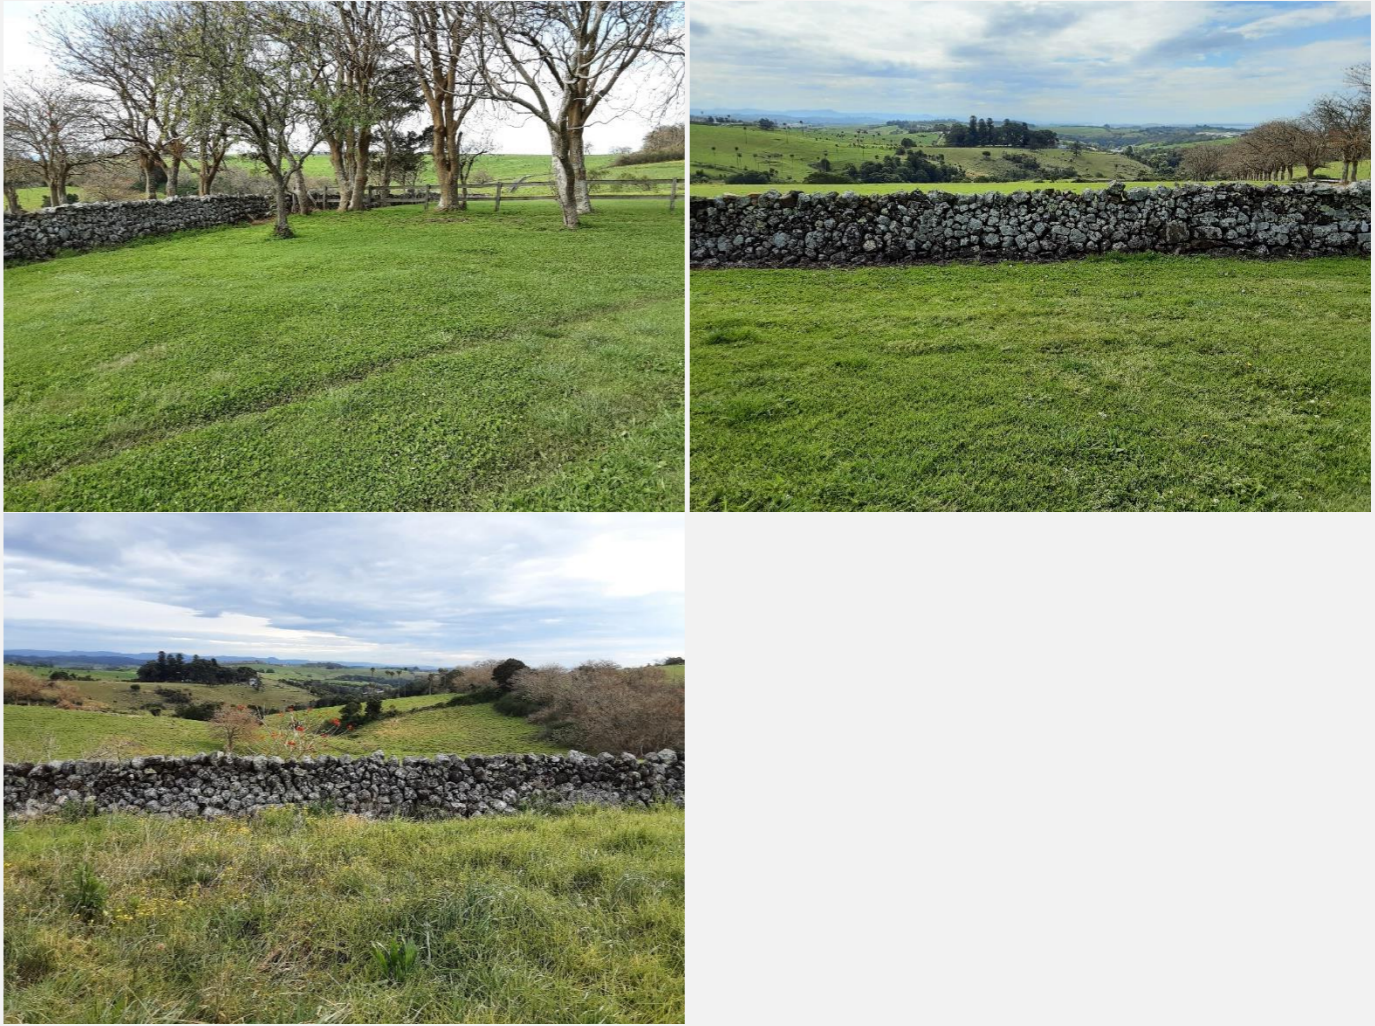
Kiama Dry Stone Walls Inventory No.	Description and condition	
	Kiama Heritage Inventory sheet - technical values	Current Biosis observations
70	Inventory sheet unavailable.	<ul style="list-style-type: none"> • Good condition. • Sighted at northern end of Greyleigh homestead complex, and also further east near junction with wall 54.

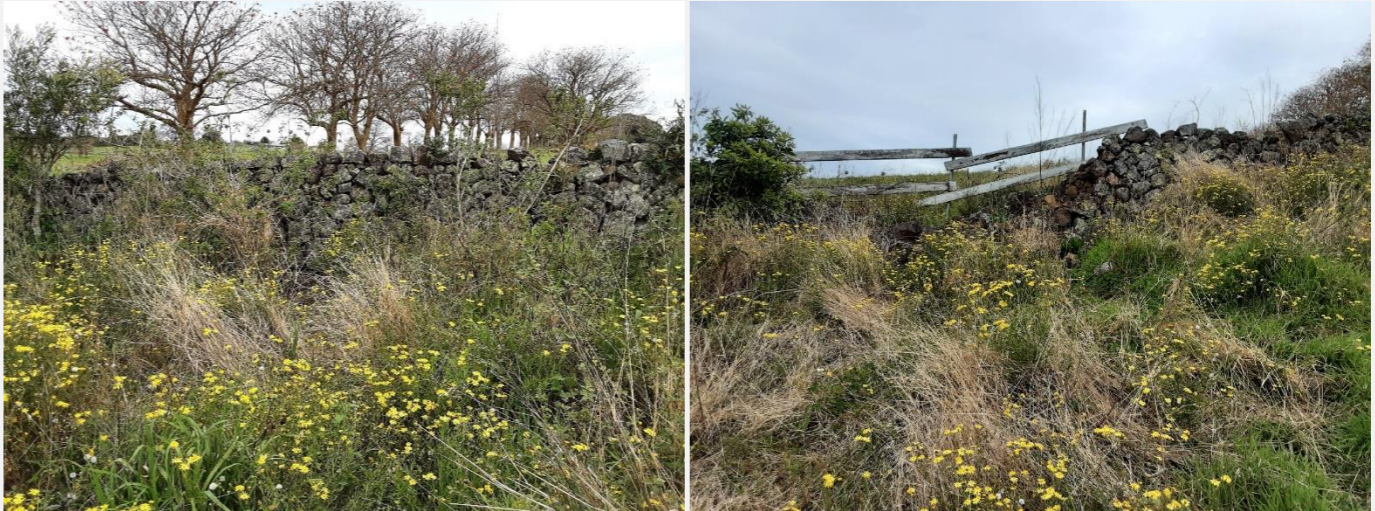
Kiama Dry Stone Walls Inventory No.	Description and condition	
	Kiama Heritage Inventory sheet - technical values	Current Biosis observations
72	Inventory sheet unavailable.	<ul style="list-style-type: none"> • Average to poor condition. • Partial collapse in central part of wall length; timber used to block cattle. • Overgrown with vegetation. • Stones missing from coping.

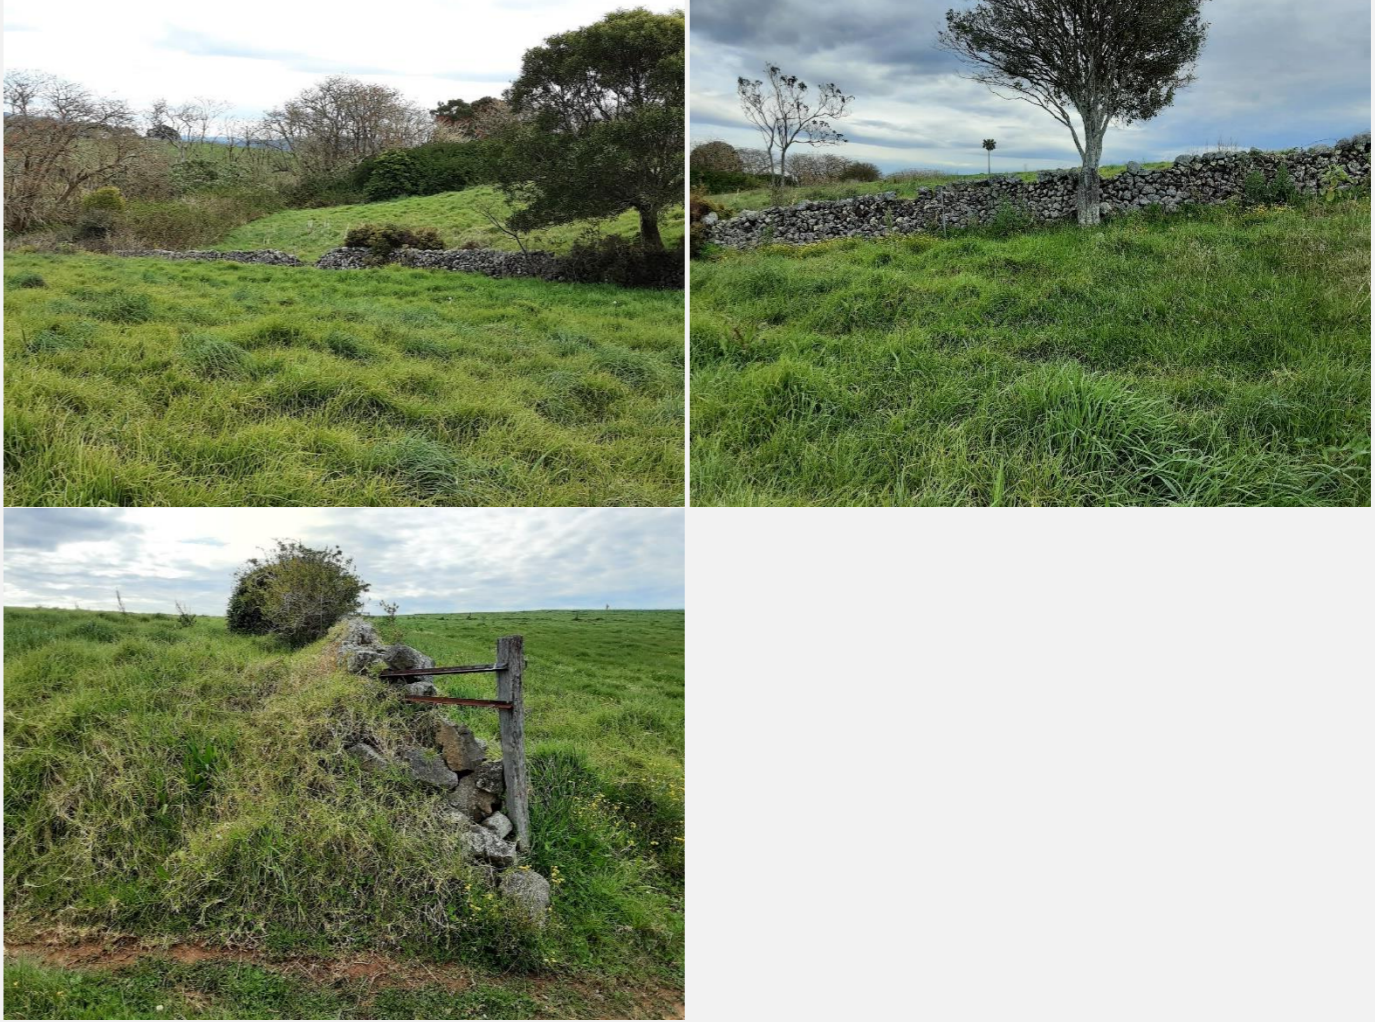
73	Inventory sheet incomplete.	<ul style="list-style-type: none"> • Average to poor condition. • Partial collapse near western end. • Stones missing from coping in numerous locations. • Overgrown in places with soil build up adjacent.

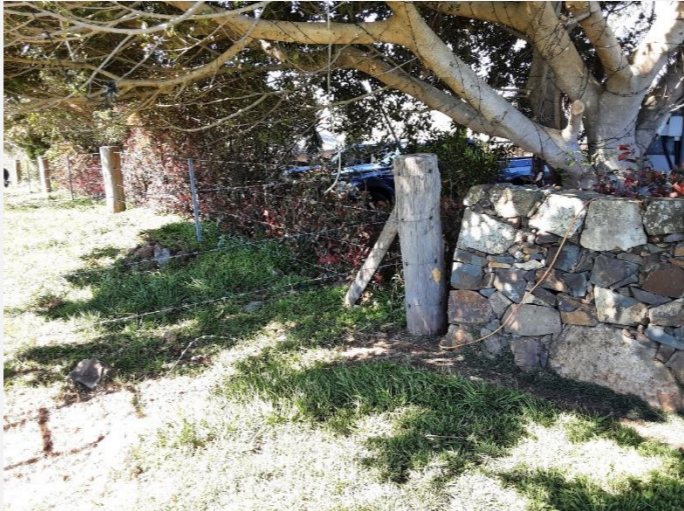
Kiama Dry Stone Walls Inventory No.	Description and condition	
	Kiama Heritage Inventory sheet – technical values	Current Biosis observations
149	<ul style="list-style-type: none"> • Excellent cross section proportions for stability. • Very large foundations steins with use of in situ rock. • Excellent positioning of facing stones, high care. • Generally very high coping stones. • Intactness: Average 90%, continues to east of creek onto next ridge but deteriorates into vegetations. 	<ul style="list-style-type: none"> • Inaccessible except at corner of Jerrara Road. • Potentially no longer extant at western end; small cluster of stones eroding from topsoil and turf.

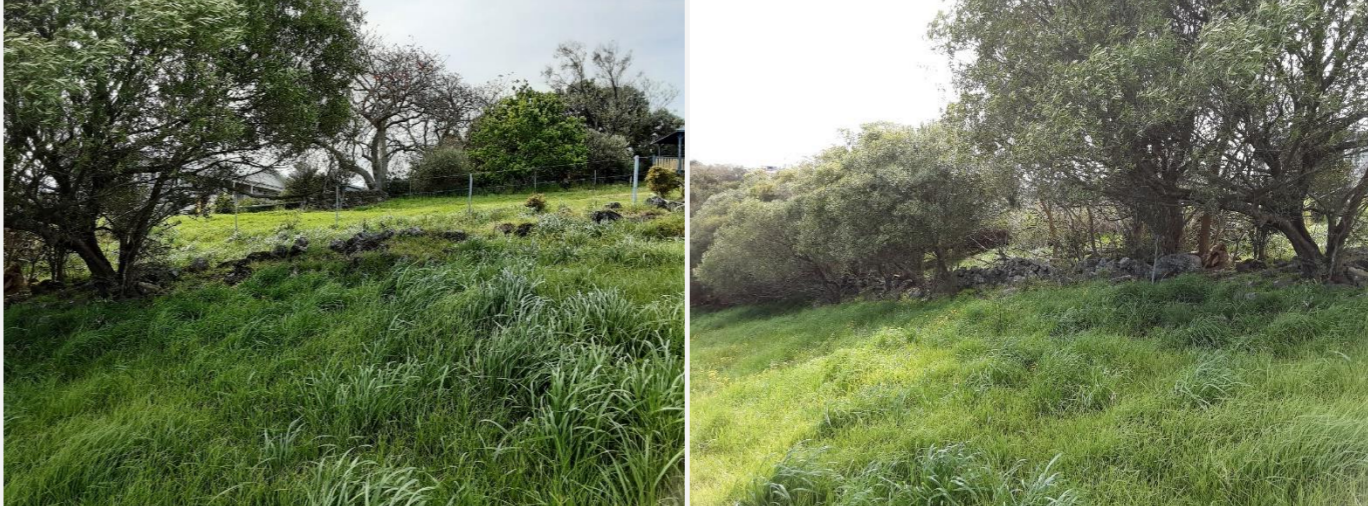
153	<ul style="list-style-type: none"> • Correct overall proportions for stability. • Medium-large base course of foundation stones for support. • Tight engagement of facing stones. • Most of coping remains intact at northern end. • Intactness: Varies between 90% and 30% at parts of its southern end. 	<ul style="list-style-type: none"> • Poor condition. • Only lower / foundation courses visible. • Overgrown with vegetation including trees.

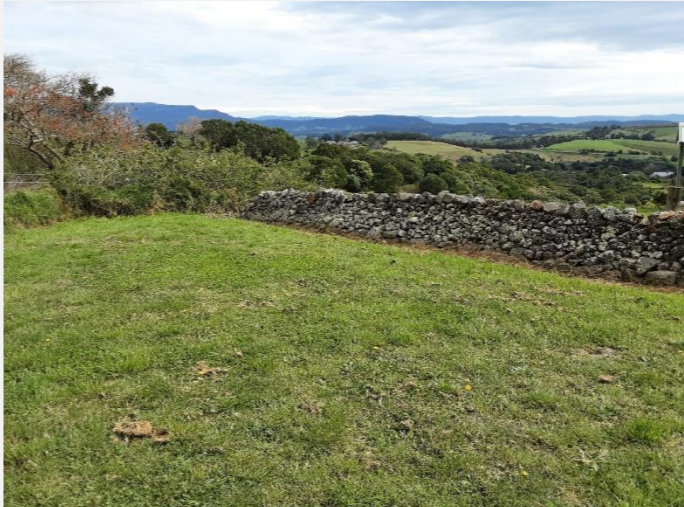
156	Inventory sheet incomplete.	<ul style="list-style-type: none"> • Good condition. • Wall face and coping in situ. • Likely maintained.

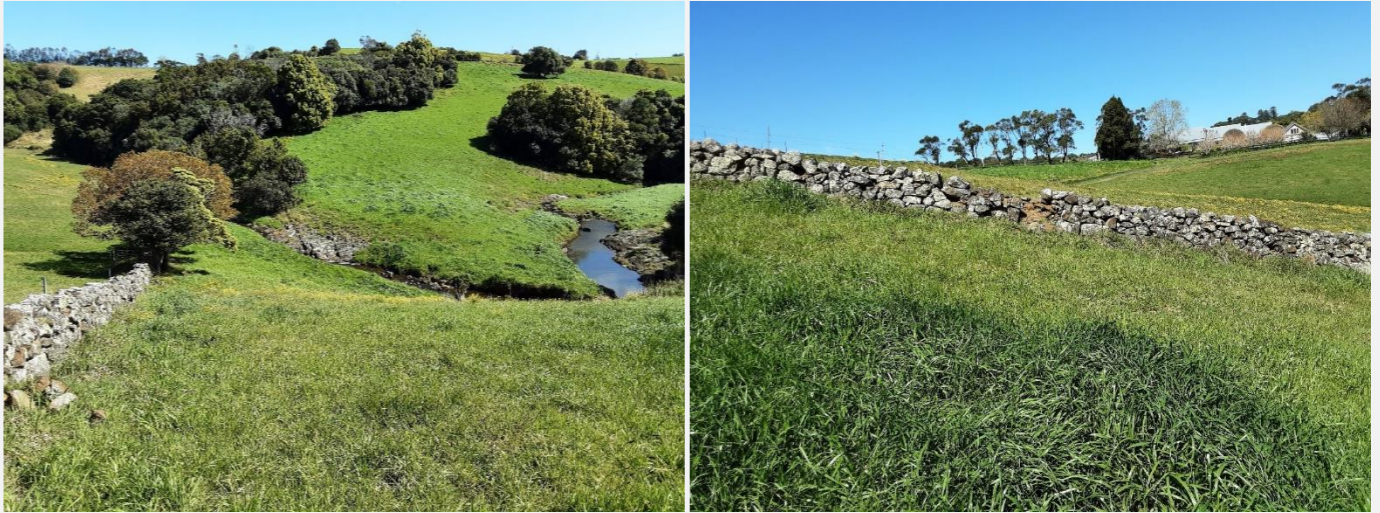
Kiama Dry Stone Walls Inventory No.	Description and condition	
	Kiama Heritage Inventory sheet – technical values	Current Biosis observations
205	Inventory sheet unavailable.	<ul style="list-style-type: none"> • Good to average condition. • Coping course no longer extant. • Some instances of partial collapse.

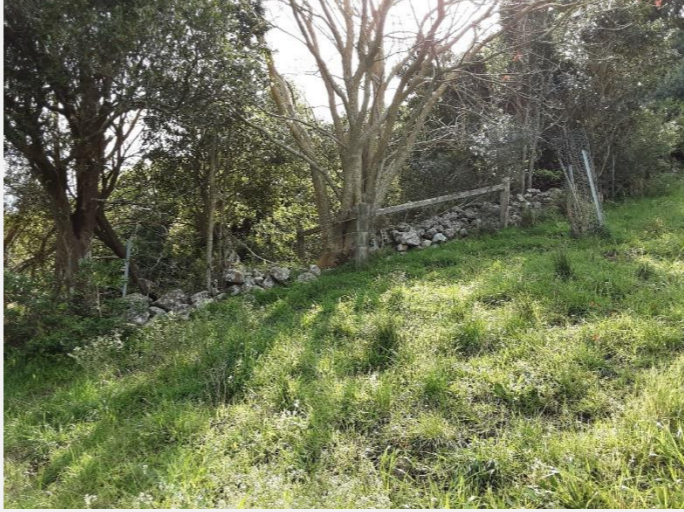
206	Inventory sheet unavailable.	<ul style="list-style-type: none"> • Poor condition. • In a dilapidated state. • Appears to be collapsing down the slope. • Only lower and foundation courses extant.

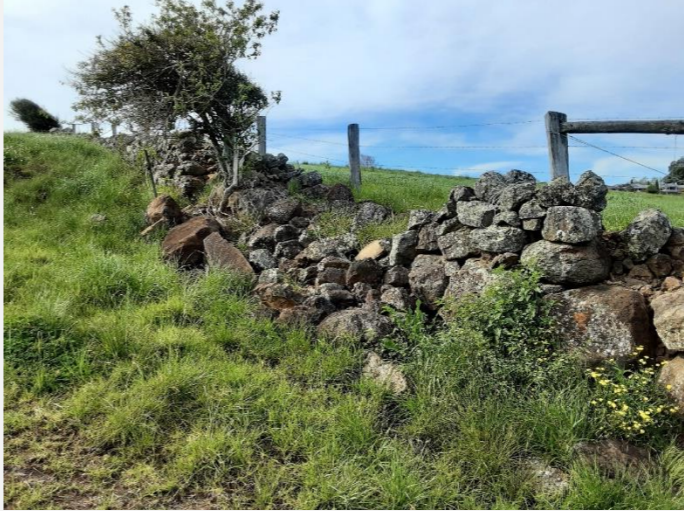
207	<ul style="list-style-type: none"> • Correct base width proportions cross section for stability. • High base course of foundations stones for support. • High engagement of face stones where intact, good batter. • No identifiable coping layer remains. • Intactness: 30% 	<ul style="list-style-type: none"> • Poor condition • Lower or foundation courses extant. • Overgrown with grasses and some smaller trees. • Some sections partially collapsed.

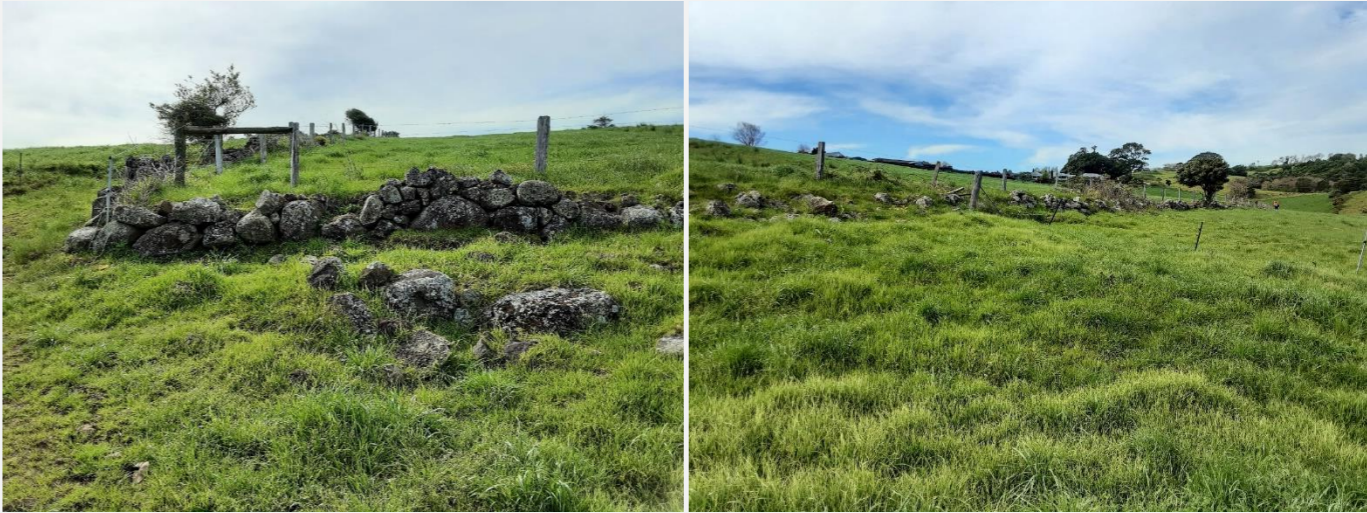
Kiama Dry Stone Walls Inventory No.	Description and condition	
	Kiama Heritage Inventory sheet - technical values	Current Biosis observations
209	Inventory sheet unavailable.	<ul style="list-style-type: none"> Poor condition Only lower or foundation courses visible. Overgrown with grasses and some smaller trees.

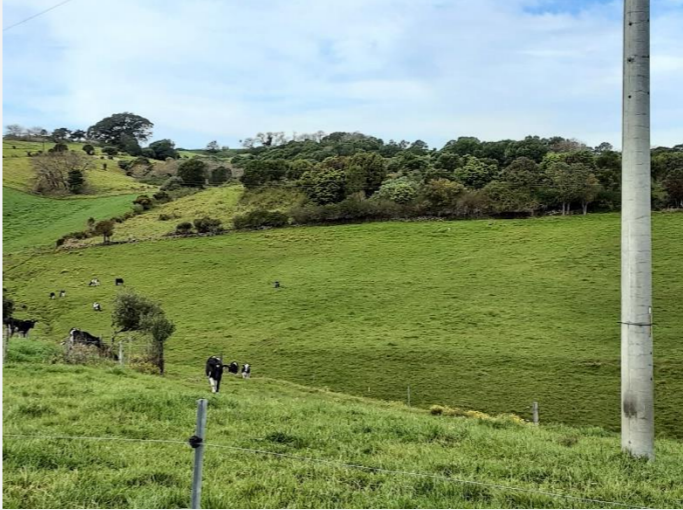
218	Inventory sheet unavailable.	No longer extant/not visible
219	Inventory sheet unavailable.	No longer extant/not visible
220	<ul style="list-style-type: none"> Very secure 'A' frame visible on eastern face. Moderate size foundations stones but very deeply set. High interlocking of face stones if not removed or collapsed. Most of the copies stones have fallen due to the severe slope. Intactness: Average 50% where visible. 	Not accessible due to dense vegetation.

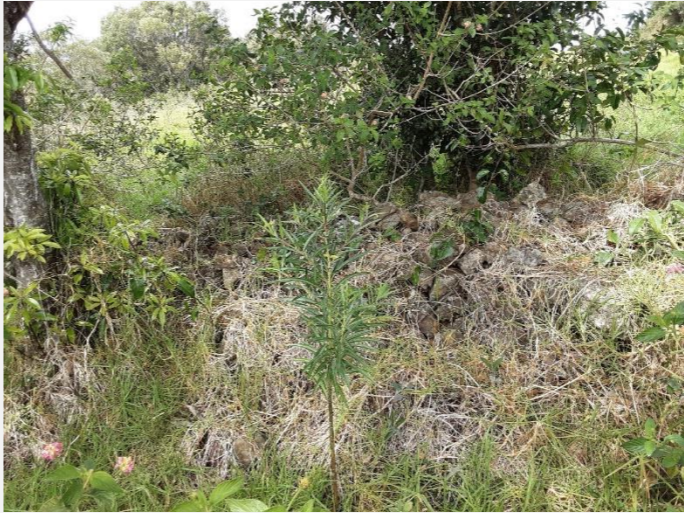
Kiama Dry Stone Walls Inventory No.	Description and condition	
	Kiama Heritage Inventory sheet - technical values	Current Biosis observations
221	<ul style="list-style-type: none"> • Base remains appear to be very wide in parts. • No foundation layer visible, presumed small foundations stones. • High engagement of very small facing stones. • No coping stone layer remains to assess. • Intactness: Eastern end is more intact than the western portion. Approximately 10% for total length. 	<ul style="list-style-type: none"> • Poor condition. • Almost completely collapsed. • Overgrown with climbing vegetation and trees.

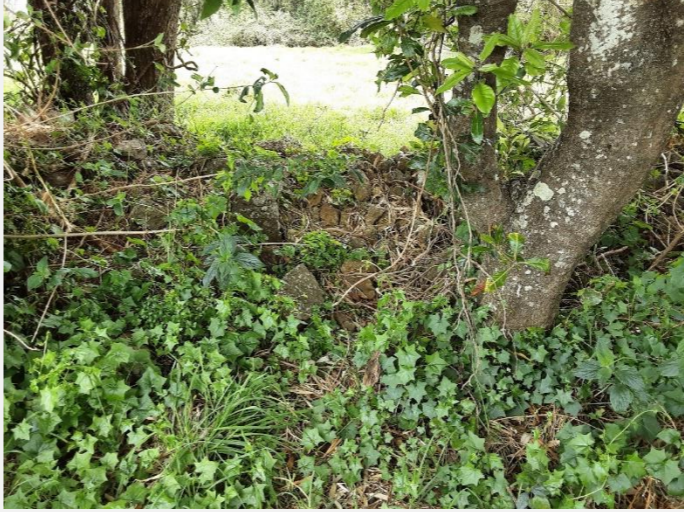
222	<ul style="list-style-type: none"> • Small 'double- dyke' proportions. • Moderate sized base course layer support. • High engagement of very small facing stones. • No coping layer stones remain to assess. • Intactness: Approximately 40-45%. 	<ul style="list-style-type: none"> • Poor condition. • Almost completely collapsed. • Overgrown with climbing vegetation and trees.

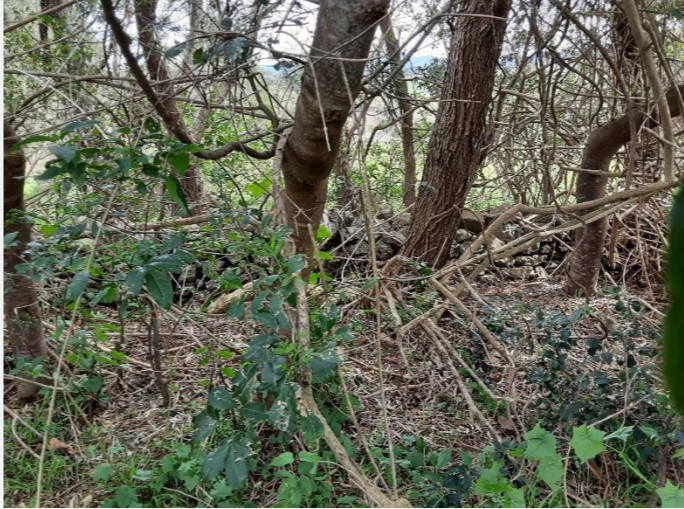
223	<ul style="list-style-type: none"> • Predominantly a vestigial form in terms of proportions. • Moderate sized base course layer support. • No significant face portion remains to assess. • No coping layer remains to assess. • Intactness: Less than 10% for most of its length. 	<ul style="list-style-type: none"> • Poor condition. • Almost completely collapsed. • Overgrown with climbing vegetation and trees.

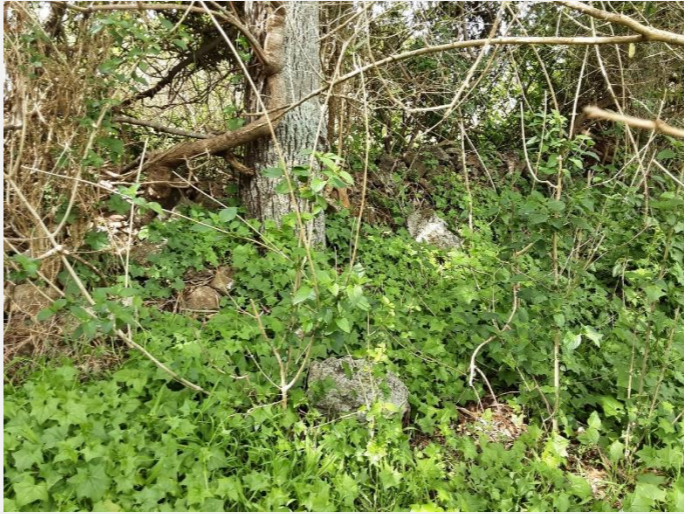
Kiama Dry Stone Walls Inventory No.	Description and condition	
	Kiama Heritage Inventory sheet - technical values	Current Biosis observations
224	<ul style="list-style-type: none"> • Base appears to have been very wide. • Foundation layers no longer visible. • All of face lengths are broken down. • No coping layer remains to assess. • Intactness: 5% of original length, 10% of original height. 	<ul style="list-style-type: none"> • Poor condition. • Almost completely collapsed. • Overgrown with climbing vegetation and trees.

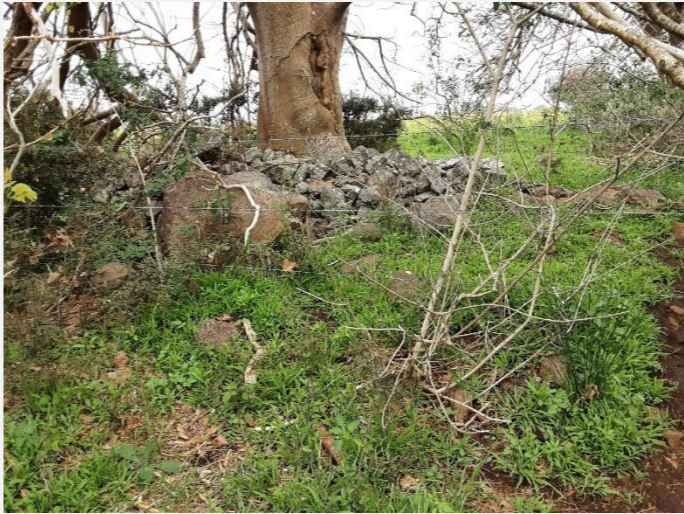
Biosis reference number	Identification source	Biosis condition observation
DSW001	DP 1148007	<ul style="list-style-type: none"> • Poor condition. • Small section of recorded wall identified. • Potentially dismantled. • Overgrown with vegetation, tree growing immediately adjacent.

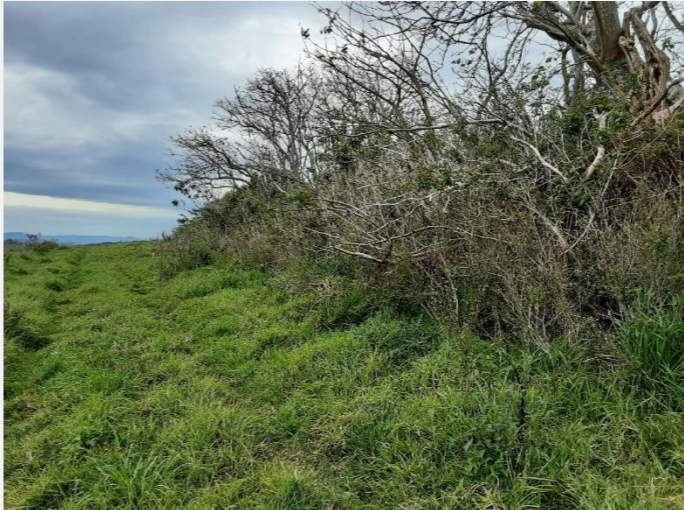
DSW003	DP 1042908	<ul style="list-style-type: none"> • Poor condition. • Partial collapse from animal access tracks. • Overgrown by vegetation. • Some potential repairs as evidenced by stones without growth and aging effects. • Likely to be associated with DSW002.

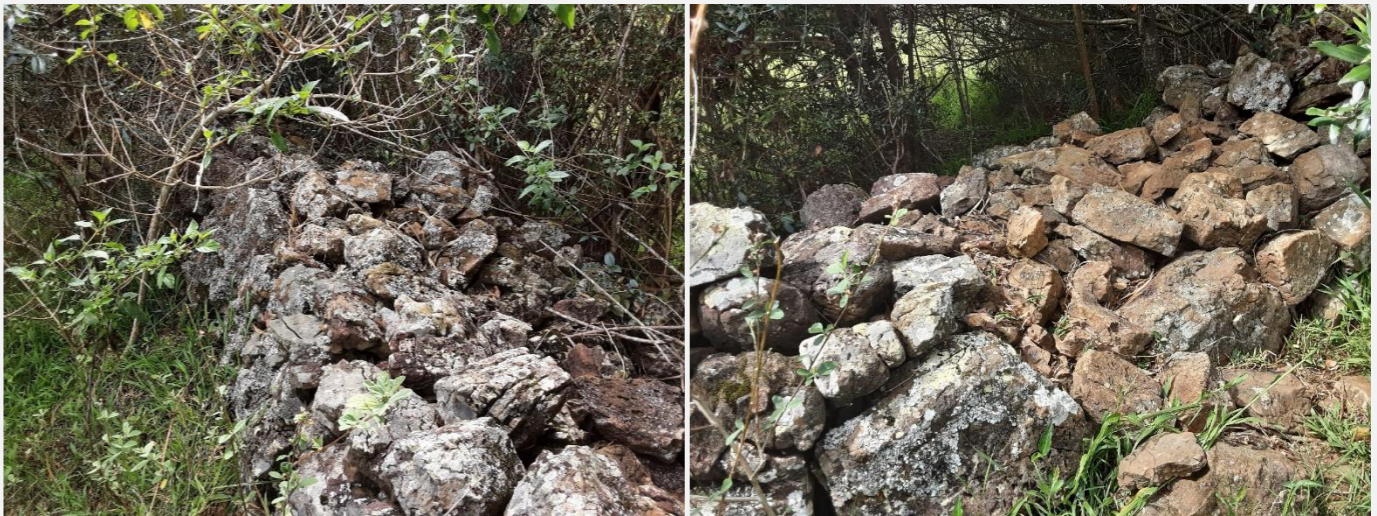
DSW004	DP 1042908	<ul style="list-style-type: none"> • Poor condition. • Much of stone has been removed. • Only several metres could be identified.
