Kiama West Masterplan: Historical Heritage Constraints Assessment

FINAL REPORT

Prepared for Traders in Purple

26 January 2023

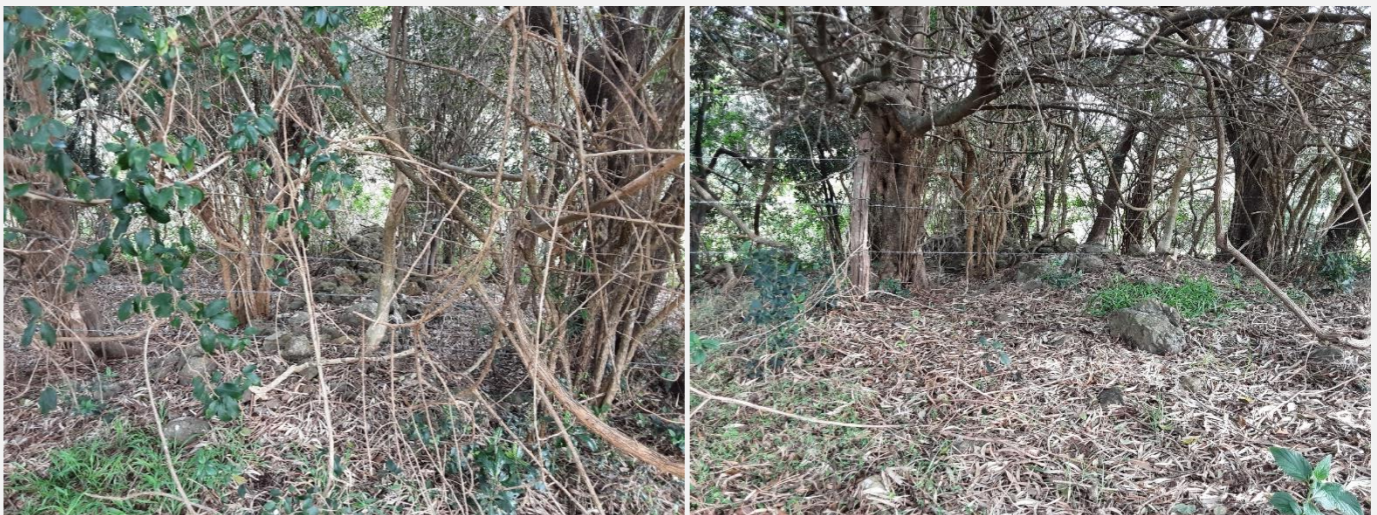
Biosis reference number	Identification source	Biosis condition observation
DSW005	DP 1042908	<ul style="list-style-type: none"> • Poor condition. • Much of stone has been removed. • Trimmed vegetation has been stacked on top of wall.

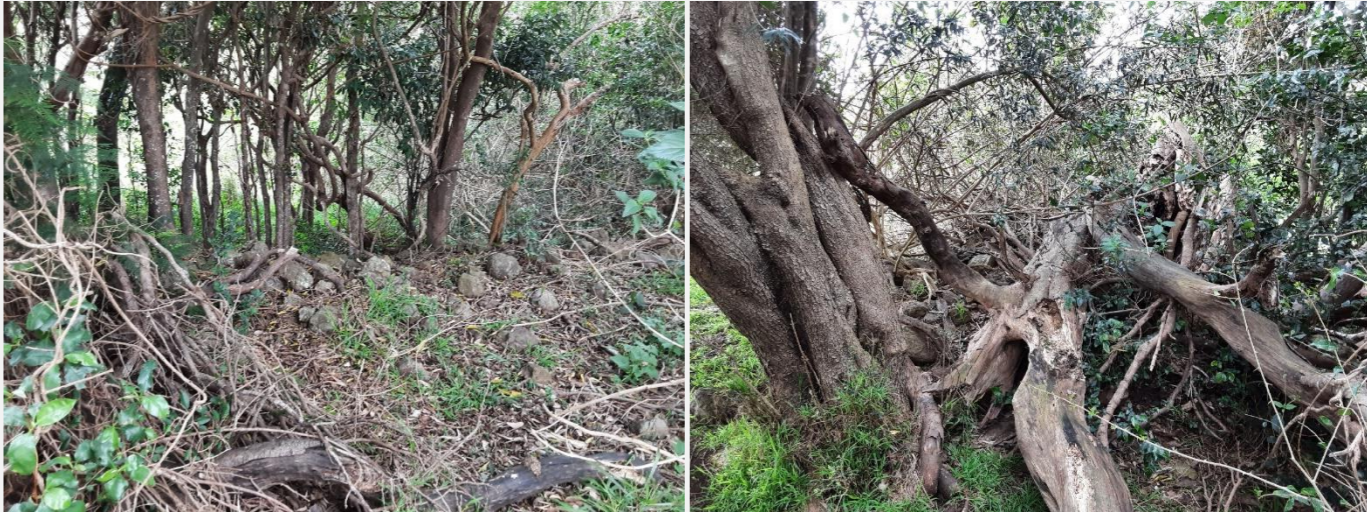
DSW006	DP 1176643	<ul style="list-style-type: none"> • Poor condition. • Overgrown with vegetation including trees and climbing species.

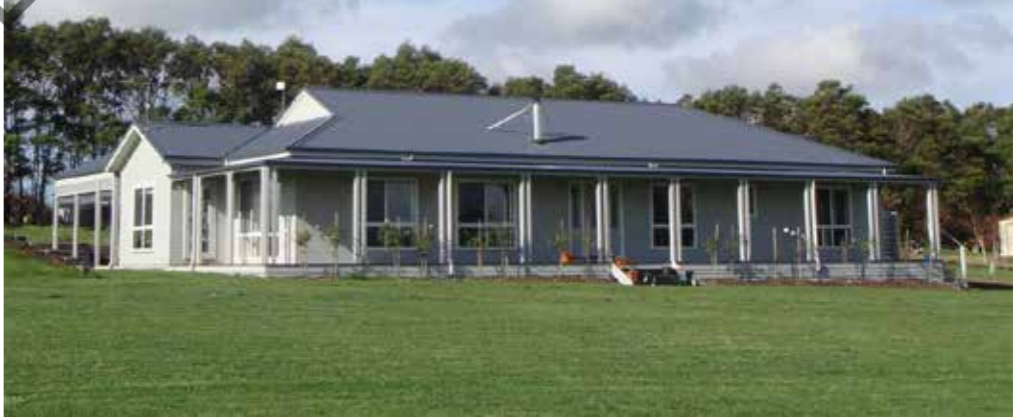
PROJECT HOME ON LARGE RURAL LOT

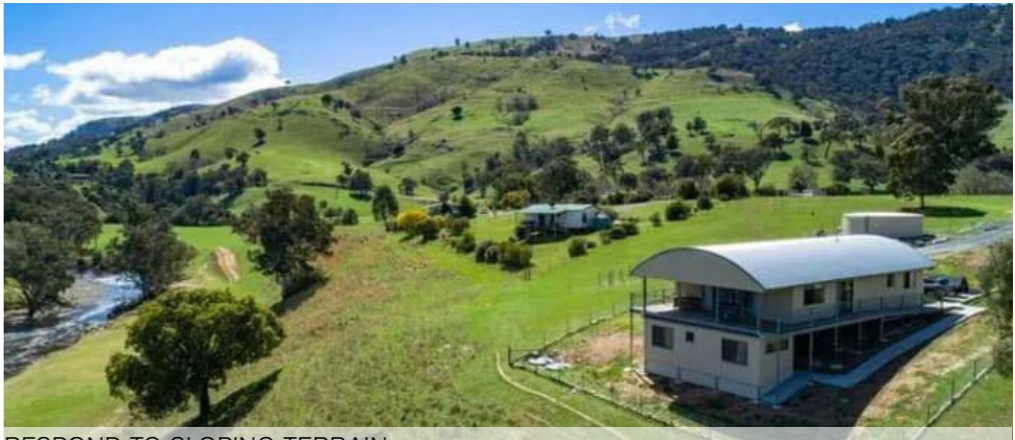
RESPOND TO SLOPING TERRAIN

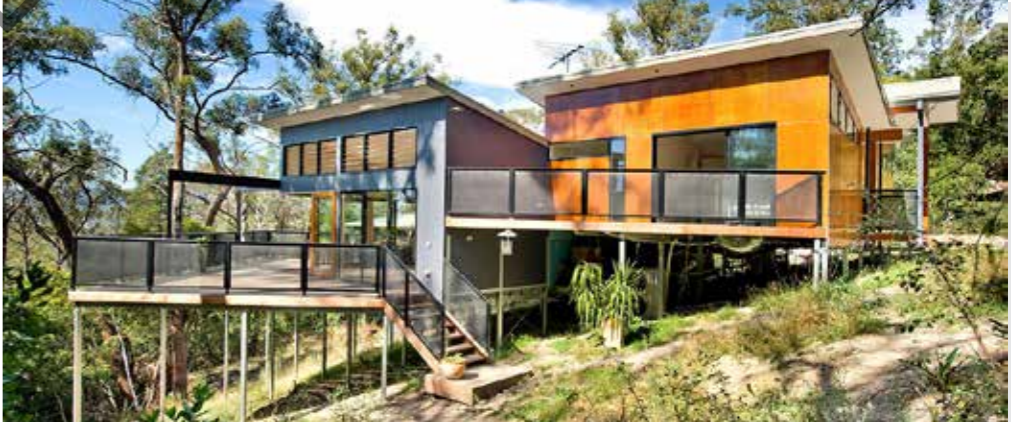
SLOPE HOUSING EXAMPLE

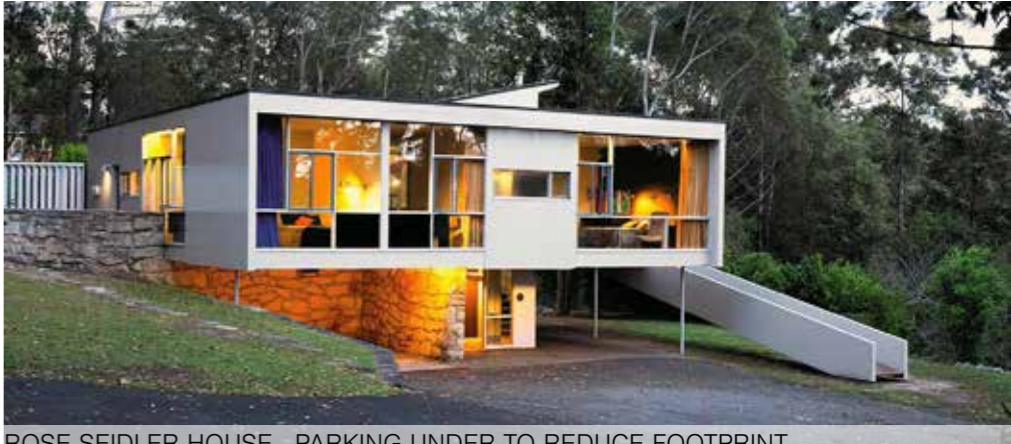
ROSE SEIDLER HOUSE - PARKING UNDER TO REDUCE FOOTPRINT

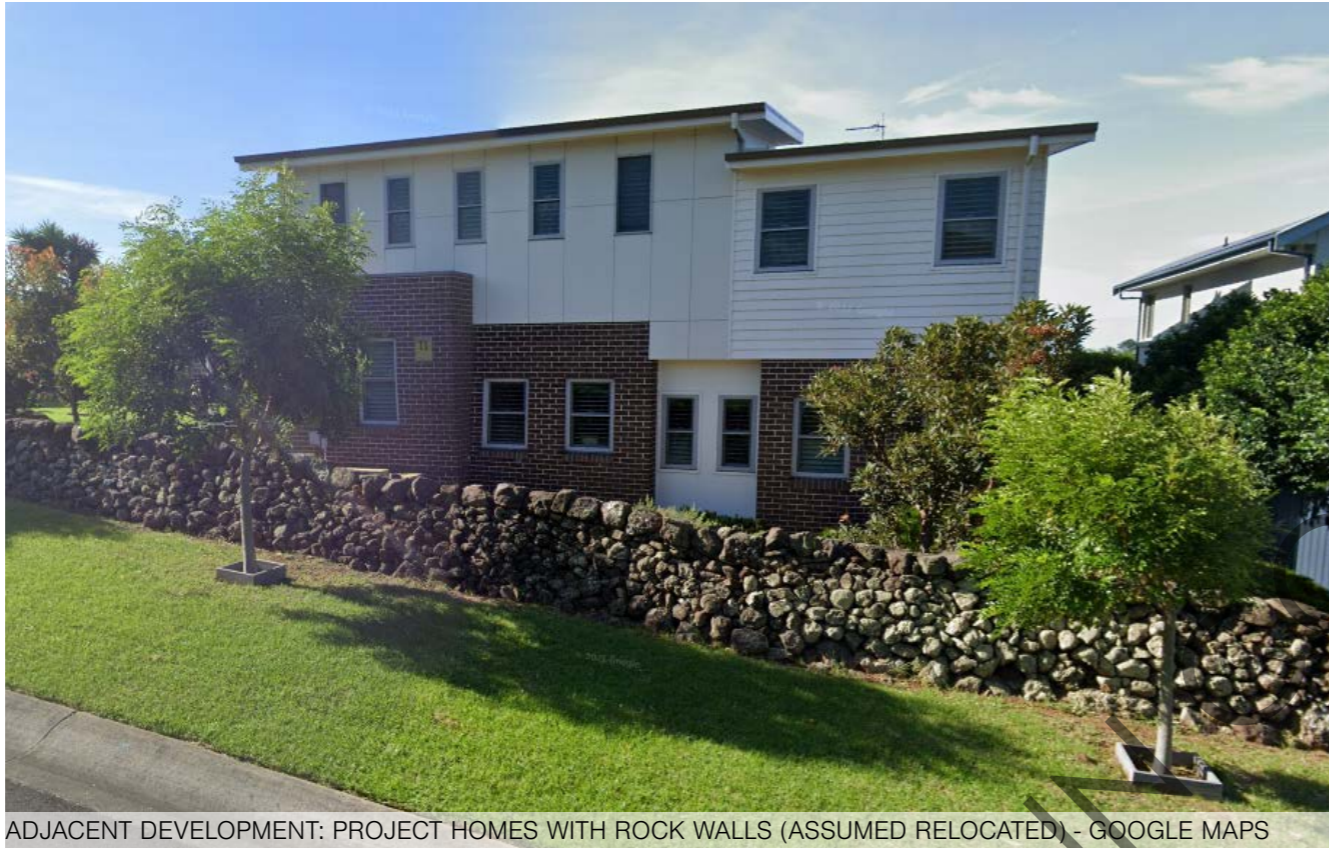
ADJACENT DEVELOPMENT: PROJECT HOMES WITH ROCK WALLS (ASSUMED RELOCATED) - GOOGLE MAPS
