Geotechnical Assessment: Former Broken Head Quarry

Lot 1 in DP123302 and Lot 2 in DP700806, Broken Head Road, Suffolk Park, NSW 2481

Final Report

P2410392JR01V02

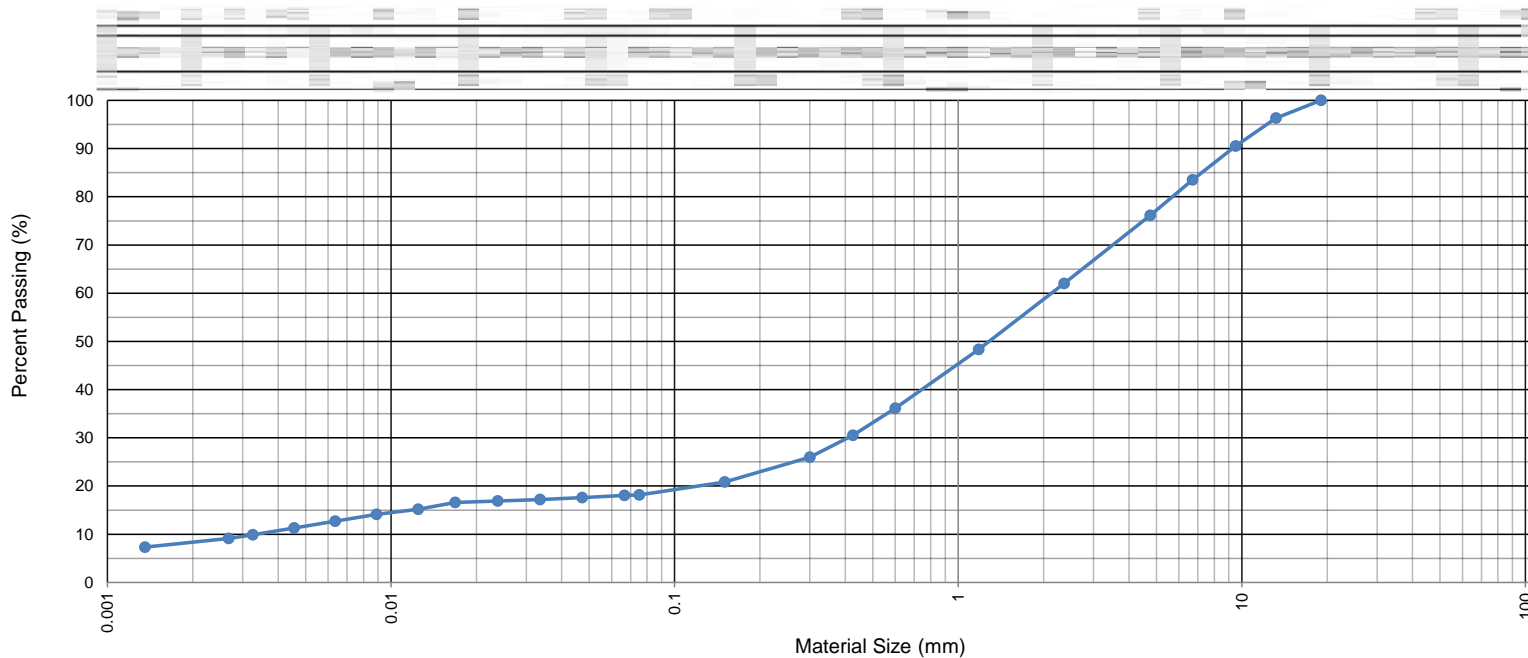
Material description: sandy GRAVEL, with silt and clay, dark brown

AS Sieve	% Passing
19.0mm	100
13.2mm	96
9.5mm	91
6.7mm	83
4.75mm	76
2.36mm	62
1.18mm	48
600µm	36
425µm	31
300µm	26
150µm	21
75µm	18
Particle Diameter*(mm)	% Finer
0.0665	18
0.0472	18
0.0335	17
0.0237	17
0.0168	17
0.0124	15
0.0089	14
0.0064	13
0.0045	11
0.0033	10
0.0027	9
0.0014	7

Notes: * Results obtained by hydrometer analysis, Hydrometer type: g/L. Method of dispersion: Mechanical. Method of preparation: as received natural state. Particle density: 2.63 g/cm³.

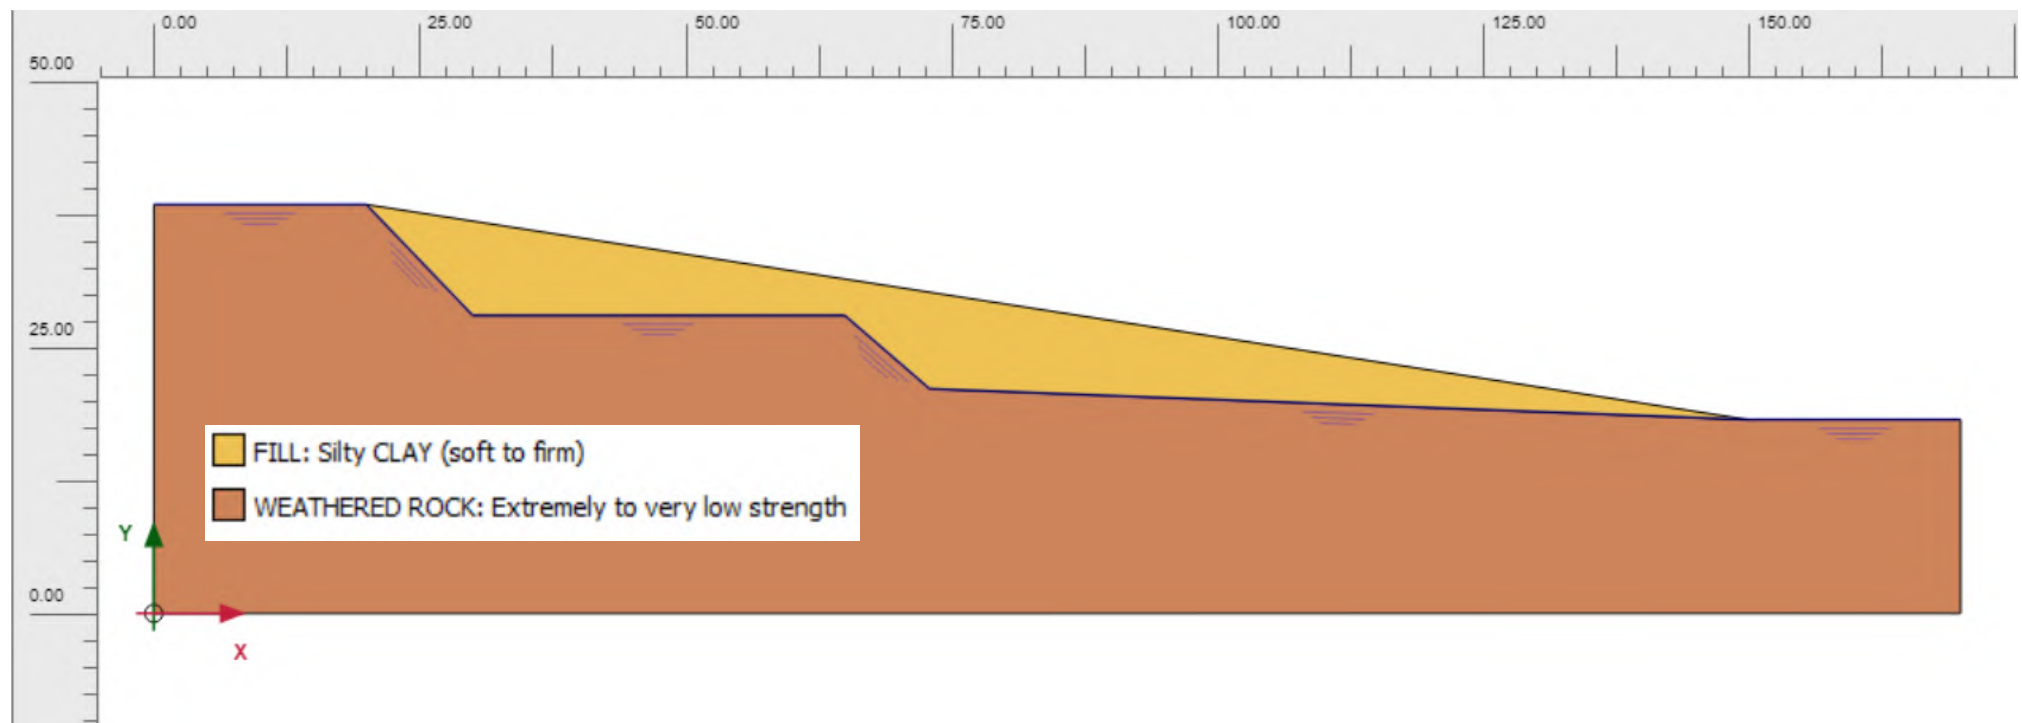
Martens & Associates Pty Ltd ABN 85 070 240 890		Environment Water Wastewater Geotechnical Civil Management	
Drawn:	WB	GEOTECHNICAL MODEL (Section A-A) Former Broken Head Quarry - Broken Head Road, Suffolk Park, NSW	Drawing:
Approved:	RE		FIGURE 1
Date:	23.07.2024		
Scale:	NA		File No: P2410392JR01V02

Considering the variable subsurface conditions, depth of fill and fill batter grades across the Site, four cross sections (A-A, B-B, C-C and D-D) were selected, considered to best represent most unfavourable ground conditions with steepest grades (refer to Map 06, Appendix A, for cross section locations) as discussed below:

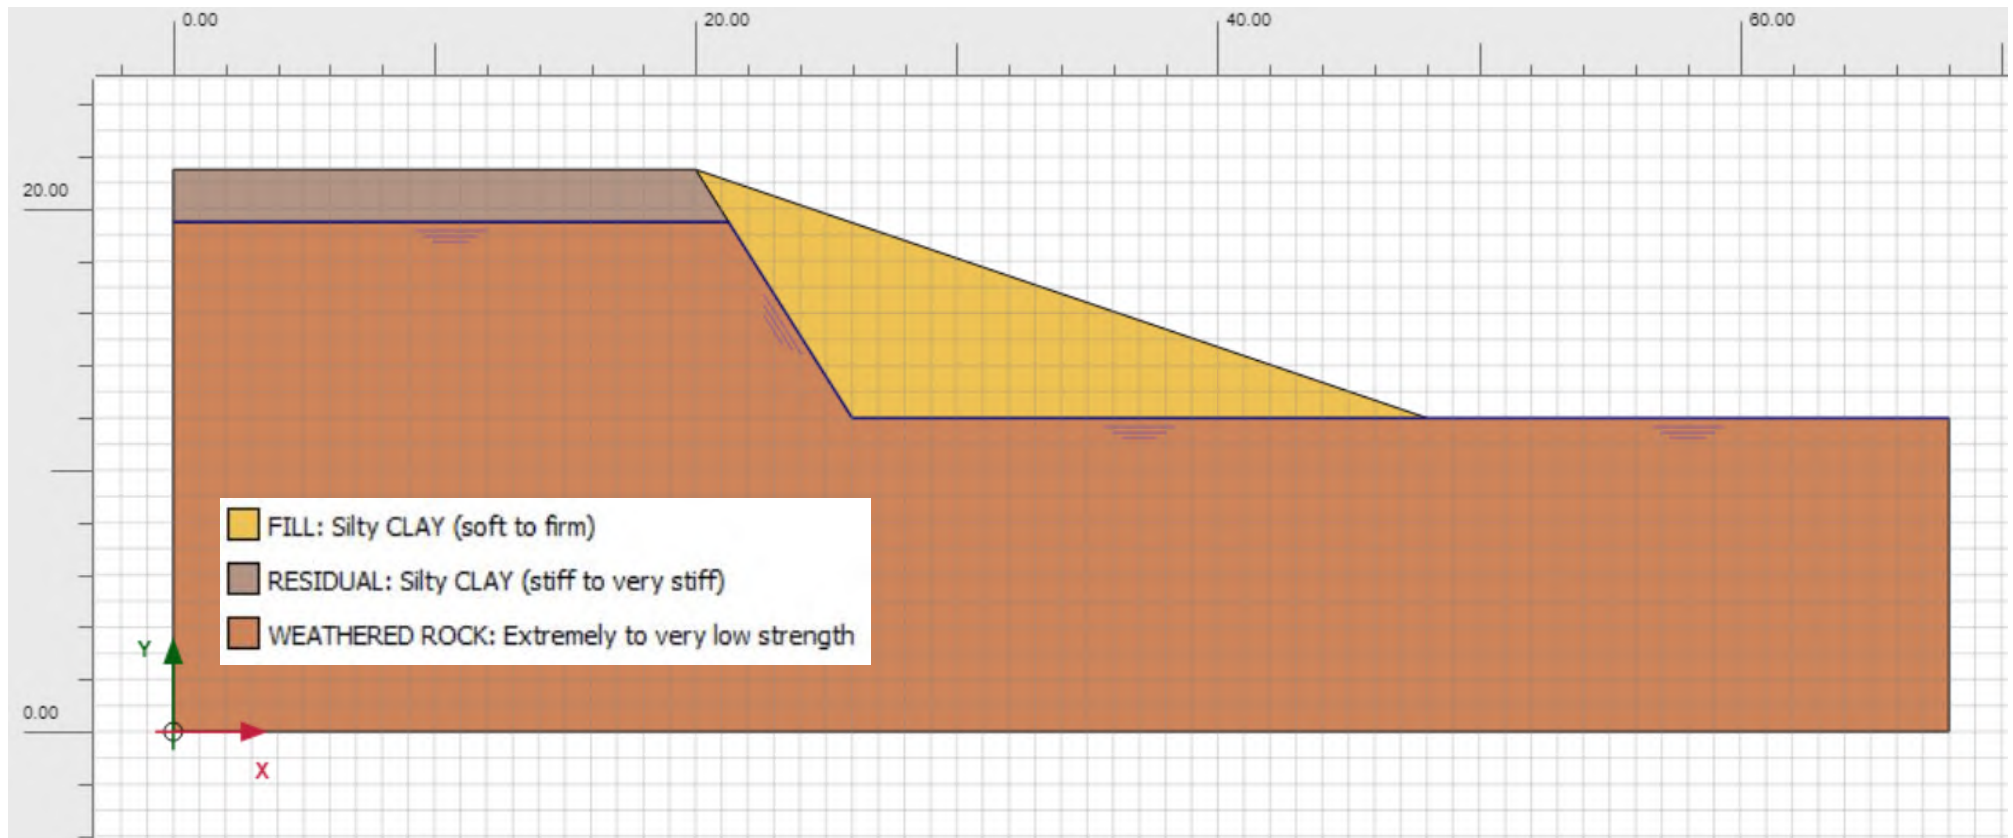
Martens & Associates Pty Ltd ABN 85 070 240 890		Environment Water Wastewater Geotechnical Civil Management	
Drawn:	WB	GEOTECHNICAL MODEL (Section C-C) Former Broken Head Quarry - Broken Head Road, Suffolk Park, NSW	Drawing:
Approved:	RE		FIGURE 3
Date:	23.07.2024		File No: P2410392JR01V02
Scale:	NA

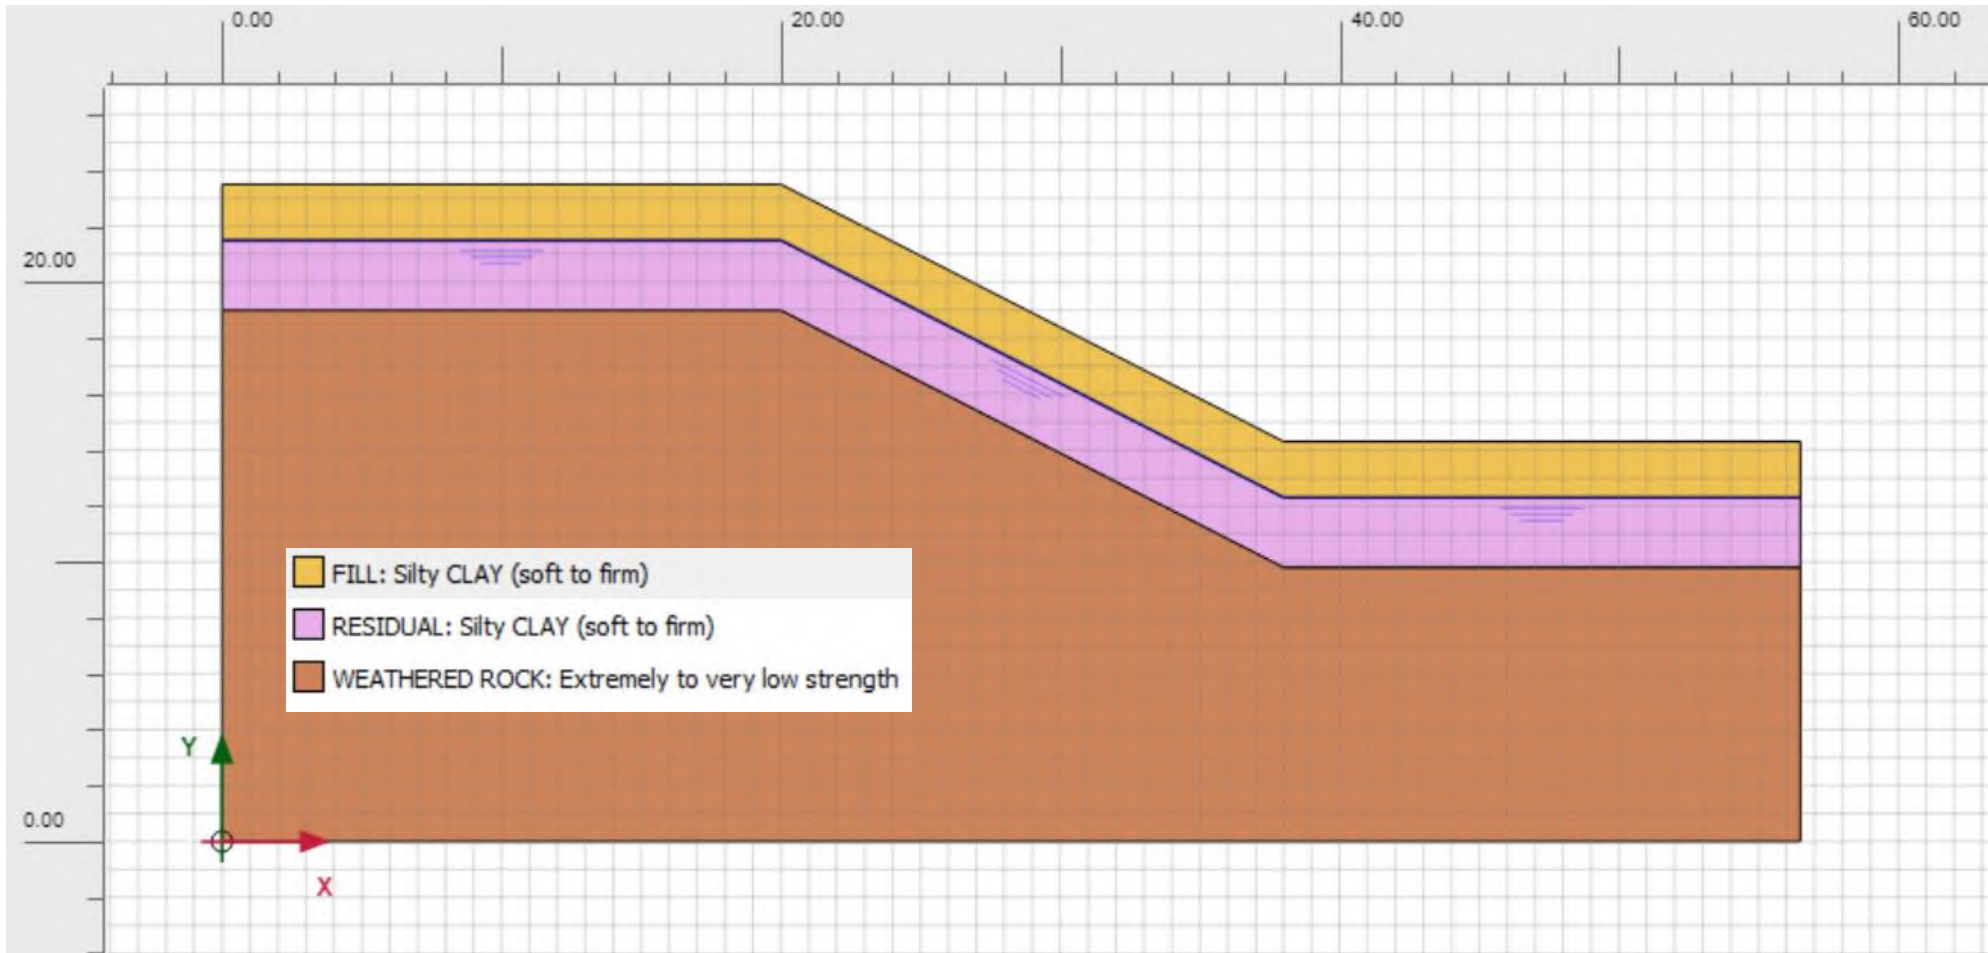
Drawing:	FIGURE 4
File No: P2410392JR01V02

GEOTECHNICAL MODEL (Section D-D)
Former Broken Head Quarry - Broken Head Road, Suffolk Park, NSW
