Strategic Bushfire Study

STRATEGIC BUSHFIRE STUDY

Broken Head Quarry, Broken Head

Winten Property Group

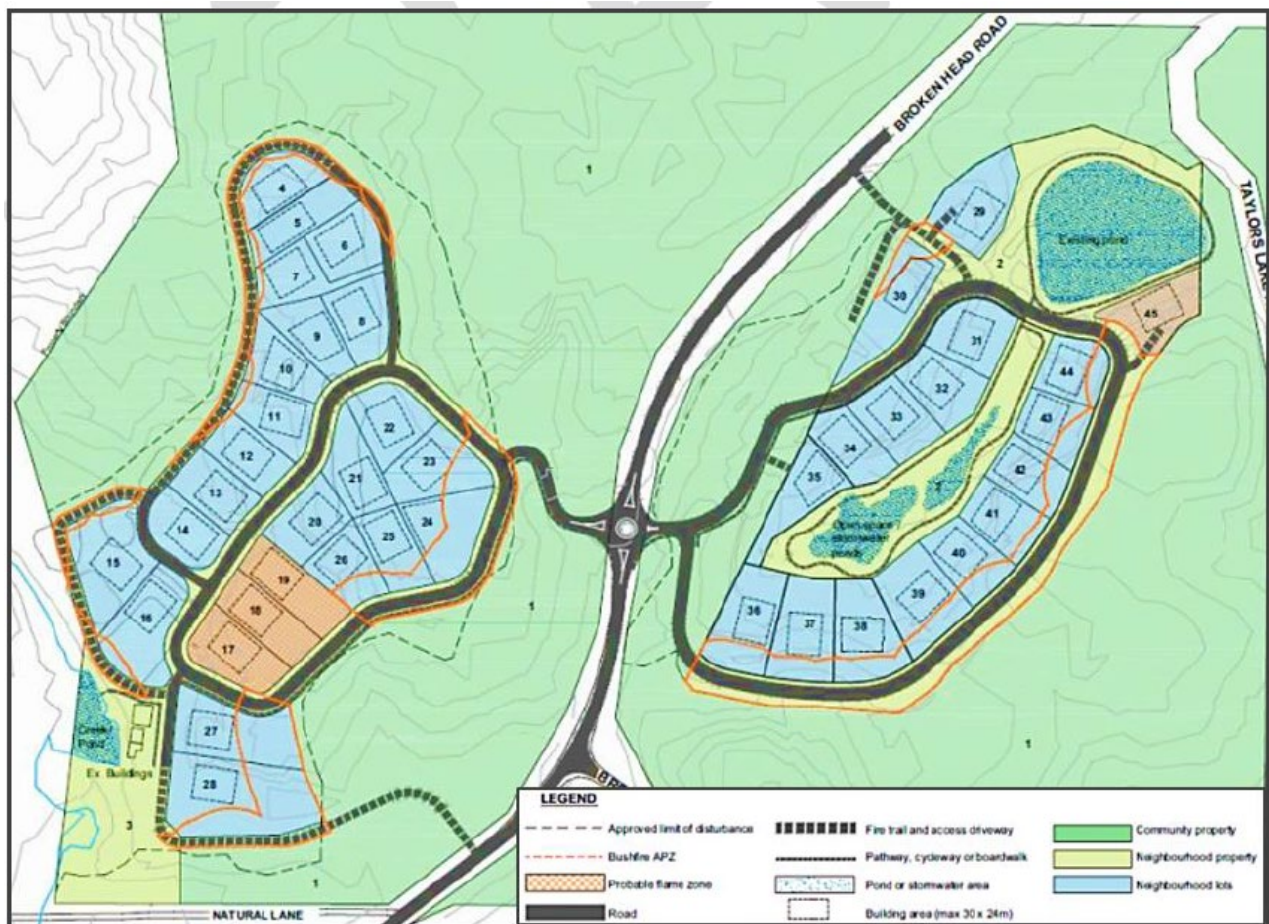
Figure 6: Indicative plan of proposed community title subdivision

The Planning Proposal is based on a conceptual subdivision design which was prepared in 2014 and is an indicative layout only. It should be noted that any reference to bushfire asset protection zones (APZ) or flame zone in the indicative plan is superseded by this assessment. The conceptual subdivision plan is contained in **Appendix A** and shown in **Figure 6**.

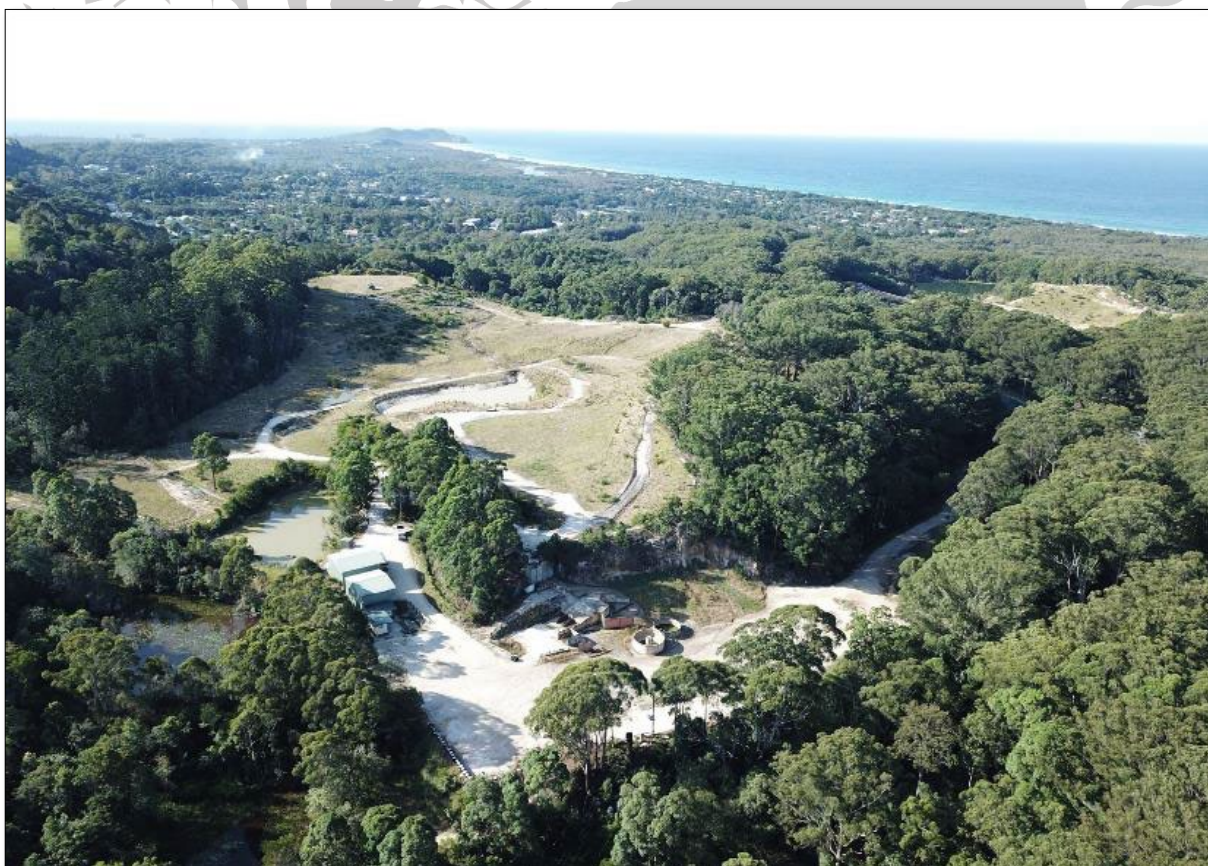
Plate 1: West quarry looking north east towards Cape Byron Lighthouse

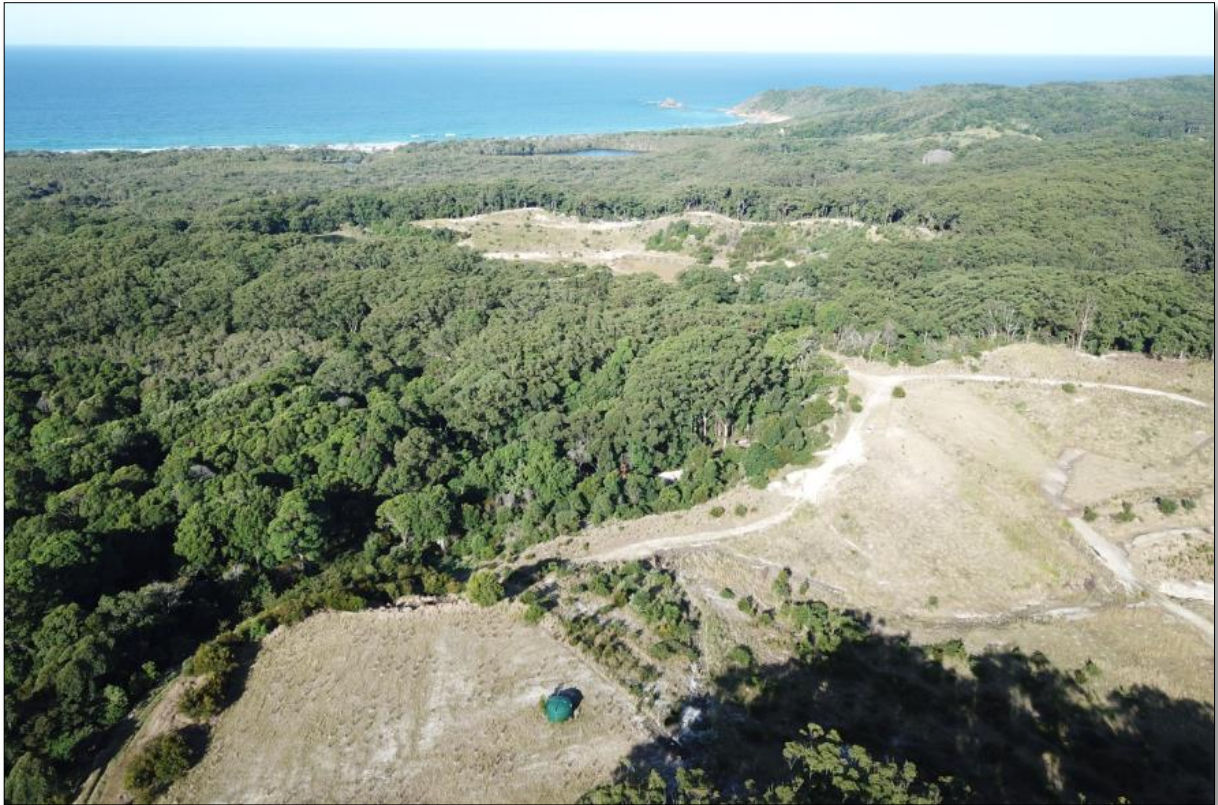
Plate 2: Looking south east across west quarry to east quarry

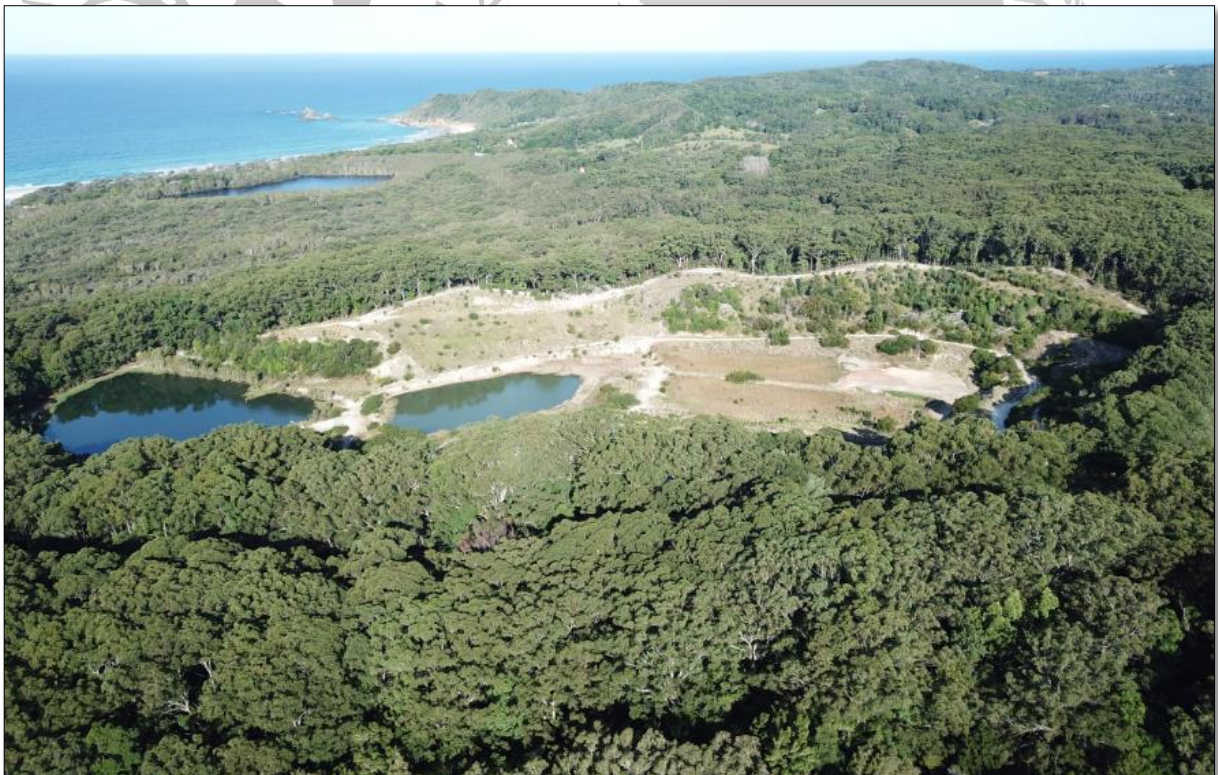
Plate 2: Looking south across the east quarry towards Broken Head

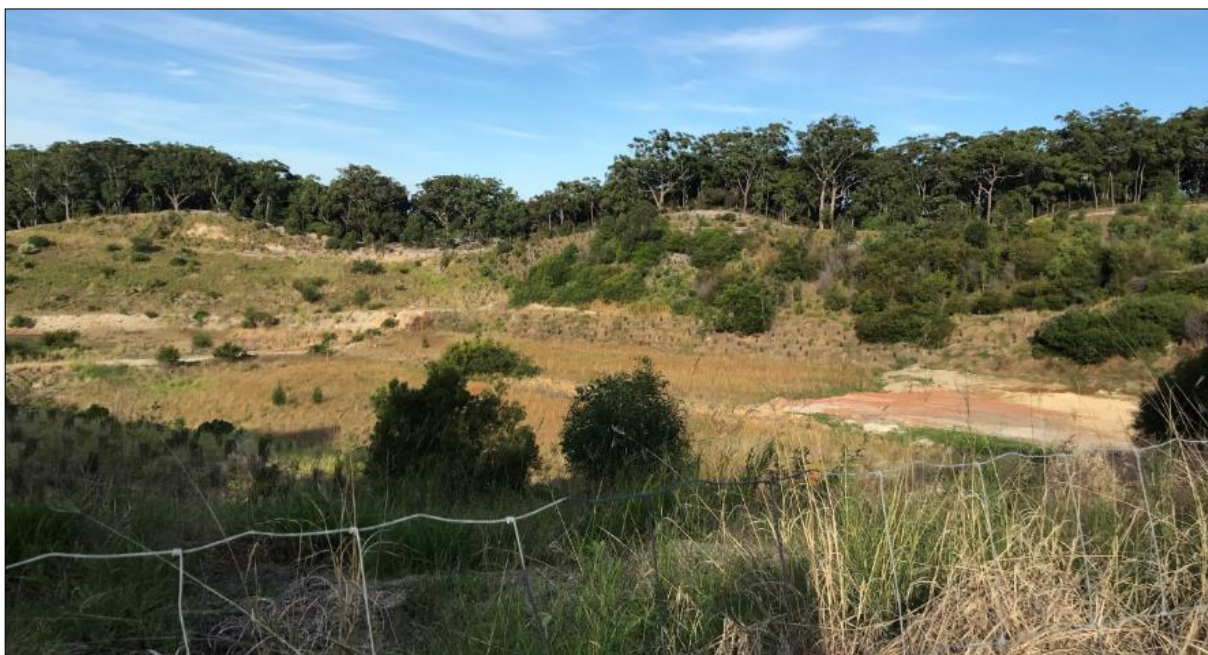
Plate 3: West quarry looking west – forest above rim of quarry

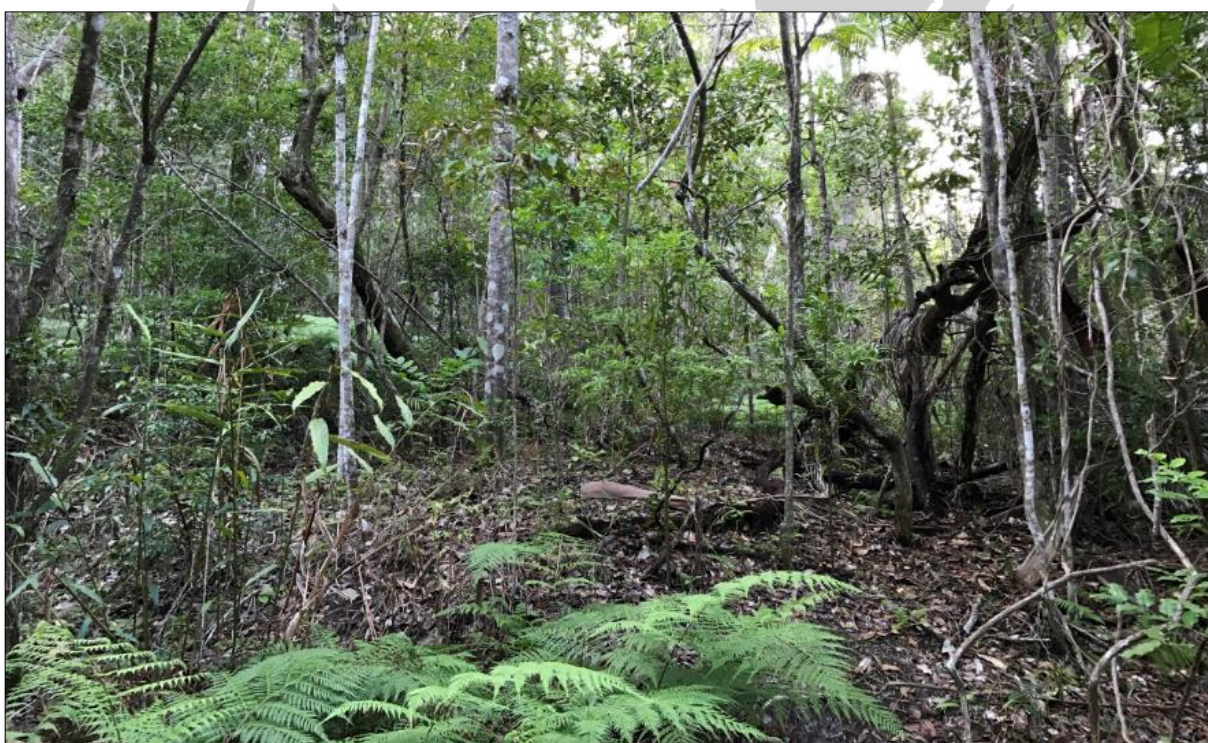
Plate 4: Rainforest vegetation to the north and west of the west quarry

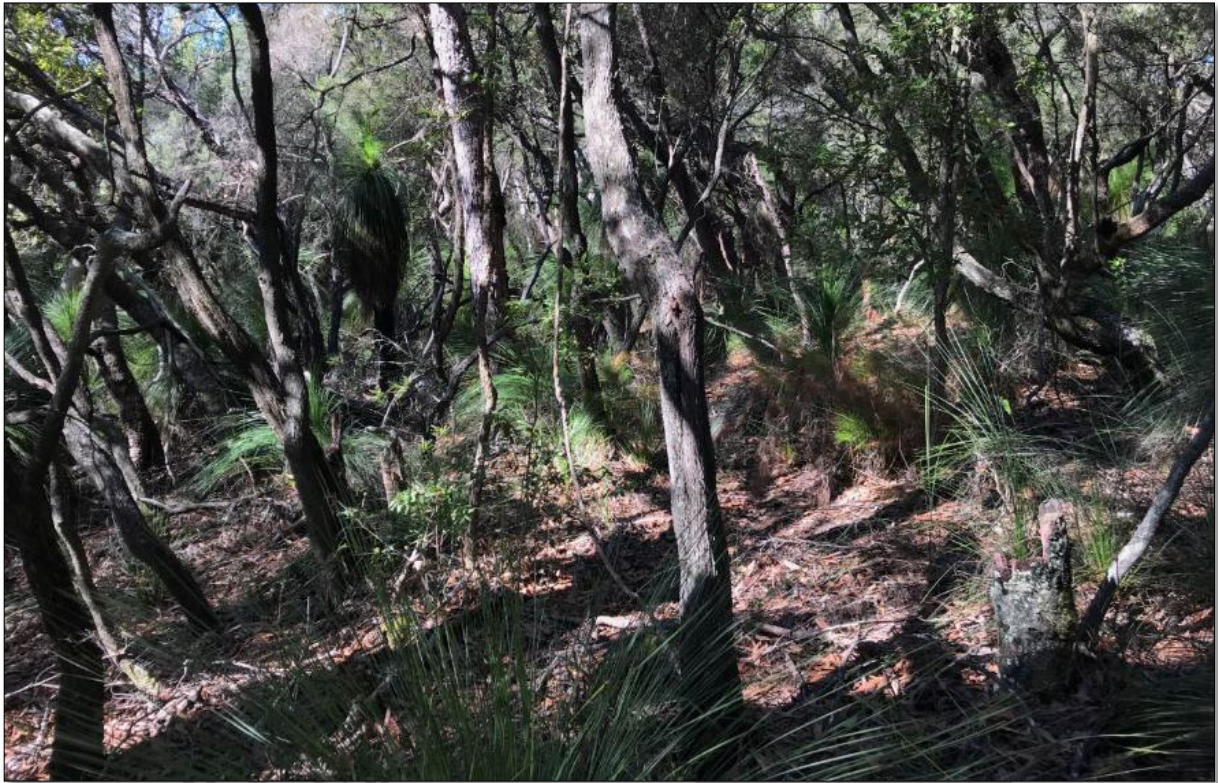
Plate 7: Tall heath vegetation is located towards the east

To the east of the quarry beyond the North Coast DSF lies an area of Wallum Sand Heath, which is a tall heath of over 2m in height and Coastal Heath Swamps, which is a short heath less than 2m in height. To the west of the quarry is a strip of Subtropical Rainforest, which has a multi-layered tree canopy up to 20-40m in height. The fuel load of a rainforest is typically the lowest of the forest communities due to its moisture content. Beyond the rainforest communities there are large rural residential land holdings which are mostly grassed areas with pockets of forest and rainforest communities.

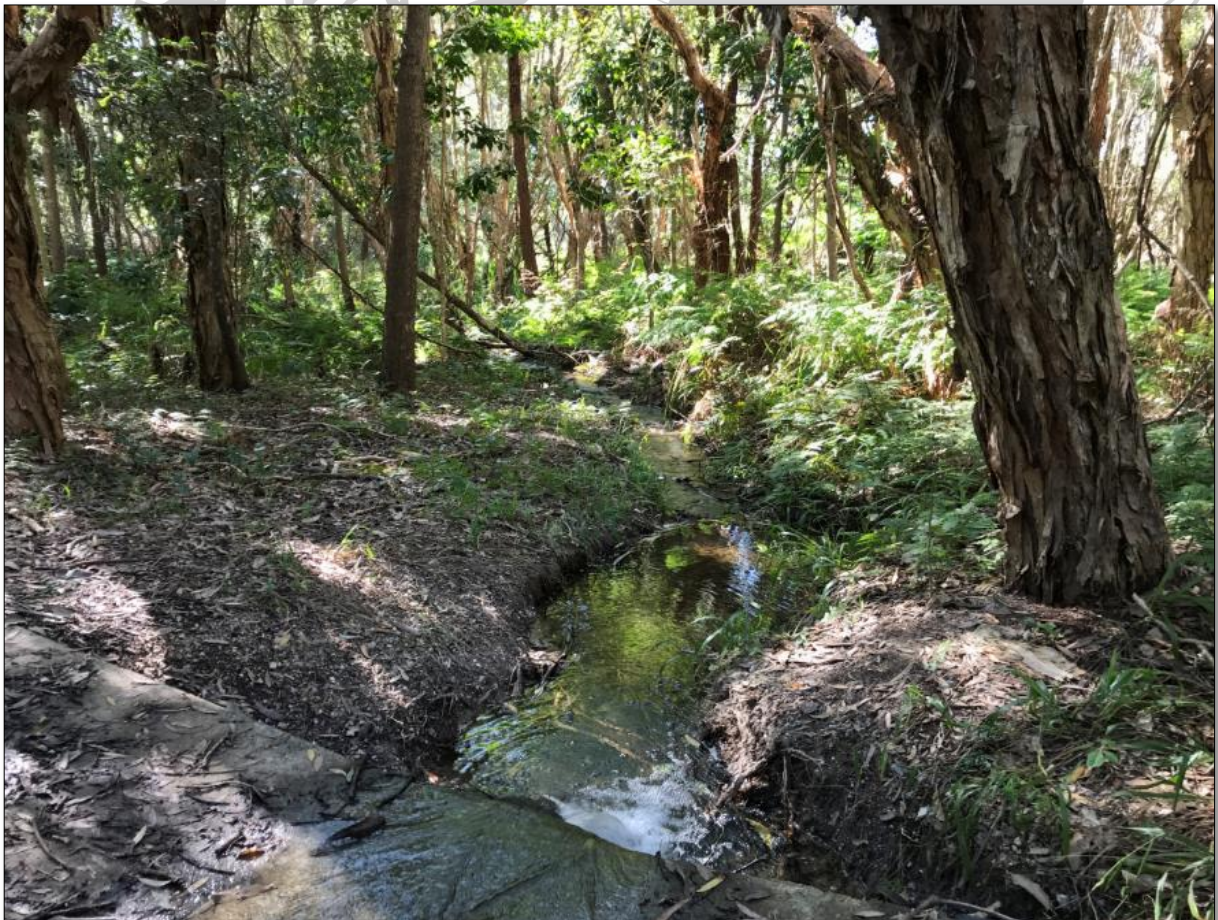
Plate 8: Forested wetland leading away from the site to the north east

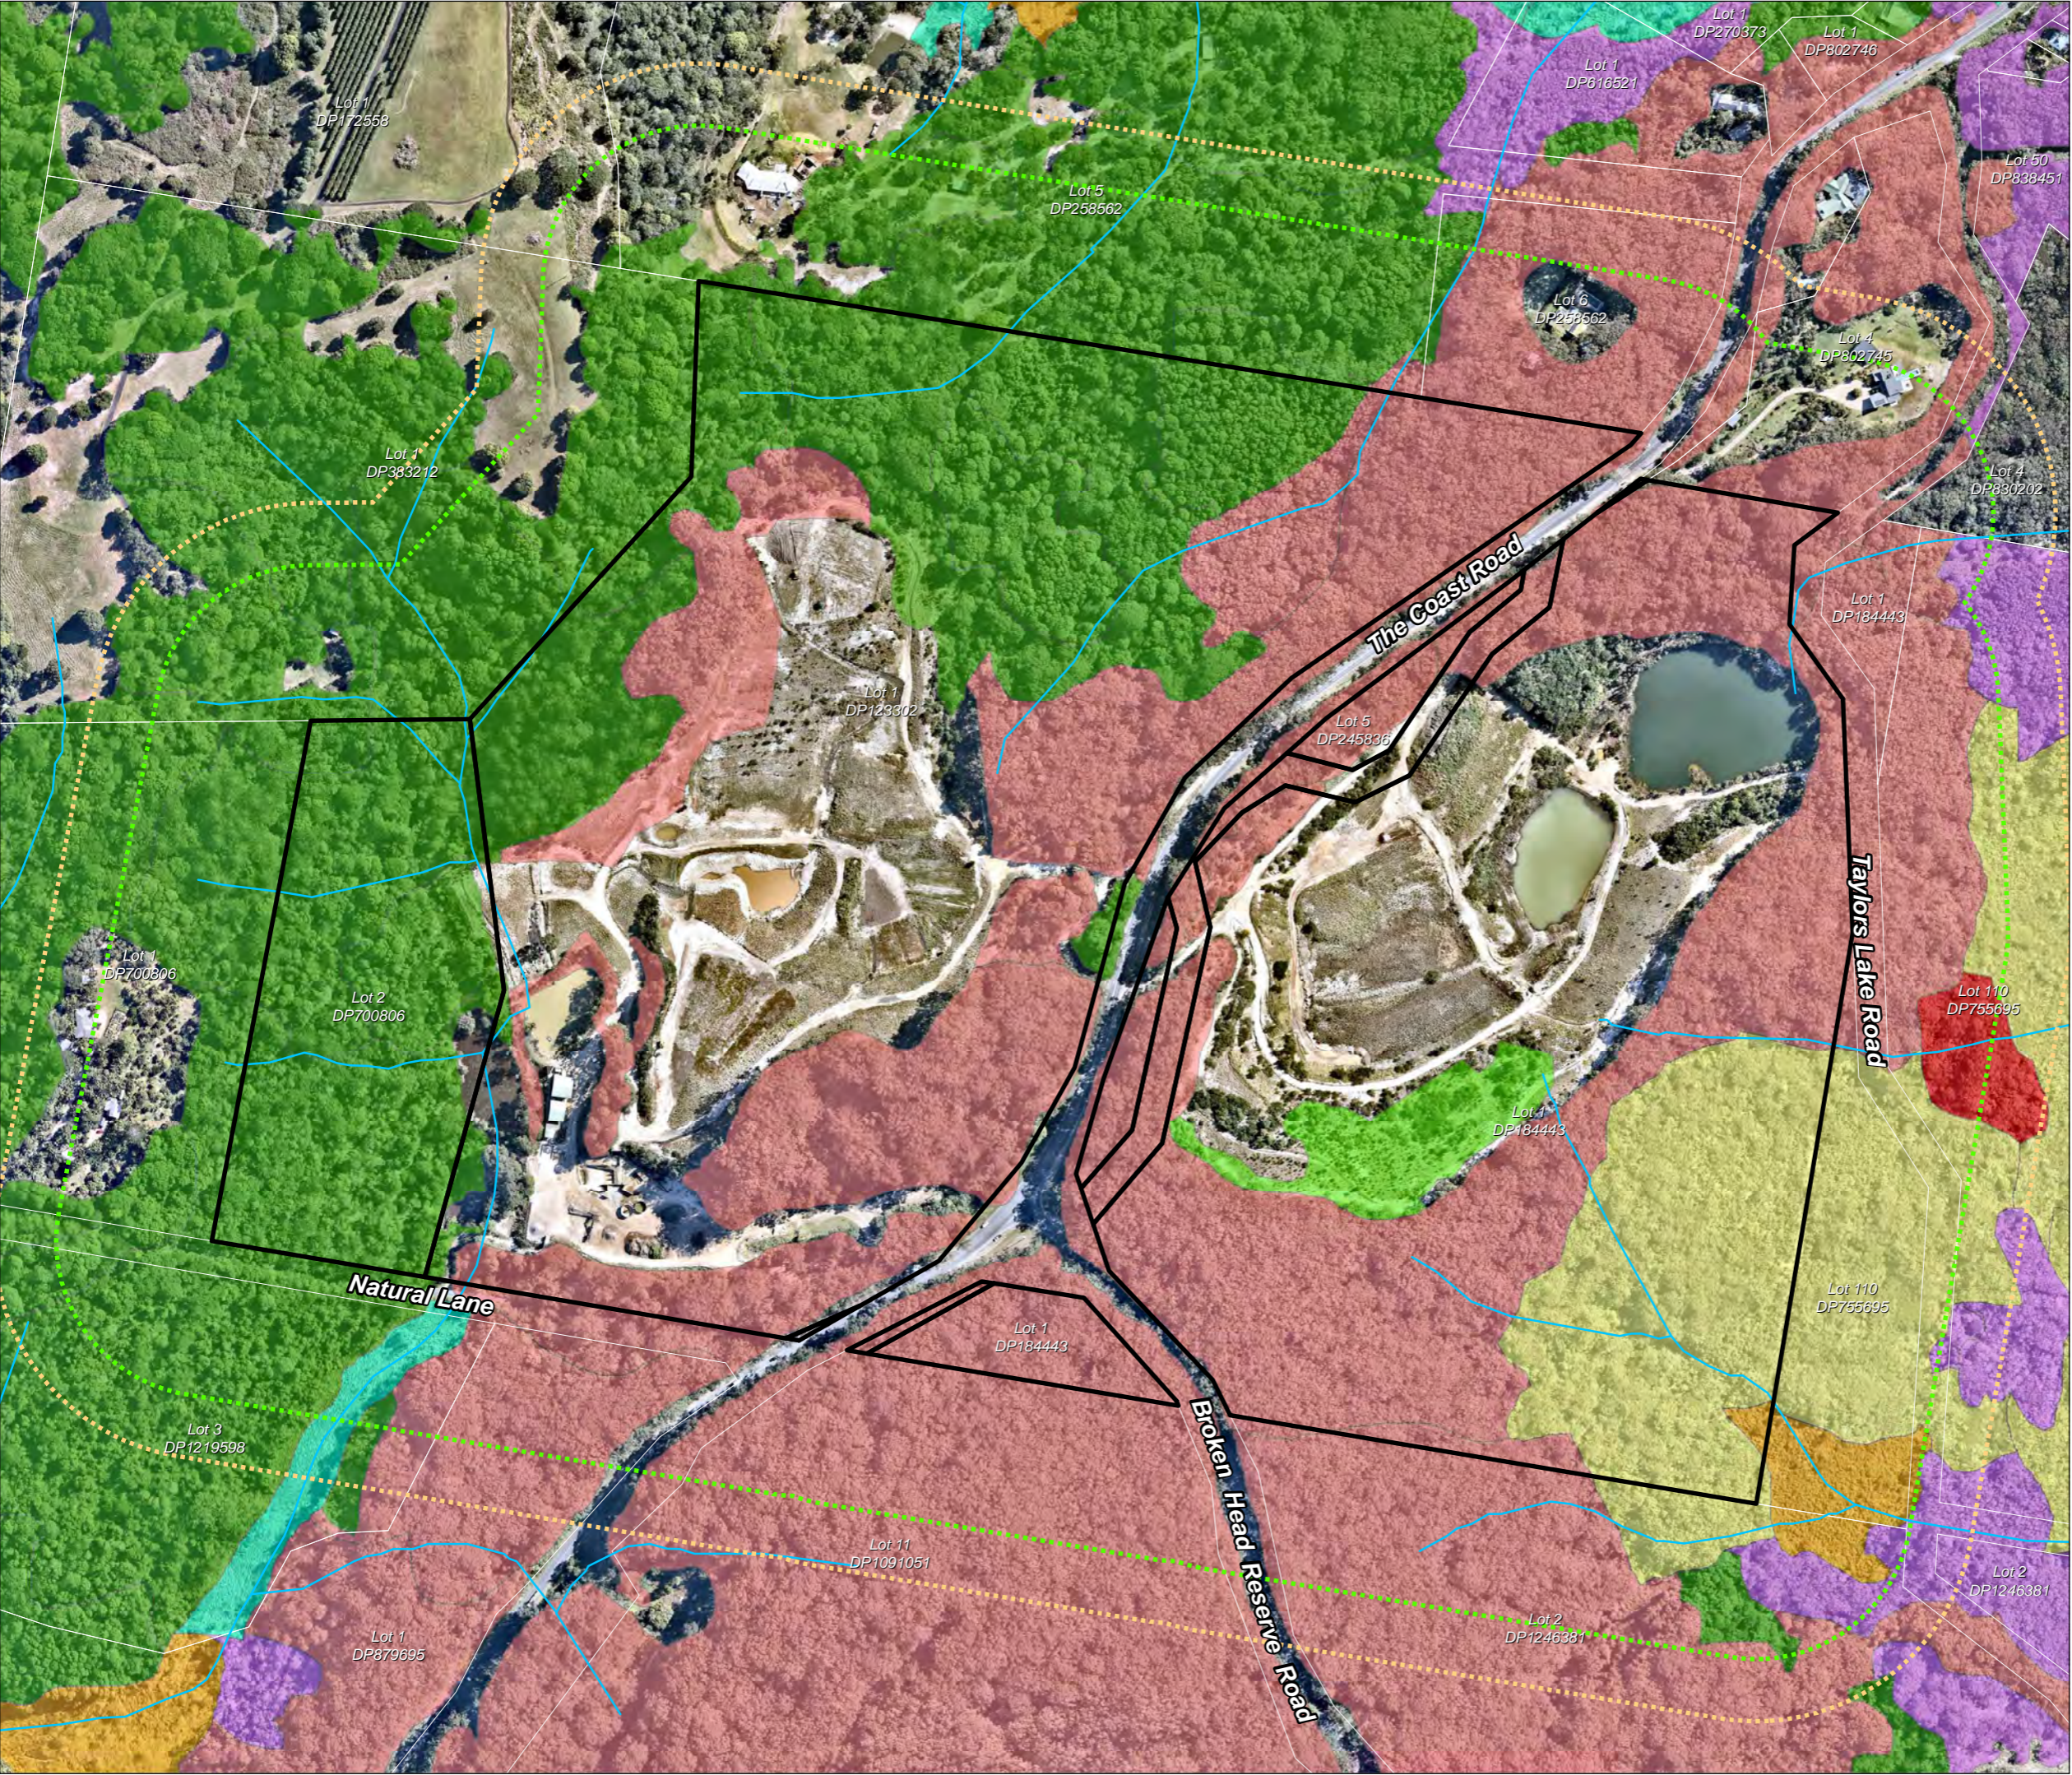
Figure 9
Ground Truthed Vegetation

The vegetation on and around the site was verified by a qualified ecologist (Adam McArthur, JWA Ecological Consultants) on 25th May 2020. The verified vegetation mapping is provided in **Figure 9**.

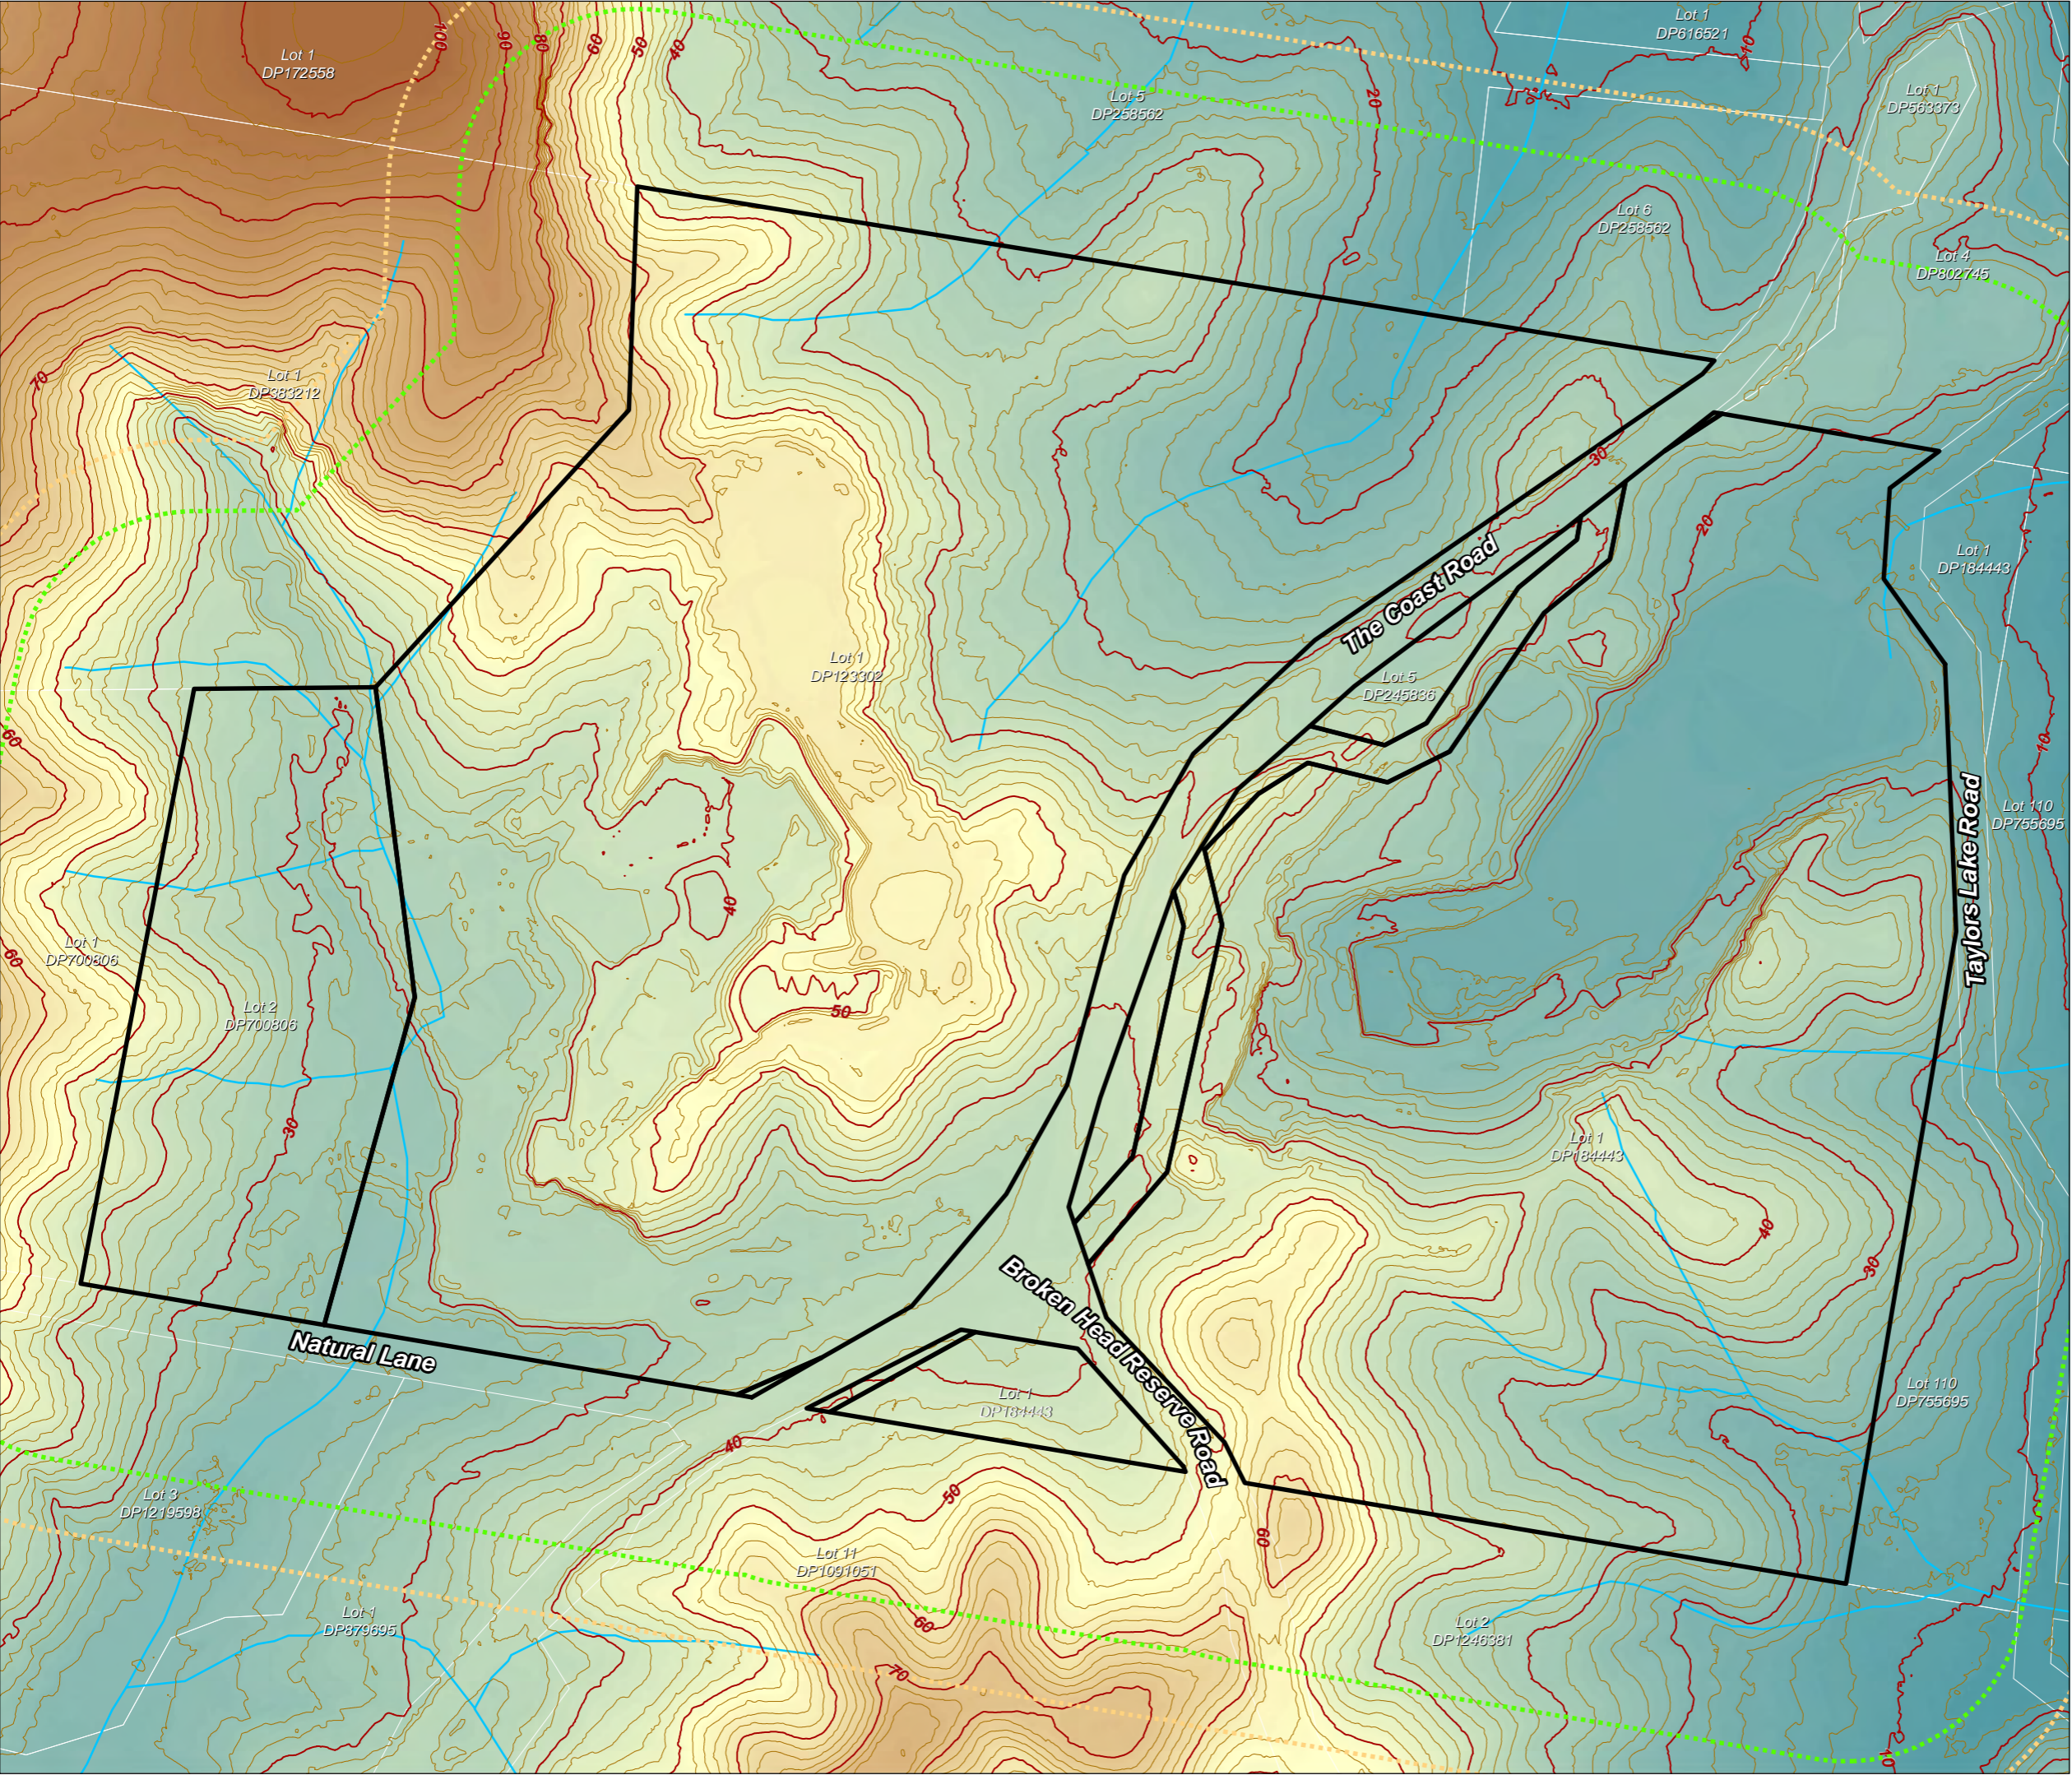
Figure 10
Digital
Elevation
Model

- ❑ Digital Elevation Model – **Figure 10 and 11**;
- ❑ Topographical Contours (2m contour internals @ 140m and 5m contour intervals @ 2km) – **Figure 12 and 13**; and
- ❑ Slope analysis in gradients of 5 degrees – **Figure 14 and 15**.

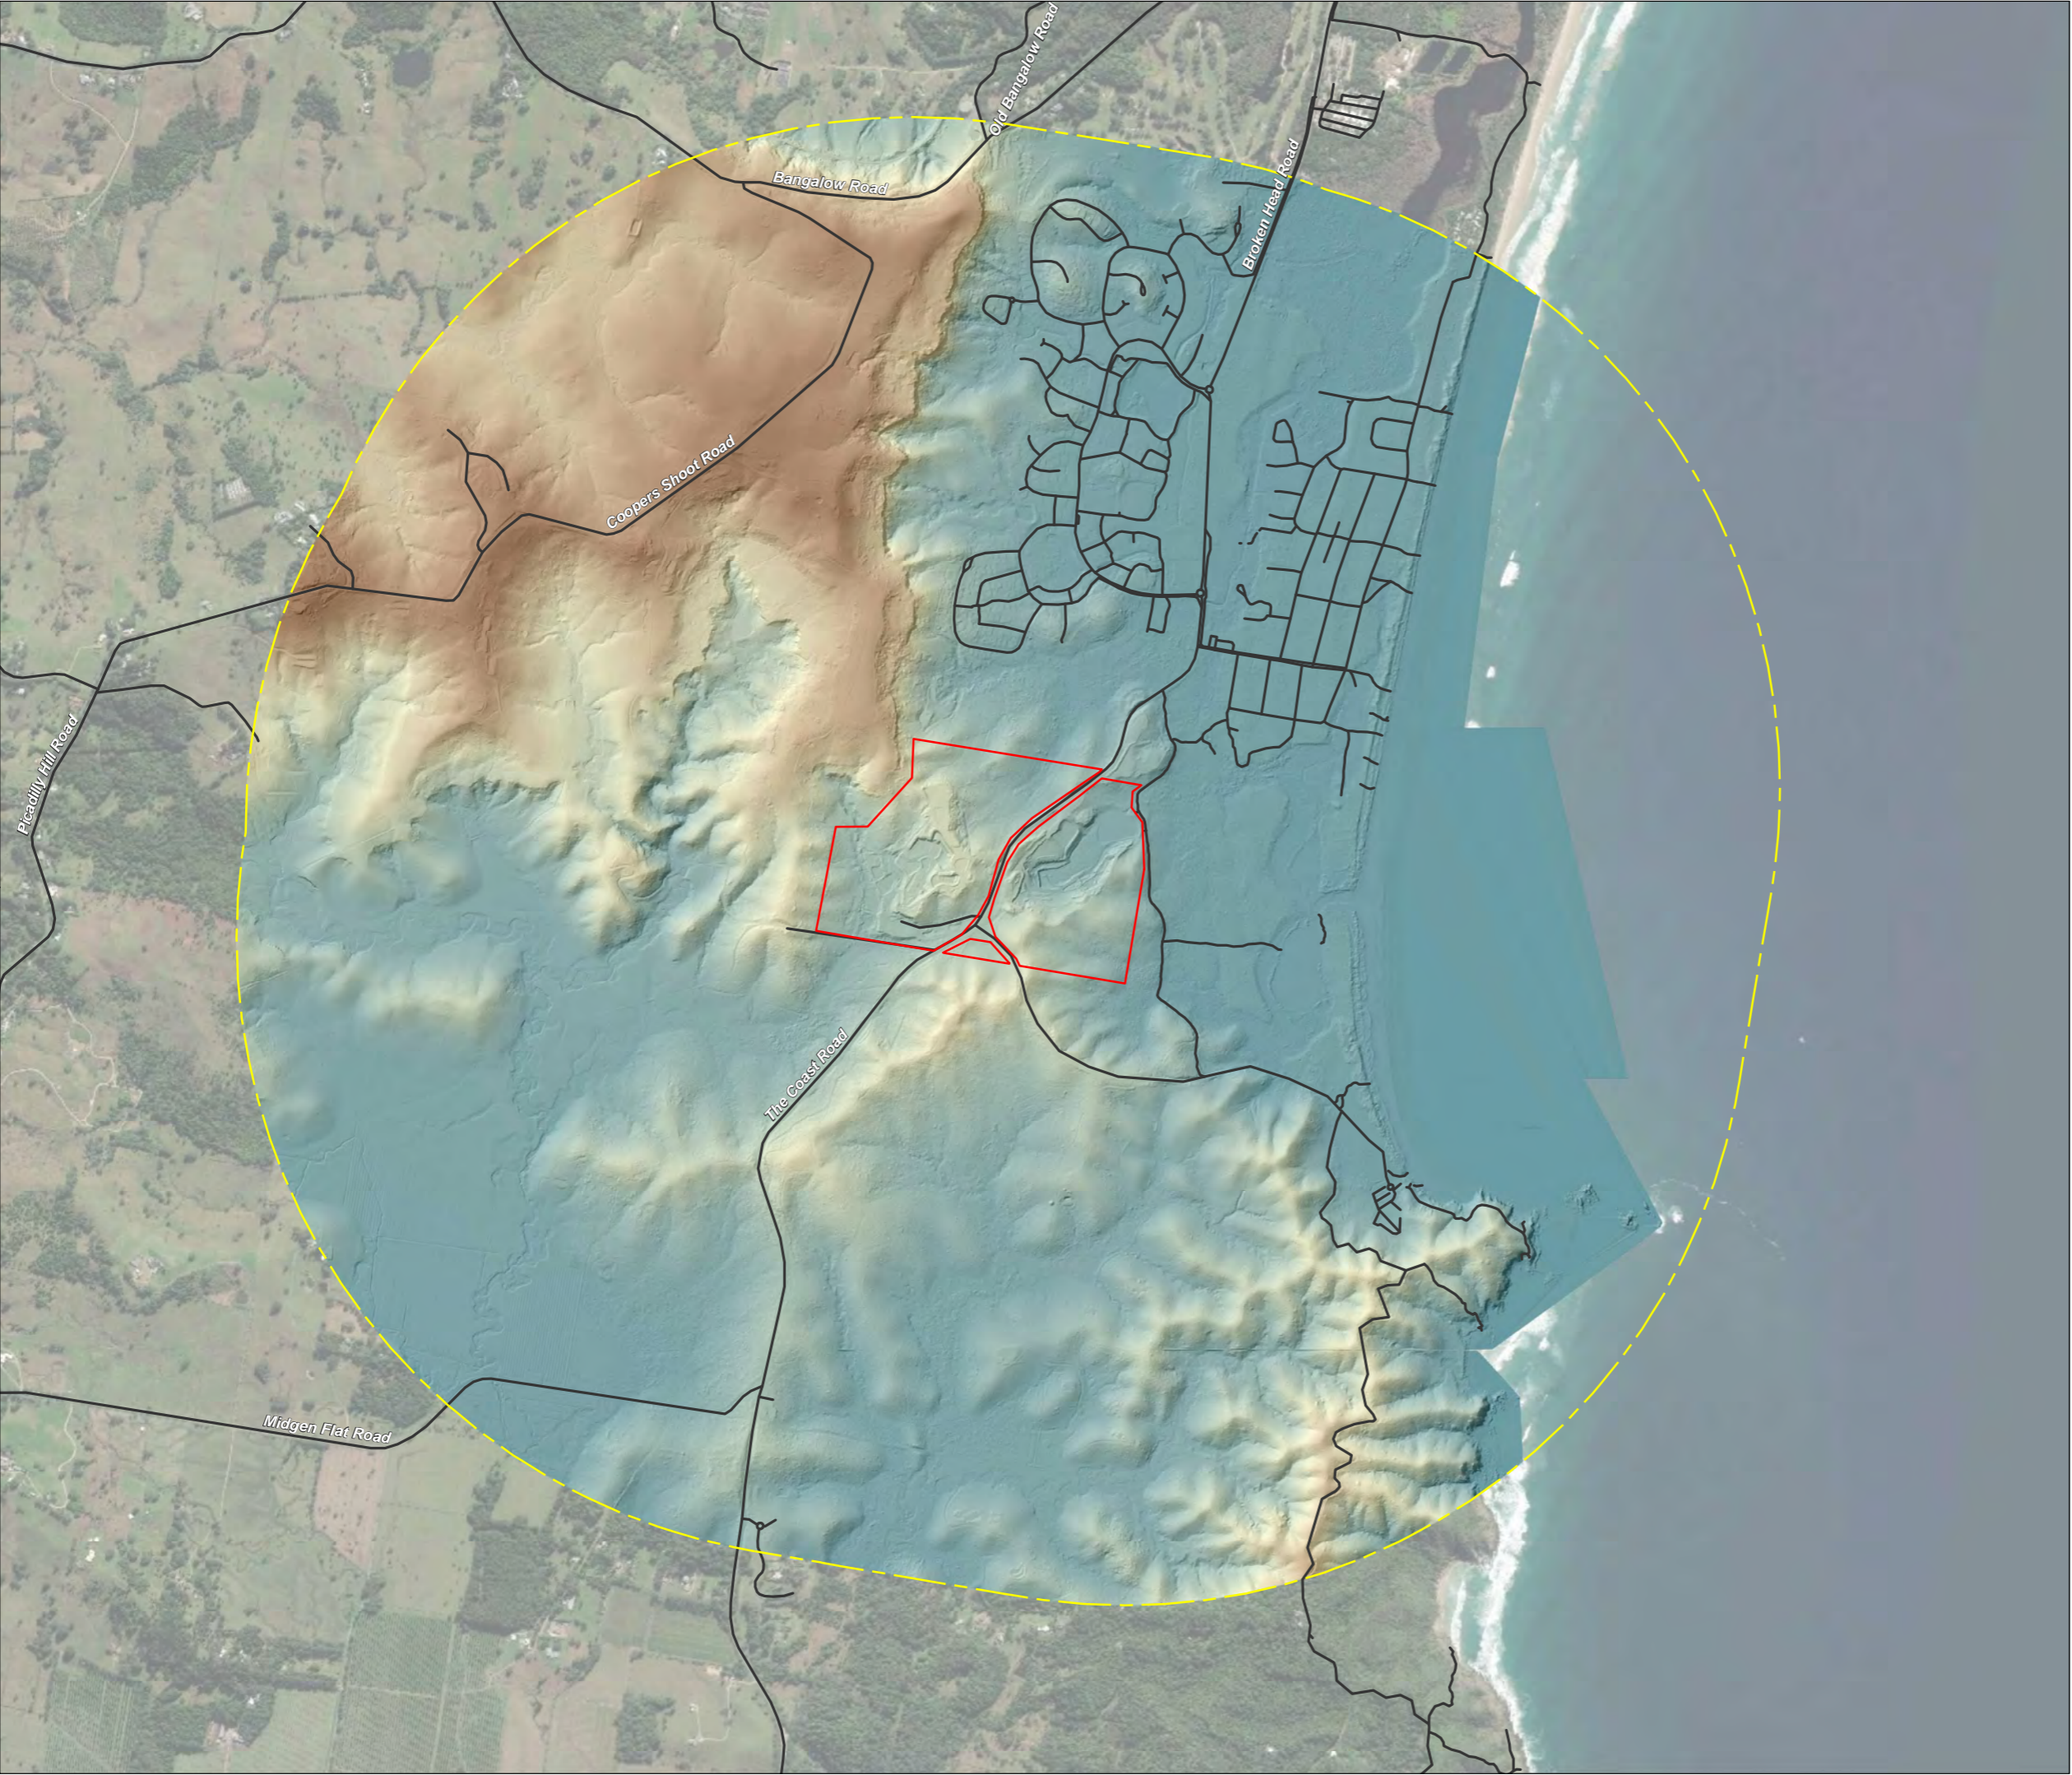
Figure 11
DEM
2km buffer
