Strategic Bushfire Study

STRATEGIC BUSHFIRE STUDY

Broken Head Quarry, Broken Head

Winten Property Group

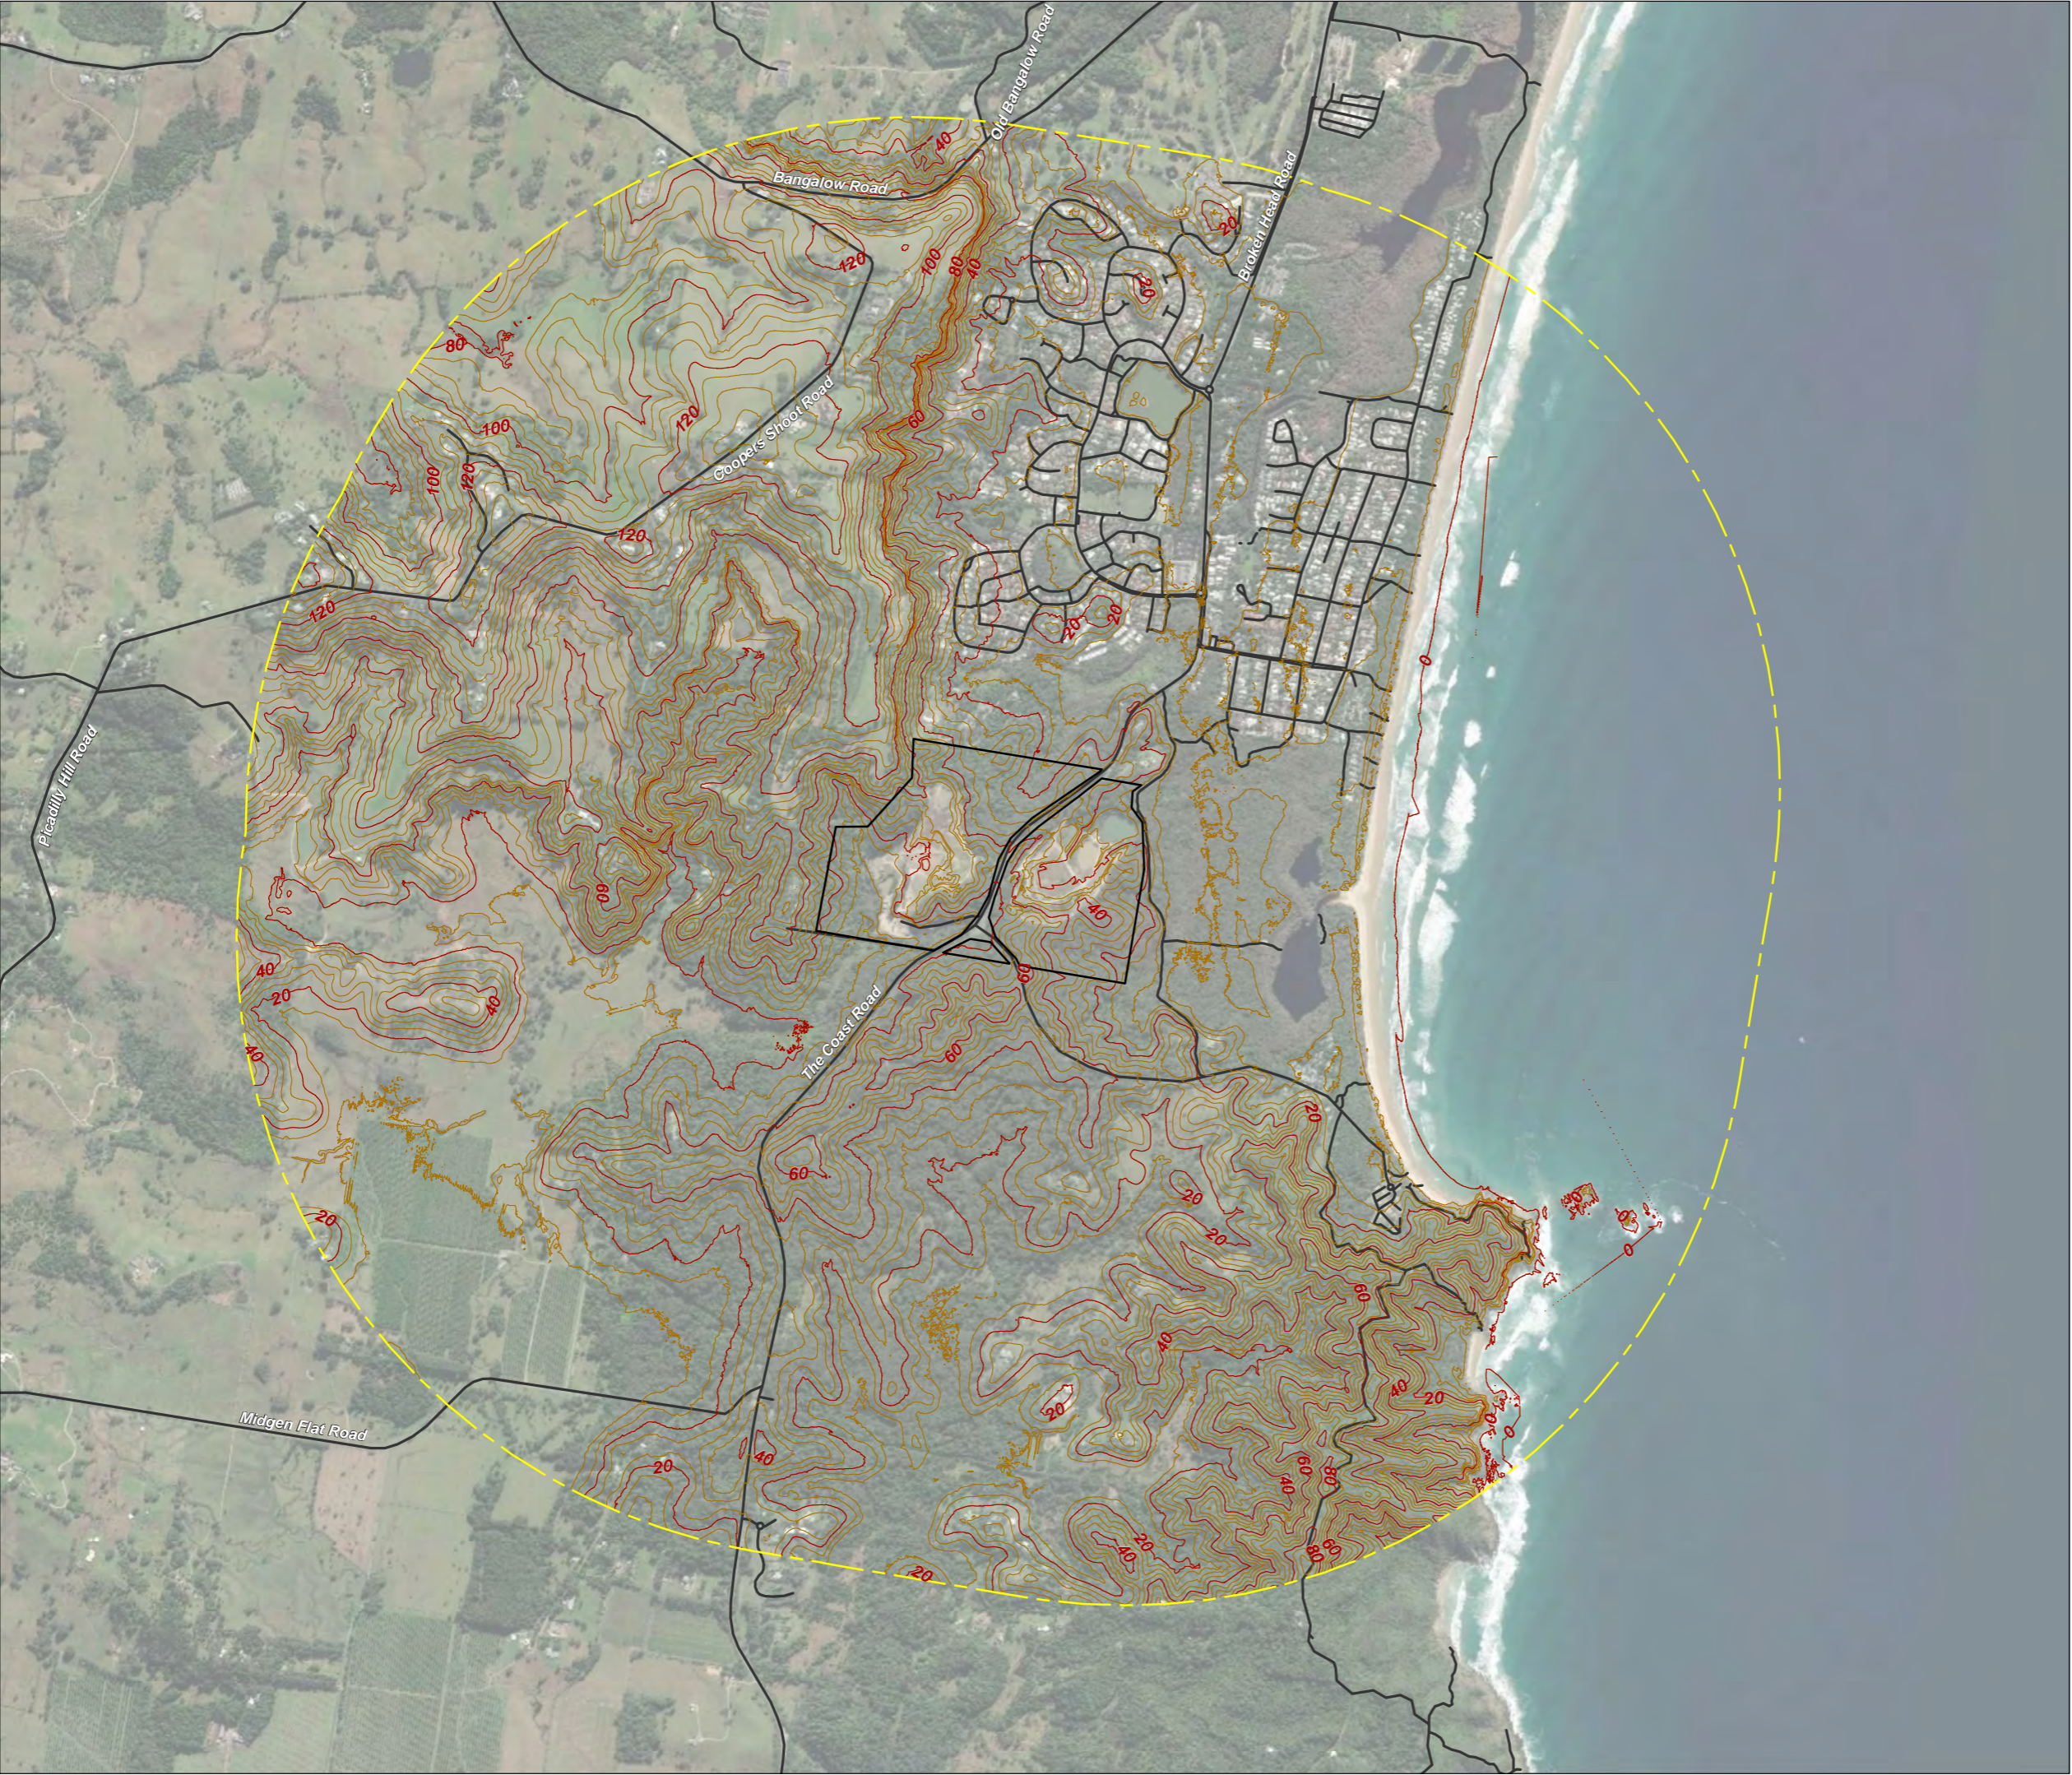
Figure 13
**Contours -
2km buffer**

- ❑ Digital Elevation Model – **Figure 10 and 11**;
- ❑ Topographical Contours (2m contour internals @ 140m and 5m contour intervals @ 2km) – **Figure 12 and 13**; and
- ❑ Slope analysis in gradients of 5 degrees – **Figure 14 and 15**.

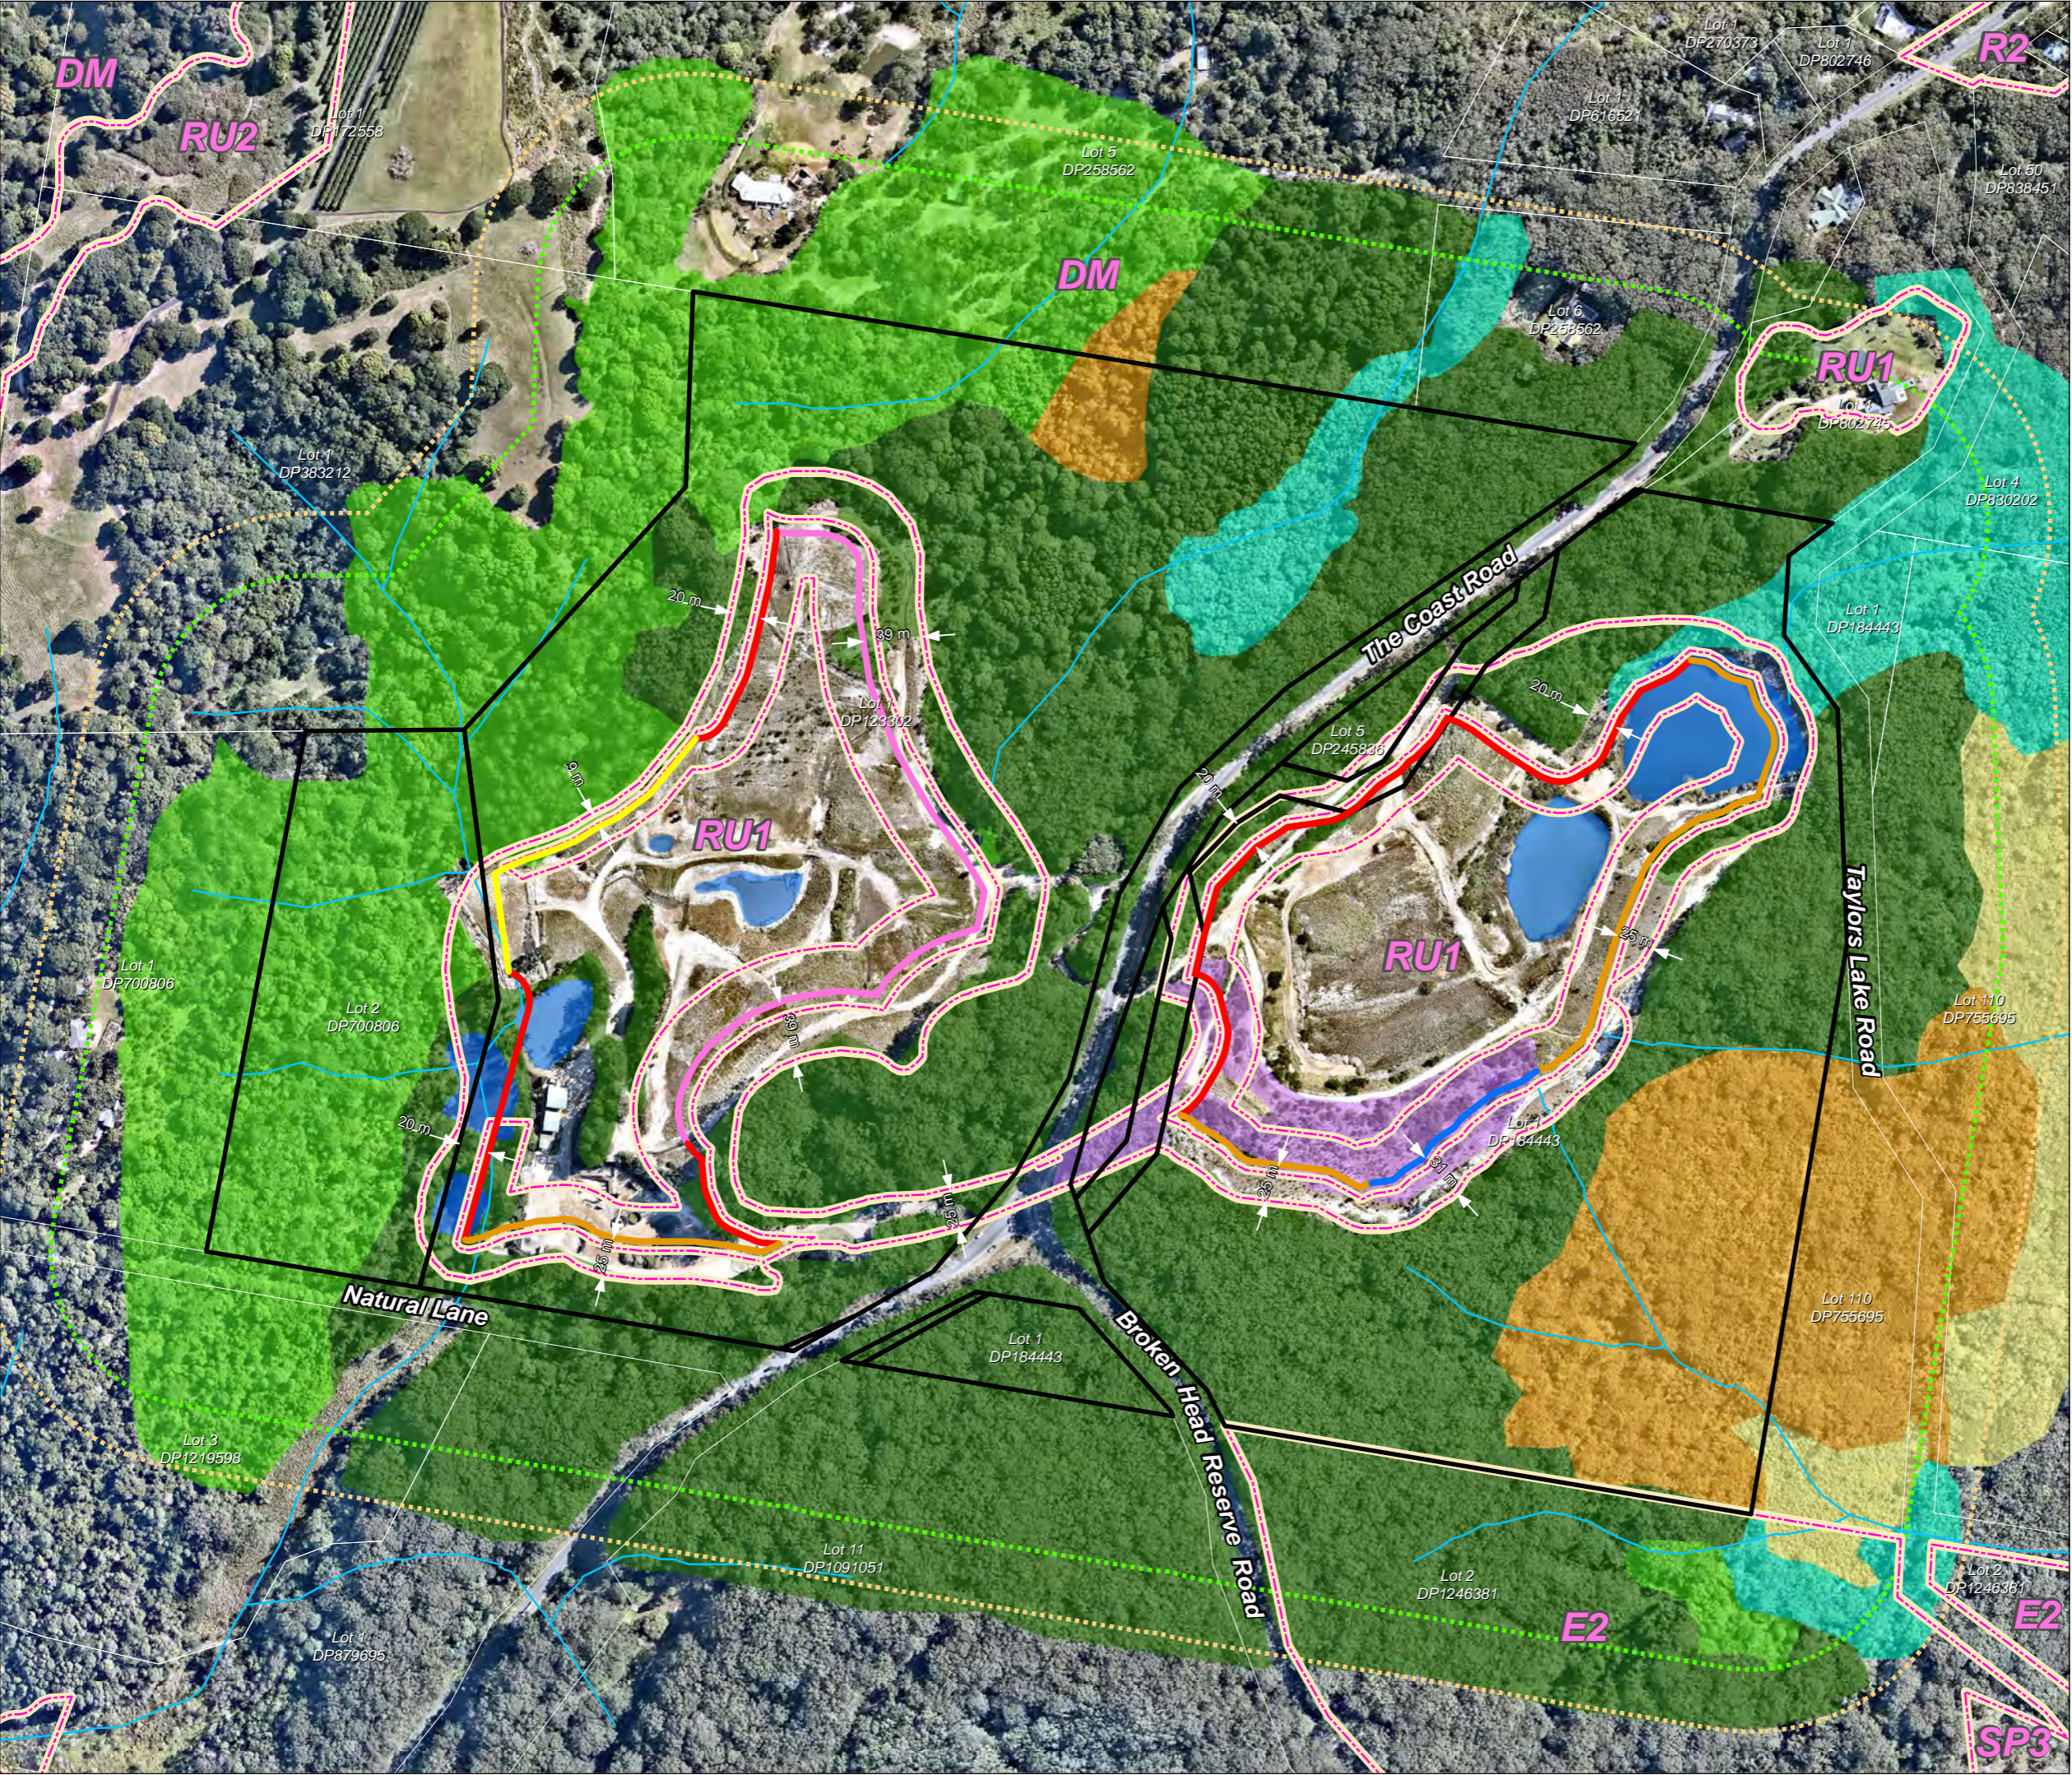
Figure 21

Asset Protection Zone

All new lots and dwellings are provided with sufficient separation distance to minimise the bushfire risk to an acceptable level.

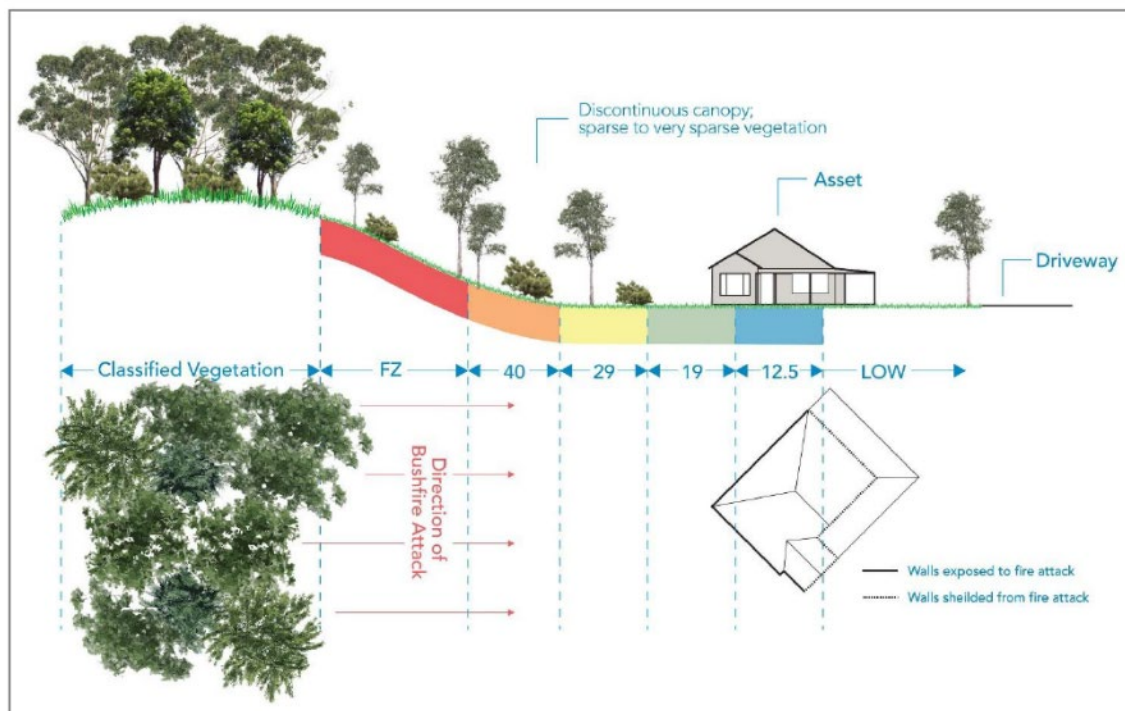
Figure 22: Bushfire Attack Level

- ☐ Relevant FDI = 80;
- ☐ Flame temperature = 1090K;
- ☐ Slope = variable;
- ☐ Vegetation classification = *forest*, and
- ☐ Building location.

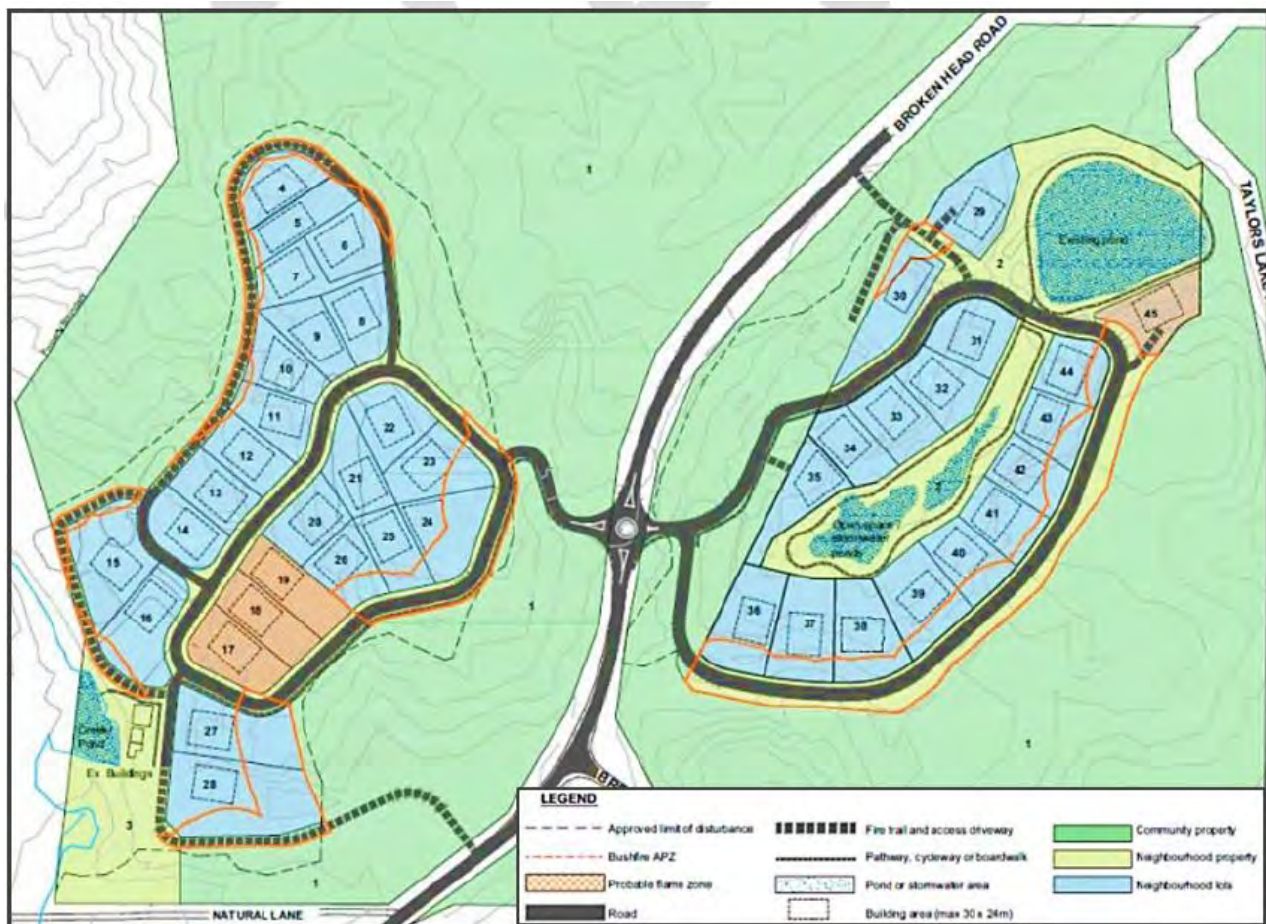
Appendix A: Plan of Community Title Subdivision

The Planning Proposal is based on a conceptual subdivision design which was prepared in 2014 and is an indicative layout only. It should be noted that any reference to bushfire asset protection zones (APZ) or flame zone in the indicative plan is superseded by this assessment. The conceptual subdivision plan is contained in **Appendix A** and shown in **Figure 6**.
