The Belmore Road Precinct

Riparian Land Assessment

CKDI Bringelly Pty Ltd

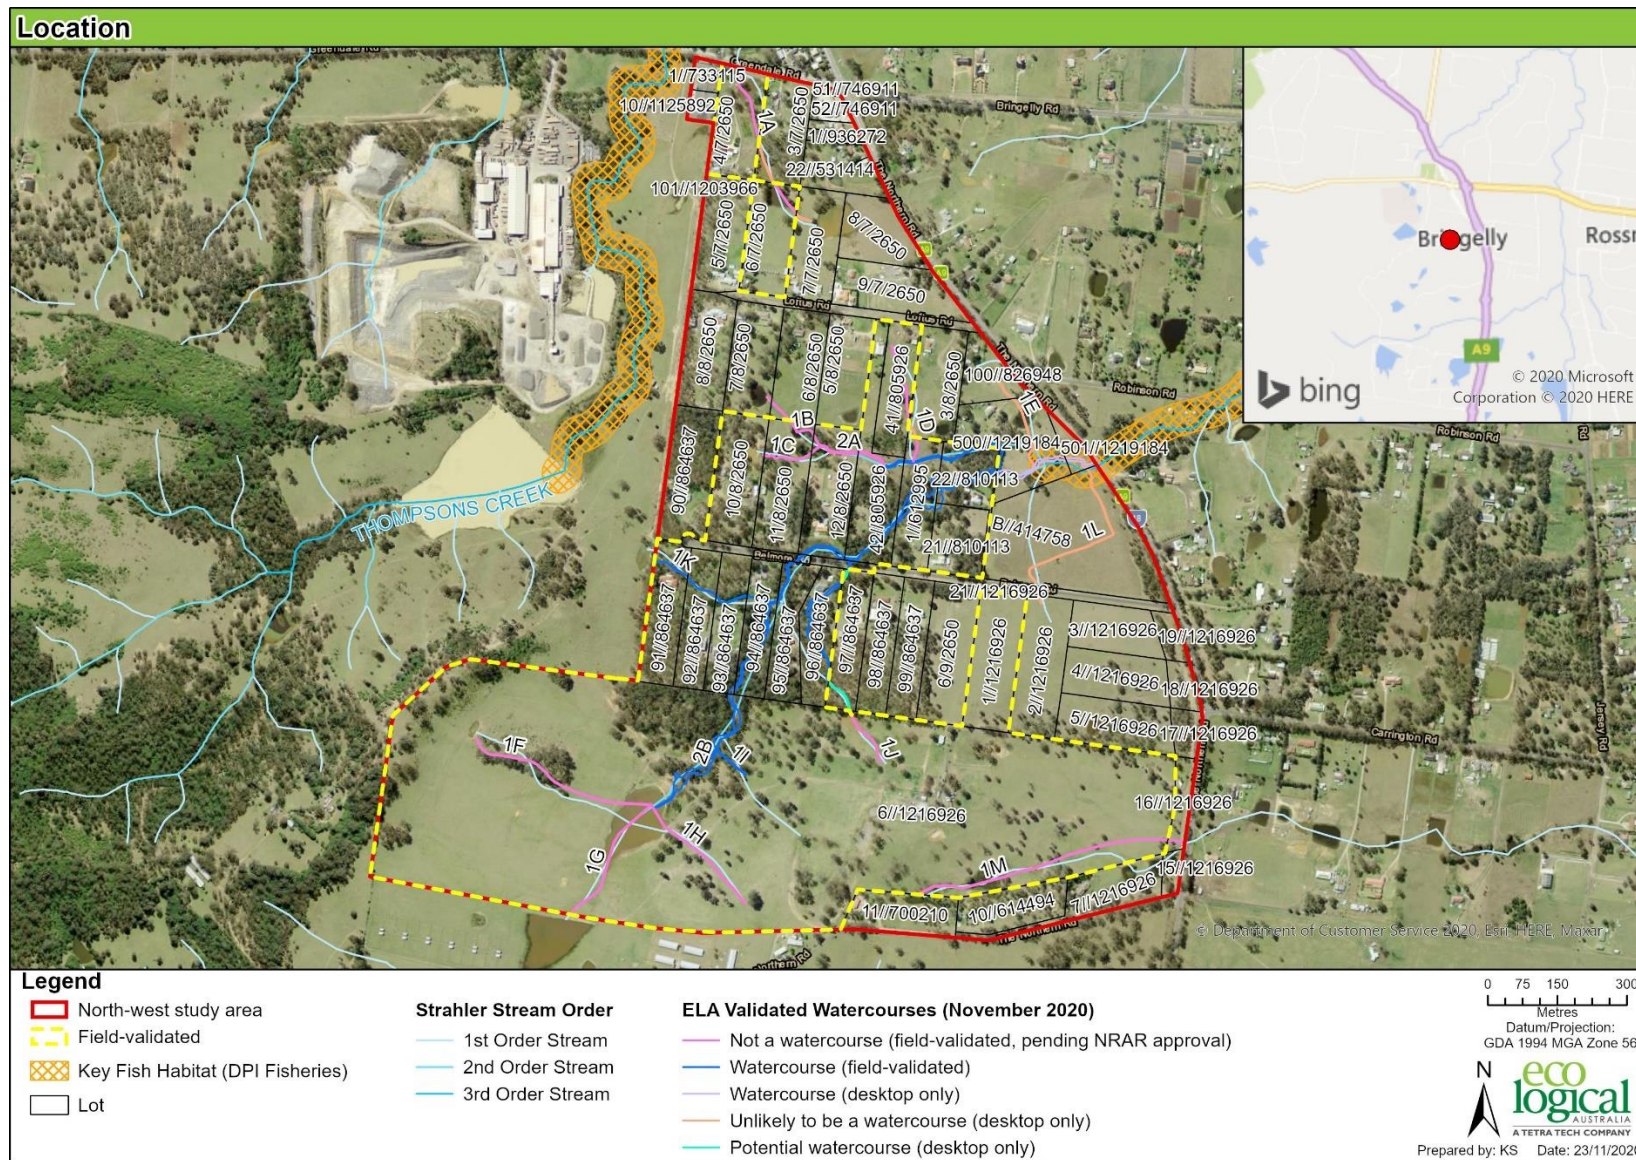
Figure 1-1: Study area

Figure 1-1 illustrates the broad location of the study area. The study area lies within the Hawkesbury-Nepean Catchment. The Hawkesbury-Nepean is the second largest in NSW and has its headwaters located within largely pristine regions including the Blue Mountains World Heritage Area and Sydney Catchment Authority's lands in the NSW Southern Highlands. These upper reaches provide over 90% of Sydney's drinking water. Once into flatter, floodplain country, the Hawkesbury River flows eastward towards the ocean through rural and semi-rural areas of western Sydney. These middle and lower reaches of the system are highly impacted and degraded, both directly through waterway modifications and indirectly through adjacent land-use practises. Hydrological and sediment regimes have been dramatically altered due to vegetation clearance and increasing urbanisation. Increasing impervious surfaces in the catchment are causing changes to hydrology which has greatly altered the geomorphology and ecology of the watercourses.

The study area is in the South Creek / Wianamatta sub-catchment. Numerous first, second and third order tributaries are mapped within the study area. The first order watercourse at the north of the site is a tributary of Thompsons Creek that flows from south to north and the first order watercourse in the southeast corner of the study area is a tributary of Lowes Creek. The remainder of the watercourses in the study area are tributaries of South Creek / Wianamatta and flow through the site from southwest to east. The downstream extent of the third order tributary of South Creek within the site is mapped as Key Fish Habitat (Figure 1-1) by DPI Fisheries.

Field surveys were conducted along the length of the watercourse wherever access was permitted. There were areas of the study area that were unable to be accessed due to restrictions by landholders. Figure 1-1 shows the area accessed and surveyed.

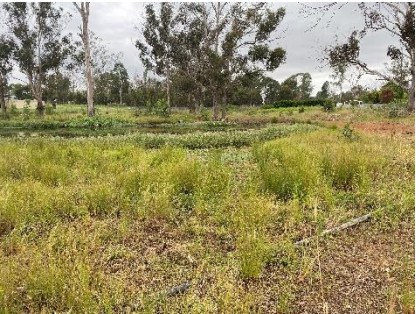
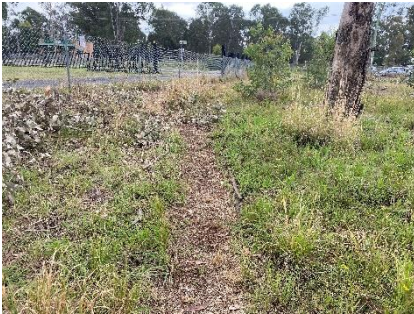
Reach	Proposed WM Act Status (pending NRAR approval)	Description	Condition	Photo Facing Upstream	Photo Facing Downstream
1A	Not a river	No defined bed or banks. Overland flow path in times of overtopping dam	Poor

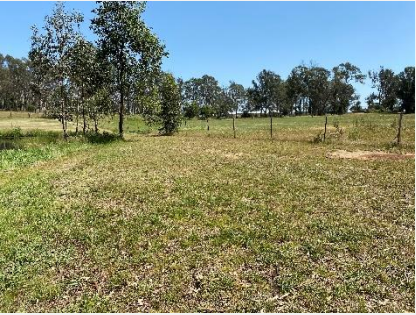
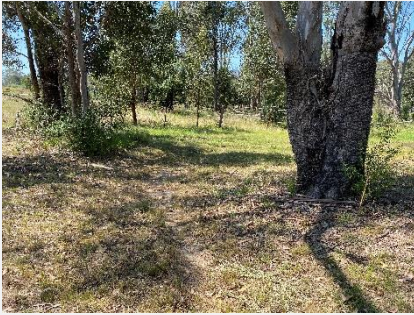
1B	Not a river	No defined bed or banks	Poor

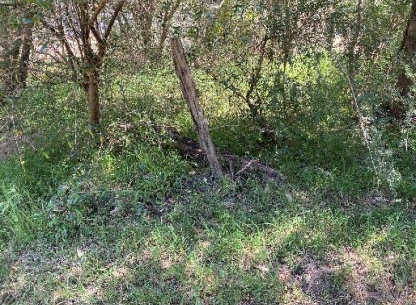
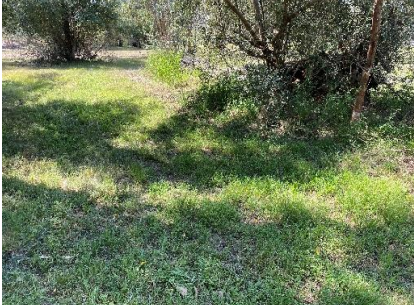
1C	Not a river	No defined channel, bed or banks	Poor

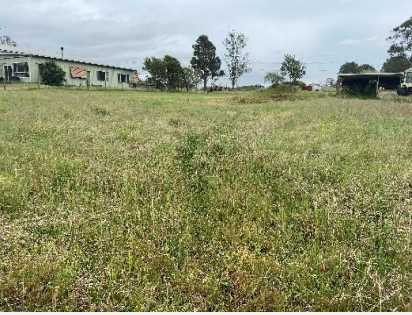
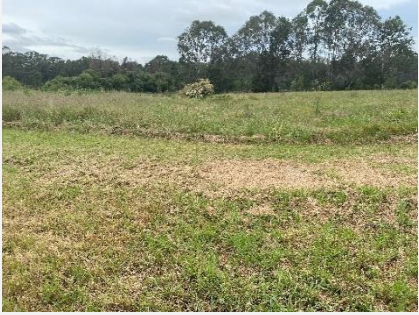
Reach	Proposed WM Act Status (pending NRAR approval)	Description	Condition	Photo Facing Upstream	Photo Facing Downstream
1D	Not a river	No defined bed or banks. Mown grass for almost entire length of mapped location.	Poor

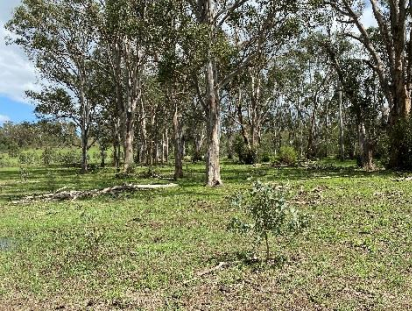
1G	Not a river	No defined bed or banks. Areas of saturated soil following recent heavy rain.	Poor

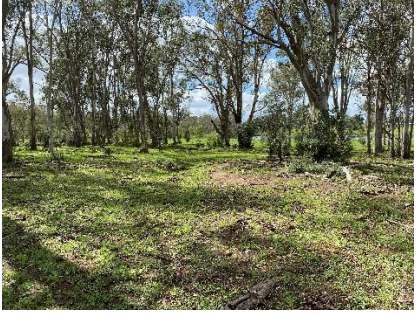
1F	Not a river	No defined bed or banks. Overland flow path at a low point only.	Poor

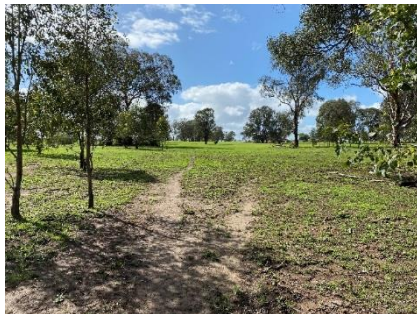
Reach	Proposed WM Act Status (pending NRAR approval)	Description	Condition	Photo Facing Upstream	Photo Facing Downstream
1H	Not a river	No defined channel. Informal track near mapped location of this watercourse, likely created by stock accessing dam.	Poor

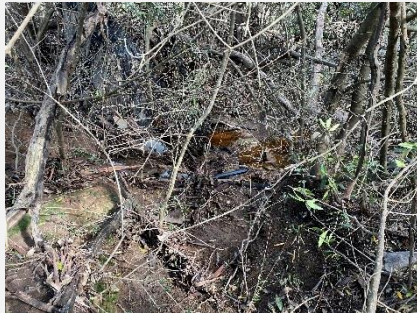
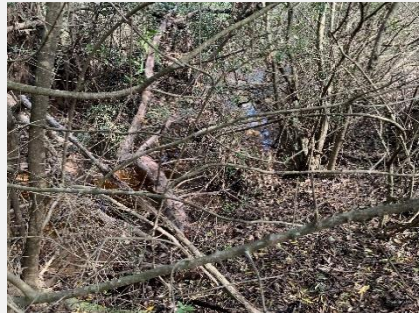
1I	River	Defined channel approximately 1 m wide that started at a head cut about 60 m to the south east of the main channel 2B. Densely covered in <i>Olea europaea</i> subsp. <i>cuspidata</i> (African Olive) and no groundcover vegetation, allowing for easy erosion of banks and bed of channel. Right bank steeply sloped, approximately 0.5 m high. Household rubbish visible within this channel.	Poor

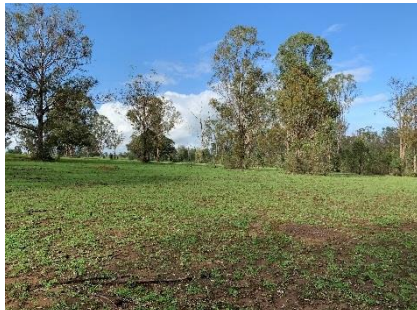
1J - upper	Not a river	No defined channel upstream of the dam on this watercourse.	Poor

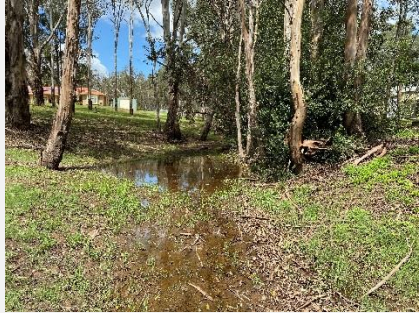
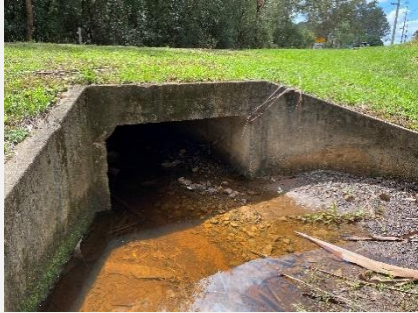
Reach	Proposed WM Act Status (pending NRAR approval)	Description	Condition	Photo Facing Upstream	Photo Facing Downstream
1J - lower	River	Defined channel at Belmore Road. Single concrete box culvert approximately 1.5 m wide and 0.75 m high carries flow under Belmore Road to confluence with 2B.	Moderate

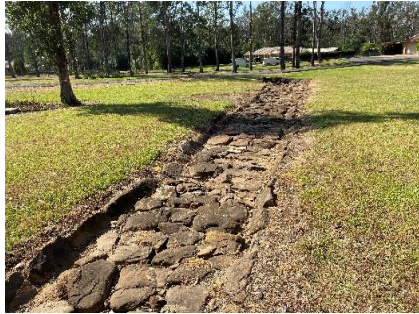
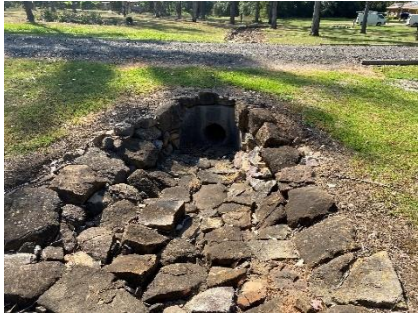
1K	River	Near the top of this watercourse, the channel had been rock lined within multiple properties. The channel was less defined as it neared the confluence with 2B.	Poor - moderate

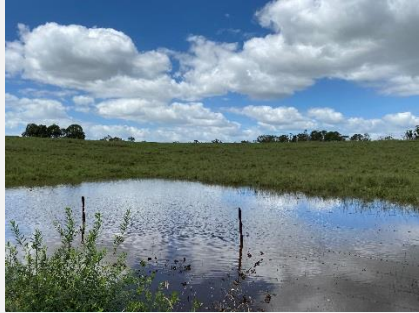
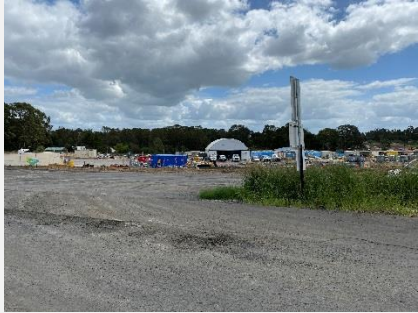
1L (at Belmore Road)	River	Upstream of Belmore Road there was no defined channel, however, there appears to be a constructed drainage line within the property downstream of Belmore Road where access was restricted.	Poor

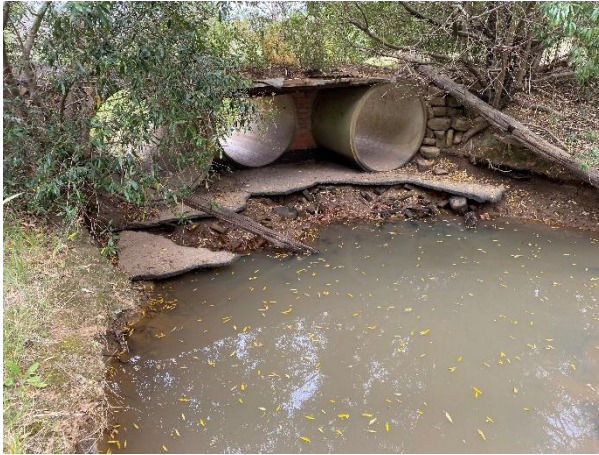
Reach 2A started further downstream than was mapped on the Strahler layer. It started as a wet depression with a variety of sedges before becoming a well-defined creek where it flowed through three large pipes. On the downstream side of these pipes, the creek was heavily disturbed, with evidence of bed and bank erosion observed and building rubble within the creek line.

Facing upstream – large pipes near top of 2A

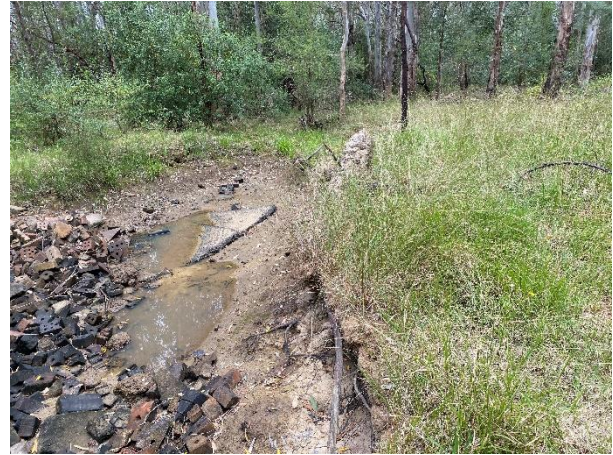
Facing downstream – eroded channel

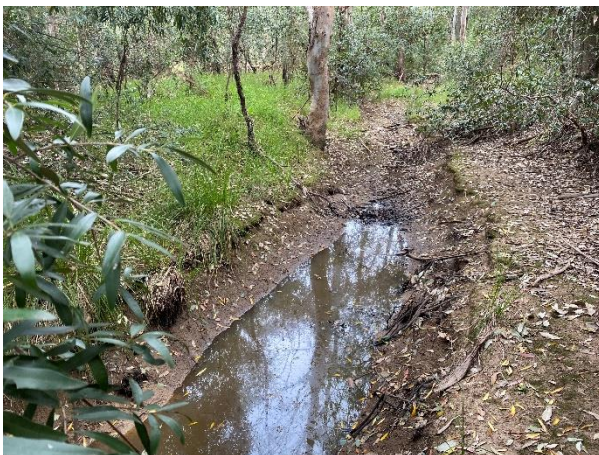
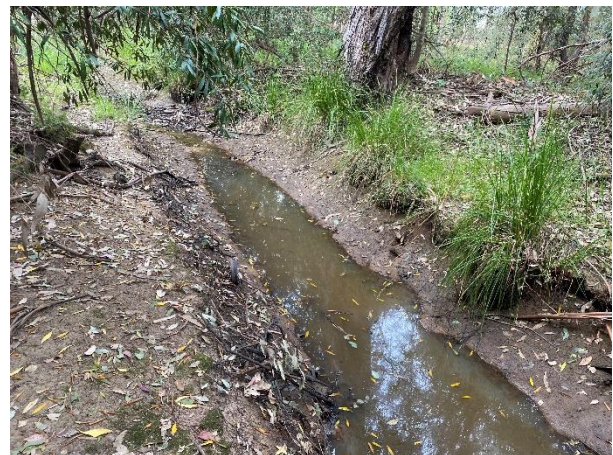
The channel narrowed as it continued downstream, with pools of standing water observed in the creek following recent rain. The channel was shallow and narrow with no aquatic flora observed. Riparian vegetation was predominantly native, with a continuous band between the right bank of 2A and left bank of 2B.

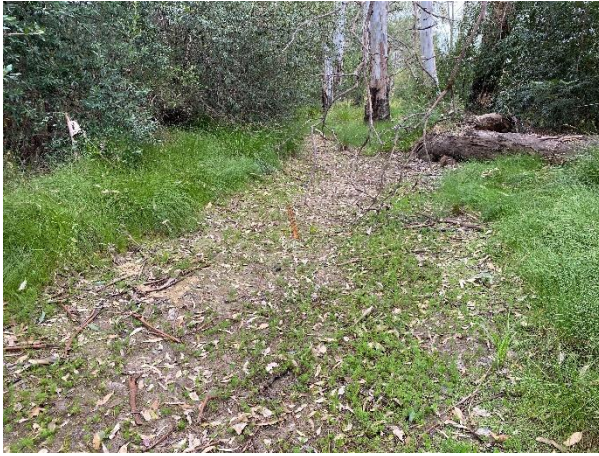
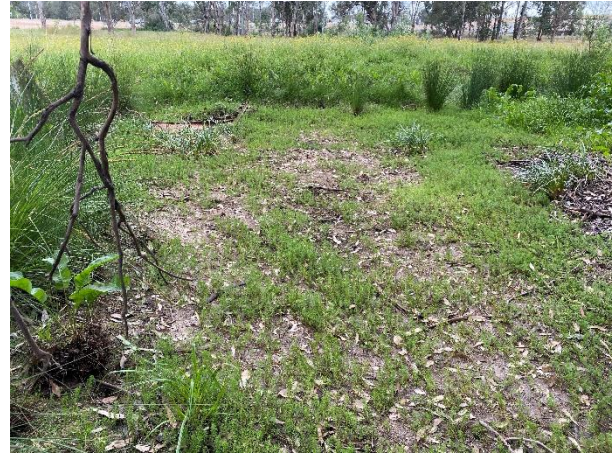
Where the channel neared the confluence with 3A, it became a wide, less-defined channel. The creek is likely to have been previously modified in this area, as it had a sharp turn in it as it flowed south towards the confluence with 3A.

Facing upstream – upstream of confluence with 3A

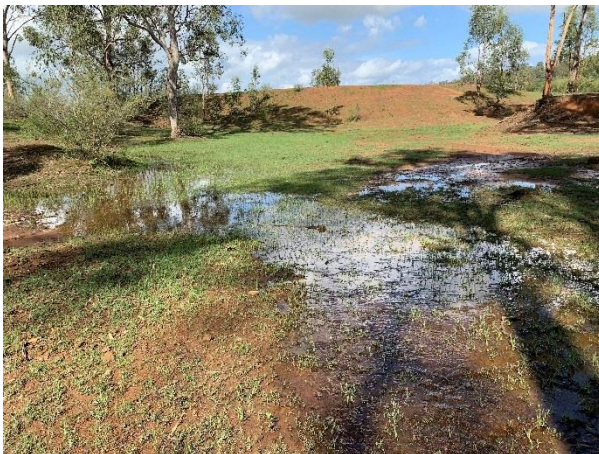
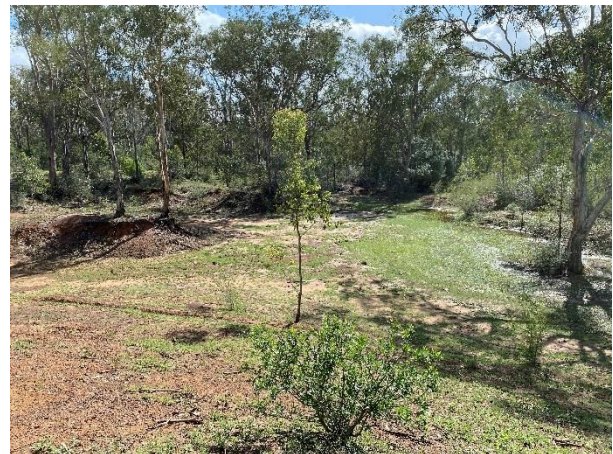
The upstream extent of 2B was a large dam at the base of sloping fields lacking in canopy cover and densely covered in exotic pasture grasses. The dam was overflowing around the north-eastern side at a low point, rather than through a defined spillway. Downstream of the dam the channel of 2B was approximately 20 m wide in some areas. Water sheeted across this area, which was covered in short exotic grass including *Cynodon dactylon* (Couch). Some small gravels (3 – 5 mm diameter) were observed on the channel bed in this wide section of watercourse and the banks showed signs of historical erosion, likely during very high flows, and were approximately 1.5 m high. The riparian vegetation was sparse and patchy alongside this section of 2B and did not form a continuous strip of vegetation alongside the dam and overflow area.

Facing upstream – below large dam

Facing downstream – wide channel.

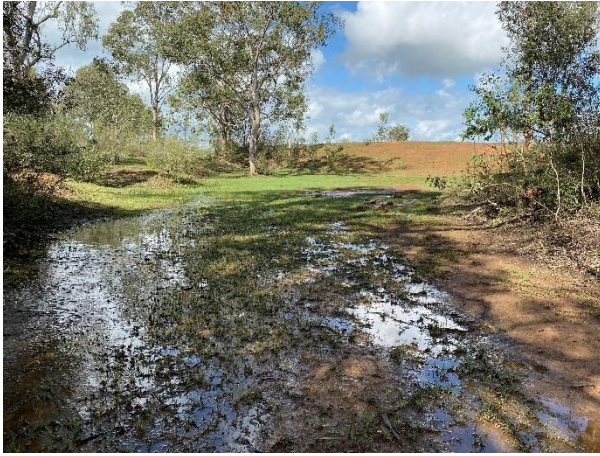
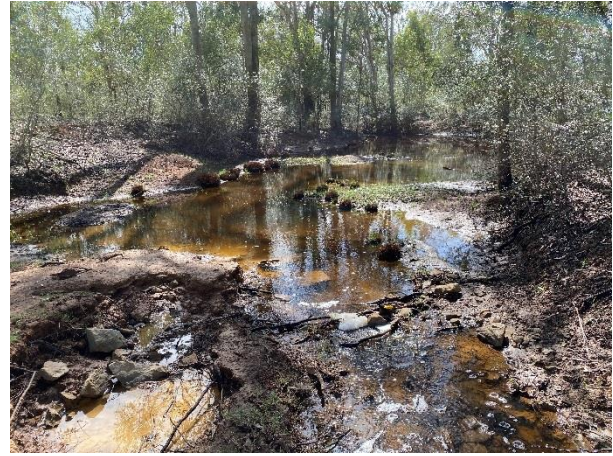
Approximately 100 m downstream of the dam on this reach, the dispersed flow converged at head cut within the channel. The head cut was shallow, in that it was approximately 0.3 m high, however erosion in this area had exposed large pieces of slate and tree roots. Water flowing over the head cut created a small riffle area and scattered *Juncus usitatus* was observed on the edge of the channel downstream of this riffle.

*Facing downstream – head cut*

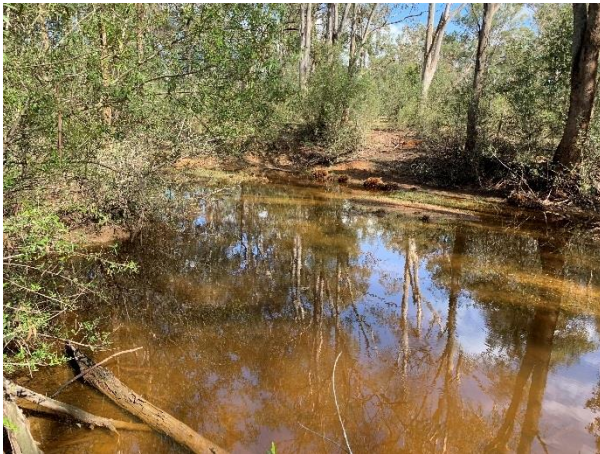
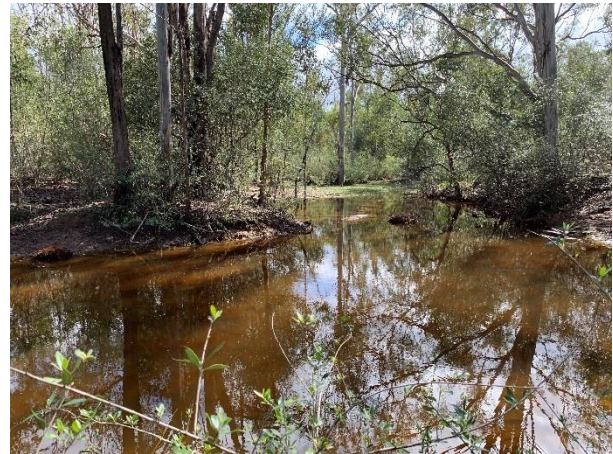
Upstream of the confluence of 2B and 1I, a head cut was observed on the right bank and a flood runner was evident parallel to the left bank. The channel was shallow, and the channel banks were low with a gentle grade. Leaf litter was observed on the channel bed and this litter was covered in a fine silty deposit. The channel was wide through this area, up to 15 m wide in some areas. The water was tannin-stained and still but not stagnant and there was a small amount of vegetation overhanging the edges of the channel. No aquatic vegetation was observed in this part of 2B.

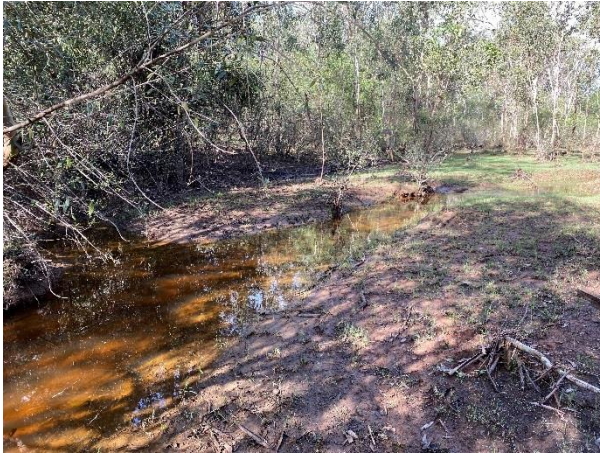
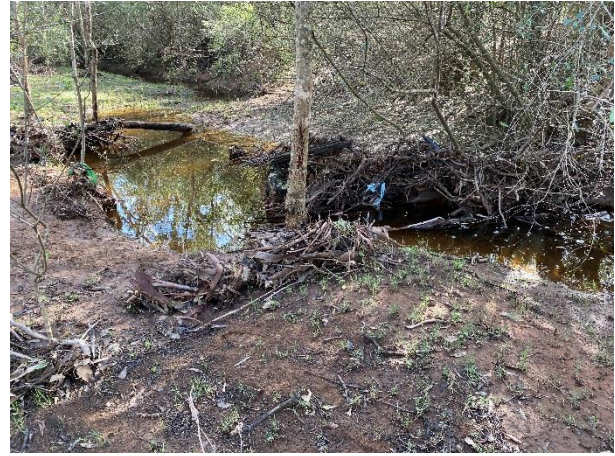
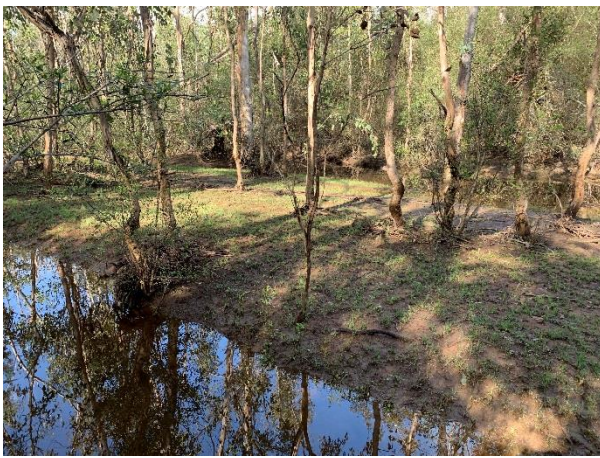
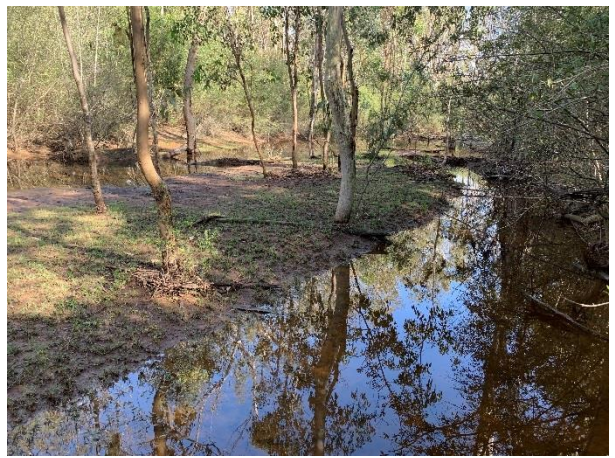
Approximately 100 m upstream of the boundary fence between Lot 6 DP 1216926 and Lot 94 DP 864637, 2B existed as a braided channel, in that the flow was split around small instream islands containing juvenile *Eucalyptus tereticornis* (Forest Red Gum). A small area of undercutting of the right bank was observed in this area. Water in the channel was stained by tannins. The channel itself was partly shaded at the time of survey (9:30 am).

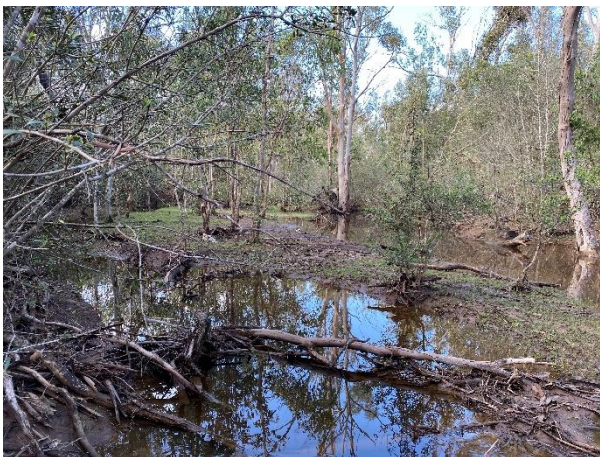
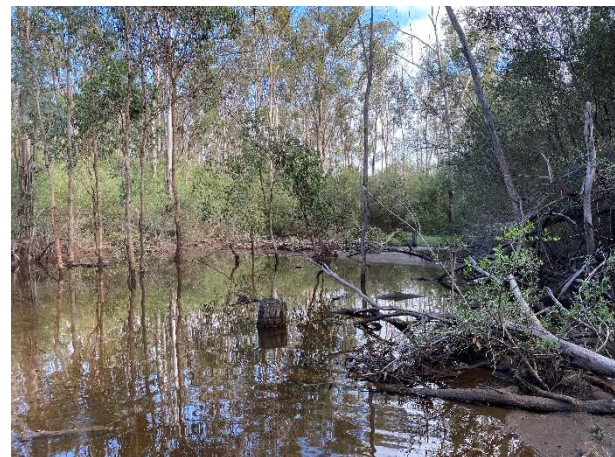
At the downstream end of the accessible portion of 2B, this watercourse was a wide, shallow creek following recent rain. A large amount of instream woody debris was present and flood debris was observed against the fence line at the northern end of this Lot. Visibility through the shallow water column was good on the day of the site survey and no odour or sheen were evident. The creek had a silty substrate, and no active areas of erosion were observed. The creek banks sloped gradually away from the channel. Riparian vegetation alongside this section of the watercourse was dense and was comprised of a native canopy with a disturbed shrub layer dominated by *Olea europaea* subsp. *cuspidata* (African Olive).

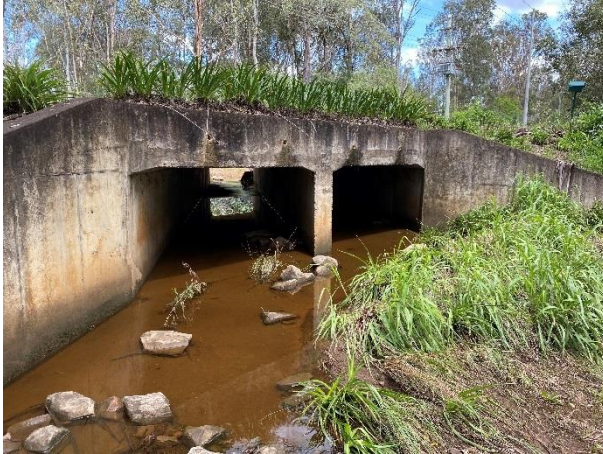
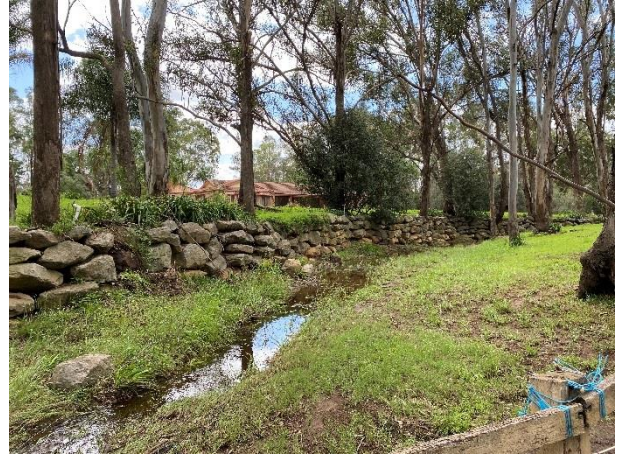
Two concrete box culverts, each approximately 1 m high and 1.5 m wide carried the flow under Belmore Road. No geomorphic features were observed downstream of this area, with the water flowing through a defined channel that had sandstone boulders armouring the left bank and a more gradual sloping right bank. No aquatic vegetation was observed in this area of the channel, whilst riparian vegetation was comprised of scattered *Eucalyptus* sp. with *Agapanthus praecox* subsp. *orientalis* (Agapanthus) growing on the top of the sandstone-boulder bank. Overall, this watercourse was in moderate condition, as it had a variety of instream geomorphological features and limited bed and bank erosion was observed, however macrophytes within the channel were non-existent.

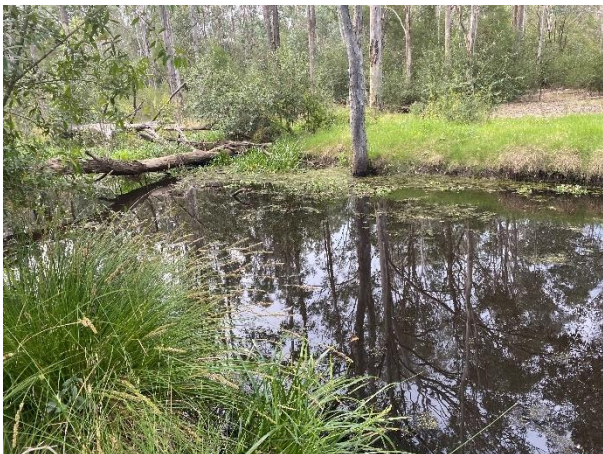
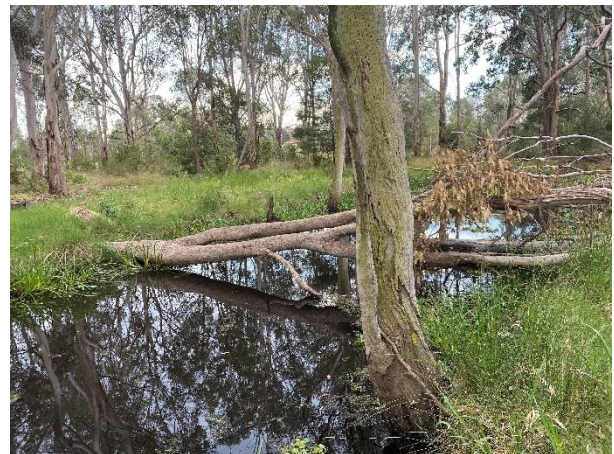
At the rear of properties along Belmore Road, 2B was a 10 m wide channel in some areas. Emergent macrophytes including *Ludwigia peploides* were observed growing on the edge of the channel and several large fallen trees have created good aquatic habitat within this area. Water in the channel was tannin-stained but not turbid. At the rear of 58 Belmore Road, the creek became a wetland up to 40 m wide and covered in dense *Typha orientalis* and *Azolla* sp. *Rubus fruticosus* (Blackberry) was observed in dense clumps along the right bank of the channel.

Facing downstream – large woody debris in channel

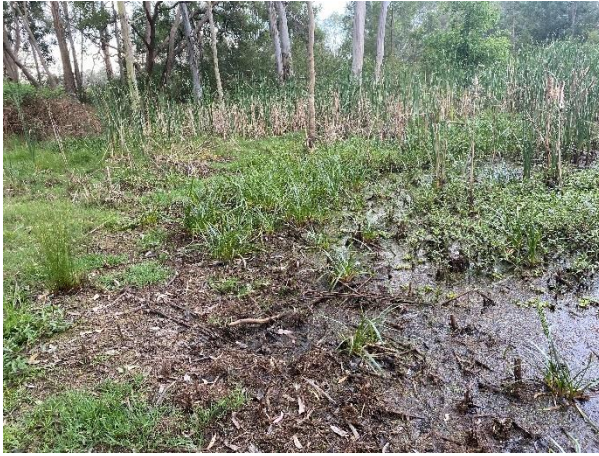
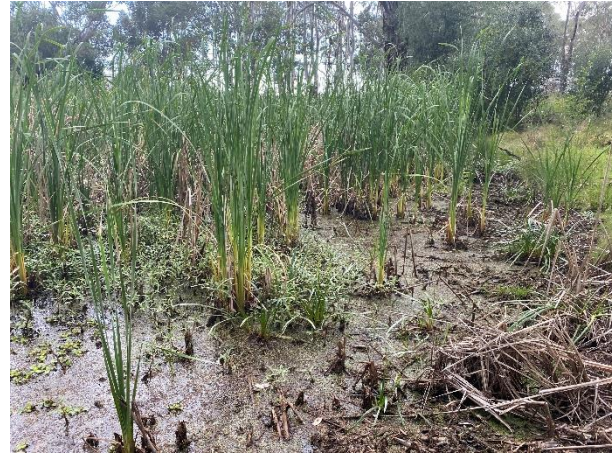
Facing upstream – wetland area

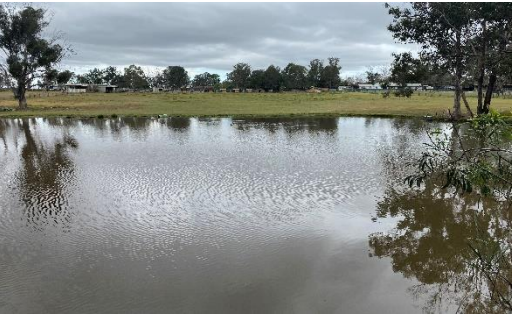
Reach	Dam Number*	Description	Aquatic Fauna Observed	Aquatic Flora Observed	Representative Photo
1A	1	Large dam near the upstream mapped extent of reach 1A. No defined spillway and a few sparse <i>Eucalyptus moluccana</i> on the edges of the dam.	<i>Platalea regia</i> (Royal Spoonbill) was observed near this dam.	No aquatic flora

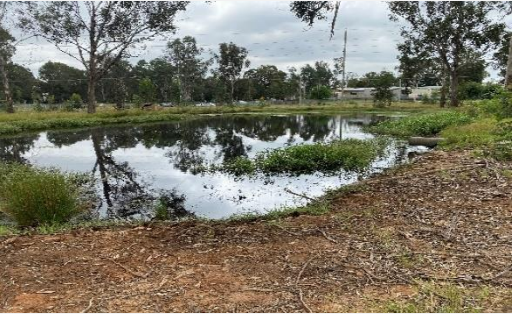
1A	2	Large dam near Greendale Road. At time of survey, water in the dam was clear with no oil sheen or odours.	No aquatic fauna observed.	Emergent macrophytes including <i>Persicaria strigosa</i>

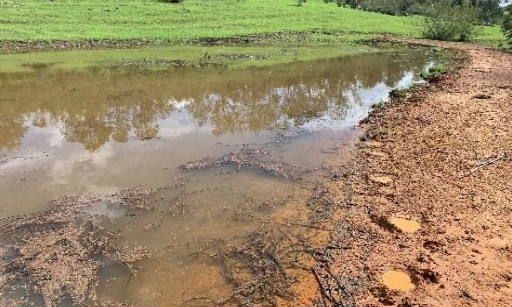
1F	1	No defined spillway but evidence of overflow after recent rain.	Frog eggs attached to submerged grasses.	Submerged <i>Typha orientalis</i> (Cumbungi).

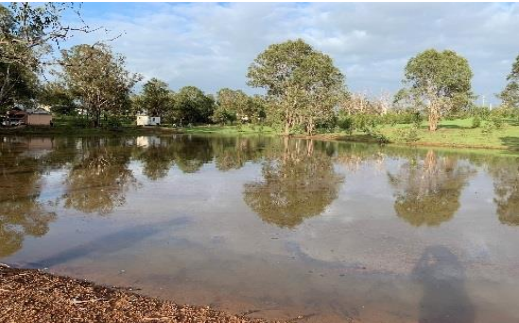
Reach	Dam Number*	Description	Aquatic Fauna Observed	Aquatic Flora Observed	Representative Photo
1M	2	Dam at capacity following recent rain, water slightly turbid and no fringing vegetation present. Clay substrate and no defined spillway on downstream side.	<i>Porphyrio porphyrio</i> (Purple Swamphen) and <i>Phalacrocorax sulcirostris</i> (Little Black Cormorant).	<i>Ludwigia peploides</i> .

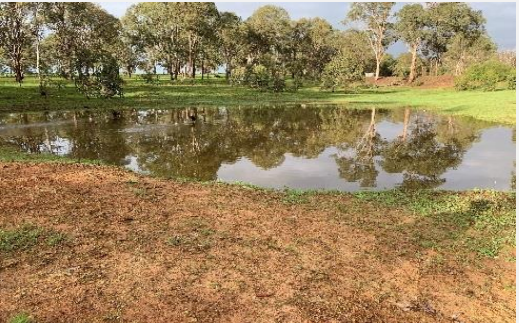
1M	3	There were no defined banks to this dam, which appeared to be nearing capacity. No macrophytes were observed in this dam and visibility through the water column was good.	<i>Porphyrio porphyrio</i> (Purple Swamphen), <i>Anas castanea</i> (Chestnut Teal) and <i>Phalacrocorax sulcirostris</i> (Little Black Cormorant).	No aquatic flora observed.

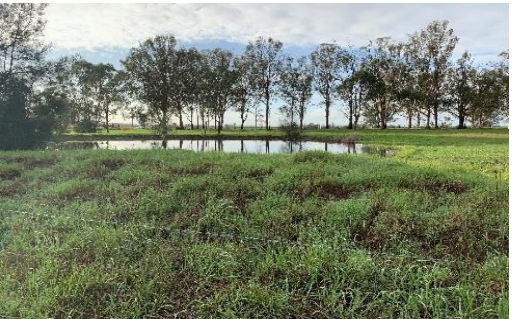
1M	4	Dam near bottom of mapped location of 1M, outside of accessible area. Dam nearing capacity and fringed by <i>Casuarina</i> sp.	<i>Porphyrio porphyrio</i> (Purple Swamphen) and <i>Litoria peronii</i> (Peron's Tree Frog).	No aquatic flora observed.

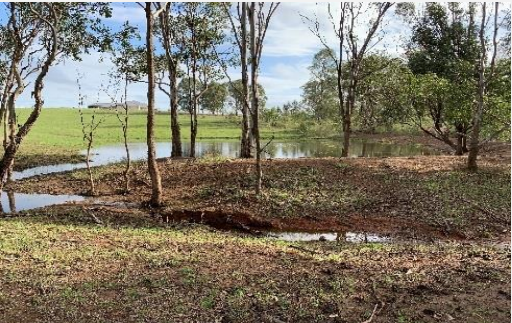
Reach	Dam Number*	Description	Aquatic Fauna Observed	Aquatic Flora Observed	Representative Photo
N/A		Dam within Lot 5 DP1216926, at base of grassy slope with cattle grazing on edges of dam. Dam overflowing to the south on day of survey, evidence of erosion in this area. Scattered <i>Eucalyptus</i> sp. around dam.	No aquatic fauna.	Floating macrophytes observed but species could not be identified due to access.

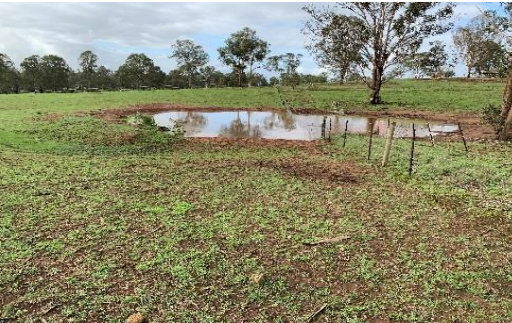
N/A		Dam located to south of driveway on Lot 6 DP 1216926. Not on a mapped watercourse, fenceline bisected dam with no fringing vegetation and a few scattered <i>Eucalyptus</i> sp. on western side of dam. Clay substrate with turbid water on day of survey.	No aquatic fauna.	No aquatic flora.

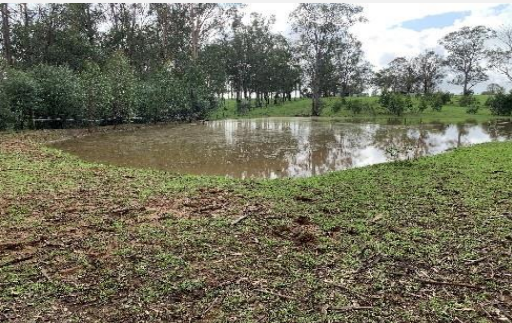
1J	1	No defined edges of dam and no defined channel upstream or downstream of dam. Turbid water observed and dam near capacity on day of site survey.	<i>Porphyrio porphyrio</i> (Purple Swamphen) and <i>Anas castanea</i> (Chestnut Teal).	<i>Lemna disperma</i> (Duckweed).

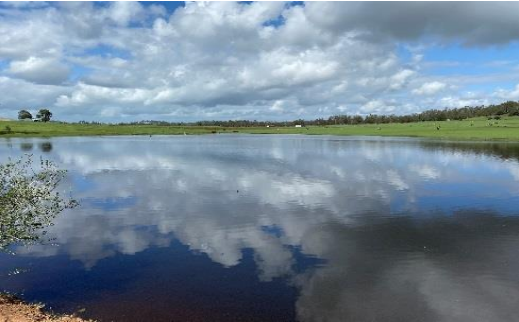
Reach	Dam Number*	Description	Aquatic Fauna Observed	Aquatic Flora Observed	Representative Photo
2B	1	<p>Large dam at capacity on day of site survey, overflowing at low point on northeastern side. No defined spillway. Visibility through the water column was approximately 0.5 m. The downstream edge of the dam had a few scattered <i>Olea europaea</i> subsp. <i>cuspidata</i>. There was no dense fringing vegetation around this dam. Cattle were in the south-western end of dam at time of site survey.</p>	<p><i>Cygnus atratus</i> (Black Swan), <i>Phalacrocorax sulcirostris</i> (Little Black Cormorant) and <i>Egretta novaehollandiae</i> (White-faced Heron).</p>	<p><i>Marsilea mutica</i> (Rainbow Nardoo), scattered sparse <i>Juncus usitatus</i>.</p>

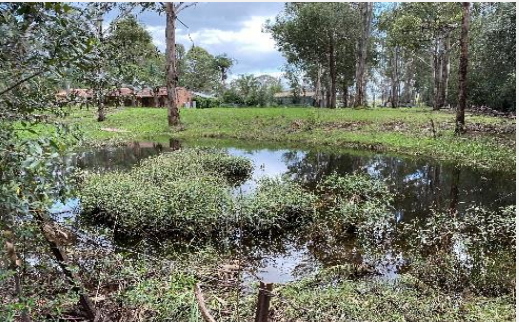
2B	2	<p>Small online dam within Lot 12 Section 8 DP2650. Good aquatic habitat, with emergent macrophytes present in dam.</p>	<p>No aquatic fauna observed.</p>	<p><i>Persicaria orientalis</i> (Slender Knotweed) and <i>Juncus usitatus</i>.</p>

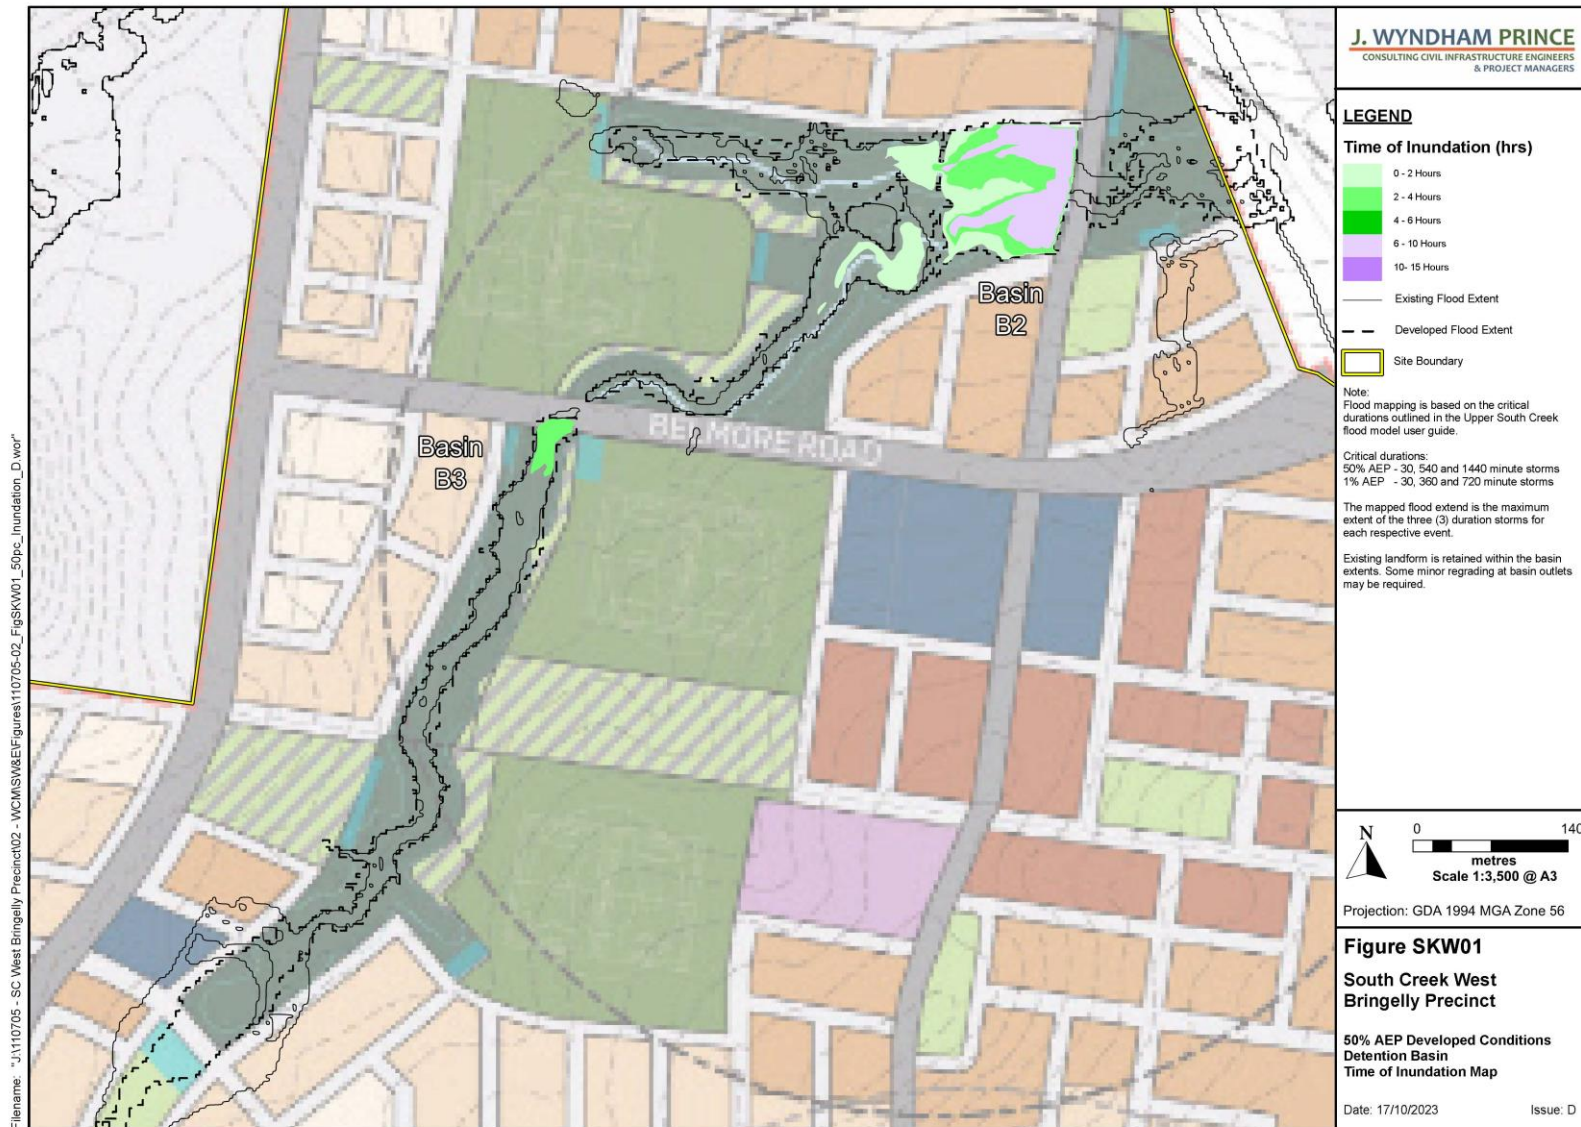
Figure 5-1: Detention basin time of inundation map for 50% AEP developed conditions (J. Wyndham Prince, 2023)

Online detention basins must be for temporary flood detention only, with no permanent water holding.	Modelling for 1% and 50% Annual Exceedance Probability (AEP) events has been completed by J Wyndham Prince (2023). Modelling shows the basins empty relatively quickly, with only the natural low points within the watercourse at the outlet structure remaining inundated for more than 4 hours in the more frequent 50% AEP event (Figure 5-1). In a rarer 1% AEP, only the lower portion of the downstream extent of the riparian corridor would be inundated for more than 2 hours, and the entire basin would empty within 14.2 hours (Figure 5-2).
Online detention basins must have an equivalent VRZ for the corresponding watercourse order.	The existing VRZ area is 12.2 ha, assuming that all mapped first order watercourses that haven't been able inspected meet the definition of a 'river' under the WM Act. The area of VRZ proposed to be retained under the ILP is 12.56 ha, which is greater than the existing VRZ area. However, if the proposed

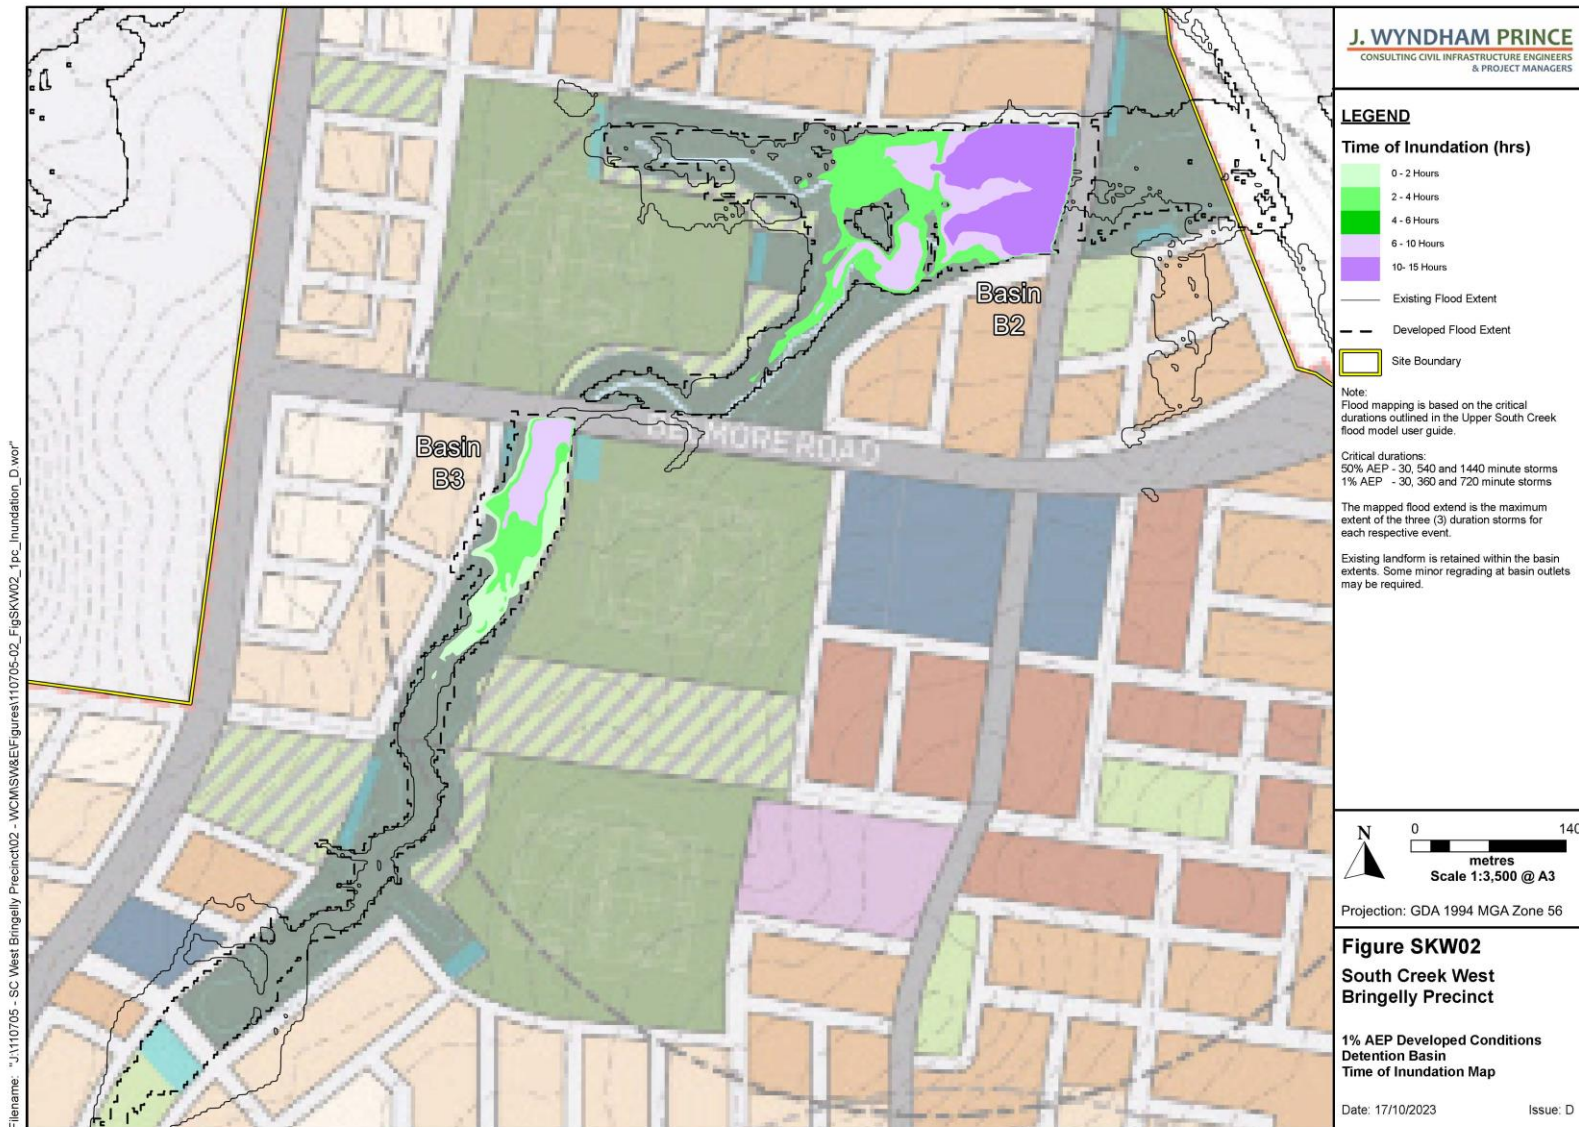
Figure 5-2: Detention basin time of inundation map for 1% AEP developed conditions (J. Wyndham Prince, 2023)

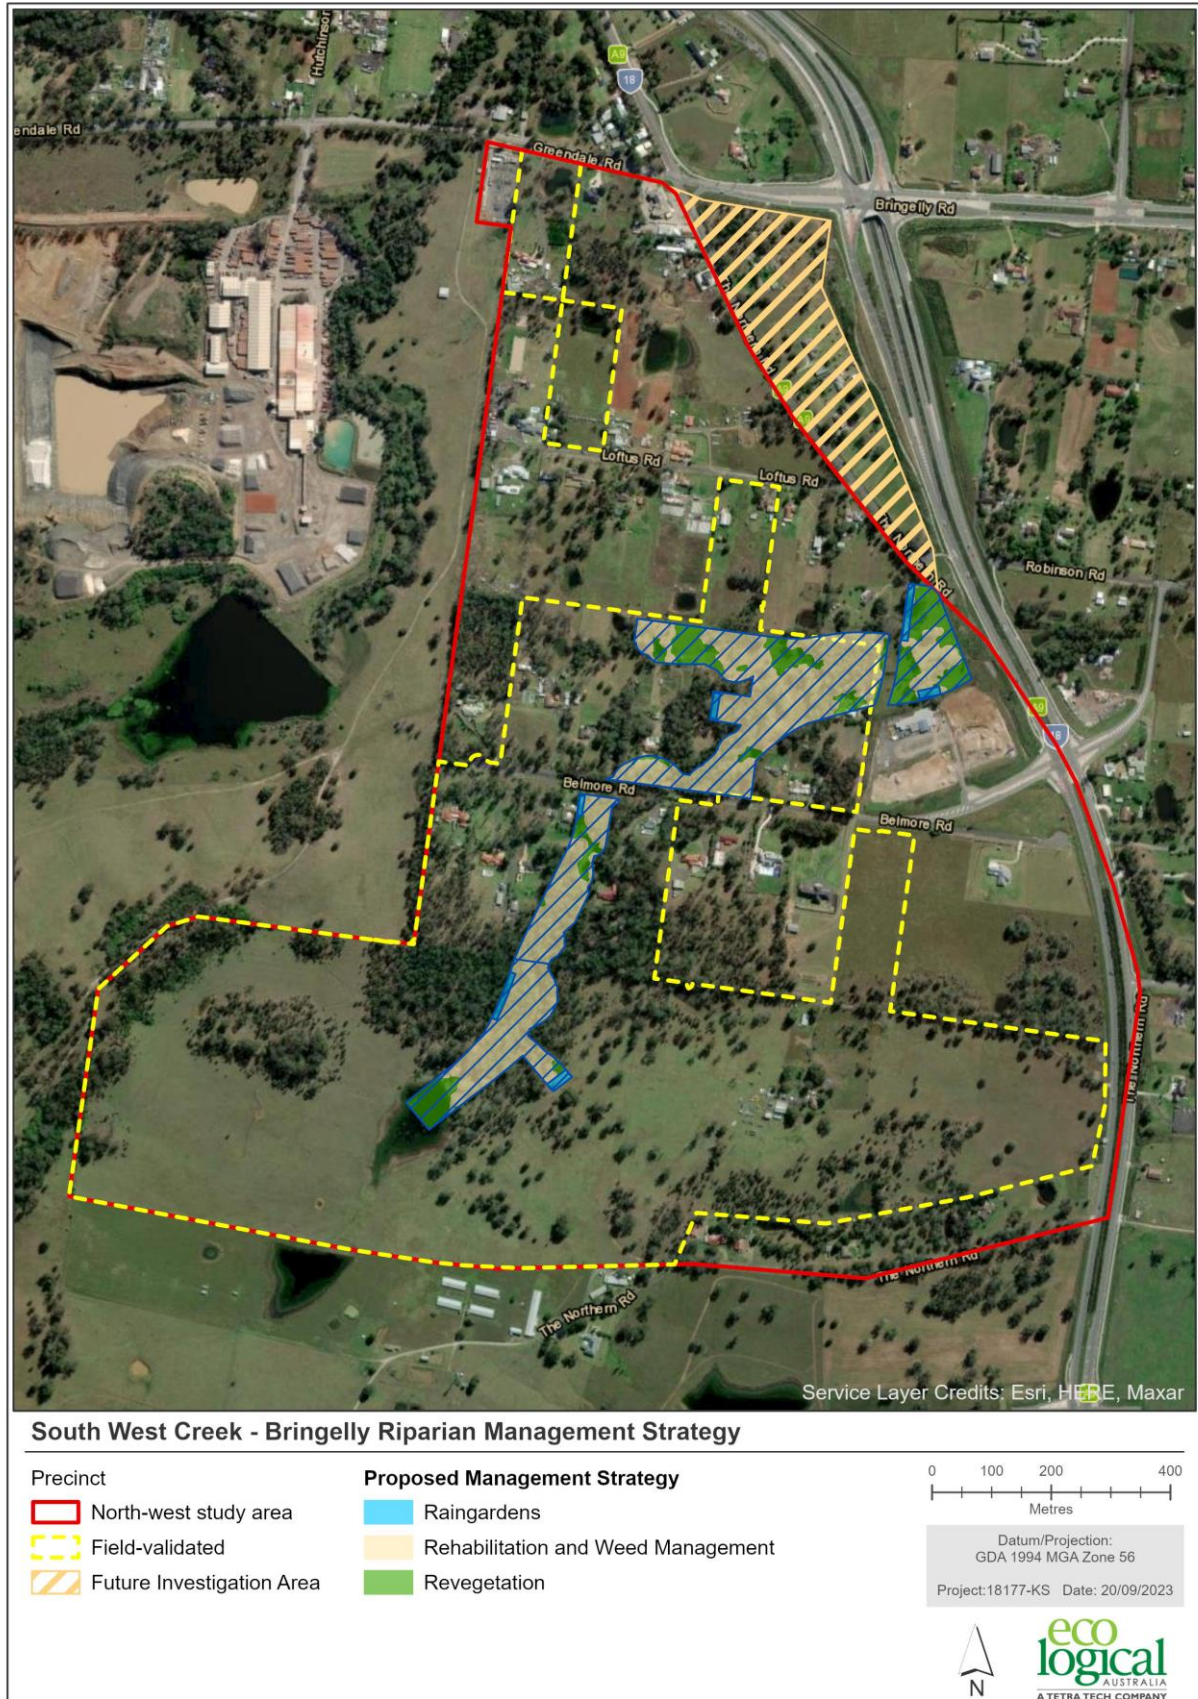
Figure 5-5: Riparian Management Strategy zones

- Target removal of priority and environmental weeds
- Control of exotic grasses and other exotic species
- Tubestock planting following weed control in areas of low resilience. Tubestock planting in areas of regular inundation should be diagnostic of the River-flat Eucalypt Forest vegetation community.
- Monitor native vegetation and weed densities.
