Report on  
Preliminary Geotechnical and Salinity Assessment

Proposed Rezoning  
Sub Precinct 5, South Creek West, NSW

Prepared for  
Boyuan Bringelly Pty Ltd

Project 92225.02  
December 2022

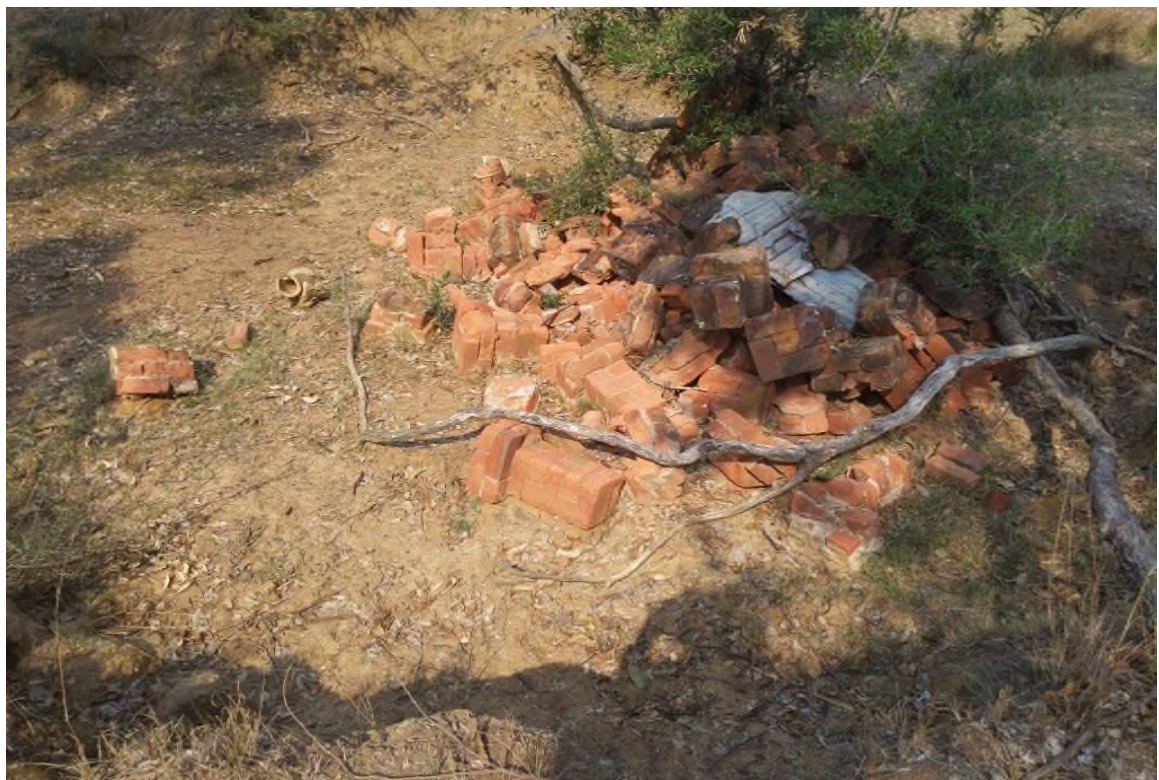
Photo 4 - Observed Fly Tipping

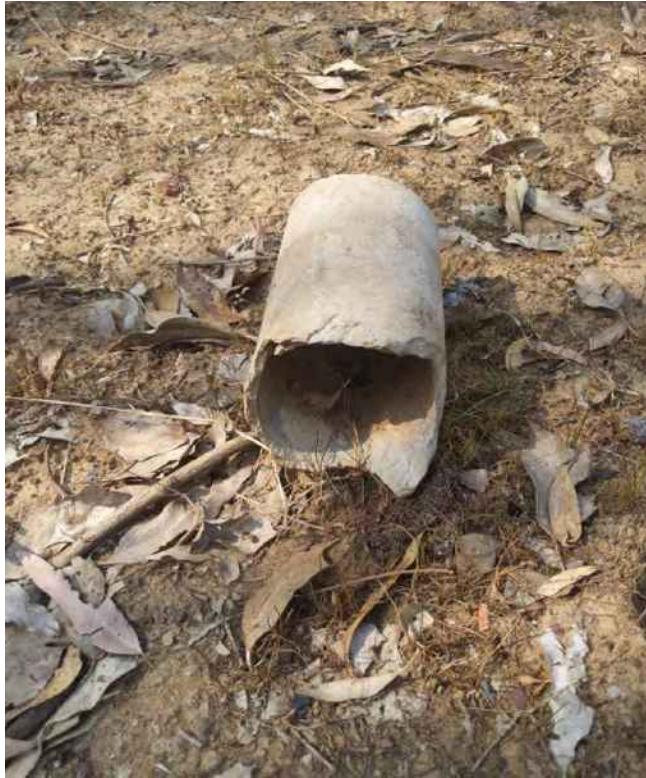
Photo 5 - Potential ACM Pipe
