Report on
Salinity Investigation and Salinity Management Plan

Proposed Rezoning
Sub Precinct 5, South Creek West, NSW

Prepared for
Boyuan Bringelly Pty Ltd

Project 92225.05
March 2023

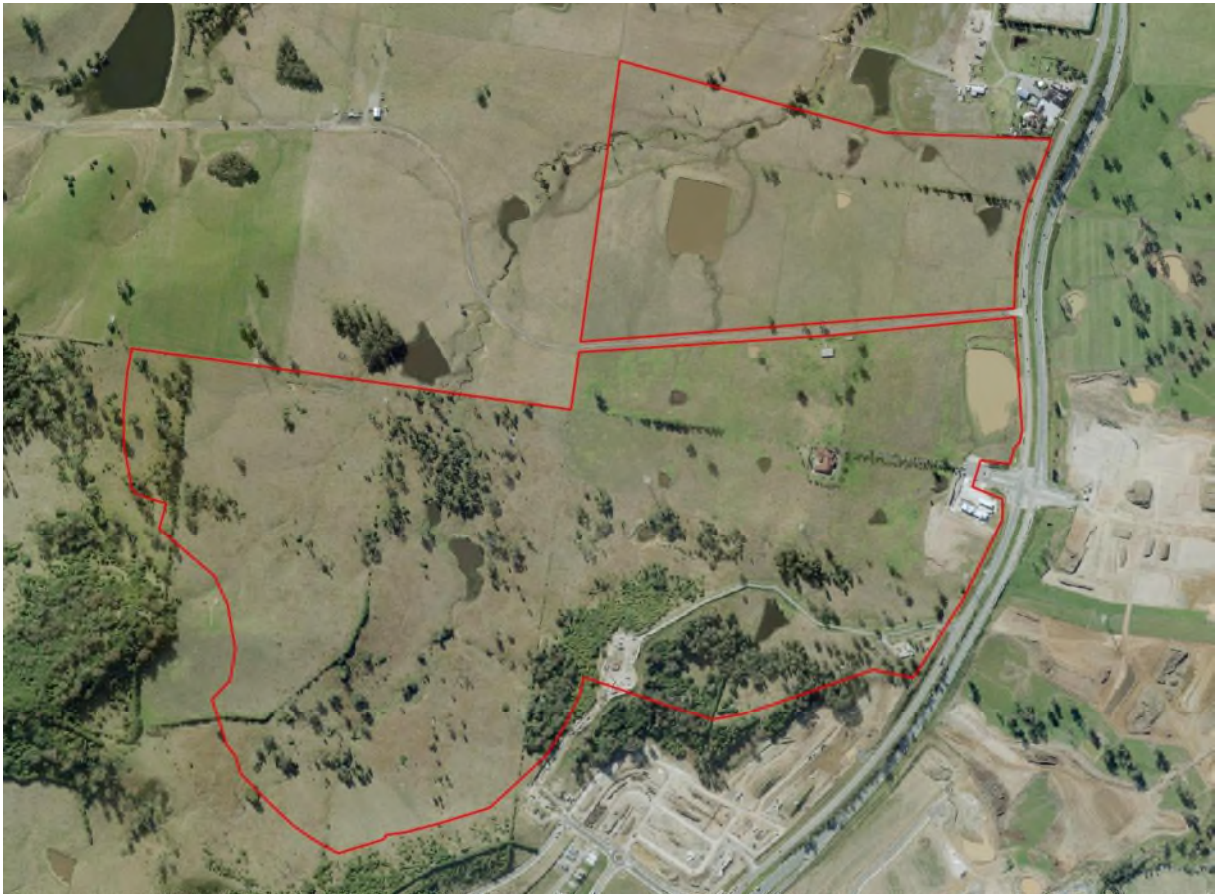
Figure 1: Site Location

The site, incorporating Lots 2 and 4 in DP1216380, Lot 4 in DP1273487, and Lot 500 in DP1231858, is an irregular, roughly 'L'-shaped site, with maximum plan dimensions 1.27 km long (approximately parallel to The Northern Road) by 1.77 km wide (approximately east-west), and a combined area of about 169 hectares. The street address for the northern limit of the site is currently 670 The Northern Road, Cobbitty. The site is bounded to the north, south and west by rural residential and agricultural land, to the south east by a newly constructed residential development and to the east by The Northern Road followed by a newly constructed residential development.

The site boundary is shown on Figure 1.

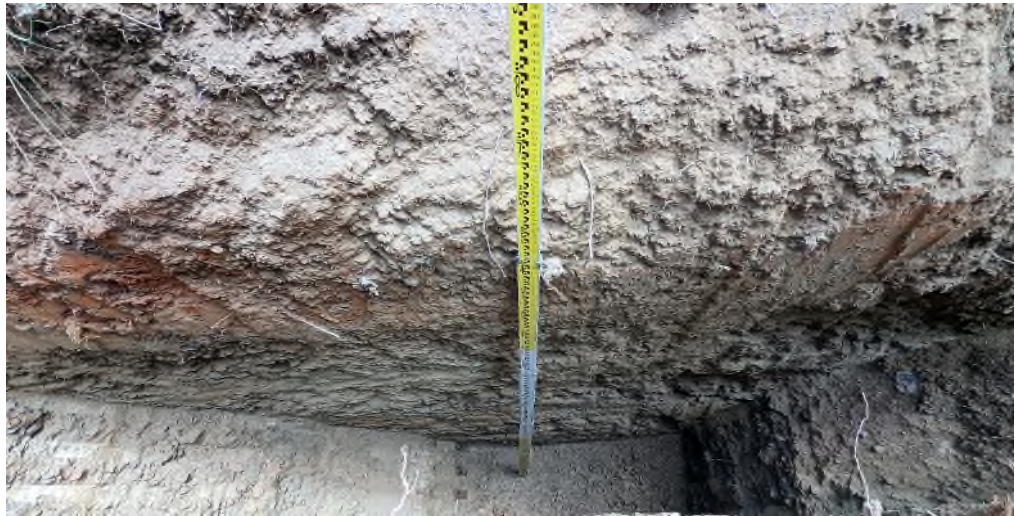
Photo 1 - View of side of Test Pit 301

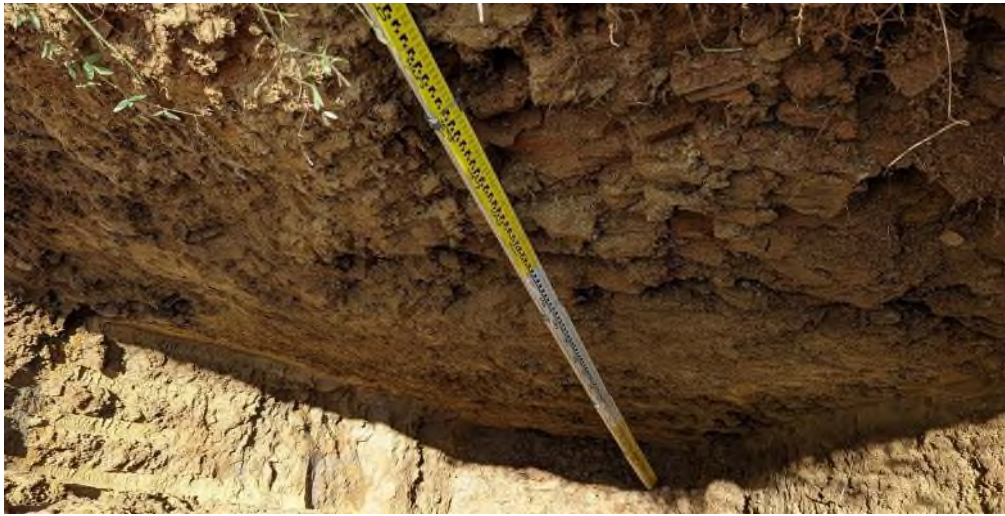
Photo 3 - View of side of Test Pit 302

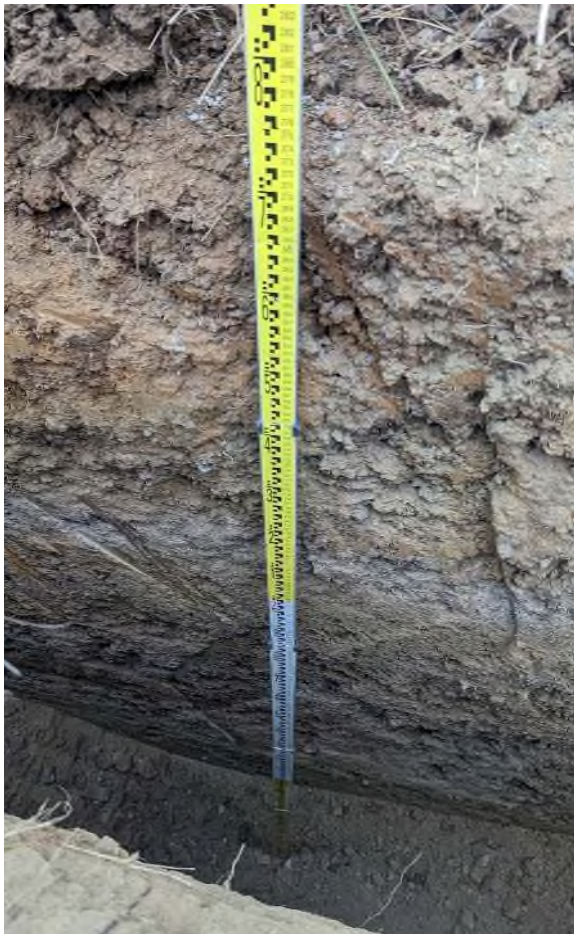
Photo 4 - View of side of Test Pit 303

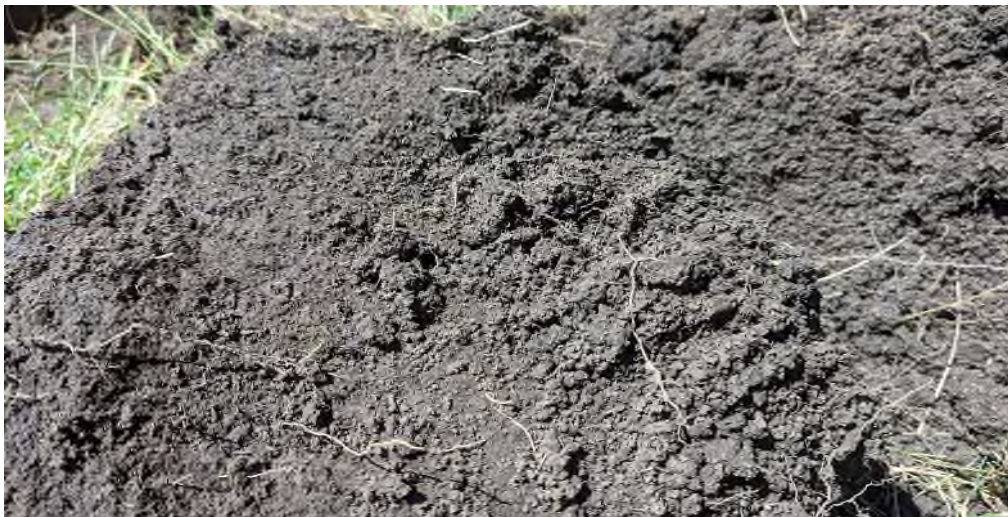
Photo 5 - View of inferred colluvial spoil from Test Pit 303

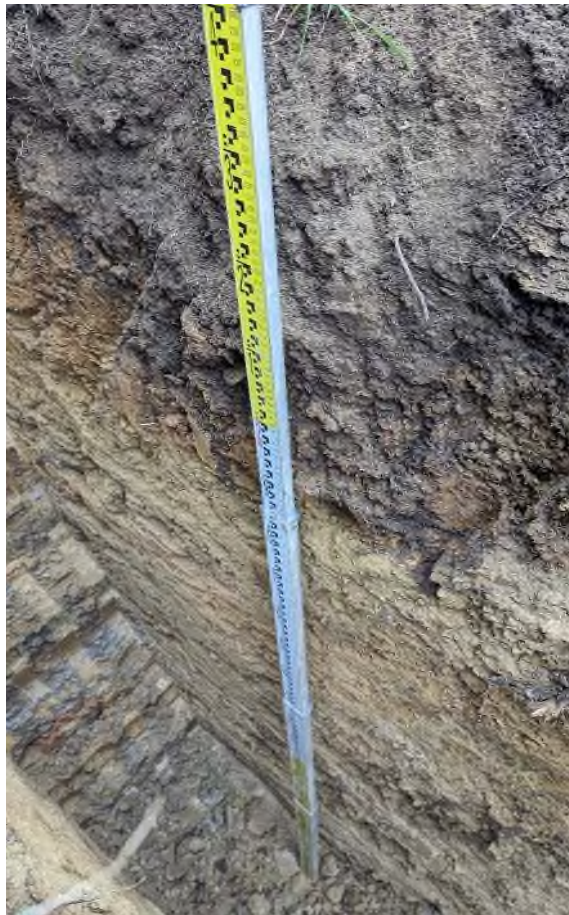
Photo 7 - View of side of Test Pit 304

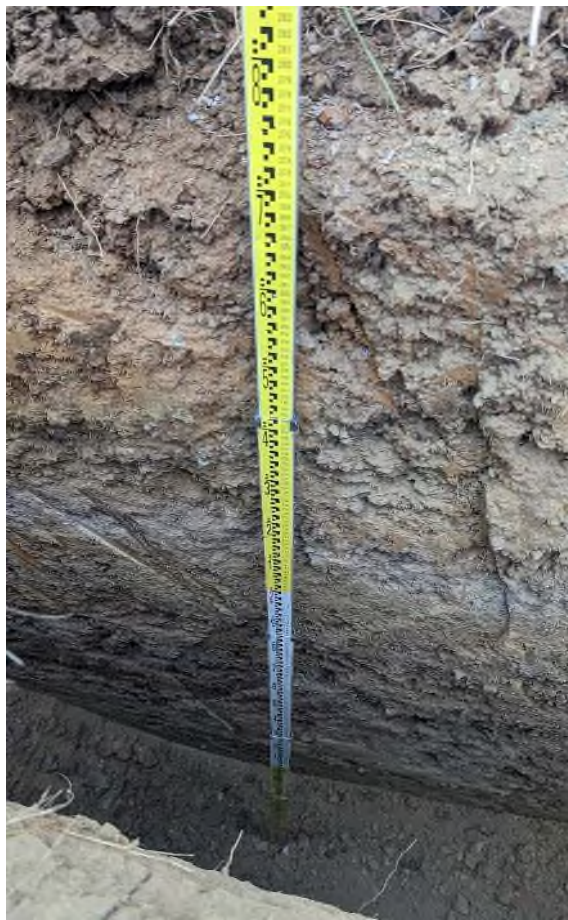
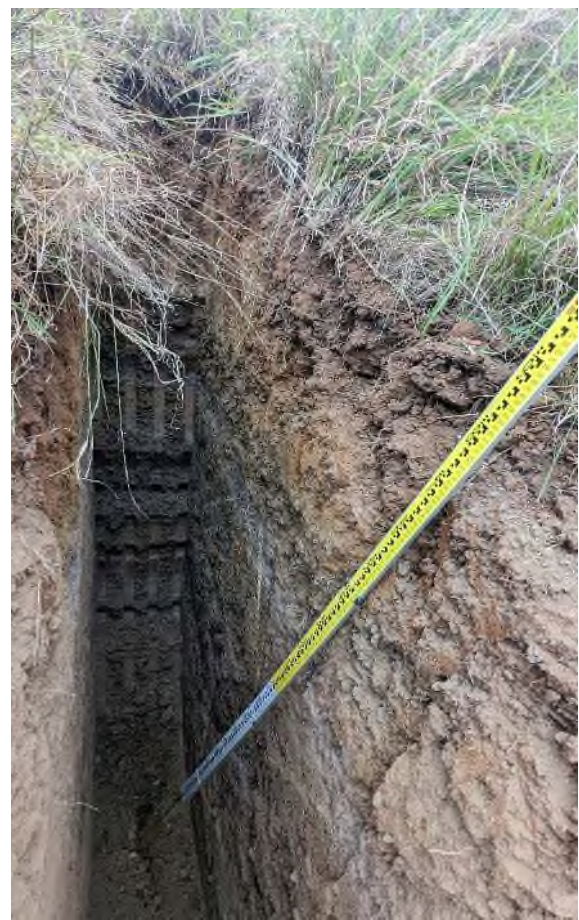
Photographs 8 and 9 - View of side and end of Test Pit 305

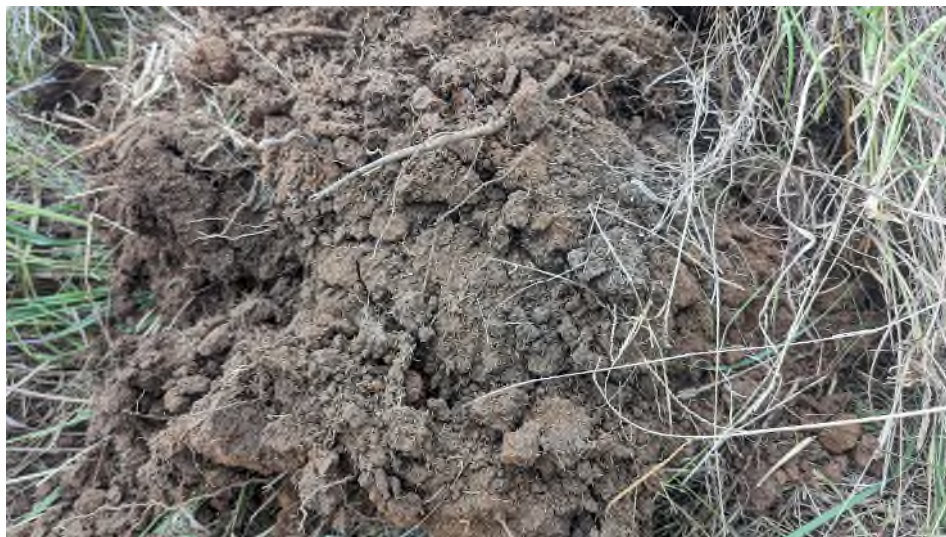
Photo 10 - View of inferred colluvial spoil from Test Pit 305

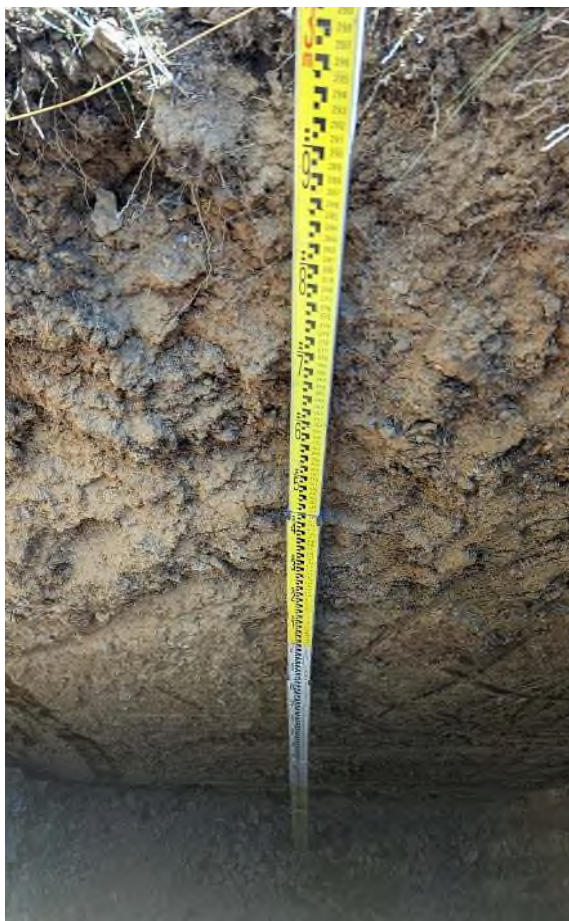
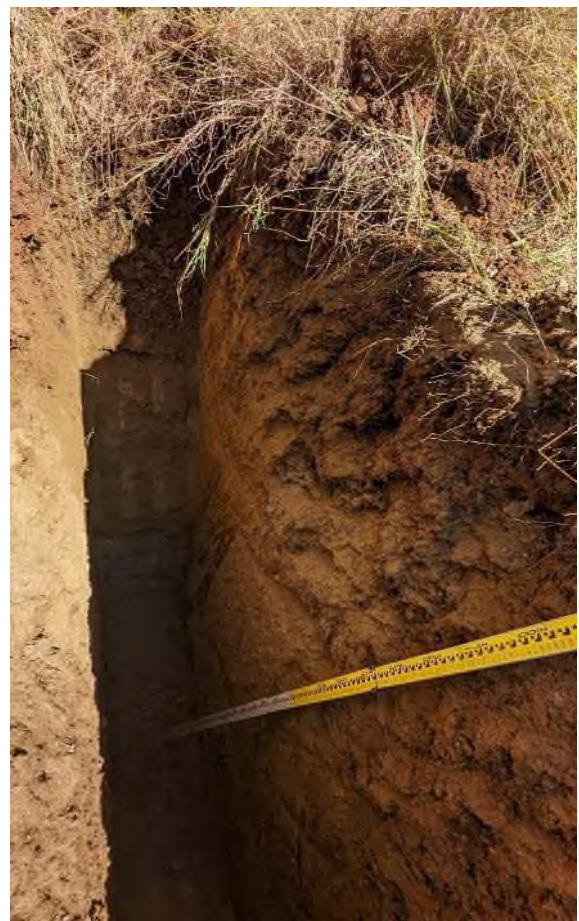
Photographs 16 and 17 - View of side and end of Test Pit 309

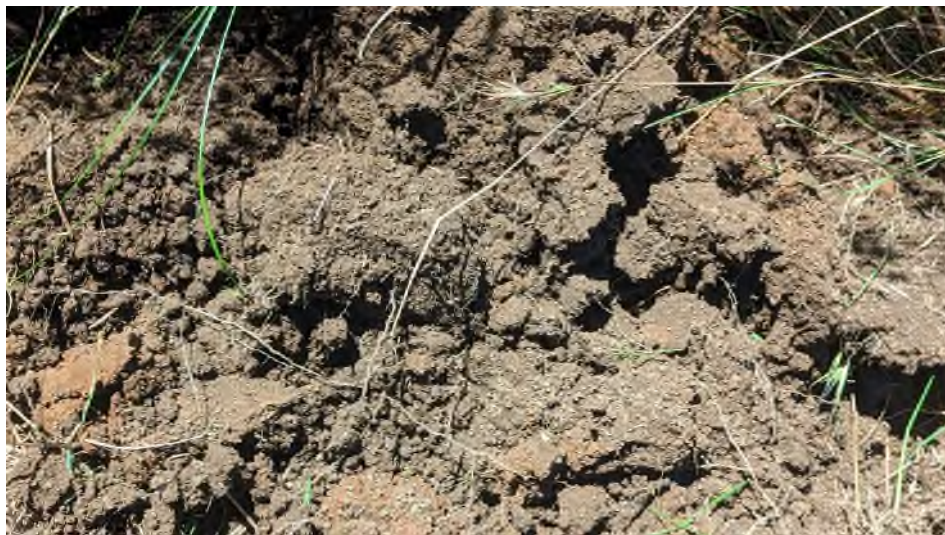
Photo 18 - inferred colluvial spoil from Test Pit 309

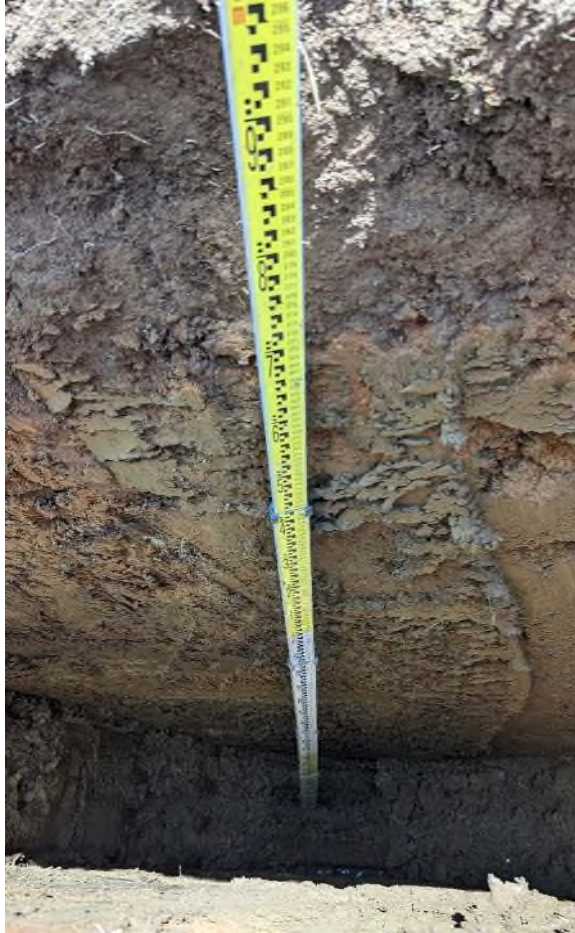
Photo 30 - View of side of Test Pit 317

Free groundwater was observed within two of the test pits on the day of site works (prior to backfilling), at test locations 317 and 319, which were positioned in the lower-lying areas of the valley, adjacent to the meandering creek. In both test pits the groundwater was observed as slow seepage inflow from the gravelly clay (extremely weathered shale), at depths in the range 2.5-2.6 m. The soil moisture content was assessed (in the field) as being greater than the plastic limit at these two test locations, whilst intervals of clay soil at or just below the soil's plastic limit were observed within the upper 0.5 - 1 m of most test pits.

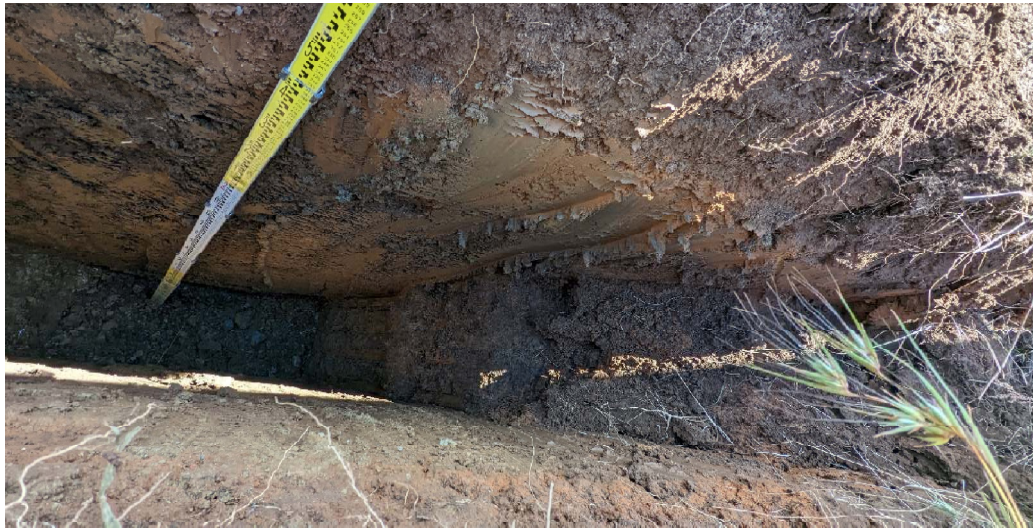
Photo 33 - View of side and end of Test Pit 319 (oblique view)
