Geotechnical and Acid Sulfate Soil Assessment

Proposed Rezoning at 196 Old Main Road, 263, 269, 271, 273, 293 and 321 Gan Gan Road, Anna Bay, NSW

Final Report

P2208888JR07V01.docx December 2024 Prepared for AB Rise Pty Ltd C/- DMPS

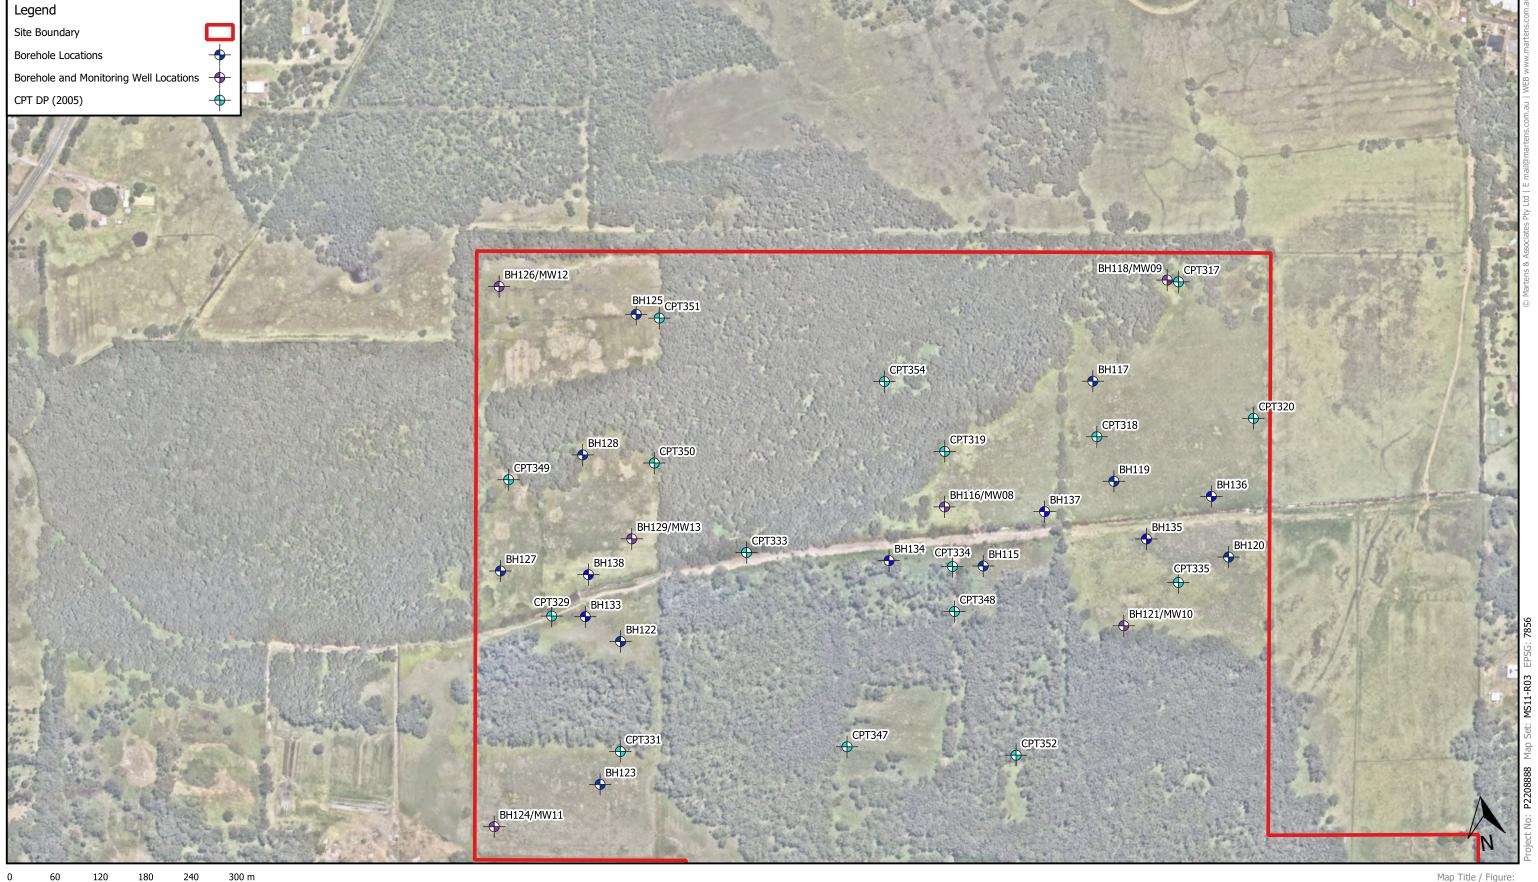
Geotechnical Investigation Plan - 1

Encountered conditions are described in more detail on the borehole logs in Appendix C. Associated explanatory notes are provided in Appendix J. For DCP and CPT test results refer to Appendix D and Appendix E, respectively. Geotechnical investigation locations are shown on Map 07 to Map 10, Attachment A.

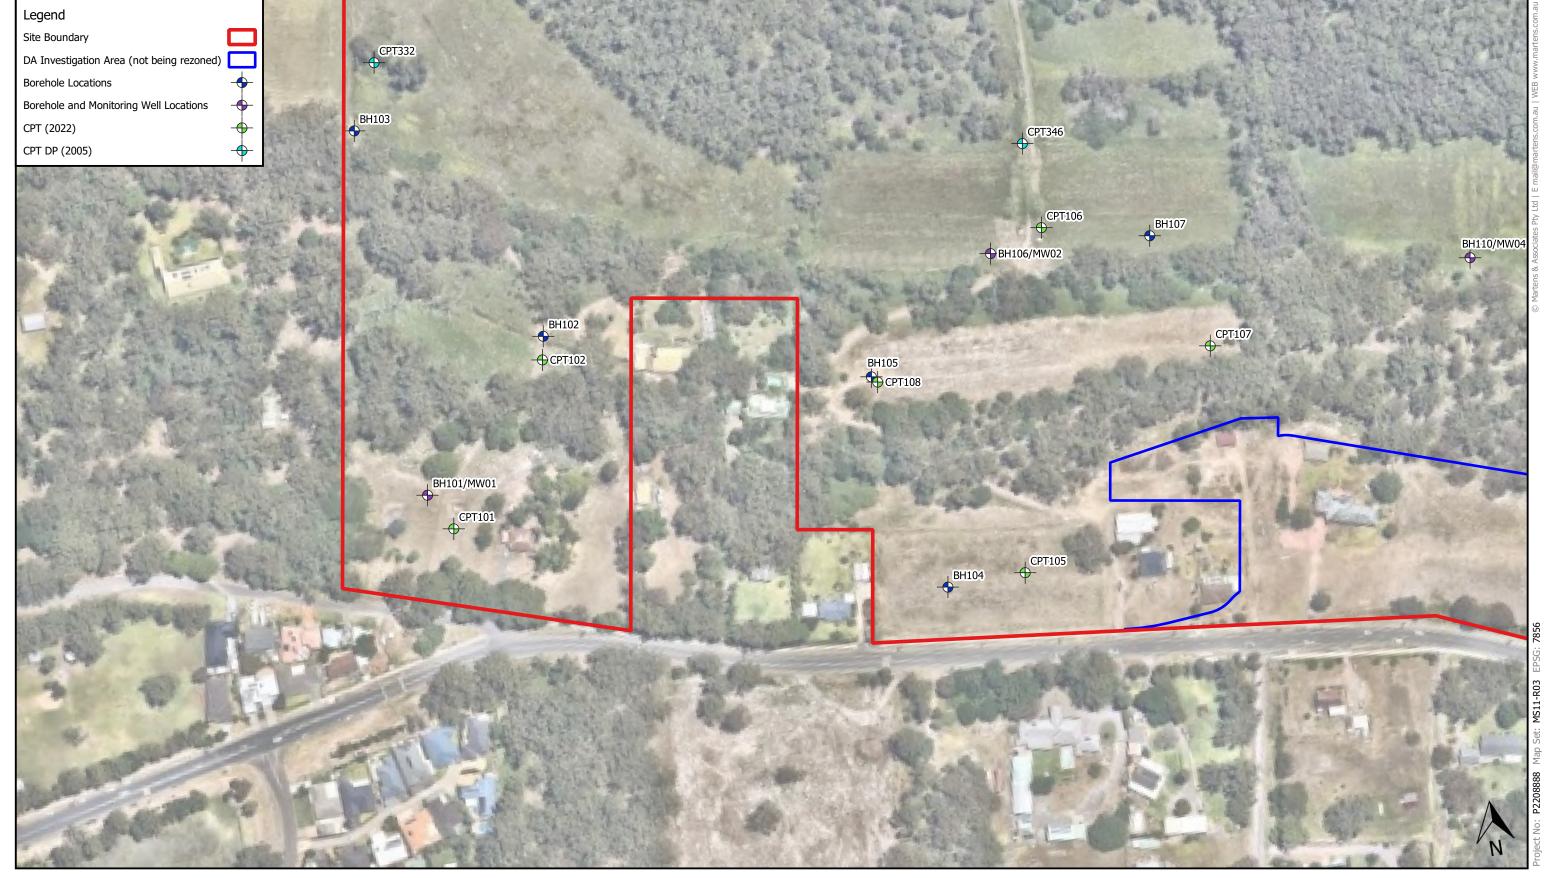
Map 09

Geotechnical Investigation Plan - 3

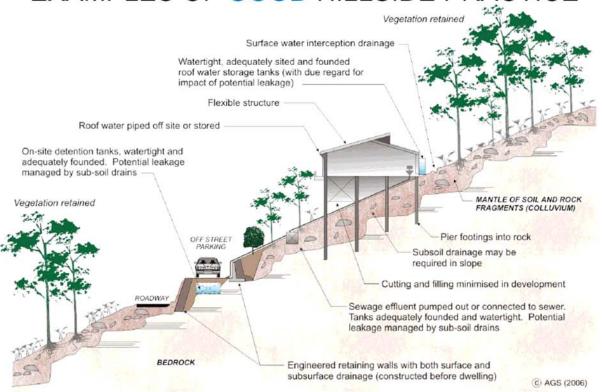
EXAMPLES OF GOOD HILLSIDE PRACTICE

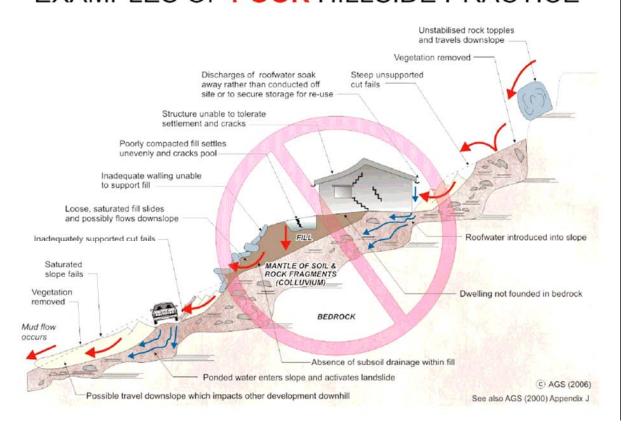
EXAMPLES OF **POOR** HILLSIDE PRACTICE
