Report on  
Geotechnical Investigation

Proposed Low-Density Residential Development  
146 Vimiera Road, Marsfield

Prepared for  
Winston Langley Pty Limited

Project 213200.00  
March 2022

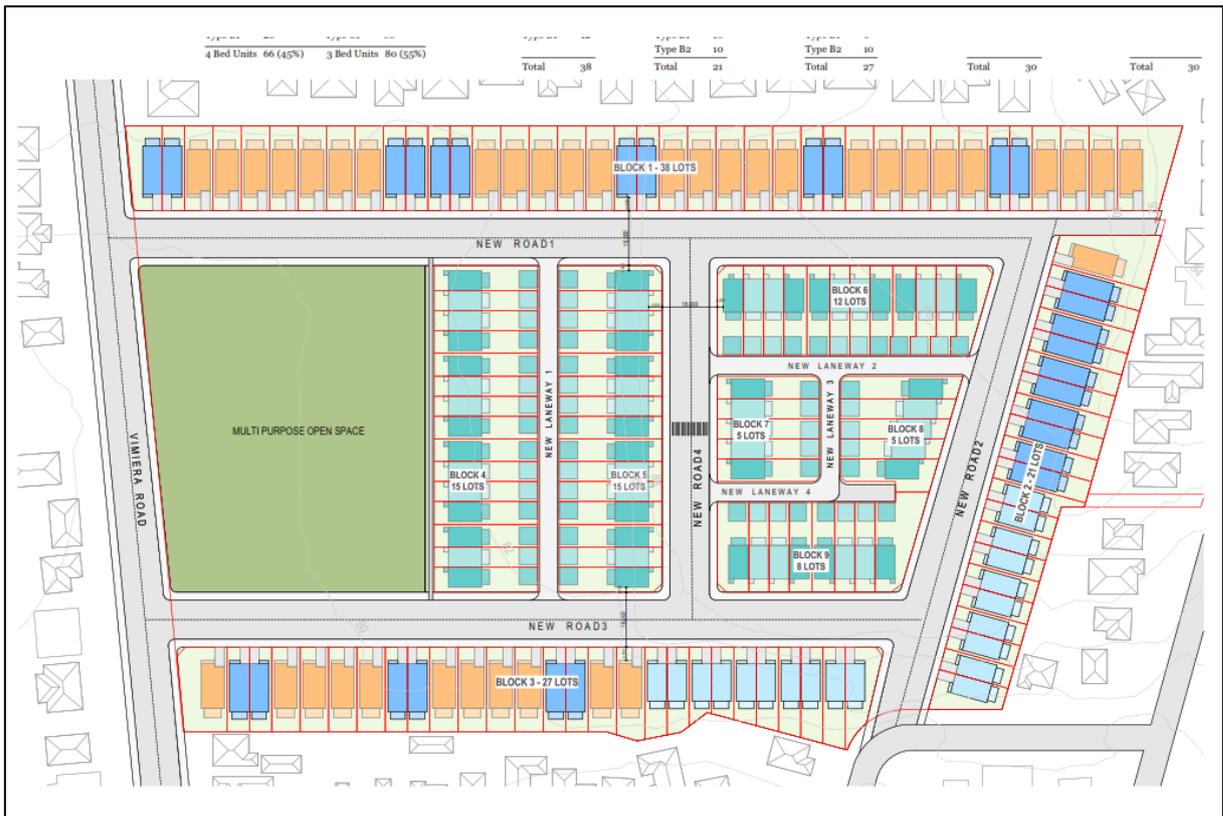
Figure 1: Master Plan of Proposed Development

It is understood that the proposed development includes about 136 two-storey residential buildings with no basement levels. Internal access roads, multipurpose sport and leisure courts, a public park and landscaping are also proposed. It is also understood that the development will generally follow the existing ground levels, and excavations for bulk earthworks are anticipated to be about 0.5 m to 1 m deep. Localised, detailed excavations for in-ground services, stormwater tanks, lift pits and building footings may extend to greater depths.

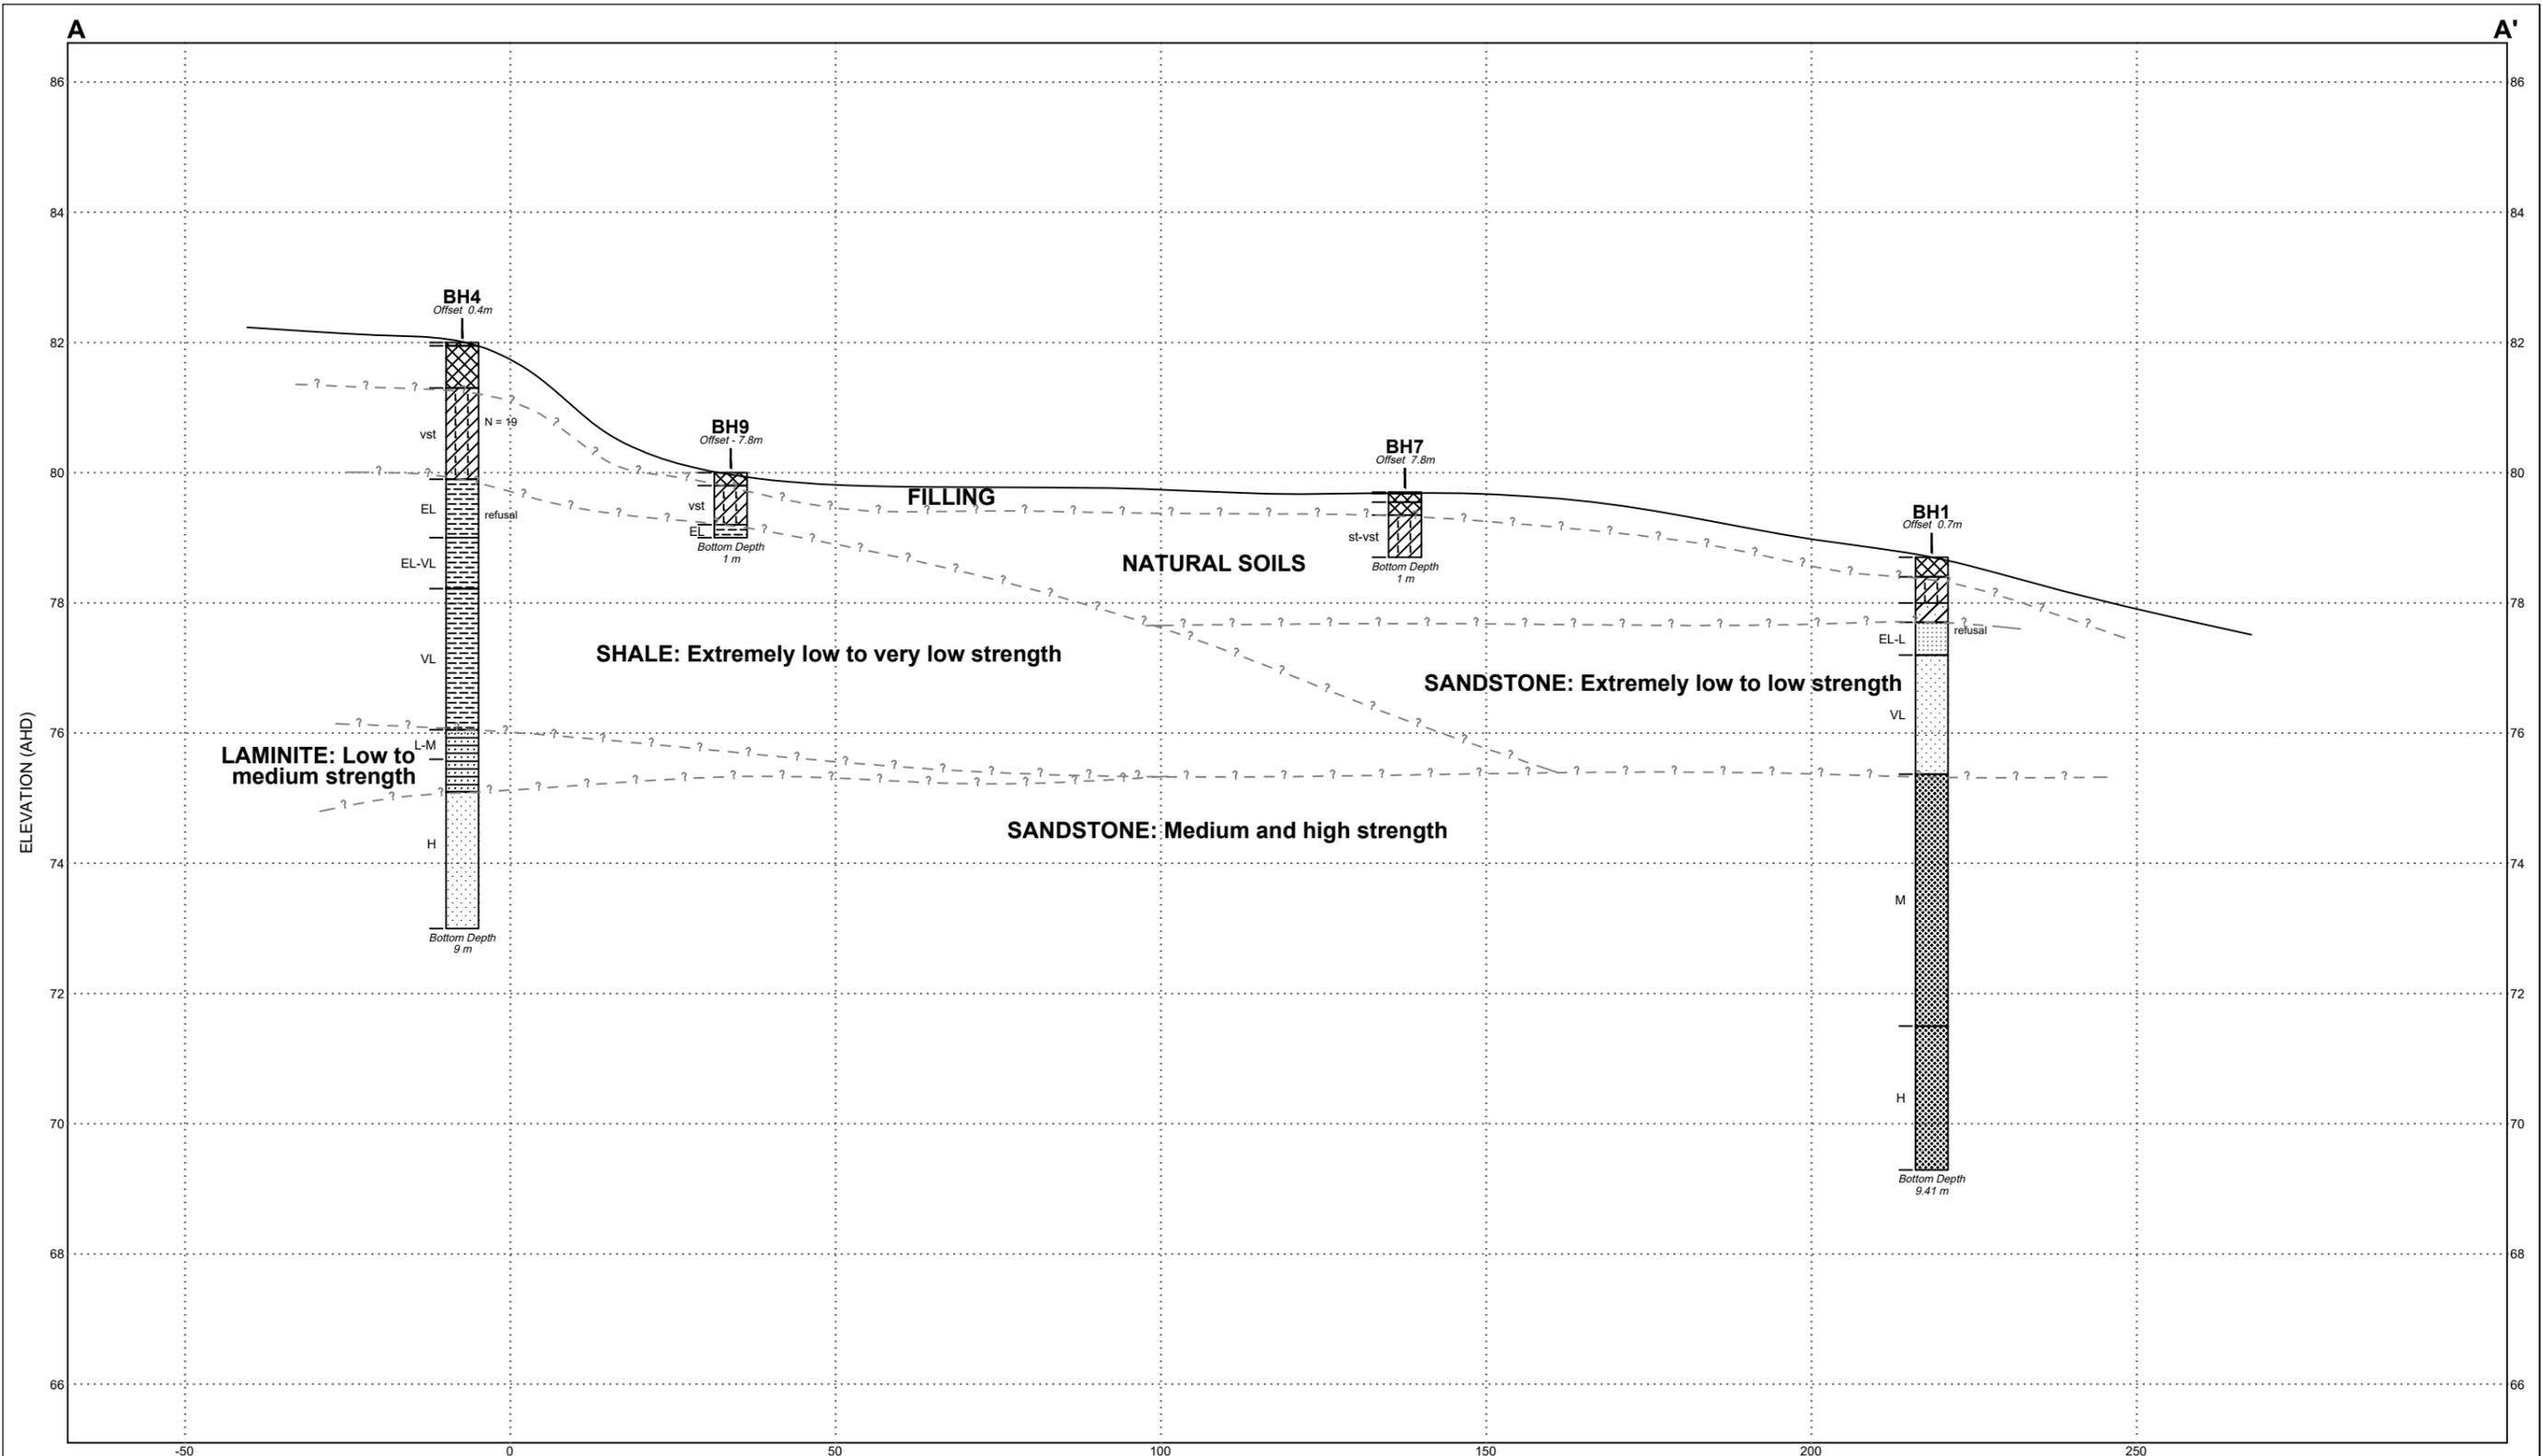
<b>Douglas Partners</b> Geotechnics   Environment   Groundwater	CLIENT: Winston Langley Pty Limited		TITLE: <b>Interpreted Geotechnical Cross Section A-A'</b> <b>Proposed Low-Density Residential Development</b> <b>146 Vimiera Road, MARSFIELD</b>	PROJECT No: 213200.00
	OFFICE: Sydney	DRAWN BY: MG		DRAWING No: 2
	SCALE: 1:1000 (H) 1:100 (V) @ A3	DATE: 04.03.2022		REVISION: 0

Boreholes BH3 to BH5, BH9 to BH11 and BH14 are located at higher levels within the eastern part of the site, and encountered shale and/or laminite bedrock overlying sandstone. Boreholes BH1 and BH2 are located on the lower side of the site and encountered sandstone bedrock (no shale). The bedrock was predominantly fragmented to slightly fractured with some unbroken sandstone within BH1 and BH4 below depths of 7.2 m and 7.6 m, respectively.

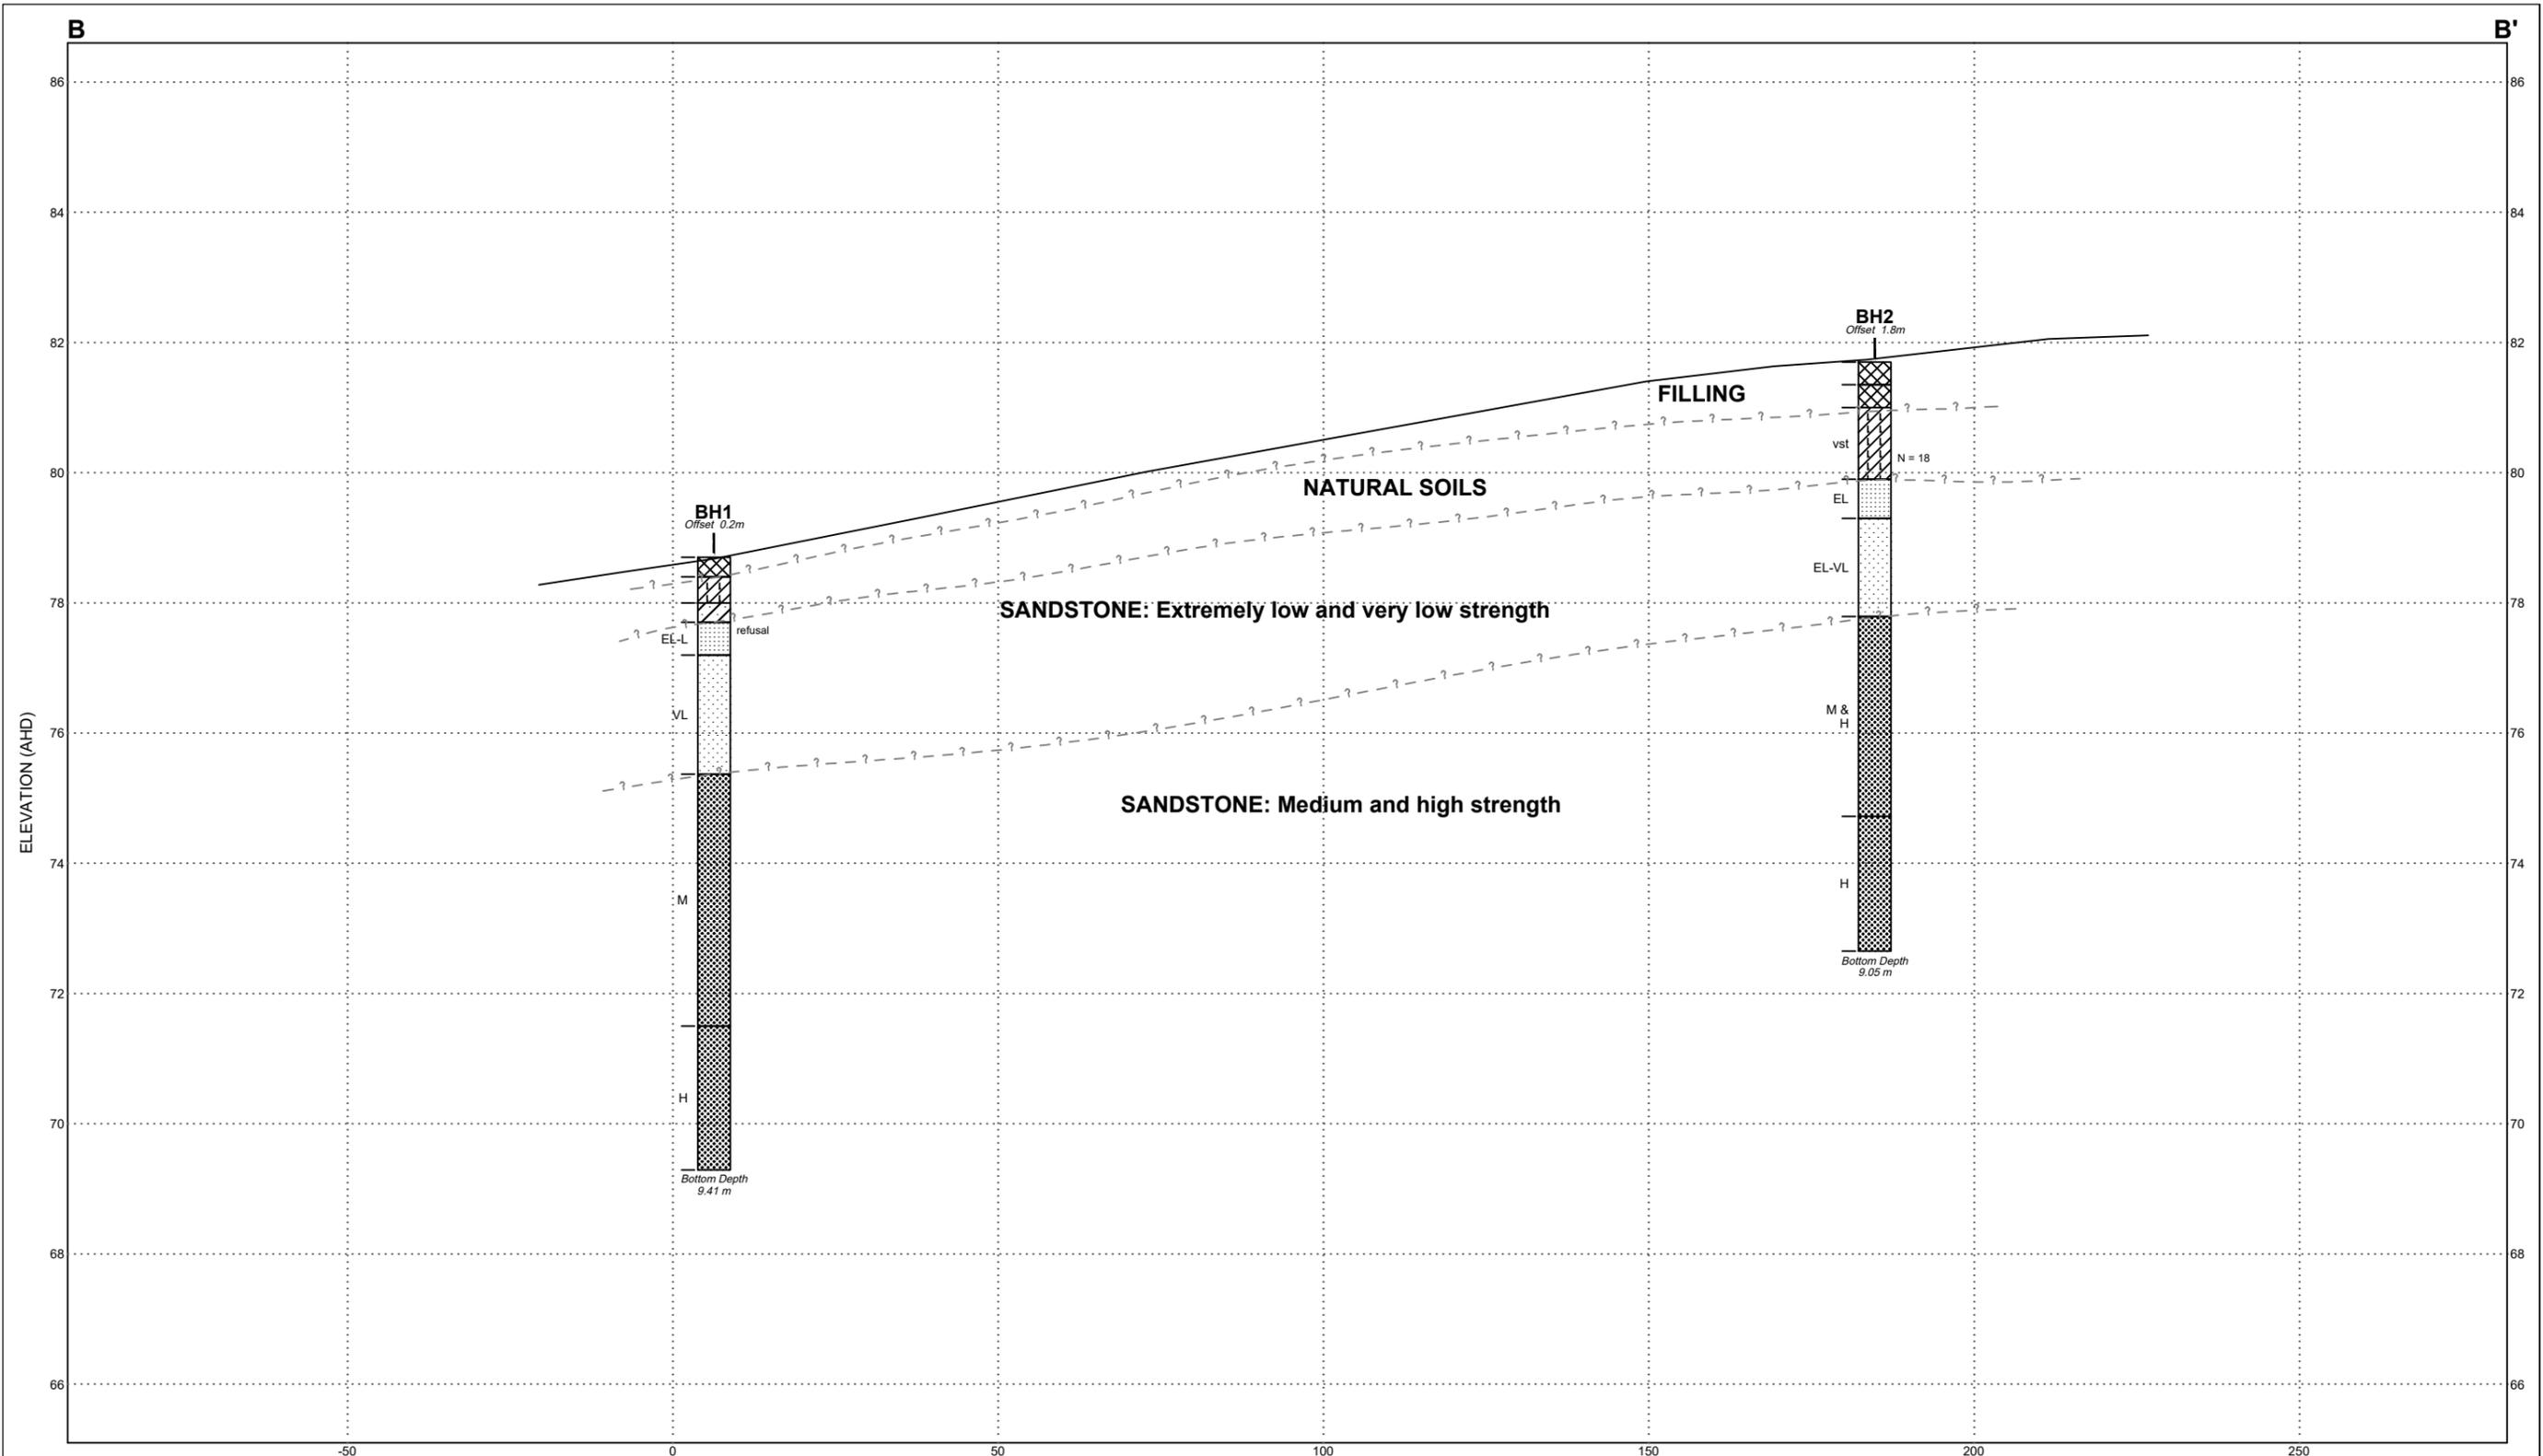
PROJECT No:	213200.00
DRAWING No:	3
REVISION:	0

**TITLE: Interpreted Geotechnical Cross Section B-B'**  
**Proposed Low-Density Residential Development**  
**146 Vimiera Road, MARSFIELD**

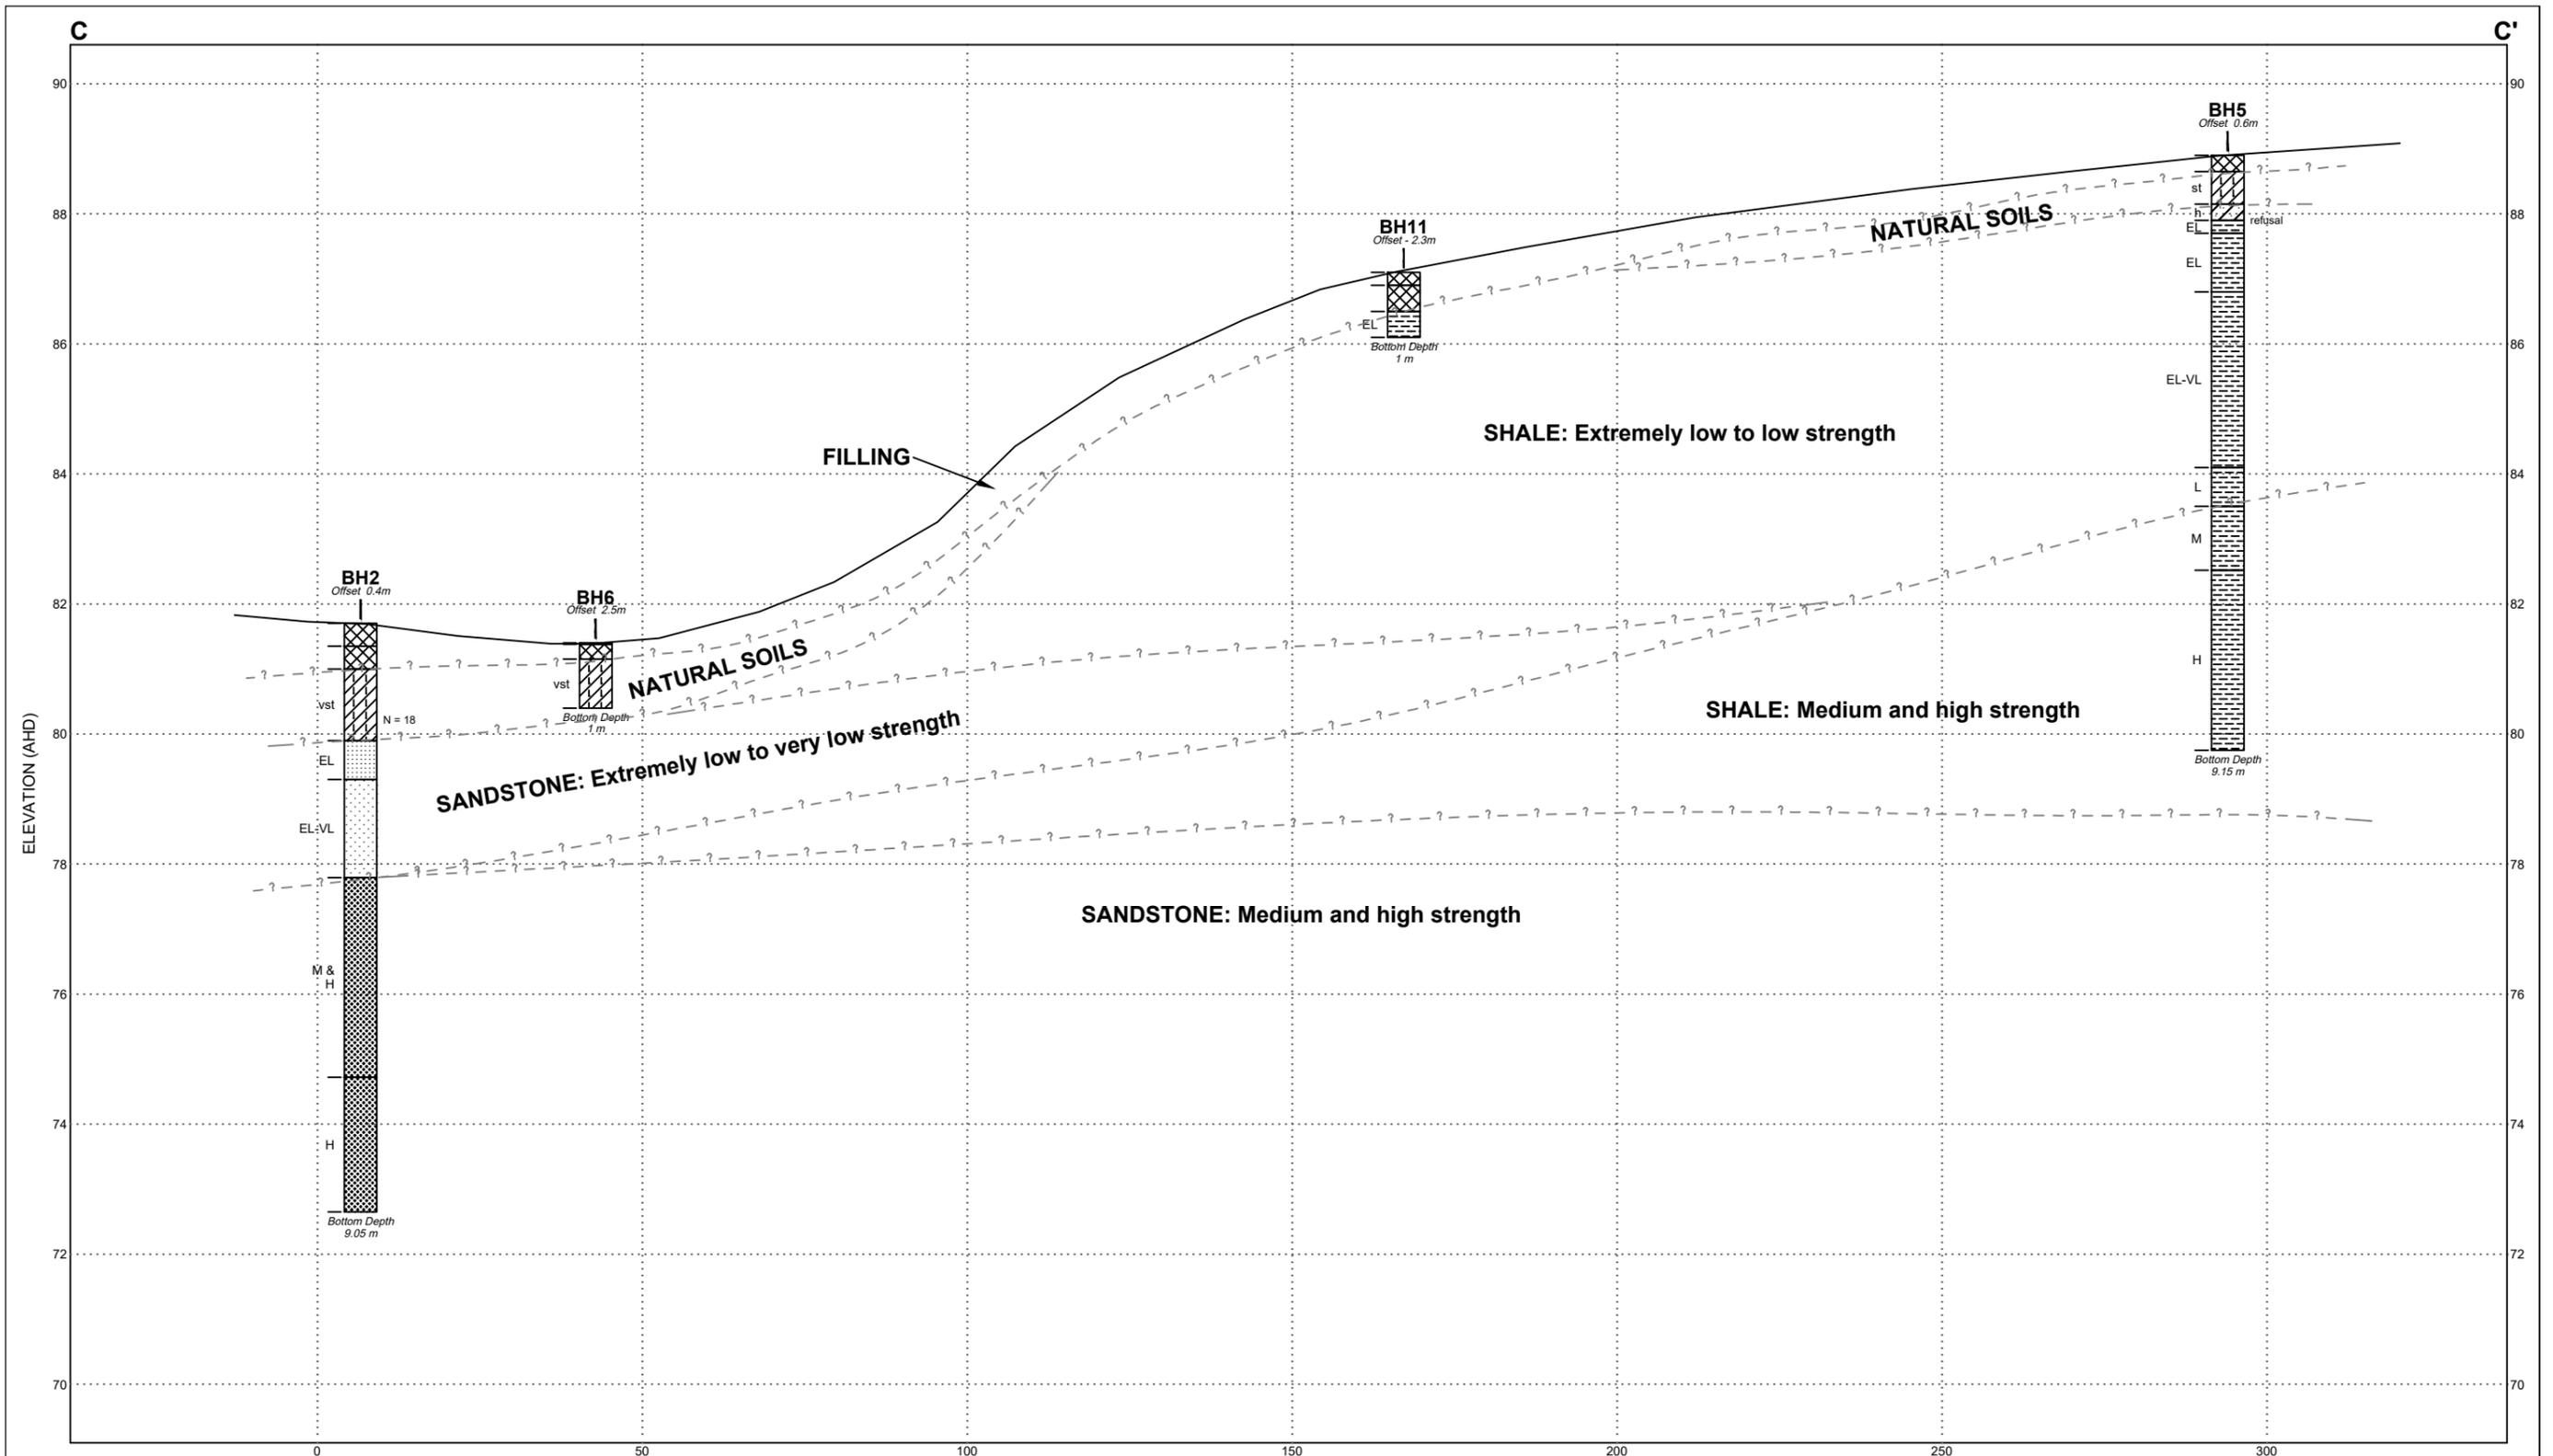
PROJECT No: 213200.00  
 DRAWING No: 4  
 REVISION: 0

TITLE: **Interpreted Geotechnical Cross Section C-C'**  
**Proposed Low-Density Residential Development**  
**146 Vimiera Road, MARSFIELD**

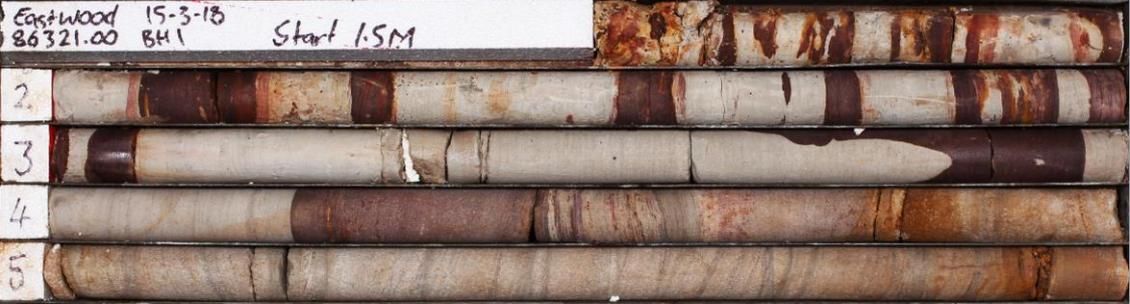
Project No: 86321.00  
BH ID: BM1  
Depth: 1.5 - 6m  
Core Box No.: 1/2

1.5 - 6.0m

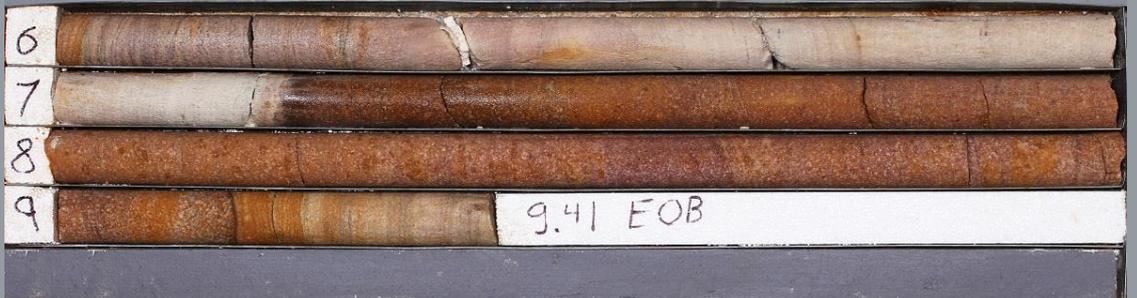
Project No: 86321.00  
BH ID: BM1  
Depth: 6 - 9.41  
Core Box No.: 2/2

6.0 - 9.41m

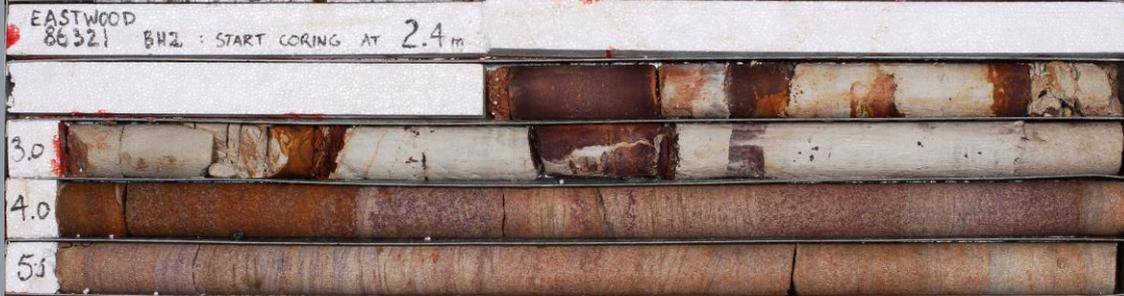
Project No: 81321.00  
BH ID: BH2  
Depth: 2.40 - 6.00 m  
Core Box No.: 1/2

2.4 - 6.0m

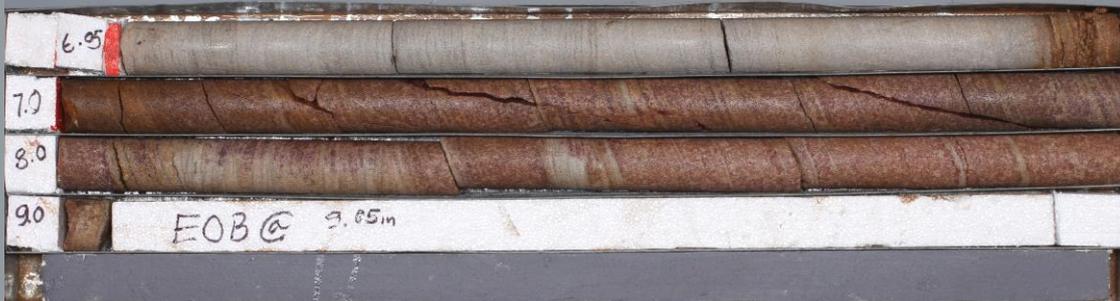
Project No: 81321.00  
BH ID: BH2  
Depth: 6.05 - 9.05  
Core Box No.: 2/2

6.0 - 9.05m

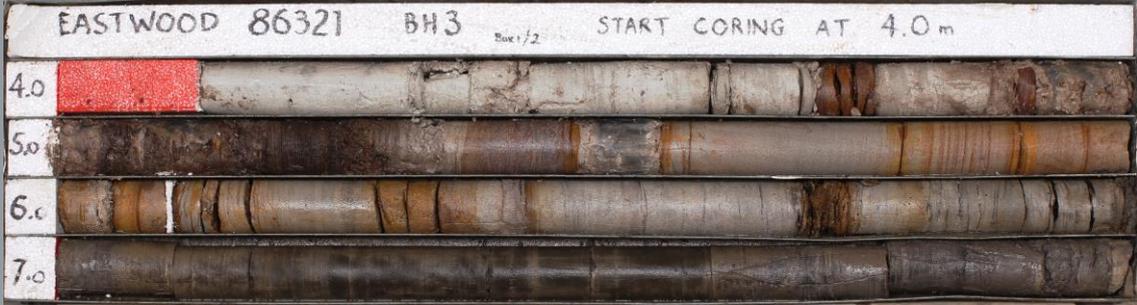
Project No: 86321.00  
BH ID: BH3  
Depth: 4m - 8m  
Core Box No.: 1/2

4.0 - 8.0m

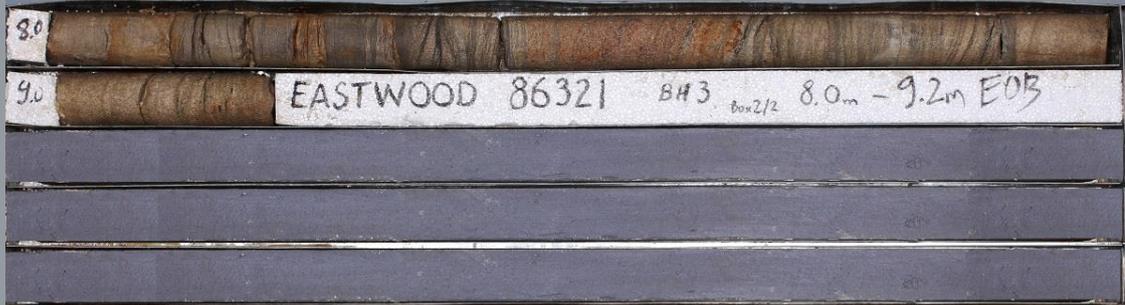
Project No: 86321.00  
BH ID: BH3  
Depth: 8.0 - 9.2m  
Core Box No.: 2/2

8.0 - 9.2m

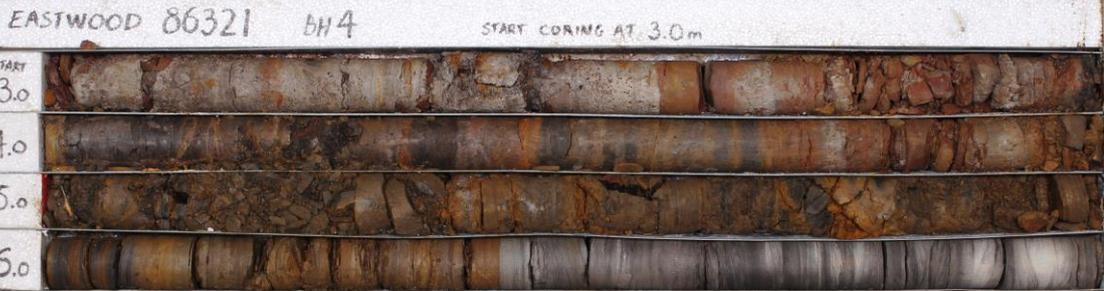
Project No: 86321.00  
BH ID: BH 4  
Depth: 3.00 - 7.00m  
Core Box No.: 1

3.0 - 7.0m

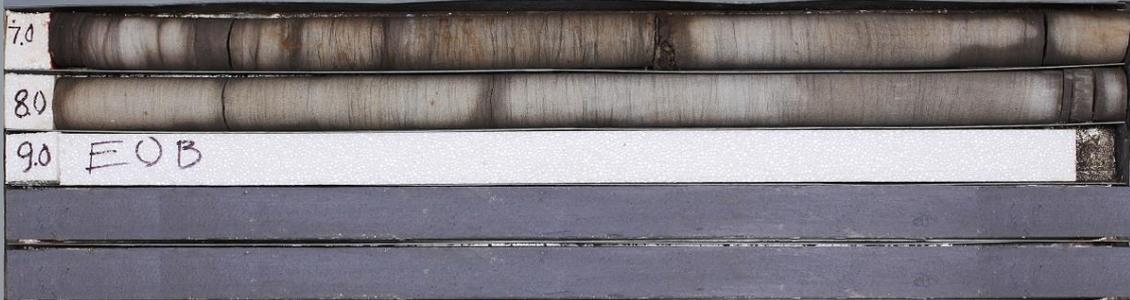
Project No: 86321.00  
BH ID: BH 4  
Depth: 7m - 9m  
Core Box No.: 2

8.0 - 9.0m

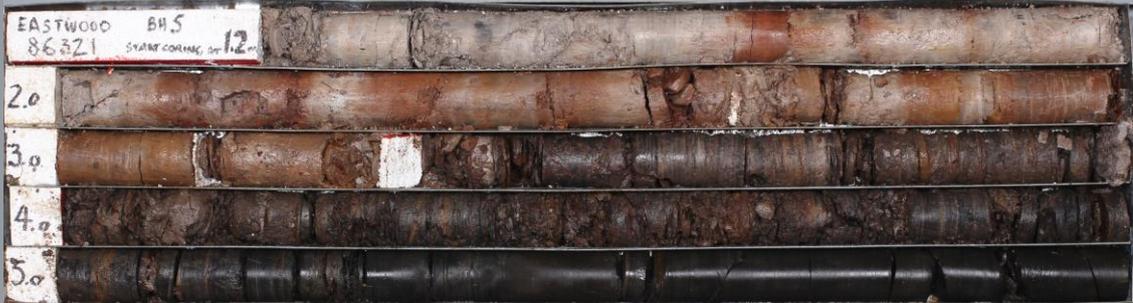
Project No: 86321.00  
BH ID: 8H5  
Depth: 1.2M - 6M  
Core Box No.: 1/2

1.2 - 6.0m

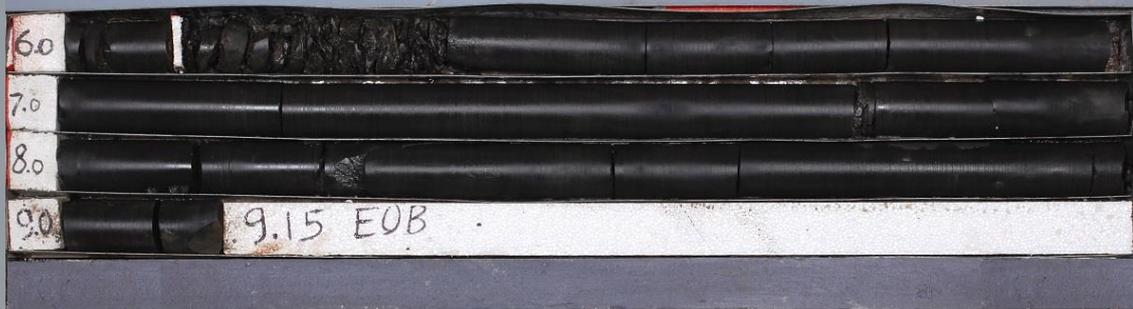
Project No: 86321.00  
BH ID: 8H5  
Depth: 6 - 9.15M  
Core Box No.: 2/2

6.0 - 9.15m

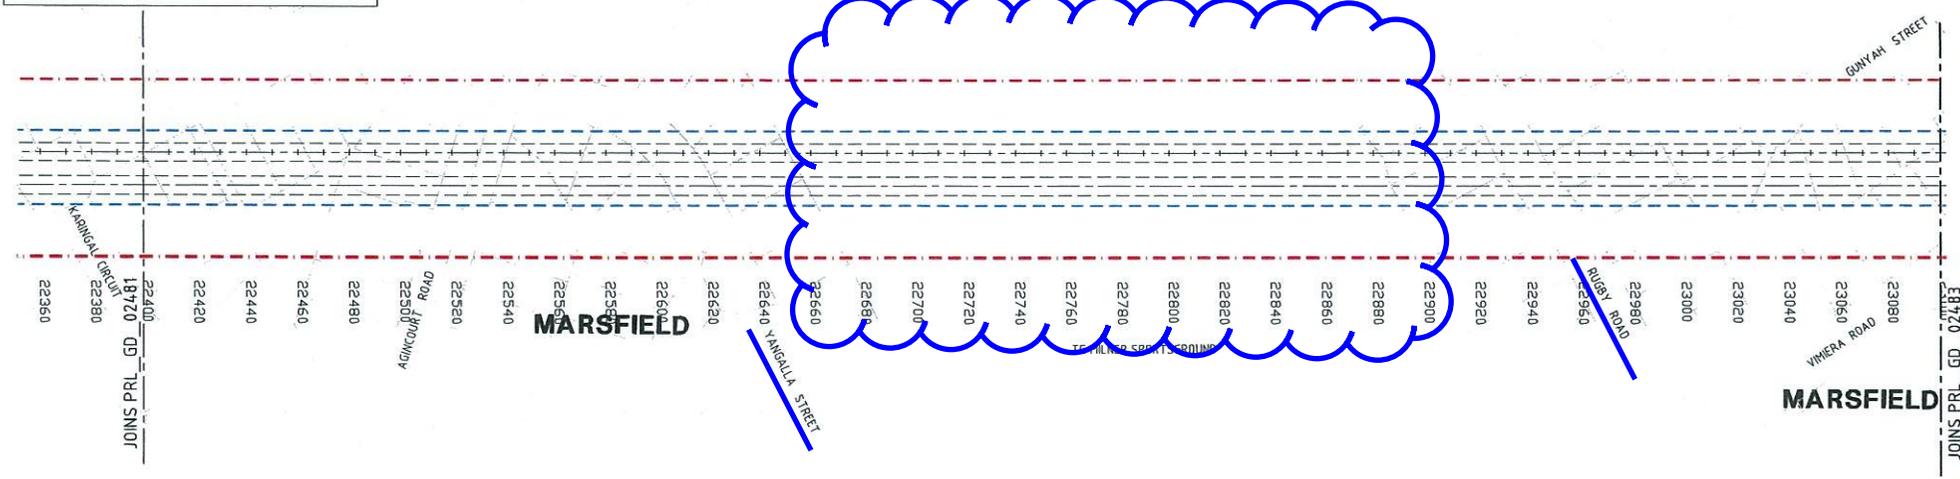
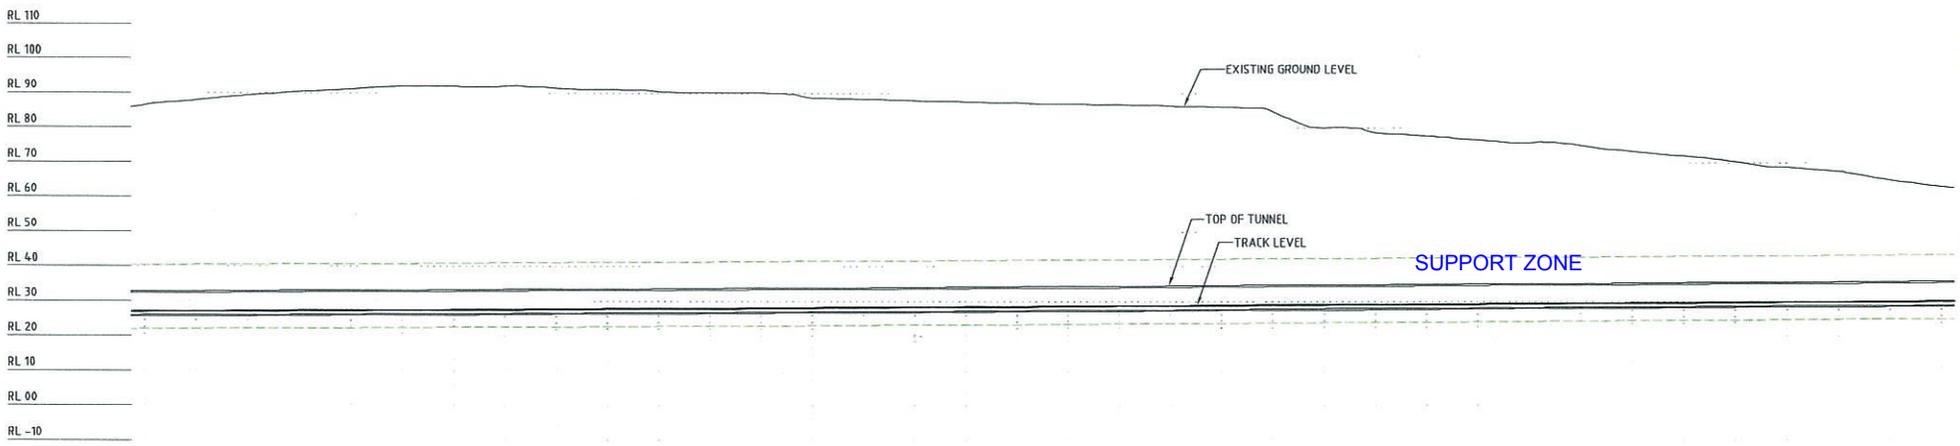
DRAWING NO: PRL\_GD\_02482

LONGITUDINAL SECTION DOWN TRACK DESIGN CENTRELINE

The TfNSW Standard (2016) indicates that shallow footings located above the second reserve should have a maximum footing load of 500 kPa. For piles located within the second reserve, their effects on the underground infrastructure including the effects of construction method should be assessed. As a guide, it is suggested that footings above the tunnel should be founded at least 1.5 times the tunnel diameter above the tunnel crown, which should not be an issue given the depth of the tunnels. Depending on the final structural loads, detailed numerical modelling may be required during the detailed design stage and footings would require review and approval by TfNSW.

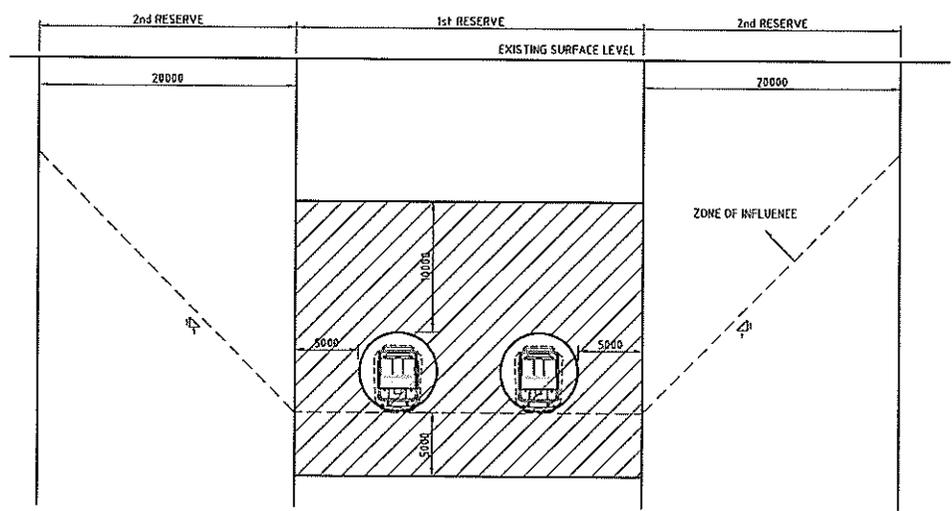
RAILCORP EDMS ID --	
ECRL DEVELOPMENT GUIDE LINES	
RAIL PROTECTION RESERVES CROSS SECTION RUNNING TUNNELS	
STATUS: FINAL	DRAWING ID: PRL_GD_02600
REV: B
