WATERCOURSE ASSESSMENT REPORT

Planning proposal

**Lots 1 & 2 DP 734561, and Lot 6 DP 734561
Barkers Lodge Road
Oakdale**

**12 March 2024
(REF: 18CR34.2)**

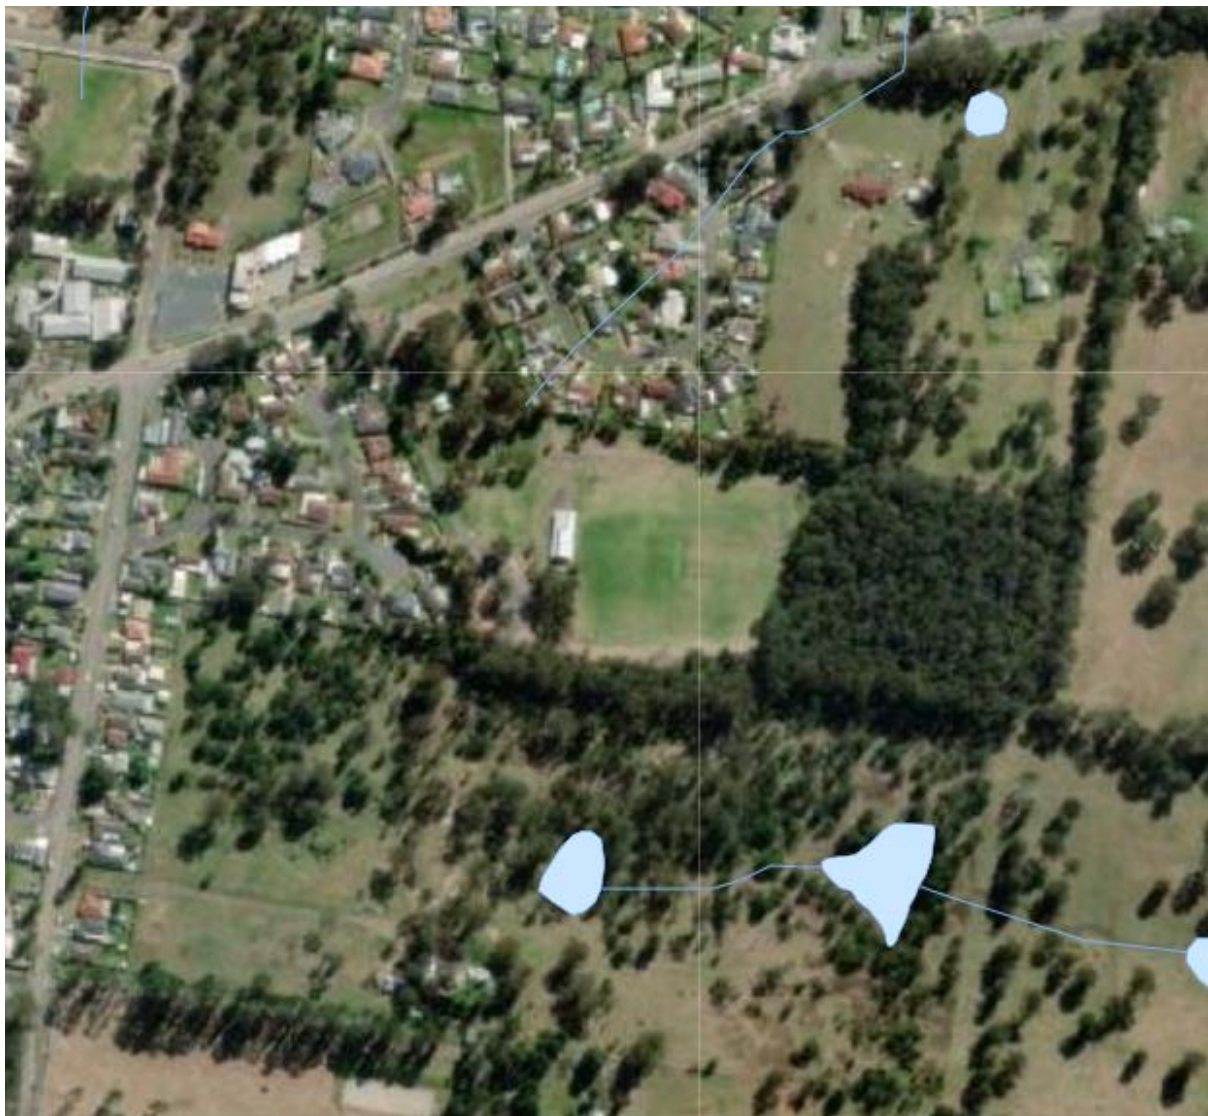
Figure 2-1 – Mapped Watercourses

Electronic aerial photography from *Google Earth Pro*, *Spatial Information Exchange* and *Hydroline* mapping interfaces were viewed to assess the watercourse prior to the site inspection. The *Hydroline* database (Figure 2-1) is viewed as the key legislative map of watercourses for assessment purposes under the *WM Act*.

Based on the desktop assessment, the watercourses looked to have run through both the lots, impacting on the concept subdivision layout. It was determined, however, that the watercourse to the south of the site is a swale as there is no defined watercourse present between the two dams or to the west of the western most dam. The watercourse in the north is defined with pool and riffles evident.

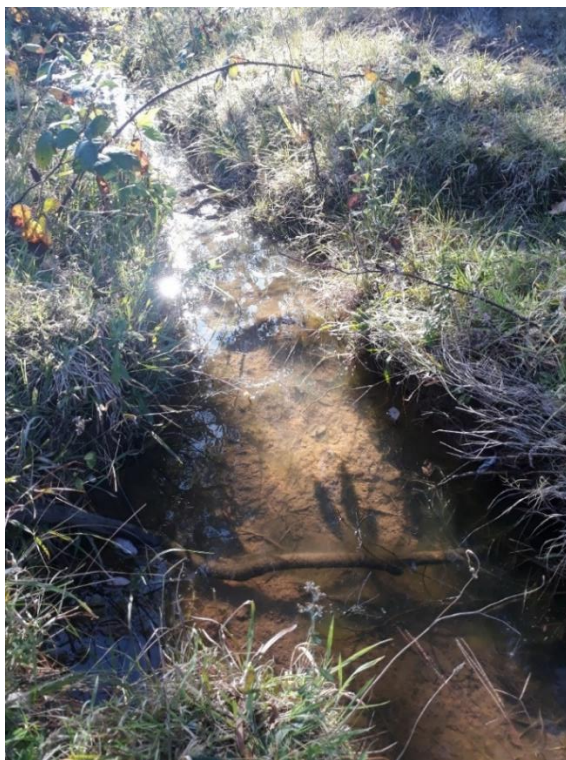
Photo 3-2 – Pool and riffle with deposits and pebble evidence

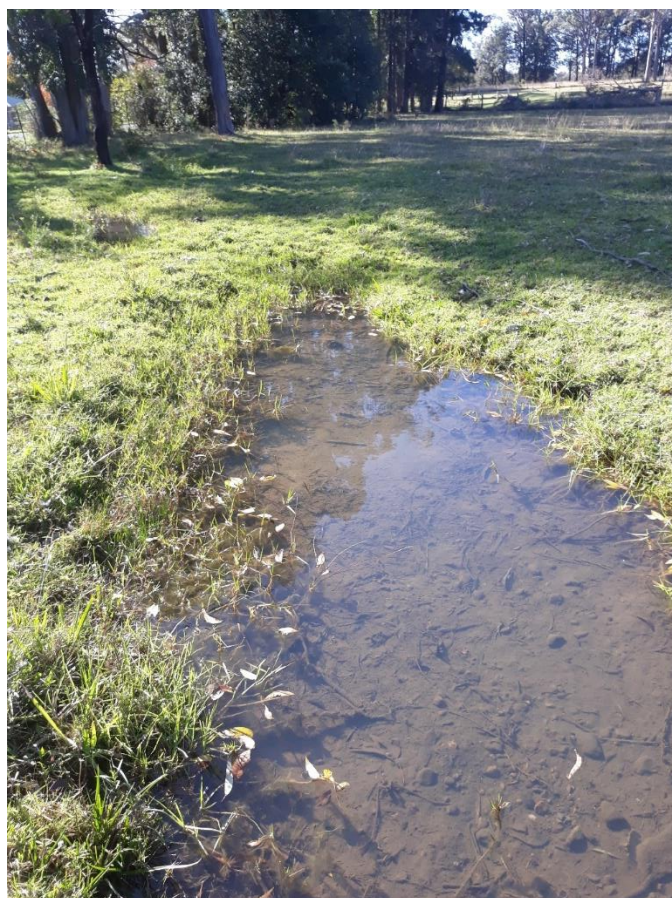
Water course feature	Confirmed or absent	
	Lot 1 and 2 DP 734561	Lot 6 DP 734561
Are there definable channel banks and a channel bed?	Yes	Not observed – presents as a swale
Are there fluvial bedforms e.g. pools, riffles, sediment point bars, etc and if so, what are they?	Yes	Not observed
Is there any evidence for substantial erosion from water flow within the drainage feature?	Yes – Minor, closer to the road	Not observed
Are there any spring lines that may indicate seasonally intermittent or perennial flow?	Not observed	Not observed
Is the catchment large enough to sustain perennial or intermittent groundwater flow?	Intermittent flow with minor seepage	Unlikely
Are there any indicators of prolonged wetness within the drainage feature?	Yes – Pools present, however they are likely temporary	Not observed
If surface flow is present, is it continuous and how extensive across the base of the drainage feature is it? Are there any visible aquatic habitats that might sustain aquatic fauna?	No surface flow was present. Water was pooling - See photo 3-3.	No surface flow

Photo 3-3 – Pooling

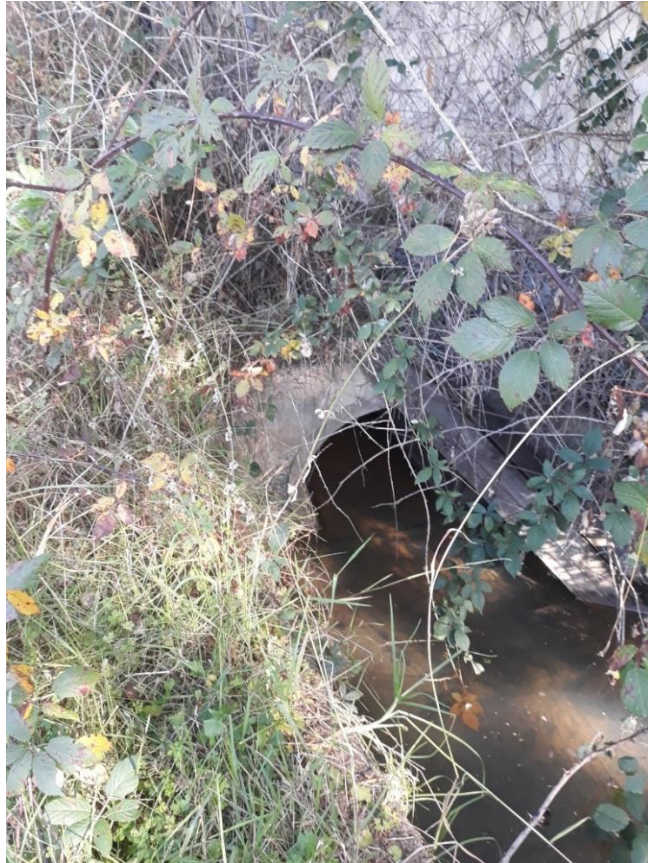
A 1st order stream is present and a 10m VRZ buffer. This watercourse runs through the northern most portion of the site existing through a culvert under the road of Lot 2 DP 734561.

Photo 3-4 – Culvert allowing waterflow underground from the neighbouring lot

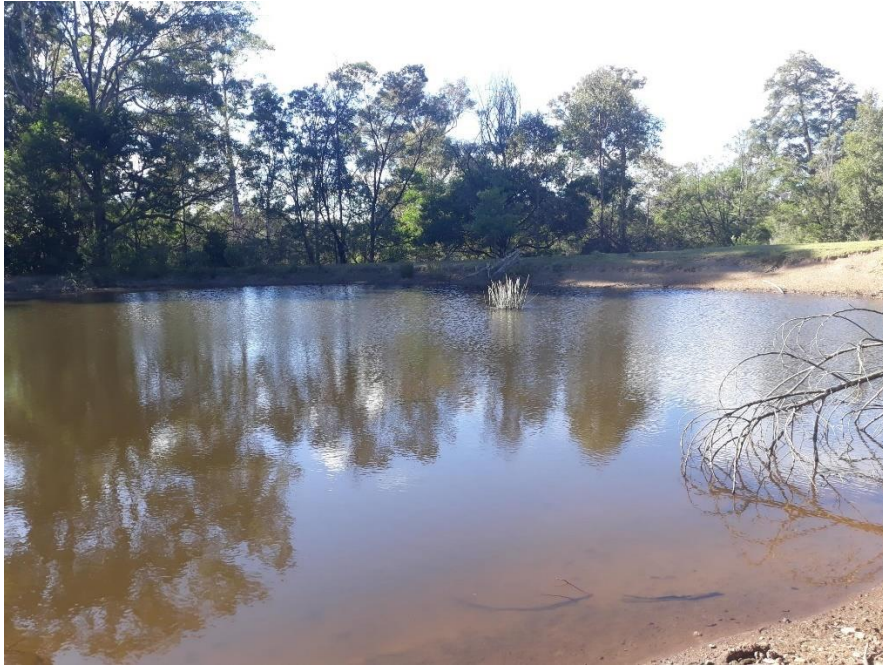
Photo 3-5 – Upper dam

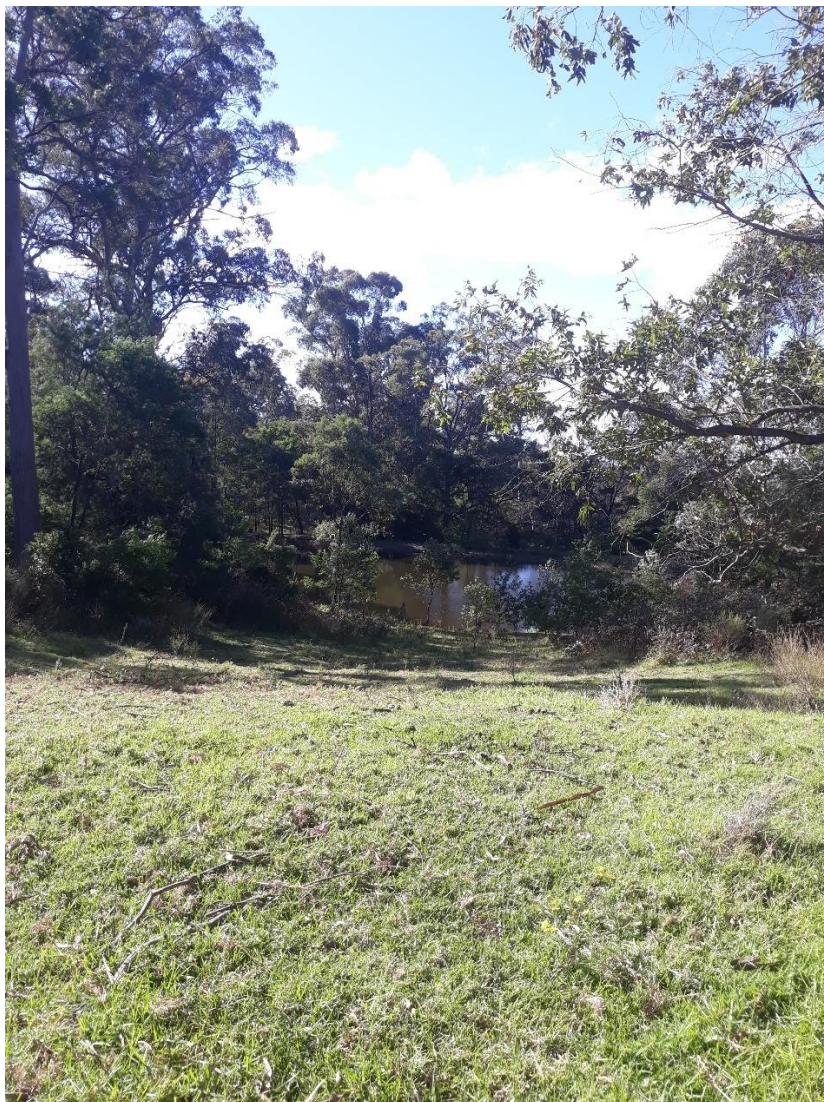
Photo 3-6 – Swale between the two dams, facing east towards the lower dam

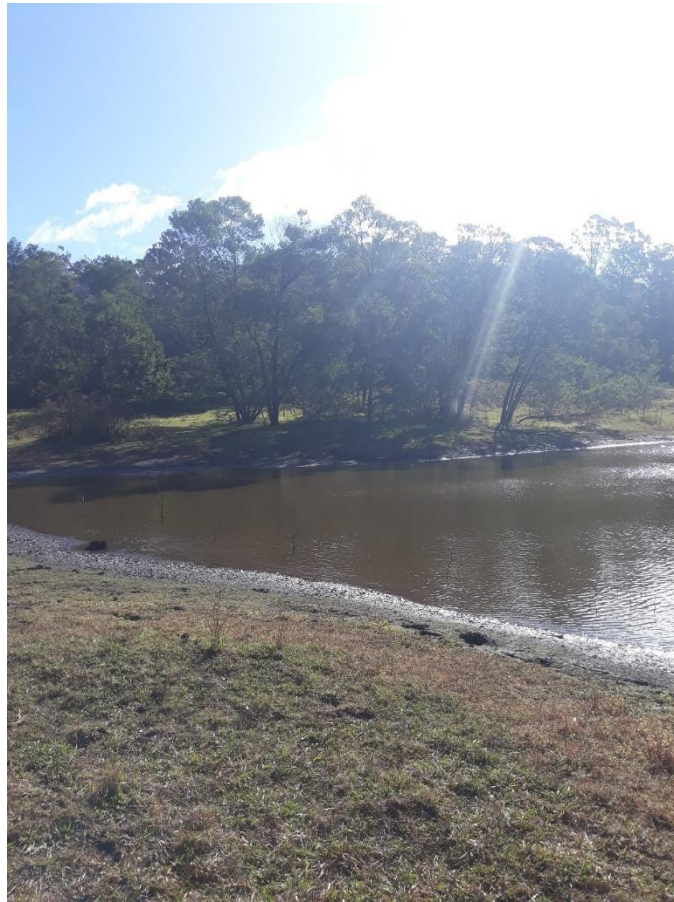
Photo 3-7 – Lower dam

- Convert first order streams to urban wetlands to provide conditioning of water from the landscape.
- Retain any existing riparian vegetation especially on the eastern most dam for ecological function.

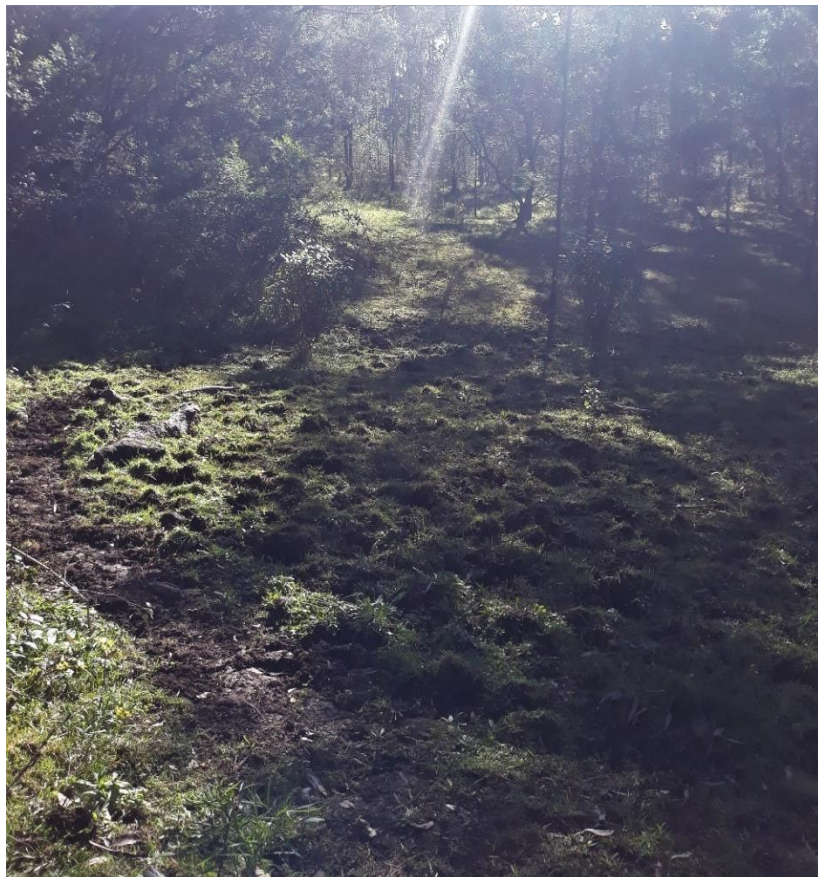
Photo 3-8 – Path of potential overflow from the top dam during periods of heavy rain/flooding
