**Preliminary Site Investigation Report  
Proposed Rural Subdivision Development  
Part Lot 3 DP 1201486 No 80 Silverdale Road  
The Oaks NSW**

**Ref: JC24471A-r1(rev)**

**March 2024**

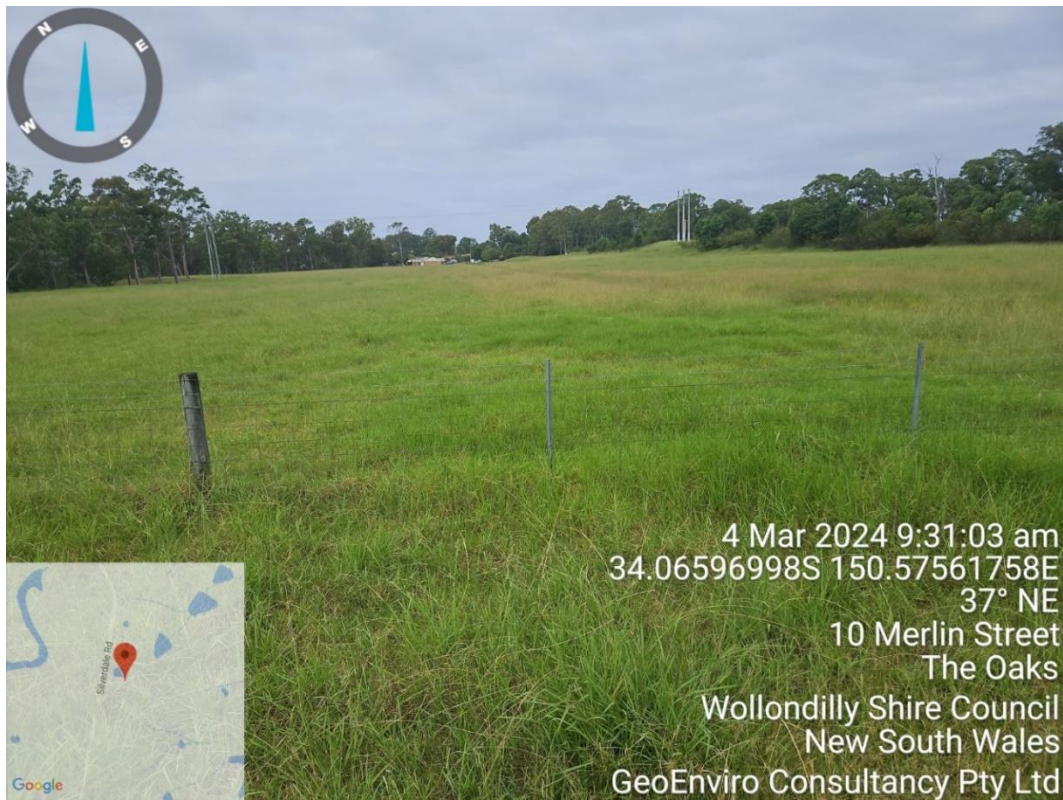
Northern end of the site facing south. Residential dwelling in the background.

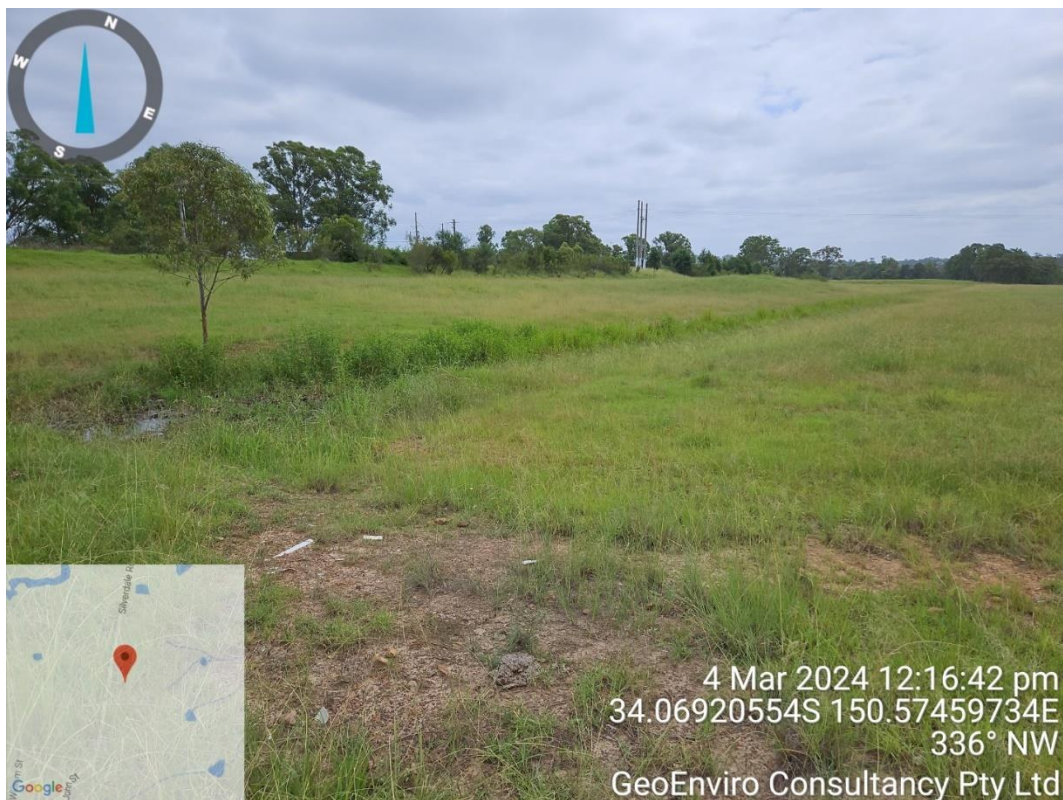
Southern end of the site facing north-west with the swale in the middle ground.
