Report prepared for: Australian Unity

ADDENDUM VISUAL IMPACT ASSESSMENT 266 LONGUEVILLE ROAD, LANE COVE

AUGUST 2018

266 Longueville Road, Lane Cove

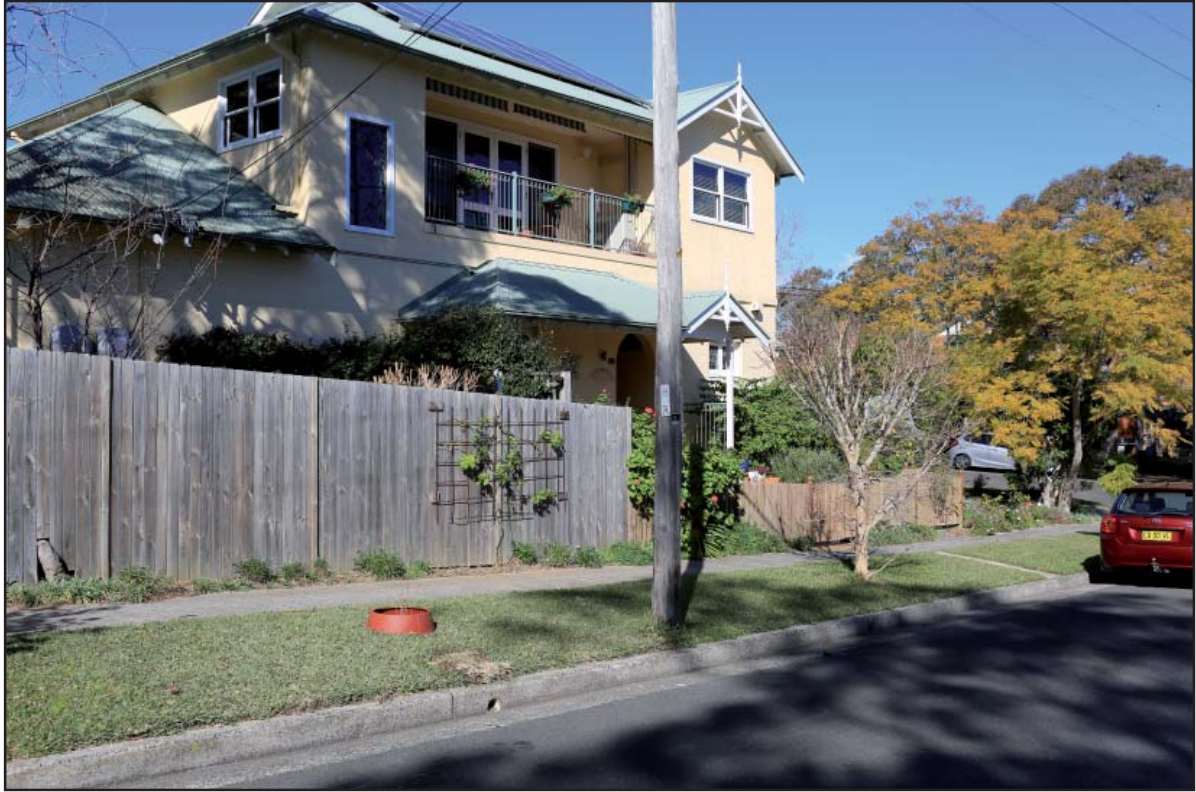
Location 5

View of 23 Third Avenue, on the intersection with Richardson Street East. The roof, gable end window and distinctive finial are visible from Longueville Road near the north-east boundary of the Site, over the rear of houses in Richardson Street West. The house is not visible from the Site.

One distinctive house, that has a high pitched light green roof, with photovoltaic cells on it and a window in the first-floor gable end, is visible from northern part of the informal carpark adjacent to the Site, in the view east toward the general vicinity of the ridge. This house is at 23 Third Avenue at the intersection with Richardson Street East. It is visible because of the absence of vegetation in the view line over the houses in Richardson Street West. The house is not visible from the Site, as between it and the Site, there is tall and dense vegetation between the house and the Site, in the Golf Course. This observation is confirmed in views from the street in the vicinity of the house, where vegetation that is as tall or taller than the house is evident in the direction of the Site.

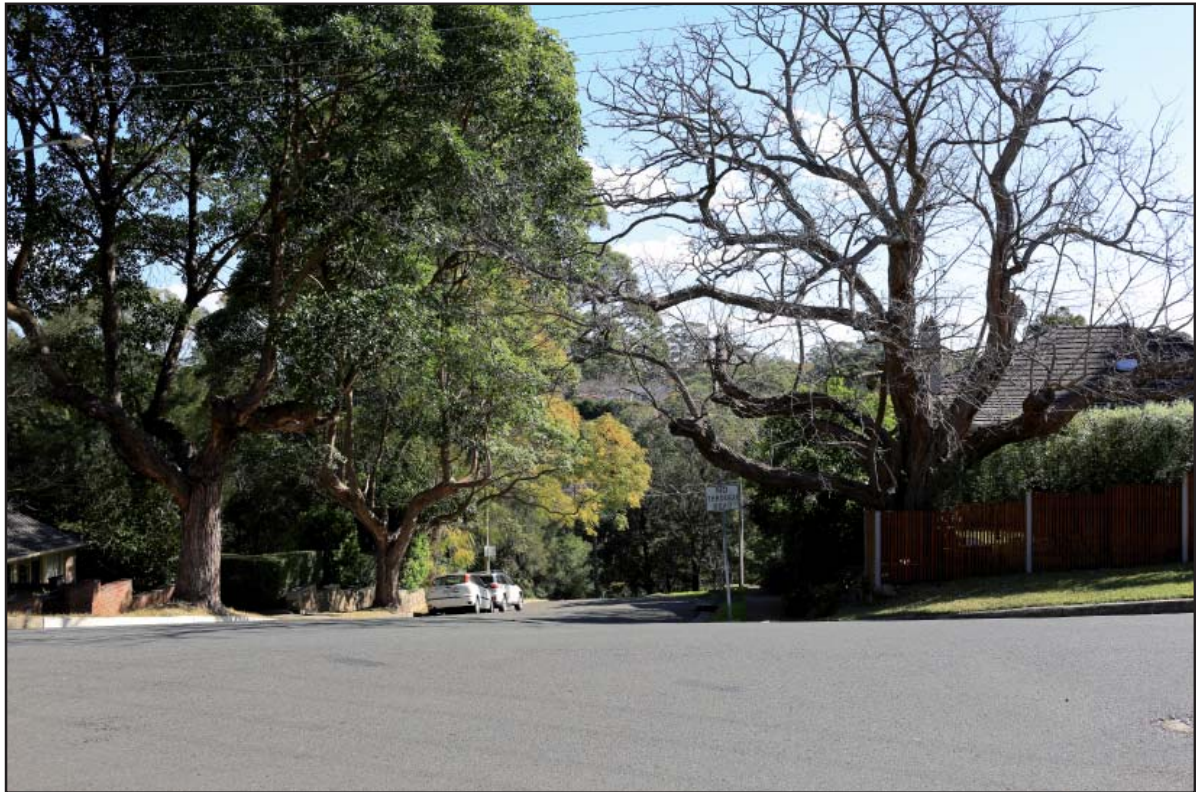
Location 6

View west down Richardson Street East from adjacent to 23 Third Avenue. The Site is to the left in the view and screened by vegetation.

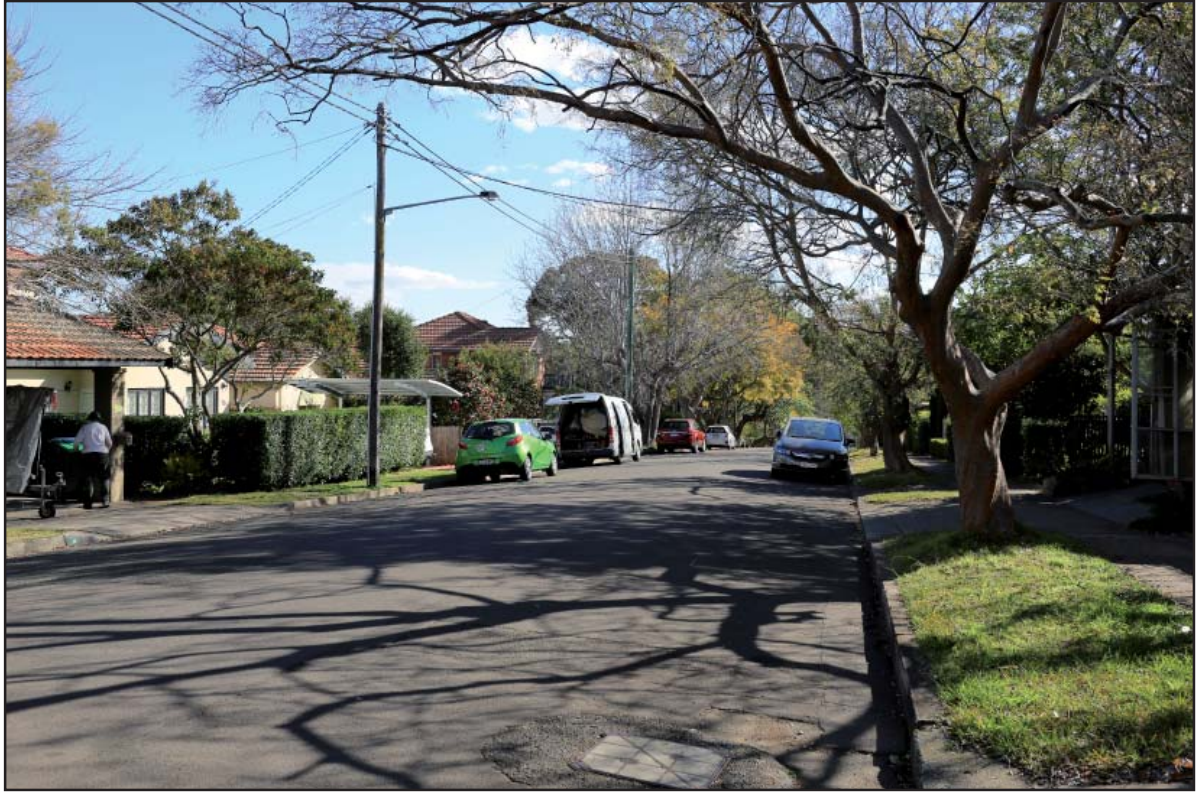
Location 7

View south-west in the general direction of the Site from Richardson Street West at the intersection with Osborne Place.

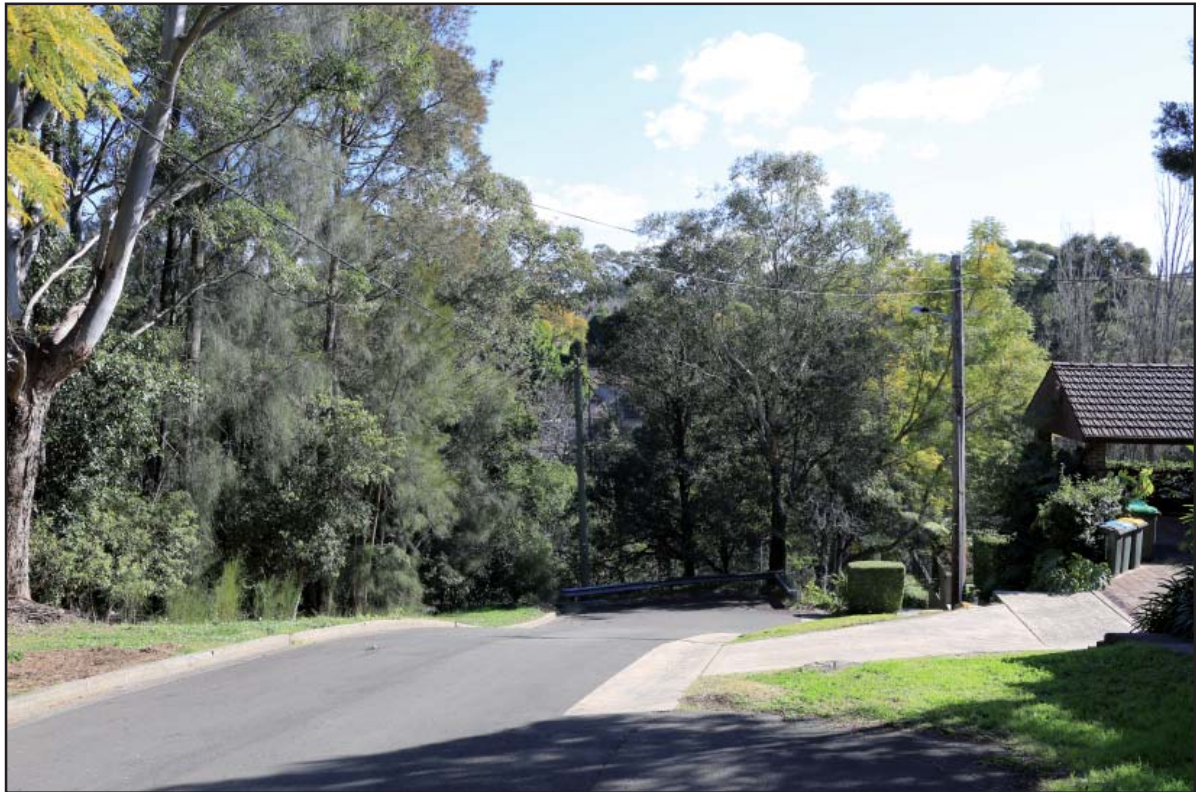
Location 8

View west near the terminus of Richardson Street West. Roofs in Richardson Street East on the south side of the street are partly visible through screening vegetation. The Site is to the left in the view and not visible.

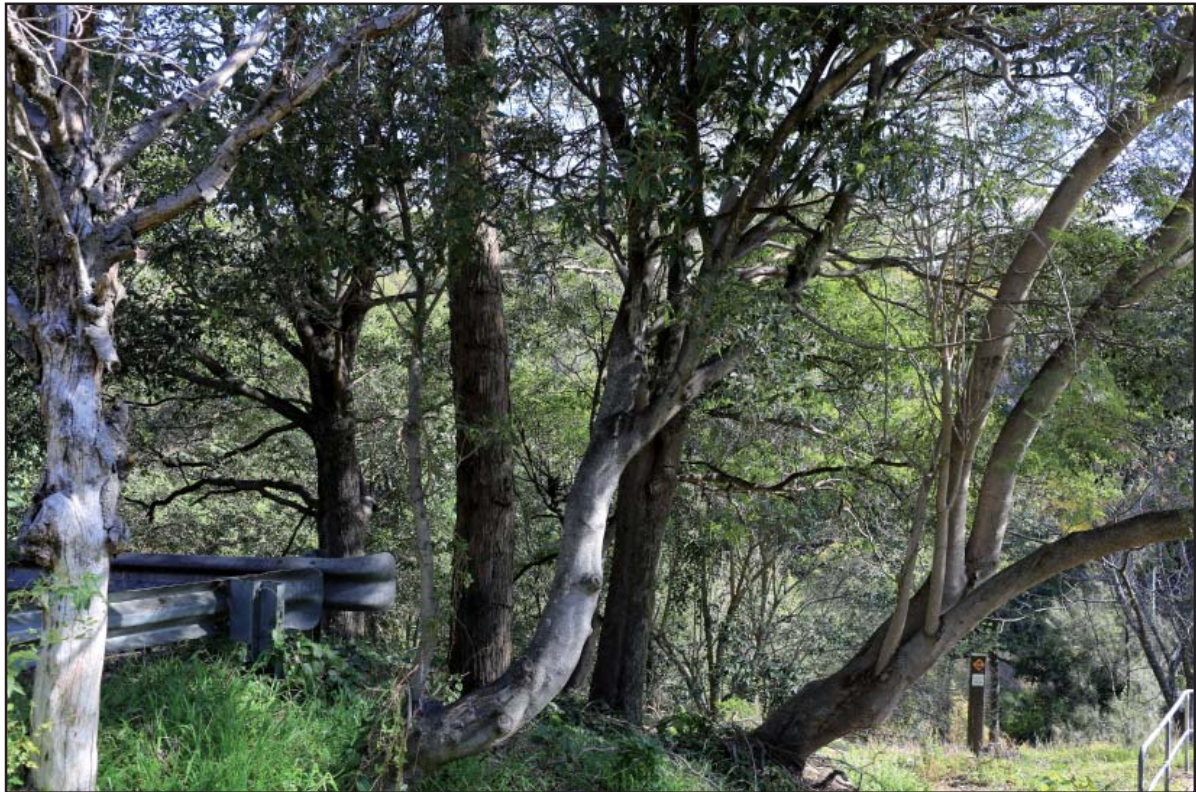
Location 10

View toward the Site from the terminus of Richardson Street East where two access tracks into the Lane Cove Golf Course diverge. The Site is not visible.

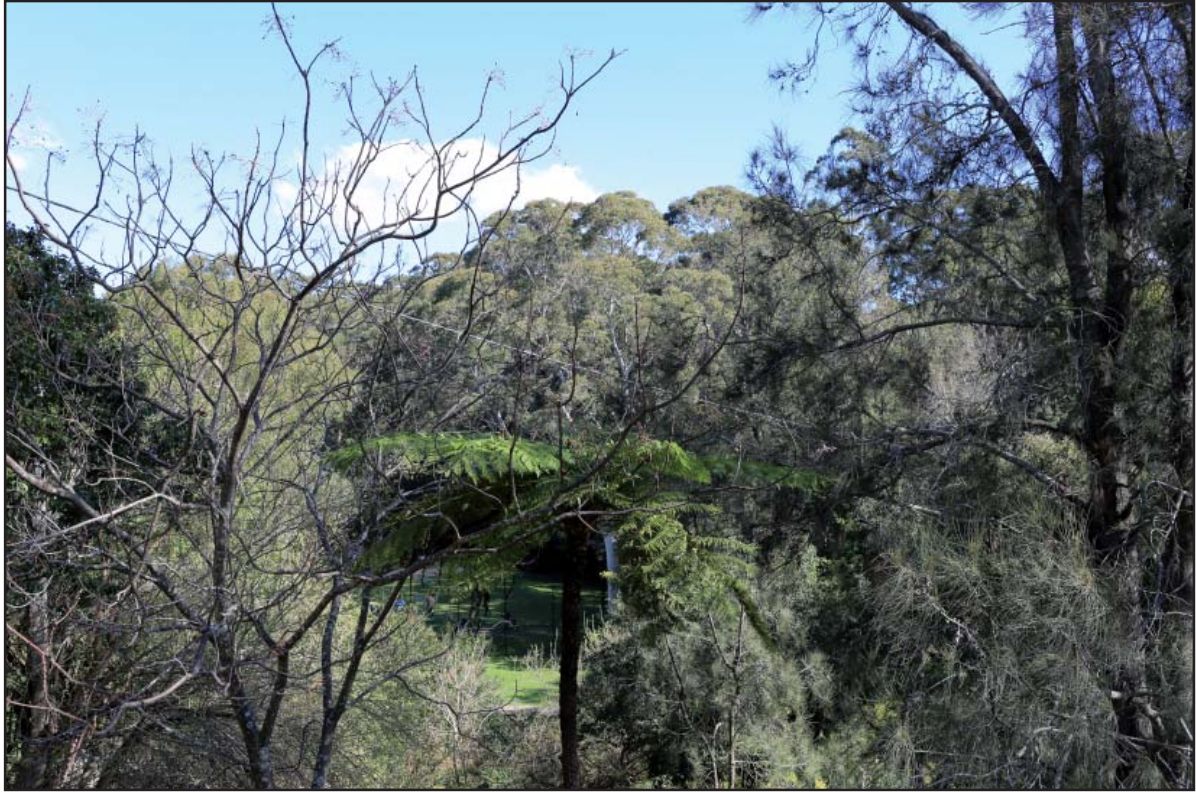
View toward the Site from a set of stairs at the end of Richardson Street East. Neither the Site nor the adjacent buildings to its south are visible, because of the screening effect of vegetation.

View of 28 Richardson Street East from the Golf Course. Based on observations from the street at similar levels to the entry and ground floor of the house, it appears unlikely that it could have a view of the Site, as both vegetation in its foreground and the vegetation shown in the view from Location 11 above would intervene

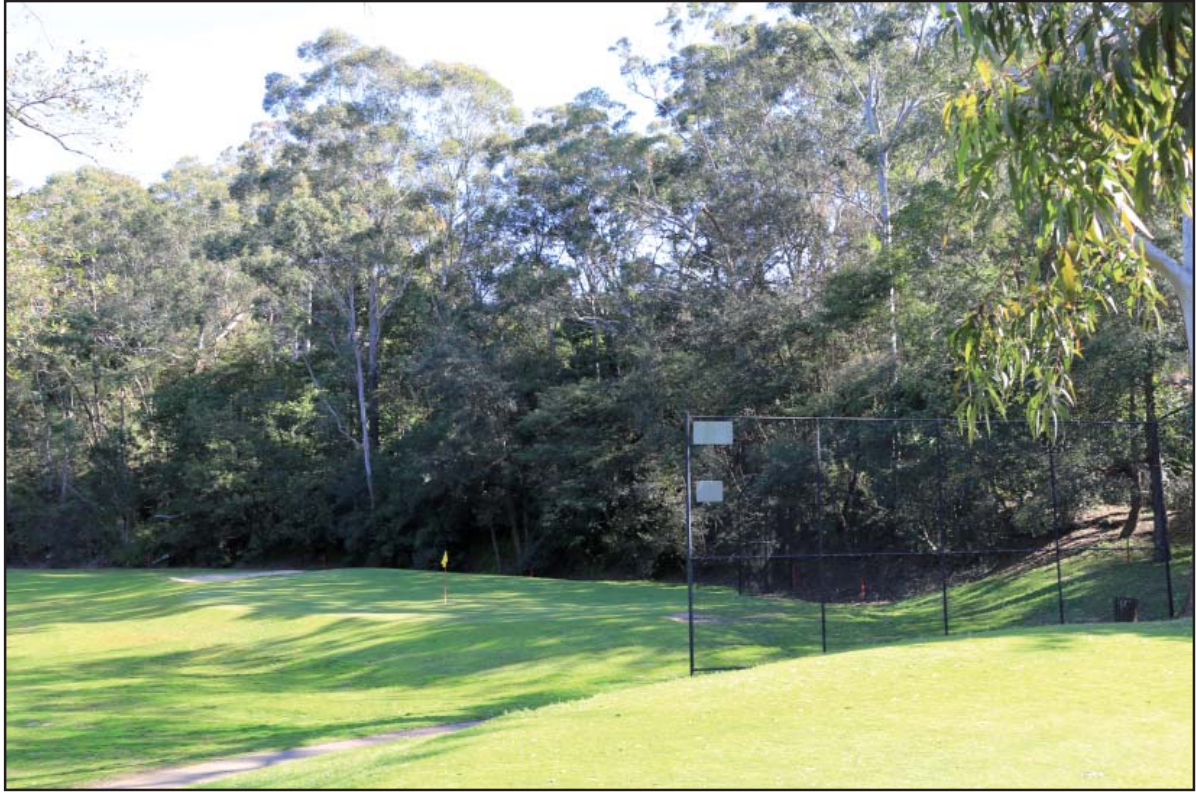
Location 13

View toward the Site and adjacent building at Timbertops from the Golf Course west of the terminus of Richardson Street East.

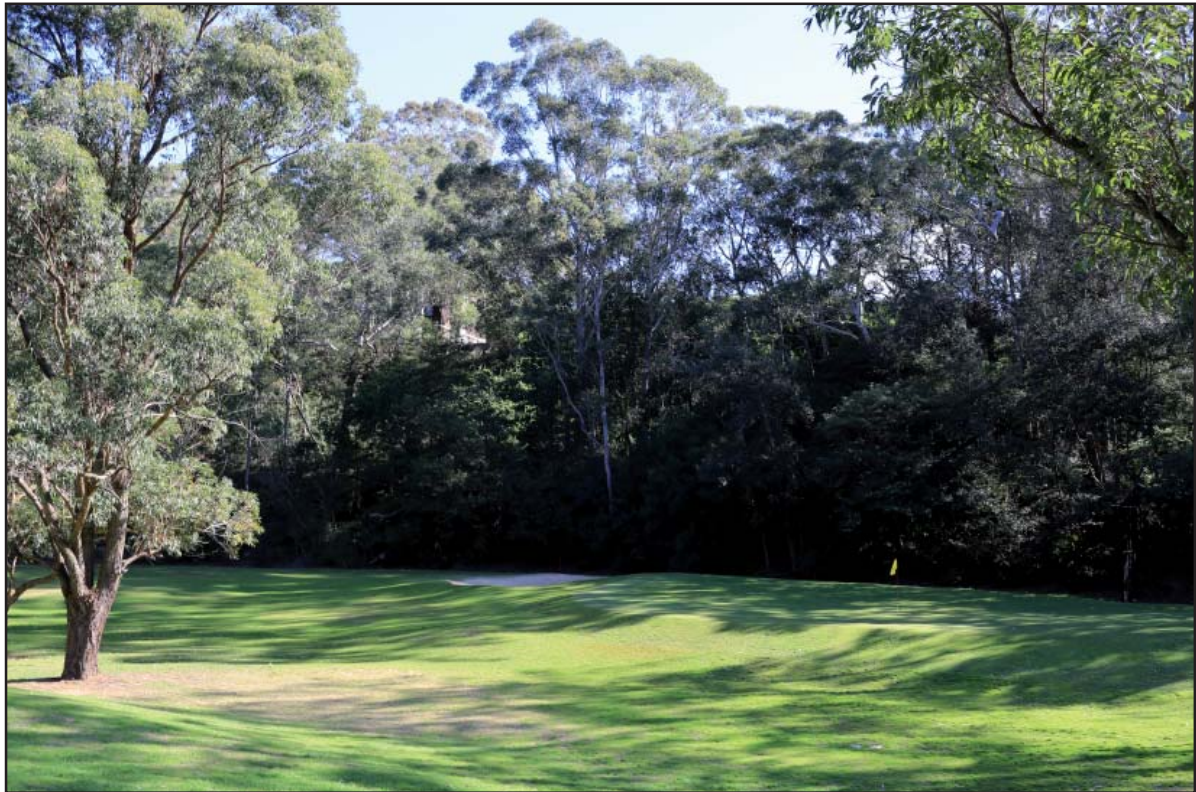
Location 14

View toward the Site from the 7/16th Hole fairway. A part of the adjacent building at Timbertops is barely visible through screening vegetation on the left side of the view. Part of the upper section of the proposed building may be visible through heavy vegetation screening and would be significantly lower than the canopy

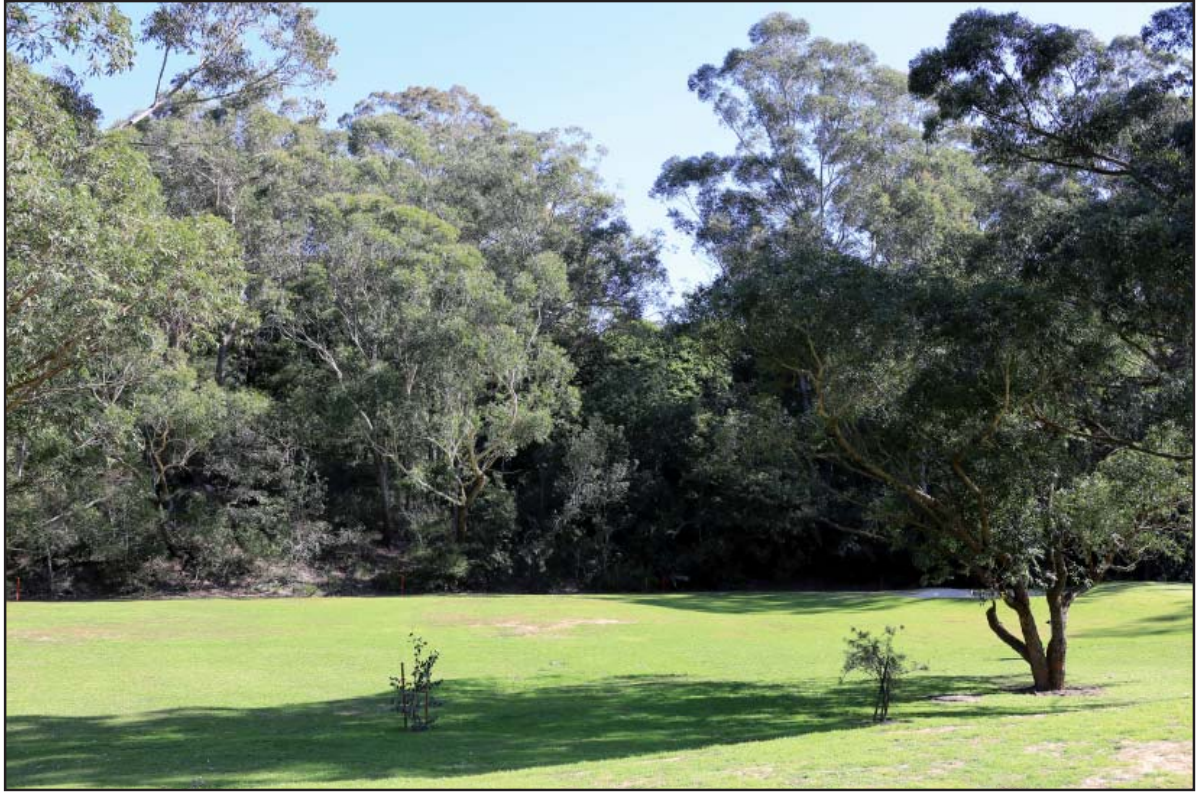
Location 15

Photomontage view location. Part of the building would be visible in the window of view between trees in the centre of the view, with a height significantly lower than the adjacent canopy.

2.3.1 Analysis of photomontage (location 15 on Map 1)

The photomontage shows that a small part of the proposed building would be visible in the window of view. Some of the lower parts of the building would also be likely to be partly visible through the vegetation after clearing of existing weed vegetation and reduction in the site level, although it would be significantly screened. The topmost part of the building at Level 7 would not be visible, because of the steep upward viewing angle, in which the leading edge of the roof, which is essentially the same height as Timbertops, would block the view.

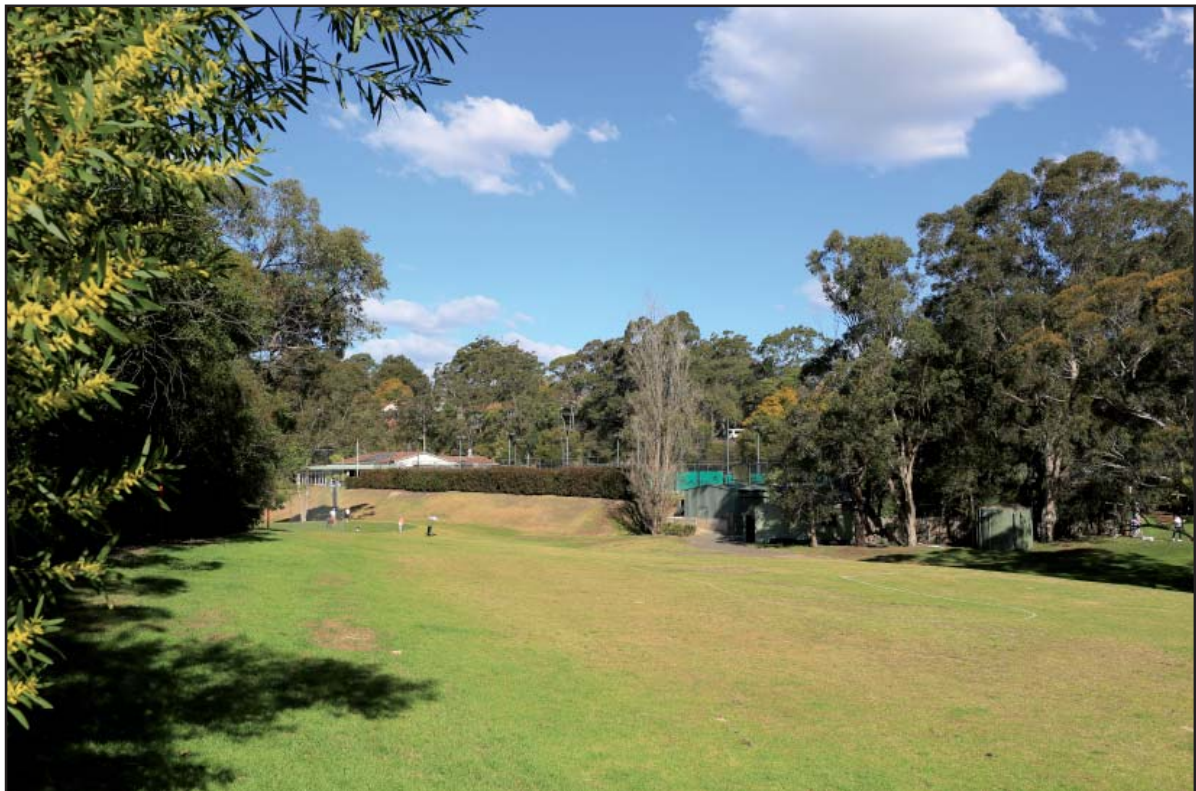
Location 16

View south from part of the 7/16th Fairway toward the clubhouse and residential development in Northwood.

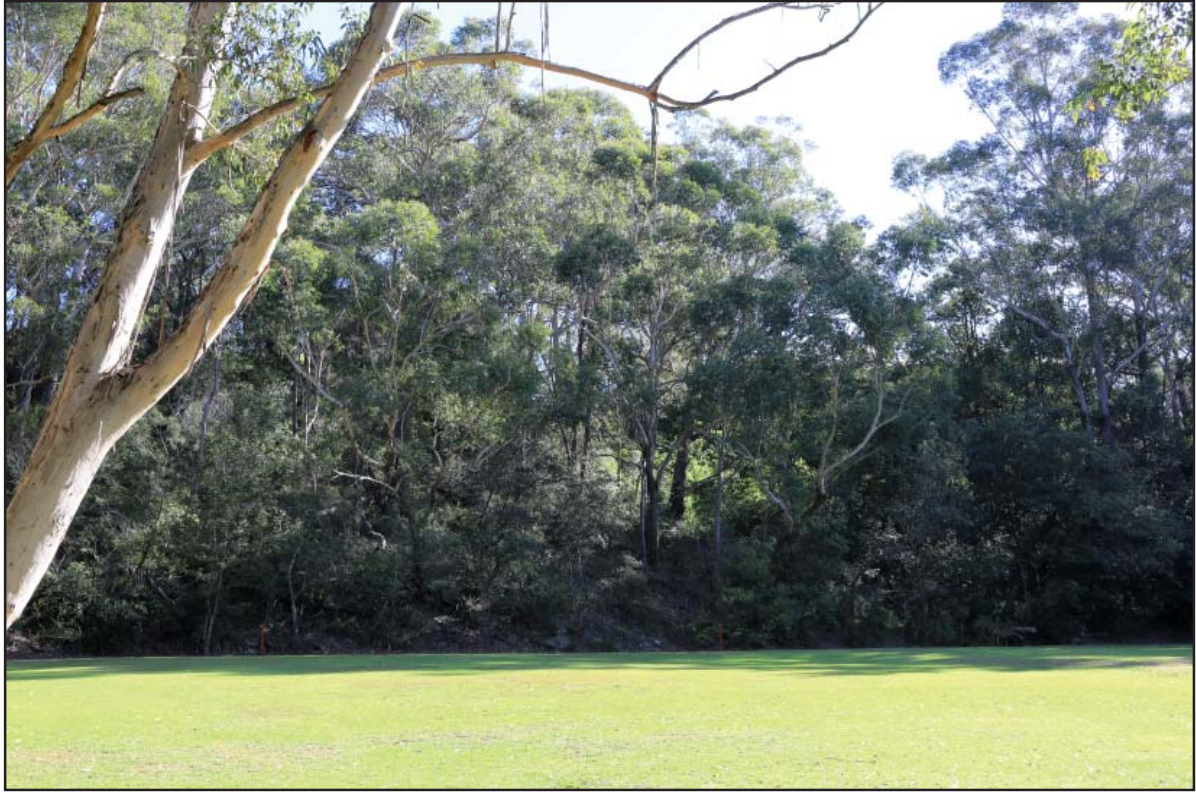
Location 17

View from between fairways toward Timbertops (not visible on the left side of the view) and the Site.

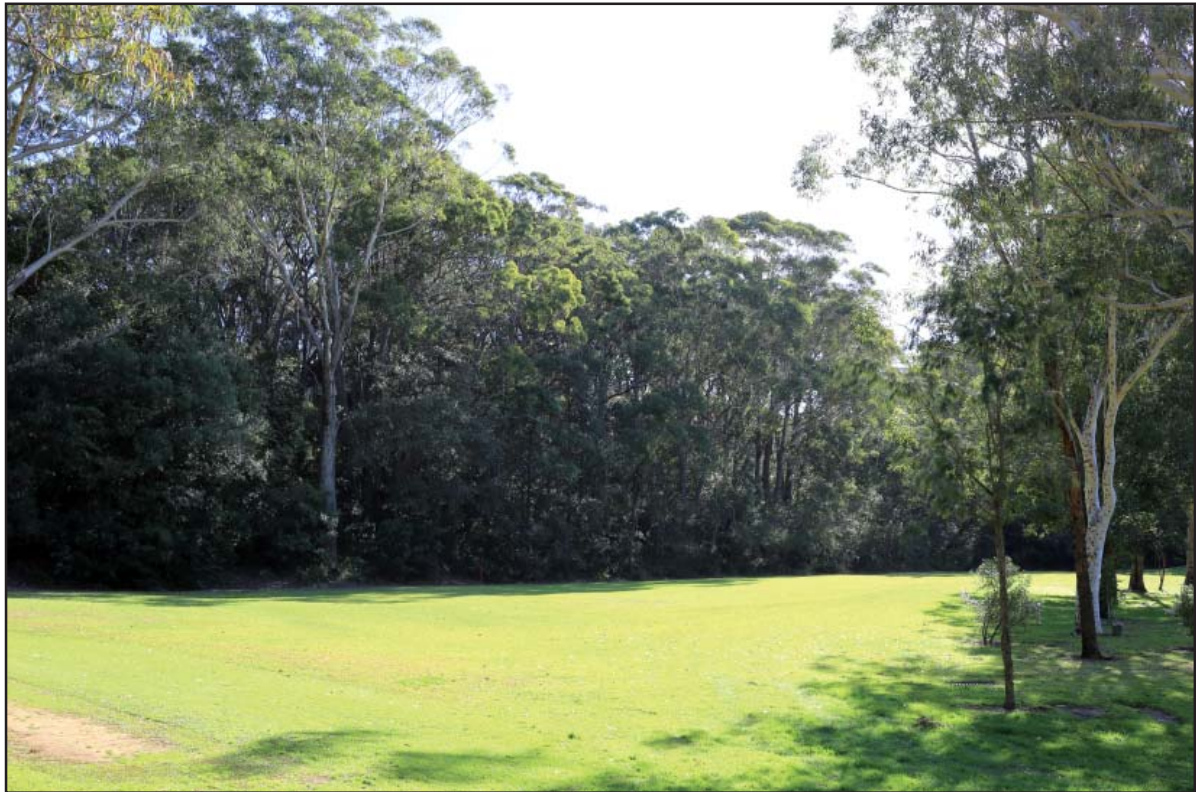
Location 18

View toward the Site from near the practice tees of the closest fairway to the Site. Timbertops would be in the approximate centre of the view if visible, with the site at centre-right.

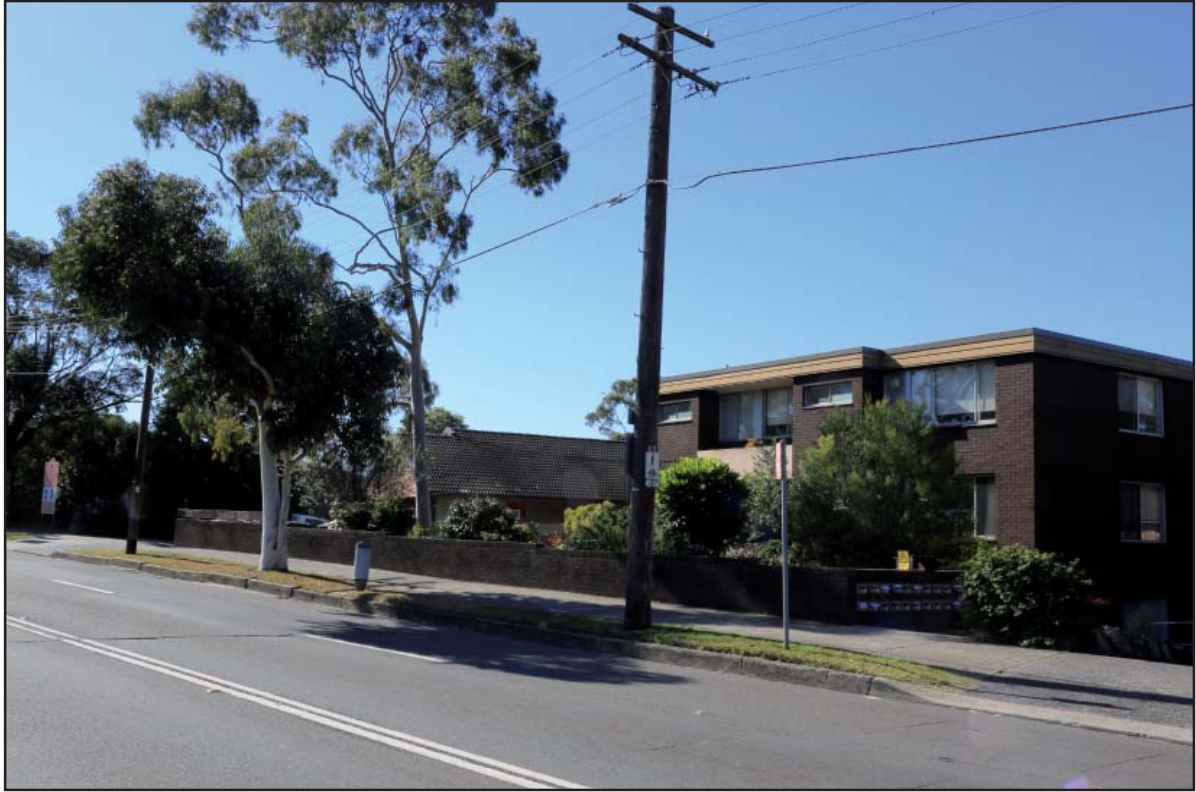
Location 19

Photomontage view location. Intersection of Longueville Road, River Road West, Northwood Road and Kenneth Street.

2.4.1 Analysis of photomontage (location 19 on Map 1)

The photomontage shows that a small part of the upper level of the proposal at Level 7 would be visible to the north of plant and lift overrun structure on the roof of Level 6. The bulk of the upper level at Level 7 is of minimal visibility and would make no significant impact on the streetscape.
