Tolucy Pty Ltd  
C/- Calder Flower Architects

# Detailed Site Investigation: Proposed Seniors Living, 58 Laitoki Road, Terrey Hills, NSW.

P1504710JR05V01  
October 2018

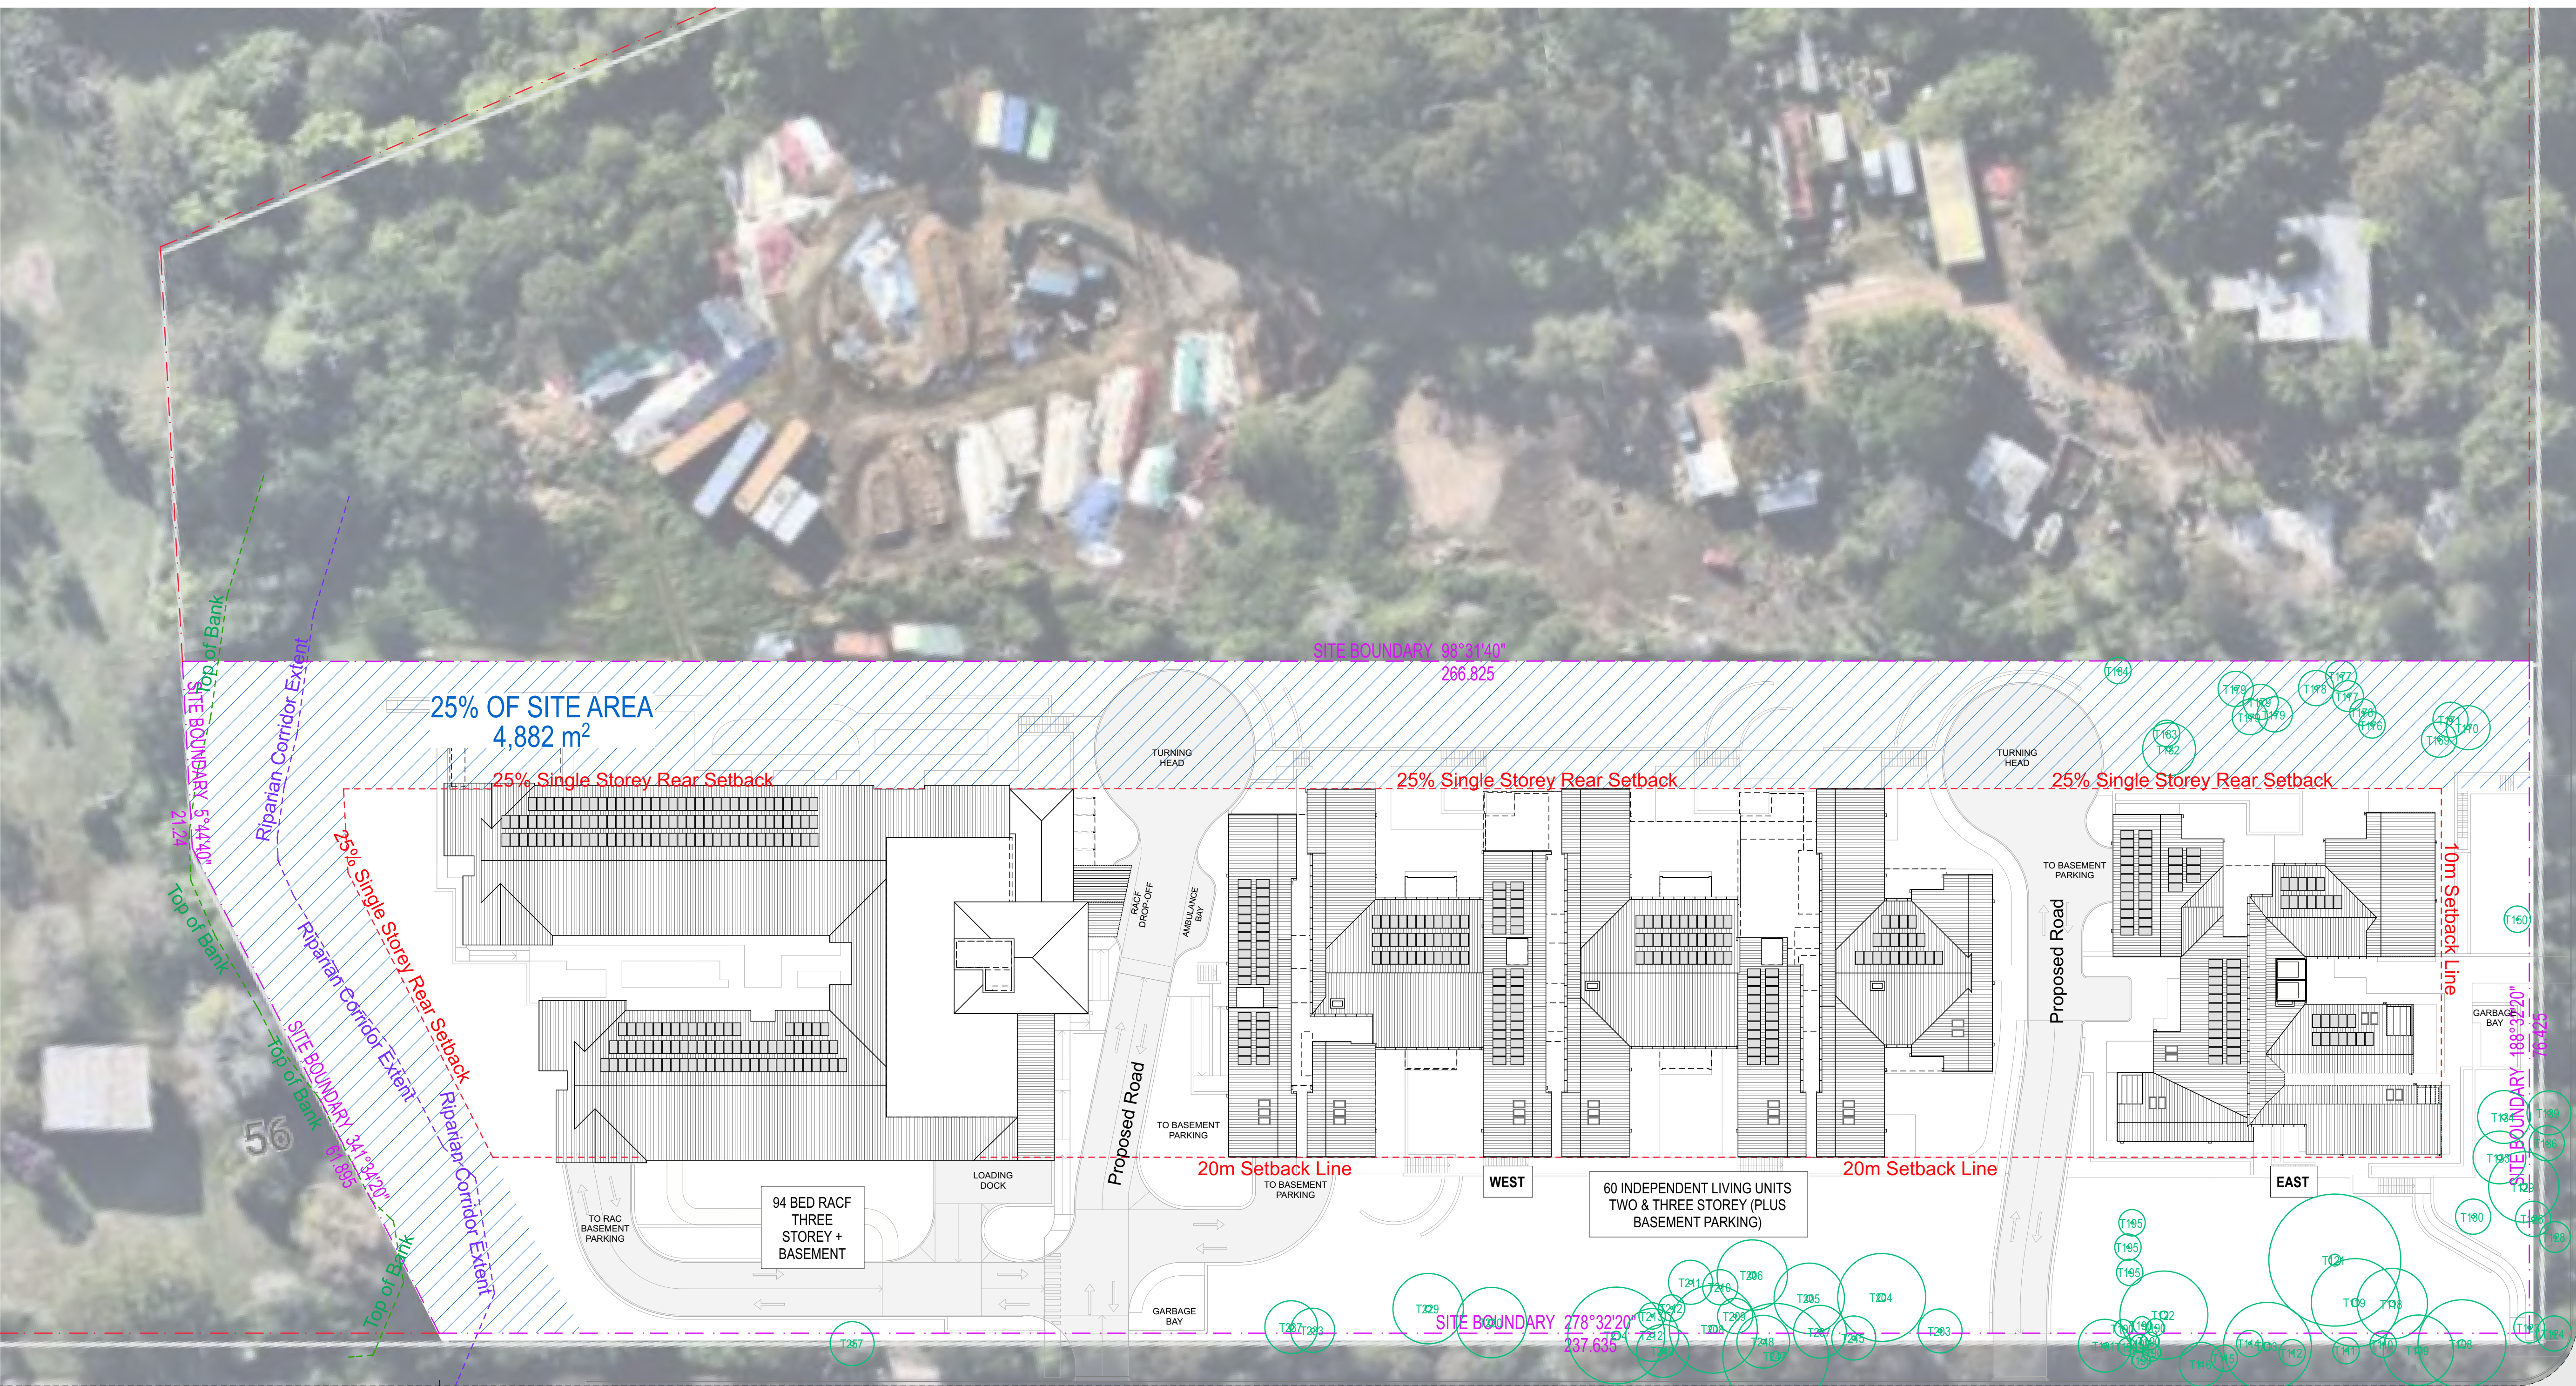
1 SITE PLAN  
1:400

The proposed layout is provided in Attachment A.

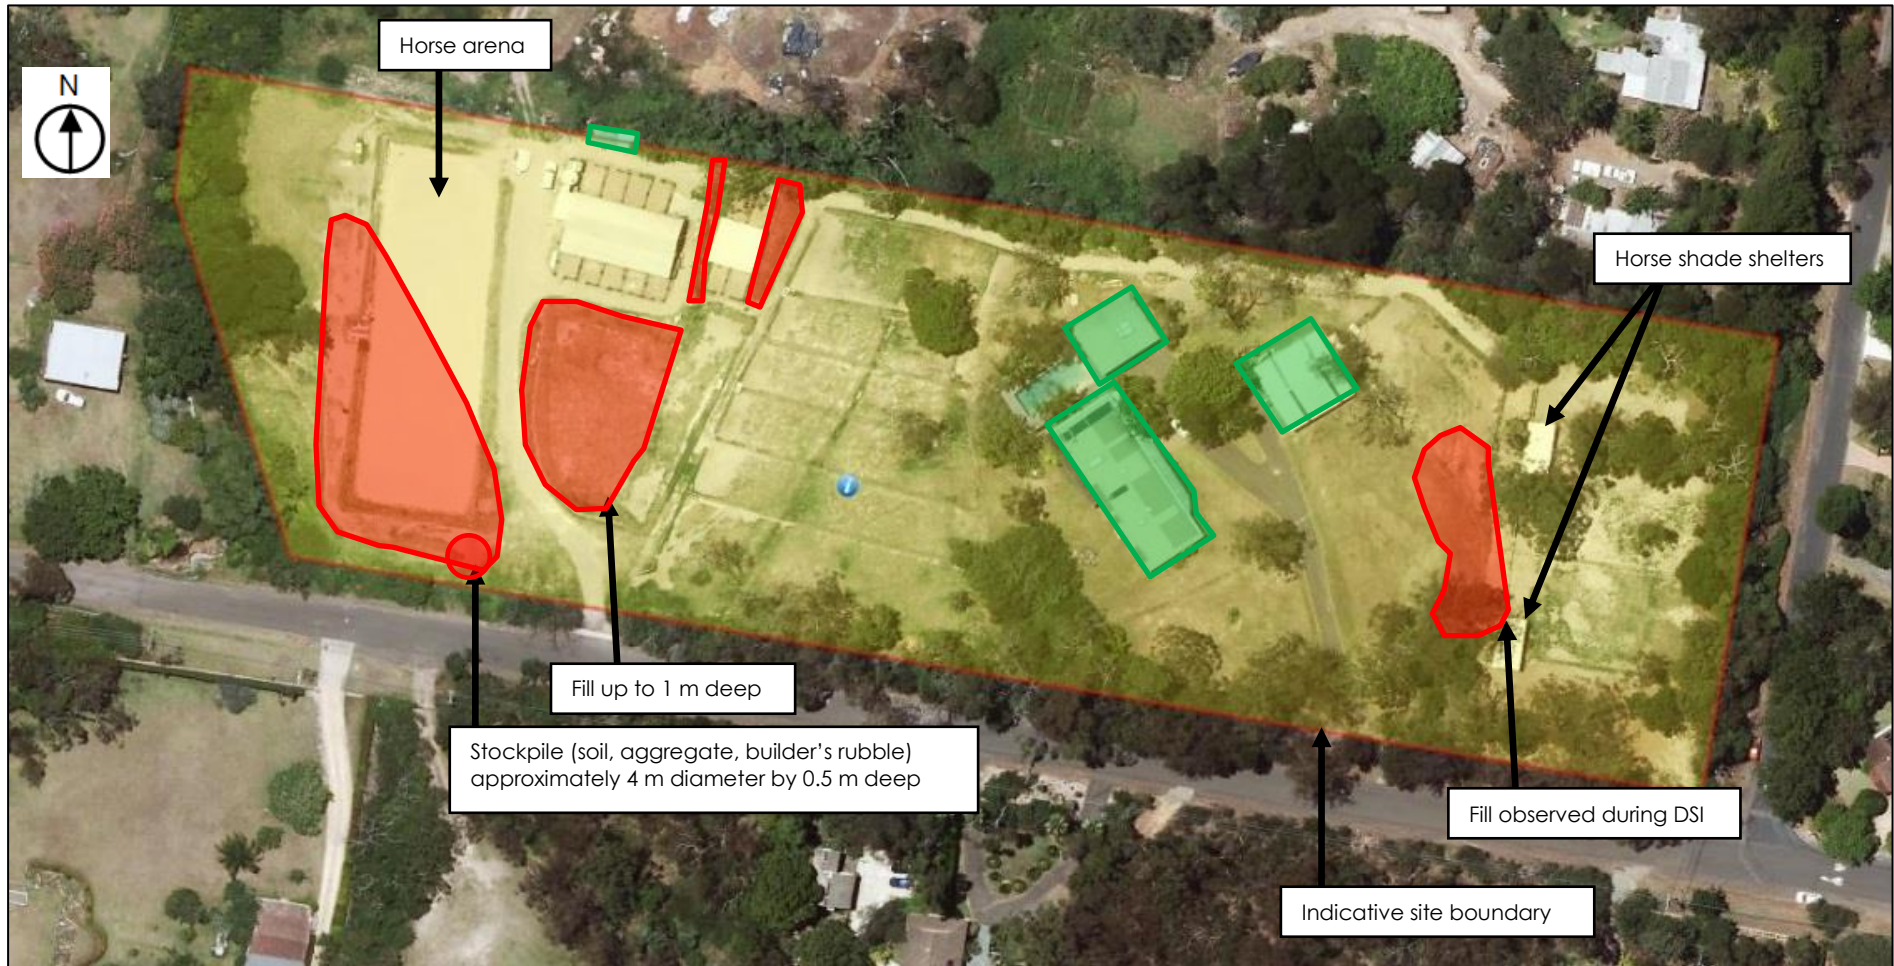
## 12 Attachment B – AEC Plan

| AEC <sup>1</sup> | Potential for Contamination | COPC |
|---|---|---|
| A – Dwelling and existing/former sheds | Pesticides and heavy metals may have been used underneath dwellings for pest control. Dwelling construction may include ACM and/or lead based paints.<br><br>Existing/former sheds may have stored fuel, oils, pesticides and/or been treated with heavy metals and pesticides (pest control). Shed construction may have include ACM and/or lead based paints. | HM, TRH, BTEXN, PAH, OCP/OPP, asbestos |
| B – Filled areas <sup>2</sup> | Fill, of unknown origin, observed to contain anthropogenic material such as brick and tile. Material may contain contaminants such as ACM, hydrocarbons or pesticides. | HM, TRH, BTEXN, PAH, OCP/OPP, asbestos |

<sup>1</sup> Locations identified on AEC map in Attachment B.

<sup>2</sup> An additional area of localised filling was observed in the eastern portion of the site during DSI investigations, as shown in the AEC map in Attachment B.
